**Beaverlodge: Year 31 Transition Phase Monitoring Annual Report (2016)**

## Beaverlodge Project 2016 Annual Report Year 31 Transition Phase Monitoring

**March 2017**

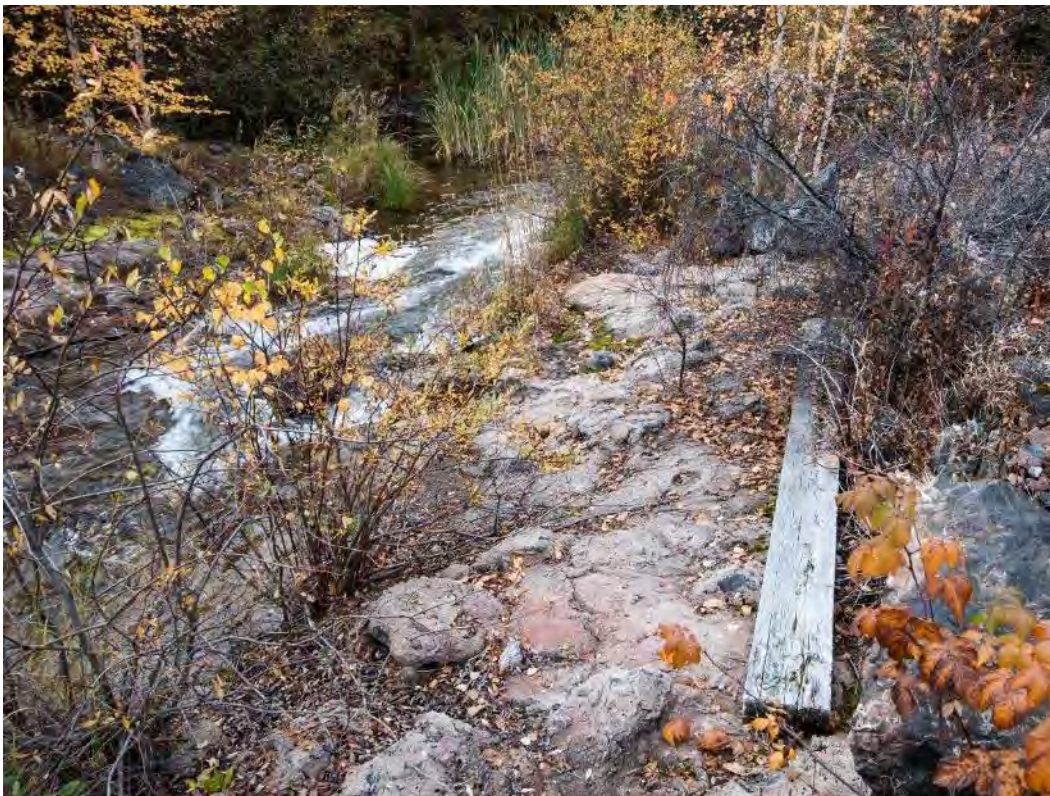
**Photo A6 – North bank, showing better condition of the grout intruded rip rap in the middle of the spillway**

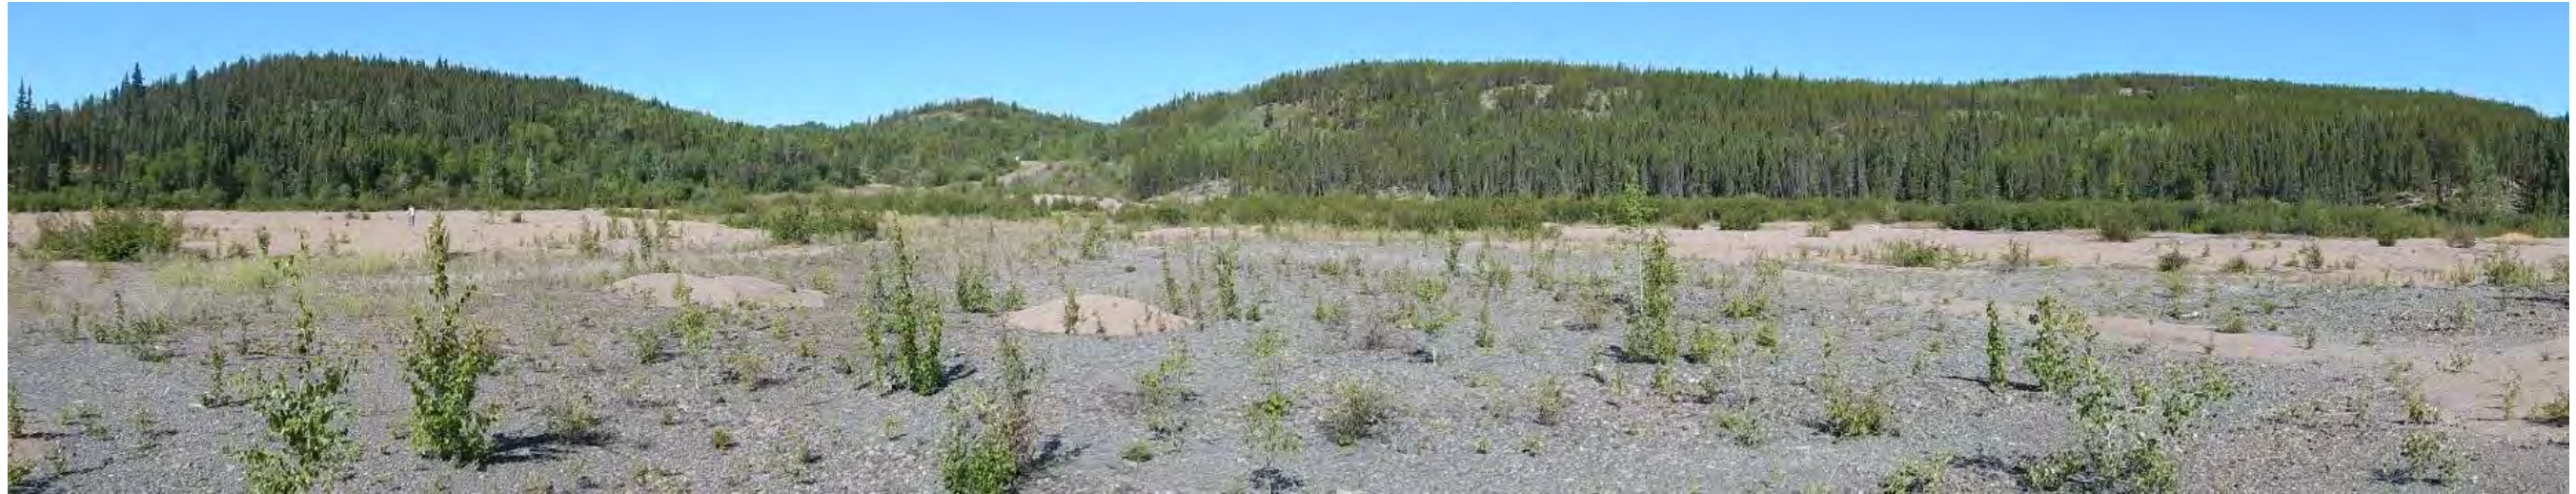
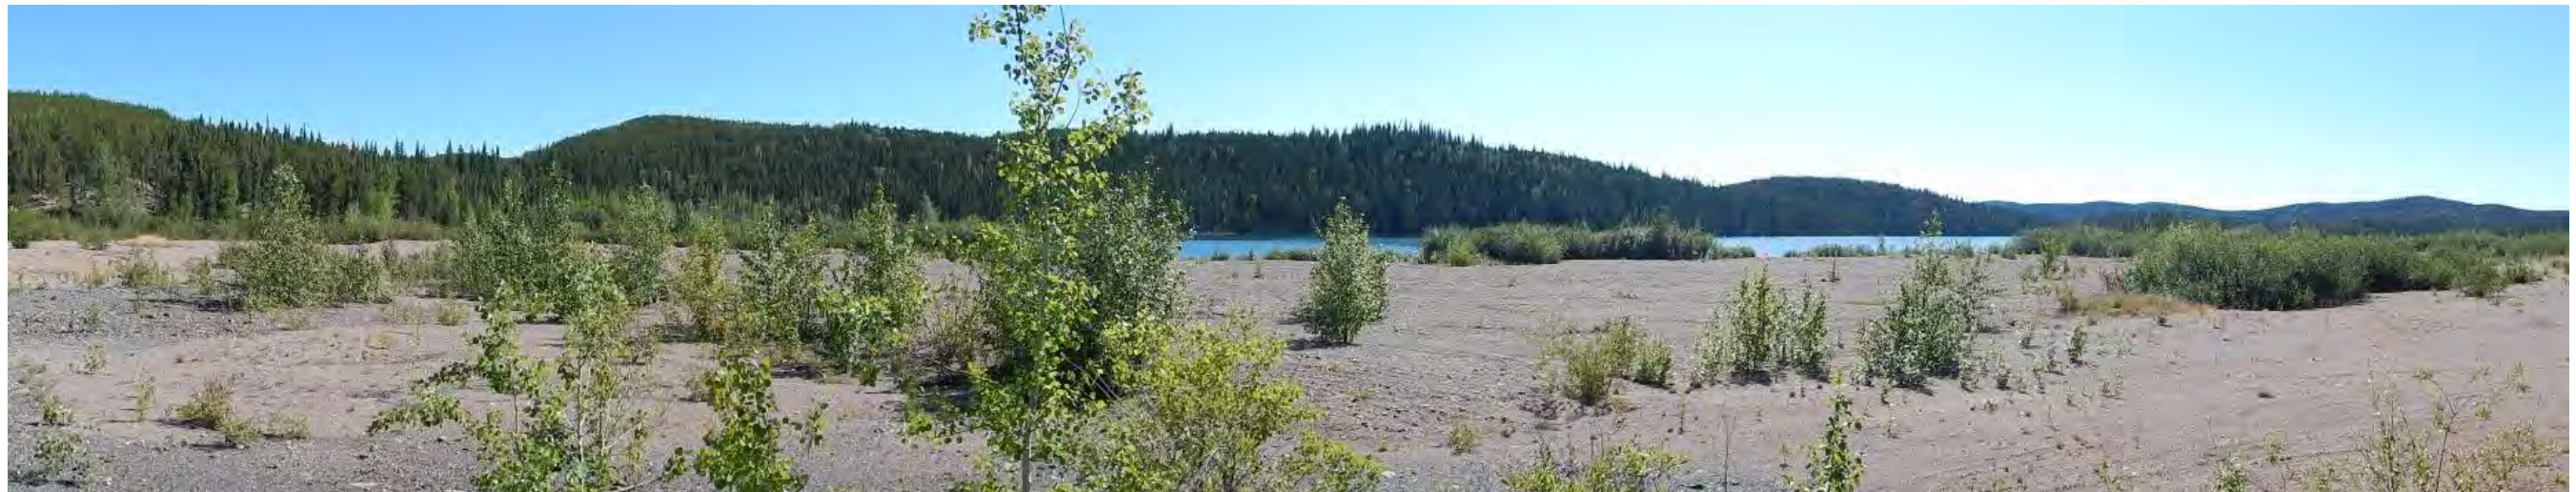
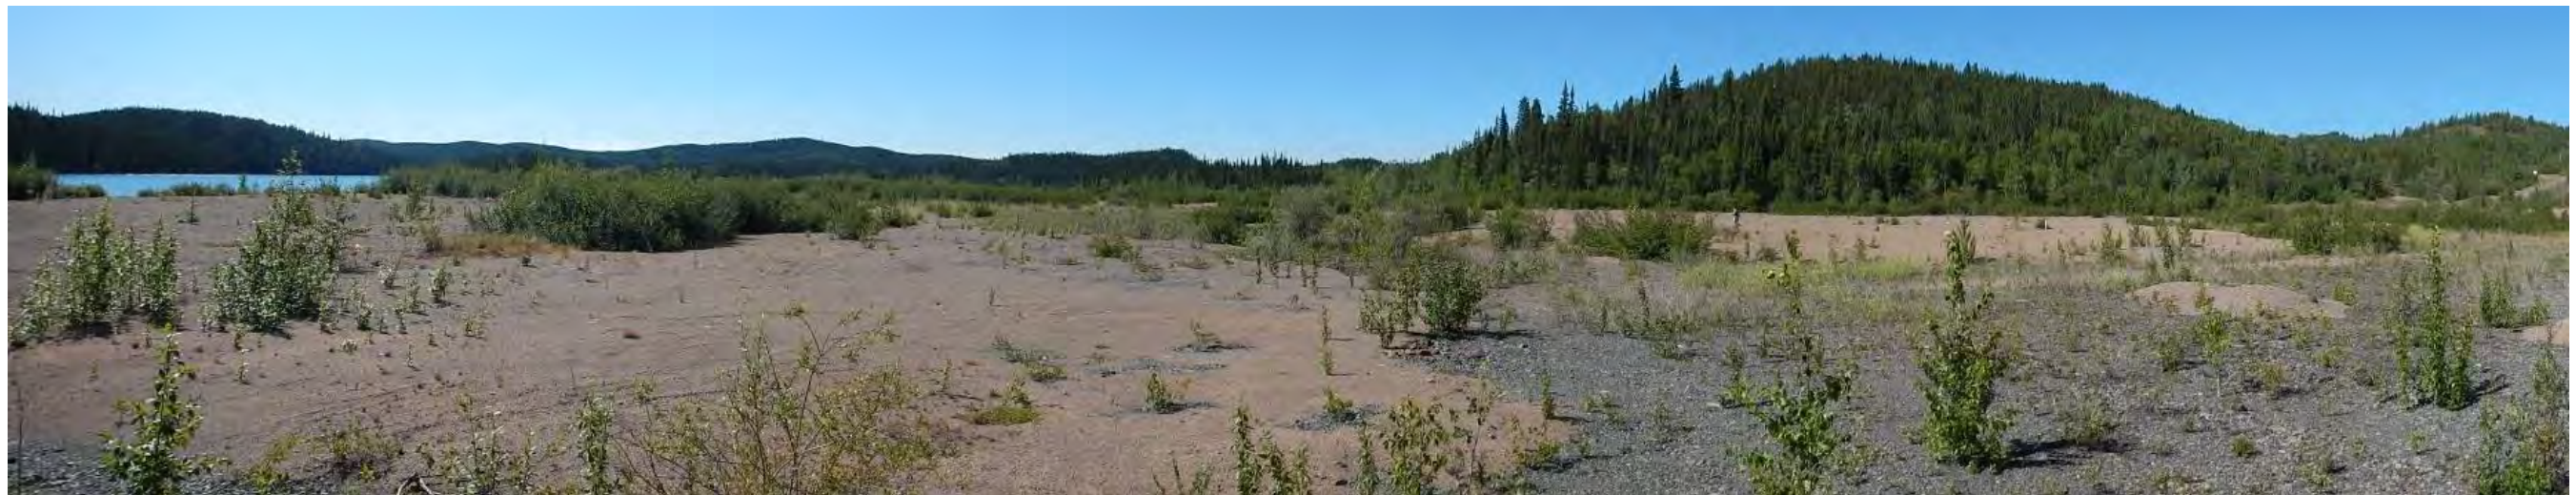
**Photo C5a-c – Panoramic views of the Fookes cover with vegetation establishing**

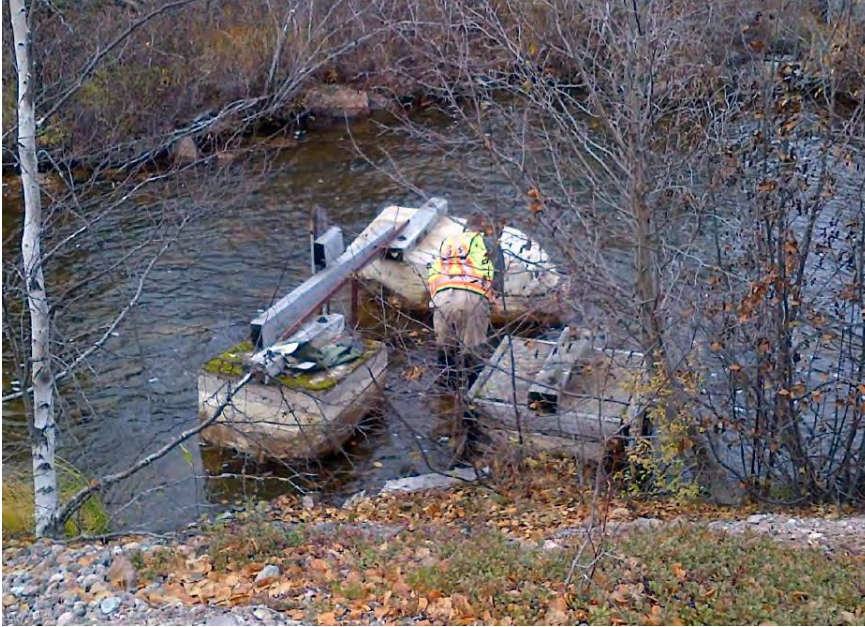
Figure 1. Piles as seen in low water, fall 2015.

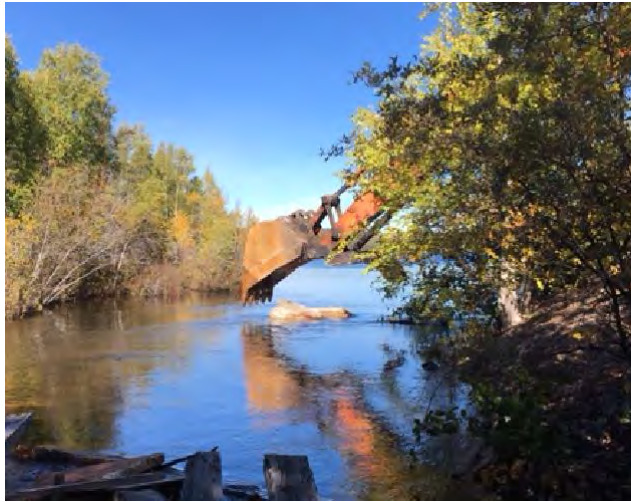
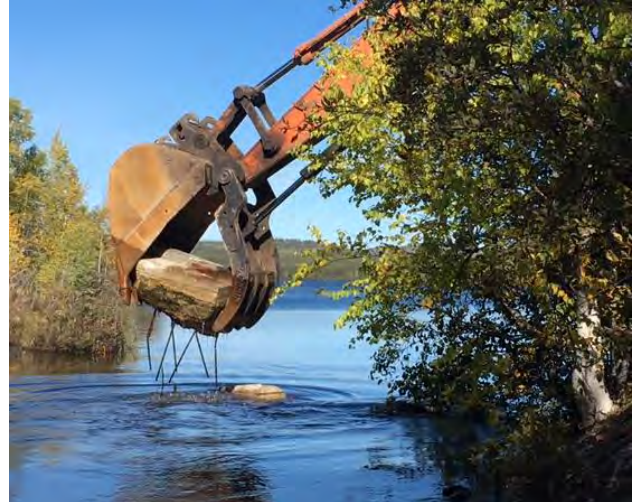
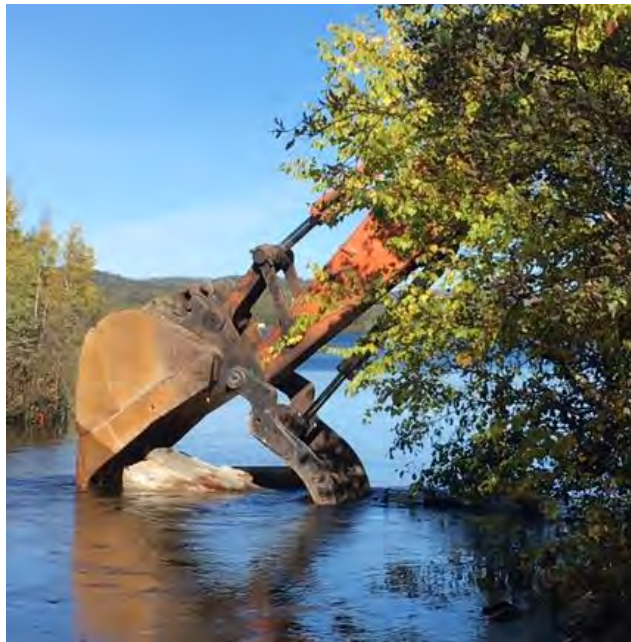
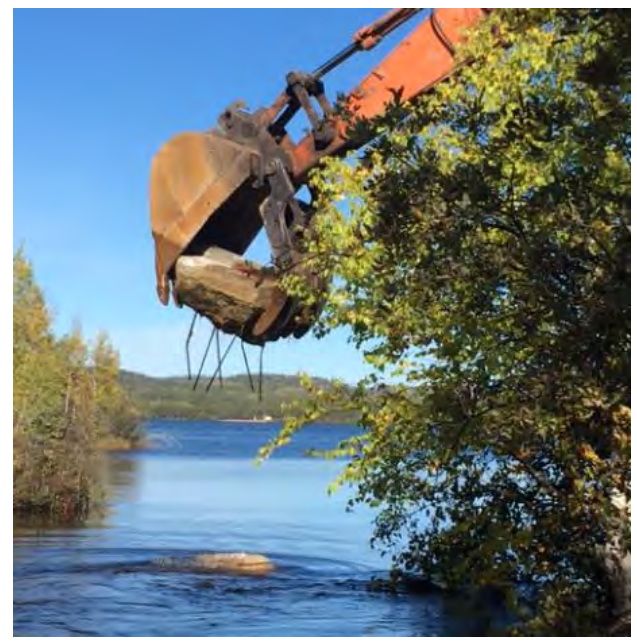
Figure 2. Sequential photos of a pile being removed from Ace Creek. Machine does not enter the water. (OEC September 12, 2016)
