**Beaverlodge: Year 33 Transition Phase Monitoring Annual Report (2018)**

## **Beaverlodge Project 2018 Annual Report Year 33 Transition Phase Monitoring**

**Prepared for:**  
Canadian Nuclear Safety Commission  
Compliance Report for Licence: WFOL-W5-2120.0/2023 &  
Saskatchewan Ministry of Environment  
Compliance Report: Beaverlodge Surface Lease

**Prepared and Submitted by:**  
Cameco Corporation

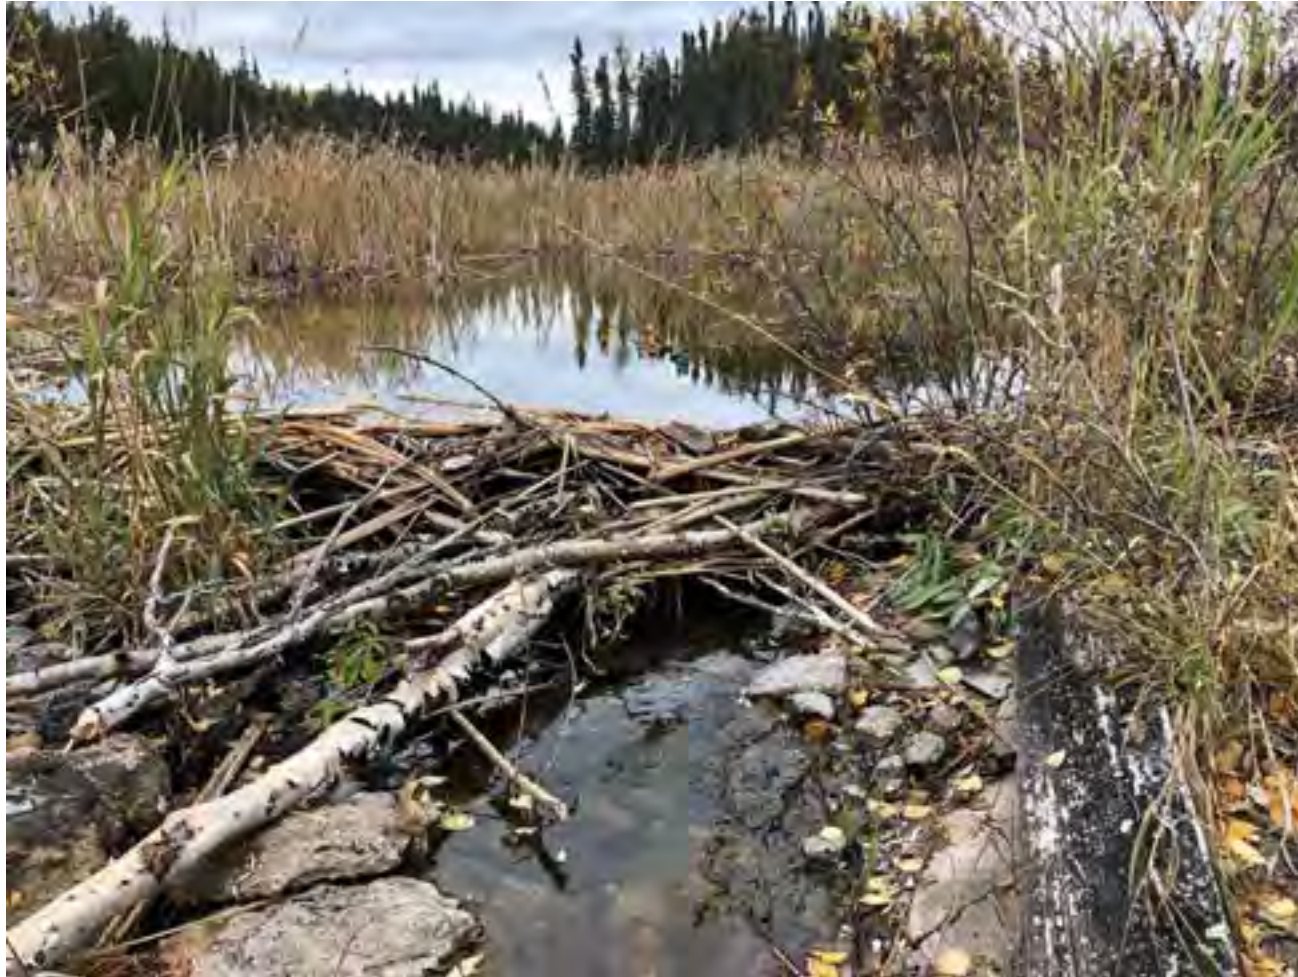
Beaver dam construction at the outlet structure for Marie Reservoir (September 2018)

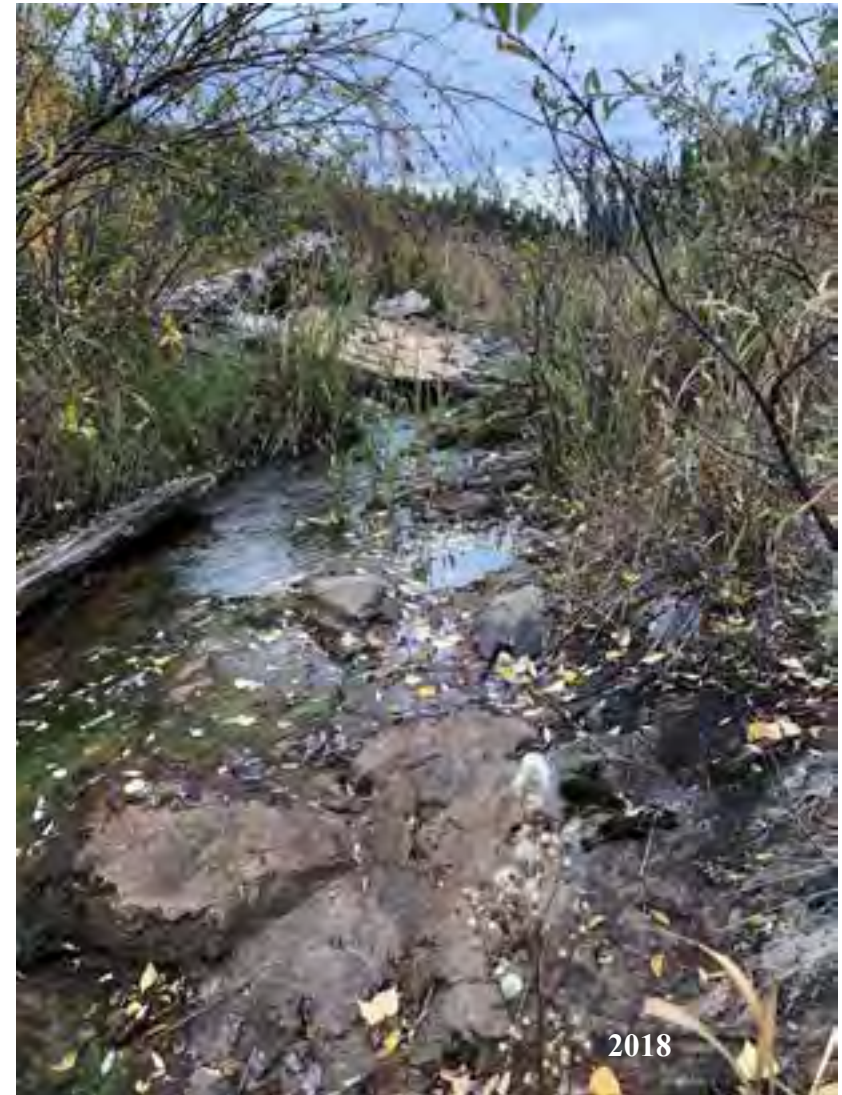
**Marie Reservoir Outlet Structure – Ice jacked block of grout intruded rip-rap**

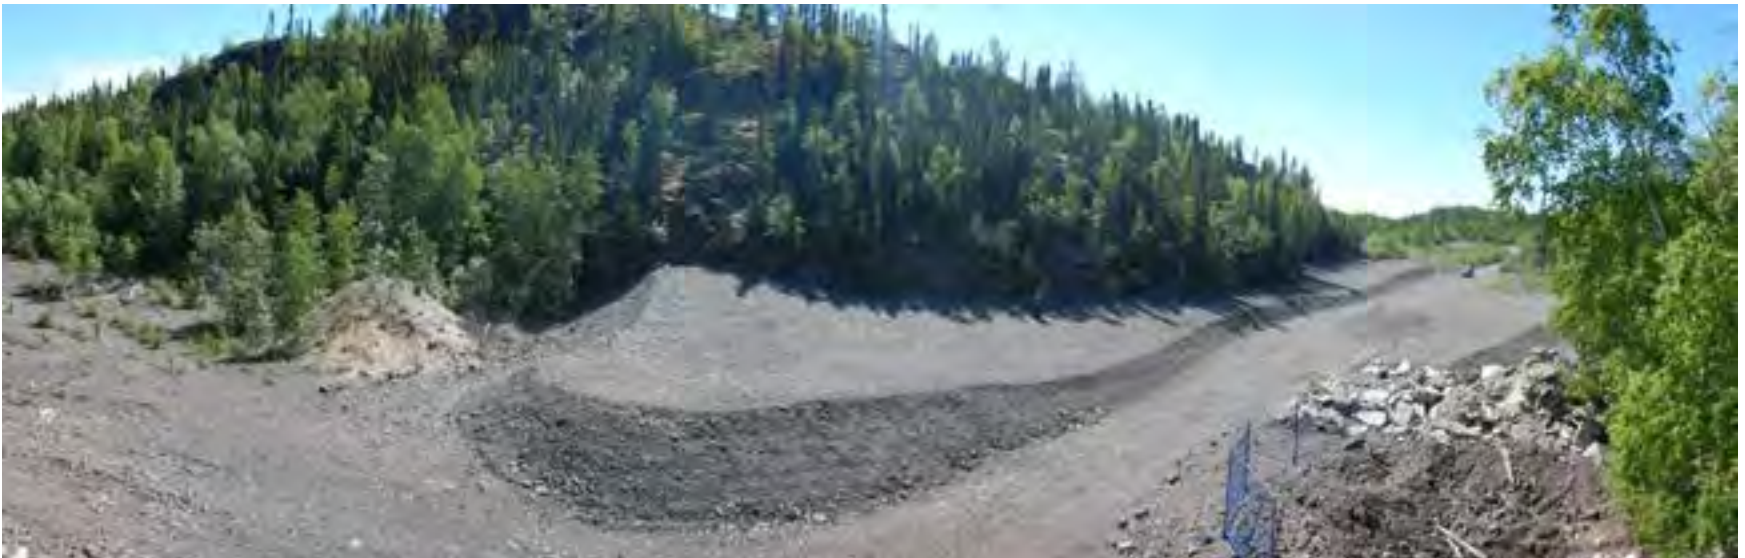
Photo D6 - Panorama photo looking south-west showing Stope 103/201 crown pillar cover on the left and Stop 208 crown pillar cover on the right. Vent Raise 105 is in the foreground (on the right) and has since been remediated.

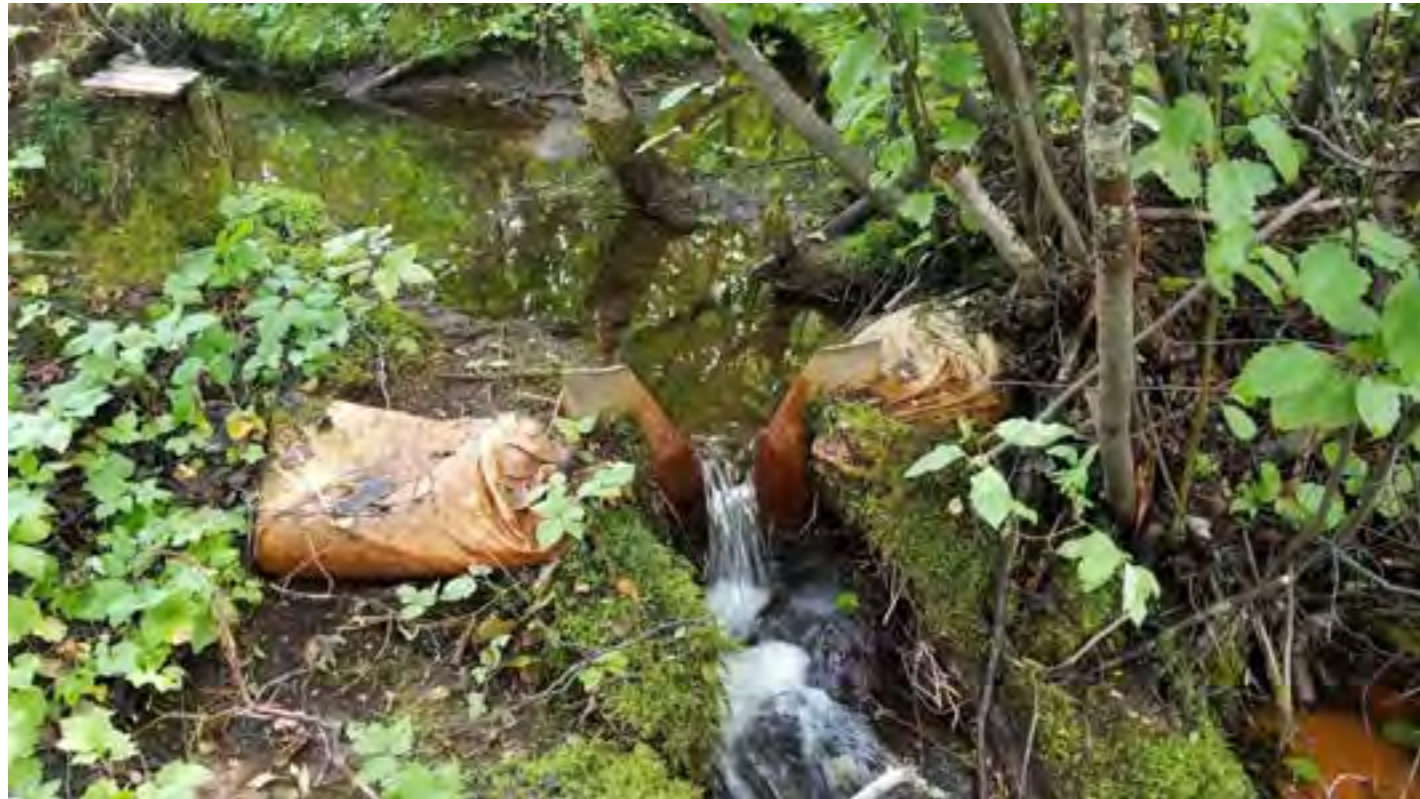
Photo 19 – V-notch weir used to estimate flow rate.

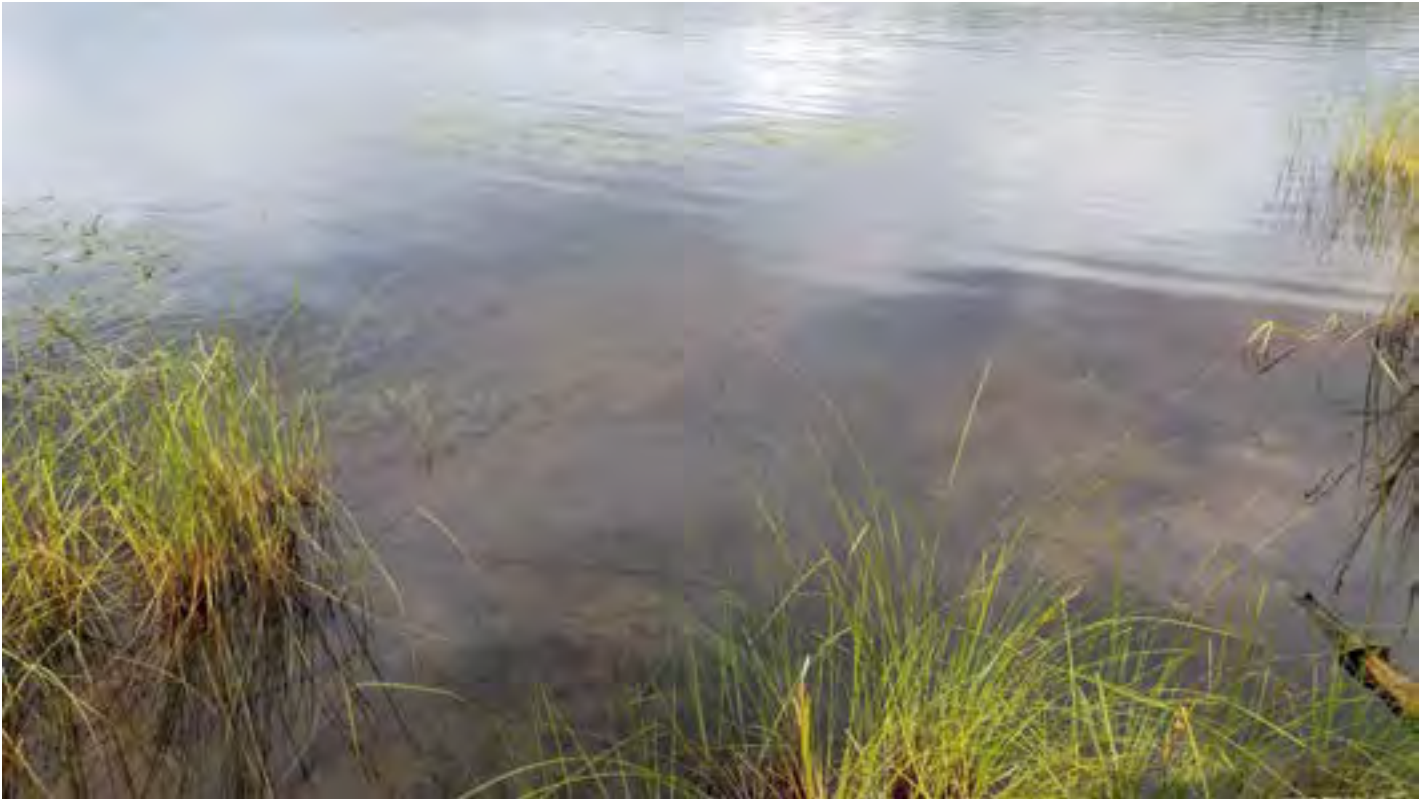
Photo 21 – Outlet of Channel into Verna Lake.

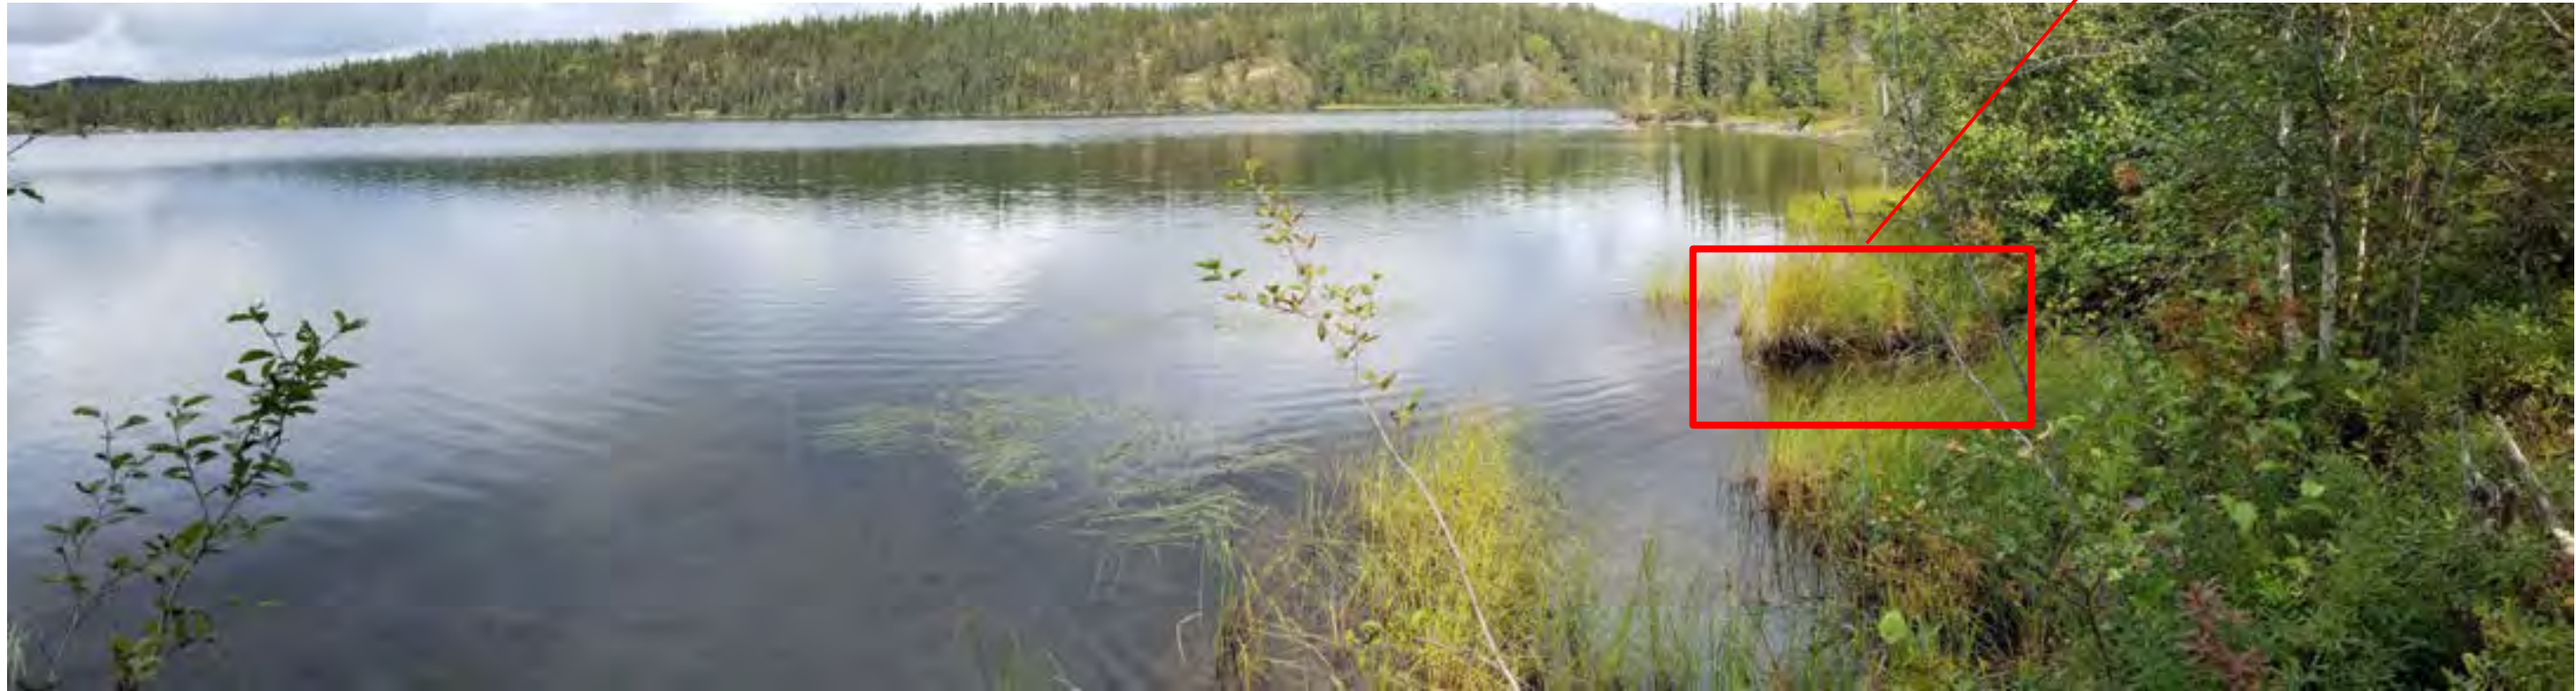
Photo 20 – Looking North where channel flow discharges into Verna Lake.
