BEAVERLODGE PROJECT

Beaverlodge Project 2021 Annual Report Year 36 Transition Phase Monitoring

Prepared for:
Canadian Nuclear Safety Commission
Compliance Report for Licence: WFOL-W5-2120.1/2023
& Saskatchewan Ministry of Environment
Compliance Report: Beaverlodge Surface Lease

Prepared and Submitted by:
Cameco Corporation

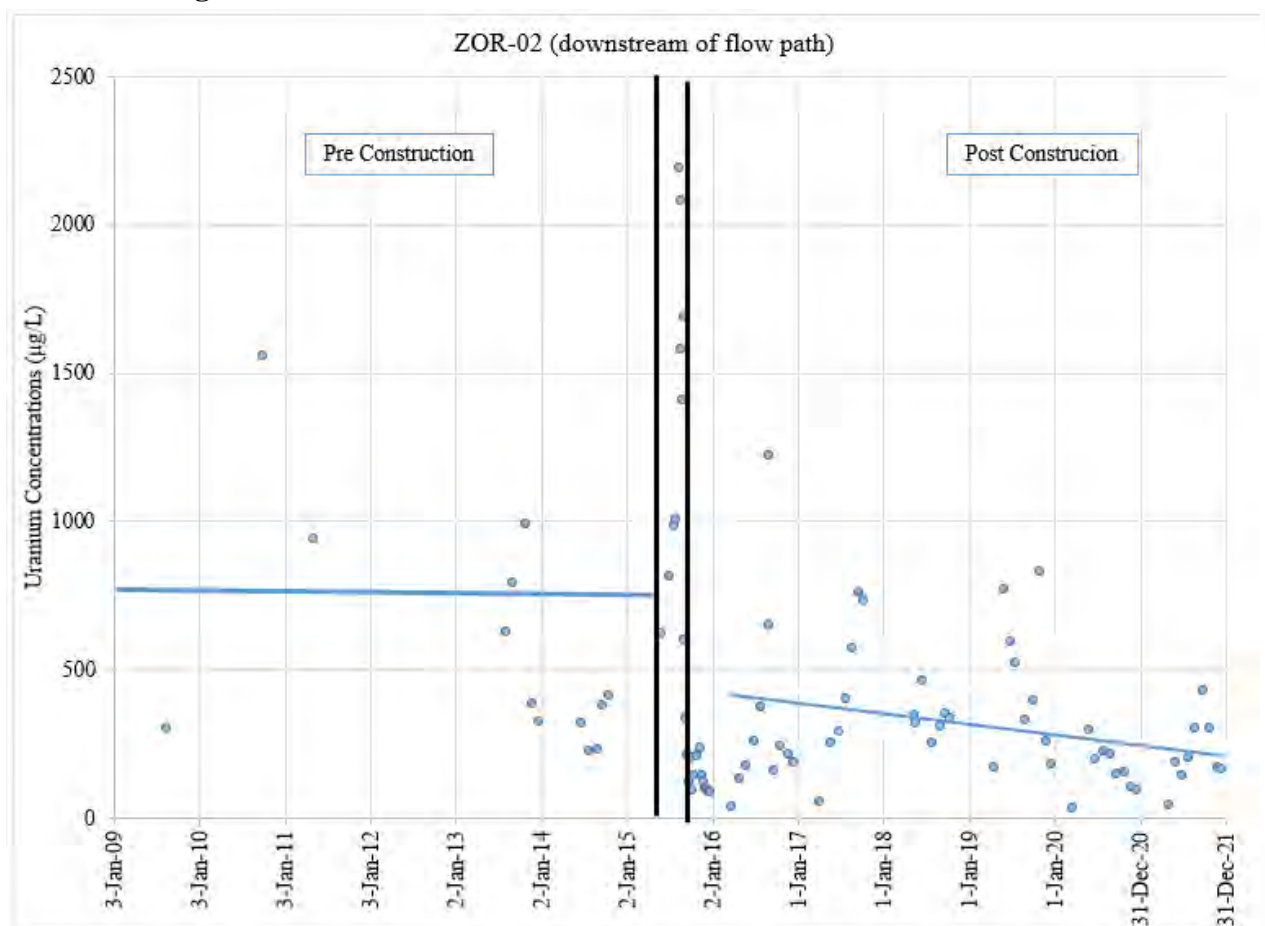
Figure 4.3-9 - ZOR-02 Uranium Concentrations Pre and Post Construction

The fluctuations in U concentrations observed through construction and following construction are reflected in the concentration of U measured at the outlet of Verna Lake (AC-6A) which increased, as expected, immediately following construction but has seen improvement in subsequent years. Uranium concentrations measured at the monitoring station AC-8 located in Ace Lake (immediately downstream) have remained below the SEQG since 2012. A summary of annual mean U and ²²⁶Ra data from 2010 to 2021 at ZOR-02, AC-6A, and AC-8 is presented in **Table 4.3-3**. As AC-6A flows into Ace Lake, data from the outlet of Ace Lake (AC-8) is presented for context, as the downstream water quality monitoring station meets SEQG.

Monitoring data reflects the expected results following the remedial work, and are expected to gradually improve in the future.

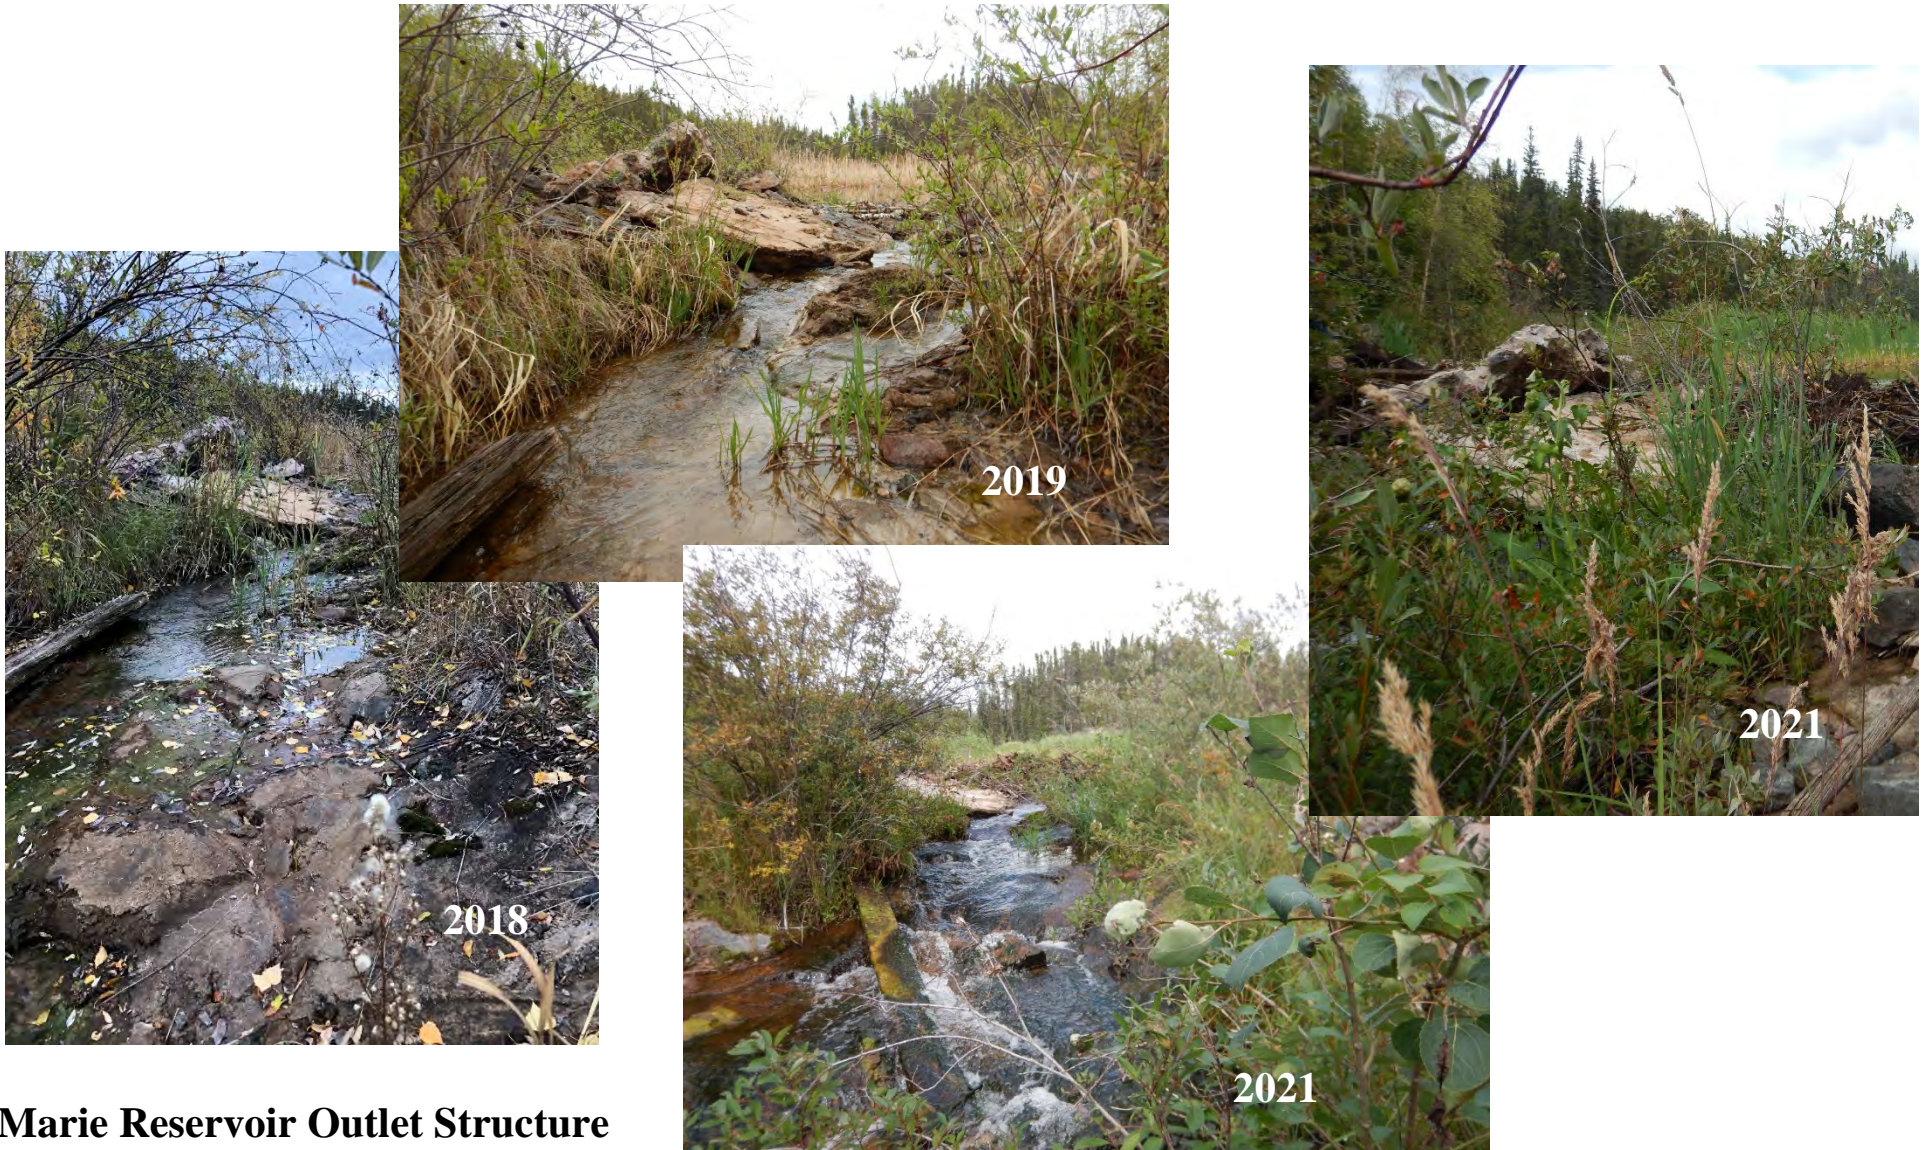
Beaver dam construction at the outlet structure for Marie Reservoir

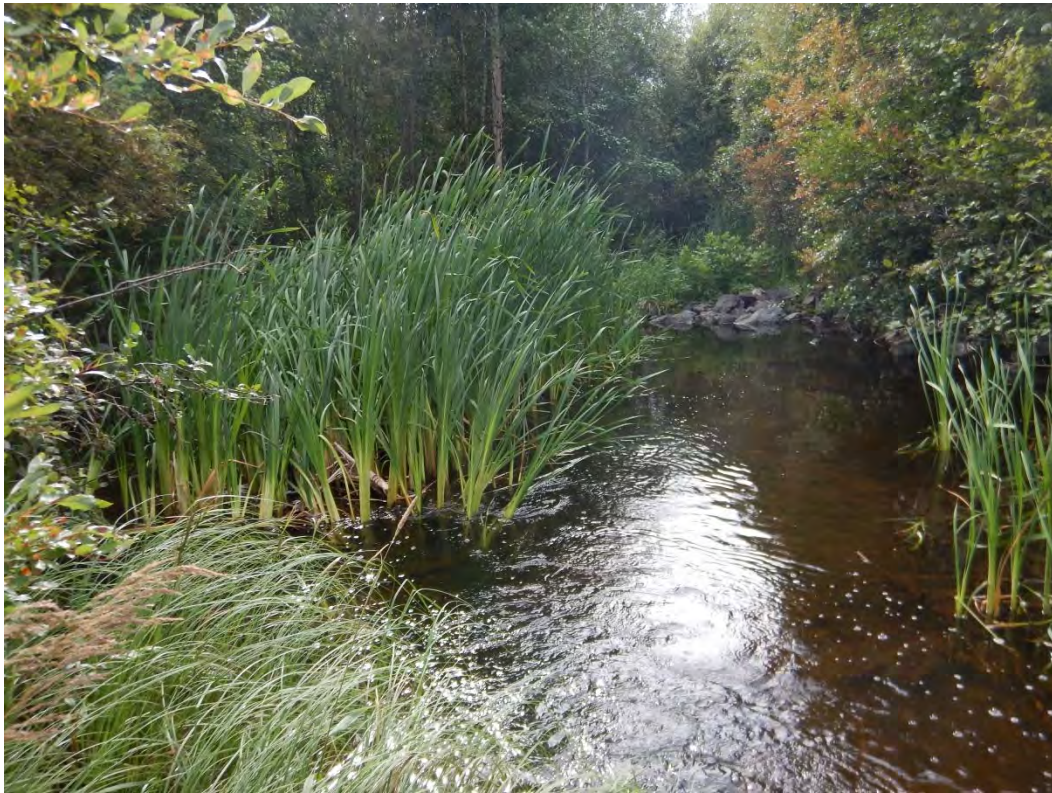
Photo A2 - Marie Reservoir Spillway inlet; beaver dam noted in 2018

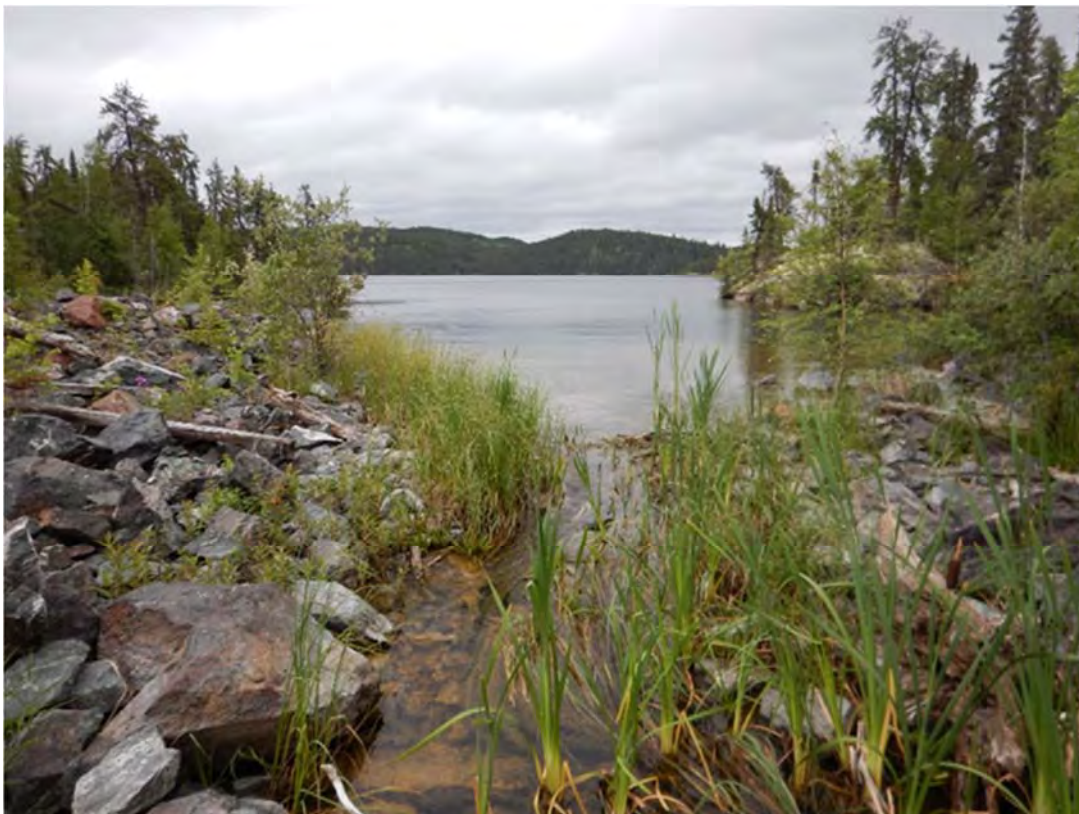
Photo B5 – Fookes Reservoir Spillway broken rip-rap on south side of channel

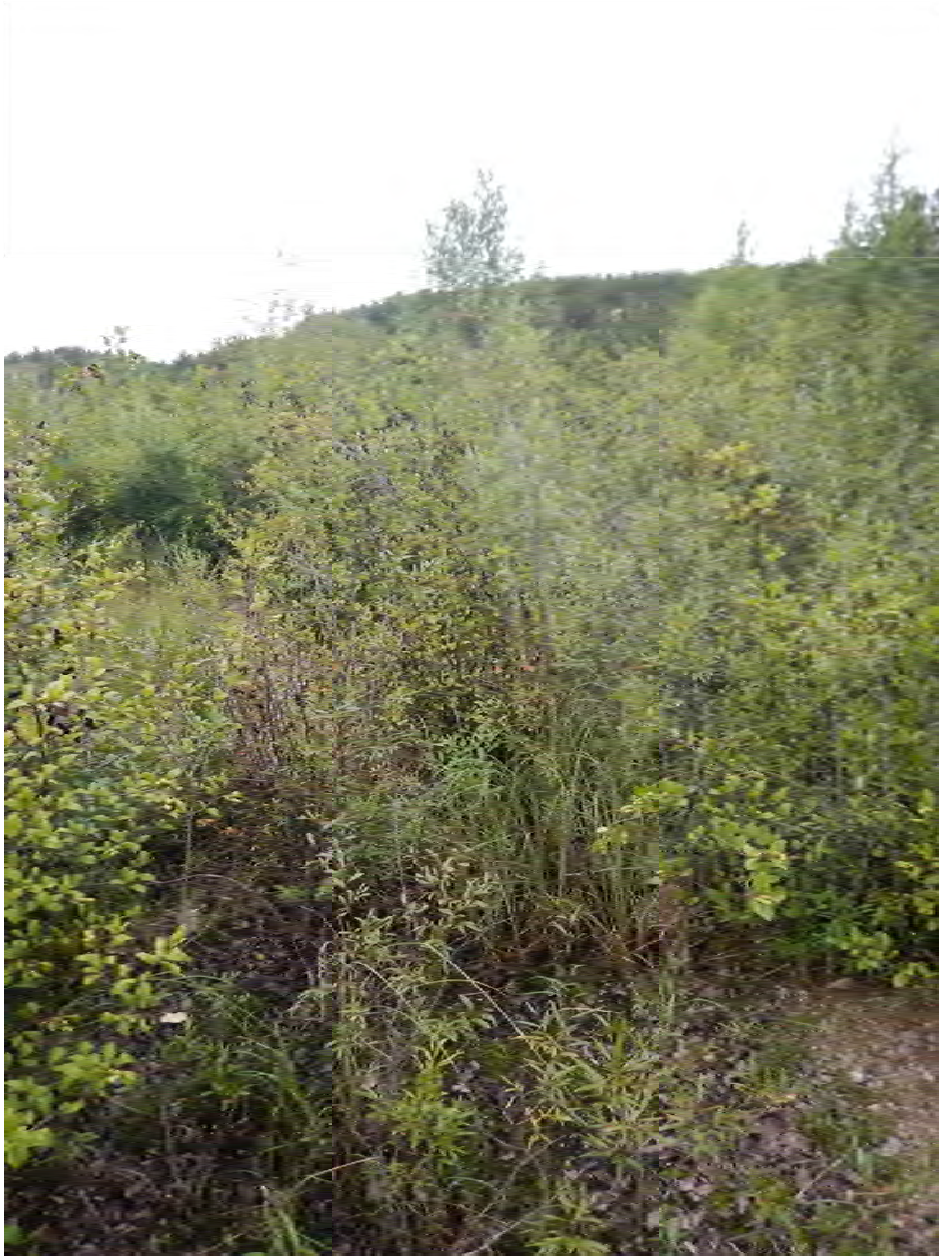
Photo C6 – View of vegetation establishing along drainage channel, no water in channel in August 2021

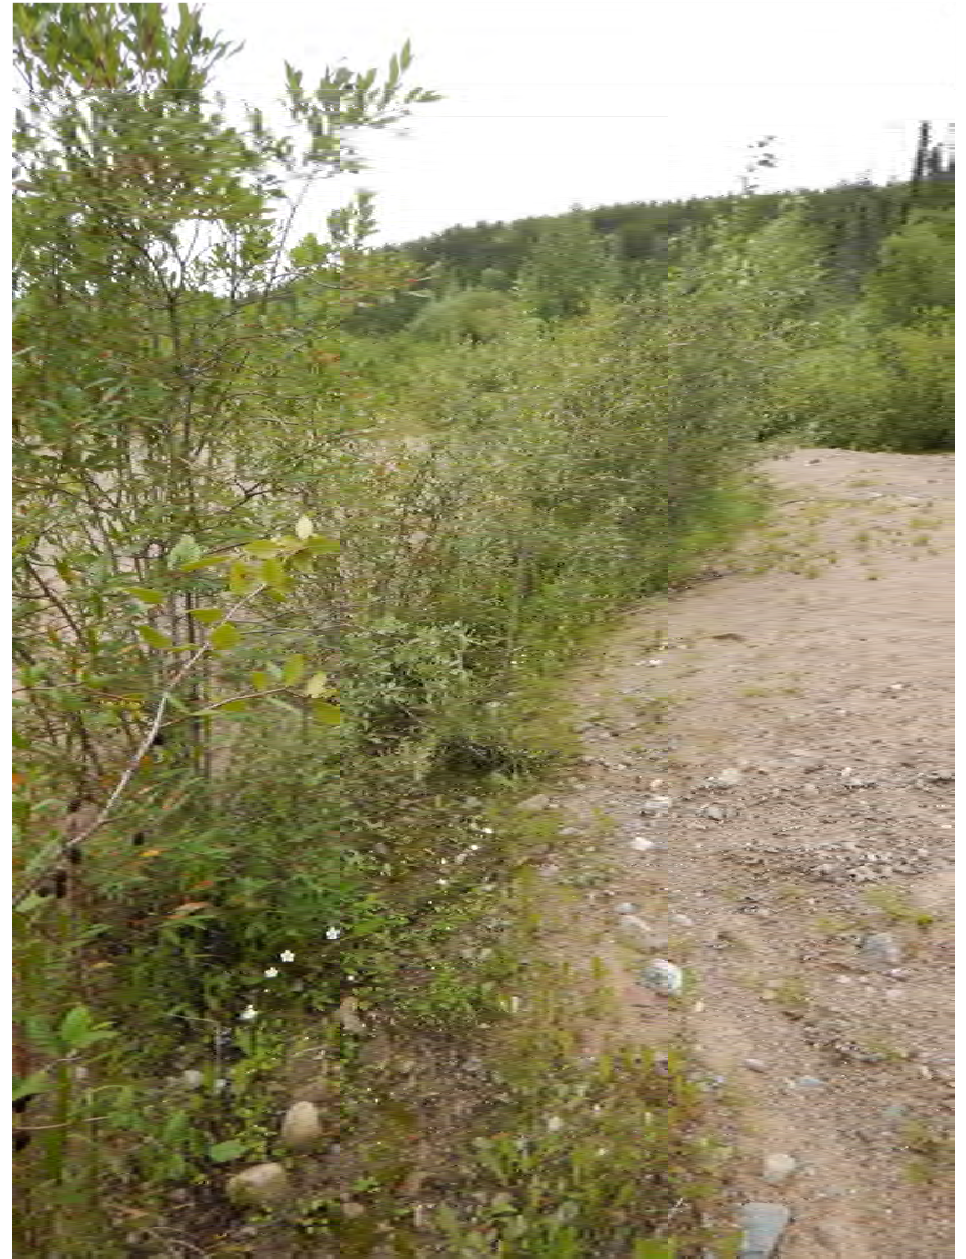
Photo C7 – View of vegetation establishing along drainage channel, no water in channel in August 2021

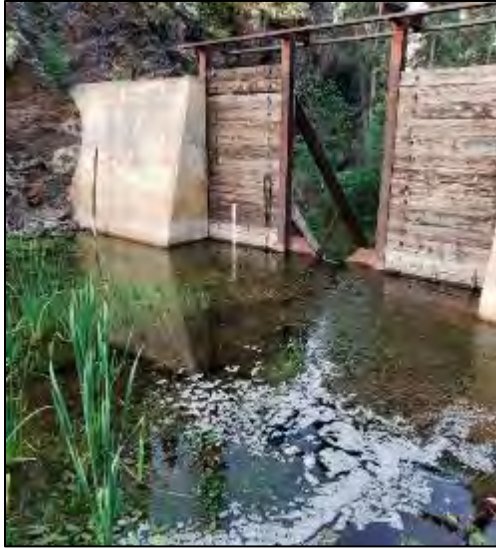
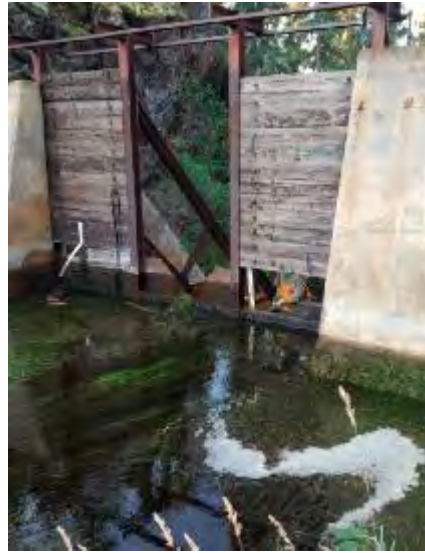
Photos 1 and 2. TL-7 prior to stoplog removal, and after water had been allowed to flow under loosened logs

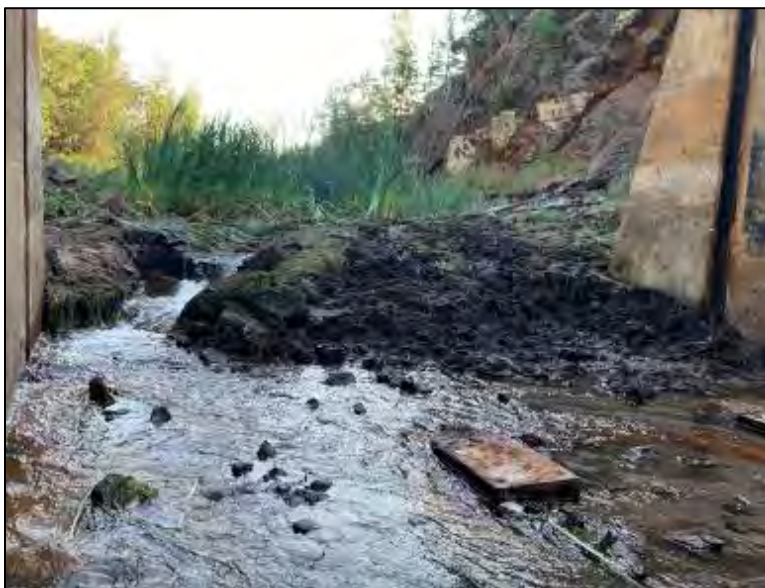
Photo 3. View over sill at TL-7. New flow path on right side of photo.

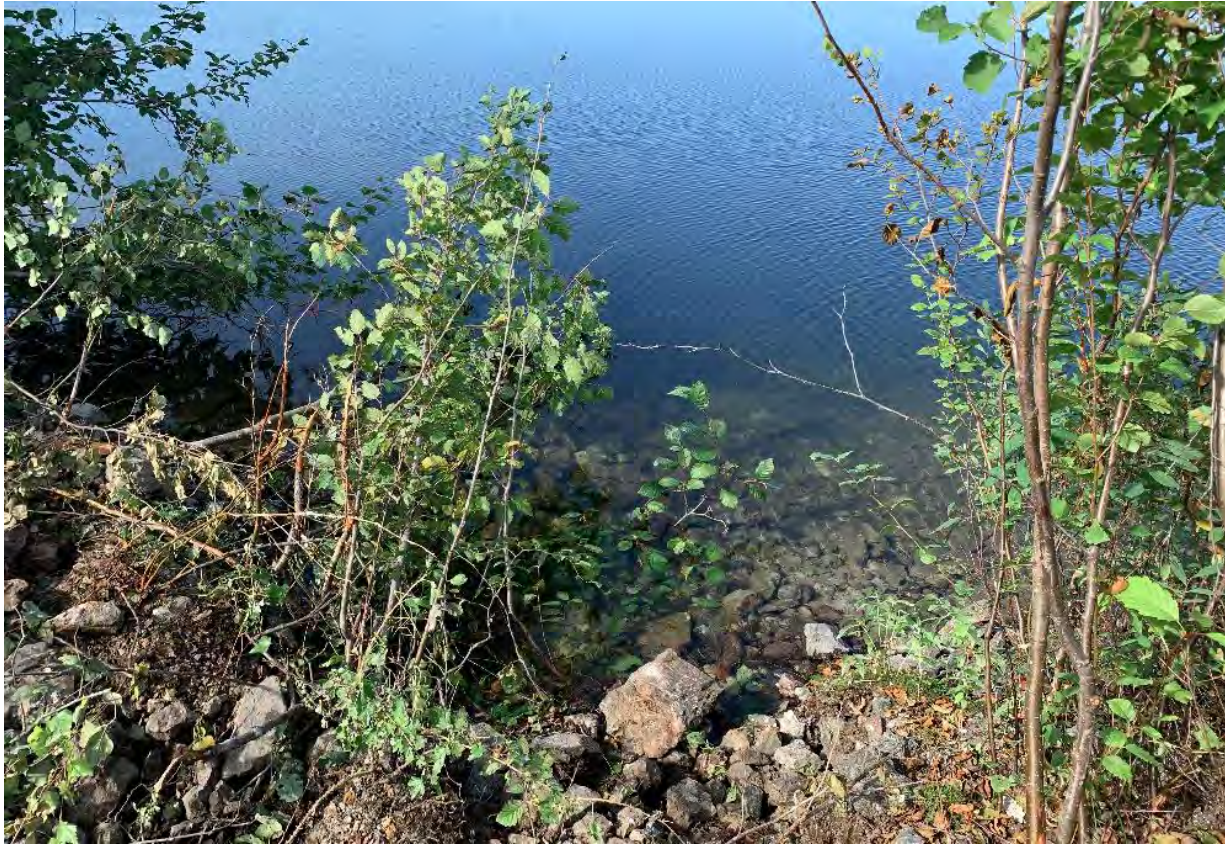
Photo 15. Location where pipeline was pulled through the shoreline of Verna Lake

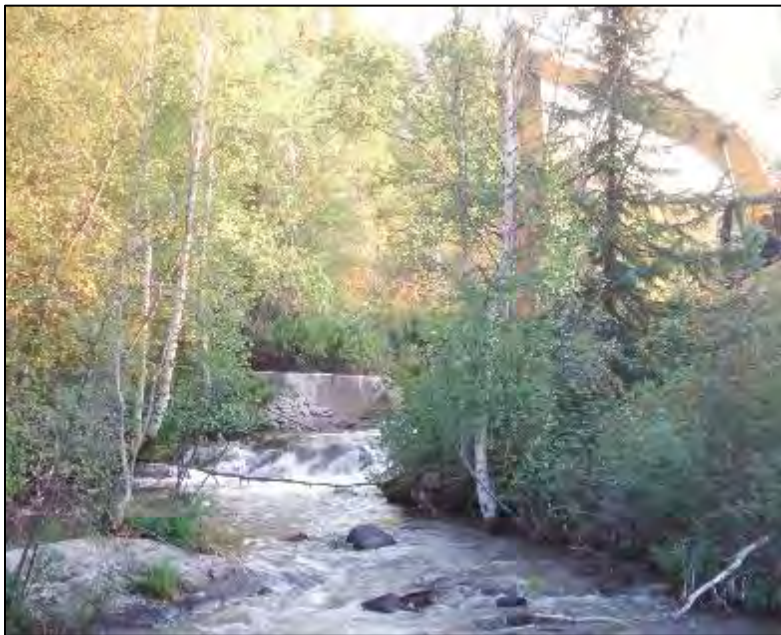
Photo 17. View looking upstream as concrete is removed from the channel.

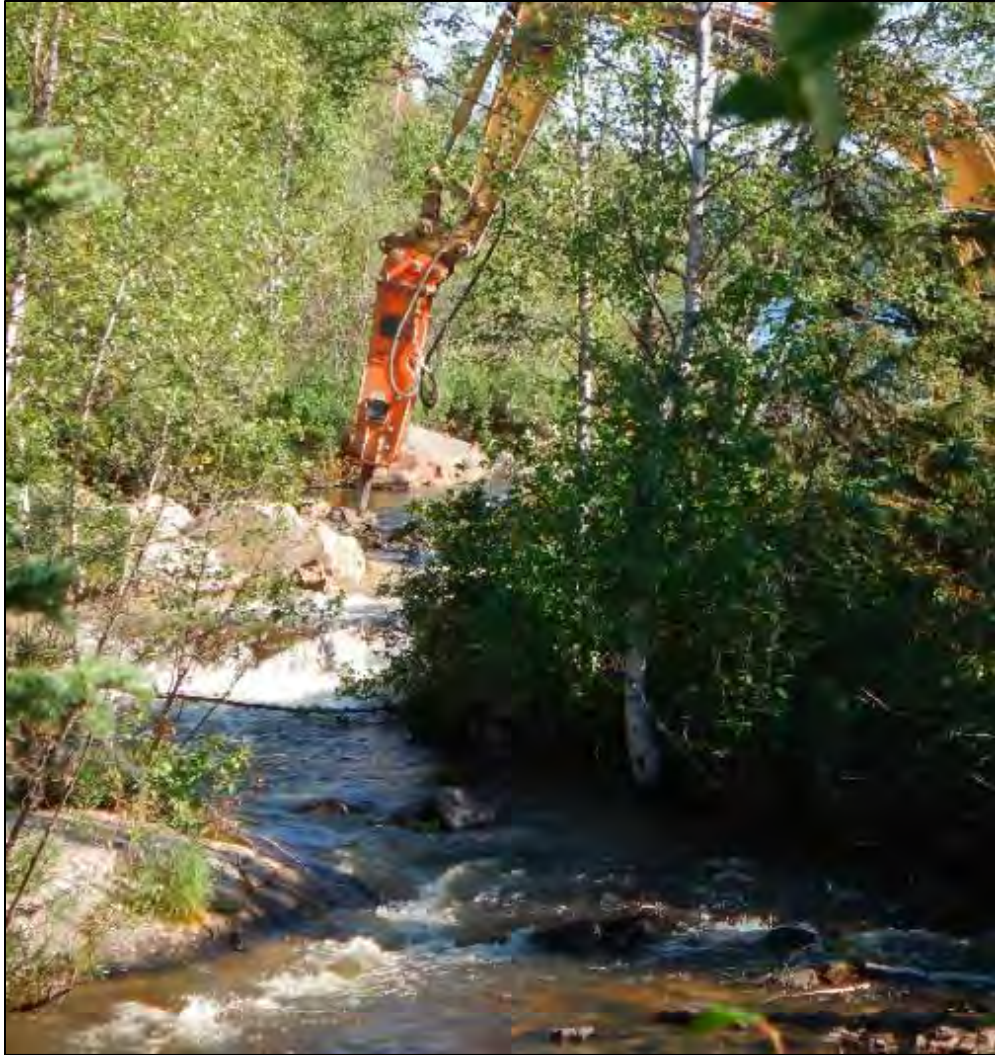
Photo 18. Concrete removal continues on Ace Creek weir
