# BEAVERLODGE PROJECT

## **Beaverlodge Project 2022 Annual Report Year 37 Transition Phase Monitoring**

**Prepared and Submitted by:**  
Cameco Corporation

**April 2023**

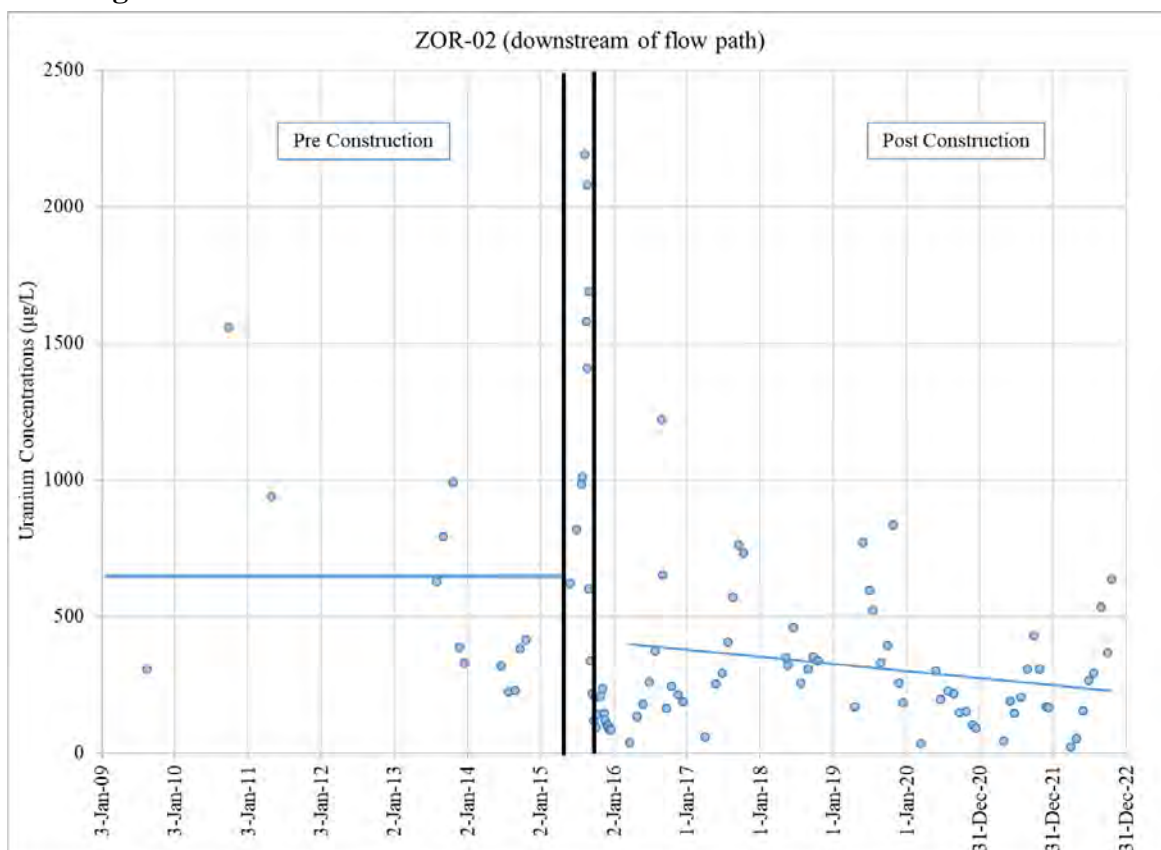
**Figure 4.3-9 - ZOR-02 Uranium Concentrations Pre and Post Construction**

**Figure 4.3-9** shows the results of water sample data collected at ZOR-02 through the various phases of pre-construction, construction and post construction. Also provided are general trend lines showing the relative improvement in water quality post-construction. The Pre-Construction trend line is the overall average U concentration for that period, while the Post-Construction (starting in 2016) is a linear trend line created using the annual U concentration averages.

The fluctuations in U concentrations observed through construction and following construction are reflected in the concentration of U measured at the outlet of Verna Lake (AC-6A) which increased, as expected, immediately following construction but has seen improvement in subsequent years. Uranium concentrations measured at the monitoring station AC-8 located in Ace Lake (immediately downstream) have remained below the SEQG since 2012. A summary of annual mean U and <sup>226</sup>Ra data from 2010 to 2022 at ZOR-02, AC-6A, and AC-8 is presented in **Table 4.3-3**. As AC-6A flows into Ace Lake, data from the outlet of Ace Lake (AC-8) is presented for context, as the downstream water quality monitoring station meets SEQG.

Monitoring data reflects the expected results following the remedial work and are expected to gradually improve in the future.

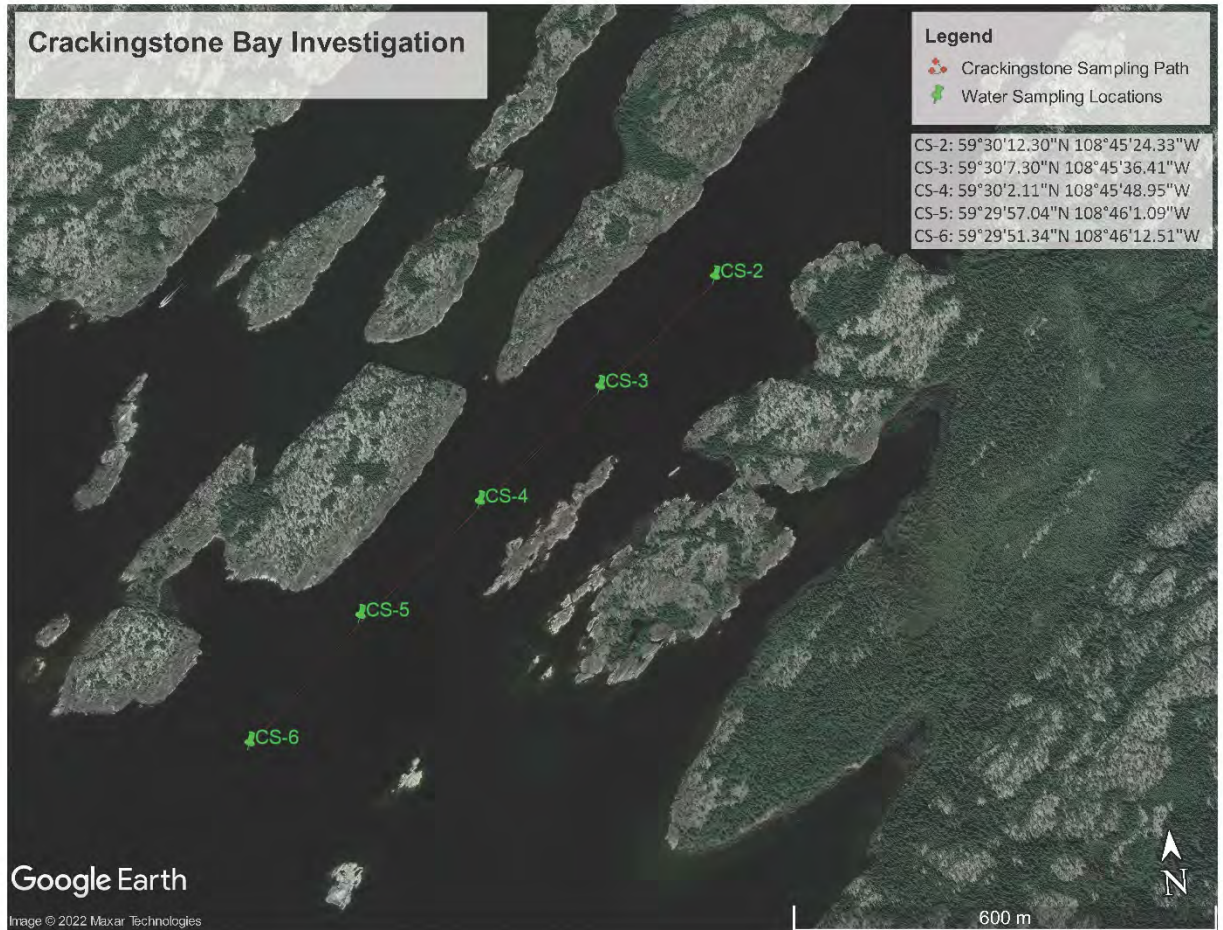
**Figure 4.3.10 – Crackingtonstone Bay sample locations**

For the past three years, U levels have been elevated relative to the stable trend previously observed at CS-2. An investigation was conducted in August 2022 to understand the spatial extent of the elevated U concentrations at CS-2. On August 28, 2022 samples were collected at five locations on a linear transect starting at CS-2 and moving south towards Lake Athabasca at 250m intervals out to 1000m (stations CS-3, CS-4, CS-5, and CS-6). **Figure 4.3.10** provides the sample locations and geographic coordinates used to conduct the investigation.

The concentrations from CS-2 into Lake Athabasca recorded were 15 µg/l, 5.2 µg/l, 3.1 µg/l, 3.2 µg/l and 3.1 µg/l, respectively. All these values are below the SEQG (15 µg/l) and show that uranium concentration is in decline as you move further away from CS-2. Lake Athabasca water levels dropped through the summer and a reduction in the measured concentration at CS-2 was noted, compared to the Beaverlodge EMP value measured in June.

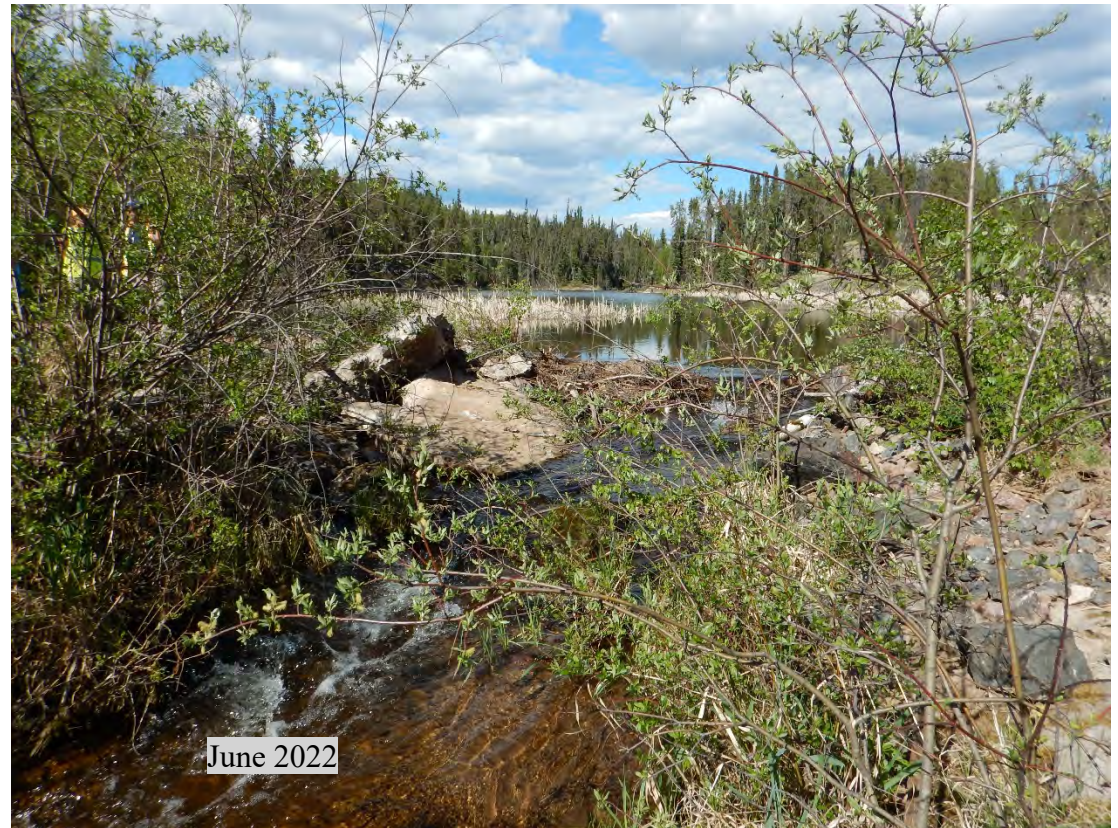
**Marie Reservoir Outlet Structure**  
**– Ice jacked block of grout intruded rip-rap**

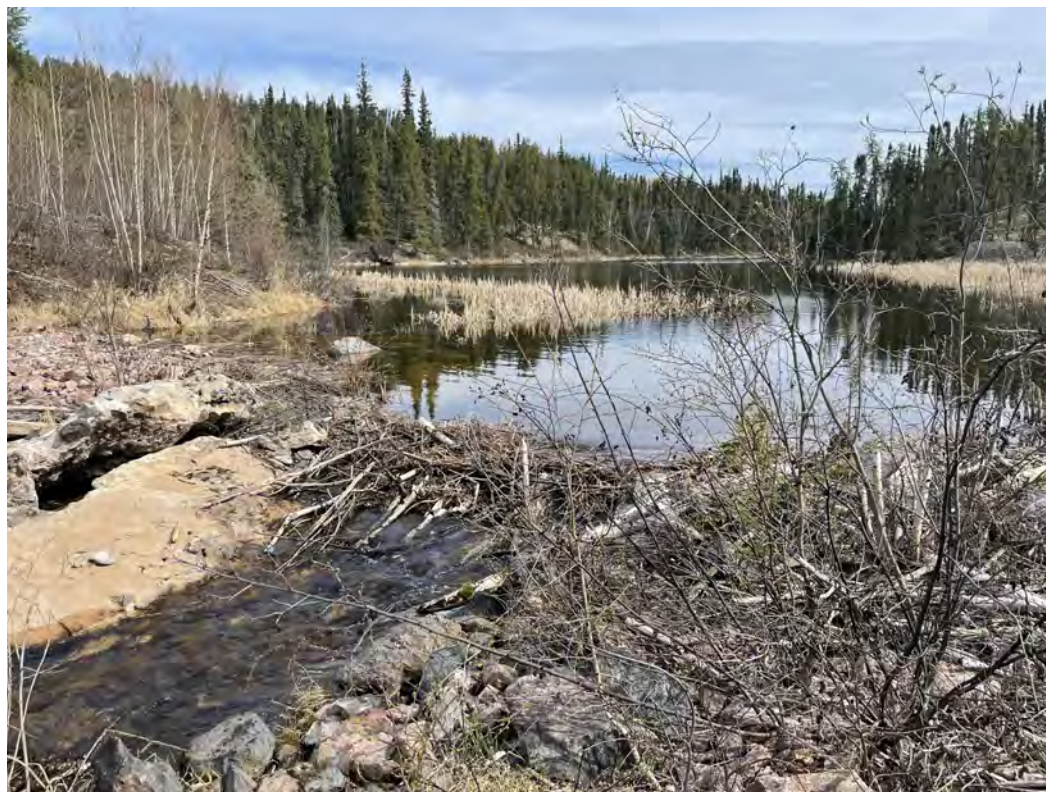
**Photo A2 - Marie Reservoir Spillway inlet; beaver dam first noted in 2018**

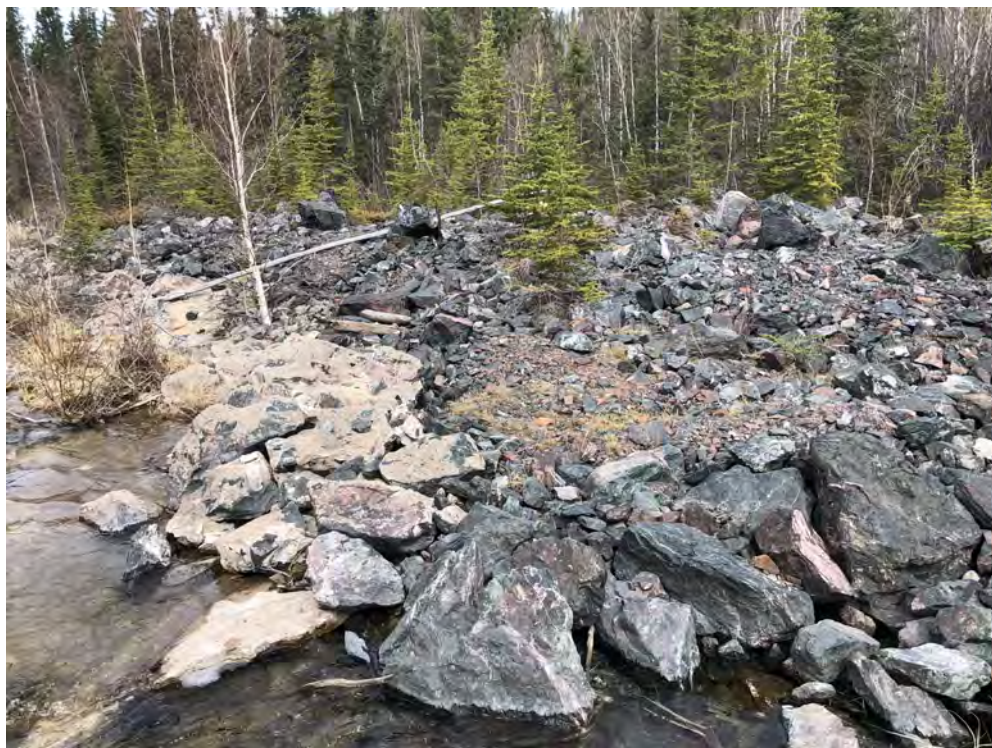
**Photo B5 – Fookes Reservoir Spillway broken rip-rap on north side of channel**

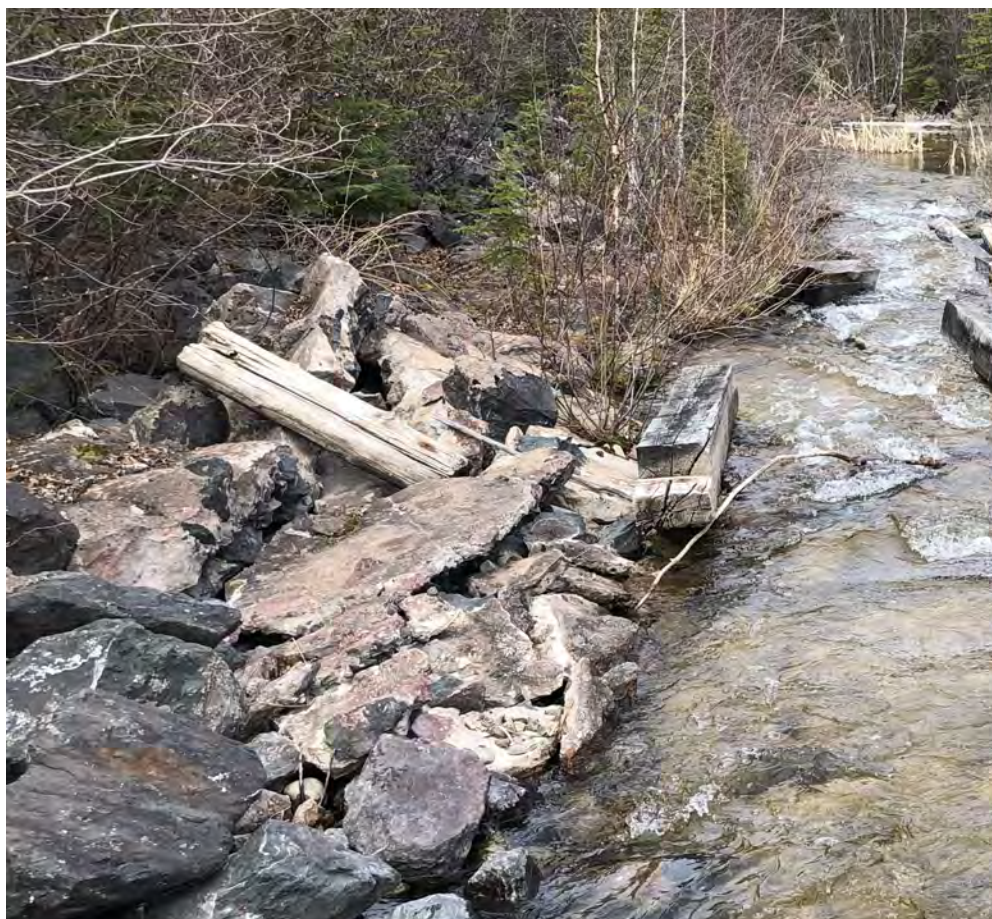
**Photo B6 – Fookes Reservoir Spillway broken rip-rap on south side of channel**

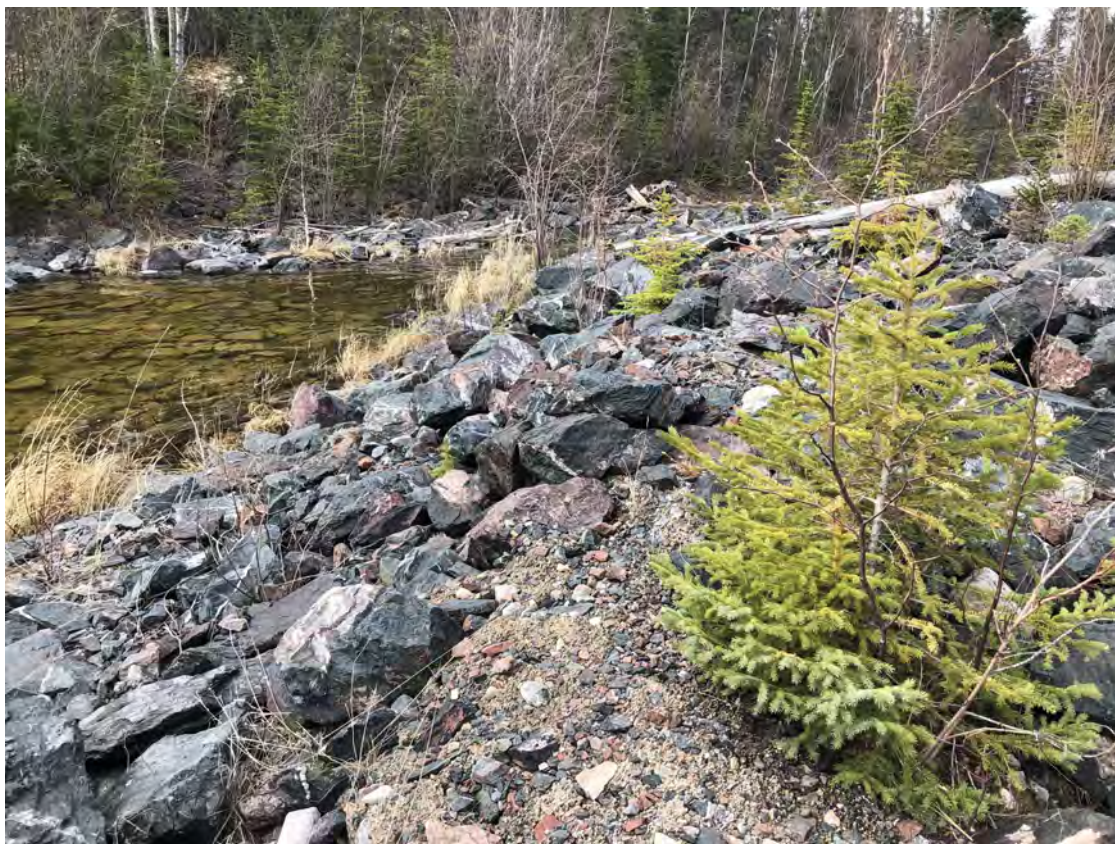
**Photo B7 - Fookes Outlet— south embankment in good condition, looking west**

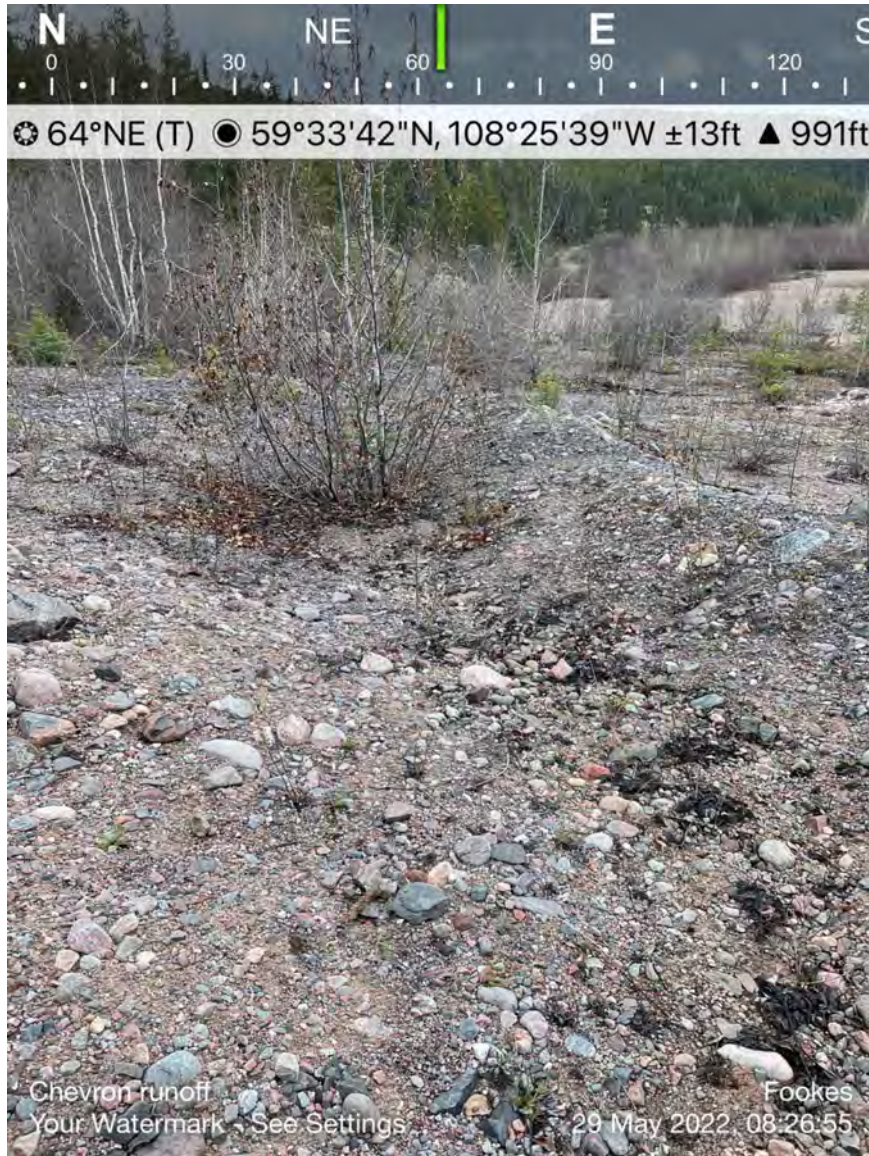
**Photo C3 – Chevron run-out structure along north access road**

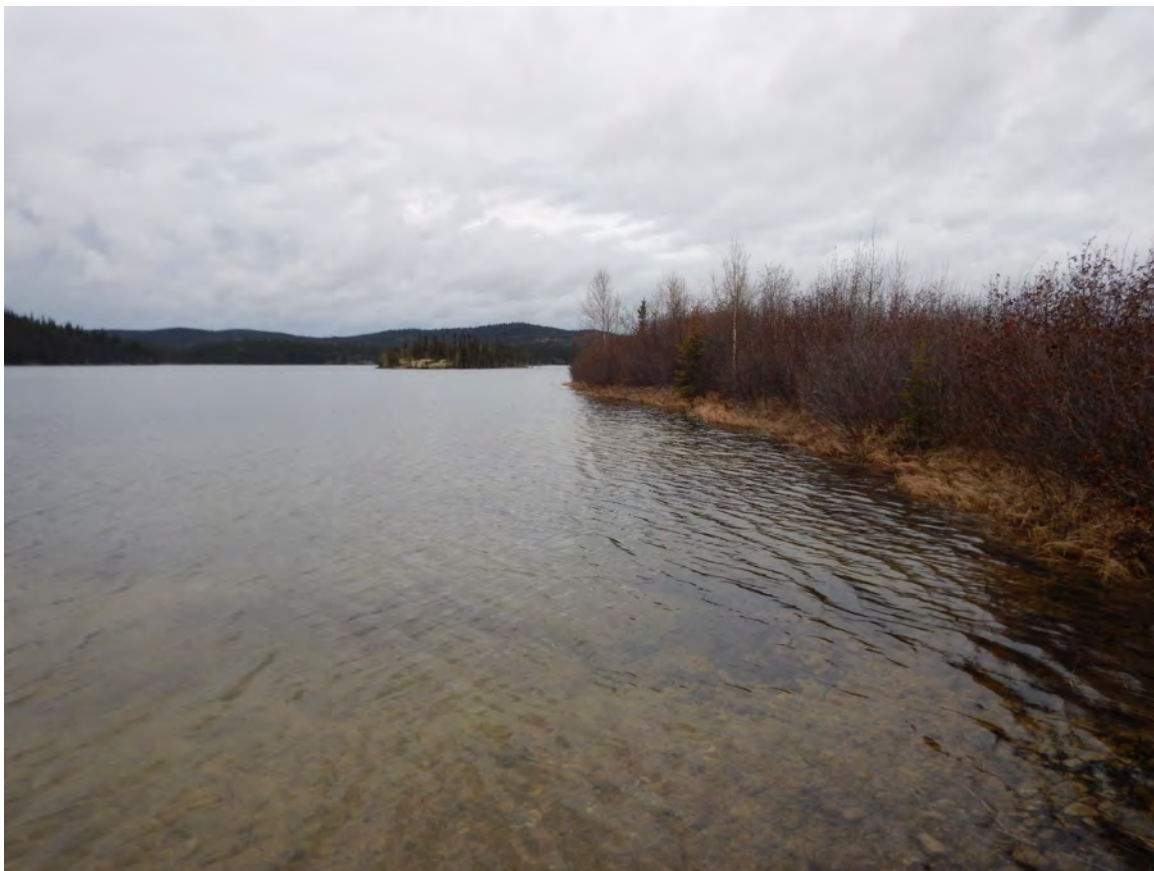
**Photo C8—Fookes Reservoir shoreline (looking west) Note vegetation along shoreline is well established despite not having leafed-out (photos from May 29, 2022)**
