Final Closure Report

Beaverlodge Properties

**URA 7, URA 1, BOLGER 1,
Tailings Management Area Properties**

NOVEMBER 2023

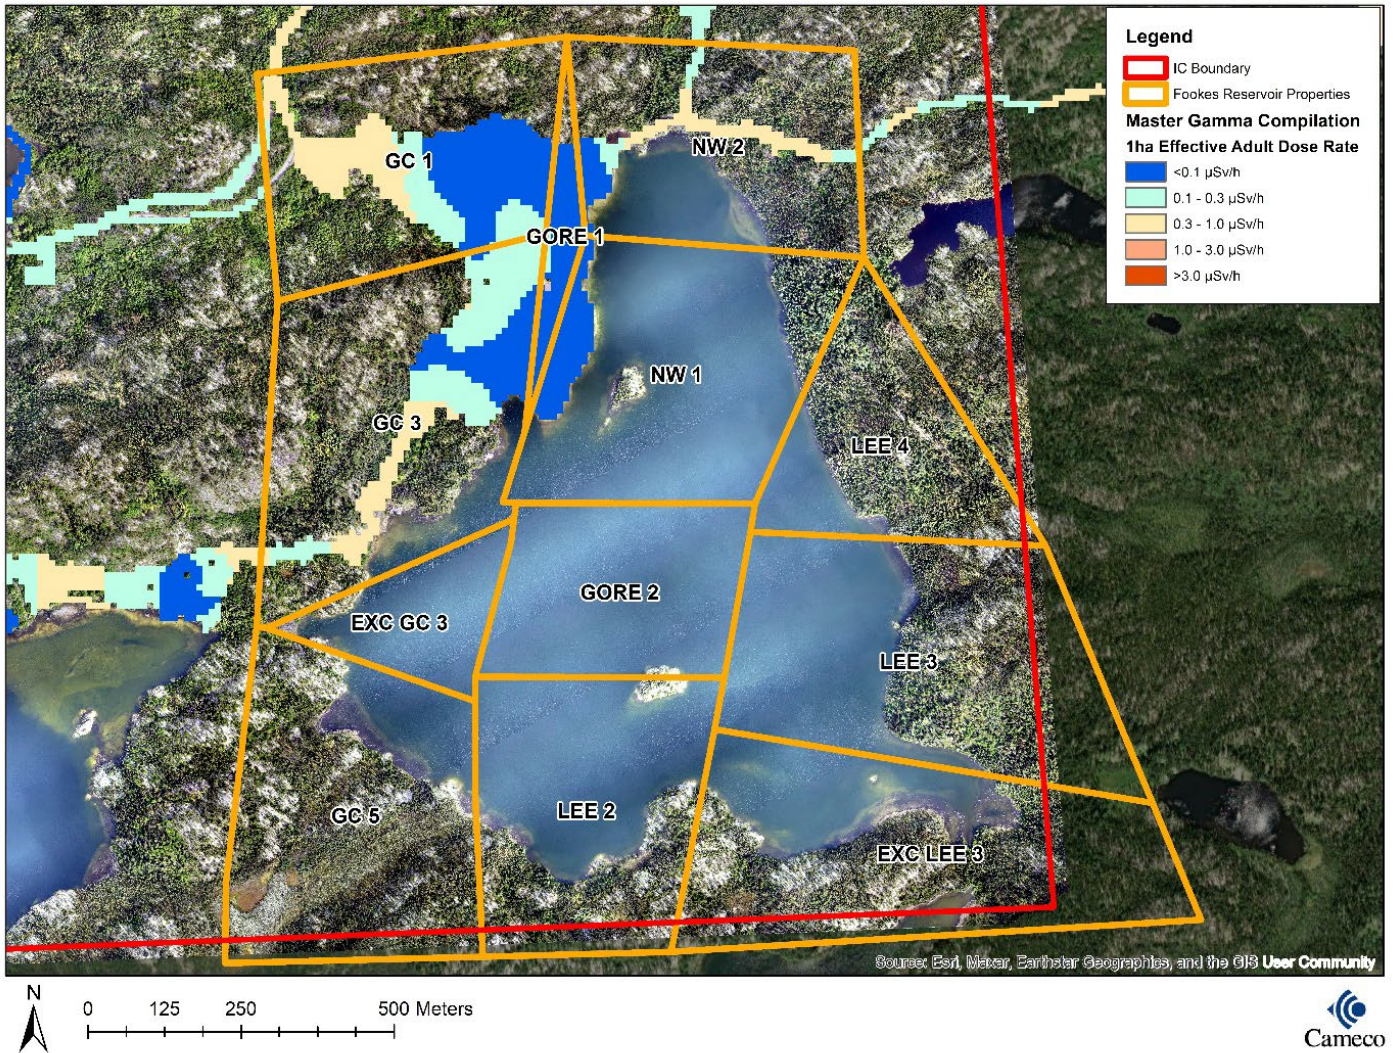
Figure 8. Incremental Gamma Radiation 1 Hectare Averages: Fookes Reservoir Properties

As shown in **Figure 8**, the surface gamma survey results ranged from $<0.1 \mu\text{Sv/h}$ to $1.0 \mu\text{Sv/h}$ above background (ARCADIS SENES 2014), which meets the *Guidelines for Northern Mine Decommissioning and Reclamation* (SkMOE 2008). Therefore, the Fookes Reservoir properties meet the Performance Indicator associated with acceptable gamma levels.

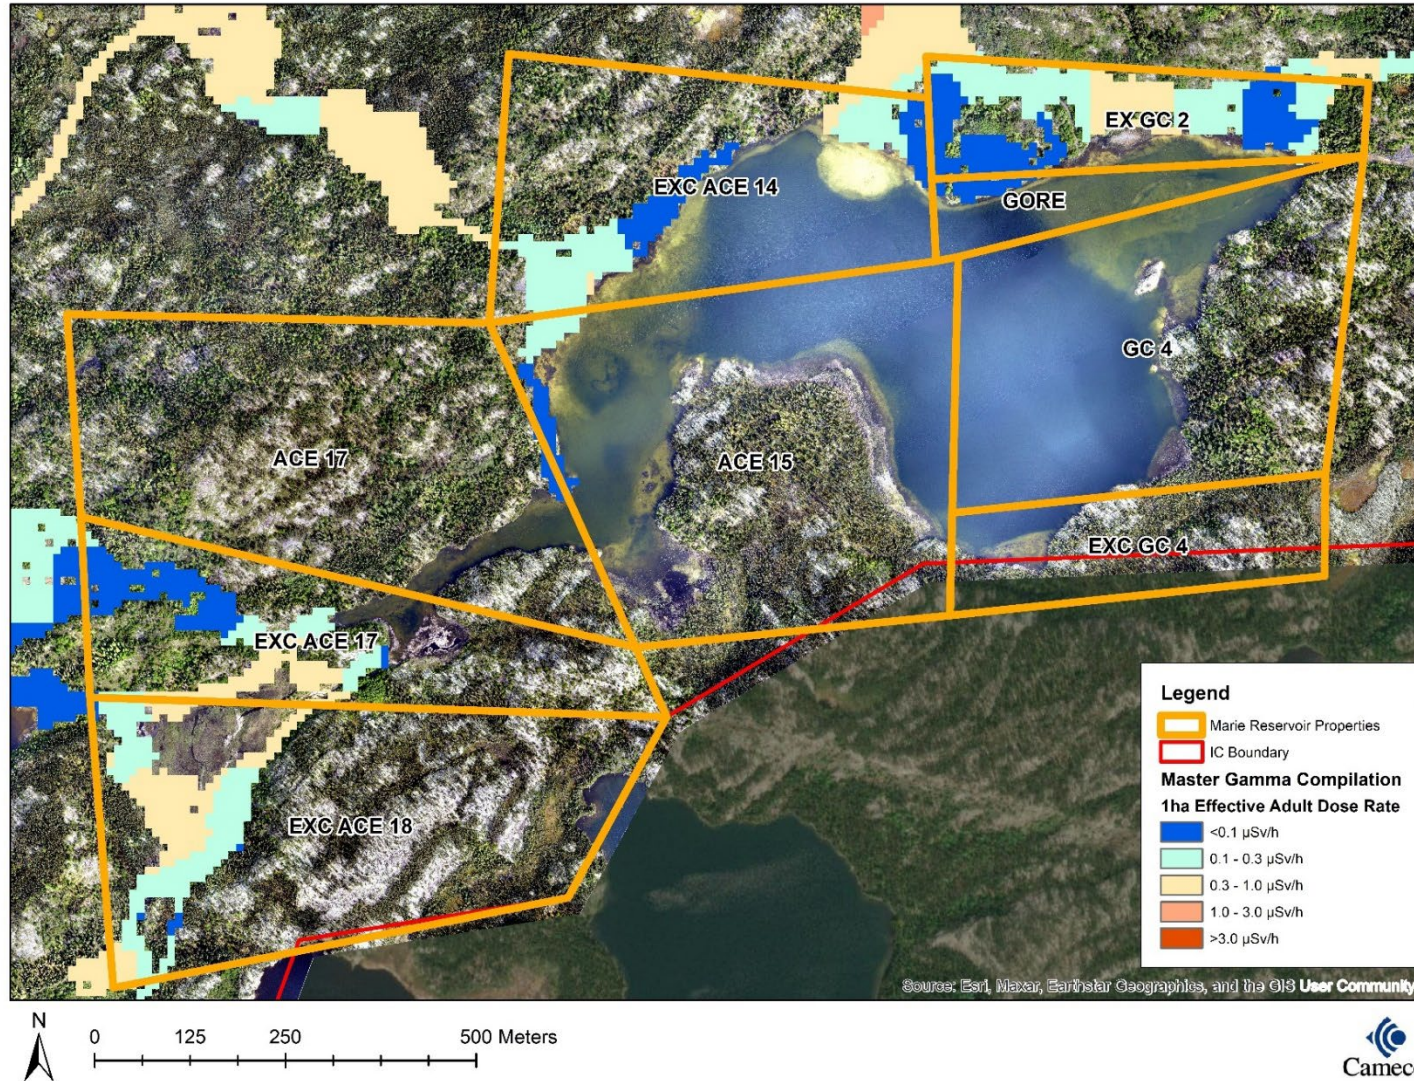
Figure 13: Incremental Gamma Radiation 1 Hectare Averages: Marie Reservoir Properties

The resulting radiation dose rates were then averaged on a 1 ha basis to allow comparison to the 1 $\mu\text{Sv/h}$ reference gamma value in the provincial *Guidelines for Northern Mine Decommissioning and Reclamation* (SkMOE 2008). As shown in **Figure 13**, the surface gamma survey results ranged from $<0.1 \mu\text{Sv/h}$ to $1.0 \mu\text{Sv/h}$ above background (ARCADIS SENES 2014), which meets the *Guidelines for Northern Mine Decommissioning and Reclamation* (SkMOE 2008). Therefore, the Marie Reservoir properties meet the performance indicator associated with acceptable gamma levels.

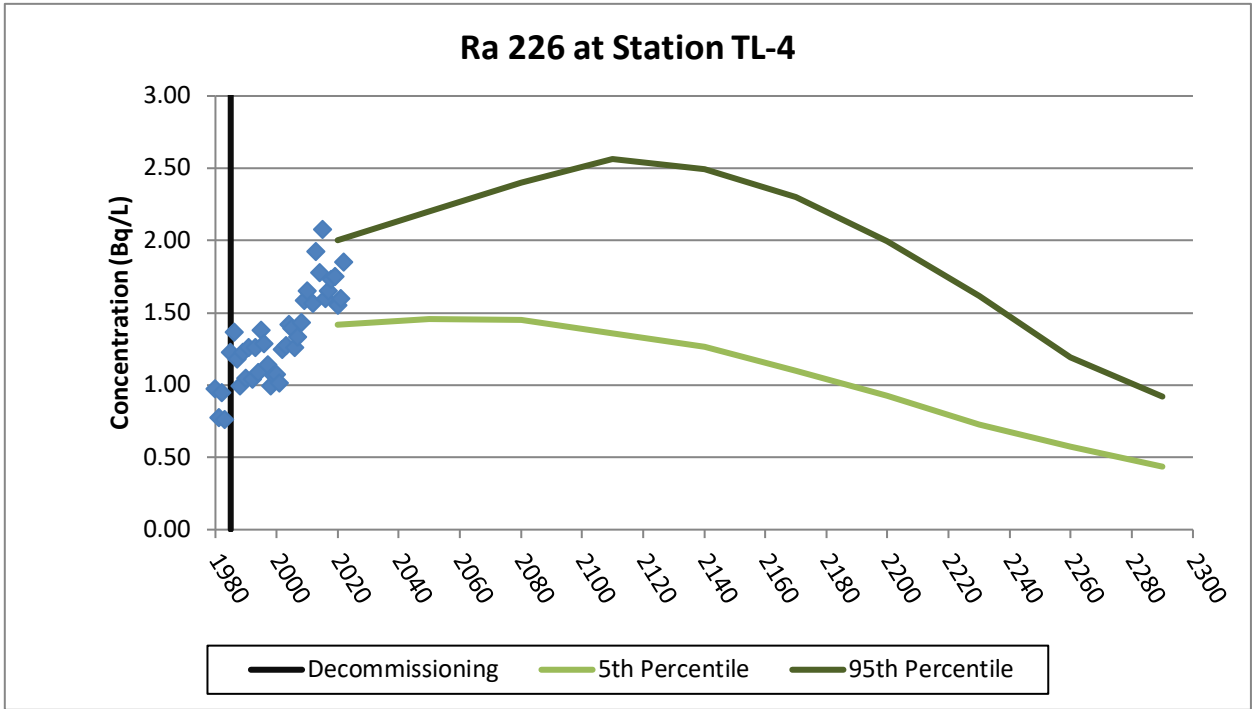
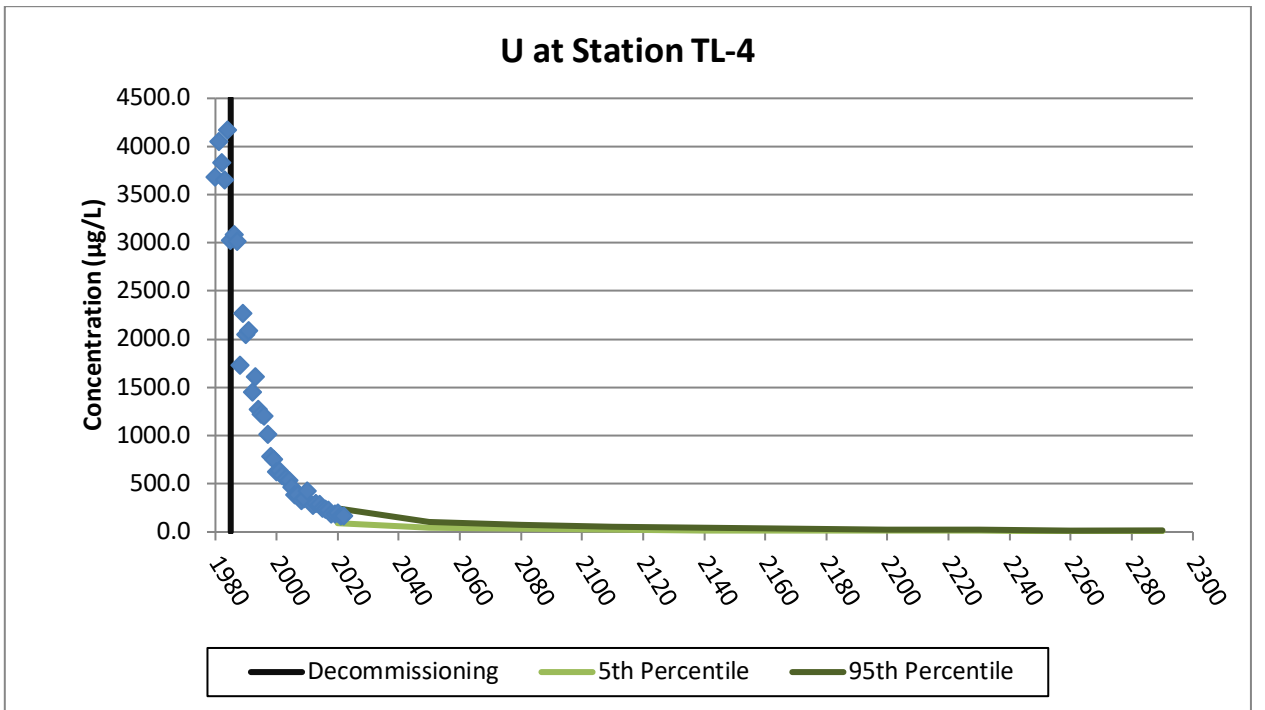
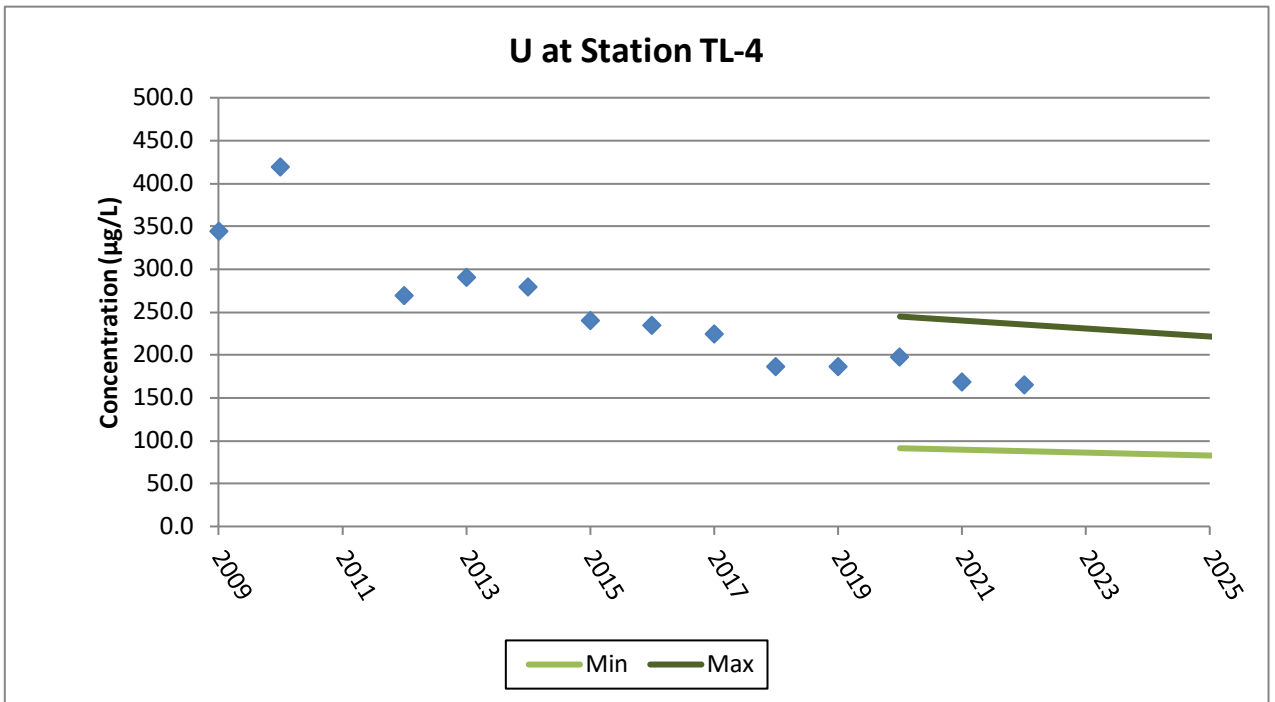
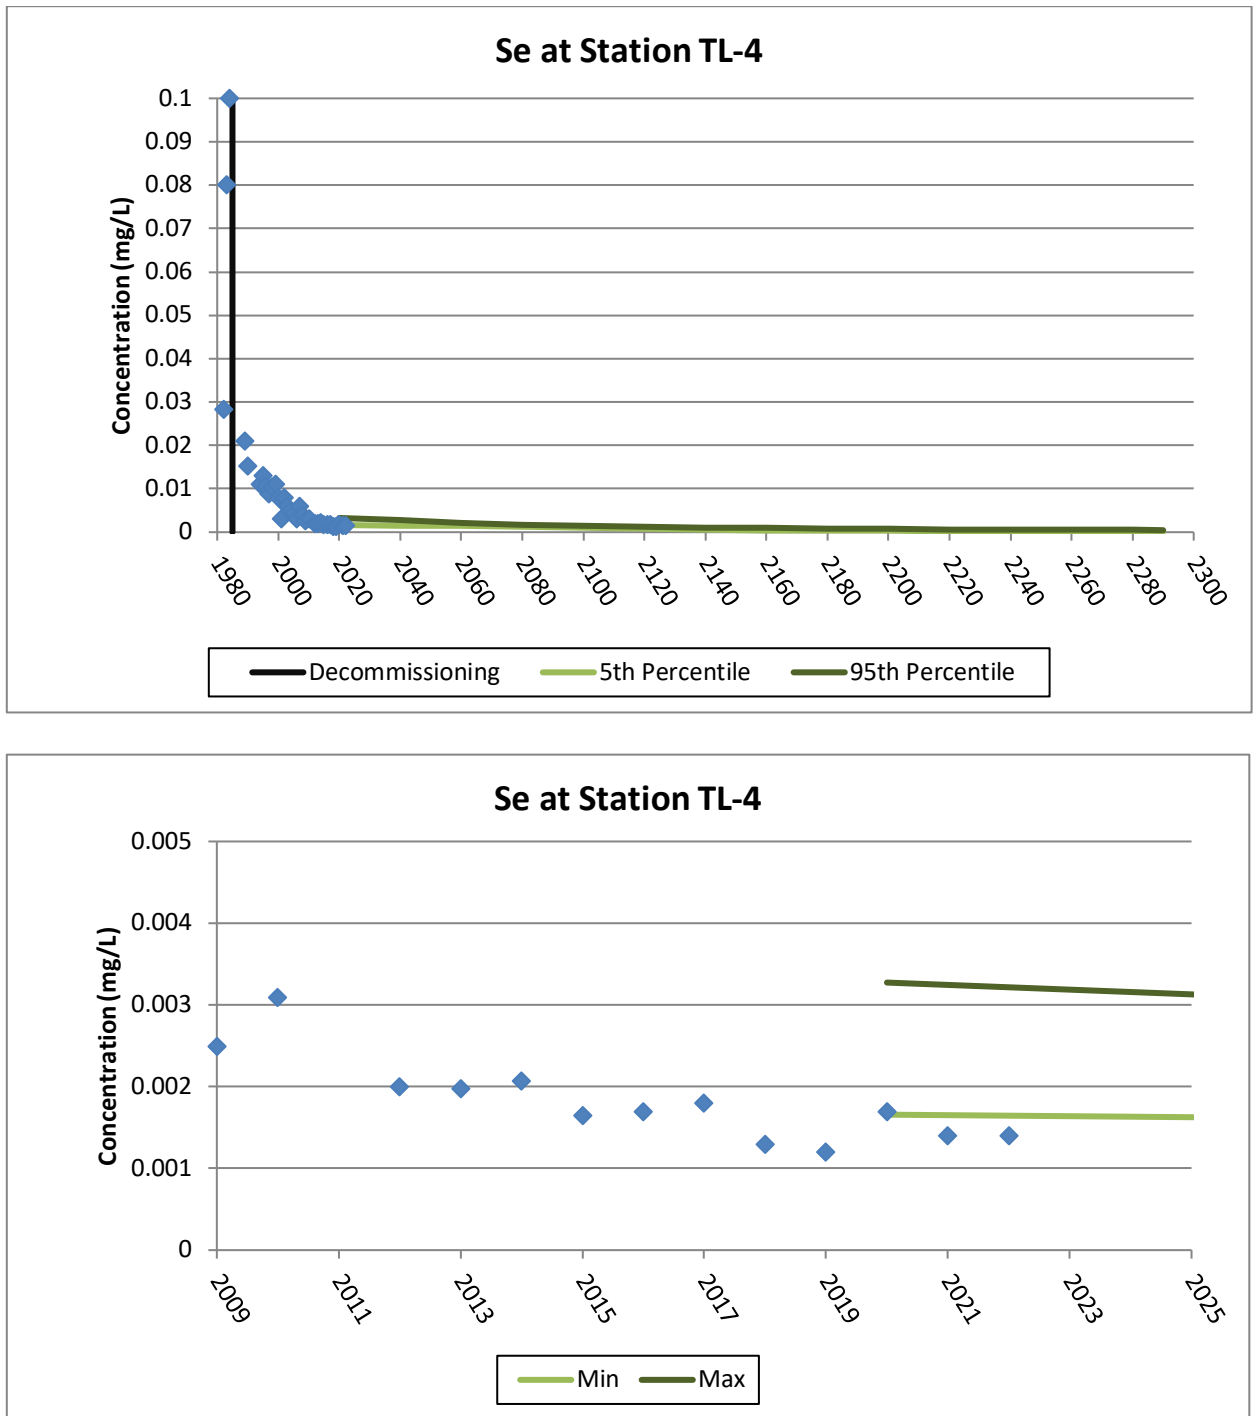
Figures 14 and 15 are provided to show the rapid decrease in uranium and selenium concentrations that occurred following decommissioning. Due to the rapid improvement of selenium and uranium concentrations following decommissioning a second graph showing a more suitable scale of current concentrations is also provided.

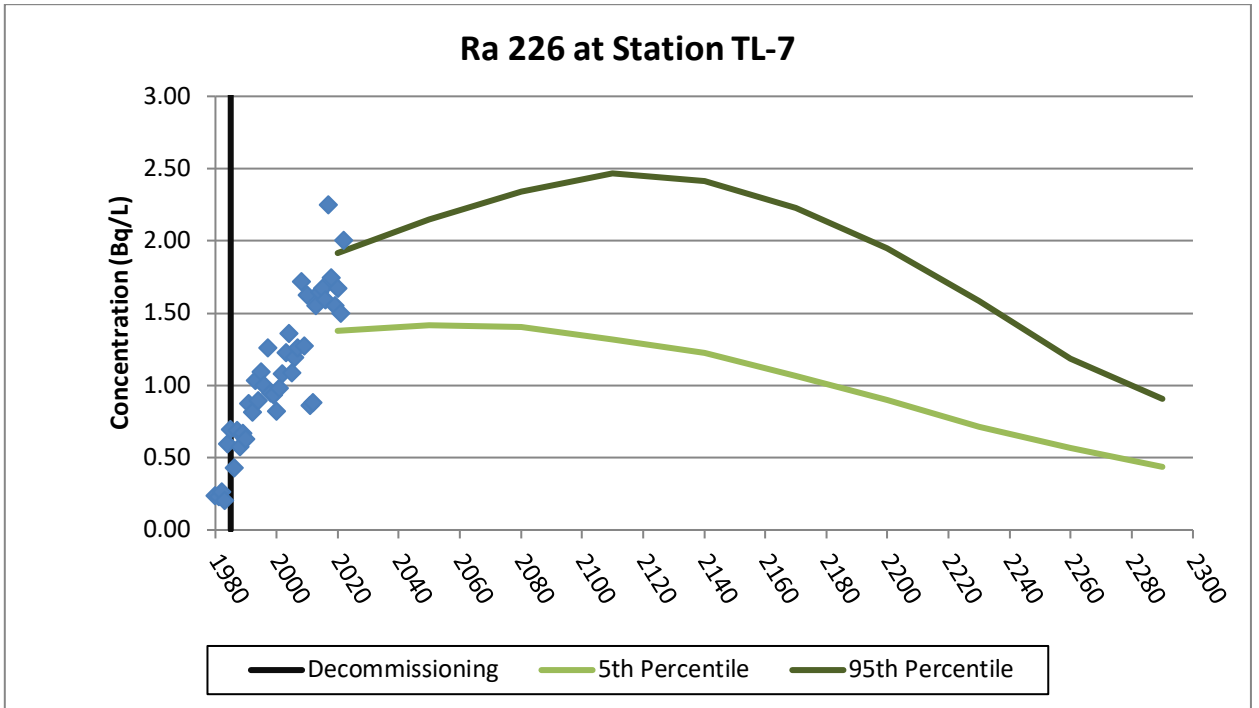
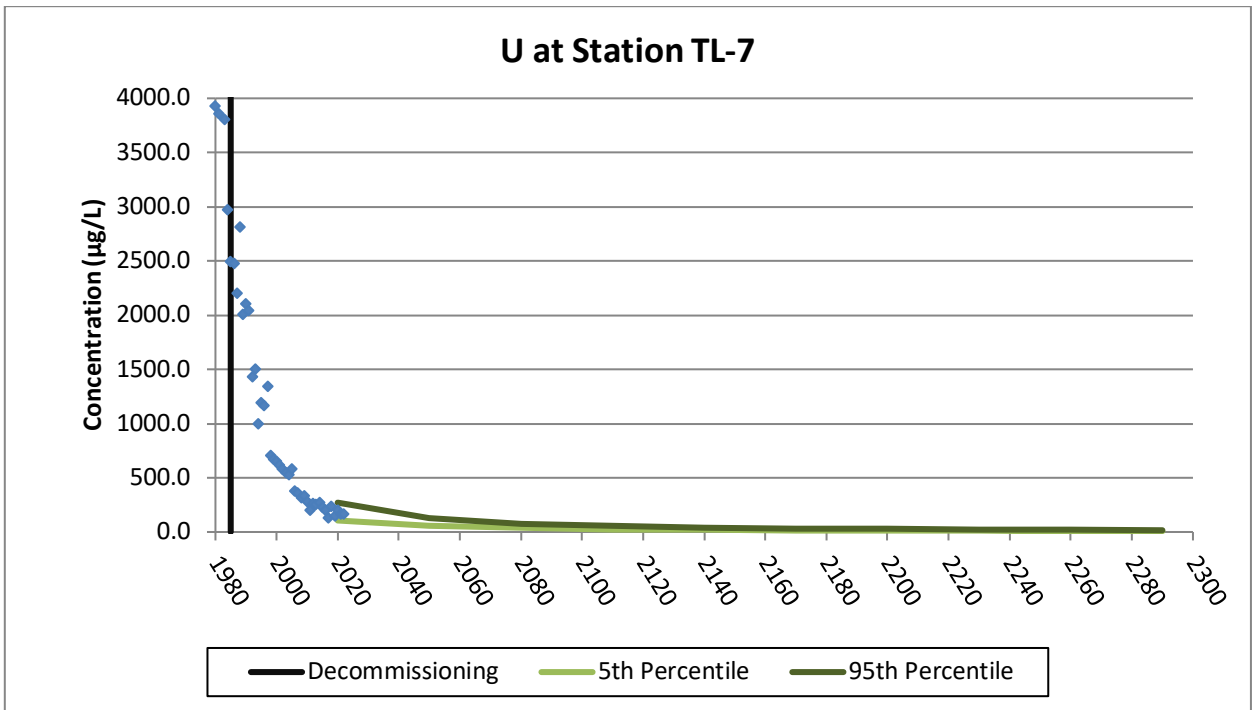
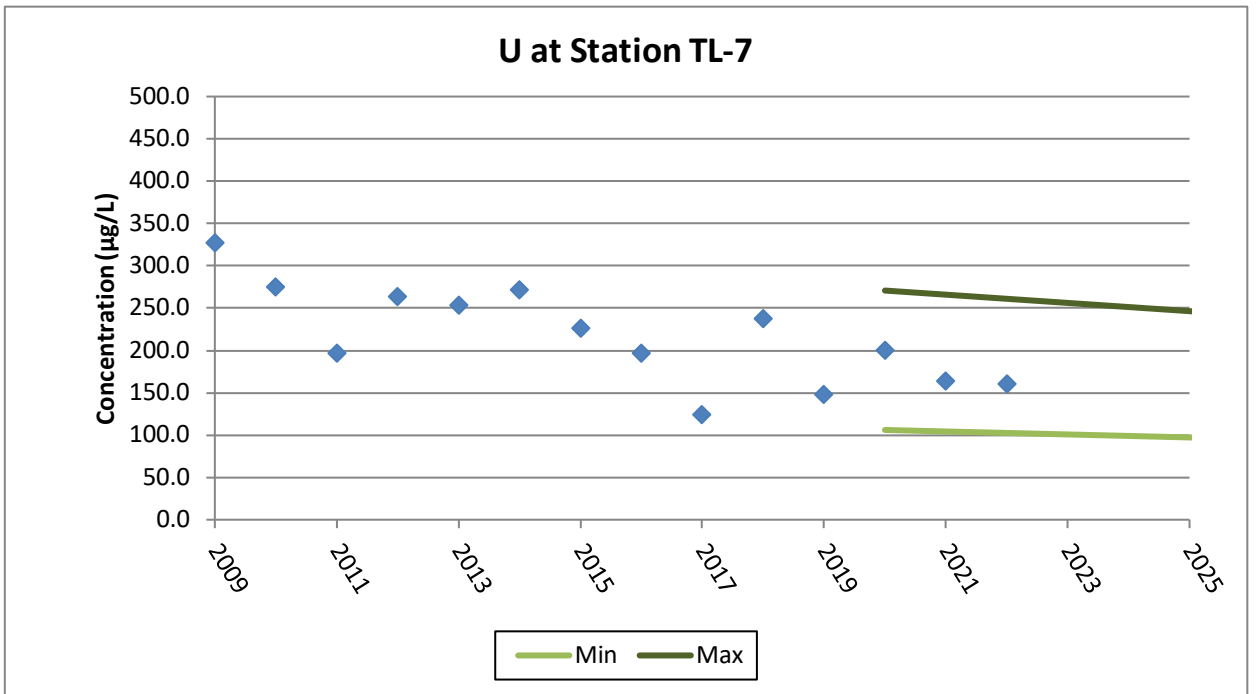
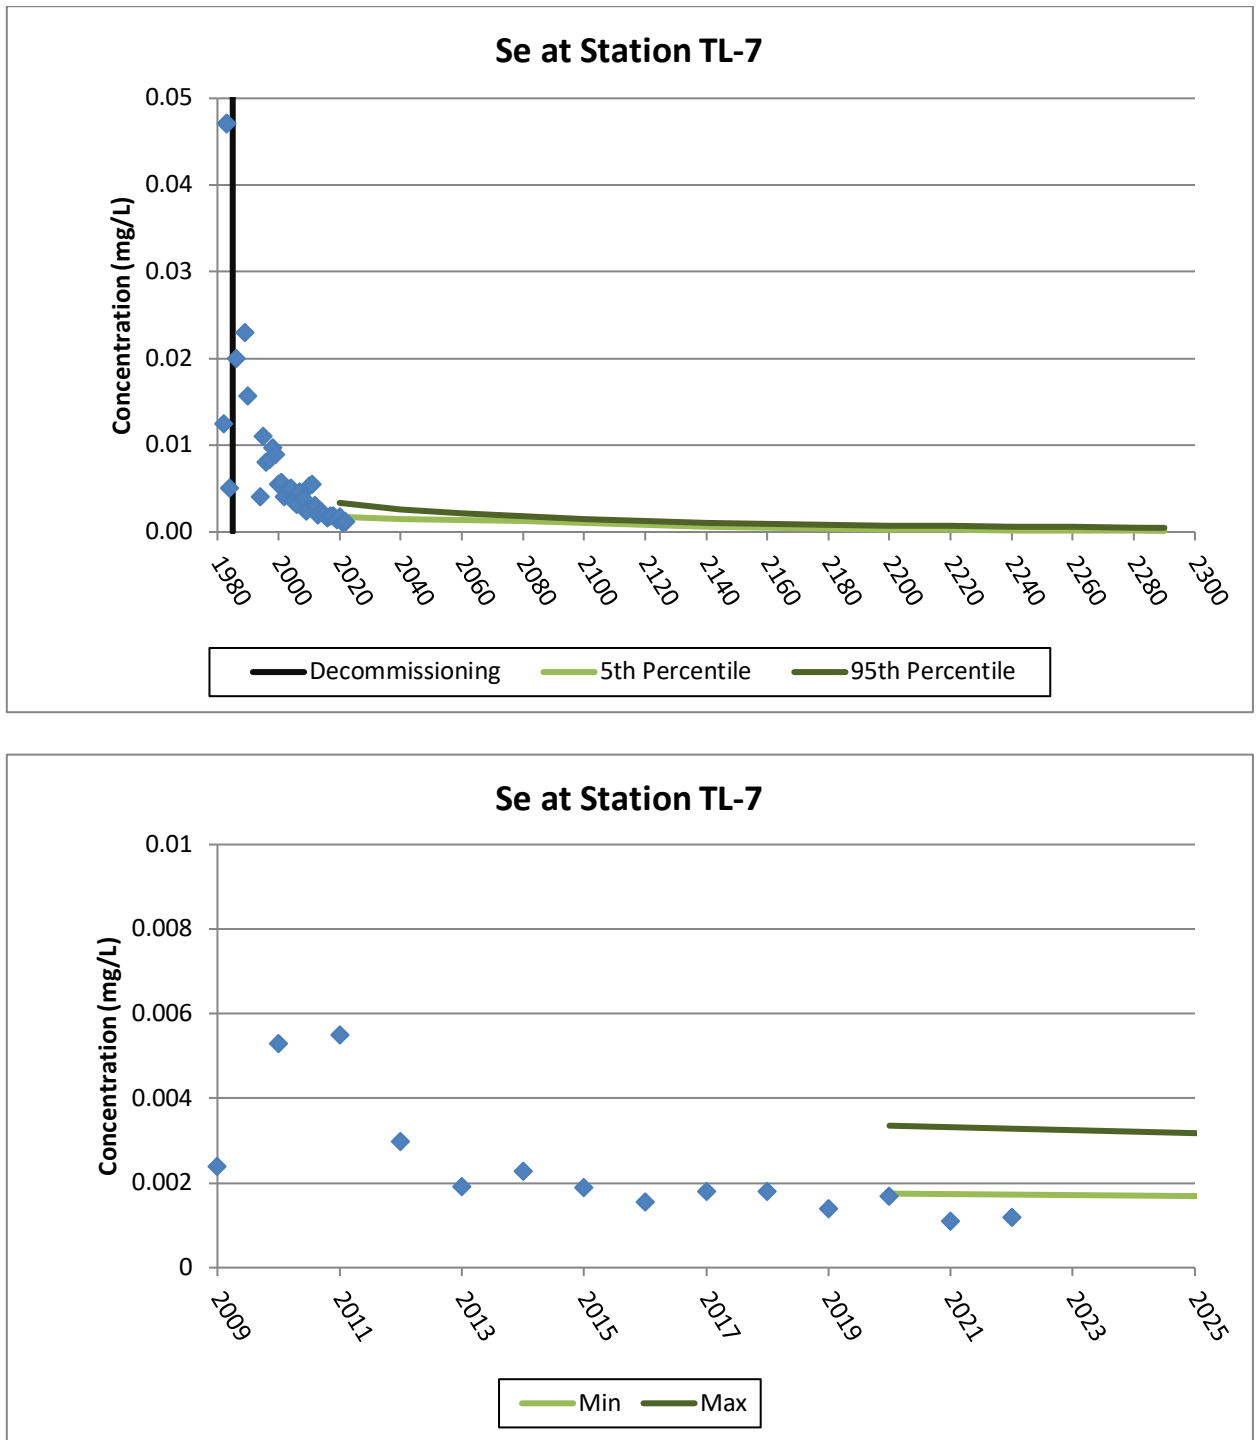
Figures 19 and 20 are provided to show the rapid decrease in uranium and selenium concentrations that occurred following decommissioning. Due to the rapid improvement of selenium and uranium concentrations following decommissioning a second graph showing a more suitable scale of current concentrations is also provided.

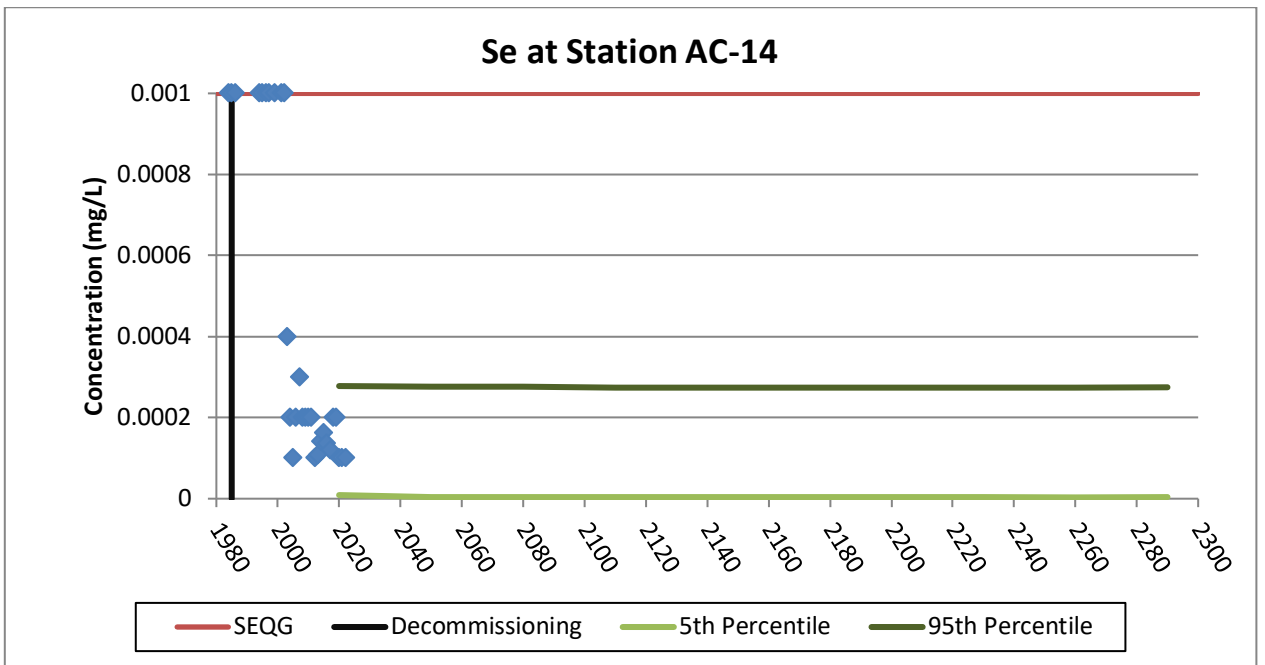
Figure 27: Se Performance Indicator at AC-14

*Note: The reduction in Se concentration noted in the figure is the result of a reduction in lab detection limits

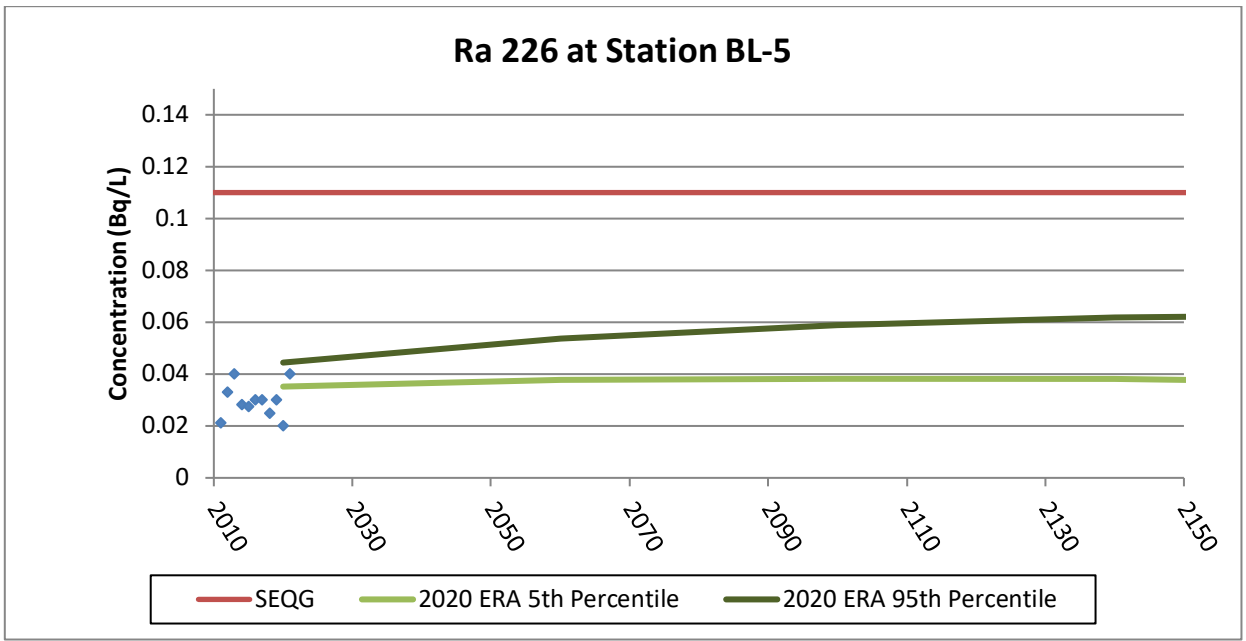
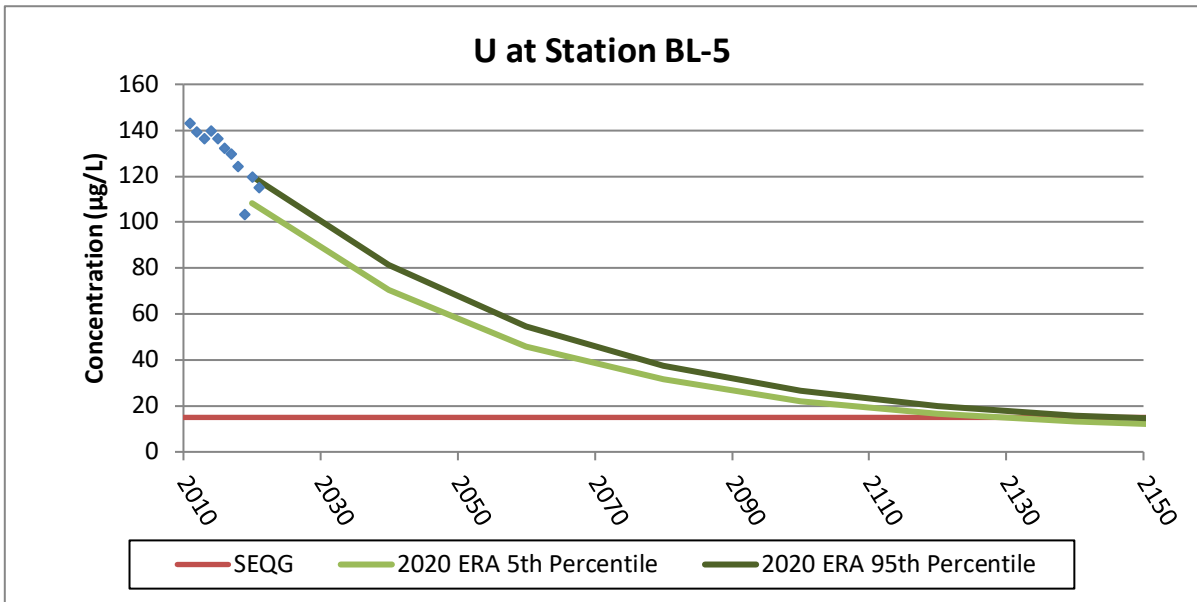
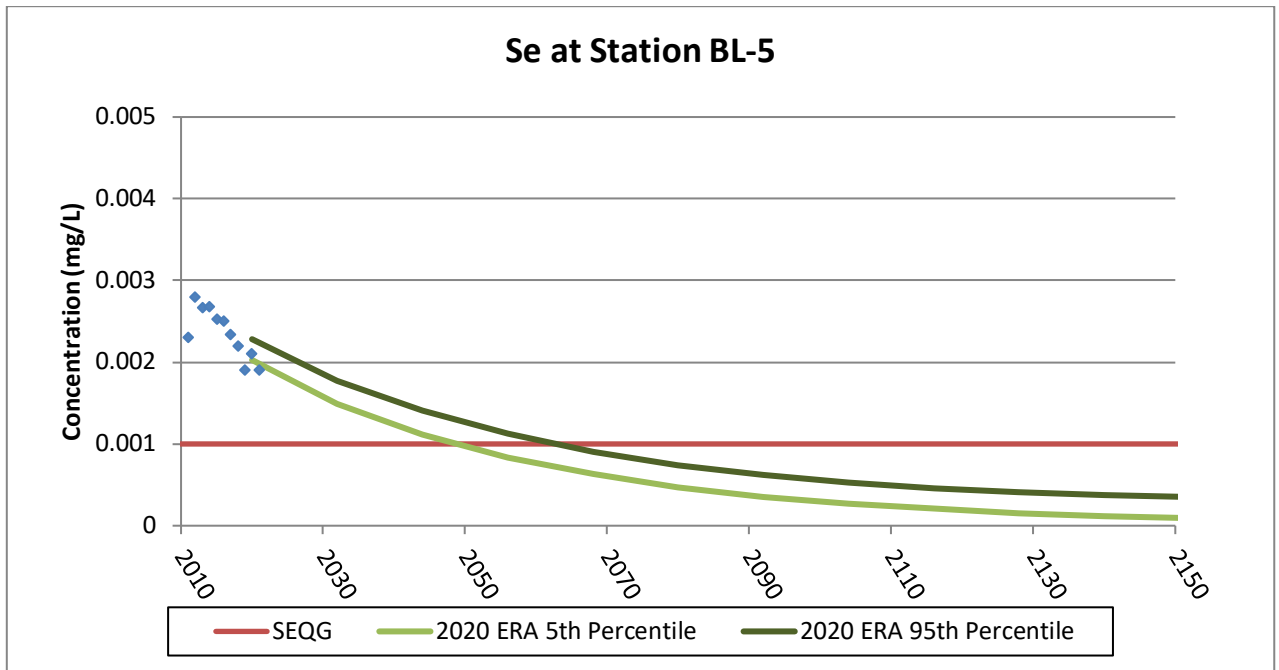
As shown below, the U, Se, and Radium²²⁶ concentrations in 2022 are within the modeled predictions. Radium²²⁶ was below the corresponding SEQG value of 0.11 Bq/L and slightly lower than the modelled predictions.
