Beaverlodge Project 2023 Annual Report Year 38 Transition Phase Monitoring

Prepared for:
Canadian Nuclear Safety Commission
Compliance Report for Licence: WFOL-W5-2120.0/2025
& Saskatchewan Ministry of Environment
Compliance Report: Beaverlodge Surface Lease

Prepared and Submitted by:
Cameco Corporation

March 2024

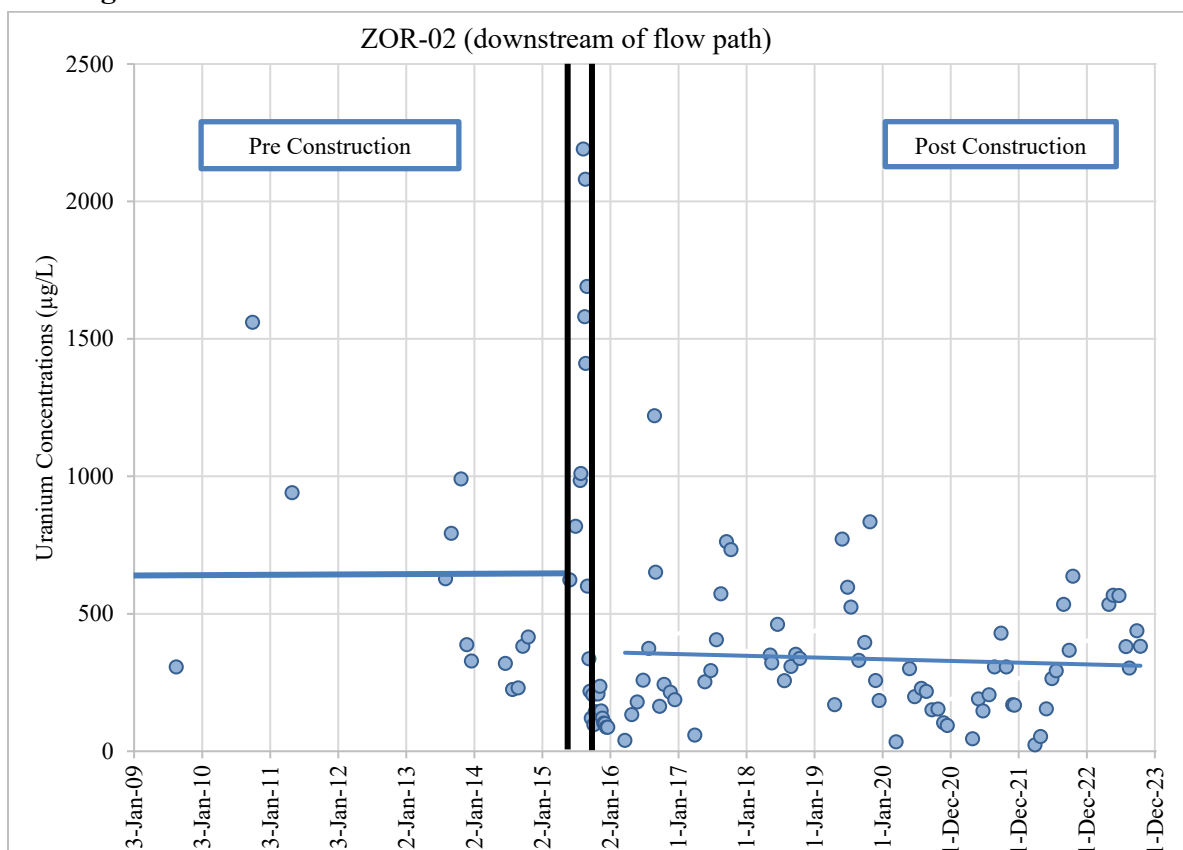
Figure 4.3-9 - ZOR-02 Uranium Concentrations Pre and Post Construction

Figure 4.3-9 shows the results of water sample data collected at ZOR-02 through the various phases of pre-construction, construction and post construction. Also provided are general trend lines showing the relative improvement in water quality post-construction. The Pre-Construction trend line is the overall average U concentration for that period, while the Post-Construction (starting in 2016) is a linear trend line created using the annual U concentration averages.

The fluctuations in U concentrations observed through construction and following construction are reflected in the concentration of U measured at the outlet of Verna Lake (AC-6A) which increased, as expected, immediately following construction but has seen improvement in subsequent years. Uranium concentrations measured at the monitoring station AC-8 located in Ace Lake (immediately downstream) have remained below the SEQG since 2012. A summary of annual mean U and Ra-226 data from 2010 to 2023 at ZOR-02, AC-6A, and AC-8 is presented in **Table 4.3.1-3**. As AC-6A flows into Ace Lake, data from the outlet of Ace Lake (AC-8) is presented for context, as the downstream water quality monitoring station meets SEQG.

Monitoring data reflects the expected results following the remedial work and are expected to gradually improve in the future.

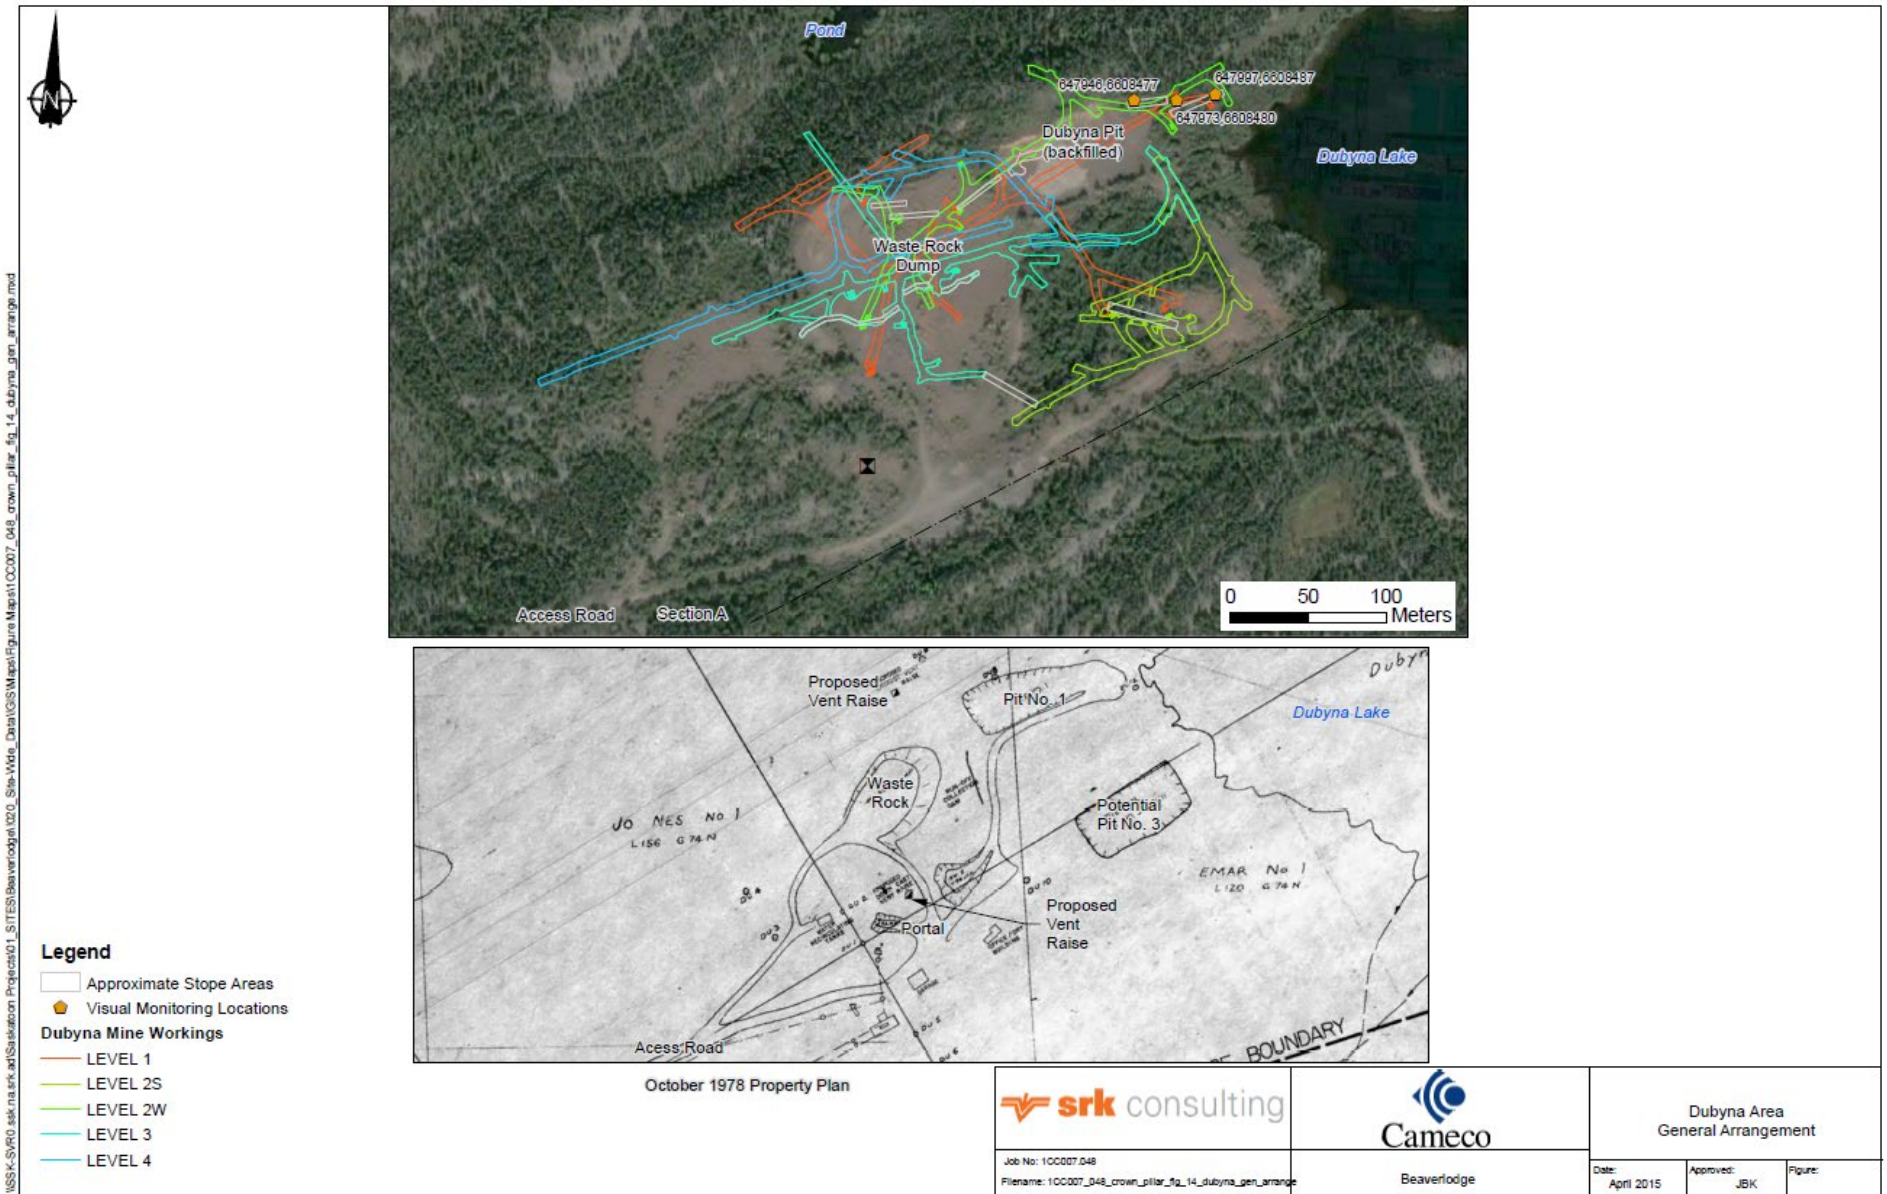
Figure 4. Dubyna area general arrangement

It was noted at Dubyna that recent beaver activity resulted in significant clearing along the crown pillar inspection area. As well, a beaver lodge was constructed along the shore of Dubyna Lake near furthest extent of the crown pillar.

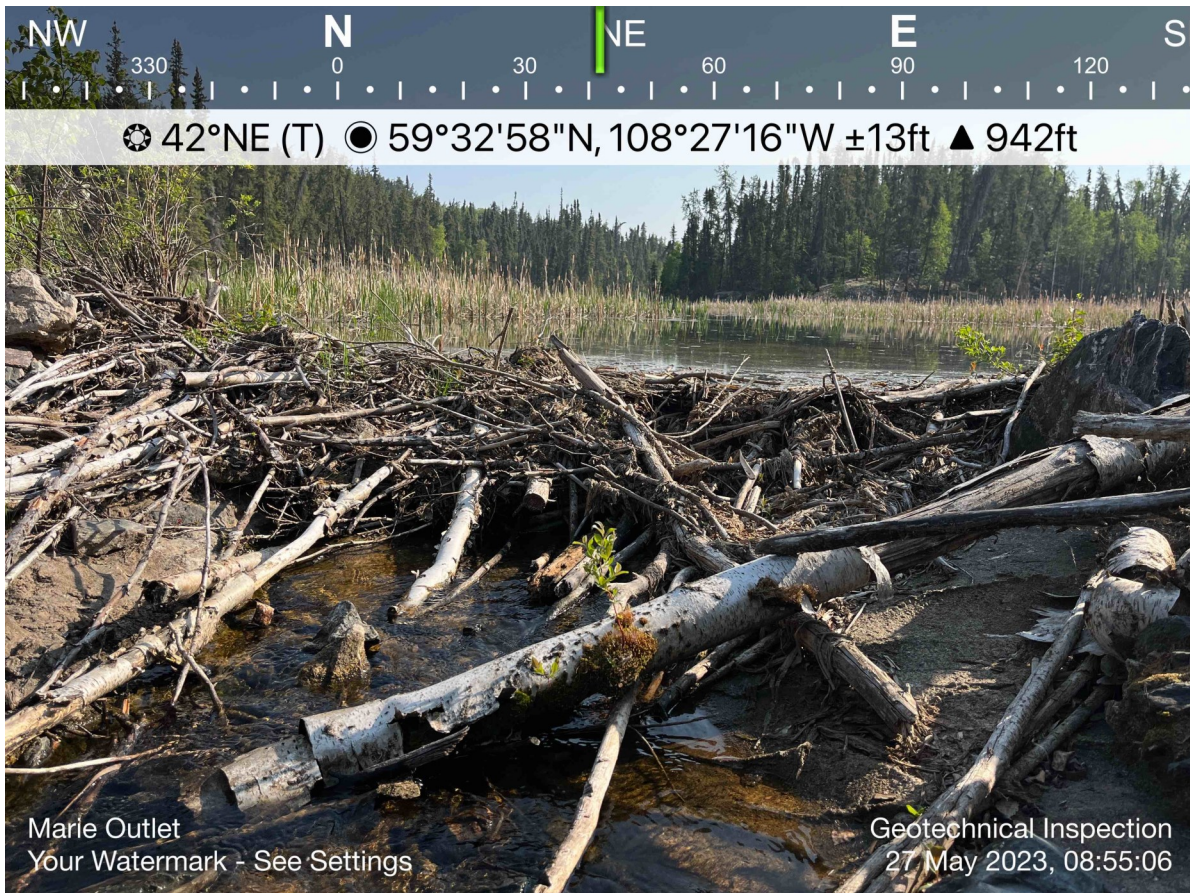
- A beaver dam previously noted at the Marie spillway remains active. The crest of the beaver dam appears to be similar to previous years, although the water level behind the dam appears to be slightly lower.

Photo A2 - Marie Reservoir Spillway inlet; beaver dam first noted in 2018

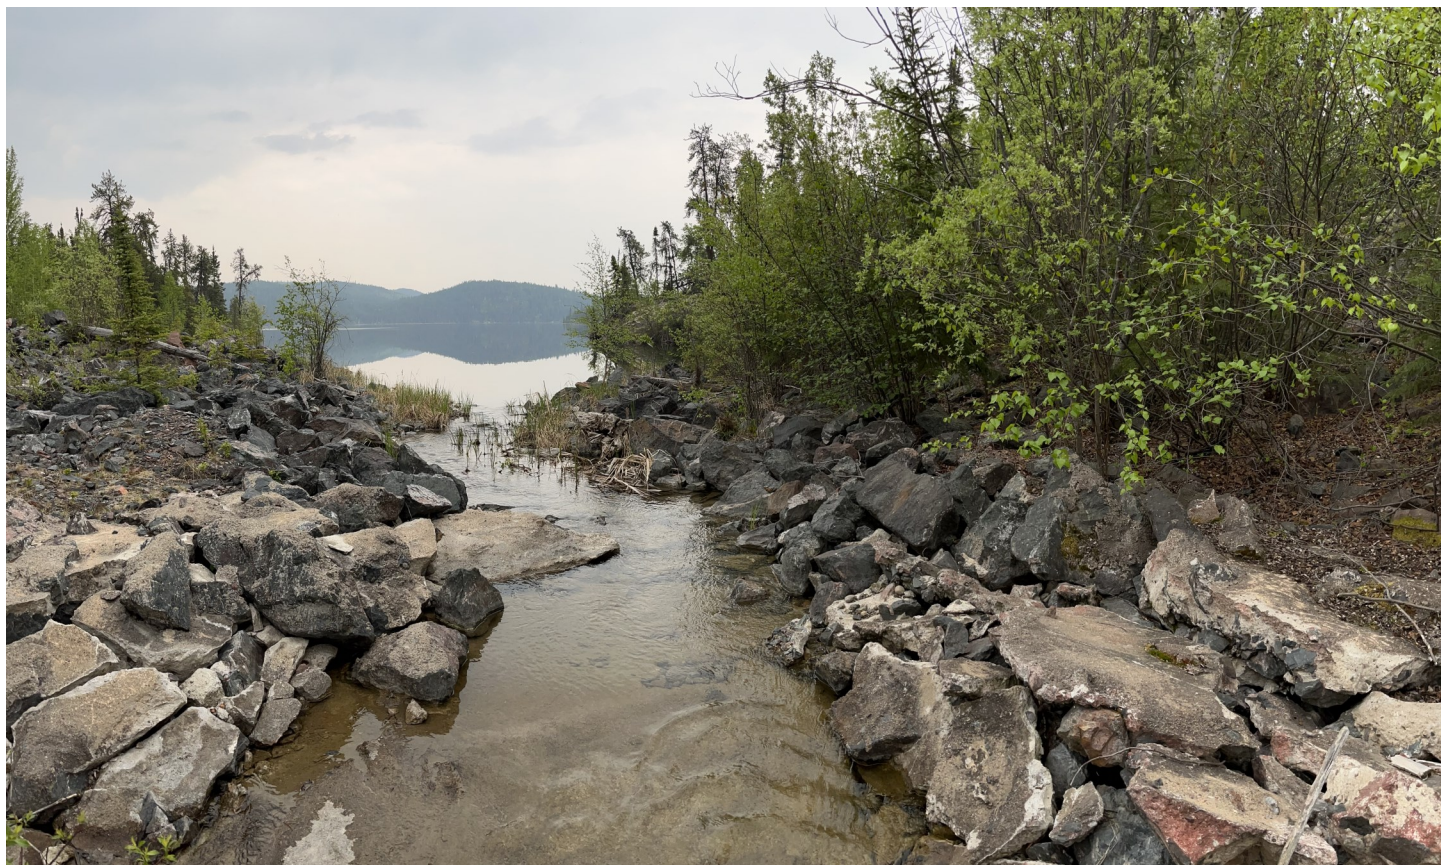
Photo B5 – Fookes Reservoir Spillway showing broken rip-rap on north and south sides of channel. Note debris has been removed since 2022 inspection.

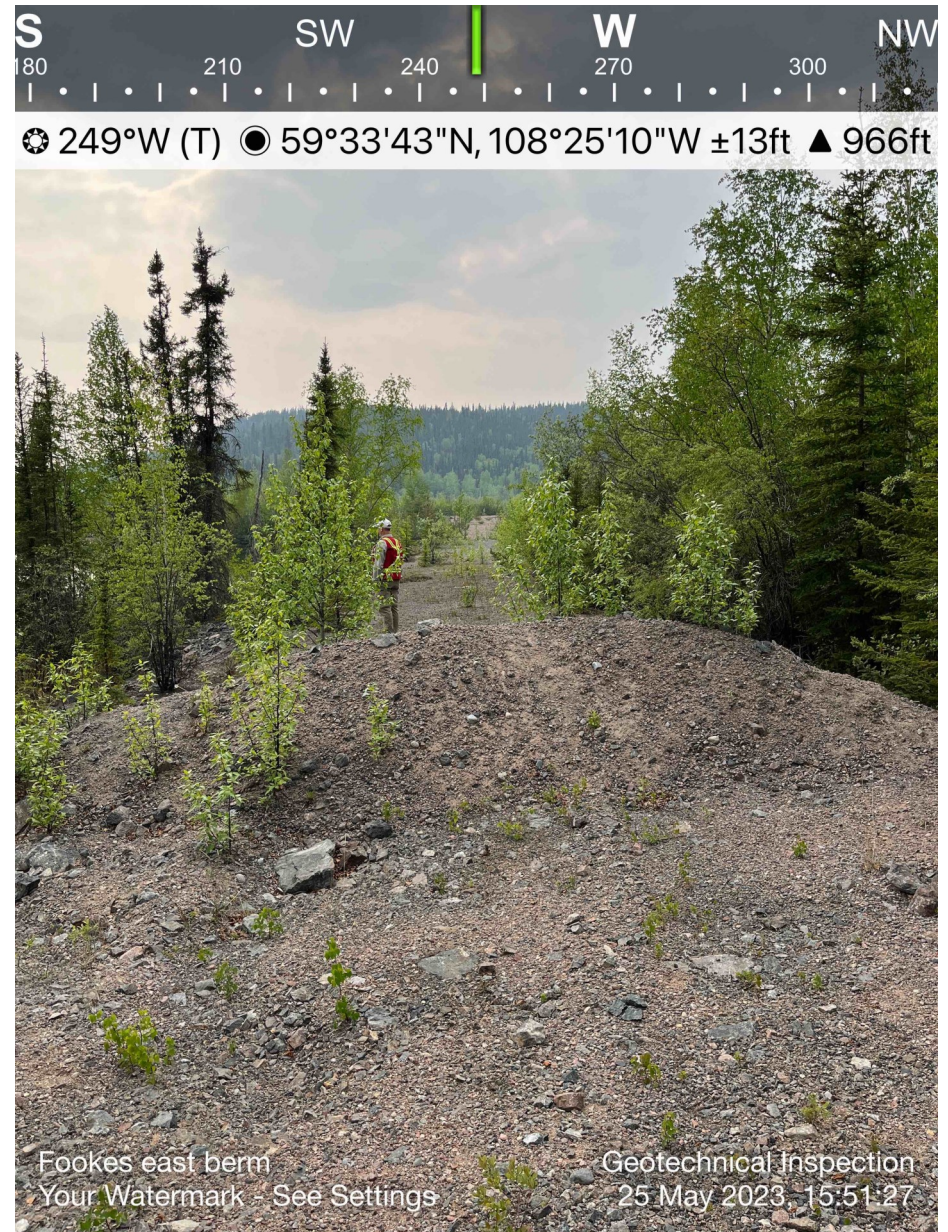
Since the earthen berms protecting the east and west access points to the Fookes Delta were repaired and reinforced in 2011 and 2012 respectively, there has not been any new evidence of passenger vehicular traffic accessing the delta. In 2022, there was some localized ATV traffic noted on the Fookes Delta cover, however no new disturbance was noted in 2023. A photo of the berm located on the east access point is provided in Appendix C (**Photo C7**).

Photo C7 – View of east berm looking onto the delta. No evidence of traffic crossing the berm (May 2023).

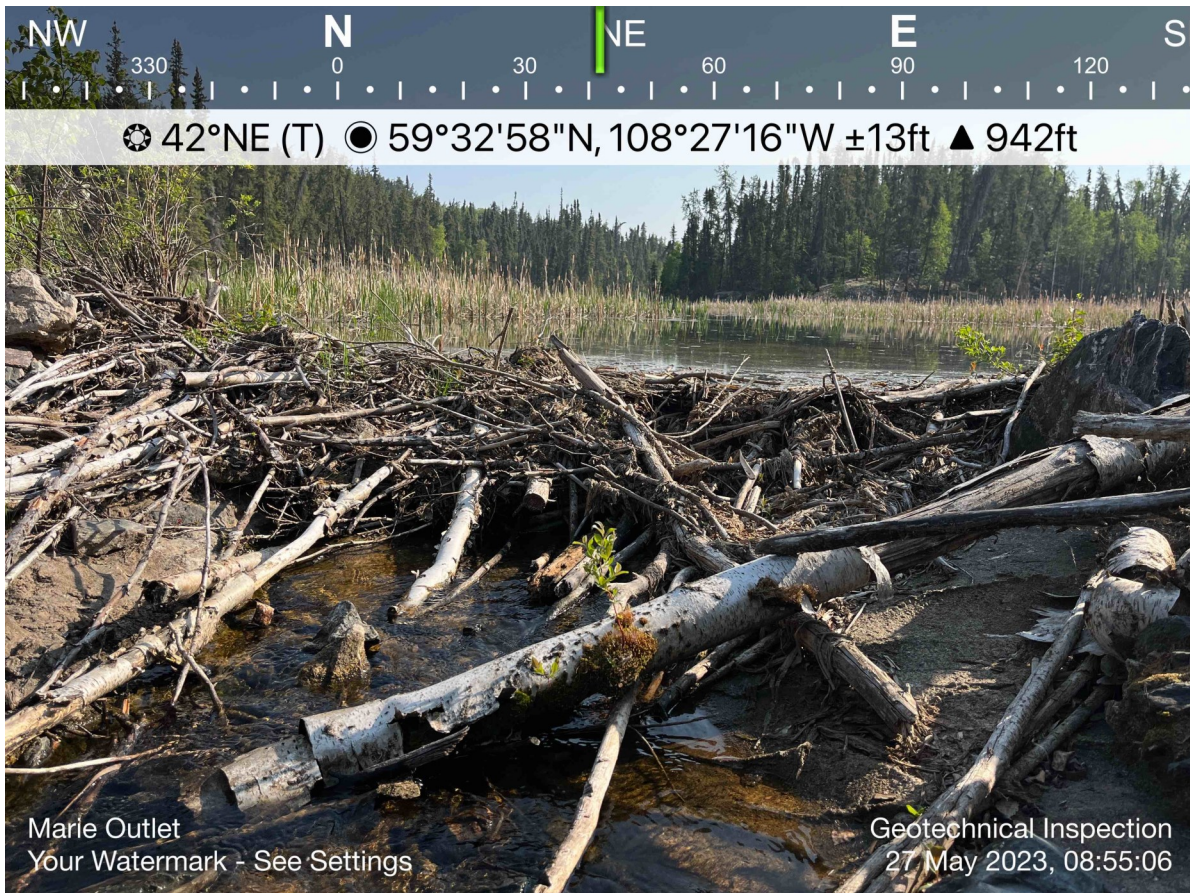
Photo A2 - Marie Reservoir Spillway inlet; beaver dam first noted in 2018

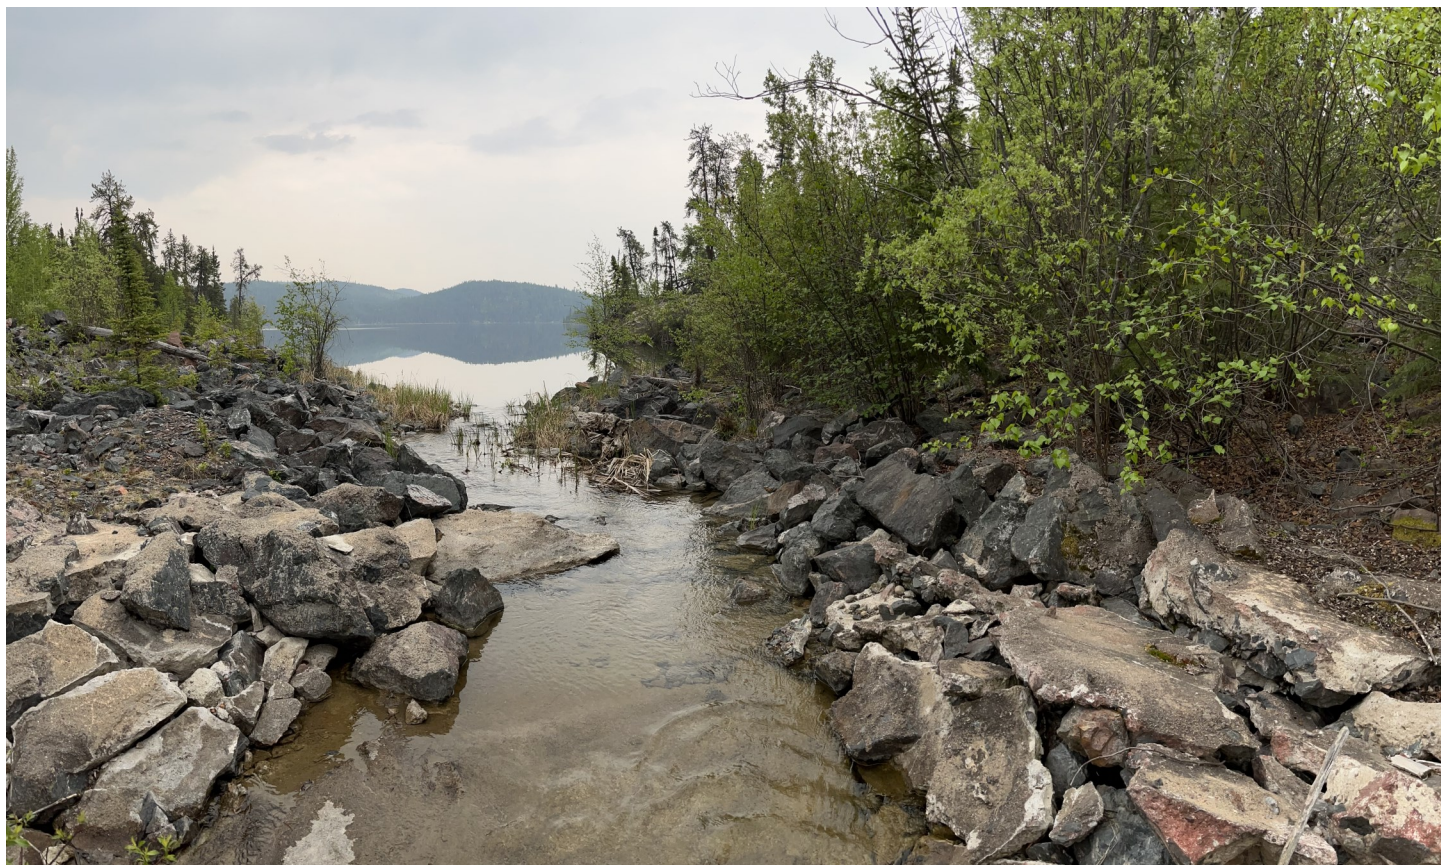
Photo B5 – Fookes Reservoir Spillway showing broken rip-rap on north and south sides of channel. Note debris has been removed since 2022 inspection.

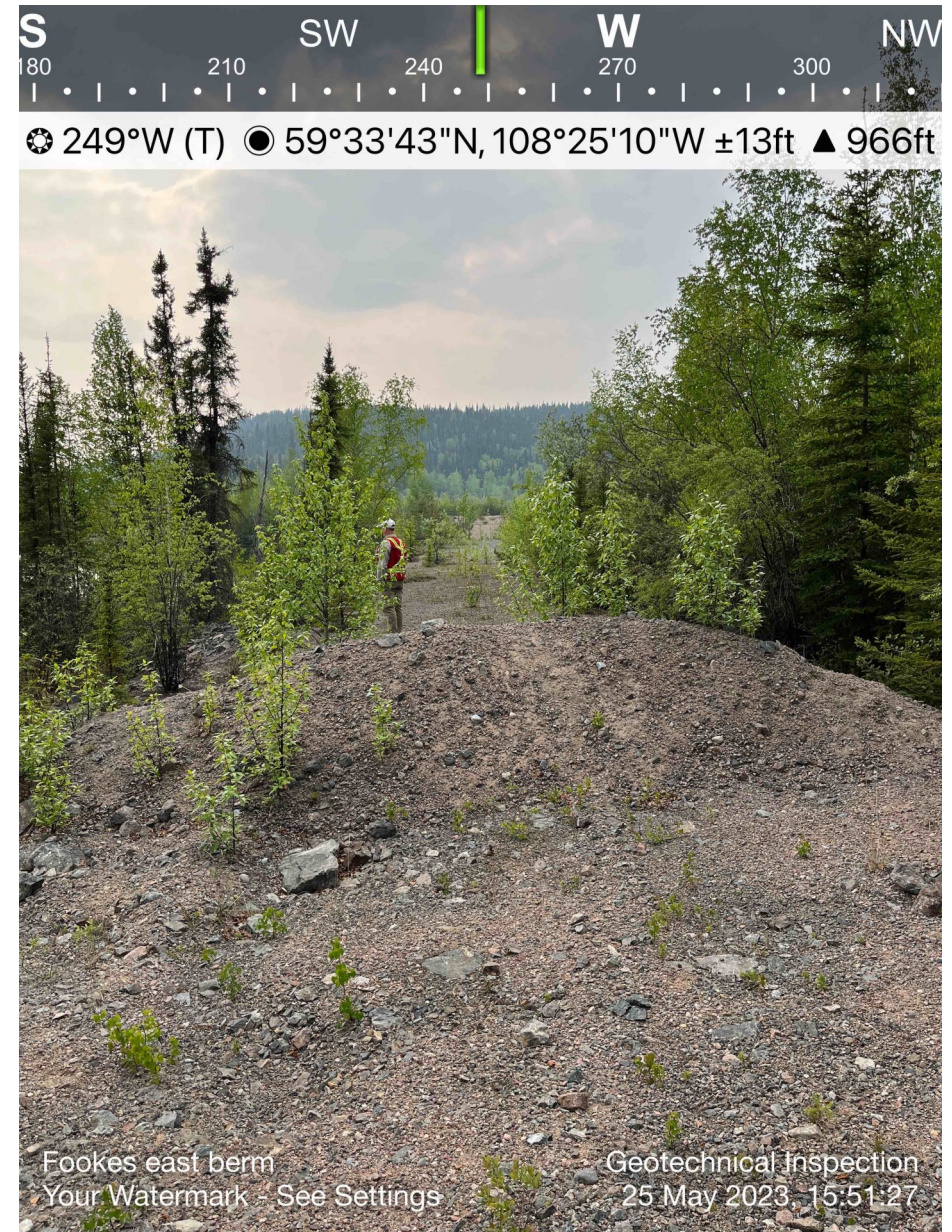
Photo C7 – View of east berm looking onto the delta. No evidence of traffic crossing the berm (May 2023).
