BEAVERLODGE PROJECT

Beaverlodge Project 2015 Annual Report

Year 30 Transition Phase Monitoring

Cameco Corporation

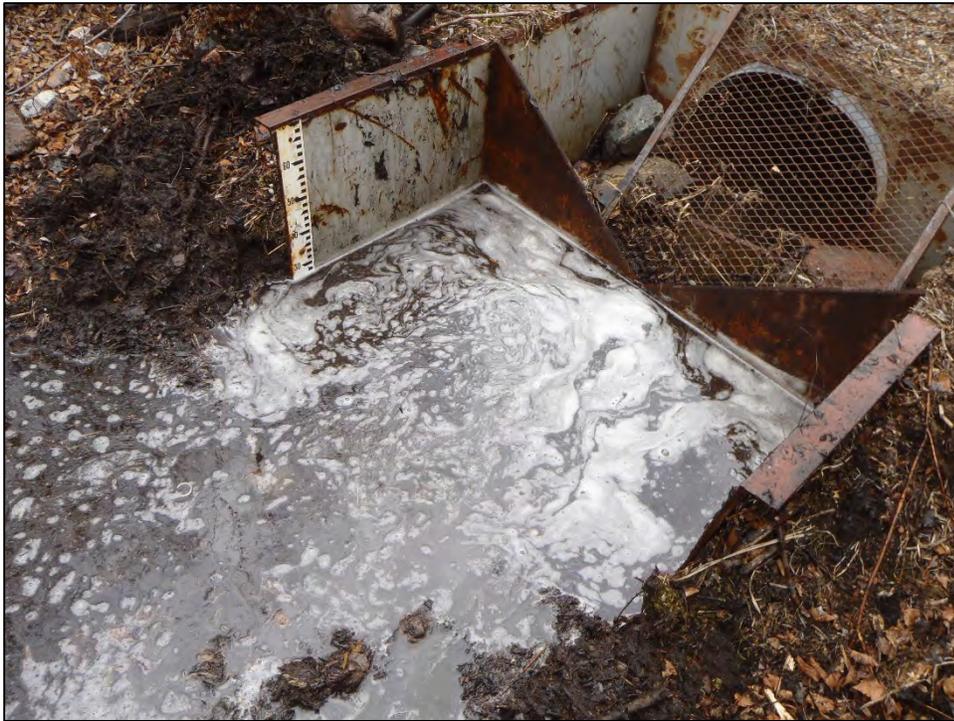
Photo 1: AC-6A No Flow – May 2, 2015

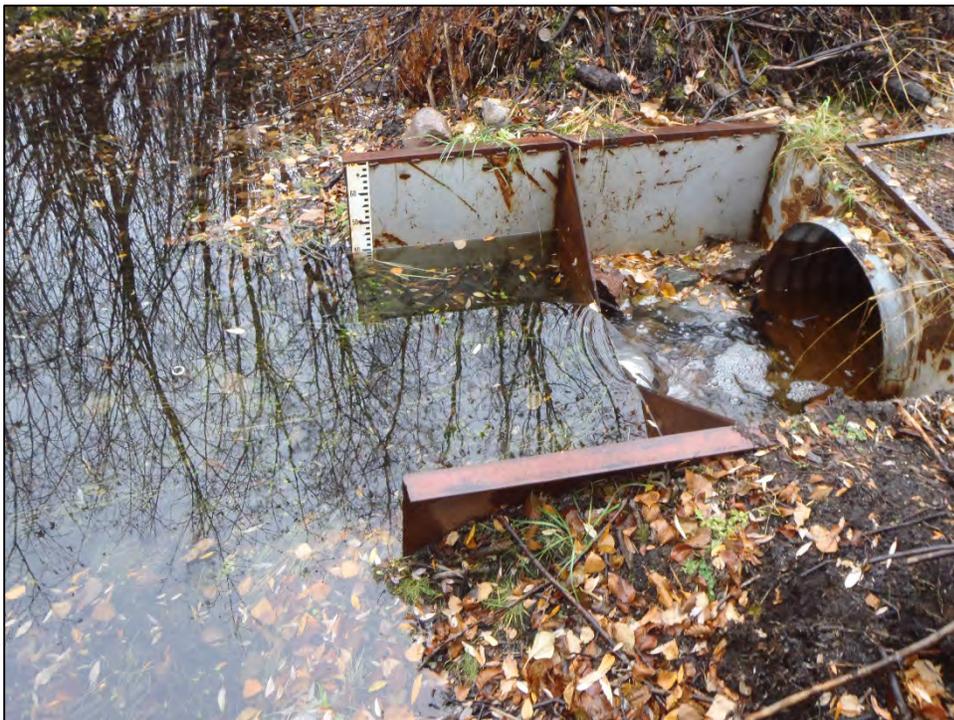
Photo 2: AC-6A Fall Flow Condition – October 2, 2015

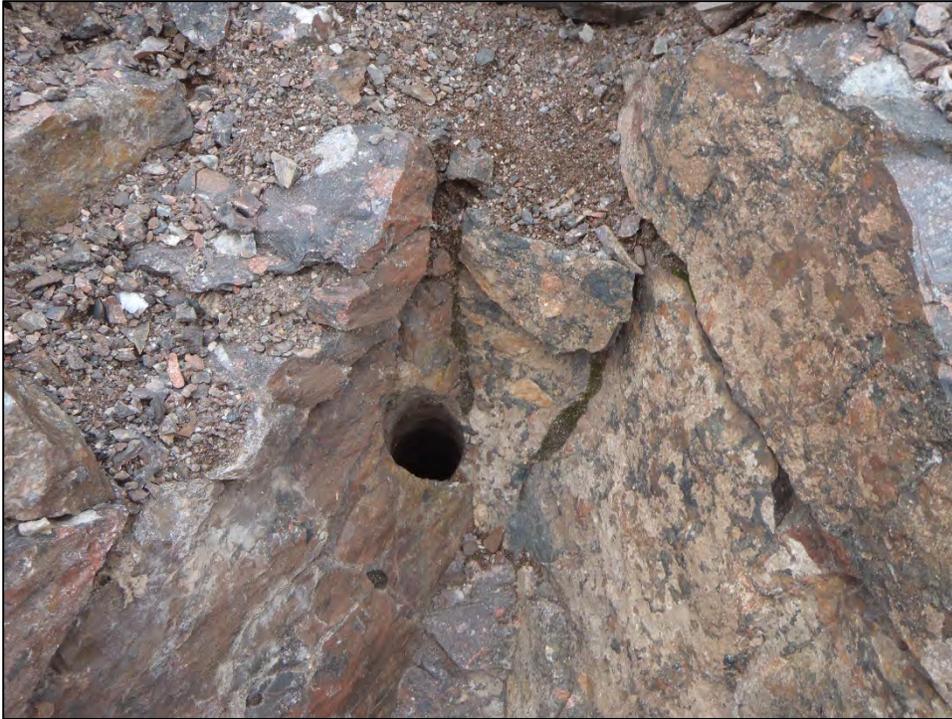
Photo 17: New Borehole on Bedrock Bench

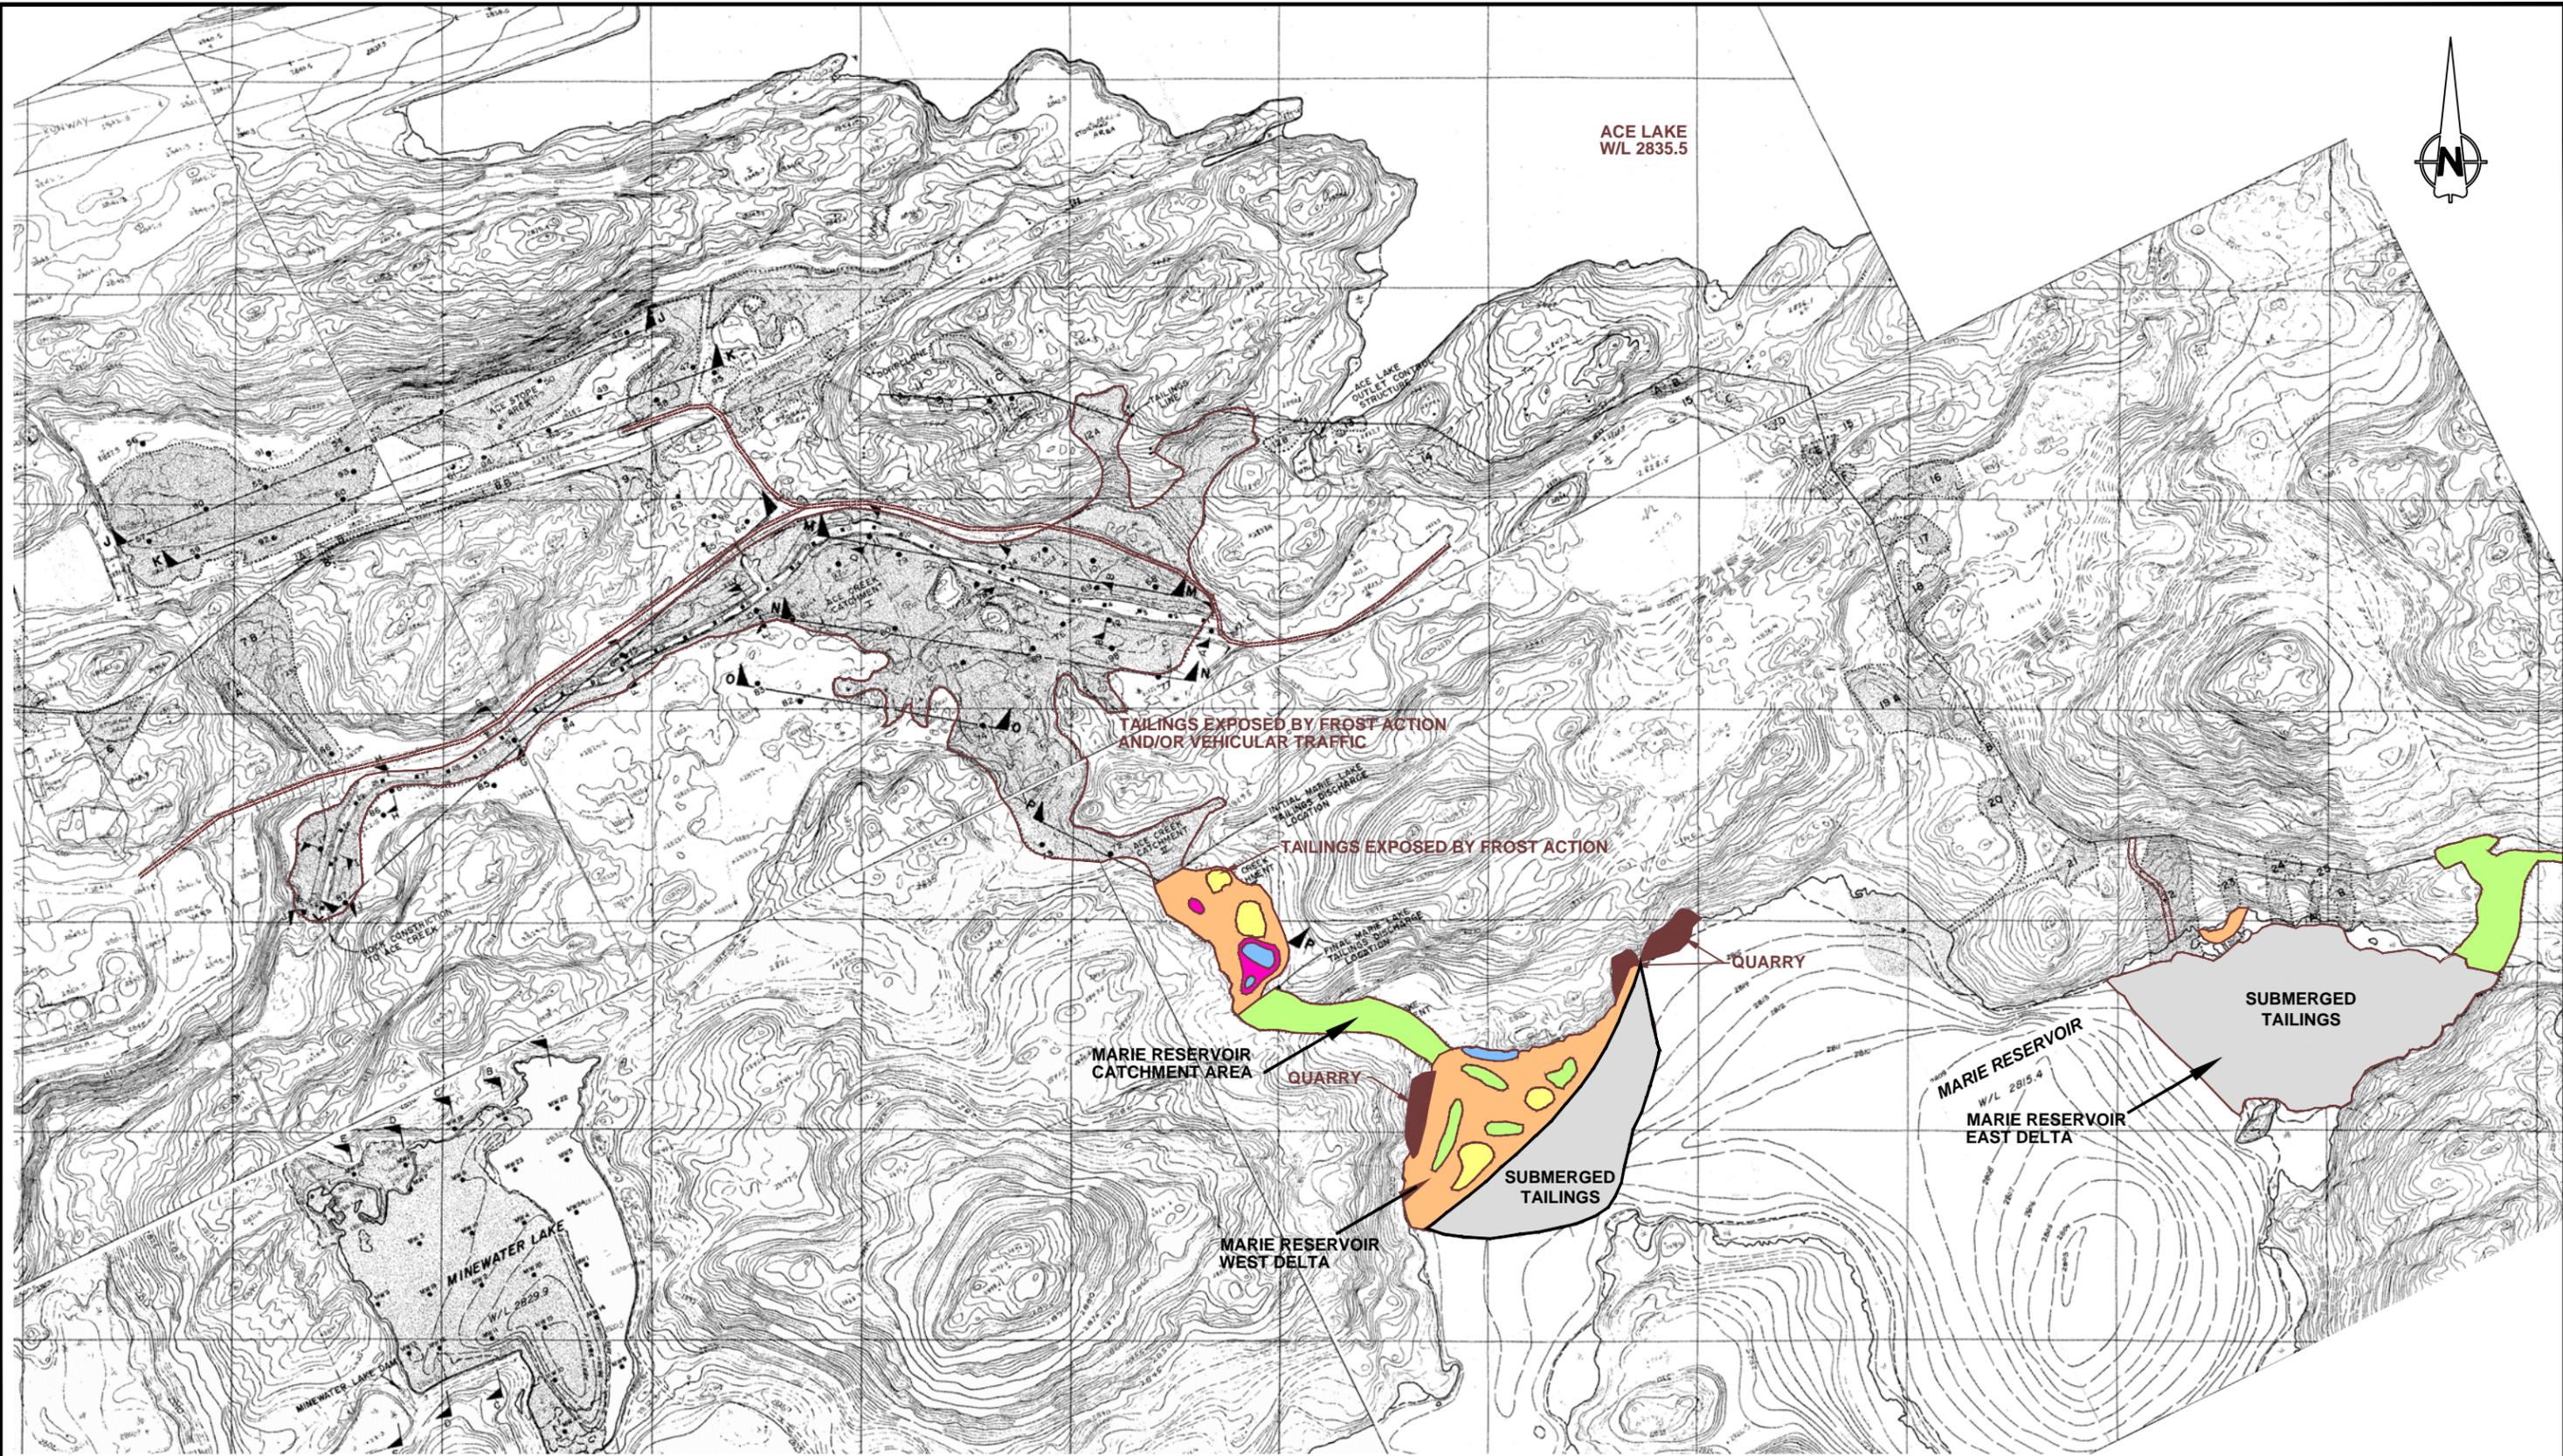
BEAVERLODGE INSPECTION			
COVER MAP BASED ON 2015 ASSESSMENT			
PROJECT NO. 1CC007.055	DATE Feb. 2016	APPROVED CCS	FIGURE 7

In general, the condition of the waste rock cover was considered good, with little change observed on the delta areas in comparison to previous inspections. Both deltas consist of mainly rock fill cover with some small trees, shrubs and grass. During the inspection, some areas of the cover were noted to be thin and tailings appeared to have worked their way to surface in some isolated locations due possibly to either frost action or high water table, or a combination of both.

Based on the results of the 2014 Site Wide Gamma Survey (SENES 2014) as well as the follow up Risk Assessment (Arcadis 2015), the risk to members of the public presented by gamma radiation at the Marie Reservoir Delta Areas was considered negligible. Low readings from the survey along with very low reported usage of these areas (along with limited access) led to the recommendation that no further cover was required.
