BEAVERLODGE PROJECT

Beaverlodge Project 2020 Annual Report Year 35 Transition Phase Monitoring

Prepared for:
Canadian Nuclear Safety Commission
Compliance Report for Licence: WFOL-W5-2120.0/2023 &
Saskatchewan Ministry of Environment
Compliance Report: Beaverlodge Surface Lease

Prepared and Submitted by:
Cameco Corporation

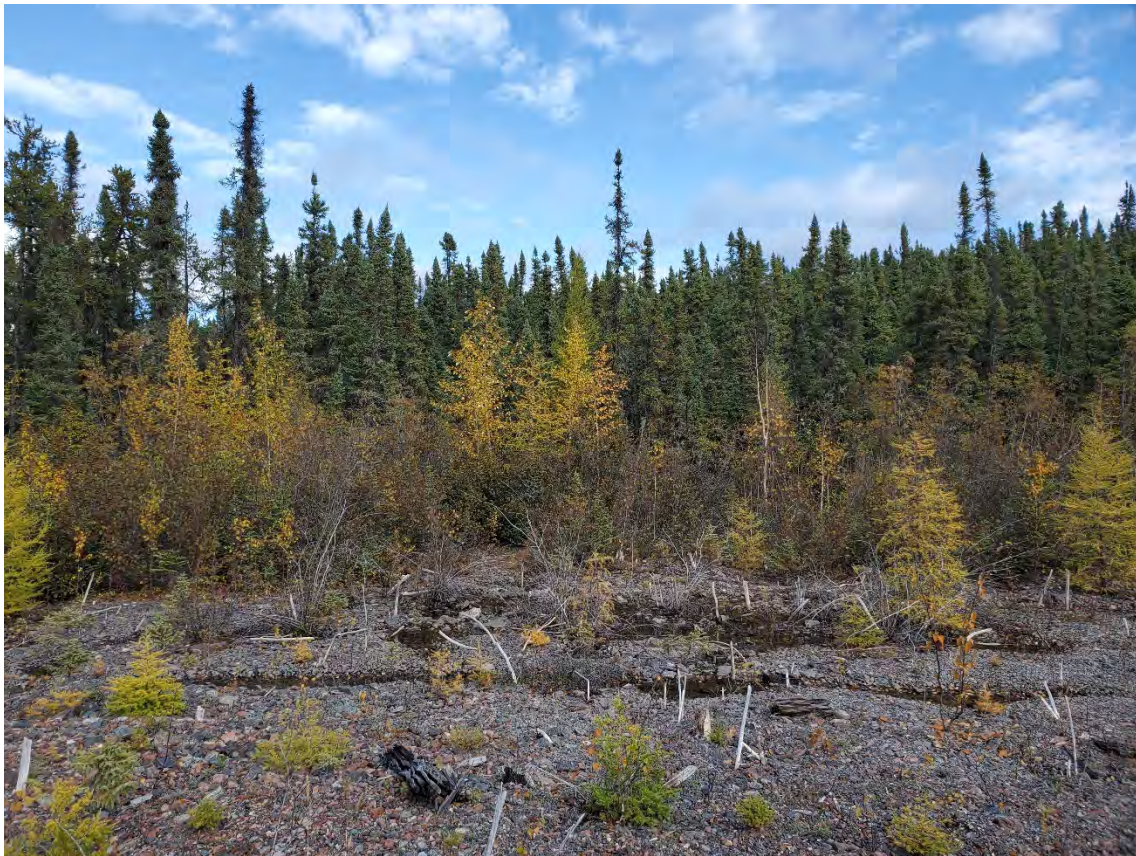
Photo 40: Looking east along the eastern boundary of the Ace Creek catchment area III. Small depressions that coalesced into one another can be seen. Photo taken on September 16, 2020.

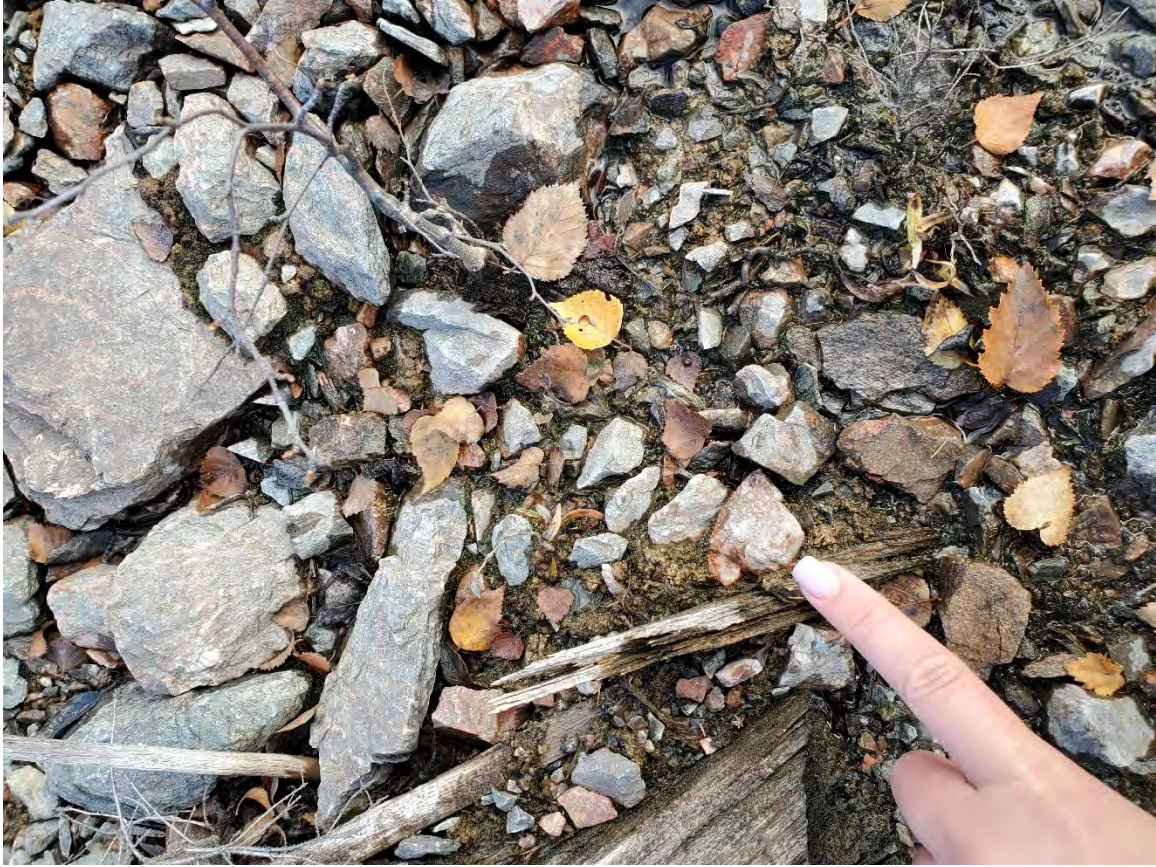
Photo 41: Along the eastern boundary of the Ace Creek catchment area III, same location as Photo 40, possible tailings have day-lighted at surface. Photo taken on September 16, 2020.

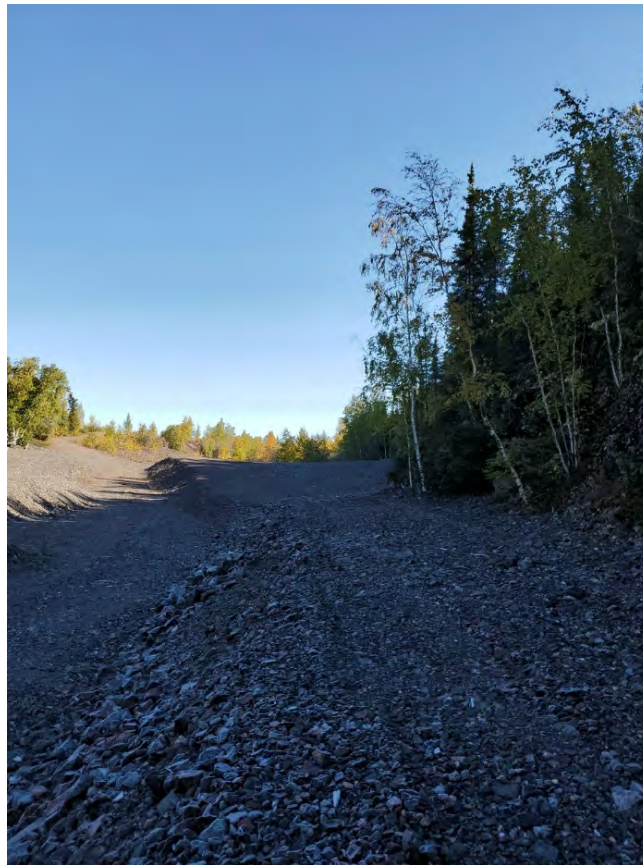
Photo 43: Looking northeast along the southern area. No surface subsidence or tension cracks visible along the surface. Photo taken on September 16, 2020.

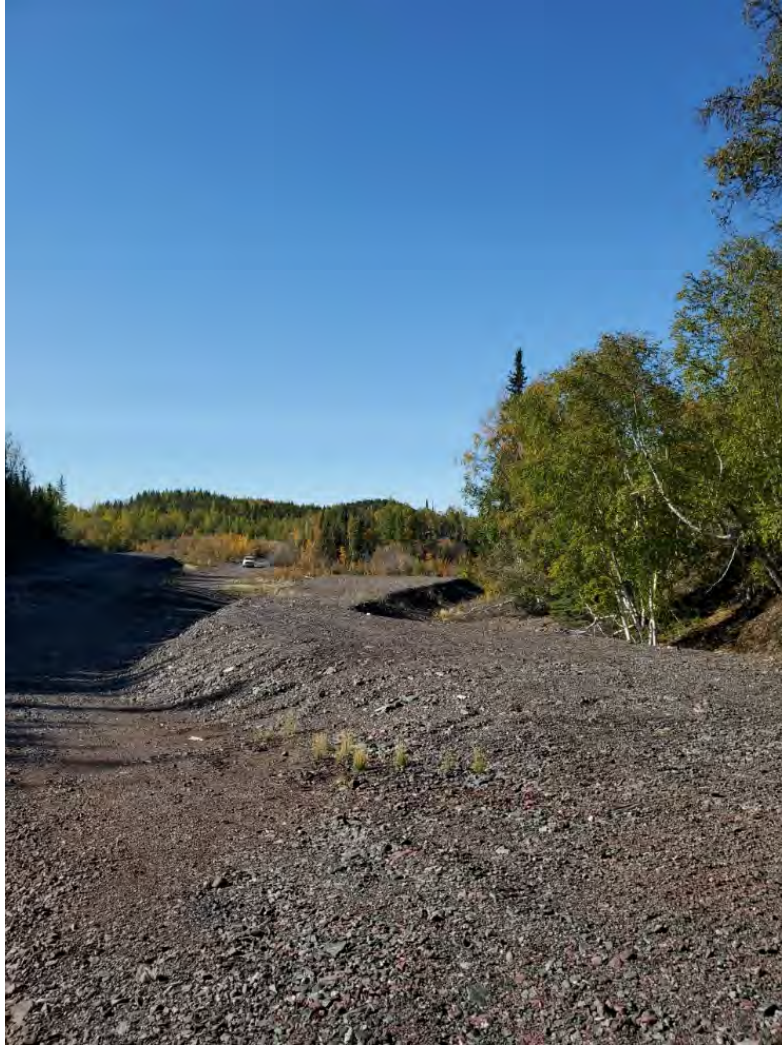
Photo 44: Looking south along the northern area. No surface subsidence or tension cracks visible along the surface. Photo taken on September 16, 2020.

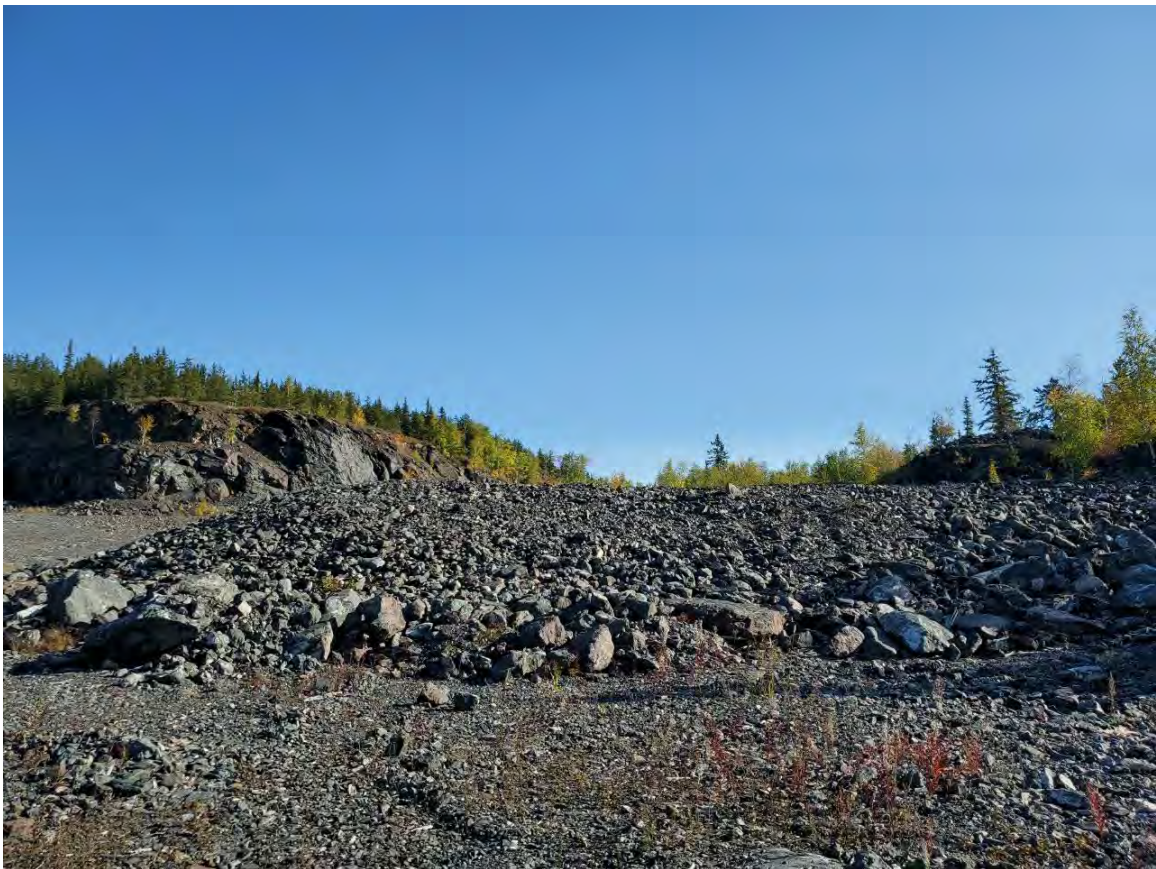
Photo 46: Looking northeast towards the Bolger Pit, the berms are still intact. Photo taken September 17, 2020.

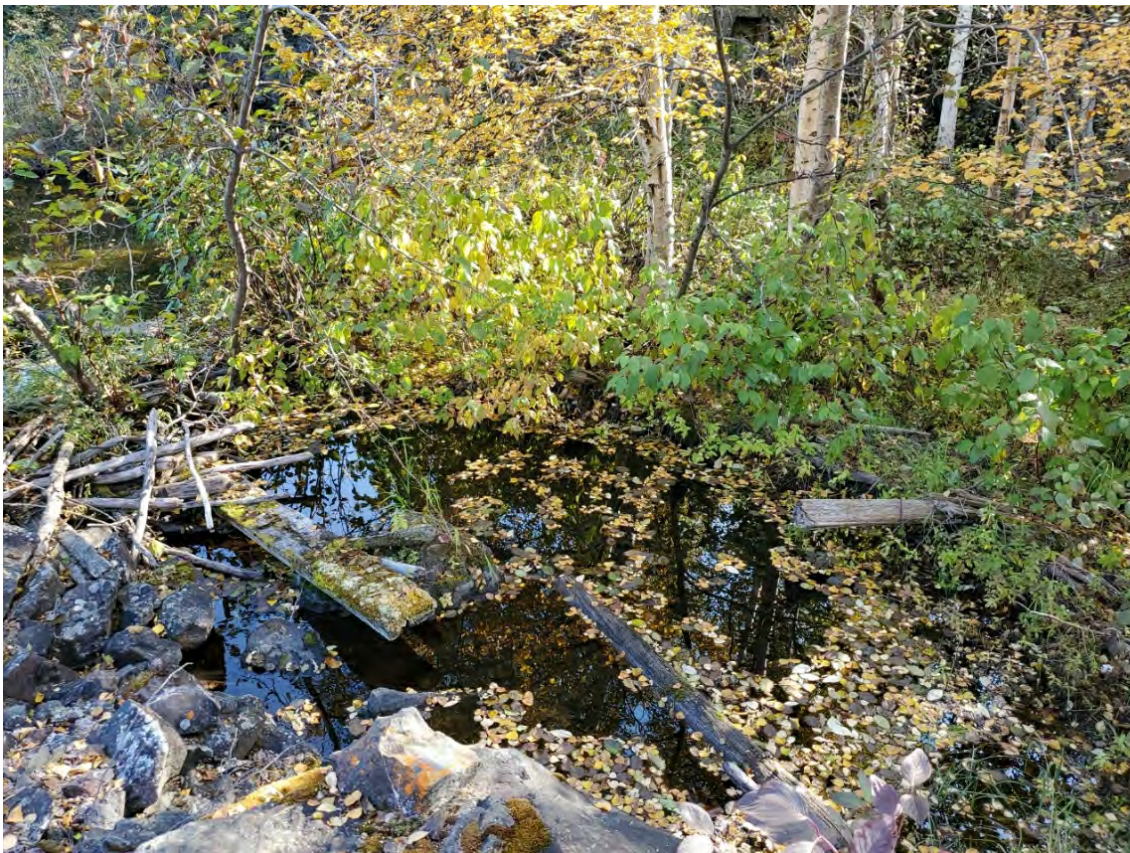
Photo 48: Looking south at the edge of the beaver dam at the upstream limit of the Zora Creek channel. This is the start of the Drainage Channel flow path (Figure 9). Photo taken September 17, 2020.
