Beaverlodge Institutional Control Inspection Field Guide

Ministry of Energy and Resources Government of Saskatchewan

Cameco Corporation

Issued Date: March 2024

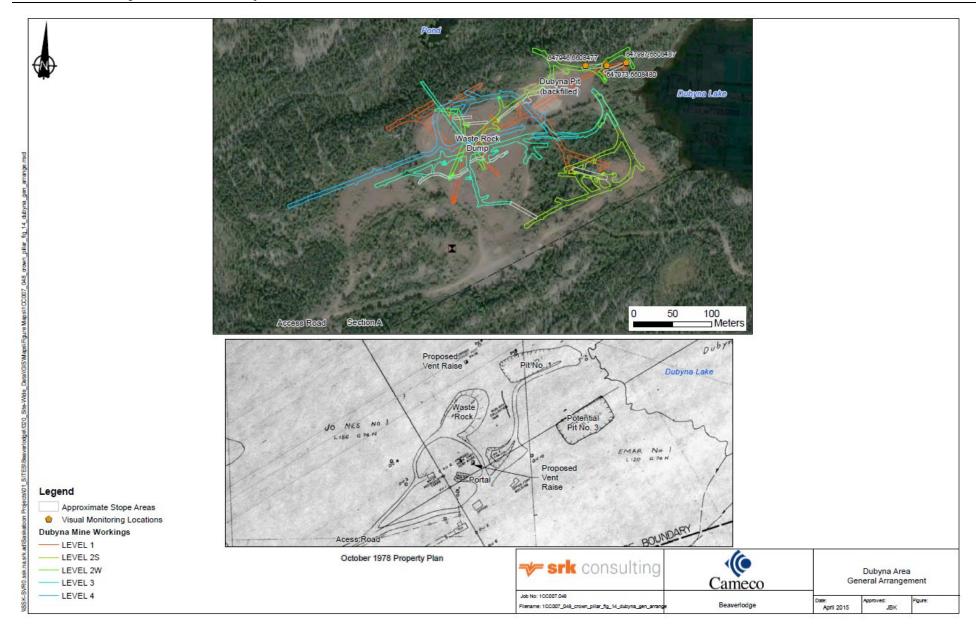
Figure 4. Dubyna area general arrangement

It was noted at Dubyna that recent beaver activity resulted in significant clearing along the crown pillar inspection area. As well, a beaver lodge was constructed along the shore of Dubyna Lake near furthest extent of the crown pillar.

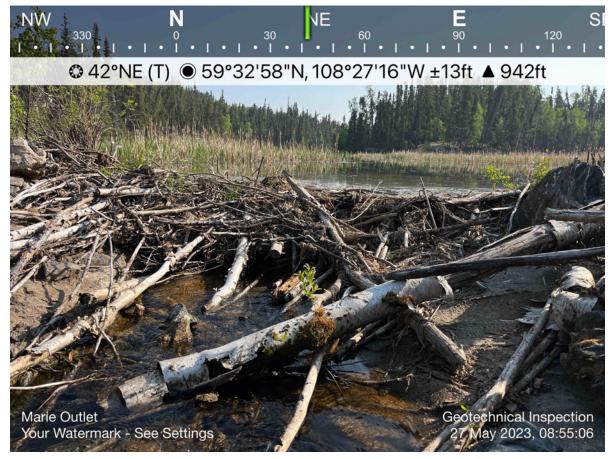
Photo A2 - Marie Reservoir Spillway inlet; beaver dam first noted in 2018

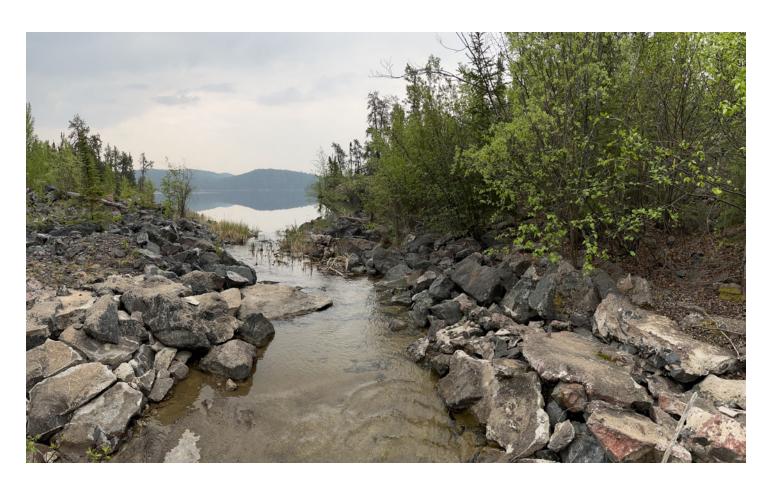
Photo B5 – Fookes Reservoir Spillway showing broken rip-rap on north and south sides of channel. Note debris has been removed since 2022 inspection.

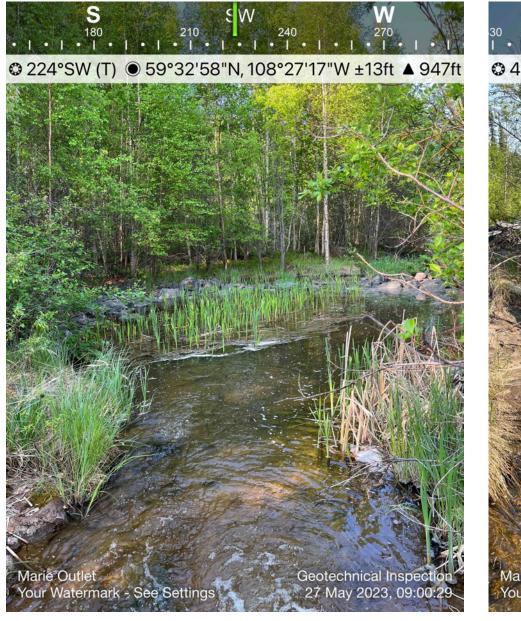
Photo A2 - Marie Reservoir Spillway inlet; beaver dam first noted in 2018

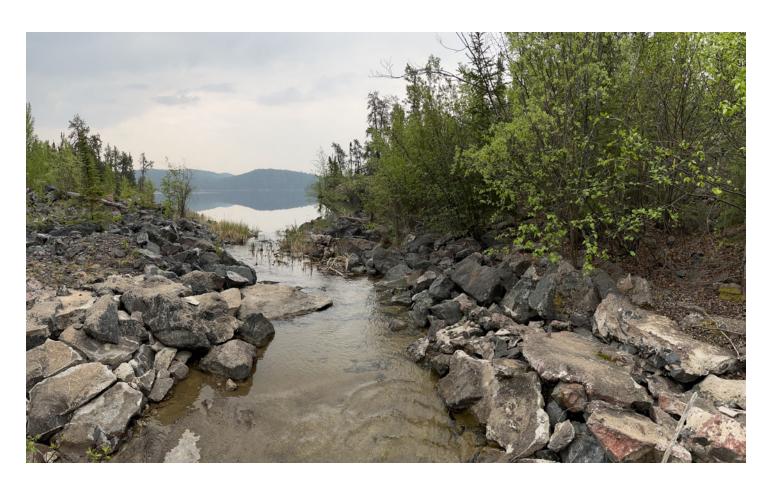
Photo B5 – Fookes Reservoir Spillway showing broken rip-rap on north and south sides of channel. Note debris has been removed since 2022 inspection.
