Beaverlodge Project 2023 Annual Report

Year 38 Transition Phase Monitoring

> Prepared and Submitted by: Cameco Corporation

> > March 2024

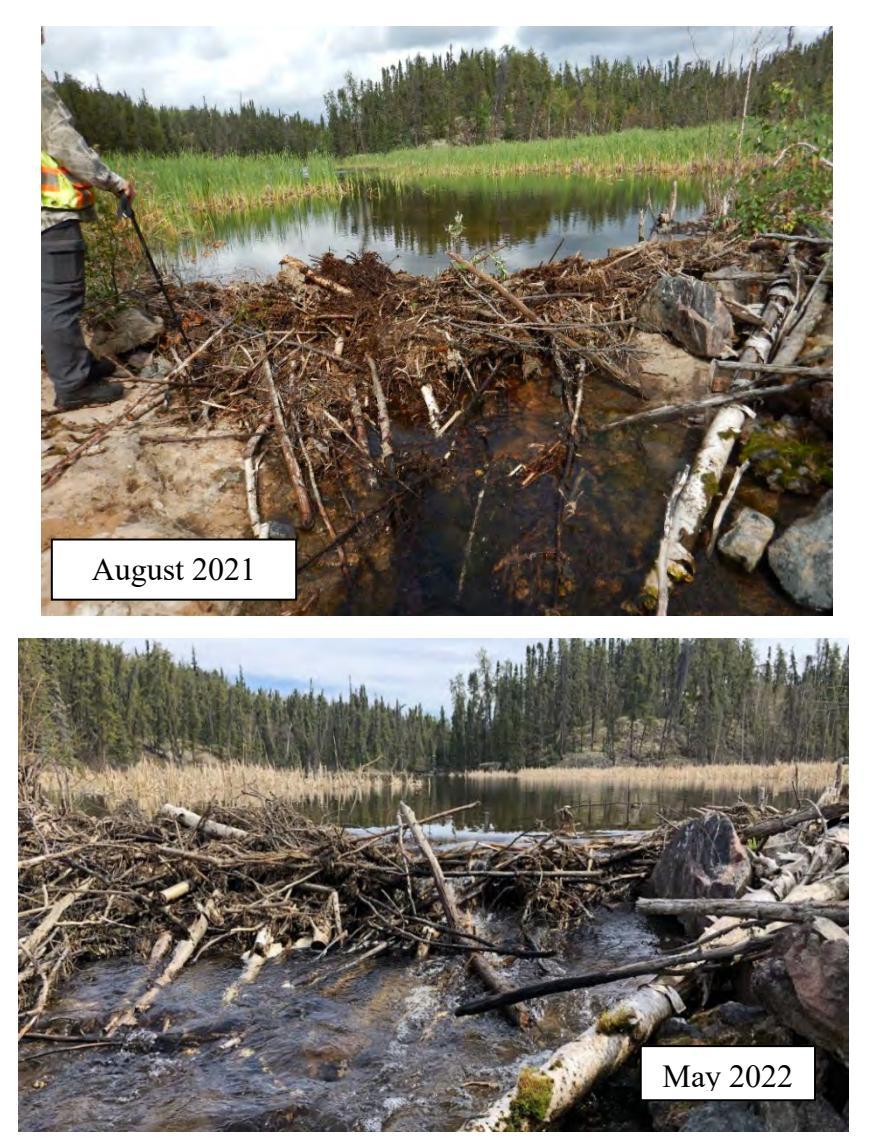
Beaver dam constuction at the outlet structure for Marie Reservoir

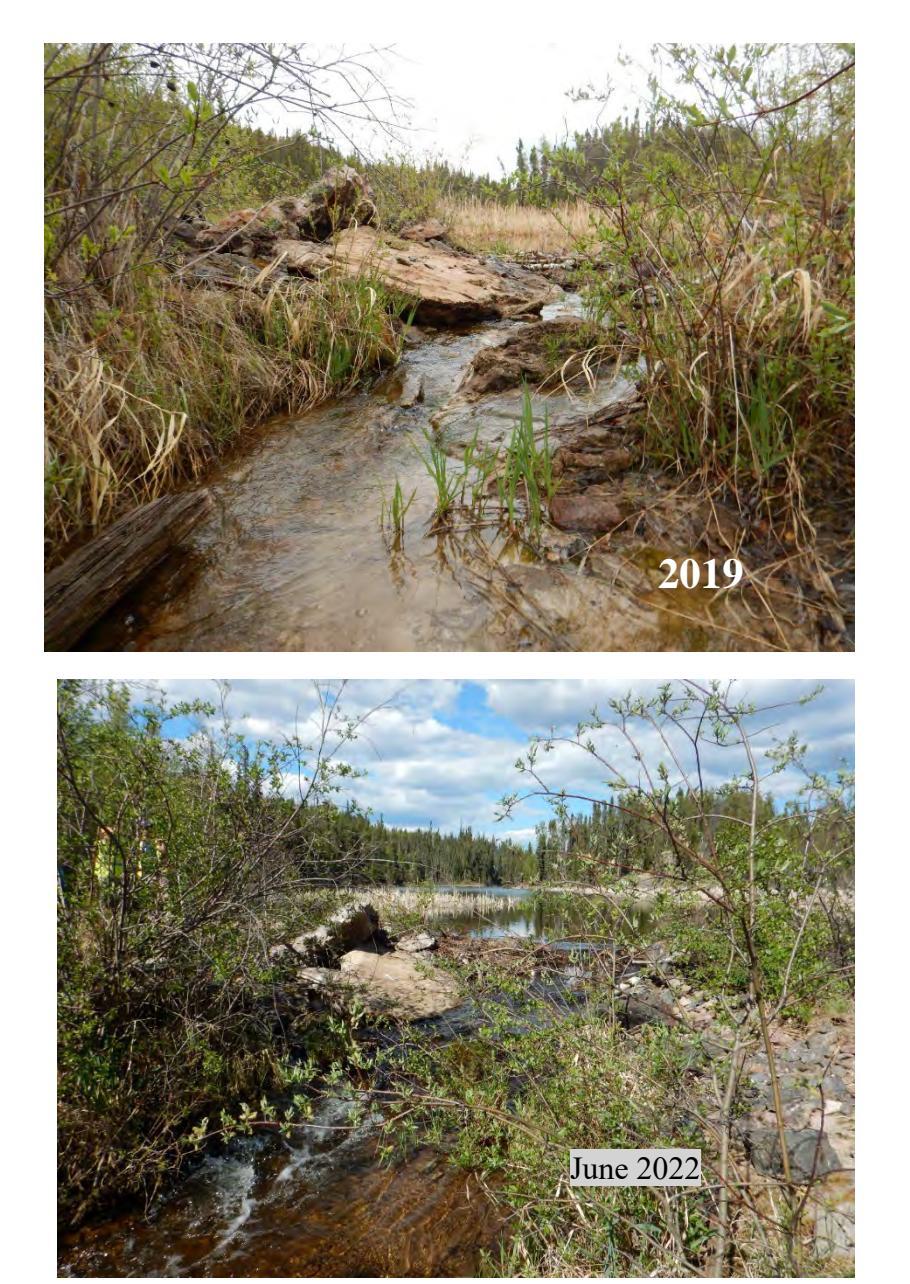
Marie Reservoir Outlet Structure

– Ice jacked block of grout intruded rip-rap

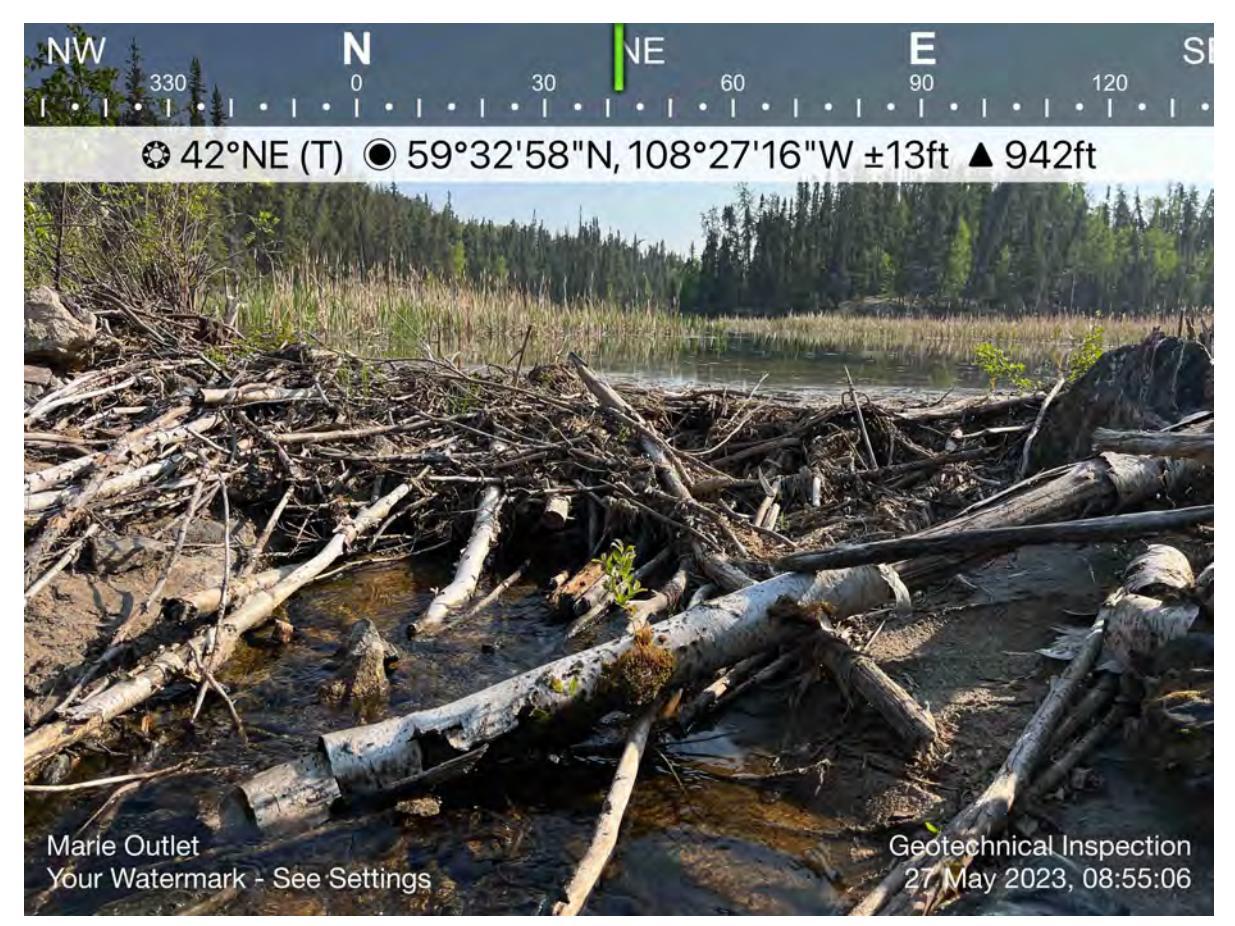
Photo A2 - Marie Reservoir Spillway inlet; beaver dam first noted in 2018

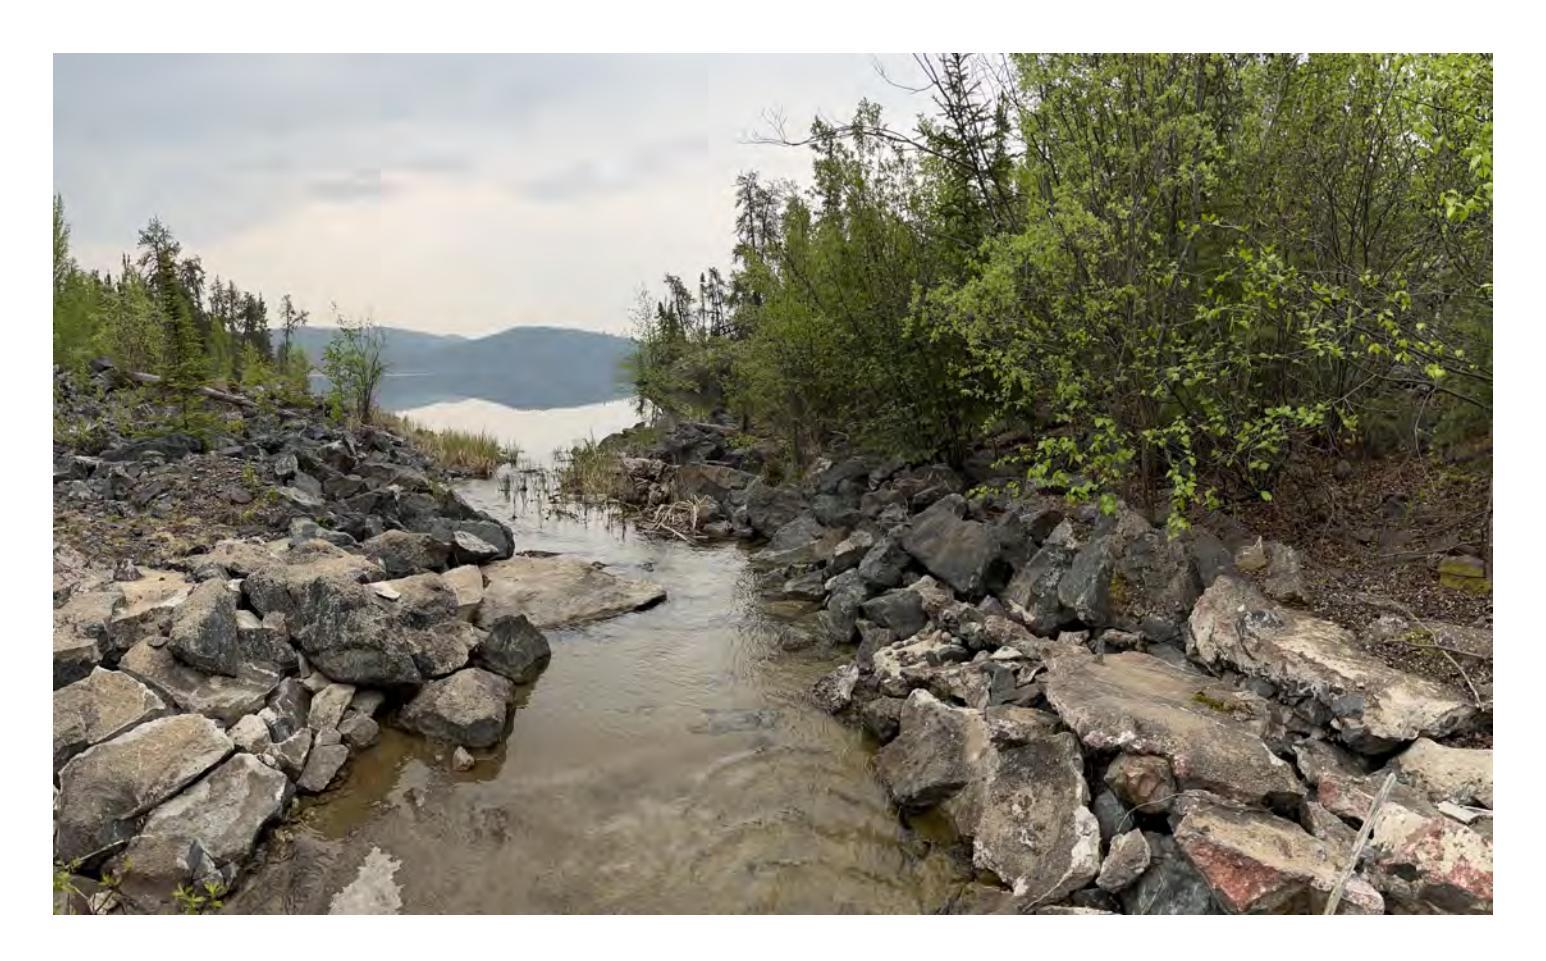
Photo B5 – Fookes Reservoir Spillway showing broken rip-rap on north and south sides of channel. Note debris has been removed since 2022 inspection.

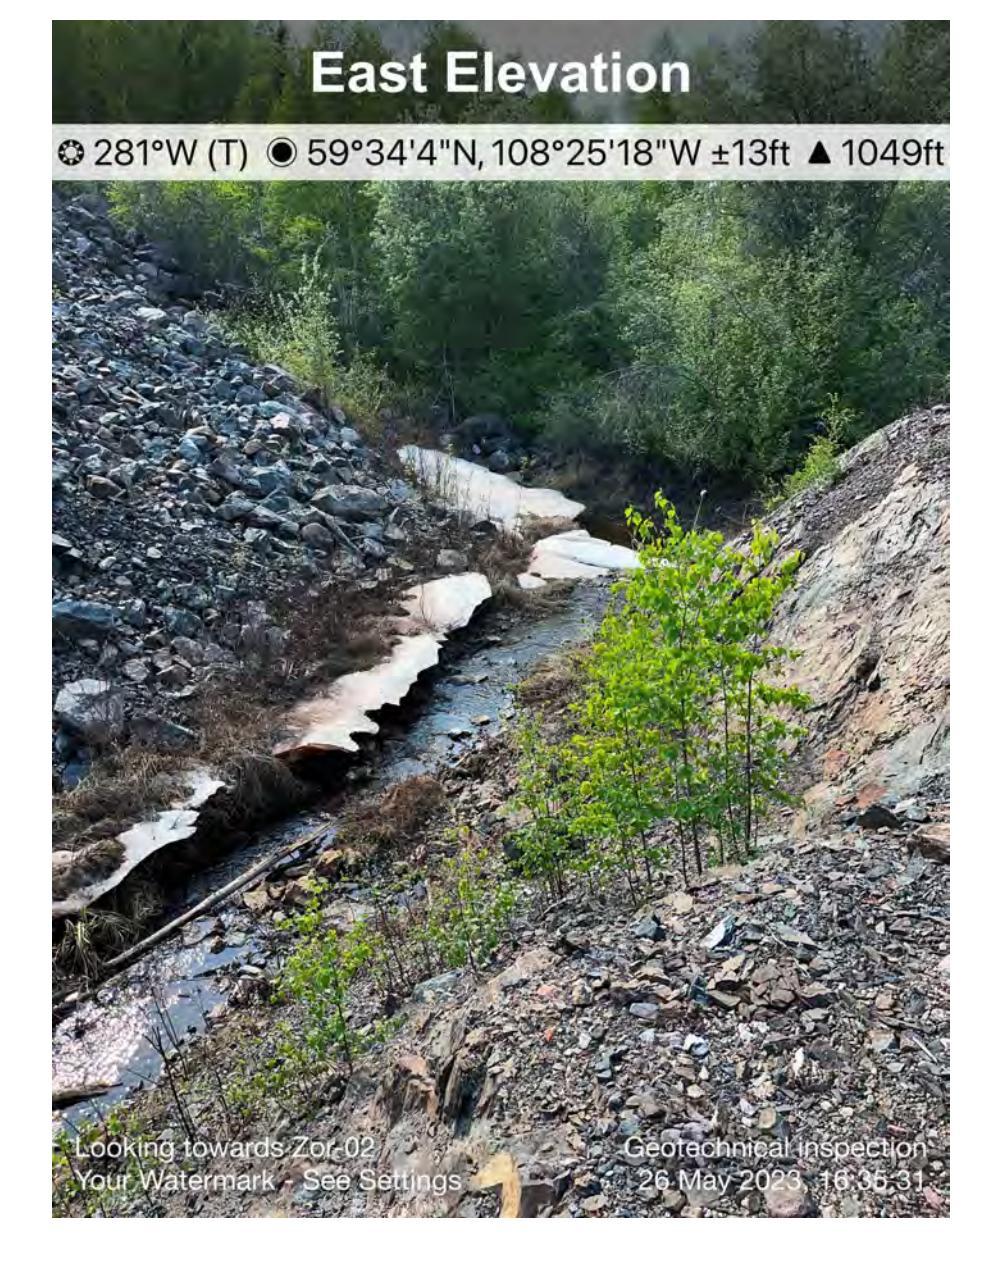
Photo E04—View near stilling basin, looking downstream at stilling basin (May 2023). Note the glaciation remaining from the late spring
