# **Beaverlodge Project Annual Report**

**Year 26**

**January 1, 2011 to June 30, 2012**

Cameco Corporation

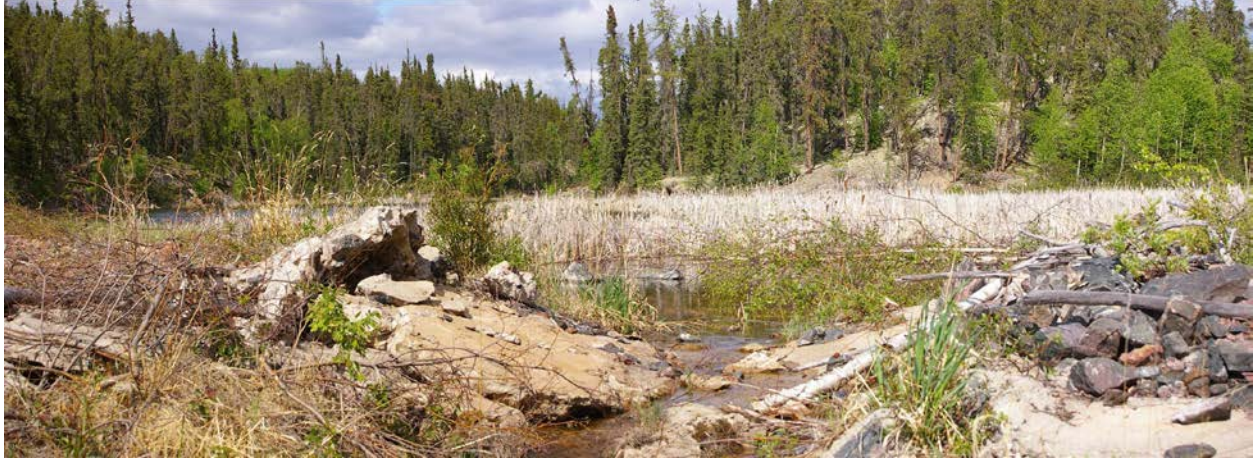
**Photo 1 – Marie Reservoir Spillway looking upstream**

Photos 1 to 3, taken during the June 5, 2012 inspection, provide photographic record of the condition of the Marie Reservoir spillway channel.

right side of the spillway (looking downstream from Marie Reservoir) continue to displace due to ice-jacking.

The photographic record supports the observations made by SRK Consulting and the spillway continues to perform as designed.

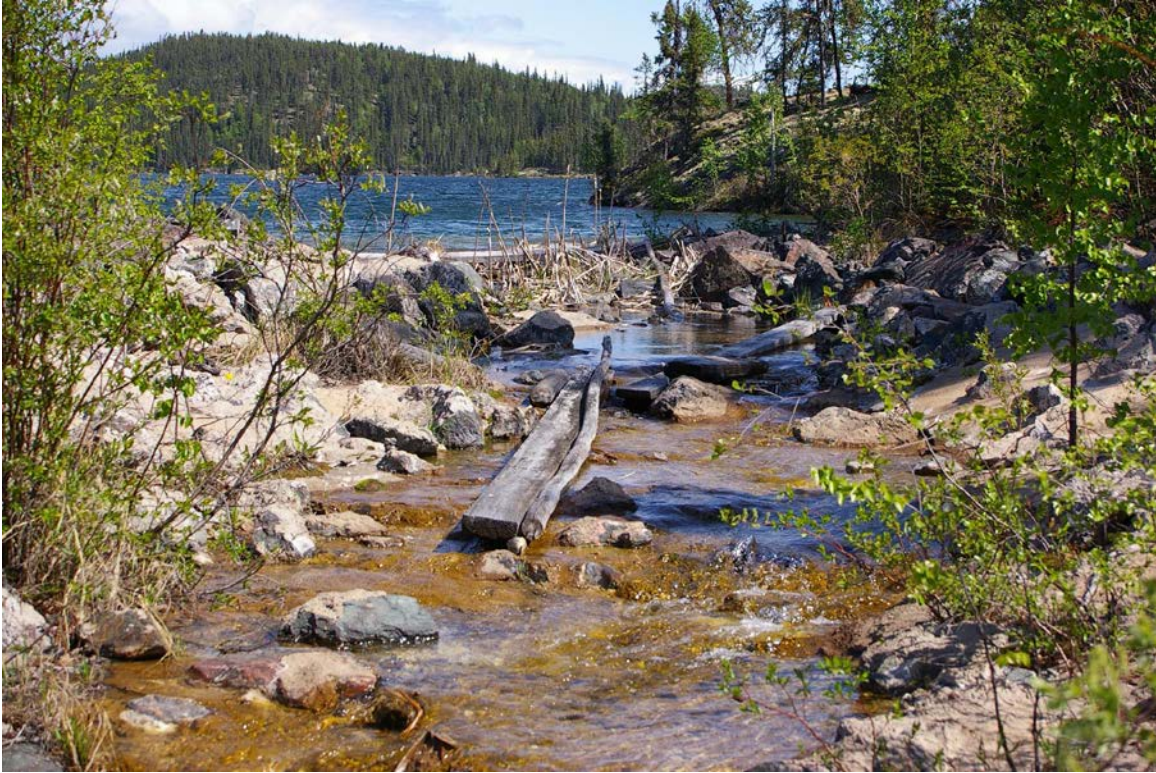
**Photo 4 – Fookes Reservoir Spillway looking upstream**

Previously SRK Consulting identified that the grout-intruded rip-rap along the length of the Fookes Reservoir outlet spillway show signs of cracking. In addition, there has been some ice-jacking, with the most significant displacements located near the upper part of the spillway, i.e., on the sides of the spillway, within 5 to 6 m of the spillway entrance.

The photographic record shows there has been no change in the condition of the spillway from previous inspections and the spillway continues to perform as designed.

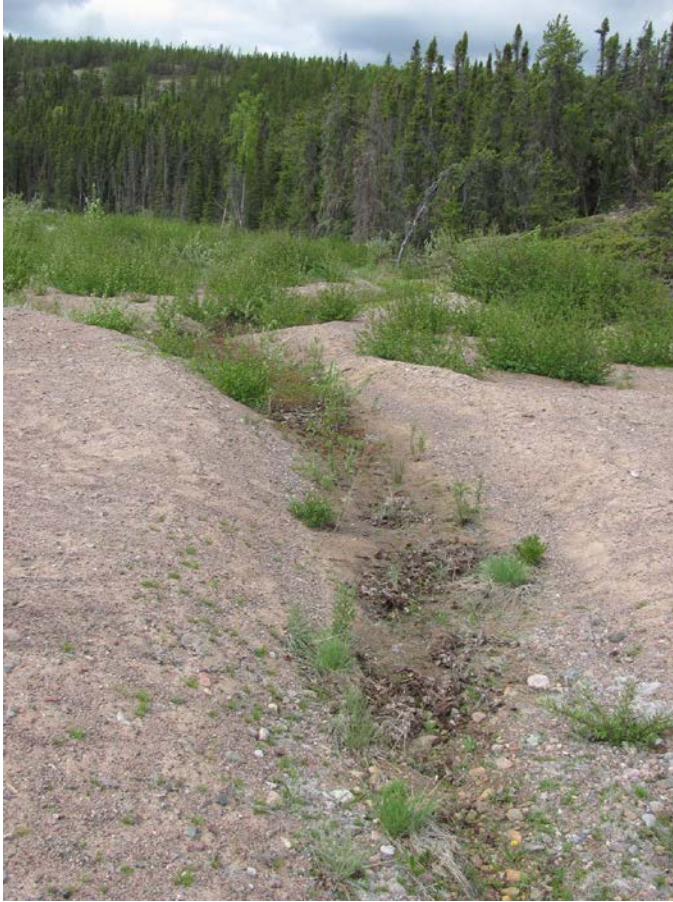
**Photo 9 – Vegetation growth near drainage trench on the Fookes delta**

A drainage trench is located along the east side of the Fookes delta to channel surface water runoff during heavy precipitation events and spring freshet. It was noted in previous inspections that sand has flowed along the base of the drainage trench that has a rock-fill base. This sand flow is not expected to threaten the functionality of the ditch in the medium term. In the longer term, as vegetation continues to establish itself, the risk to ditch functionality will diminish further. There were no new sand flows identified in the drainage trench during the 2012 inspection. Photo 9 shows the vegetation growth in and around the drainage trench.

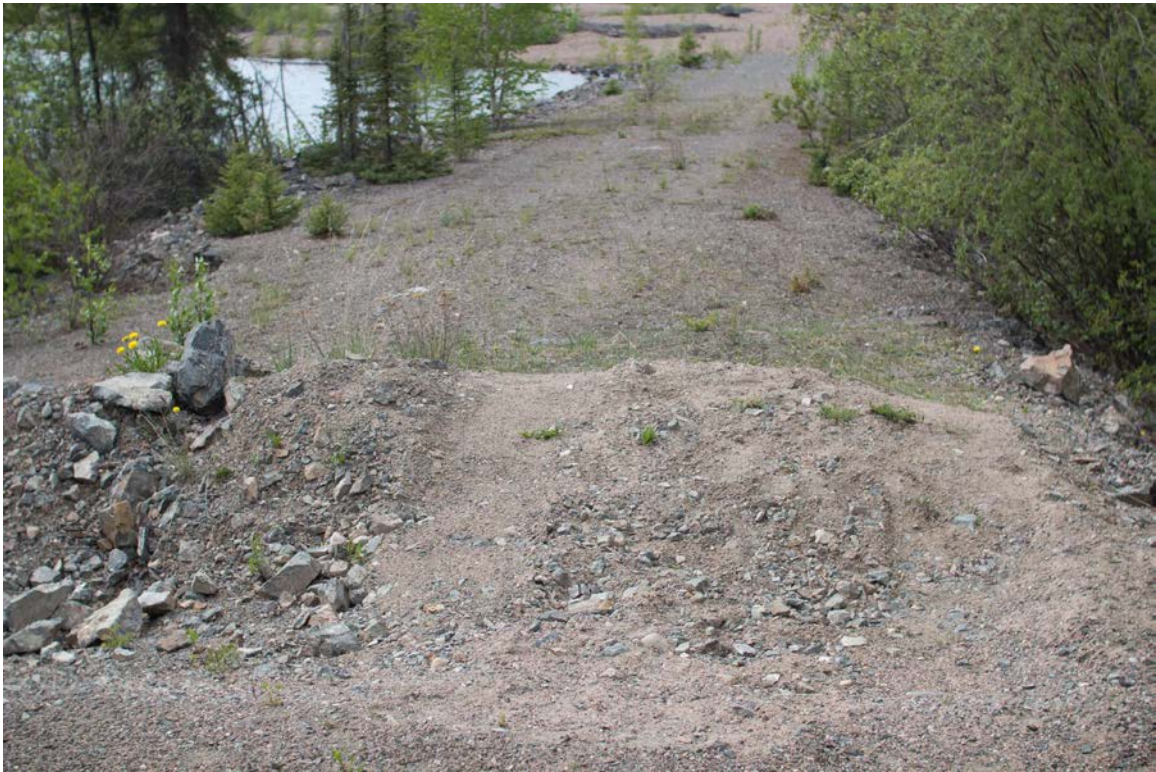
**Photo 12 – East berm showing tire tracks driving over control point**

During the 2012 inspection it was discovered that the east access berm had been compromised and vehicles had gained access to the delta from this point (photo 12). Although vehicles had accessed the delta they did not appear to have compromised the integrity of the sand cover.

Following the inspection Cameco hired a local contractor to place repair and improve the berm along the east access point to prevent further access. This work will be completed in prior to September 15, 2012 and will be inspected during the 2013 annual JRG inspection.
