CAMECO CORPORATION

Beaverlodge: Year 27 Transition Phase Monitoring Annual Report (2012)

**Beaverlodge
2012 Annual Report**

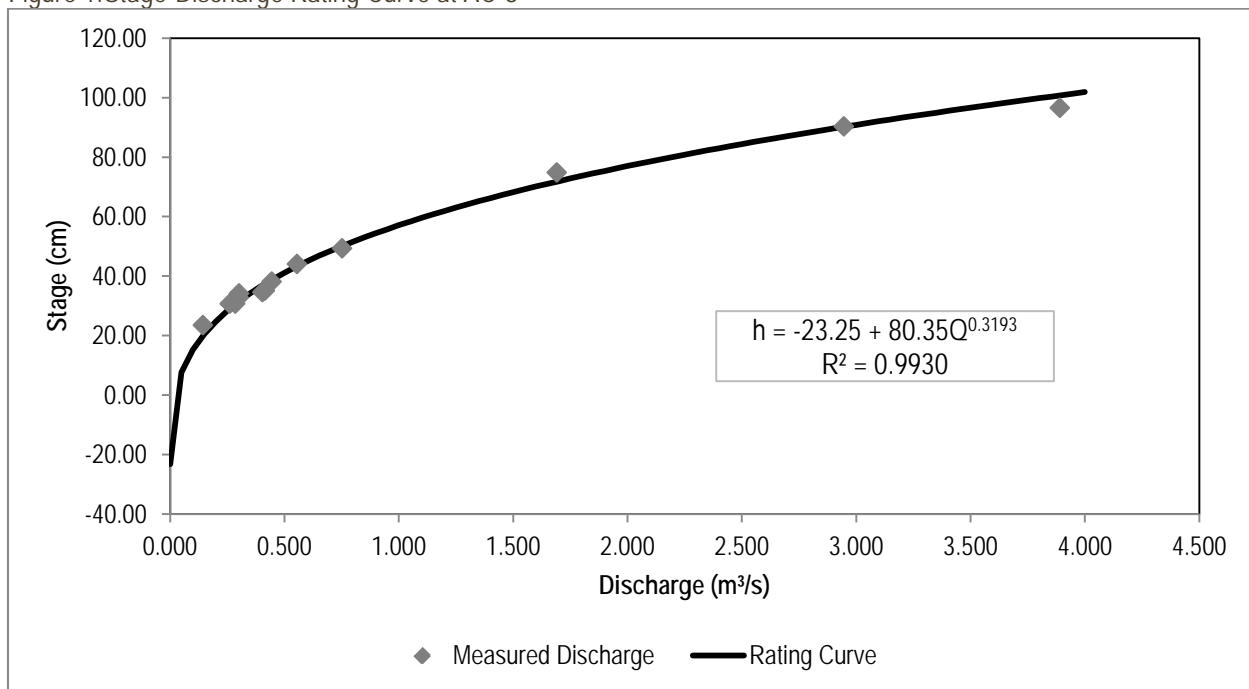
Figure 1: Stage-Discharge Rating Curve at AC-8

Streamflow monitoring at Ace Creek (AC-8) and Fulton Creek (TL-7) is maintained as a part of the site monitoring program. The station known as AC-8 is located at the outlet of Ace Lake where the outlet configuration is a rectangular concrete weir. The drainage area reporting to Ace Lake is approximately 152 km². Solinst Levelloggers have been used to record stage height at AC-8 since approximately 2004 and prior to that time a Steven's recorder was operated at the site. The stage height record is used to calculate discharge via a stage-discharge rating curve. The rating curve used to estimate discharge from the stage data is presented in Figure 1 and is based on manual measurements of stage and discharge since 2005 (Table 2).

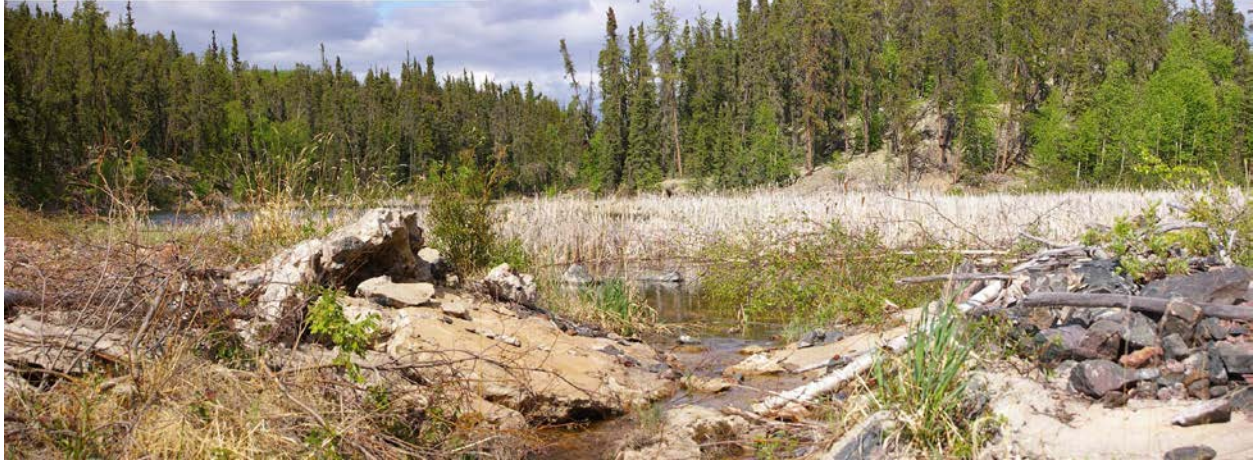
Photo 1 – Marie Reservoir Spillway looking upstream

Photos 1 to 3, taken during the June 5, 2012 inspection, provide photographic record of the condition of the Marie Reservoir spillway channel.

right side of the spillway (looking downstream from Marie Reservoir) continue to displace due to ice-jacking.

The photographic record supports the observations made by SRK Consulting and the spillway continues to perform as designed.

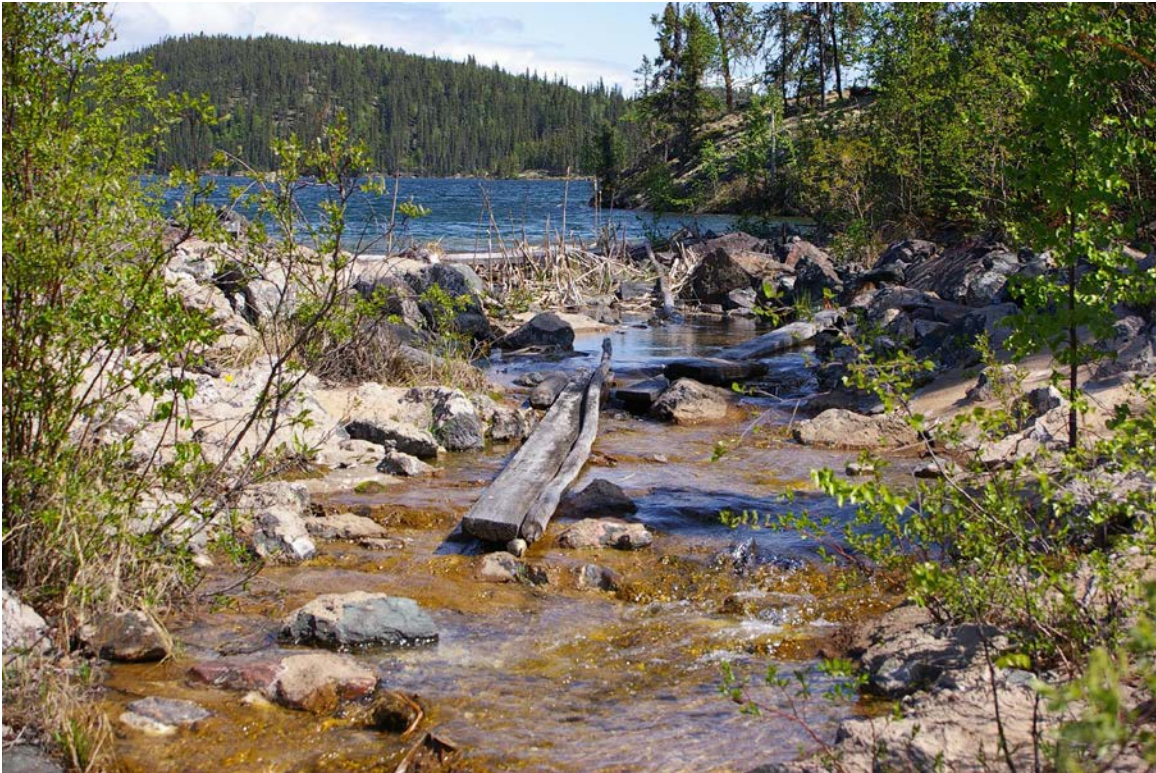
Photo 4 – Fookes Reservoir Spillway looking upstream

Previously SRK Consulting identified that the grout-intruded rip-rap along the length of the Fookes Reservoir outlet spillway show signs of cracking. In addition, there has been some ice-jacking, with the most significant displacements located near the upper part of the spillway, i.e., on the sides of the spillway, within 5 to 6 m of the spillway entrance.

The photographic record shows there has been no change in the condition of the spillway from previous inspections and the spillway continues to perform as designed.

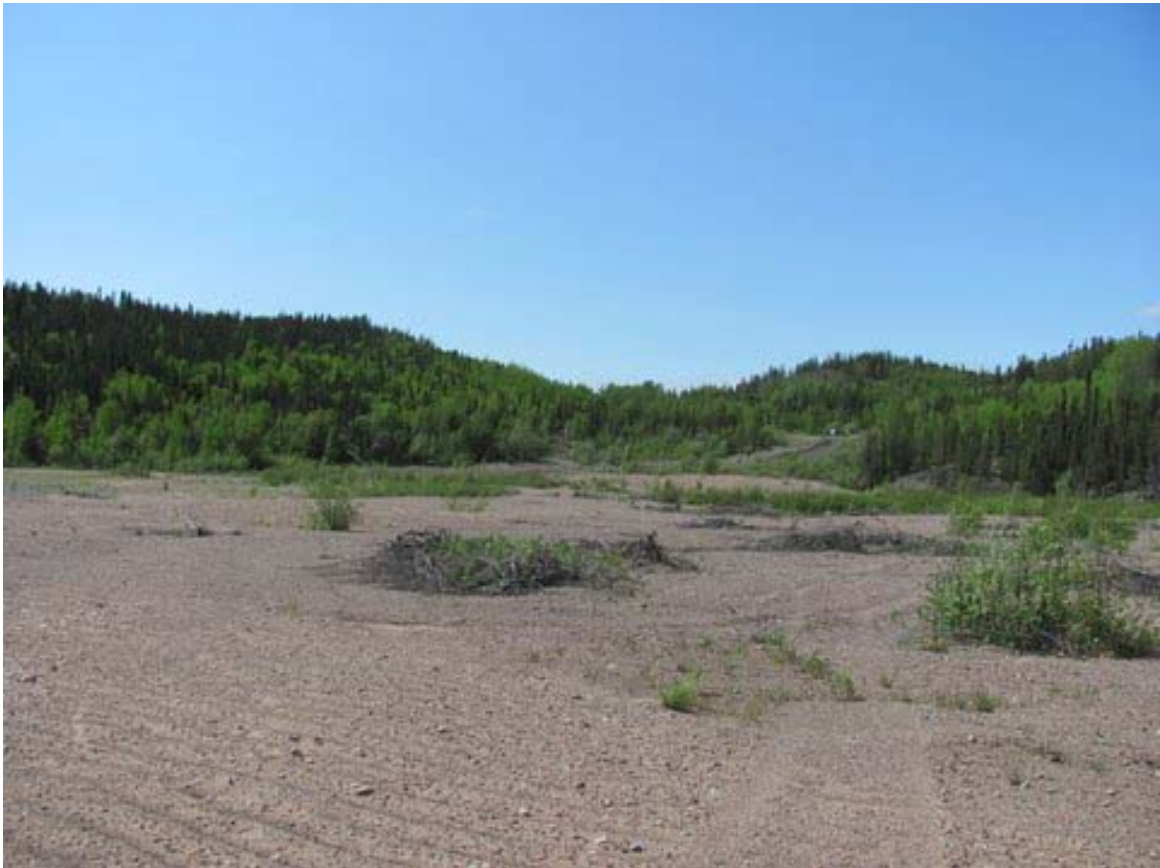
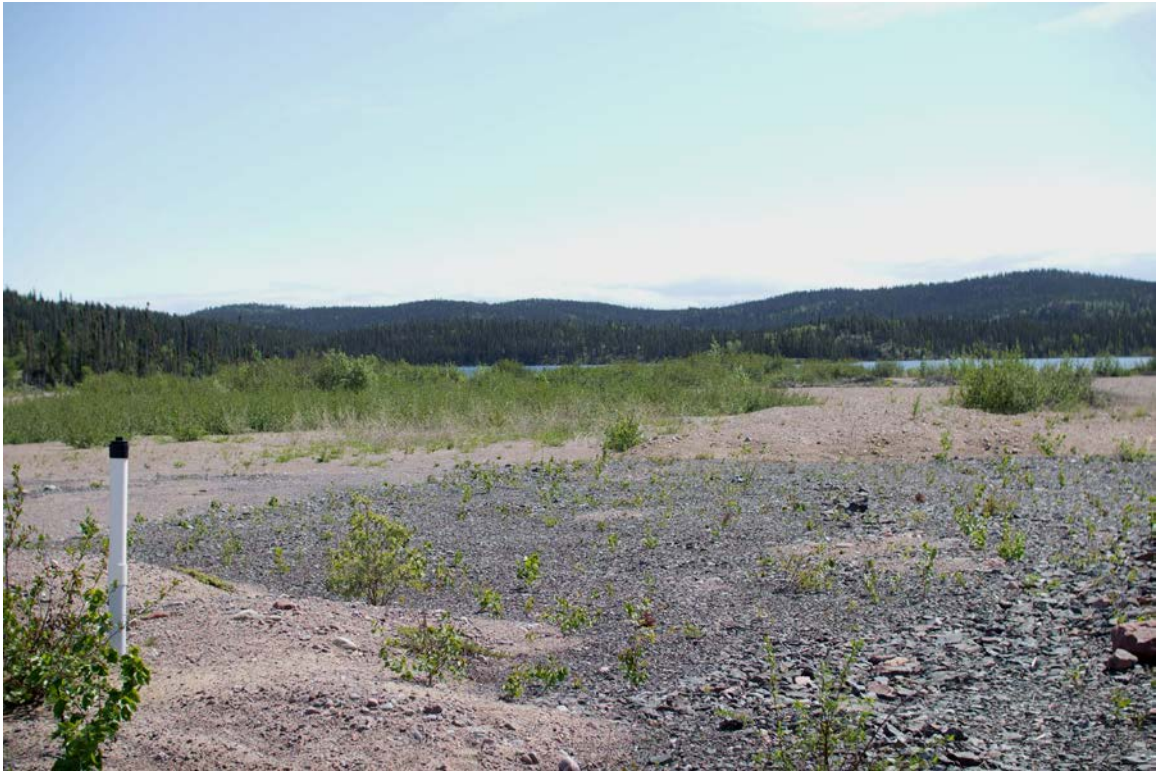
After a period of drought which saw water levels in Fookes Reservoir drop in 2011, water levels in returned to a normal level this spring following freshet. Generally the cover was in good condition showing no areas of excessive erosion. Past vehicular traffic was evident on the delta with access gained by driving over a three-foot berm on the east side of the delta. This berm will be repaired and reinforced to prevent traffic from accessing the delta. Although vegetation on the delta remains sparse over much of the area it is well established within 50 m of the Fookes Reservoir shoreline, and the engineered drainage structures. Photos 6 and 7 show the vegetation growth on the cover.

Photo 6 – Vegetation on the Fookes delta (looking NW)

Photo 7 – Vegetation on the Fookes delta (looking SW)

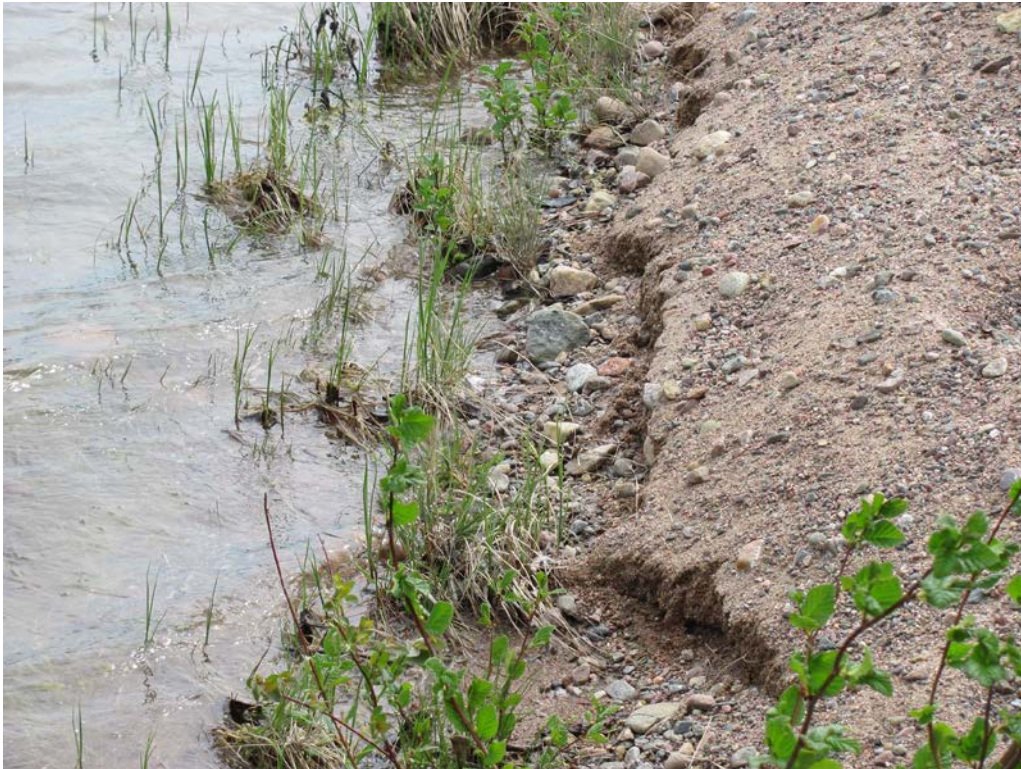
Photo 8 – Fookes Reservoir shoreline

In general the sand cover was in good condition and showed no signs of excessive erosion. As mentioned previously Fookes Reservoir water levels returned to normal in 2012. Photo 8 shows the shoreline where the water level meets the sand cover. A small amount of erosion of the sand cover can be seen due to wave action, which is to be expected. It is not anticipated that this small amount of erosion will affect the performance of the sand cover. As vegetation continues to encroach on the shoreline it will provide additional armoring and increase the stability of the cover.

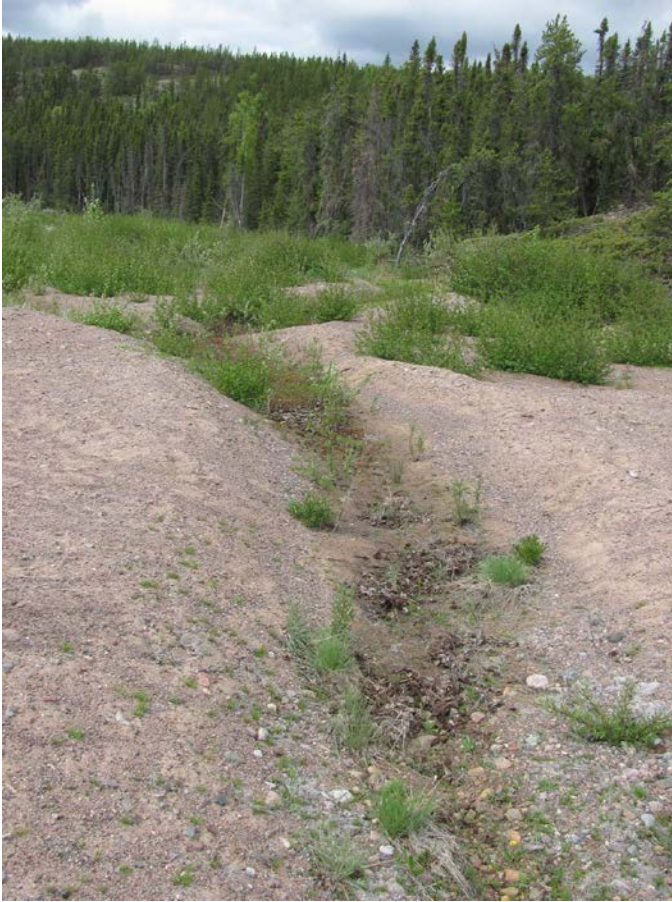
Photo 9 – Vegetation growth near drainage trench on the Fookes delta

A drainage trench is located along the east side of the Fookes delta to channel surface water runoff during heavy precipitation events and spring freshet. It was noted in previous inspections that sand has flowed along the base of the drainage trench that has a rock-fill base. This sand flow is not expected to threaten the functionality of the ditch in the medium term. In the longer term, as vegetation continues to establish itself, the risk to ditch functionality will diminish further. There were no new sand flows identified in the drainage trench during the 2012 inspection. Photo 9 shows the vegetation growth in and around the drainage trench.

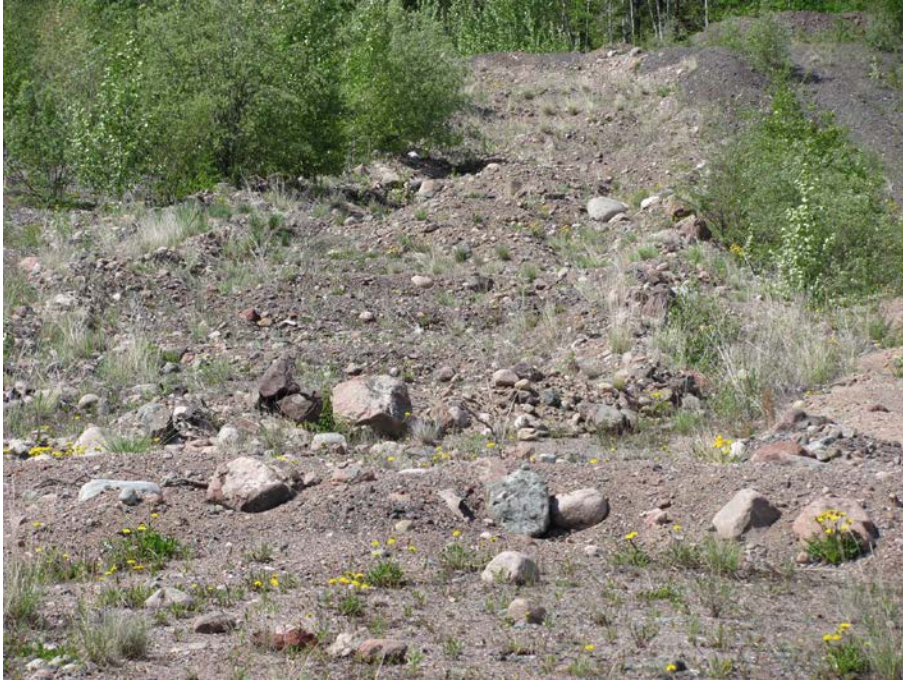
Photo 10 – Chevrons in place on north access point to the Fookes delta

As part of the design and installation of the covers in 2005 and 2007, the area considered most vulnerable to erosion was in the area on and below the access ramp at the northwest corner of the tailings delta (*SRK 2010*). The general condition of the ramp is very good. Access to this ramp is closed off by a windrow of material at the top of the ramp. The water bars (chevrons) are performing as expected and show little sign of erosion (Photo 10). In addition to the chevrons, run-out structures were installed to carry away excessive water during extreme run-off events. These run-out structures are also in good shape and have seen no additional eroded material beyond that observed during previous inspections (Photo 11).
