**Cameco**

**2013 Beaverlodge Annual Report**

**April 2014**

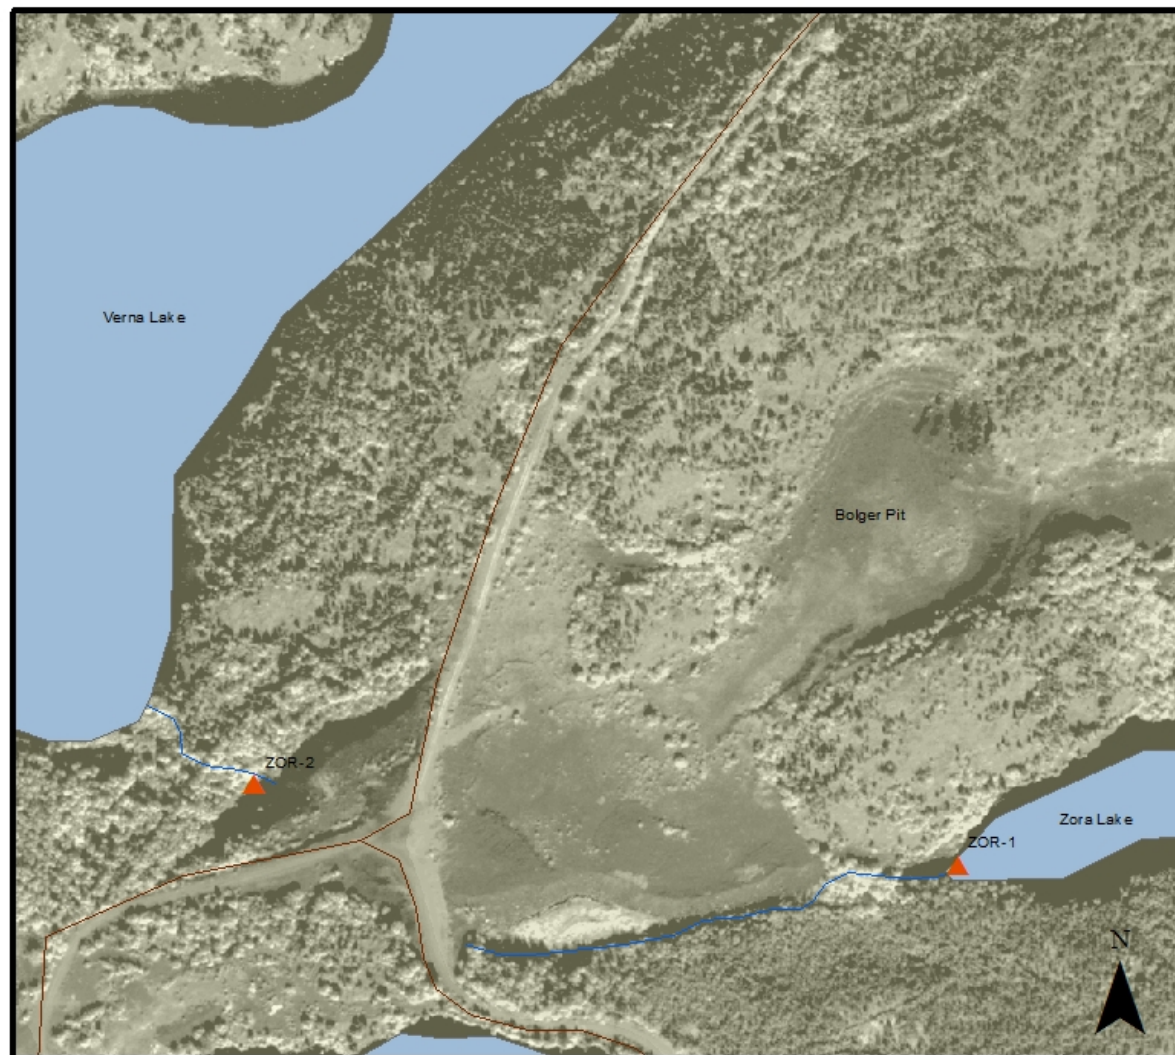
**Figure 4.4**  
**ZOR-1 and ZOR-2 sampling locations**

Cameco has assessed additional remedial measures and developed a path forward for the Beaverlodge properties that will facilitate the eventual transfer of these properties to the Province of Saskatchewan's Institutional Control program. One of the potential remedial measures taken into consideration in the 2012 Path Forward Report (*Cameco, 2012*) was the flow path reconstruction of the Zora Lake outflow. This diversion would reduce contact between Zora Creek and the Bolger waste rock pile in which it currently flows through before reaching Verna Lake ([Figure 4.4](#)).

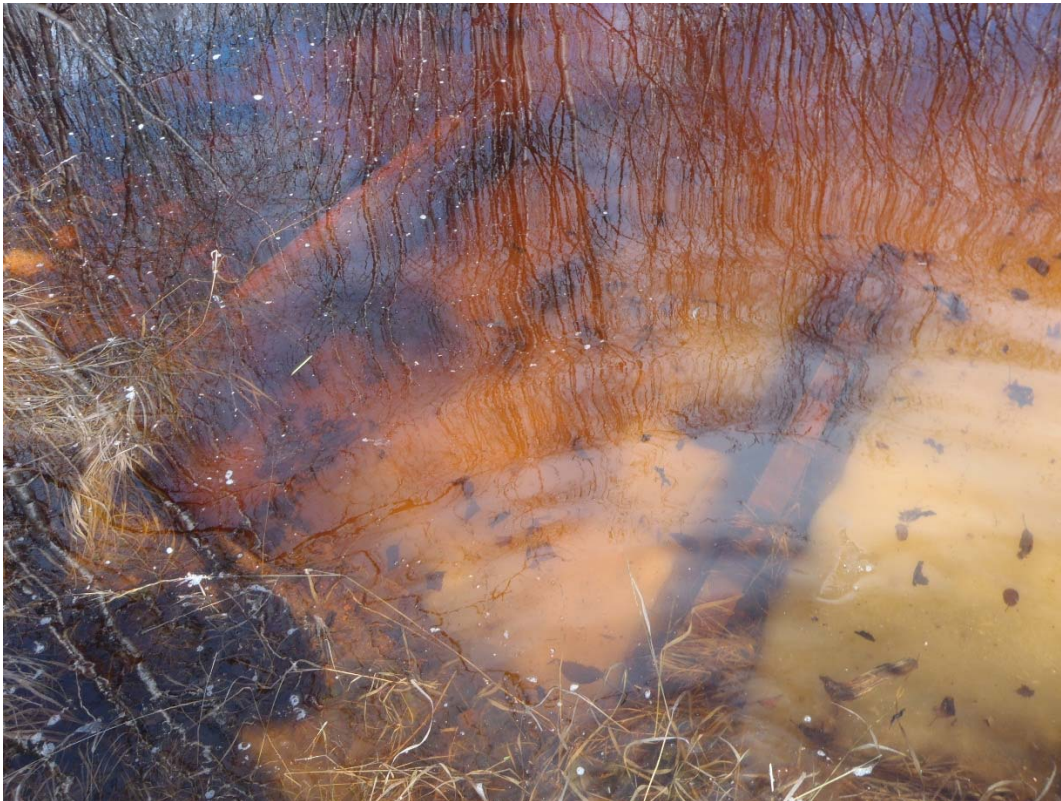
Photo 1: AC-6A - May 15, 2013

A v-notch weir installed at AC-6A is used to monitor discharge via hydraulic relationships. The weir was installed in August 2011 and mounted to the existing culvert through the road around the perimeter of Ace Lake. During the spring program the v-notch was filled with ice and flow was discharging over the road (Photo 1); thus no measurement was recorded and the Levelogger could not be installed. During the fall program the creek bed was dry (Photo 2). The Levelogger was installed on May 20, 2013 by Uranium City Contracting but no discharge was reported. Stage and discharge measurement data are presented in Table 2 and graphically in Figure 2. The hydrograph and daily average discharge values are presented in Figure 3 and Table 3, respectively.

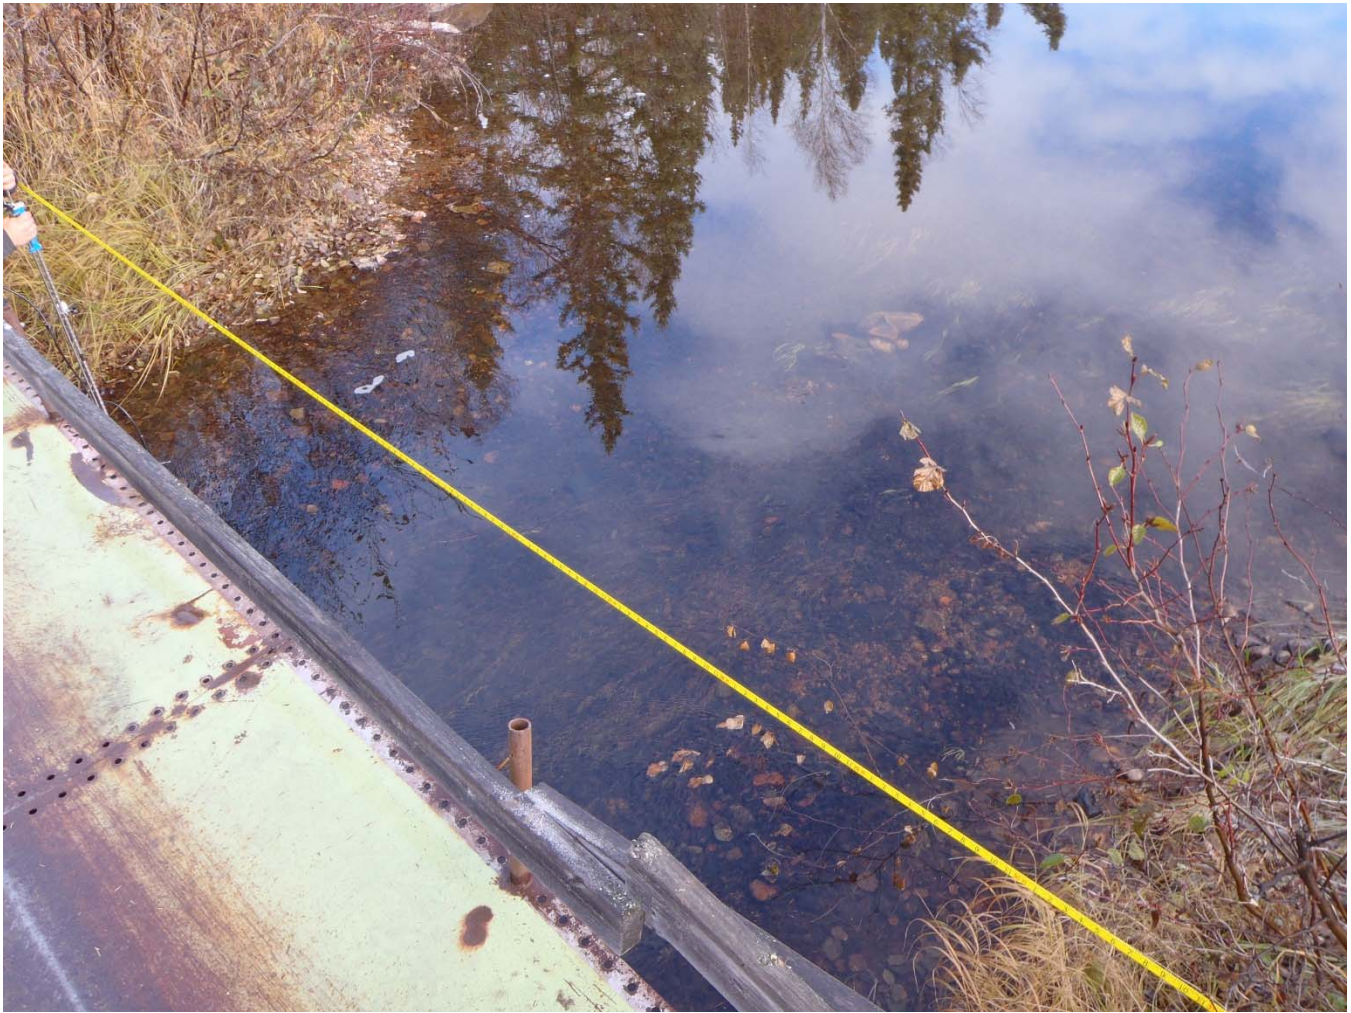
The gauging station located on Ace Creek at AC-6B is located immediately upstream of a bridge crossing (Photo 3). Two measurements of discharge during the spring freshet were recorded during the spring program on May 15 and 16, 2013 (Table 4) and provide additional high flow data for the rating curve (Figure 4). The data logger installed at this location registered peaks in the winter which McElhanney believes are a result of snow encroachment on the channel and not of an increase in discharge; this data has been corrected with data from AC-8. Hydrograph data (Figure 5 and Table 5) at AC-6B is in part synthesized from the record at AC-8 (prior to the spring program and following the fall program).

Photo 3: AC-6B - October 12, 2013

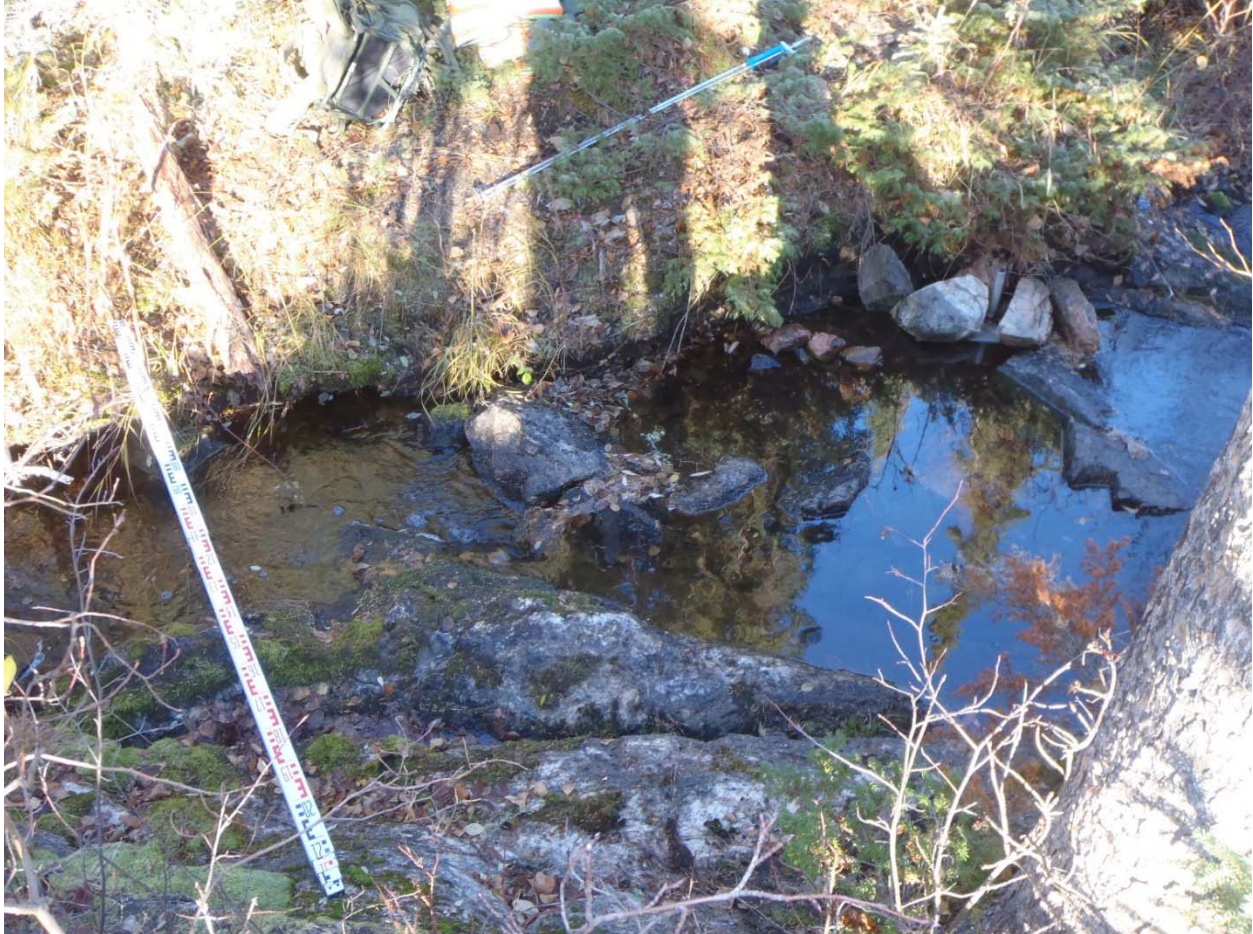
Photo 4. Station summary data are provided in Table 6 while the rating curve is presented on Figure 6. The hydrograph and daily average discharge data presented as Figure 7 and Table 7: Mickey Lake Outflow 2013 Daily Average Discharge (m<sup>3</sup>/s), respectively.

Photo 4: Mickey Lake Outflow - October 12, 2013

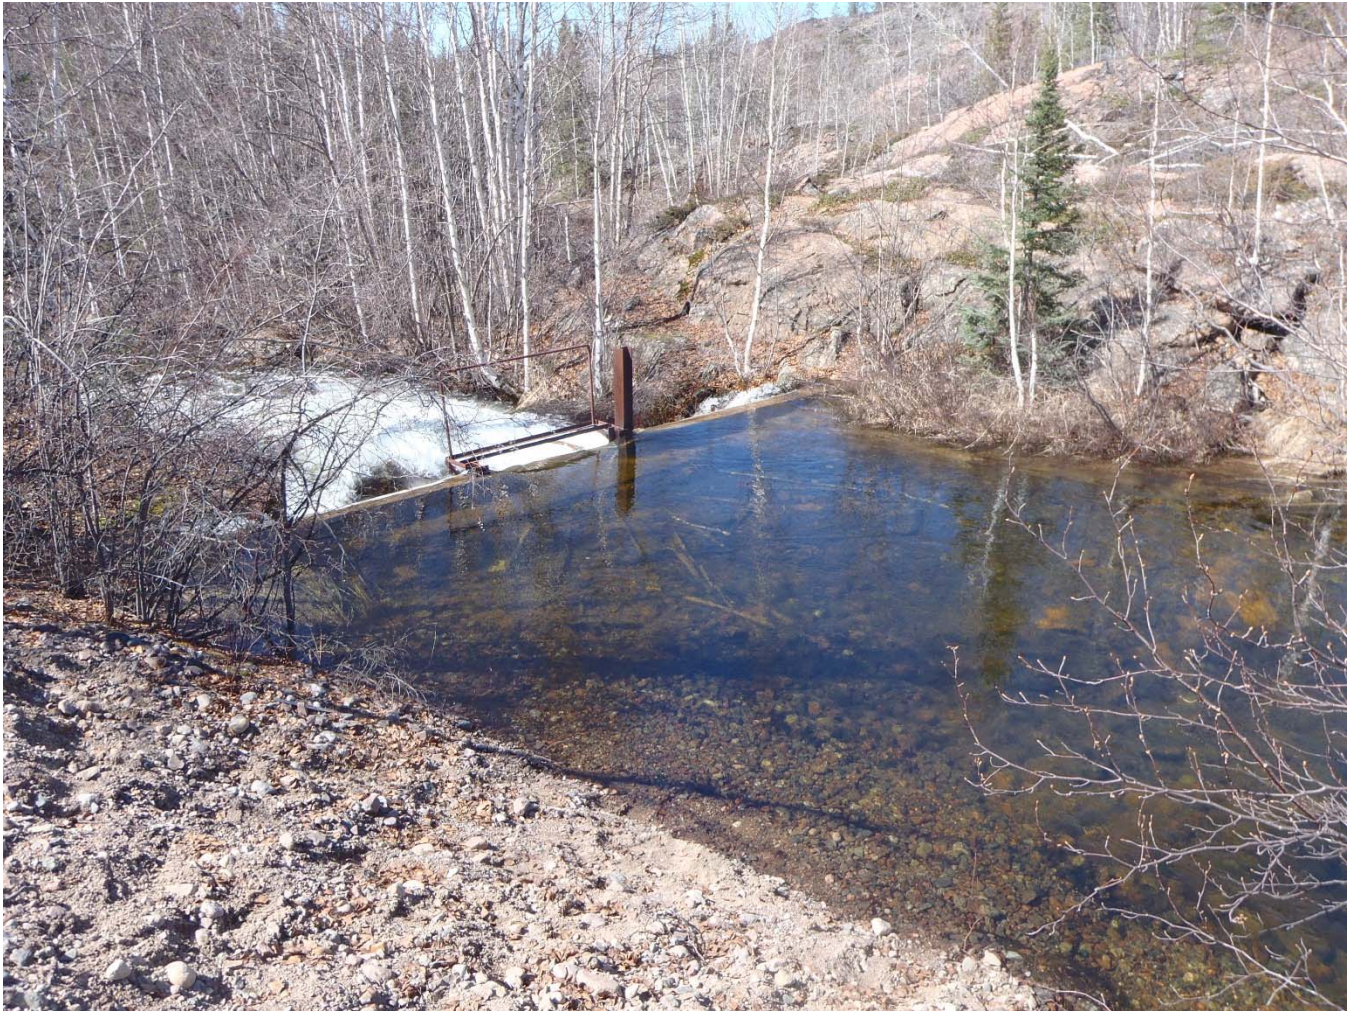
presented in Table 9. Historic monthly average discharge is reported for AC-8 and the updated data are presented in Table 10. A new sensor mount was installed in the fall of 2013 at AC-8.

*Photo 5: AC-8 - May 16, 2013*

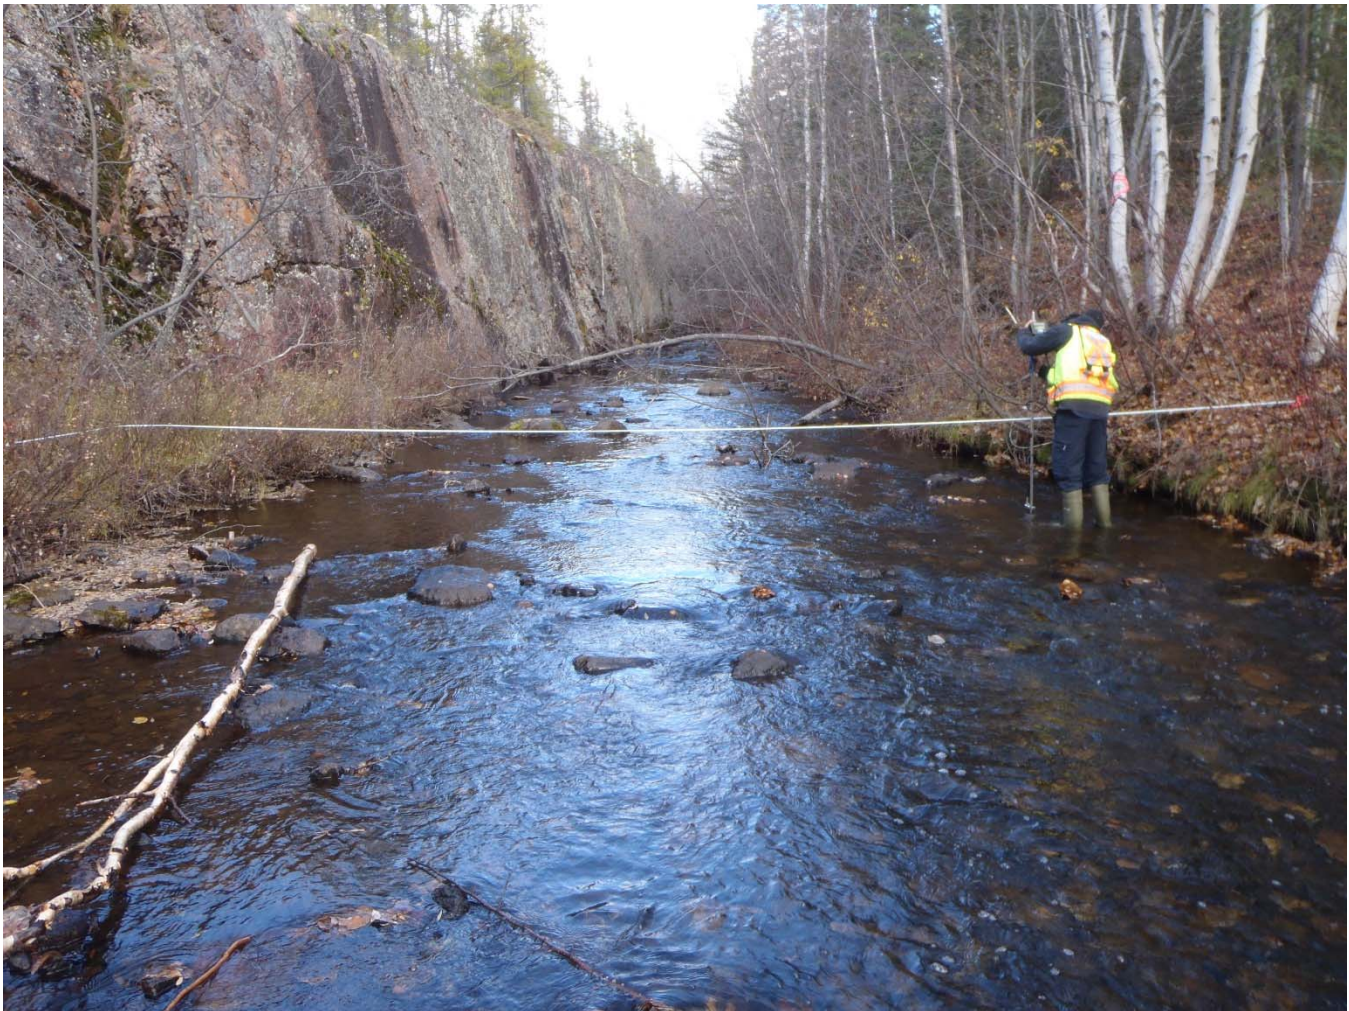
The hydrograph at AC-14 indicates a high flow event in August 2013. Through communication with Uranium City Contracting, McElhanney has learned that a beaver dam was breached on August 1, 2013 which obstructed Ace Creek near the access road to the airport and the sudden rise and fall in discharge as shown in the hydrograph are the response to the flood wave. The hydrograph response is quite rapid beginning at 0.330 m<sup>3</sup>/s at 4:30 pm on August 1, 2013 and peaking at 3.040 m<sup>3</sup>/s at 6:00 pm. The hydrograph returns to 0.335 m<sup>3</sup>/s at 7:30 am on August 2, 2013.

Photo 6: AC-14 - October 12, 2013

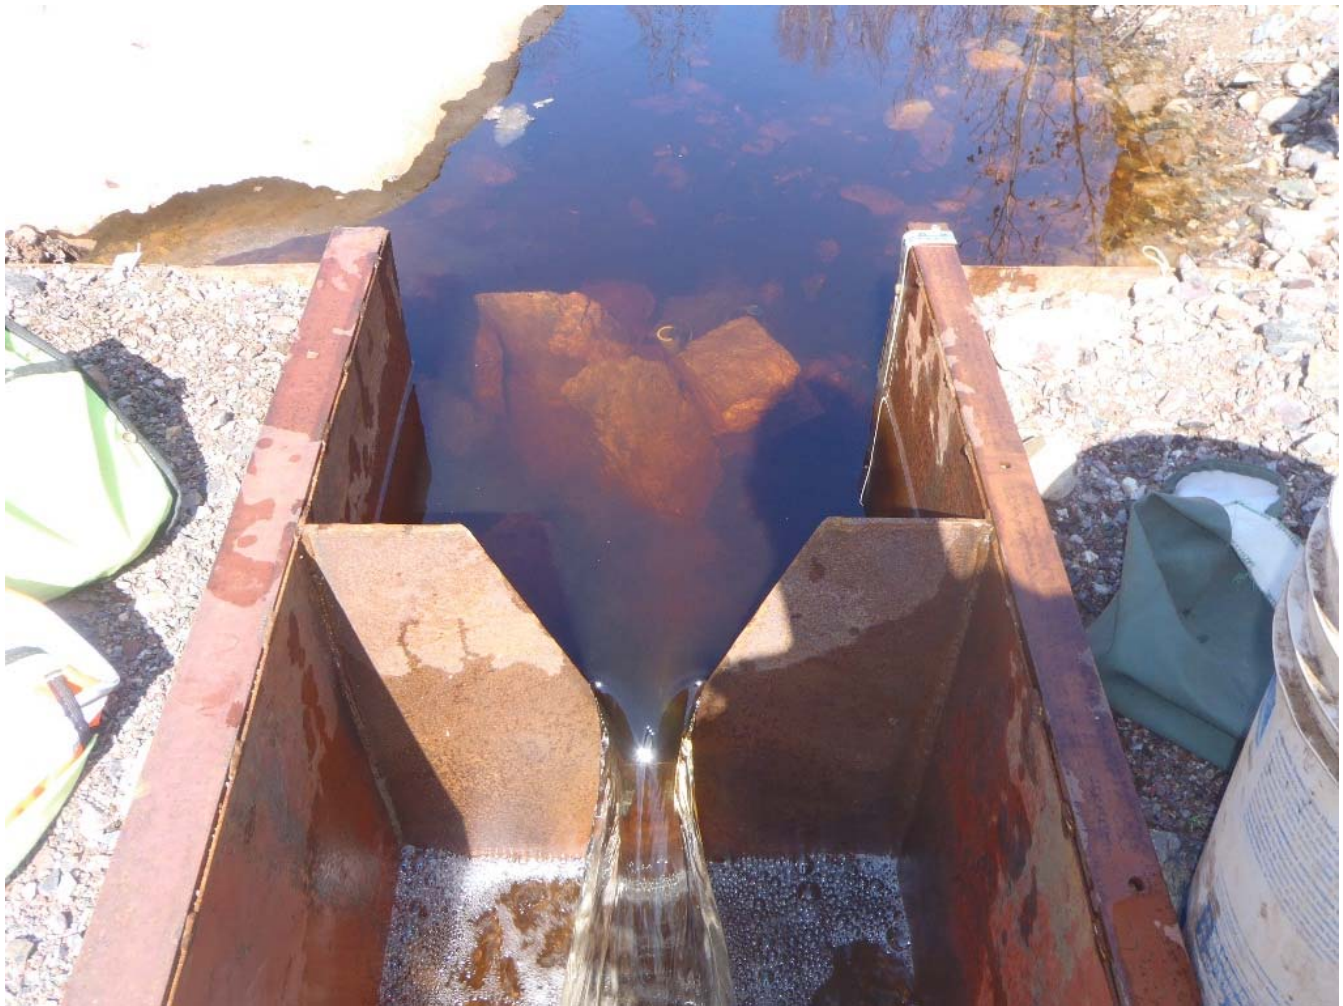
The blasted channel at the outlet of Minewater Reservoir directs runoff towards the Fulton Creek drainage. The v-notch weir installed in the blasted channel is the monitoring location known as TL-6 (Photo 7). Stage and discharge data collected at the v-notch weir are presented in Table 13. The rating curve for TL-6 is shown in Figure 12; the rating curve in TL-6 has not captured a high flow measurement. The hydrograph for TL-6 is presented as Figure 13 while the daily average discharge data is presented in Table 14.

Photo 7: TL-6 - May 16, 2013

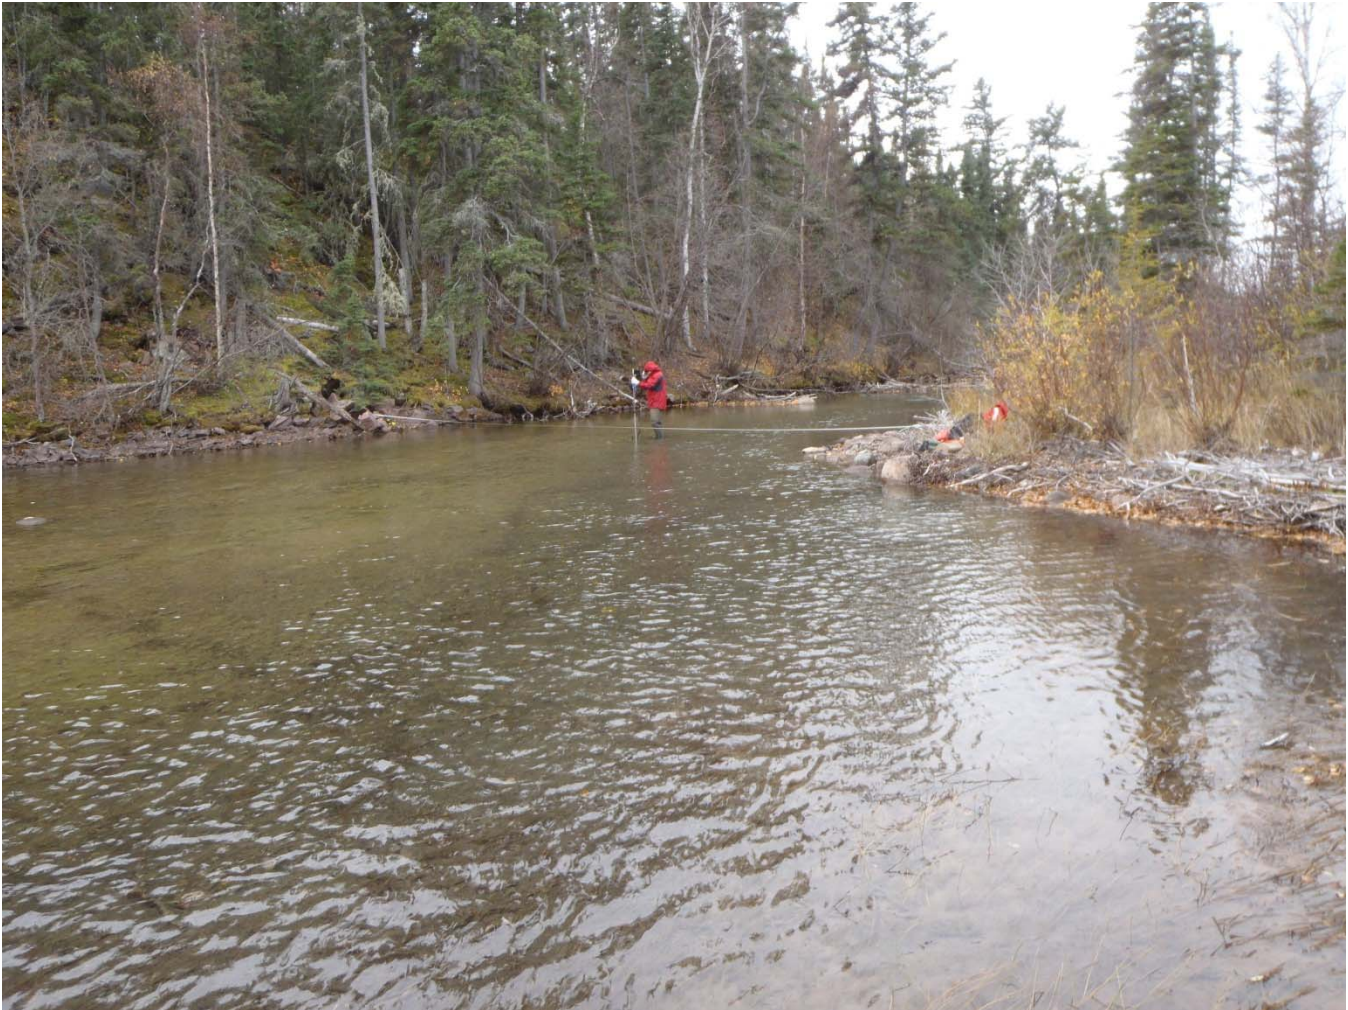
The outflow from Beaverlodge Lake is known as station BL-5 (Photo 8). This station has previously been known to be impacted by beaver activity at the outlet. The channel at the outlet of Beaverlodge Lake splits into two channels and debris jams are present on both channels. A rating curve has been developed comprised of three points with stage-discharge data presented in Table 18 and the plotted rating curve in Figure 15. The points used in the rating curve are comprised of the three most recent measurements and are believed to be the most representative of the outflow of Beaverlodge Lake at this time; there is some potential that the channel at the outflow or the debris jams have changed thus requiring reassessment of the rating curve. The hydrograph and daily average discharge data are presented in Figure 16 and Table 19, respectively.

Photo 8: BL-5 - October 13, 2013

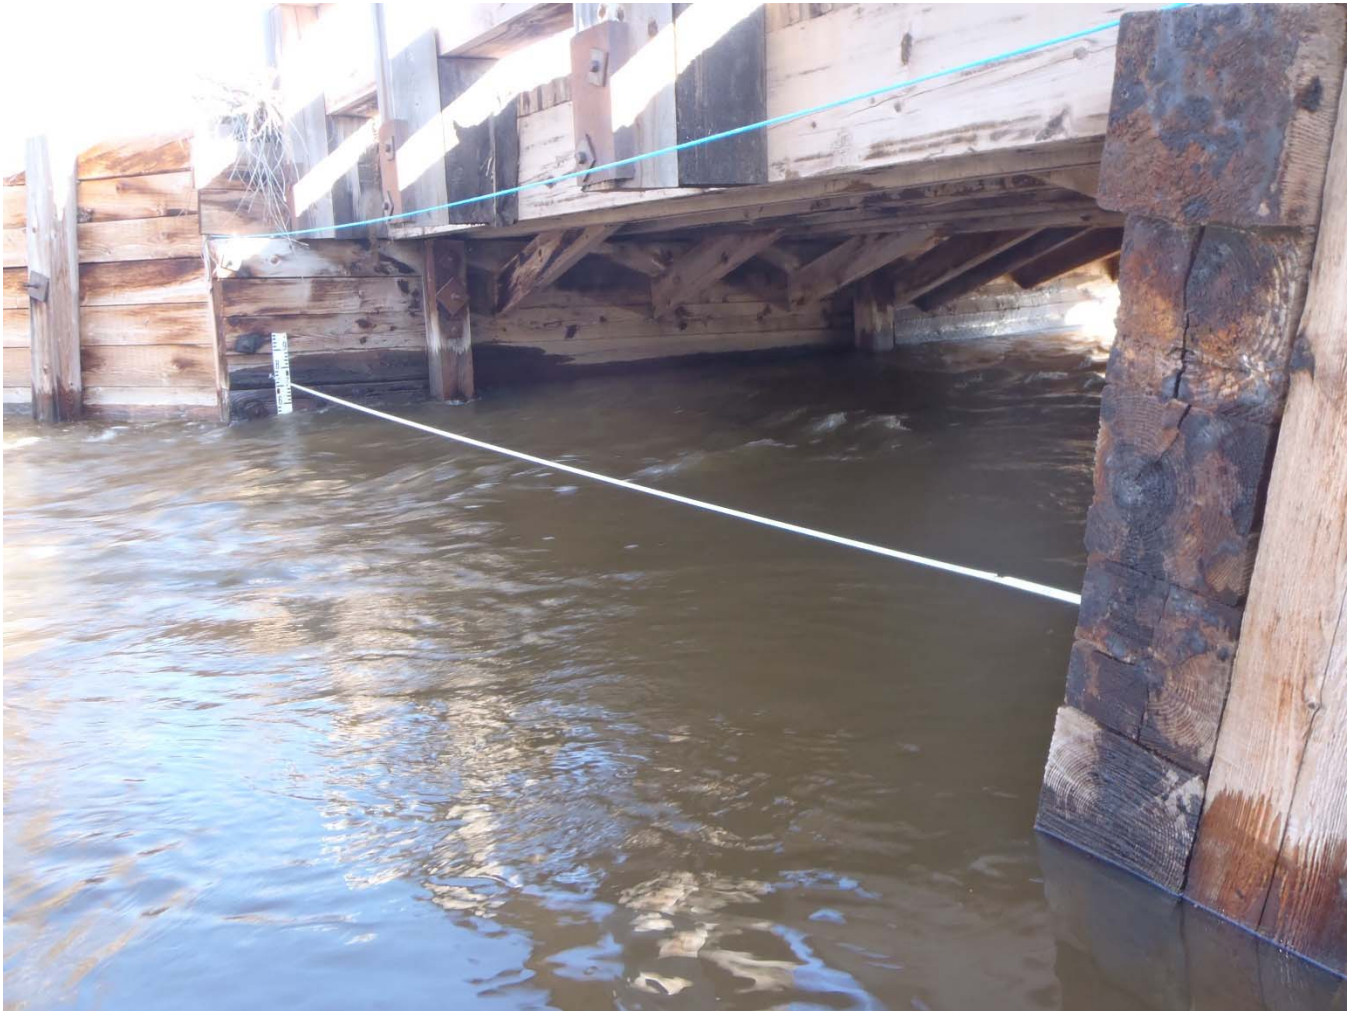
The Crackingstone River is monitored immediately downstream of a bridge crossing. The installation has a staff gauge mounted to the right wing wall of the bridge. Stage and discharge data for CS-1 are presented in Table 22 while the rating curve is shown in Figure 19. The hydrograph and daily discharge data are presented in Figure 20 and Table 23, respectively. The winter stage data at CS-1 prior to May 2013 appears to be impacted by ice; as such, the data is corrected with data from AC-8 on a unit area basis and manually adjusted to fit the trend of the hydrograph.

Photo 9: CS-1 - May 16, 2013

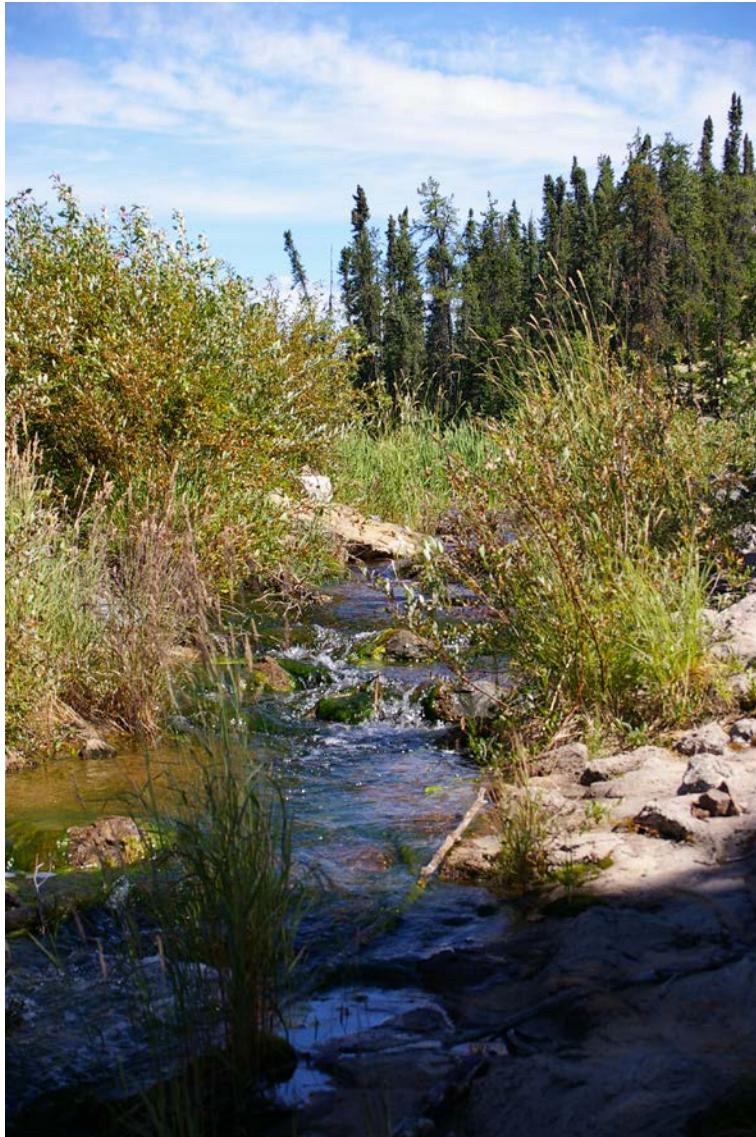
**Photo 1 – Marie Reservoir Spillway looking upstream**

Photos 1 to 3, taken on the July 18, 2013 inspection, provide photographic record of the condition of the Marie Reservoir spillway channel.

Previously SRK Consulting identified that the grout-intruded rip-rap is relatively intact except near the spillway entrance where one large block and several smaller ones on the right side of the spillway (looking downstream from Marie Reservoir) have been displaced due to ice-jacking.

The photographic record supports the observations made by SRK Consulting and the spillway continues to perform as designed.

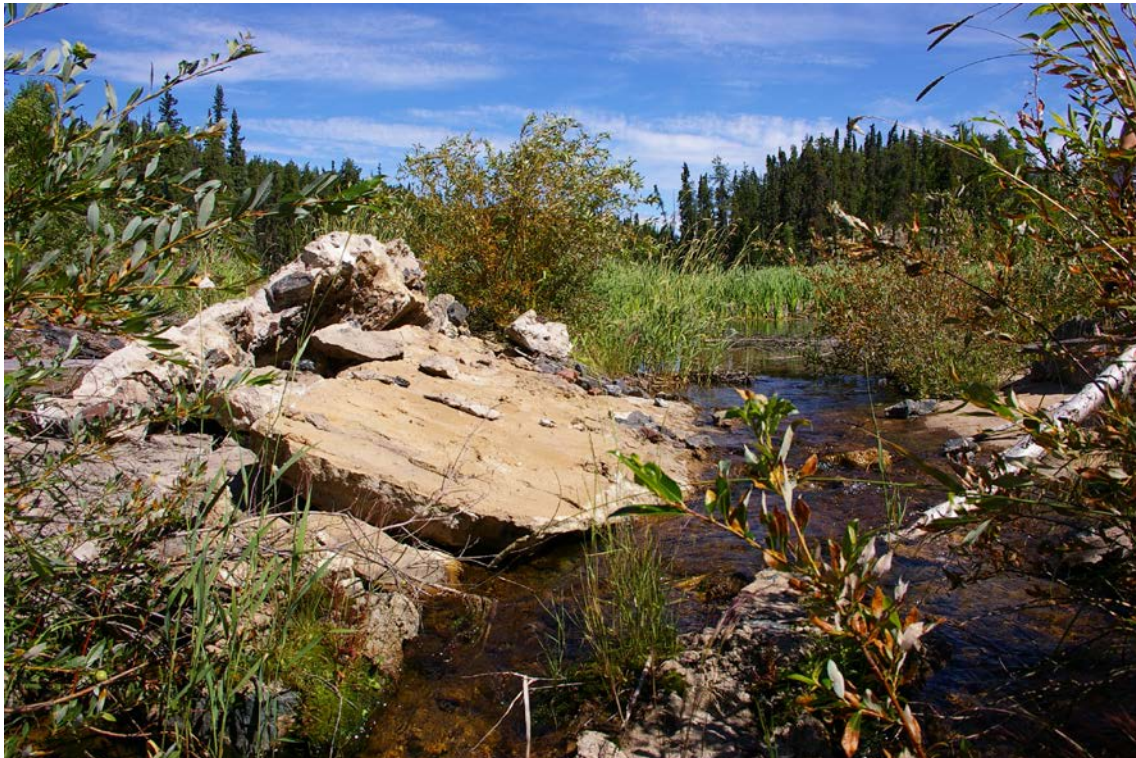
During the 2013 inspection, there was evidence of some ice-jacking in the form of fracturing of the grout-intruding rip-rap. With the most significant displacements near the upper portion of the spillway and specifically located on the sides of the spillway which were within 5 to 6 m of the spillway entrance. In addition, some natural debris was noted upstream of the structure. Photographic evidence was collected for the structure. While there was no evidence of erosion of the grout-intruding rip-rap, some displacement is present due to ice-jacking. There were no immediate concerns at the Marie Reservoir outlet structure that were noted as the structure seems to be functioning as designed.

**Photo 3 – Ice-jacked block on north side of Marie Spillway**

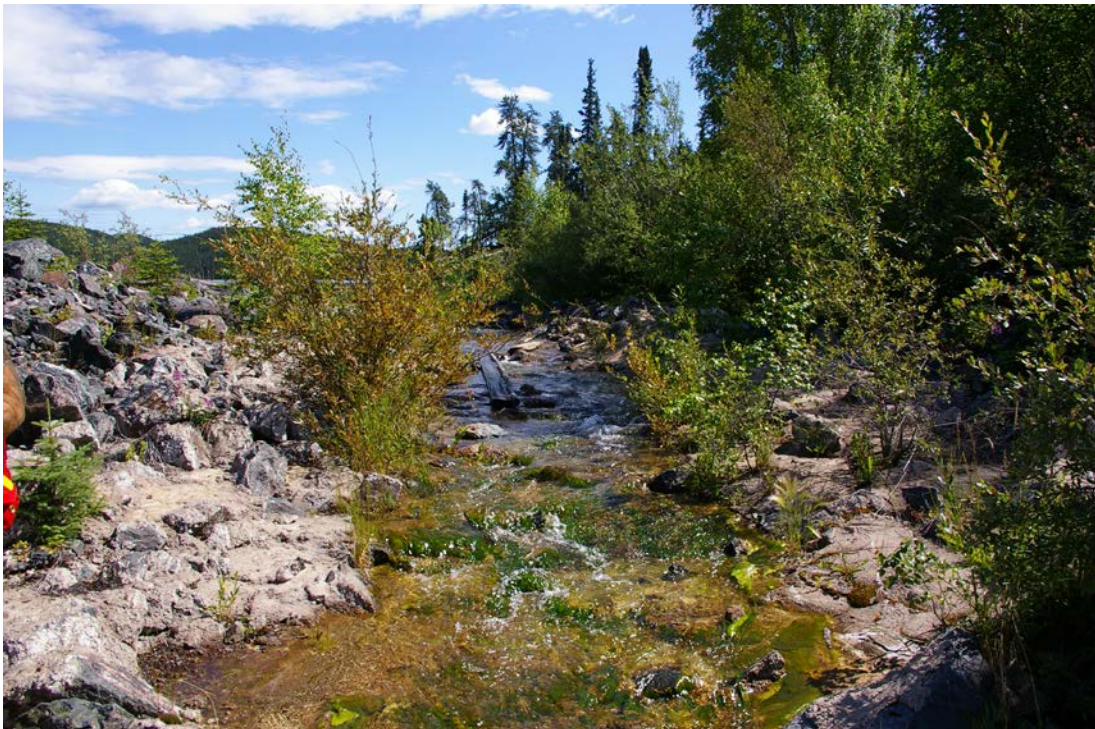
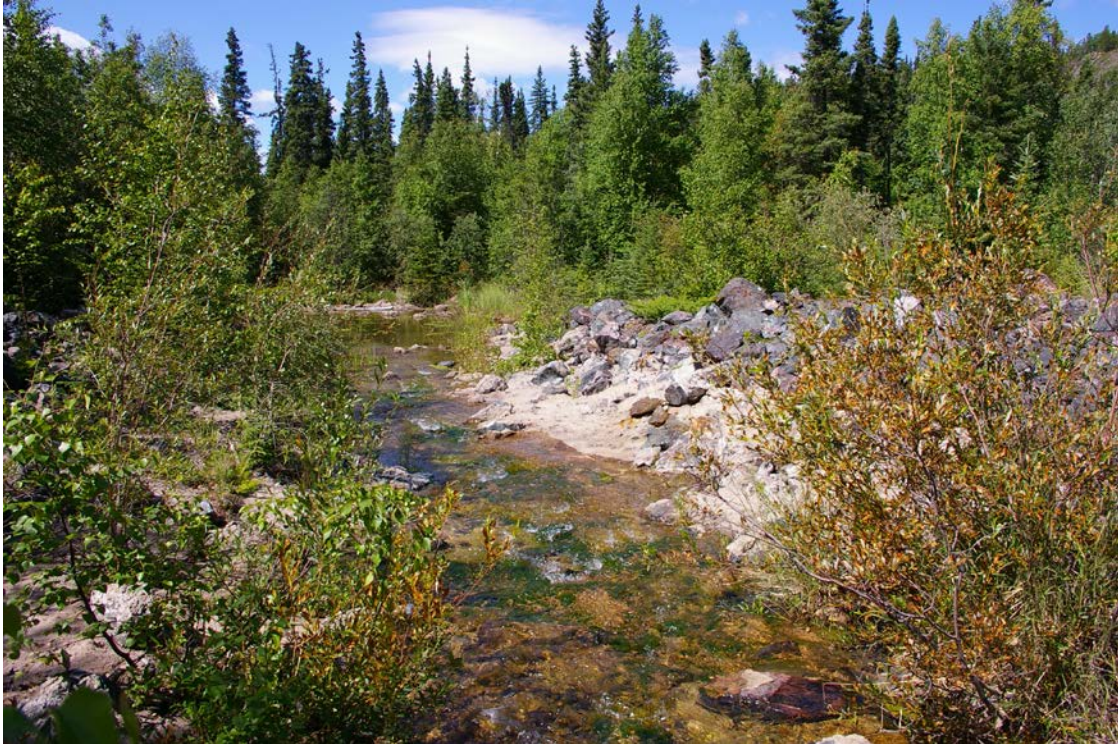
The photographic record shows there has been no change in the condition of the spillway from previous inspections and the spillway continues to perform as designed.

**Photo 4 – Fookes Reservoir Spillway looking upstream**

**Photo 5 – Fookes Reservoir Spillway looking downstream towards the stilling basin**

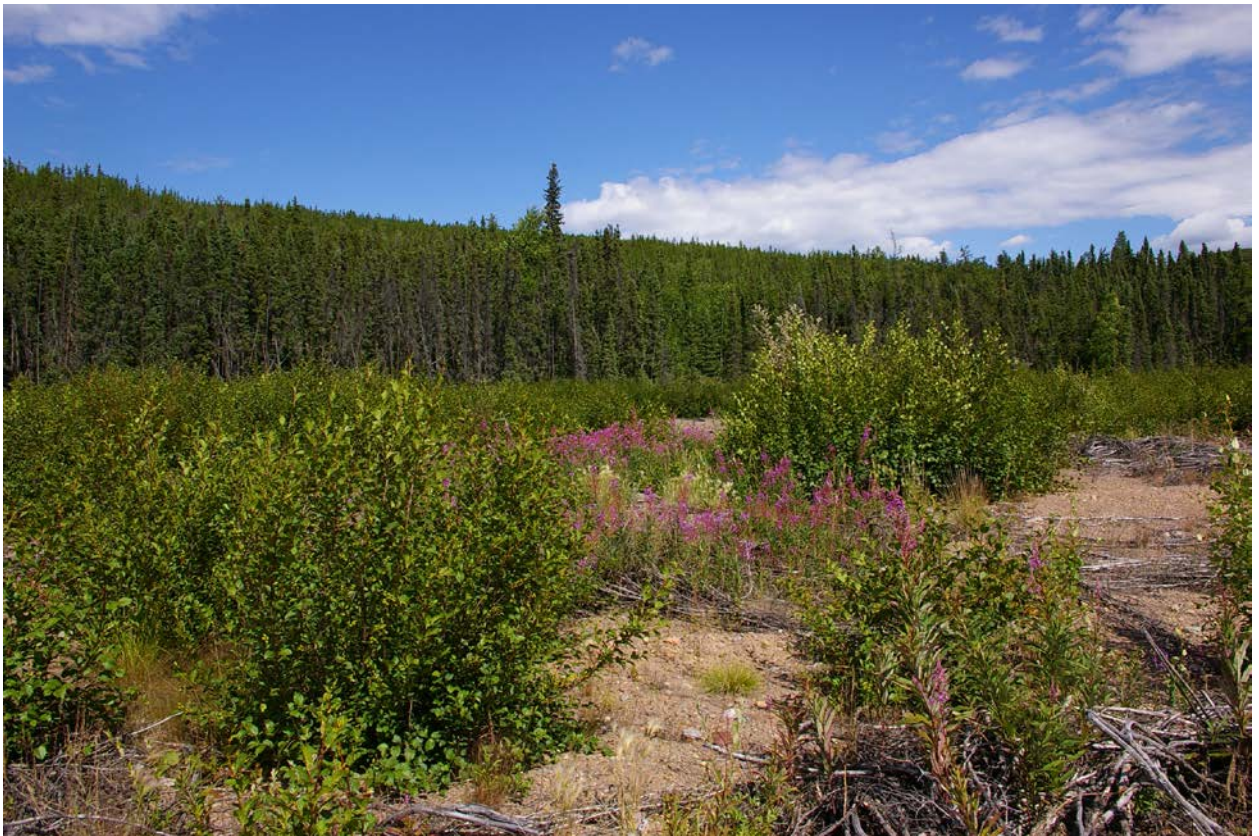
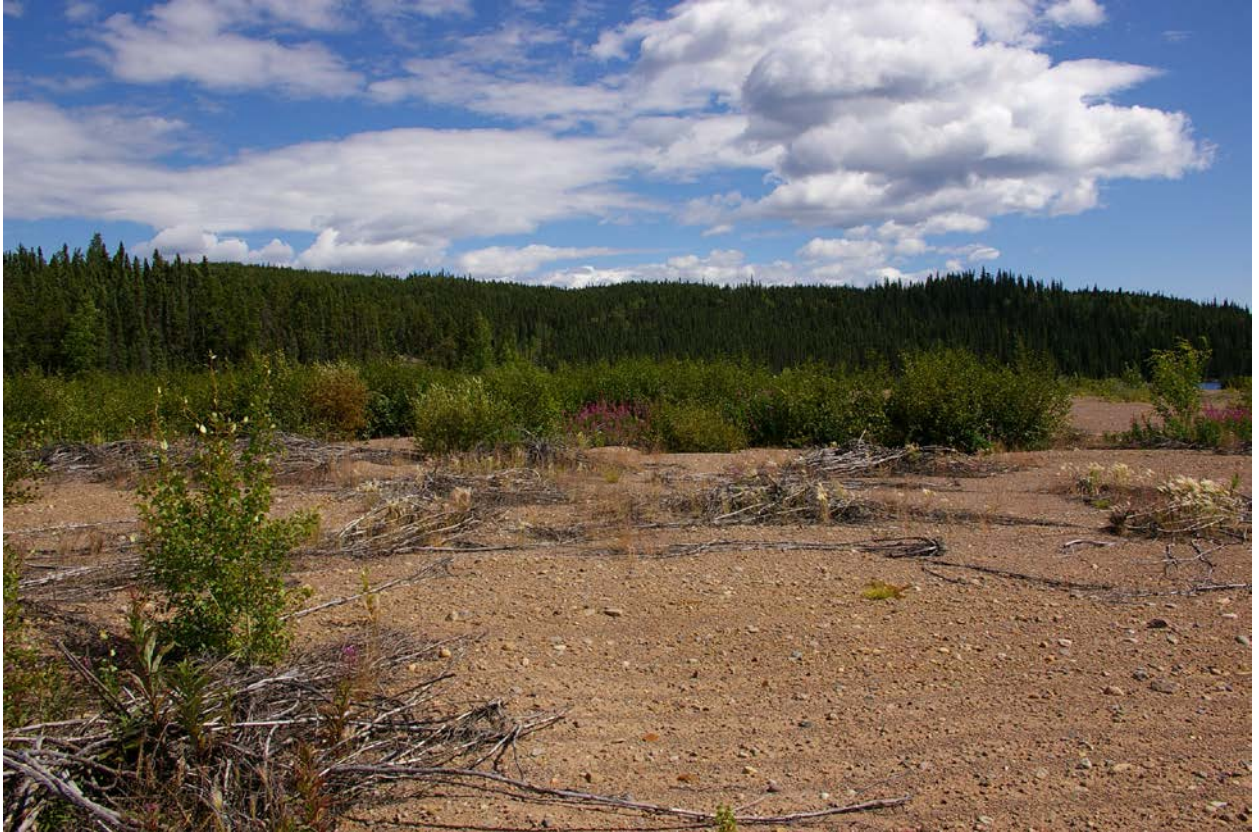
After a period of drought which saw water levels in Fookes Reservoir drop in 2011, water levels have returned to a normal level for the past two years. Generally the cover was in good condition showing no areas of excessive erosion. There was no evidence of new vehicular traffic on the delta since the berms located at the access points were repaired and reinforced, although historic tire tracks on the delta remain. Although vegetation on the delta remains sparse over much of the area it is well established within 50 m of the Fookes Reservoir shoreline, and the engineered drainage structures. Photos 7 and 8 show the vegetation growth on the cover near the shoreline.

**Photo 6 – Vegetation on the Fookes delta (looking SE)**

**Photo 7 – Vegetation on the Fookes delta (looking south)**

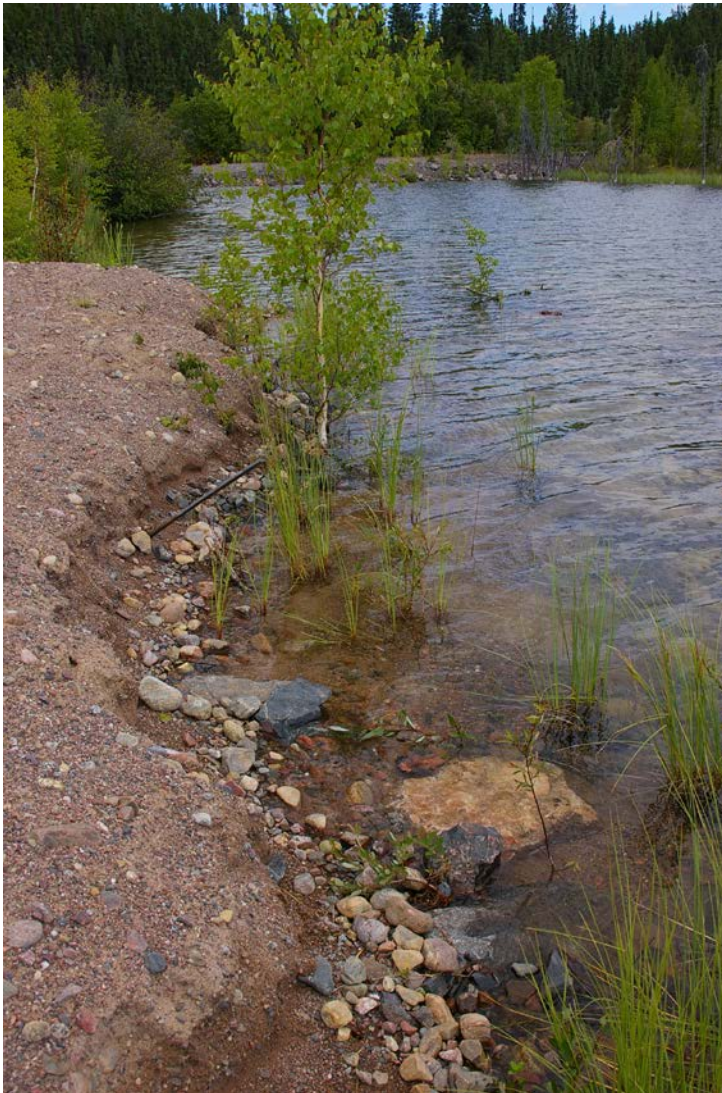
In general the sand cover was in good condition and showed no signs of excessive erosion. As mentioned previously Fookes Reservoir water levels have been normal for the past two years after a period of drought in 2010 and 2011. Photo 8 shows the shoreline where the water level meets the sand cover. A small amount of erosion of the sand cover can be seen due to wave action, which is to be expected. It is not anticipated that this small amount of erosion will affect the performance of the sand cover. As vegetation continues to encroach on the shoreline it will provide additional armoring and increase the stability of the cover.

**Photo 8 – Fookes Reservoir shoreline**

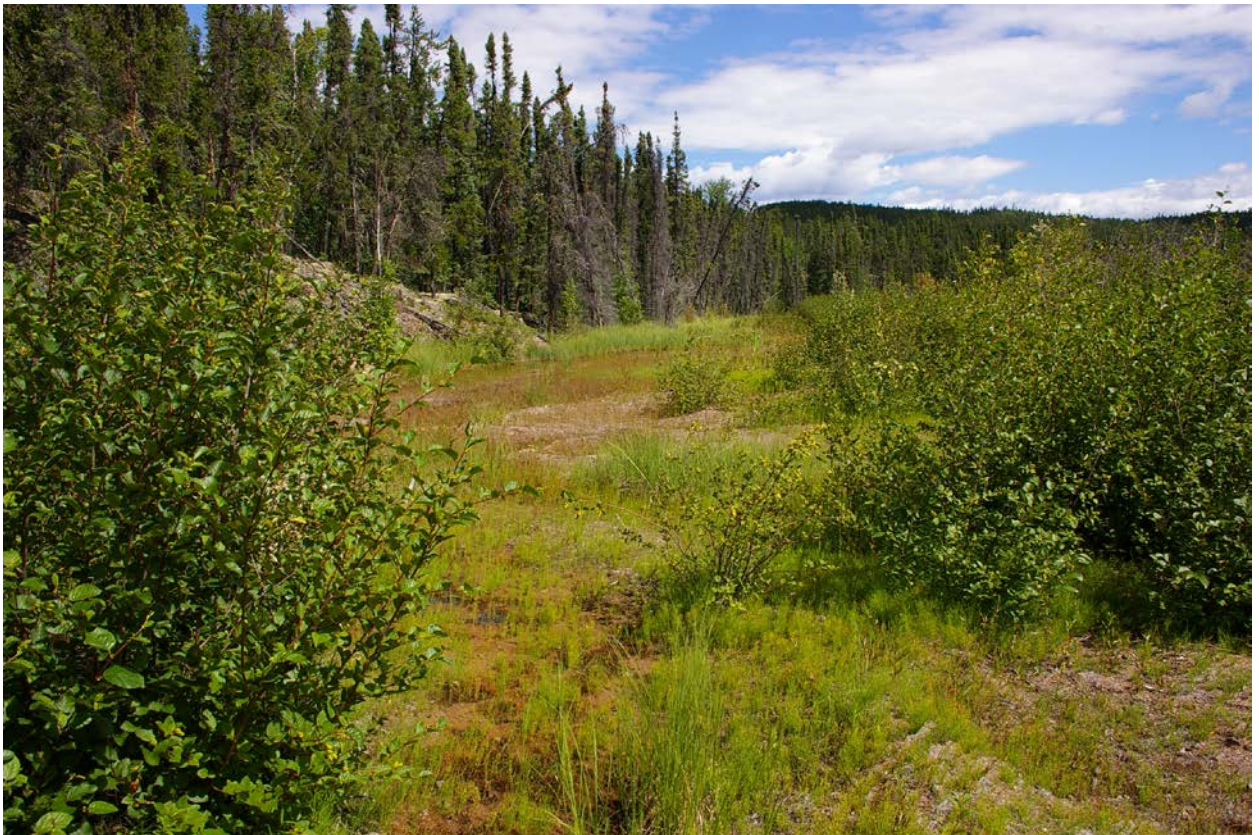
A drainage trench is located along the east side of the Fookes delta to channel surface water runoff during heavy precipitation events and spring freshet. It was noted in previous inspections that sand has flowed along the base of the drainage trench that has a rock-fill base. This sand flow is not expected to threaten the functionality of the ditch in the medium term. In the longer term, as vegetation continues to establish itself, the risk to ditch functionality will diminish further. There were no new sand flows identified in the drainage trench during the 2013 inspection. Photo 9 shows the vegetation growth in and around the drainage trench.

**Photo 9 – Vegetation growth in the drainage trench on the Fookes delta (along the tree-line looking SW)**

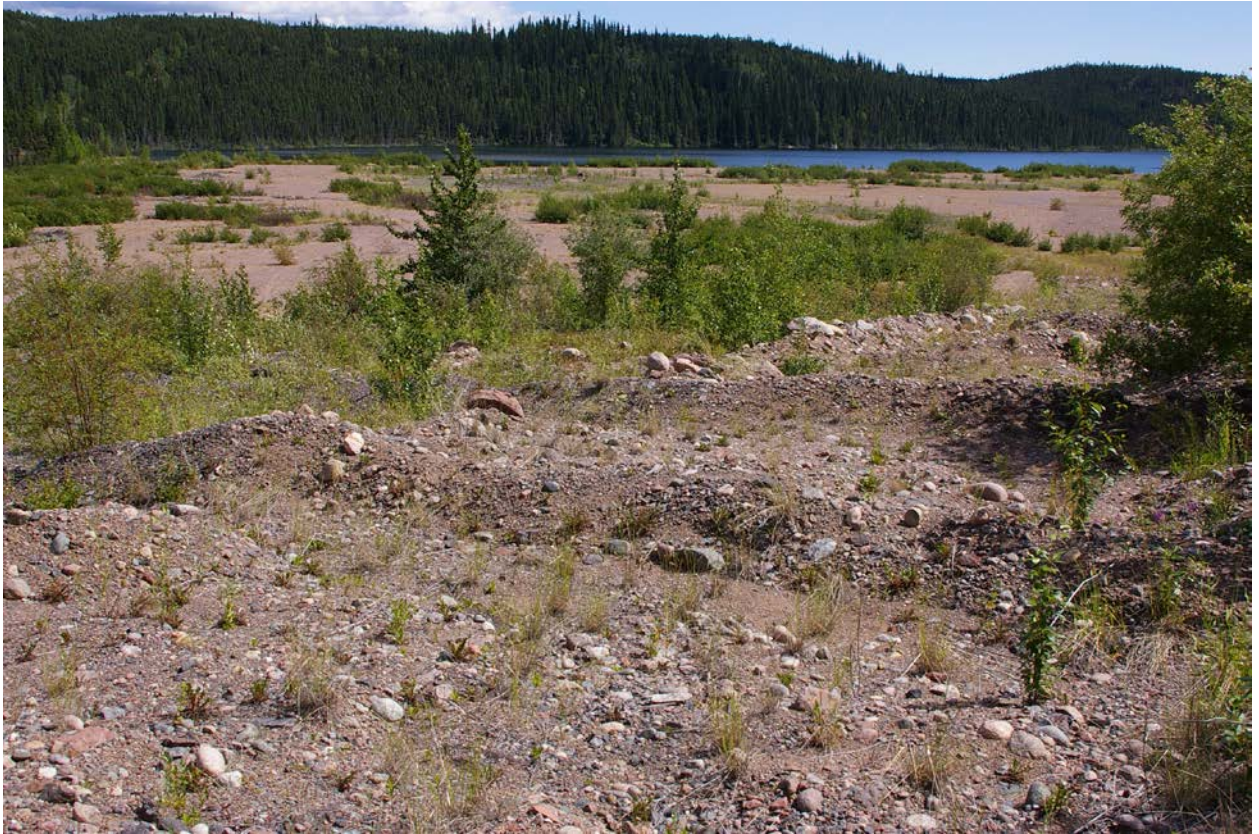
water bars (chevrons) are performing as expected and show little sign of erosion (Photo 10).

**Photo 10 – Chevrons in place on north access point to the Fookes delta**
