**Cameco**

**2013 Beaverlodge Annual Report**

**April 2014**

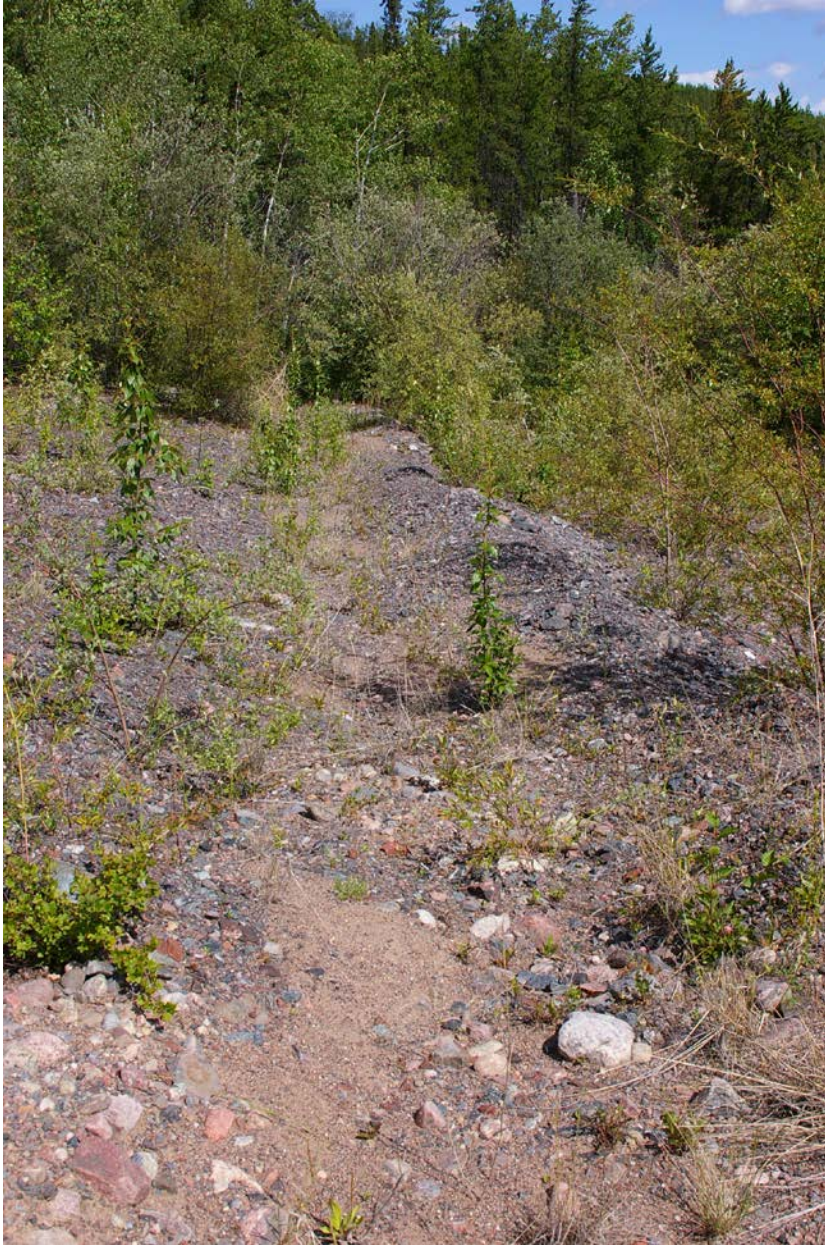
In addition to the chevrons, run-out structures were installed to carry away excessive water during extreme run-off events. These run-out structures are also in good shape and have seen no additional eroded material beyond that observed during previous inspections (Photo 11).

**Photo 11 – Run-out structure along north access road**

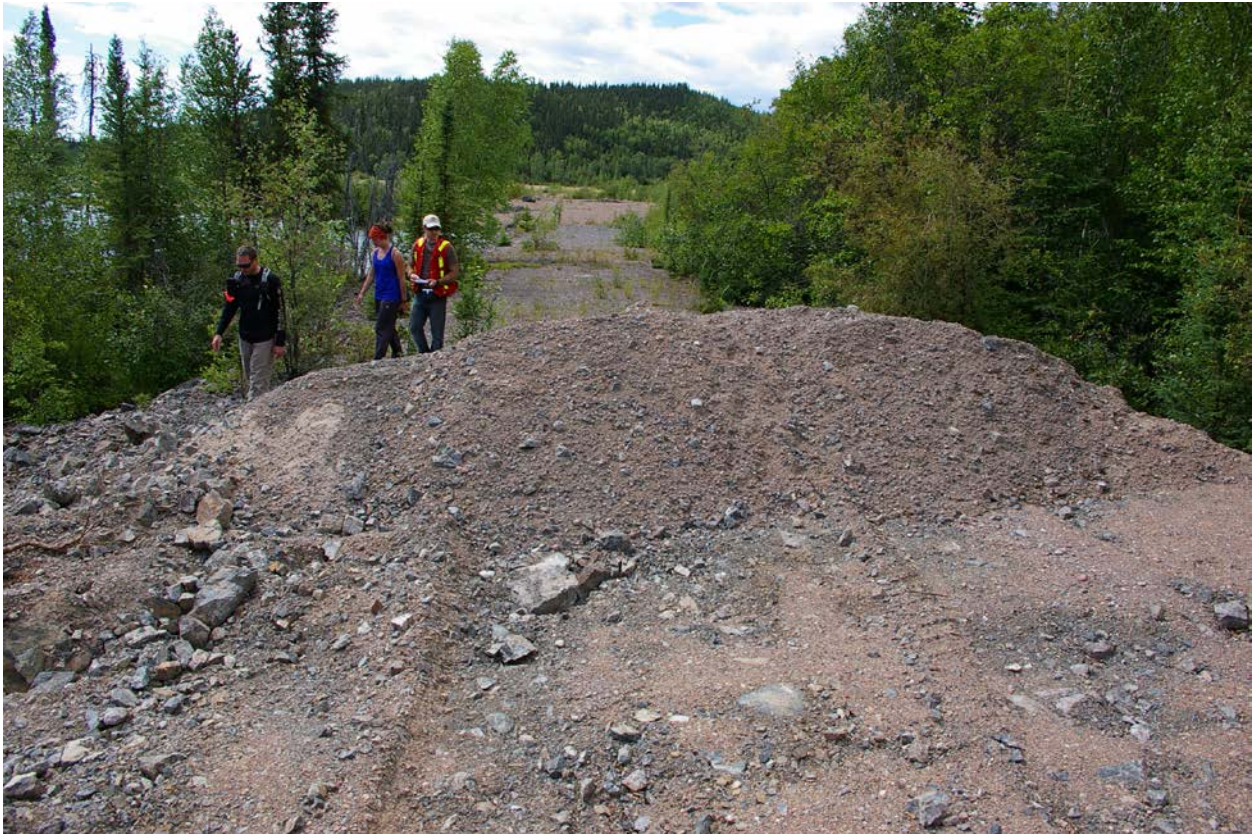
During the 2012 inspection it was discovered that the east access berm had been compromised and vehicles had gained access to the delta from this point. Following the inspection in 2012 the east berm was repaired and reinforced. This berm was inspected as part of the 2013 regulatory inspection and found to be in good condition, with no evidence that people had gained vehicular access to the delta. Photo 12 shows the repaired berm located on the east side of the Fookes Delta.

**Photo 12 – East berm (looking west) repaired to prevent vehicular traffic**

traffic had gained access to the delta by driving over a berm at the bypass access road put in place to eliminate traffic to the delta. In October 2012, the berm was repaired and made higher. The repaired berm was inspected in 2013 with no evidence of vehicle access over the berm, and no new vehicle tracks were found on the delta itself. Some minor washout from wave action was noted along the shoreline of the tailings cover, erosion was less substantial in areas where aquatic vegetation was emergent. It is indicated in the report that this activity should continue to be closely monitored in future inspections.
