**Beaverlodge: Year 31 Transition Phase Monitoring Annual Report (2016)**

## Beaverlodge Project 2016 Annual Report Year 31 Transition Phase Monitoring

**March 2017**

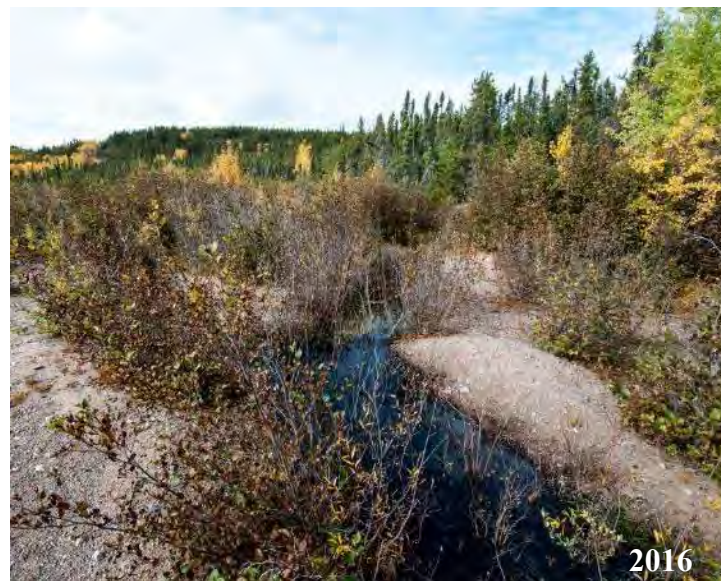
**Fookes Outlet Structure looking downstream**

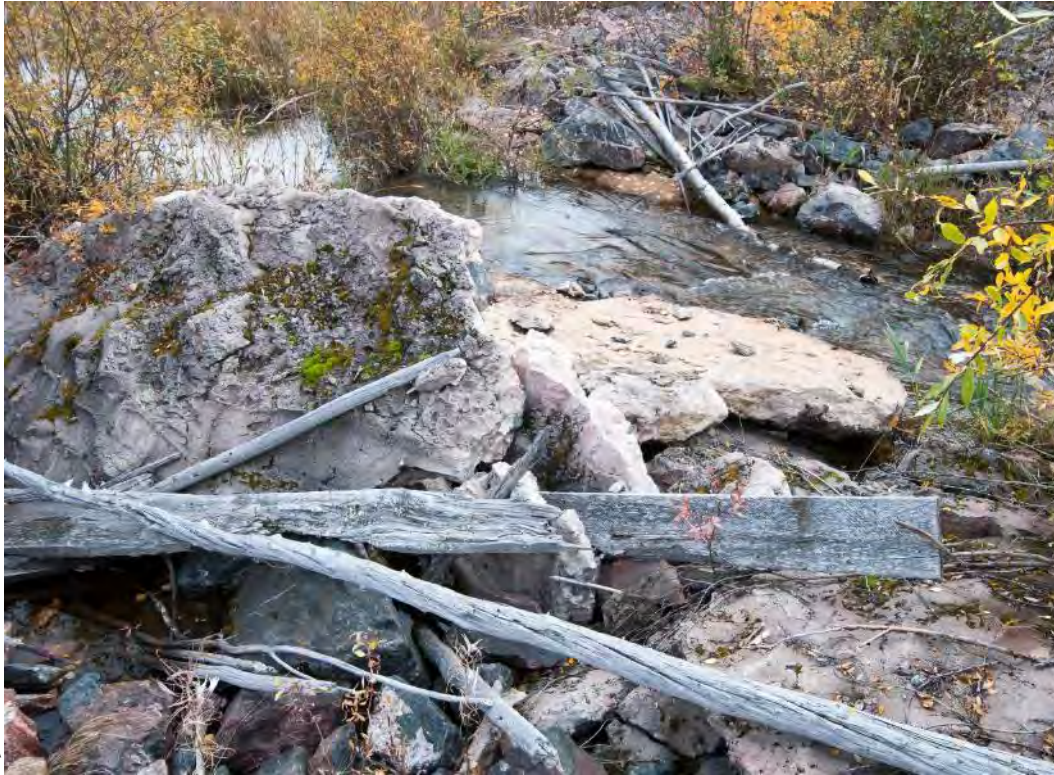
**Photo A5 – Displaced grout intruded rip rap at the entrance to the spillway**

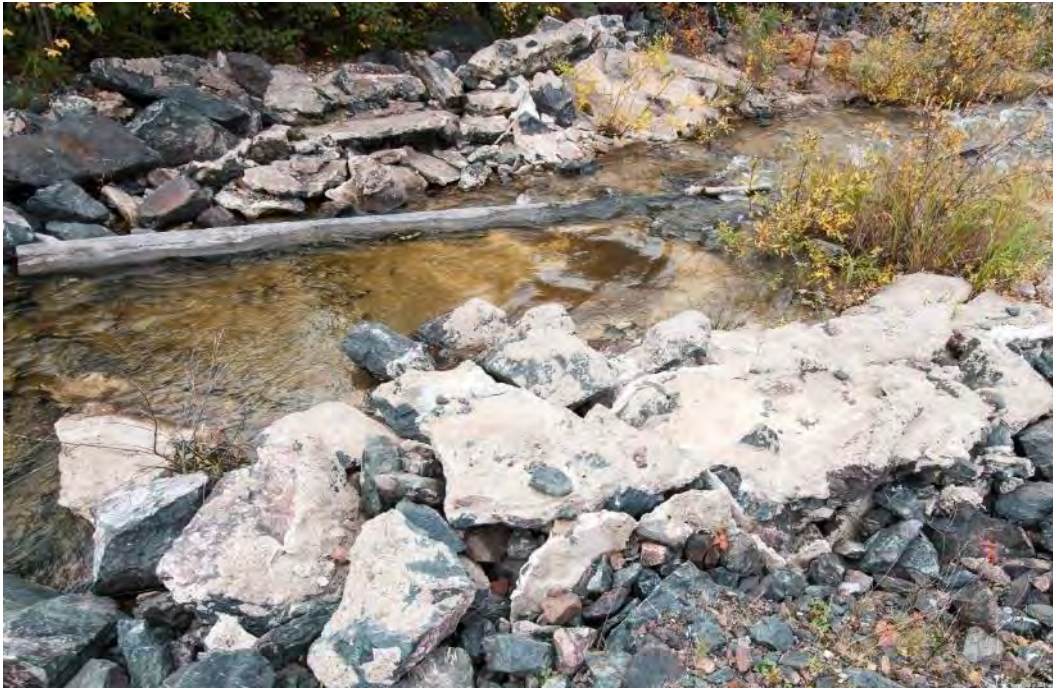
**Photo B7 – Evidence of grout displacement on both sides of the channel at the entrance**

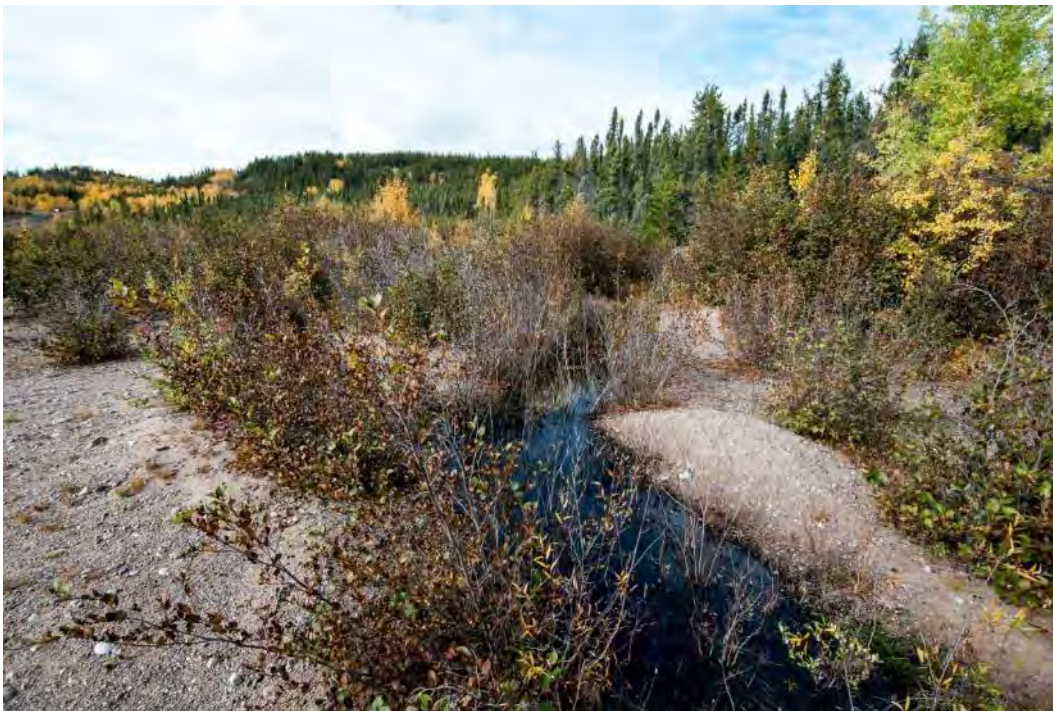
As previously noted there continues to be standing water observed along the drainage areas on the northeastern portion of the tailings delta. Due to these conditions additional attention was placed on searching for new tailings boils, particularly in areas that were not covered with filter sand during the last cover application in 2007. No new tailings boils were noted on the cover.

**Photo C2 – Drainage channel on Fookes Delta with standing water (looking NW)**

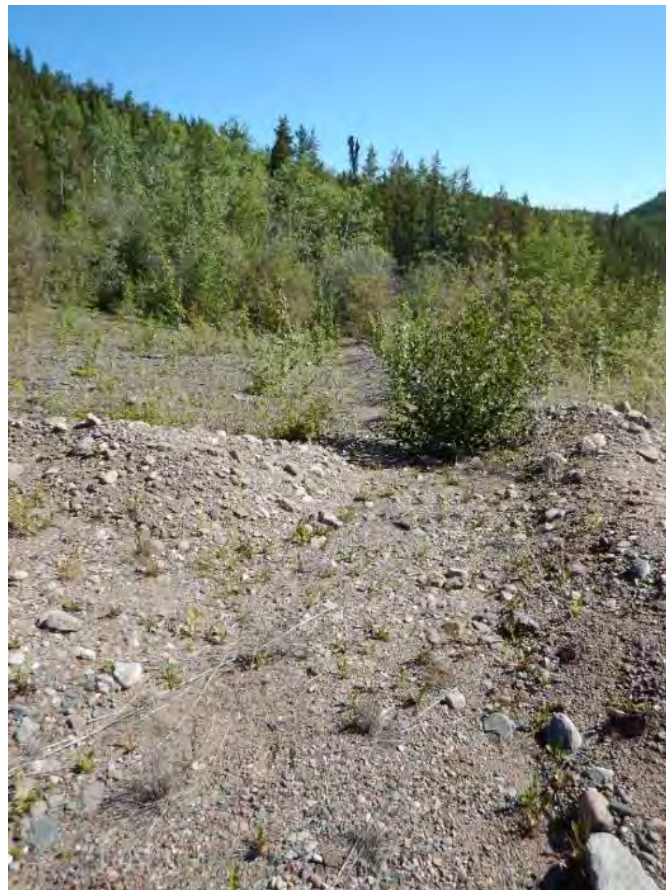
In addition to the chevrons, run-out structures were installed to carry away excessive water during extreme run-off events. These run-out structures are also in good shape and have seen no additional eroded material beyond that observed during previous inspections ([Photo C4](#)).

**Photo C4 – Run-out structure along north access road (looking east)**

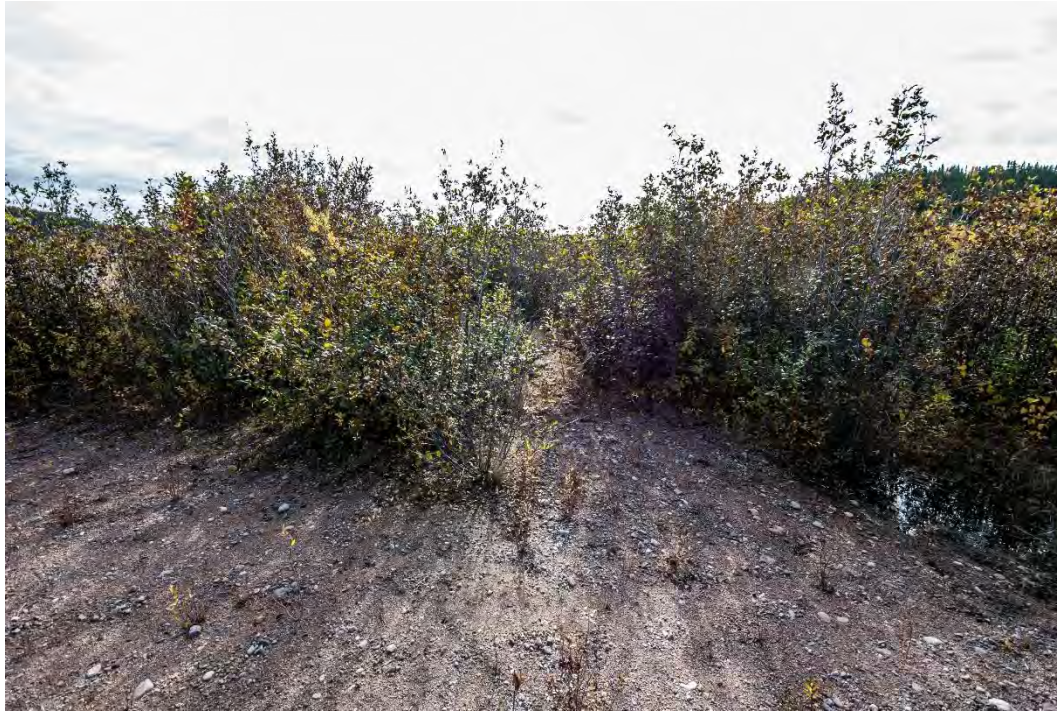
**Photo C6 – View of vegetation establishing on the cover**

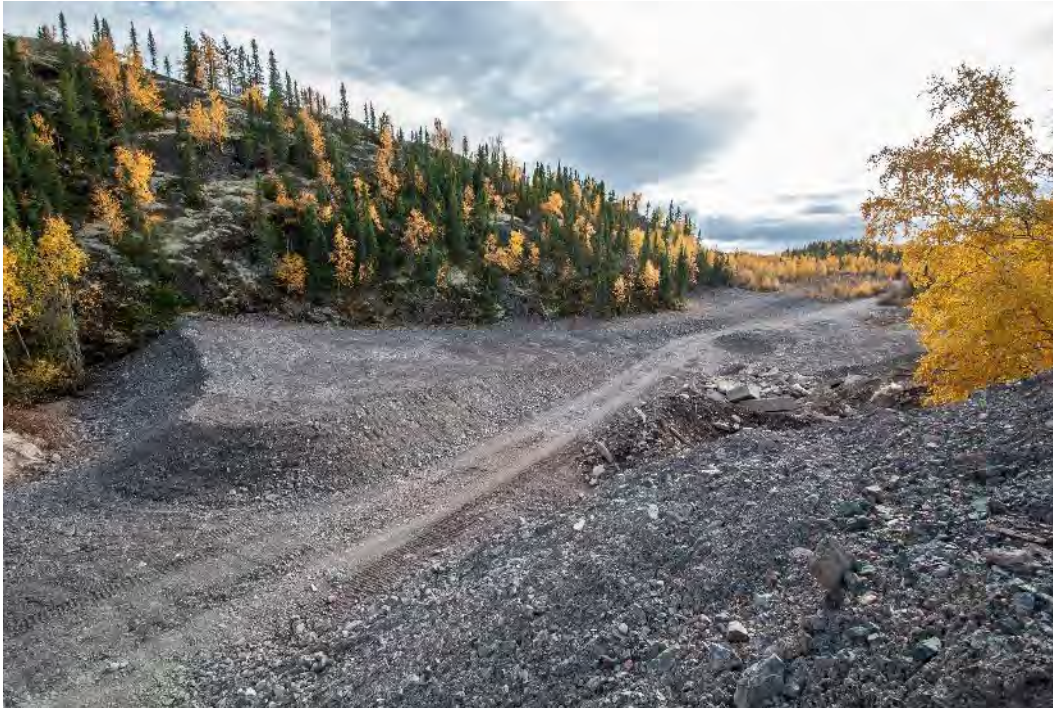
**Photo D1 - View of the cover placed over 208 Stope**

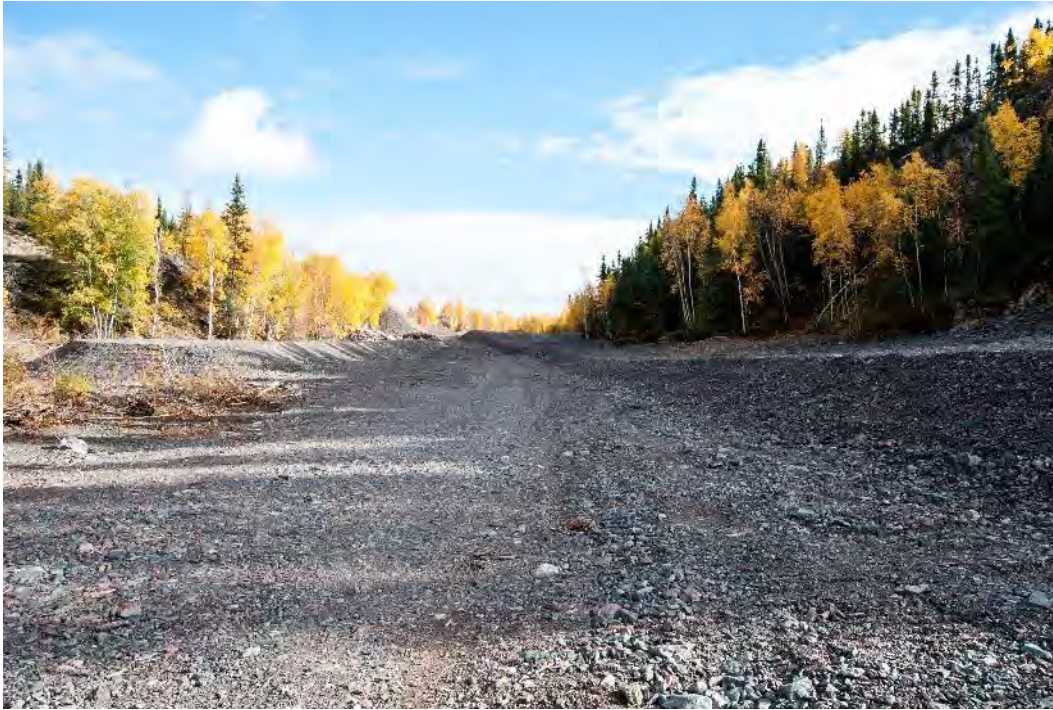
**Photo D5 – View of the road between cover placement looking NE**

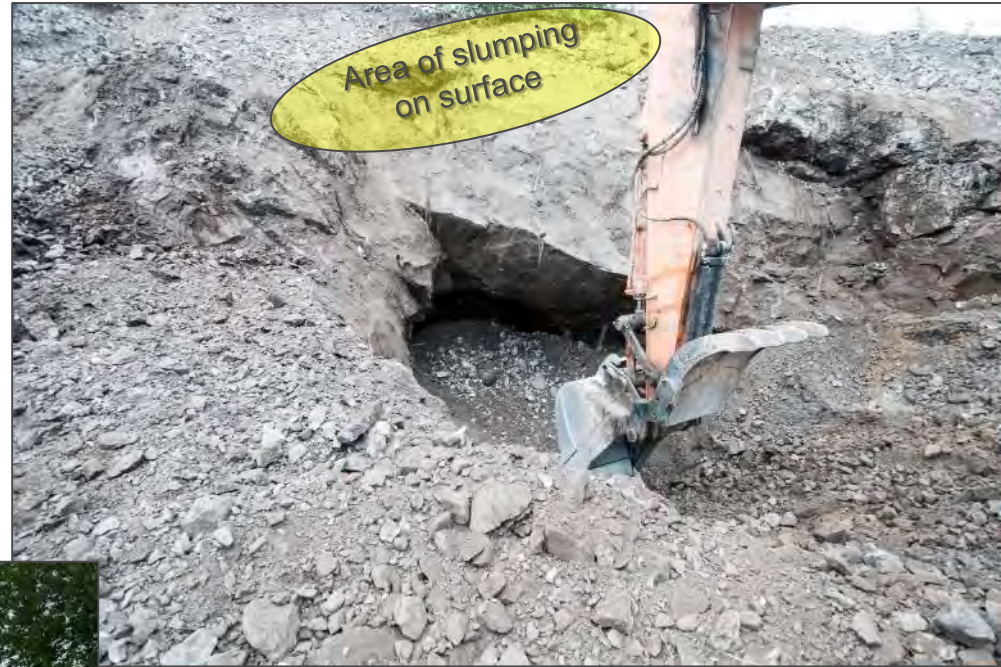
Exposing the adit

- Previous slide shows area of slumping on UAV photo
- Remediation of waste haul adit completed

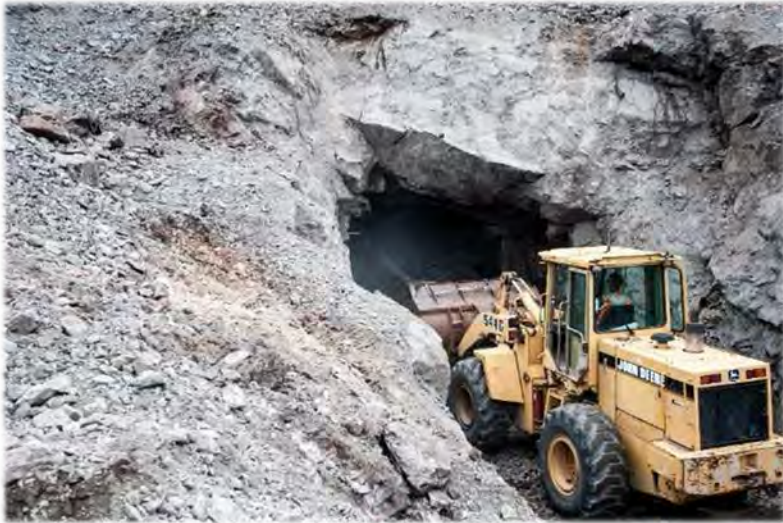
Packing waste rock into opening

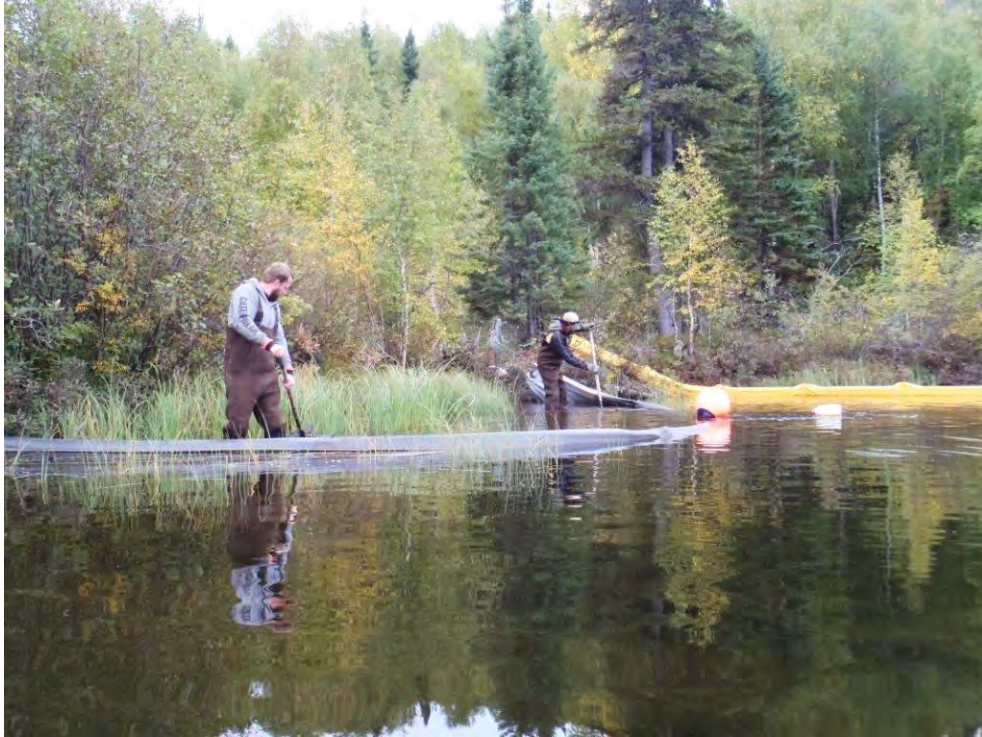
with assistance from two laborers supplied by Uranium City Contracting Ltd. (UCC). This included the innermost turbidity curtain installed in Verna Lake at the outlet of Zora Creek (Appendix A, Photo 1), as well as sediment control measures in place along the section of Zora Creek between the reconstructed channel and Verna Lake.

Photo 1. Photo showing removal of the inner turbidity curtain in Verna Lake, September 2016.

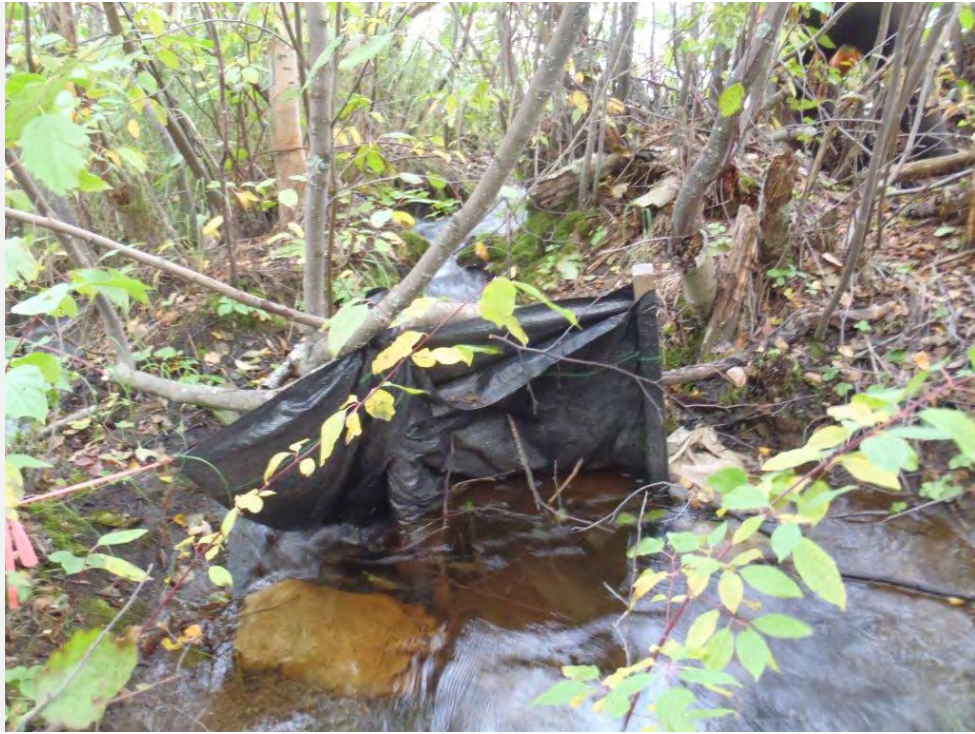
Photo 5. Photo showing sediment fence installed in Zora Creek, September 2016.

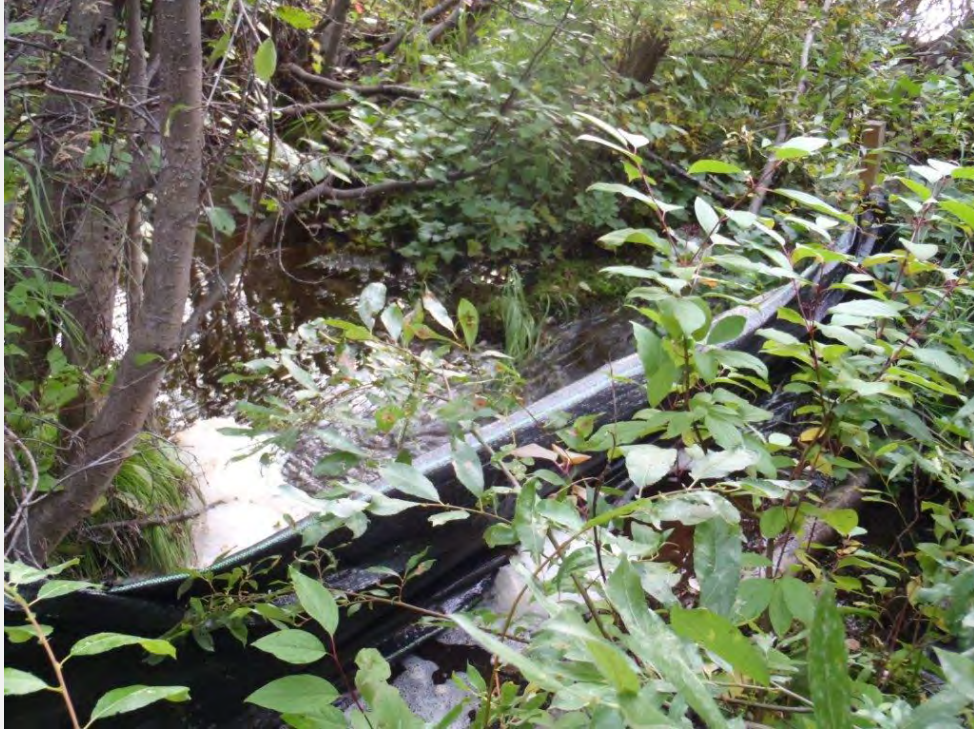
Photo 7. Photo showing sediment fence installed in Zora Creek, September 2016.
