**Beaverlodge: Year 33 Transition Phase Monitoring Annual Report (2018)**

## **Beaverlodge Project 2018 Annual Report Year 33 Transition Phase Monitoring**

**Prepared for:**  
Canadian Nuclear Safety Commission  
Compliance Report for Licence: WFOL-W5-2120.0/2023 &  
Saskatchewan Ministry of Environment  
Compliance Report: Beaverlodge Surface Lease

**Prepared and Submitted by:**  
Cameco Corporation

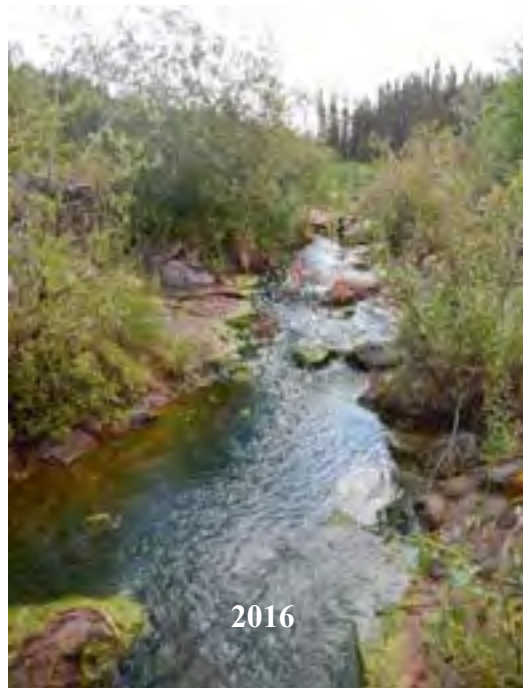
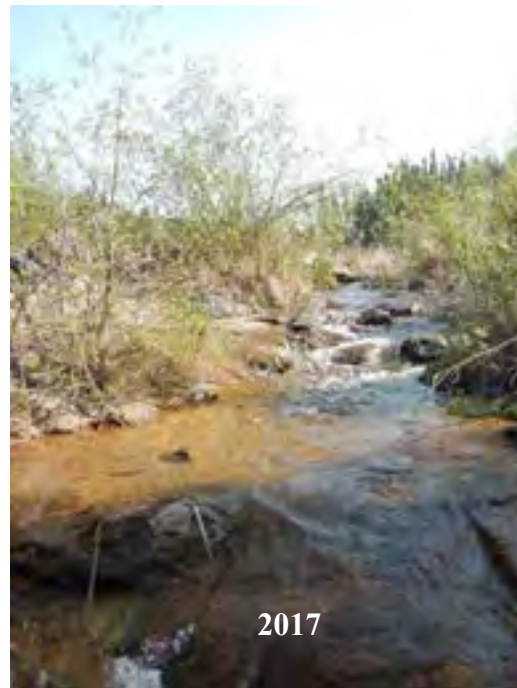
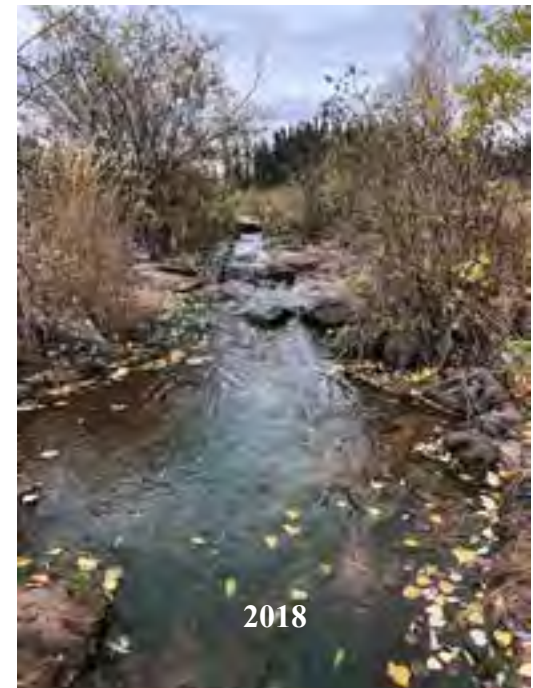
It was noted that beaver activity at the outlet of Marie Reservoir has resulted in construction of a dam. Marie Reservoir appears to be approximately 0.3 m above the drainage channel at the entrance to the outlet structure. This condition will be monitored during future inspections to ensure the integrity of the outlet structure is not compromised. There are currently no plans to remove this structure as it is naturally occurring. A photo of the Marie Outlet structure documenting the beaver dam is located in **Section 4.0**.

Beaver dam construction at the outlet structure for Marie Reservoir (September 2018)

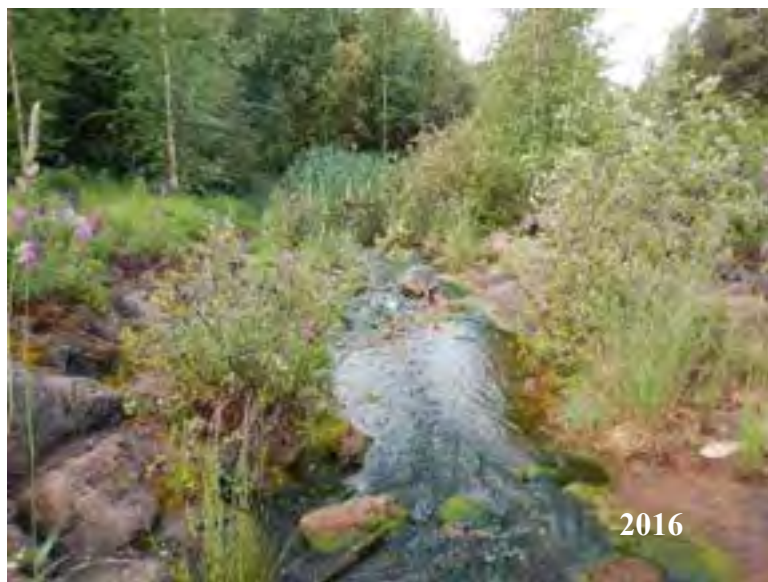
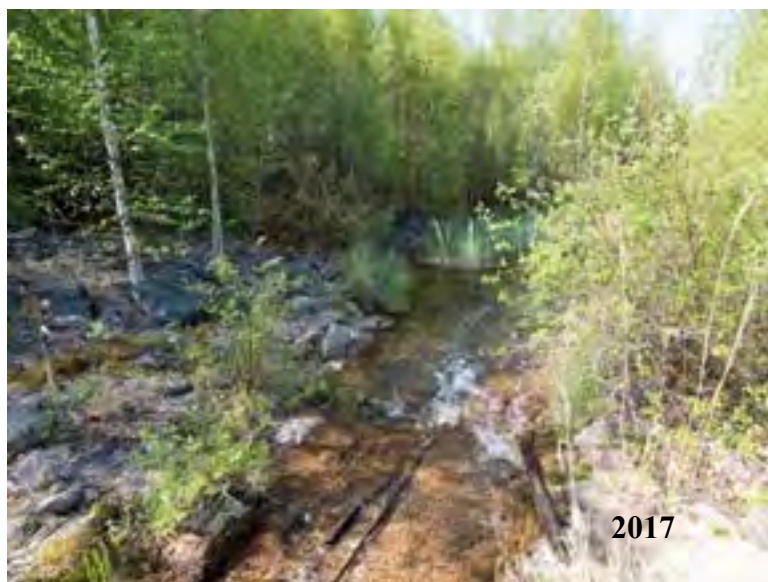
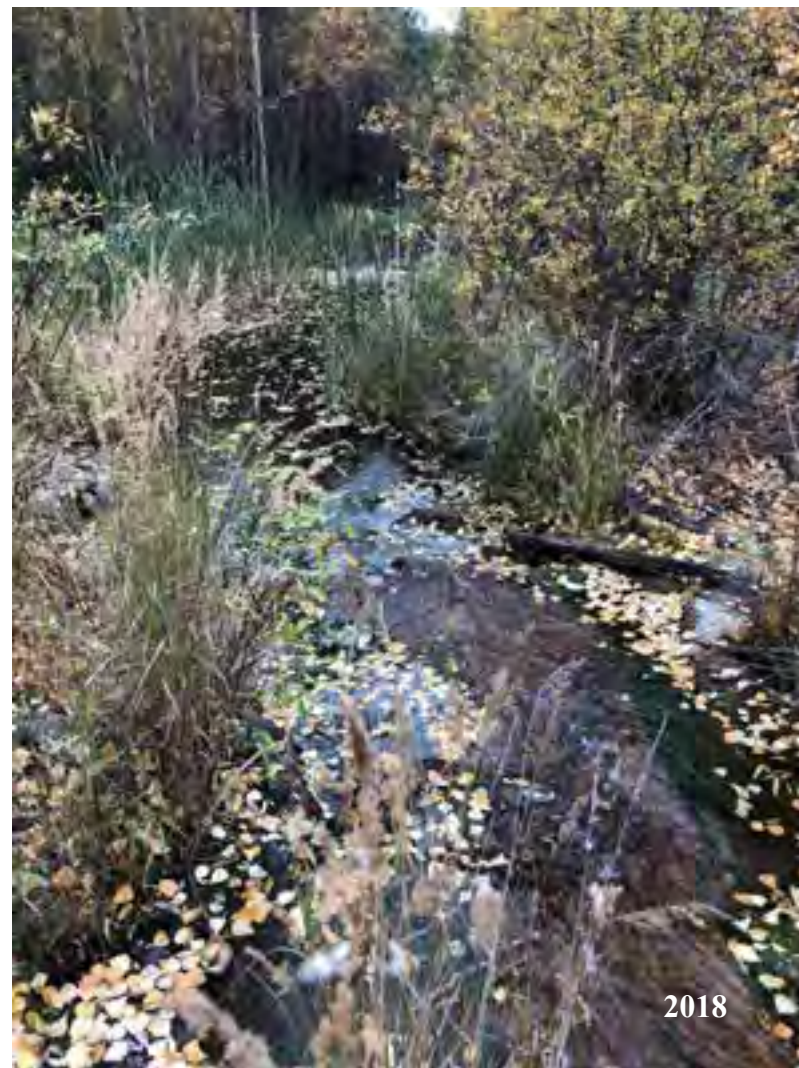
**Marie Outlet Structure looking upstream**

In addition to the comparison photos provided in **Section 4.0**, photos taken during the 2018 inspection providing photographic record of the condition of the Marie Reservoir spillway channel are included in **Appendix A**. The spillway remains in a similar condition as observed in previous inspections.

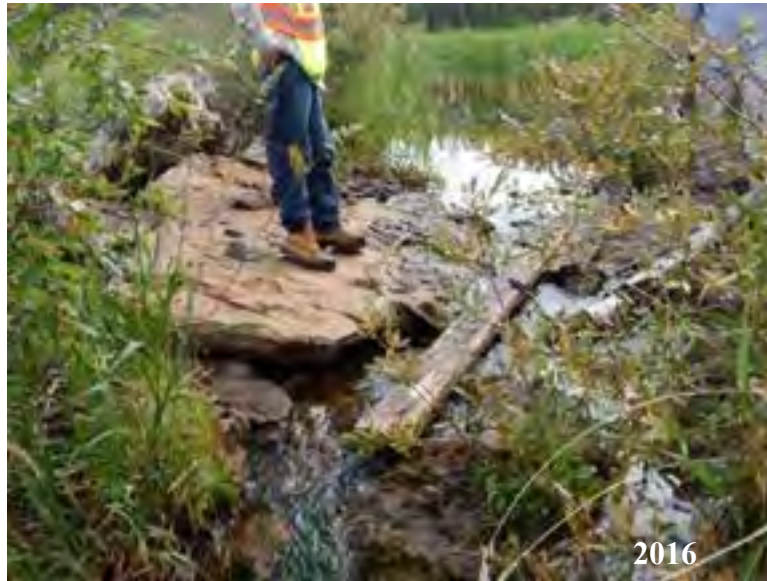
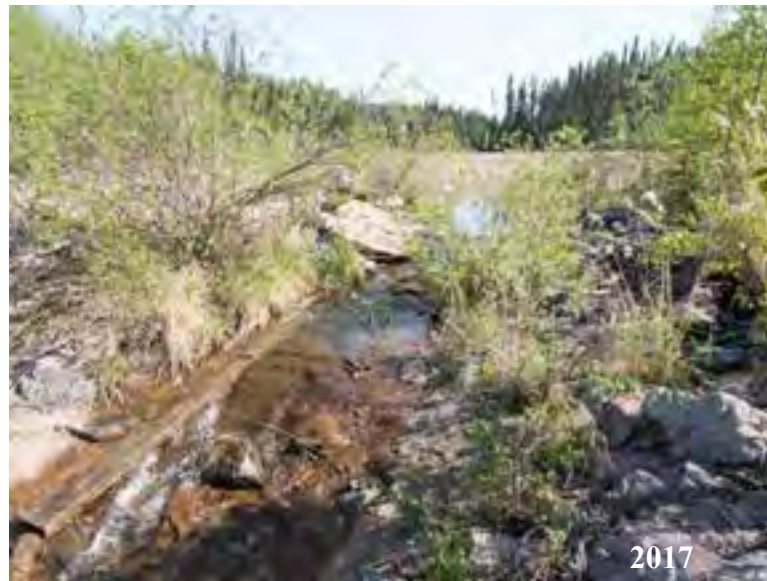
**Marie Outlet Structure looking downstream**

There is no evidence that water has overtopped the rip-rap in this area. Photographic evidence comparing past internal inspections show loose stones on the frost heaved section and other debris in the channel have not moved (or moved very little) from year to year. Photographic comparison to previous inspection photos is provided in **Section 4.0**.

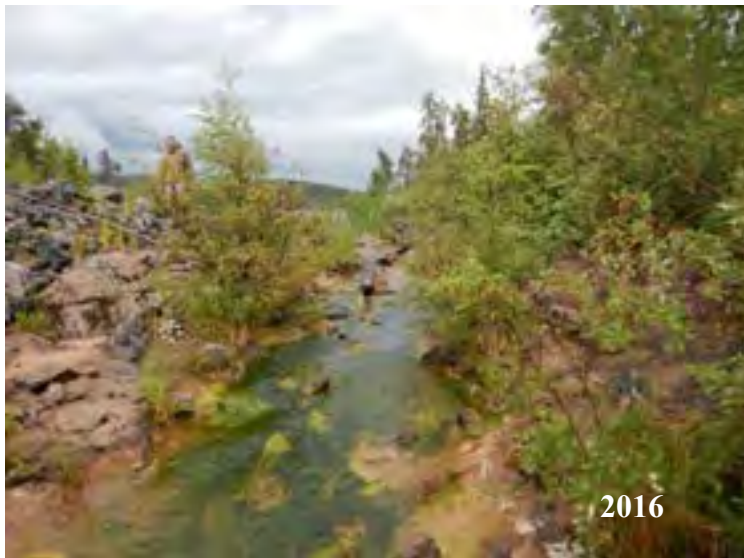
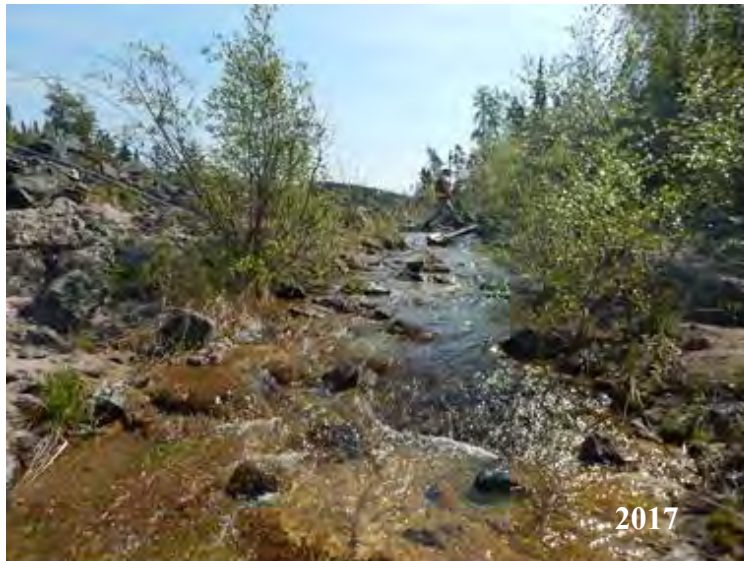
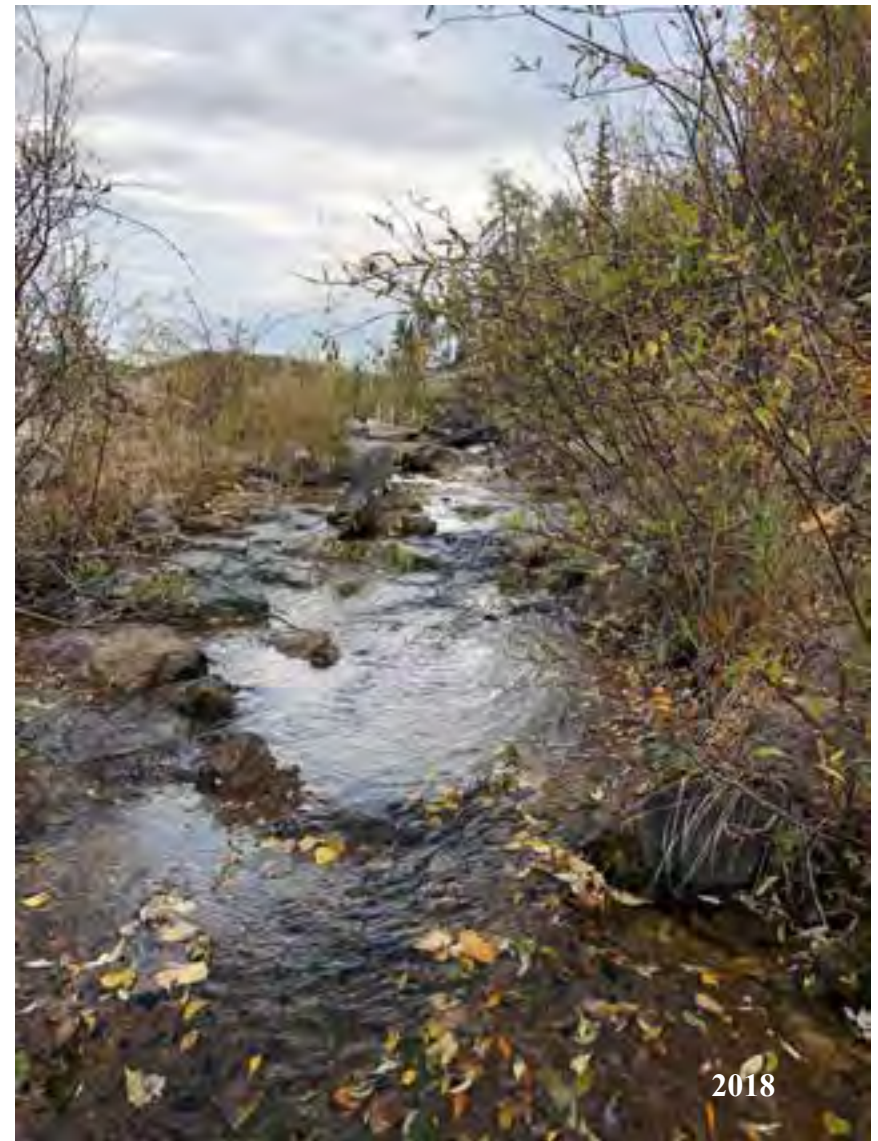
It should be noted that cracking and displacement of the grout-intruded rip-rap was anticipated in the original design and does not affect the performance of the outlet spillway. The grout that was intruded into the rip-rap is meant to serve purely as a binding agent to increase the effective block size of the rip-rap, allowing it to more effectively resist erosion. It has been acknowledged by SRK that additional cracking and grout degradation will occur with time (SRK, 2016).

**Marie Reservoir Outlet Structure – Ice jacked block of grout intruded rip-rap**

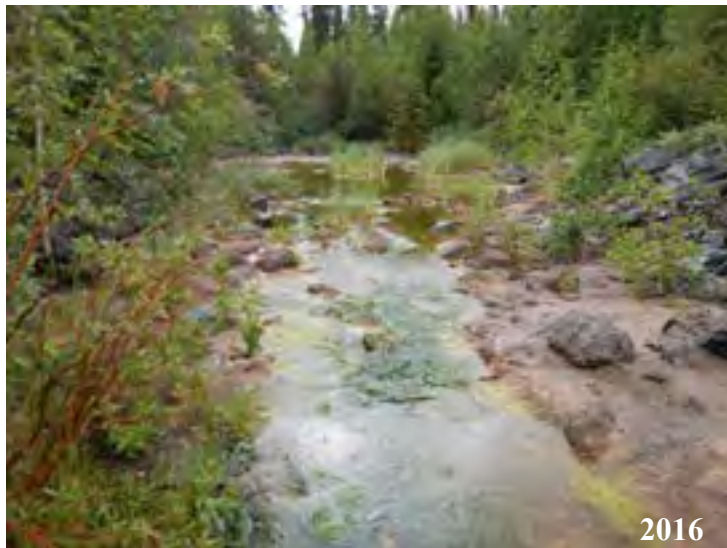
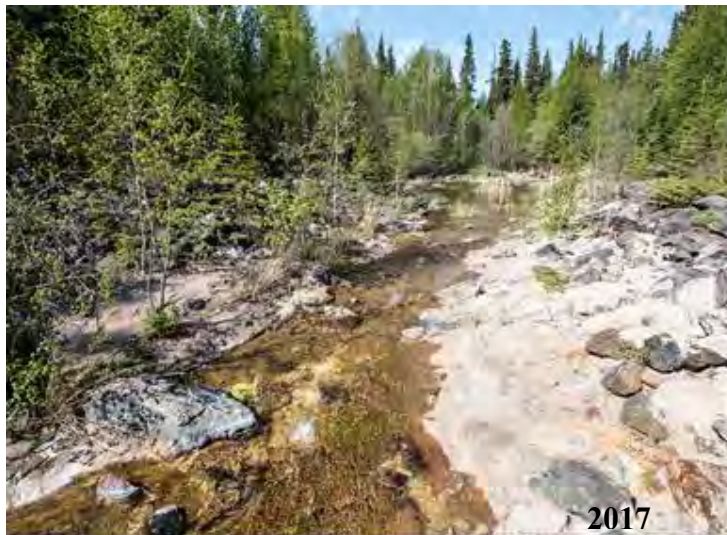
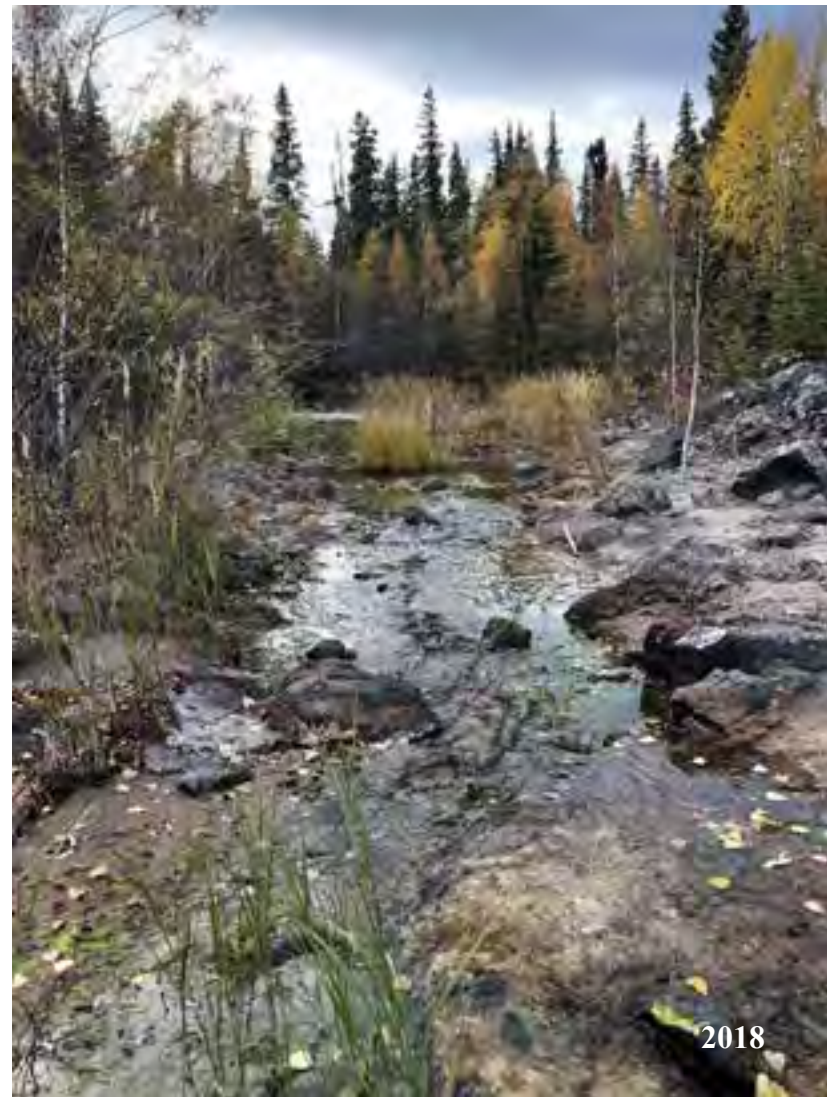
Fookes Outlet Structure looking upstream

Similar to the Marie Outlet, SRK Consulting also identified that the grout-intruded rip-rap along the length of the Fookes Reservoir outlet spillway shows signs of cracking. In addition, there has been some ice-jacking, with the most significant displacements located near the upper part of the spillway (i.e., on the sides of the spillway, within 5 to 6

In addition to the comparison photos provided in **Section 4.0**, photos taken during the 2018 inspection providing photographic record of the condition of the Fookes Reservoir spillway channel are included in **Appendix B**. The overall condition of the spillway in 2018 was observed to be similar to previous inspections, and the spillway continues to perform as designed.

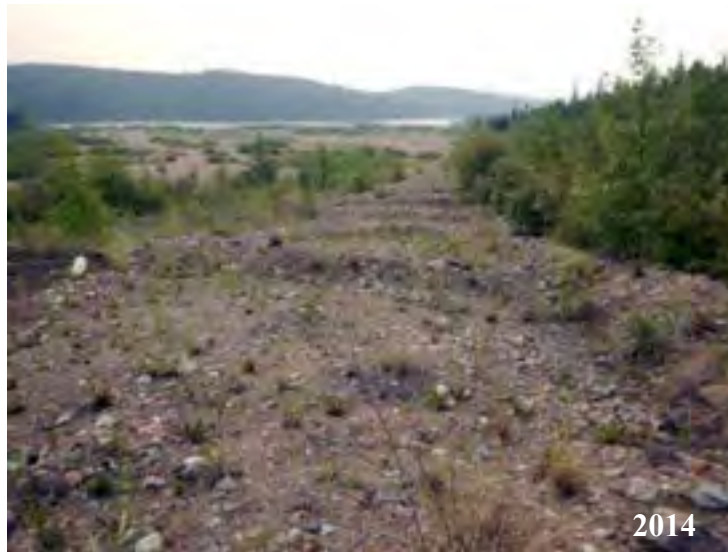
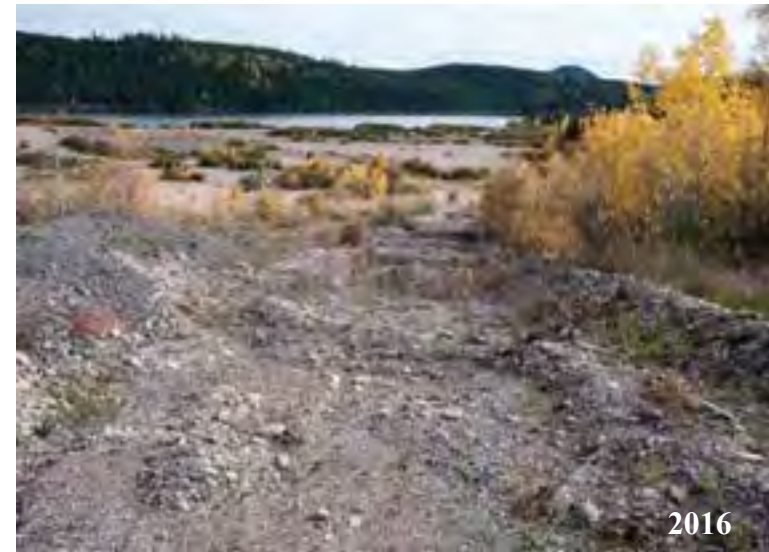
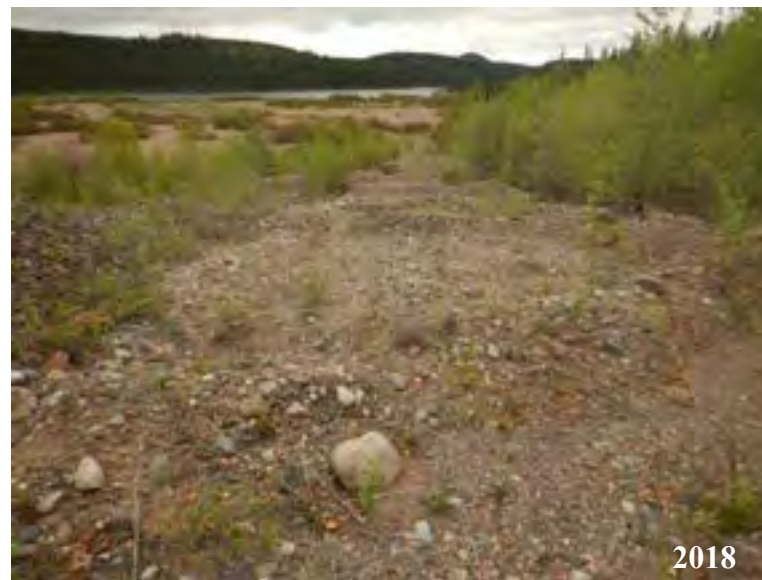
**Fookes Cover Shoreline**

The 2017 photo was not taken from same location as other two photos. The 2017 photo shows the Fookes shoreline located near the top centre of the 2018 photo

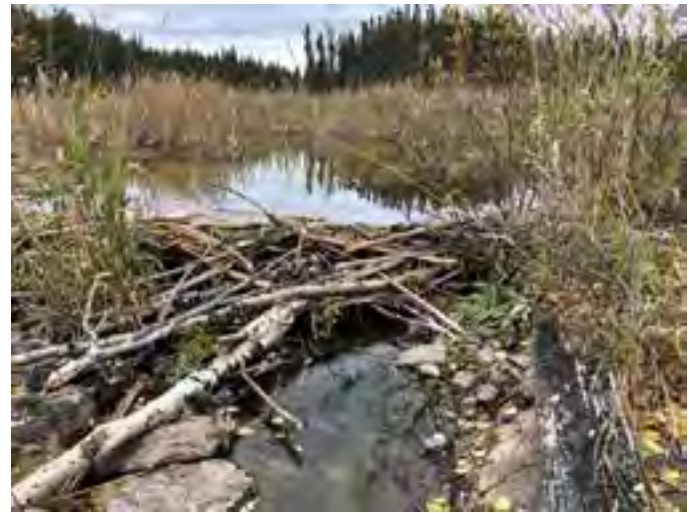
Photo A5- Marie Reservoir outlet - formation of beaver dam (September 2018)

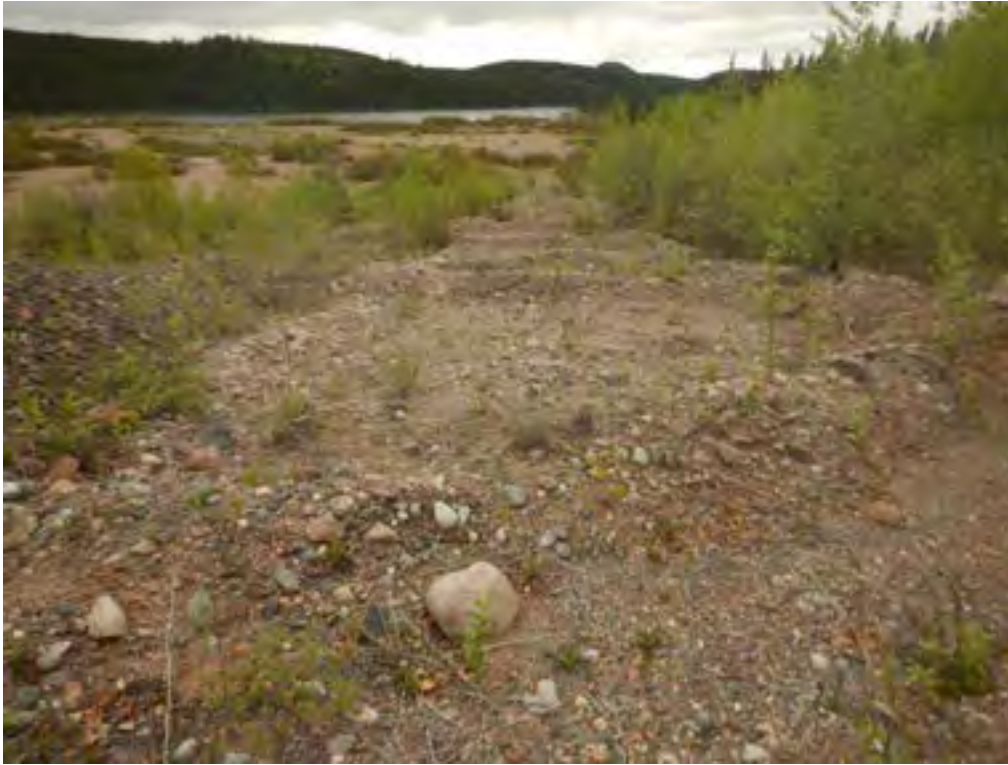
As part of the design and installation of the covers in 2005 and 2007, the area considered most vulnerable to erosion was in the area on and below the access ramp at the northwest corner of the tailings delta (SRK, 2010). The general condition of the ramp is very good. Access to this ramp is closed off by a windrow of material at the top of the ramp. The water bars (chevrons) are performing as expected and show little sign of erosion (**Appendix C, Photo C1**).

Photo C1 - Fookes Delta; Chevrons in place on north access point looking south to the Fookes delta (May 2018)

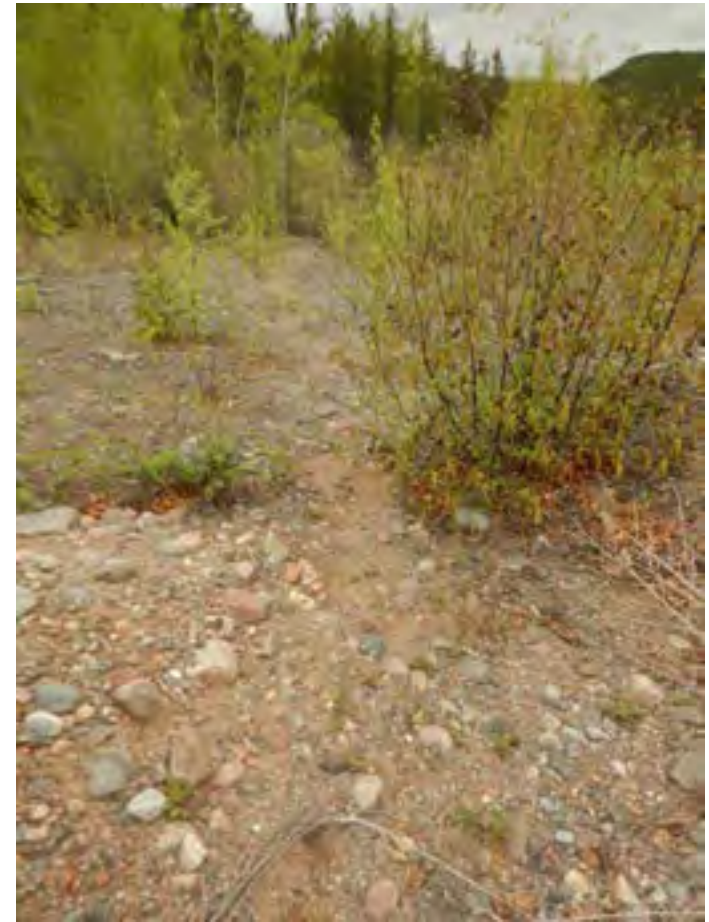
In addition to the chevrons, run-out structures were installed to carry away excessive water during extreme run-off events. These run-out structures are also in good shape with no observed additional eroded material beyond that observed during previous inspections (**Appendix C, Photo C2**).

Photo C2 - Fookes Delta; Drainage runout structure from chevrons along north access point (May 2018)

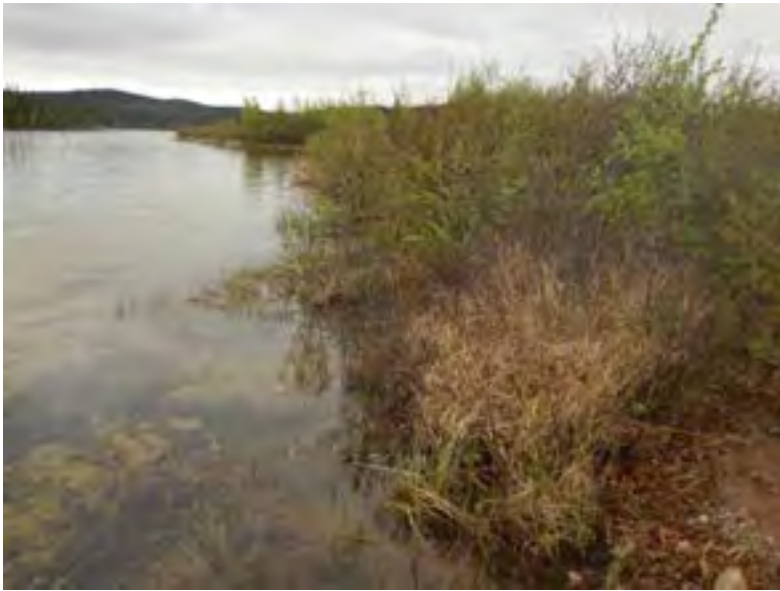
The shoreline, where the edge of the cover contacts Fookes Reservoir, was inspected and was in good condition. While the 2015 SRK inspection did note some erosion due to wave action, the overall condition of the shoreline was considered good with vegetation continuing to establish itself in the area. Photos taken in 2018 showed significant vegetation coverage along the shoreline.

Photo C5 - Fookes Reservoir shoreline looking west (May 2018)

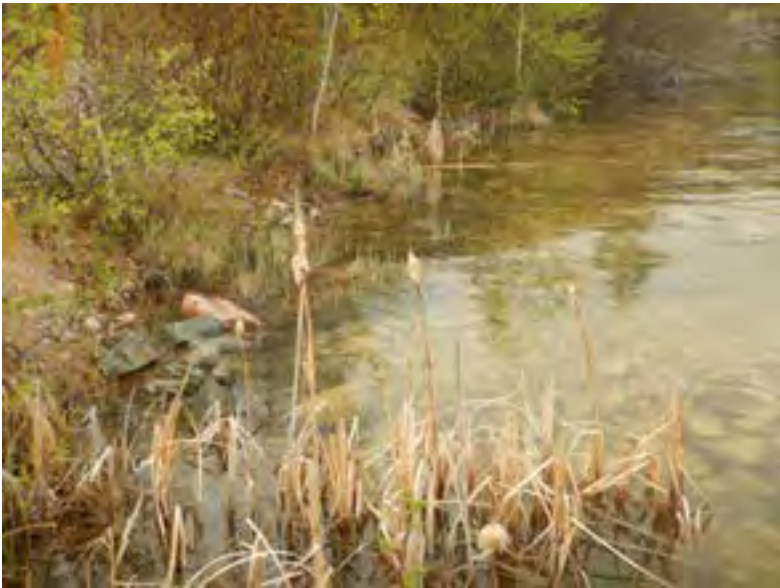
Photo C6 - Fookes Reservoir shoreline looking east (May 2018)

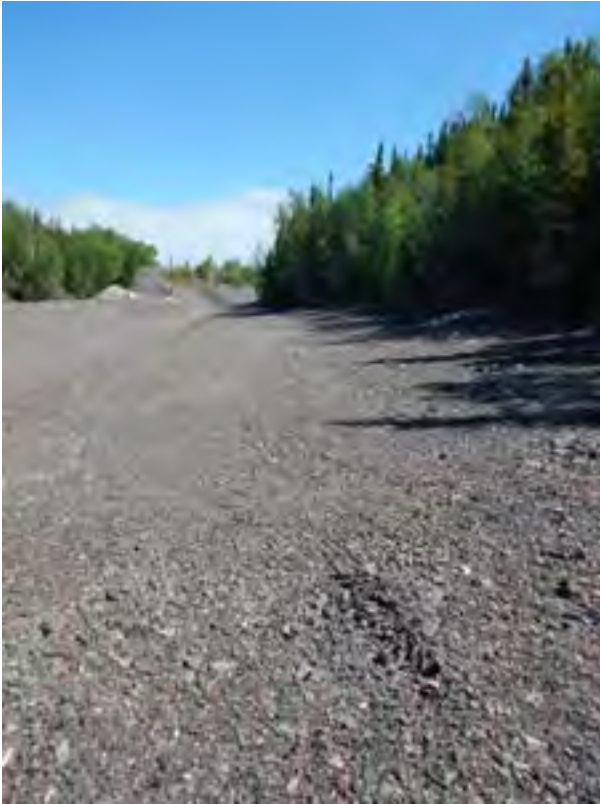
At the Ace site, the cover material over the stopes was inspected by walking the toe of the cover material, as well as the interface between the cover material and natural ground. No signs of tension cracks or visible depressions were observed along the Ace stope cover material in 2018.

Photo D1 - Stope 201/103 crown pillar cover looking east

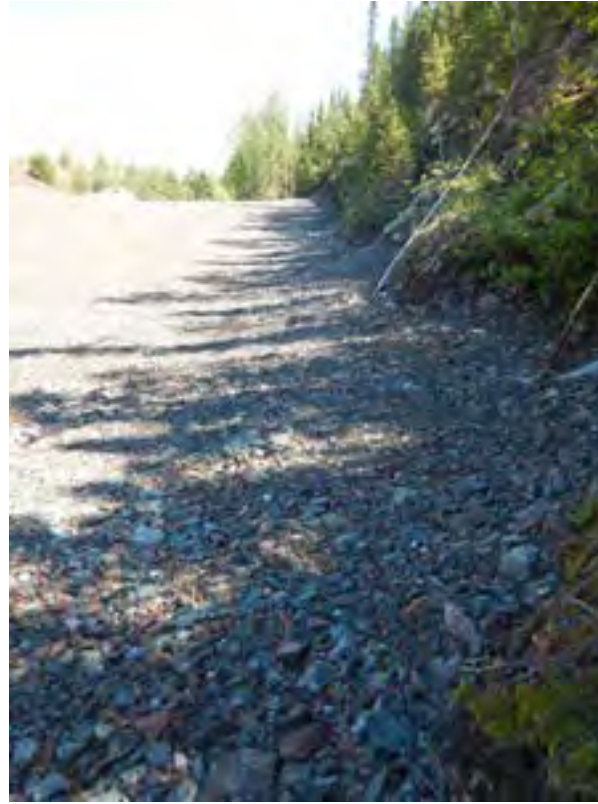
Photo D2 - Stope 201 crown pillar cover along bedrock contact with ridge, looking east

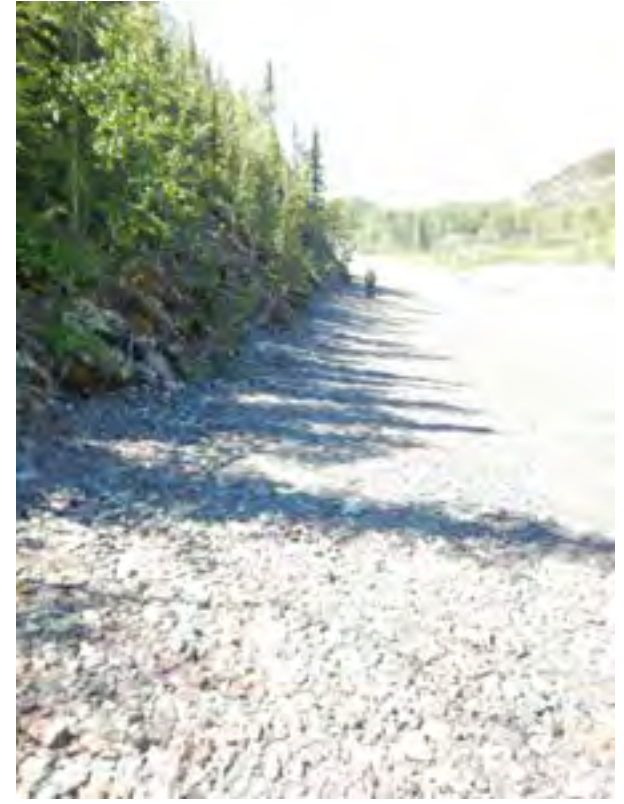
Photo D3 - Stope 201 crown pillar cover along bedrock contact with ridge, looking west

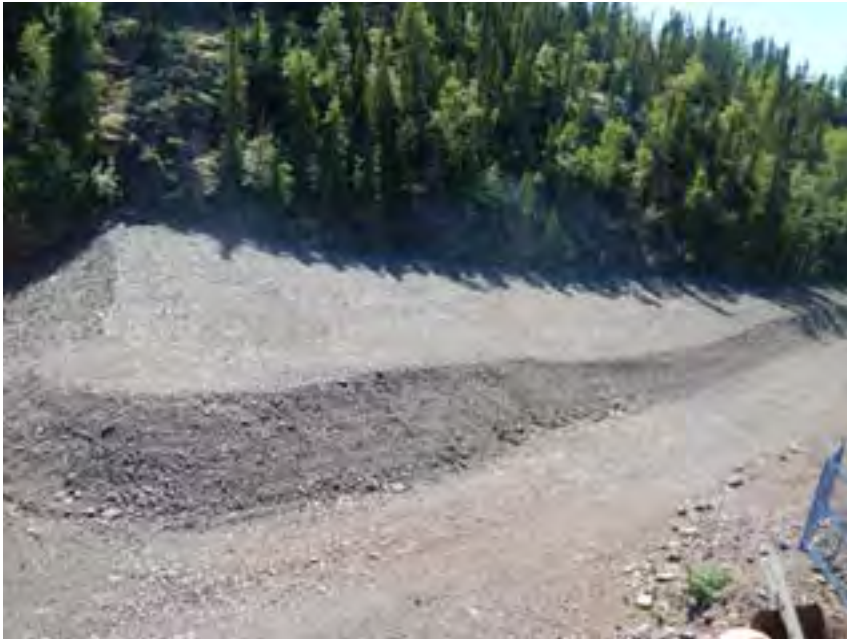
Photo D4 - Stope 103/201 crown pillar cover, looking south

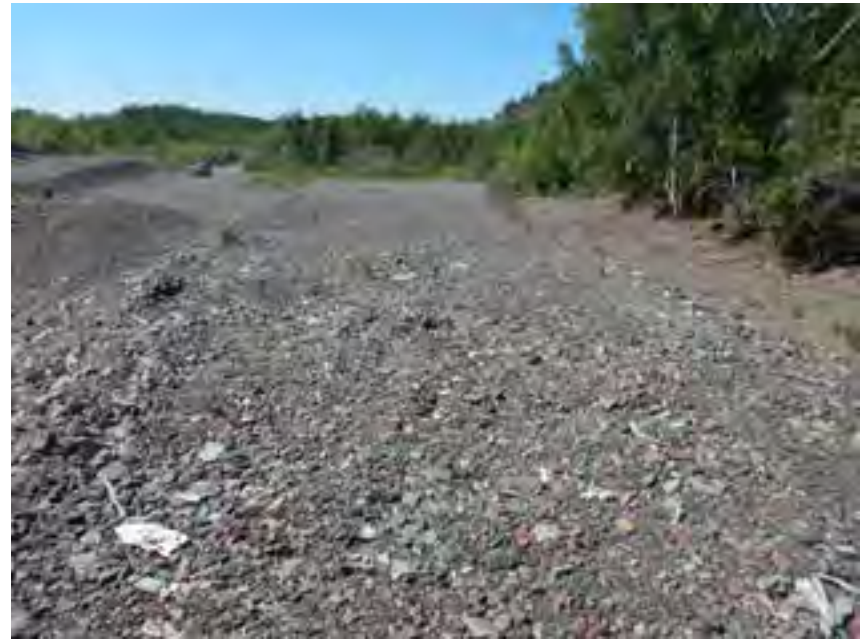
Photo D5 - Stope 208 crown pillar cover, looking west

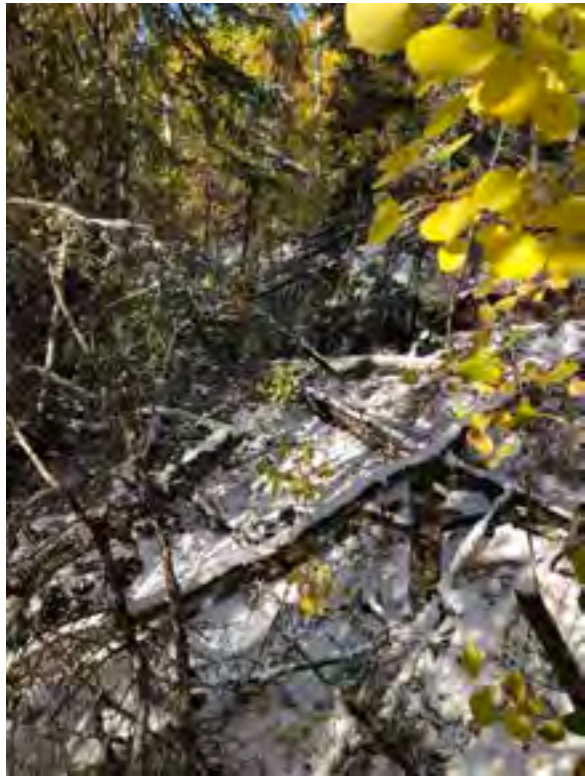
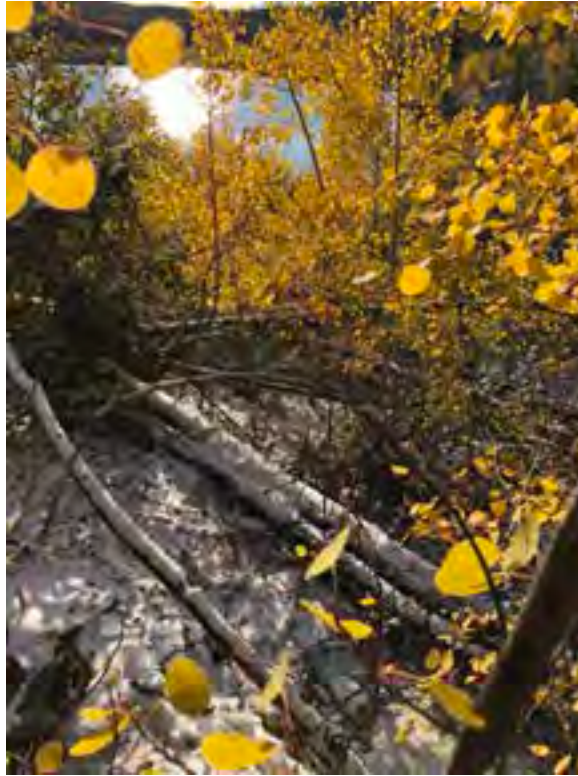
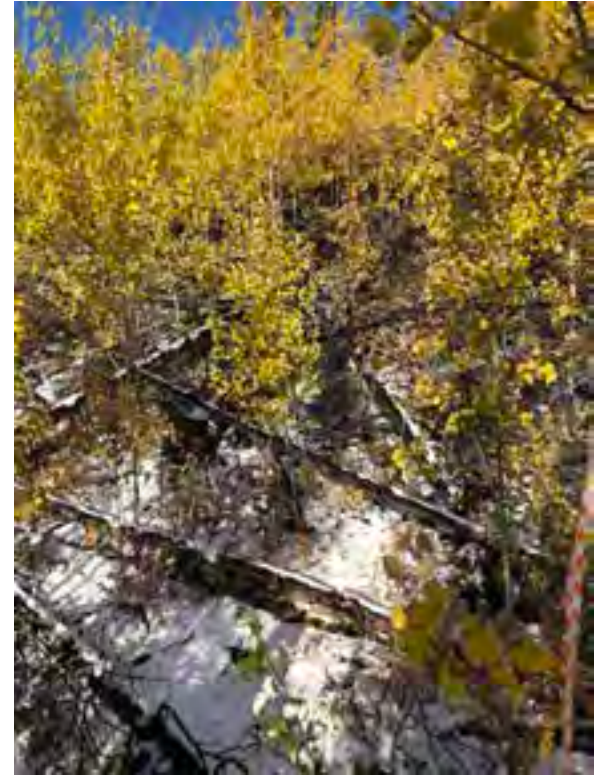
The crown pillar monitoring points at Hab and Dubyna were located, and a visual walking inspection was completed between and around the points. Observations at both areas did not show any evidence of tension cracks or slumping in 2018.

Photo E1 - Dubyna Crown Pillar Inspection Location #1 looking west towards Inspection Location #2.

Photo E2 - Dubyna Crown Pillar Inspection Location #2 looking west towards Inspection Location #3.

Photo E3 - Dubyna Crown Pillar Inspection Location #3 looking east towards Inspection Location #2.

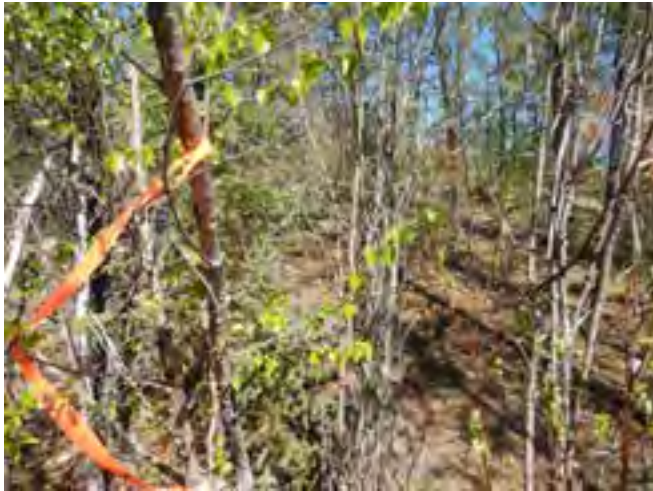
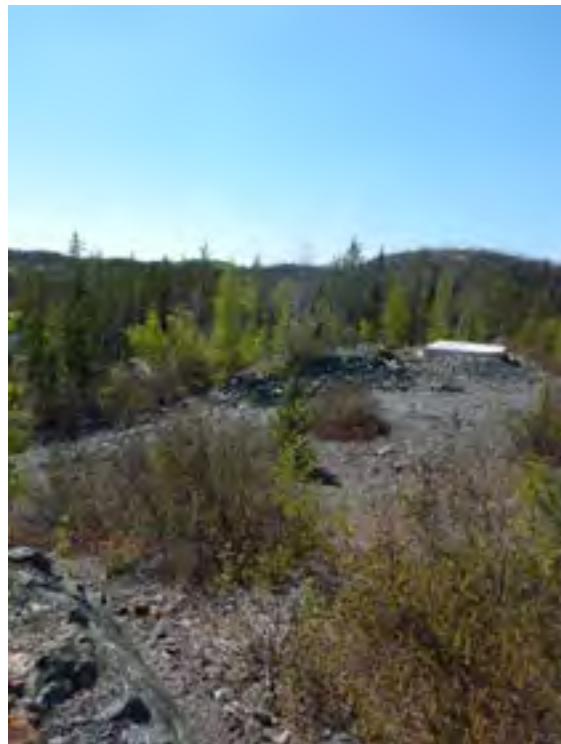
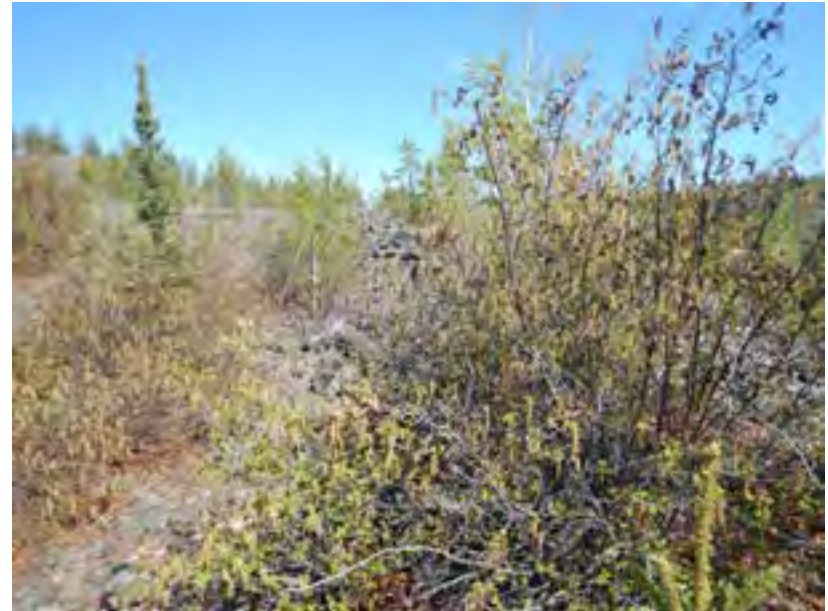
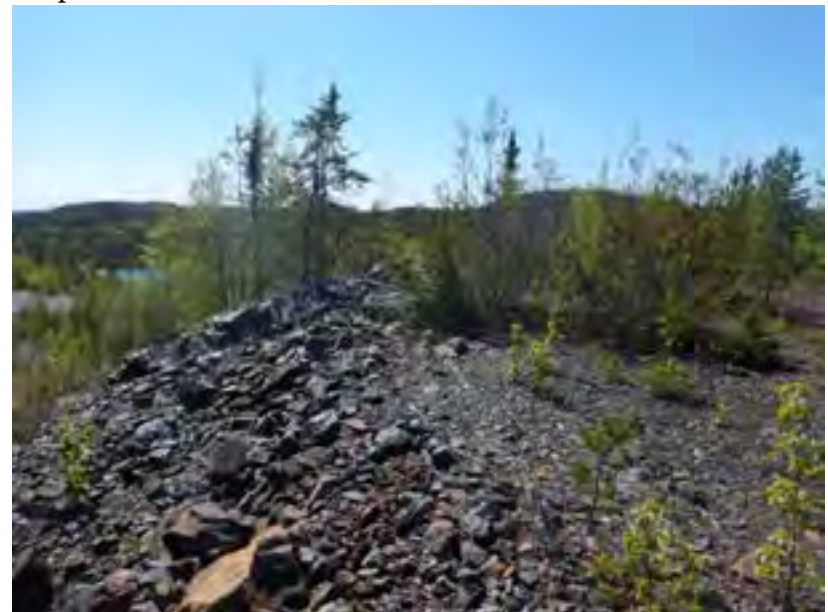
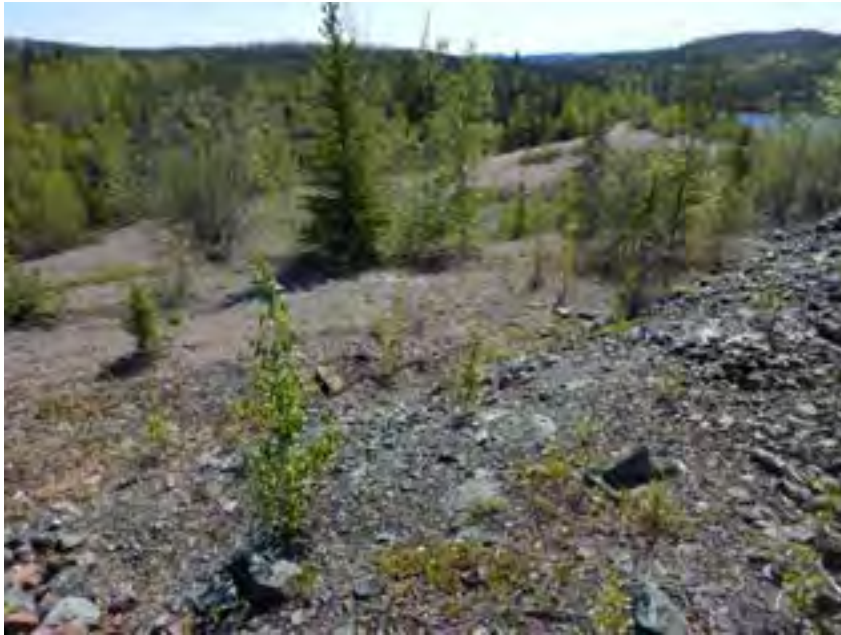
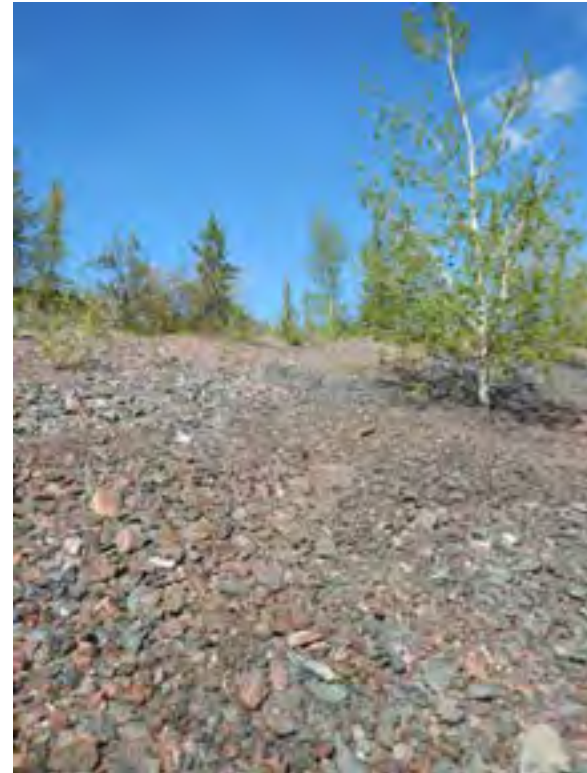
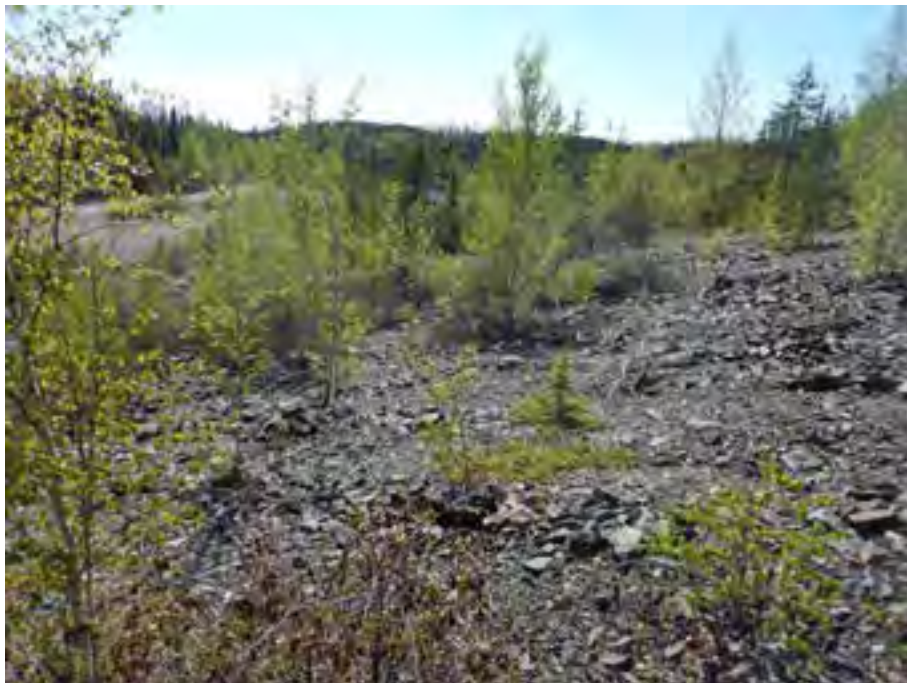
Photo F1 - Hab Crown Pillar Inspection looking east from Inspection Point Hab 039-01 to Hab 039-02.

Photo F2 - Hab Crown Pillar Inspection looking back from Inspection Point Hab 039-02 to Hab 039-01

Photo F3 - Hab Crown Pillar Inspection looking east from Inspection Point Hab 039-02 to Hab 039-03.

Photo F4 - Hab Crown Pillar Inspection looking back from Inspection Point Hab 039-03 to Hab 039-02.

Photo F5 - Hab Crown Pillar Inspection looking west from Inspection Point Hab 039-03 to Hab 039-04.

Photo F6 - Hab Crown Pillar Inspection looking back (east) from Inspection Point Hab 039-04 to Hab 039-03.

Photo F7 - Hab Crown Pillar Inspection looking west from Inspection Point Hab 039-04 to Hab 039-05.

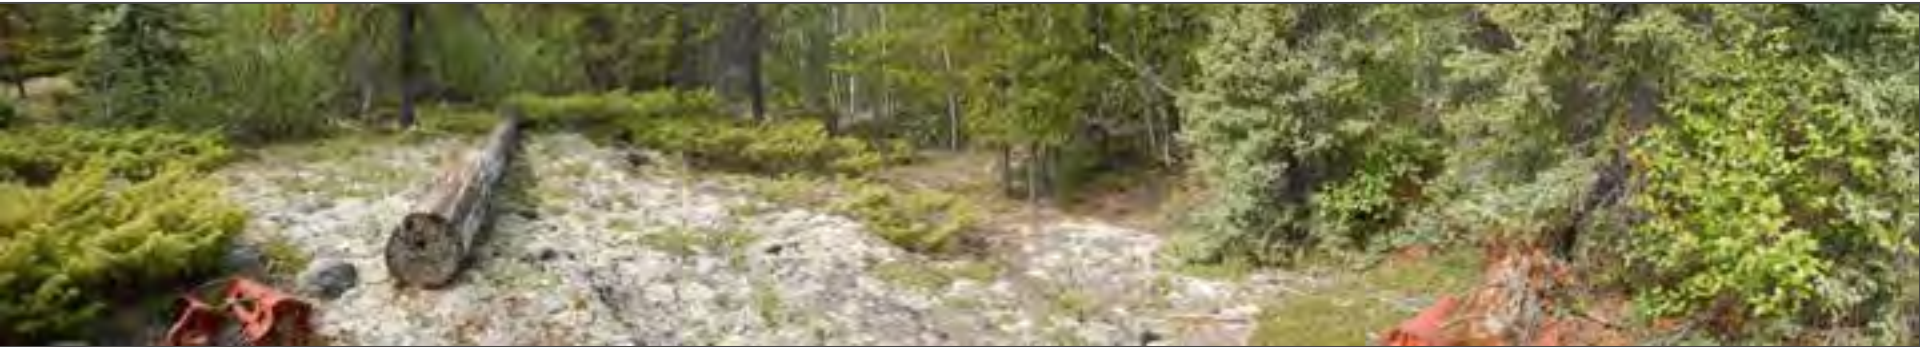
- While performing final inspection of ACE 5 property, discovered infrastructure related to power lines on the property
  - The Beaverlodge Utility Line Remediation Options Assessment report with planned path forward was reviewed with SkMOE and CNSC during the Annual Inspection in July 2016
  - Plan accepted with conditions by SkMOE on April 3, 2017
- Cleanup of the infrastructure completed in October 2017

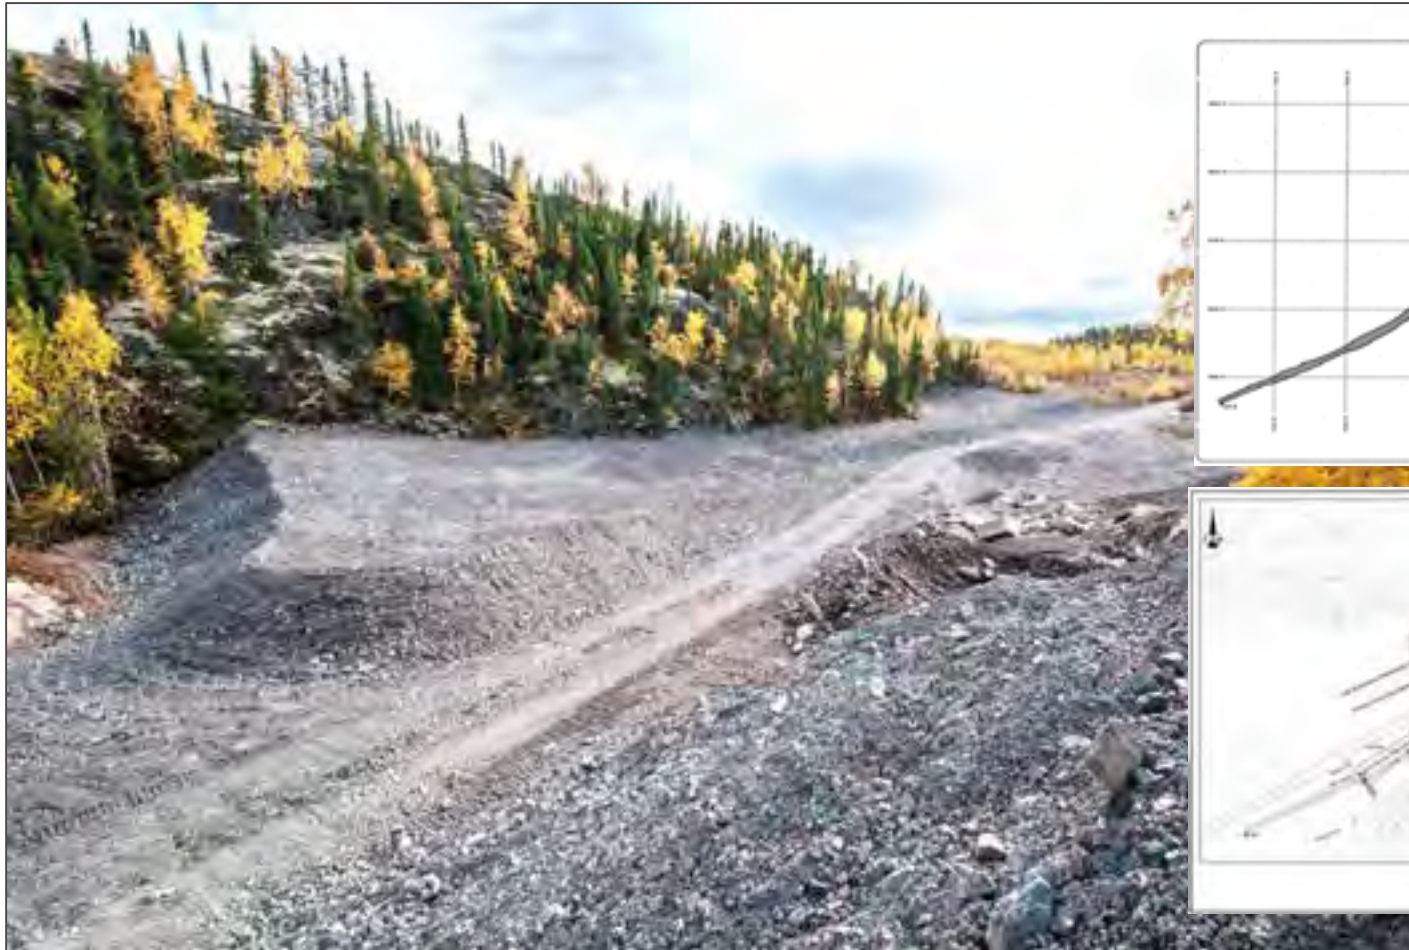
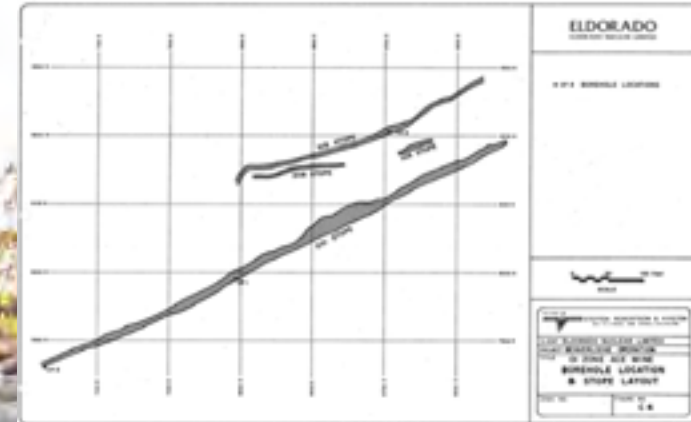
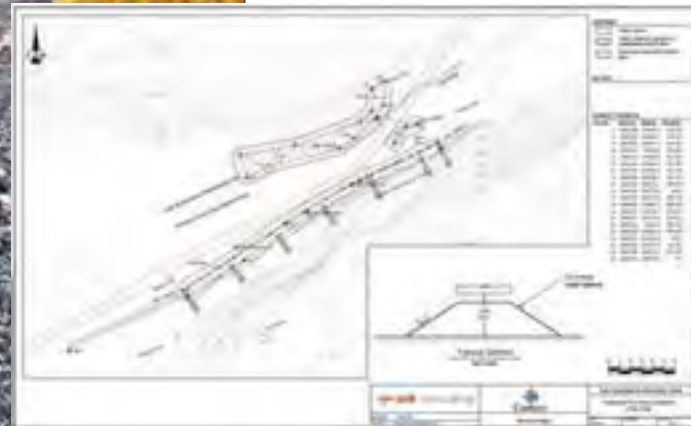
- Completed field investigation with GPR and drilling
- Determined Ace crown pillar at increased risk of potential future subsidence
- Completed additional remediation:
- Applied broken concrete and waste rock cover to areas at risk of subsidence
