**Beaverlodge: Year 33 Transition Phase Monitoring Annual Report (2018)**

## **Beaverlodge Project 2018 Annual Report Year 33 Transition Phase Monitoring**

**Prepared for:**  
Canadian Nuclear Safety Commission  
Compliance Report for Licence: WFOL-W5-2120.0/2023 &  
Saskatchewan Ministry of Environment  
Compliance Report: Beaverlodge Surface Lease

**Prepared and Submitted by:**  
Cameco Corporation

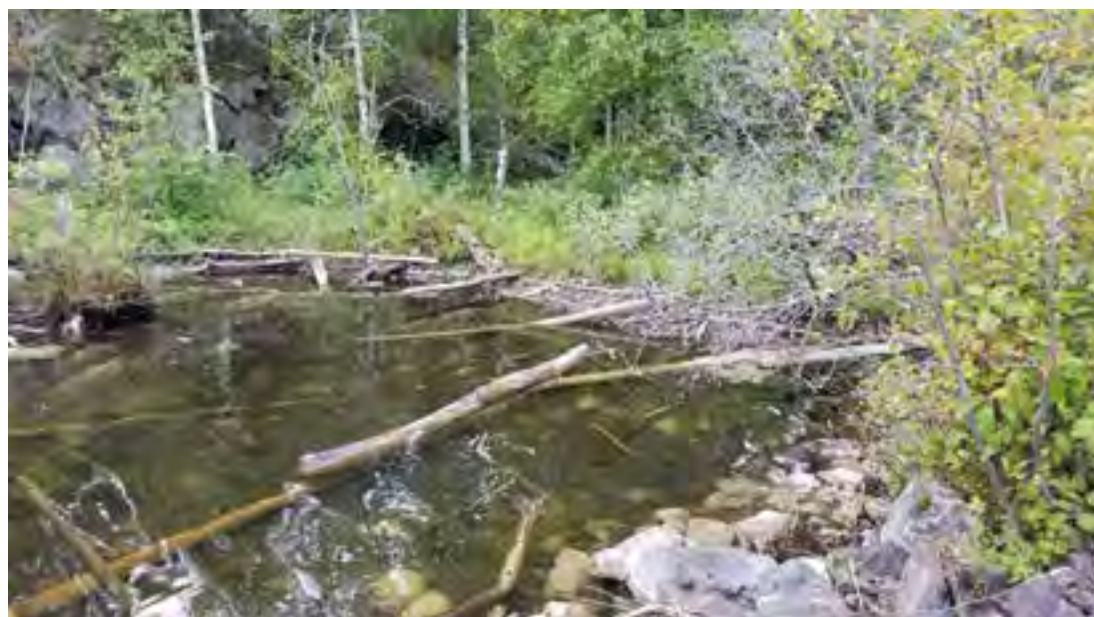
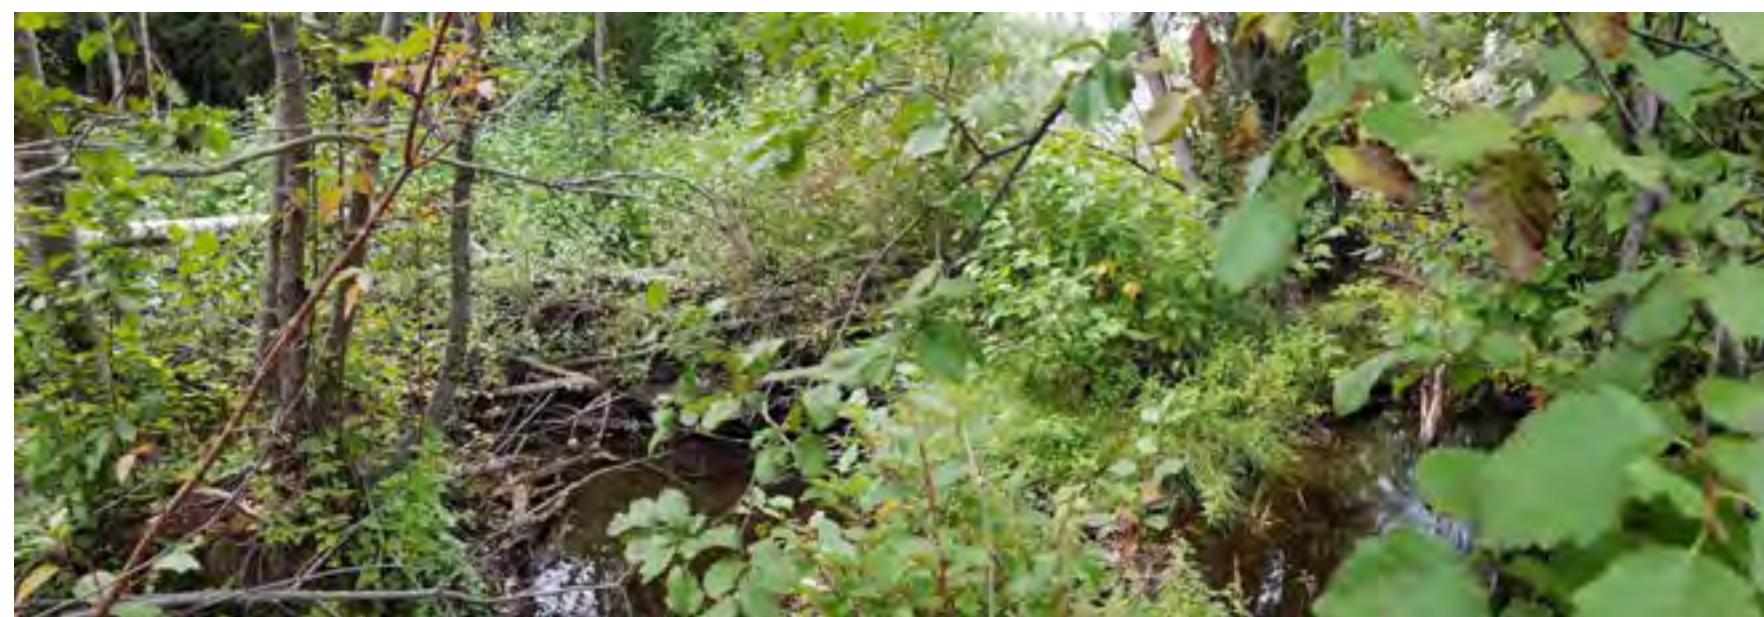
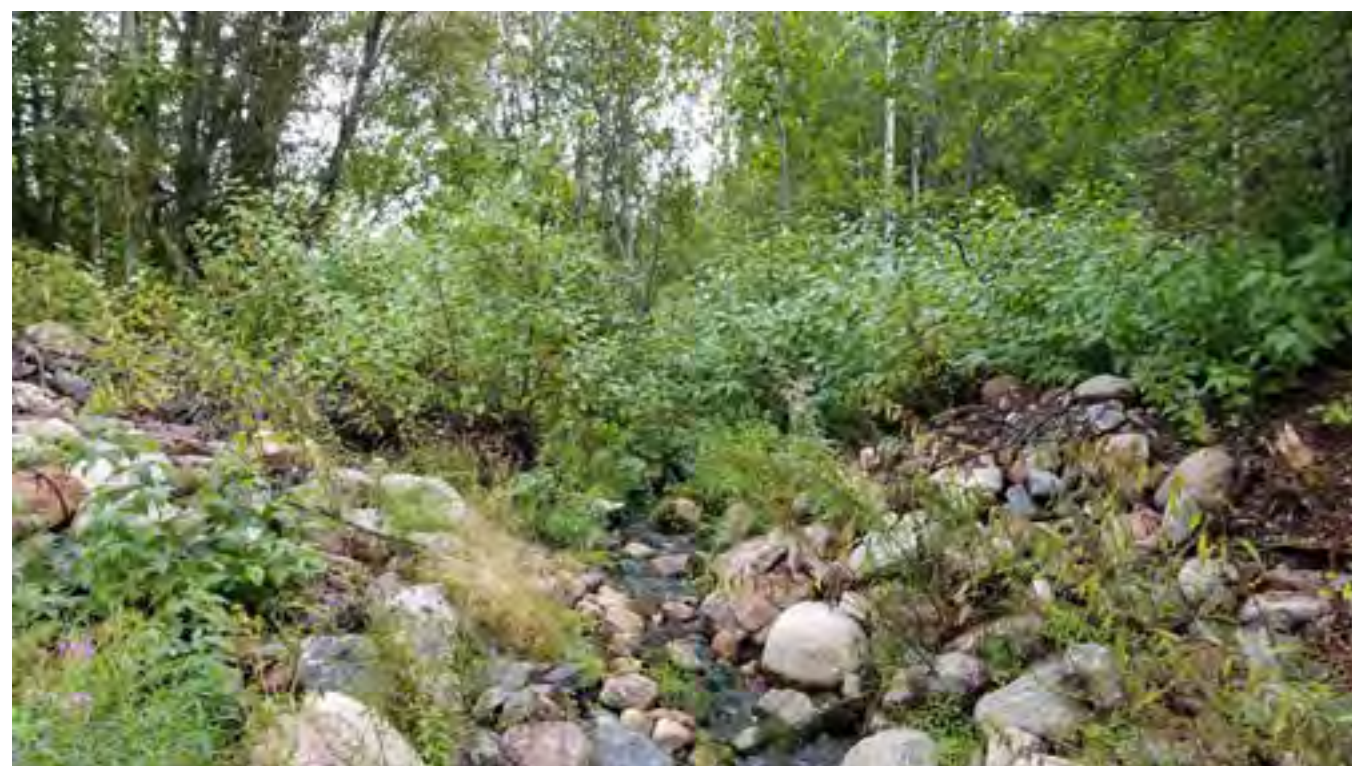
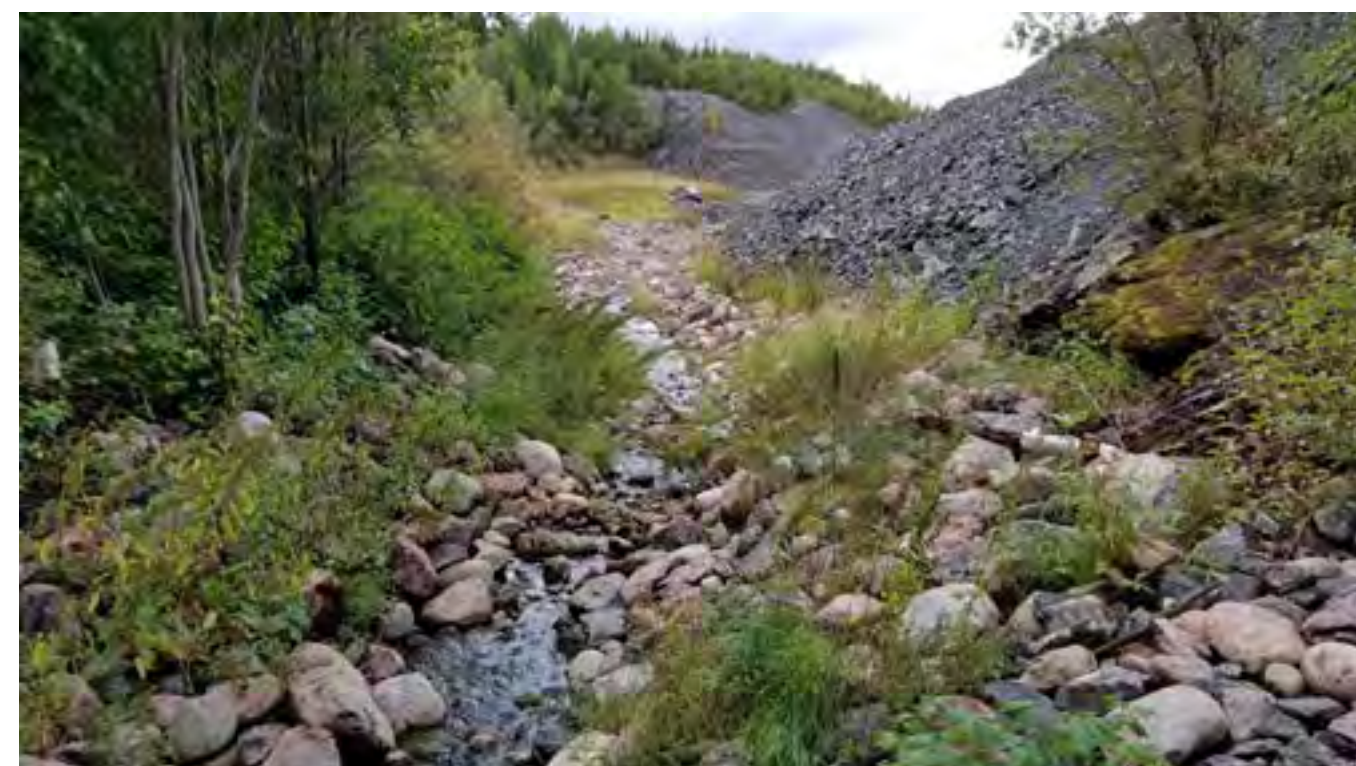
2018 Geotechnical Inspection		
		Site Inspection Photos		
Job No: 1CC007.065 Filename: Bolger Flow Path Inspection Photos.pptx	Bolger Flow Path Reconstruction	Date: February 2019	Approved: TPCP	Figure: 6

A beaver dam and heavy vegetation were observed at the inlet of the channel restricting flow from Zora Lake into the channel (Figure 6, Photos 4, 5 and 6). The flow rate was observed at approximately 1 L/s. Conditions at the inlet appeared to be consistent with the 2017 inspection with respect to the size of the beaver dam and the water level of Zora Lake. The only apparent change was that in 2017, a portion of the flow was directed to the south which then entered the channel as seepage through the south sidewall of the channel from approximately Station 0+015 to 0+030. This was not observed in the 2018 inspection as water flow was not directed to the south side of the inlet, which is likely attributed to a lower lake level at the time of the inspection.

Overall, vegetation was observed to be sparse throughout the channel with the exception of the inlet from approximately Station 0+015 to Station 0+030 where it is moderate (Figure 6, Photo 7). Similar to last year's inspection, this heavier vegetation growth was not restricting channel flow and is therefore not a concern related to channel performance.

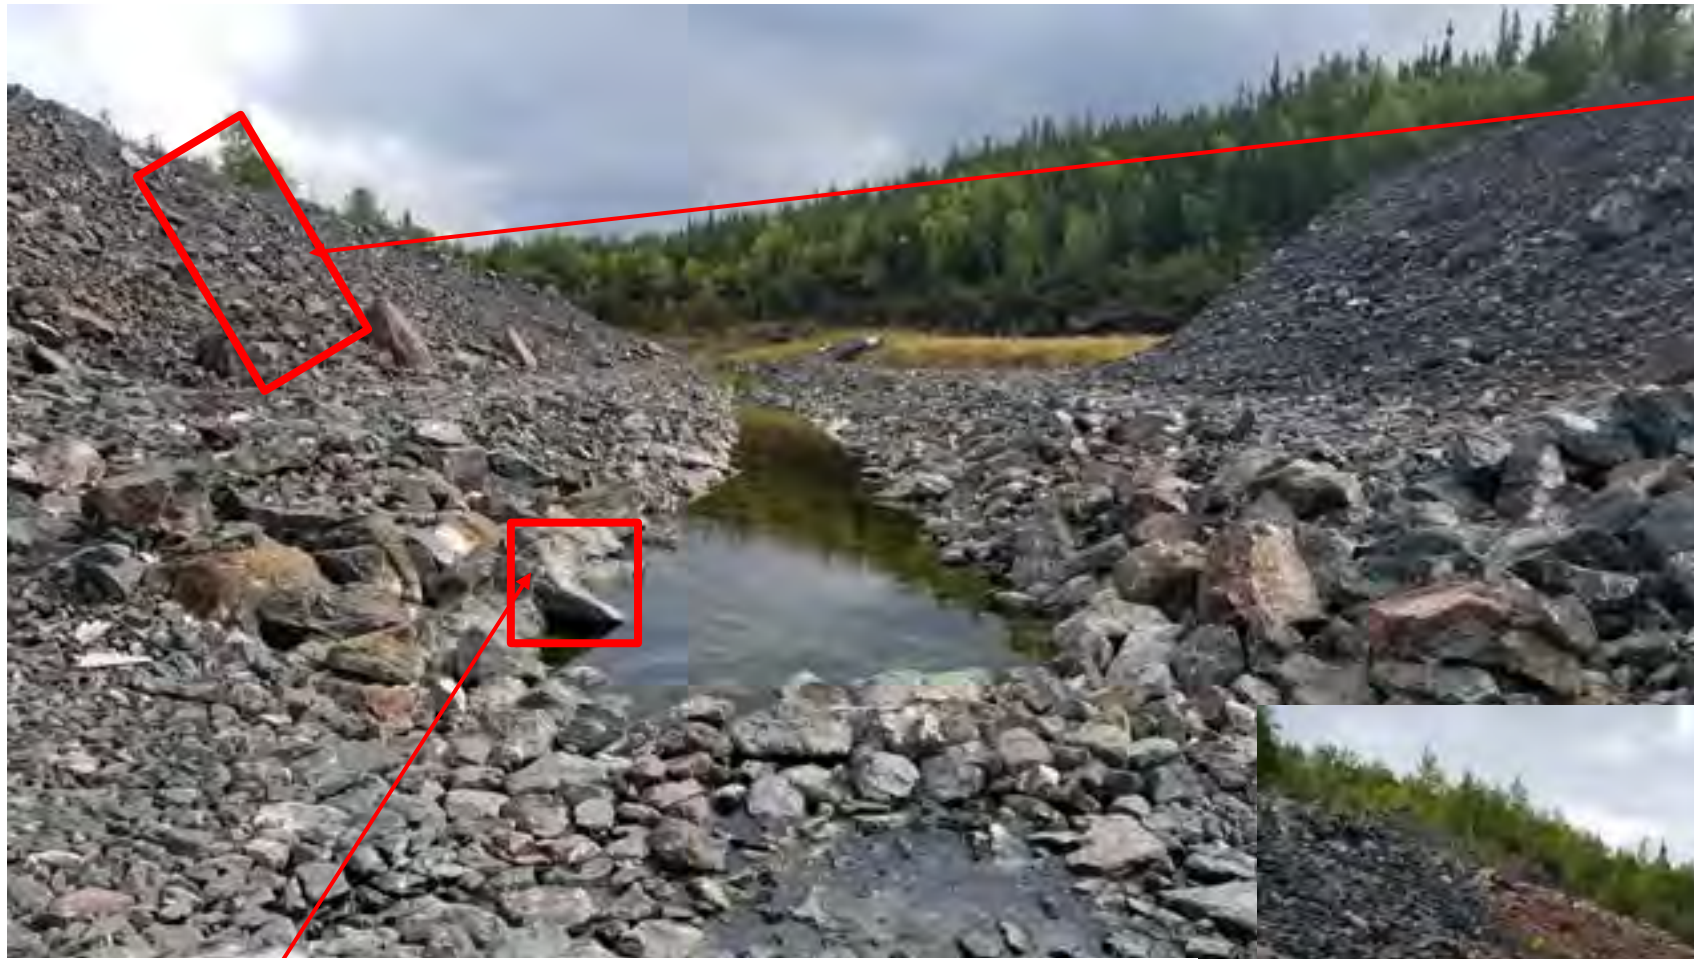
The channel crossing at Station 0+215 (Figure 8, Photos 10 and 13) was observed to be slightly above the invert elevation of the channel flow where flow was predominately through the voids of the waste rock. At the time of the inspection, minnows were observed just upstream of the channel crossing.

Photo 10 – Looking Southeast (upstream) from Station 0+215

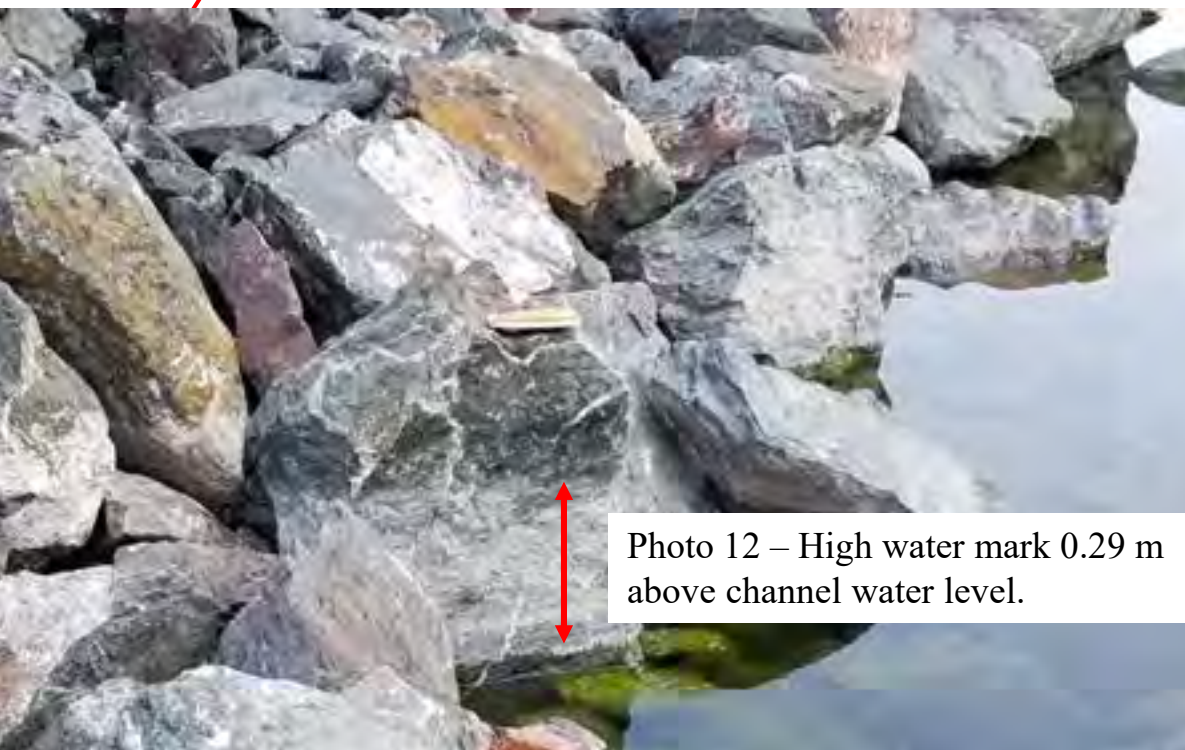
There was no vegetation on the side slopes at the time of inspection. A high-water mark was observed and measured at approximately 0.29 m above the current water level (Figure 8, Photo 12). Iron staining was evident from approximately Station 0+240 and Station 0+285 along the bottom portion of the side slopes and the base of the channel, which are founded in bedrock (Figure 9, Photos 14, 15 and 16). This is consistent with last year's inspection and as discussed with Cameco, it is understood that the water quality data indicates there is no evidence of acid rock drainage.

Photo 12 – High water mark 0.29 m above channel water level.

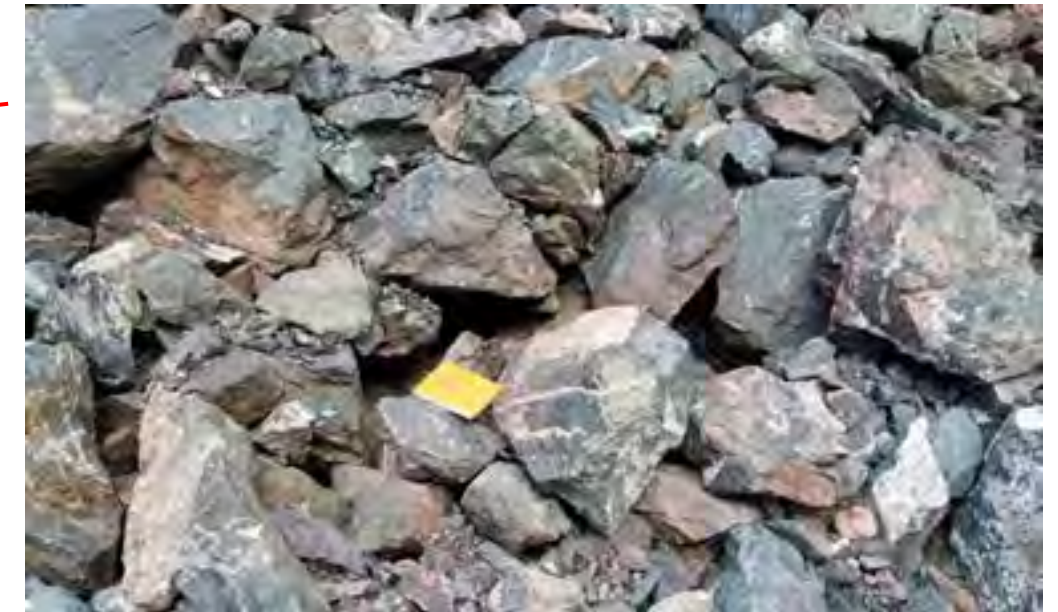
The condition of the channel side slopes were consistent with the 2017 inspection. Similar to the channel side slope crests discussed in Section 2.4, there were several small voids (0.15 to 0.3 m in size) observed throughout the channel side slopes (Figure 8, Photo 11). Although portions of the slopes do not have a tight-knit surface, such voids/configuration does not impact the geotechnical stability or performance of the channel. Surficial ravelling may occur over time in these select areas, but it is expected to be minor. The channel side slope configuration includes benches, which can accommodate such ravelling should it occur and reduce the likelihood of blockages in the channel.

Photo 11 – Example of a typical waste rock void on crest and slopes.

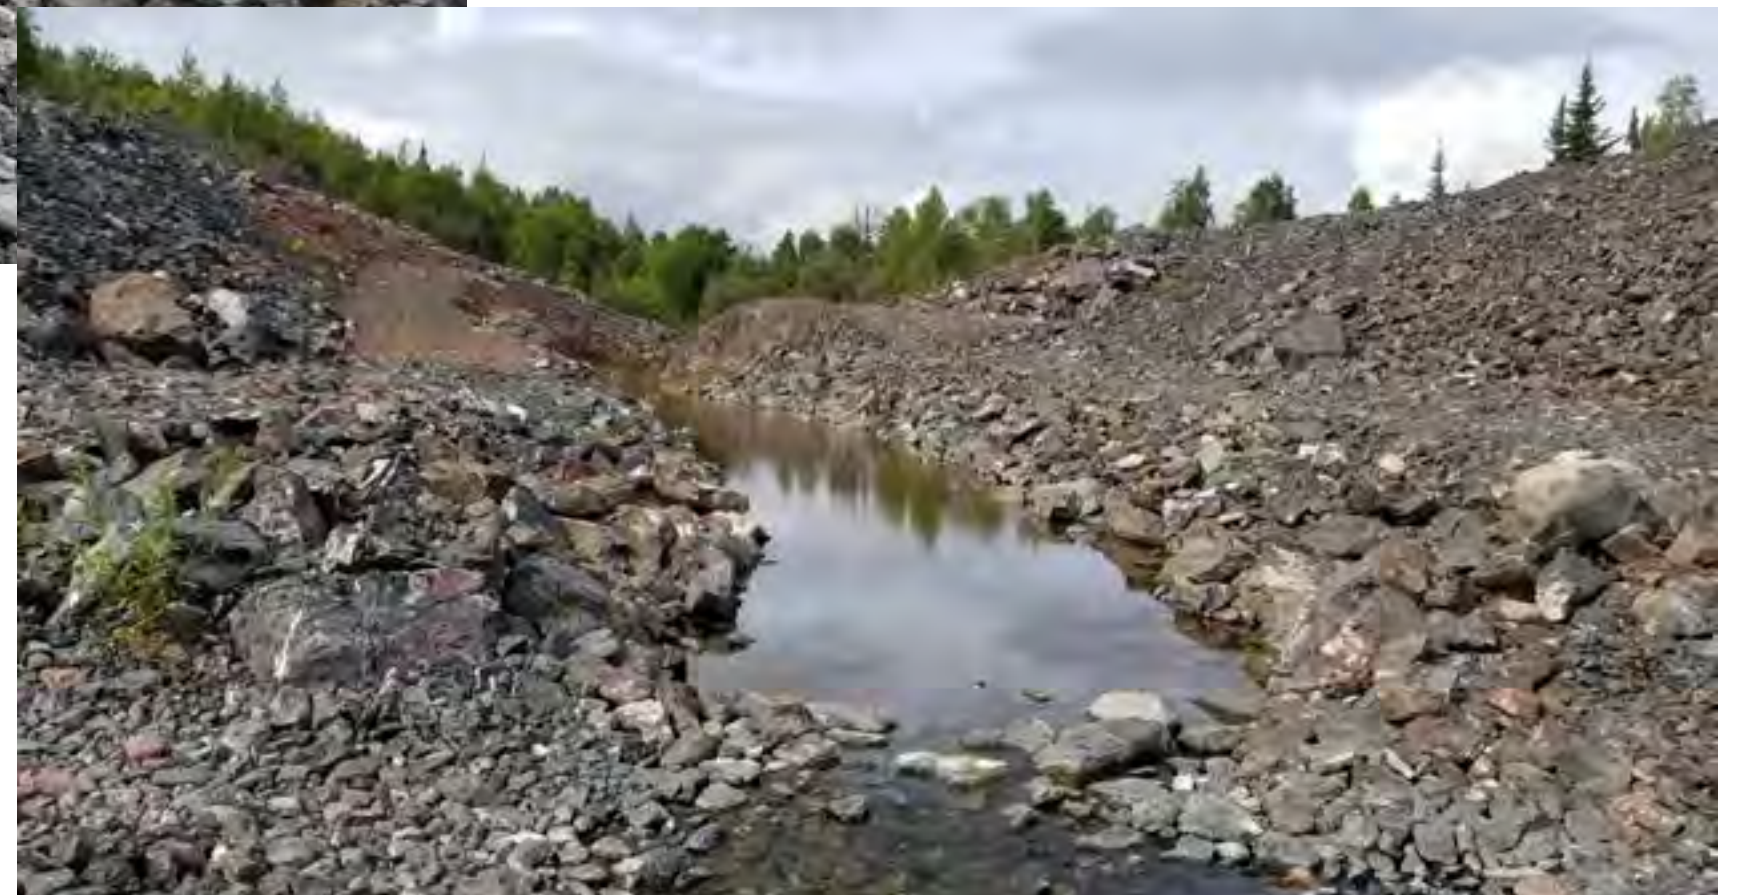
Photo 13 – Looking Northwest (downstream) from Station 0+215

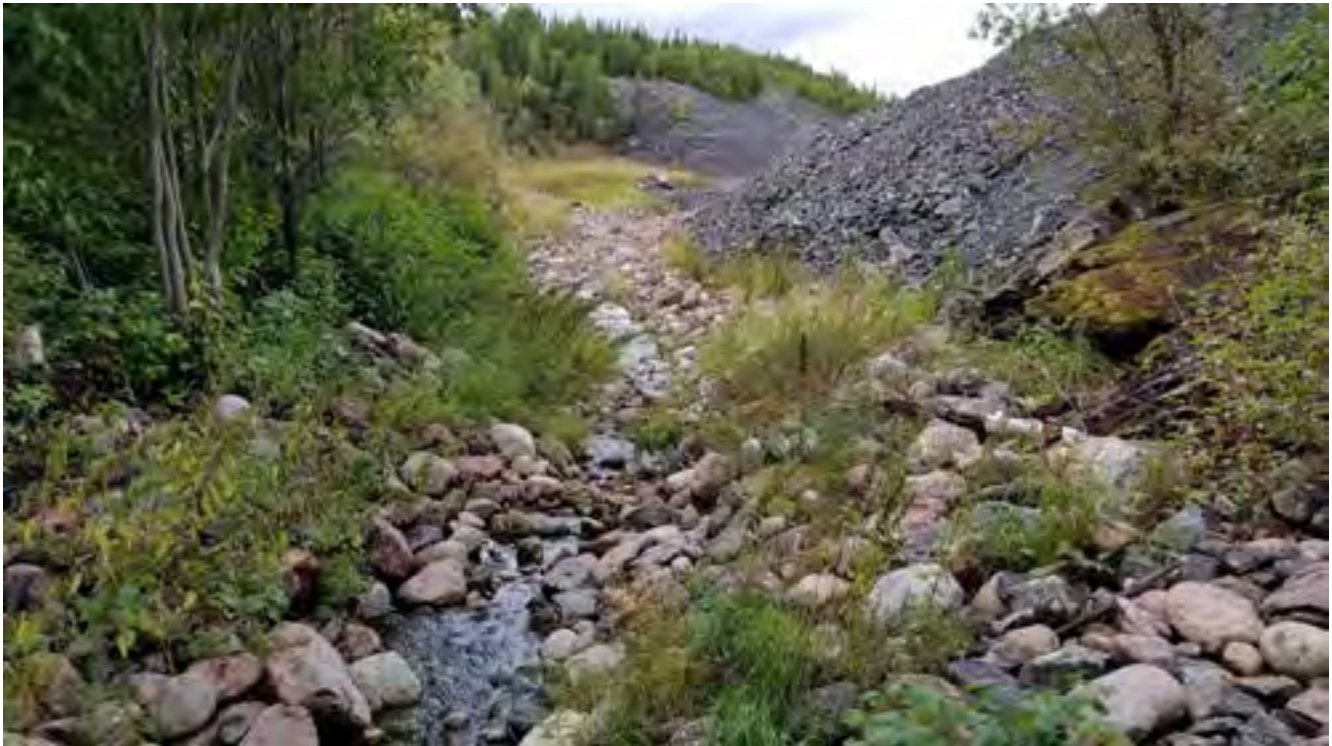
4

Photographs: North Slope at East End of Channel – Station 0+015 (Photo 4)

4. North slope at east end of channel observed to be over-steepened at toe.

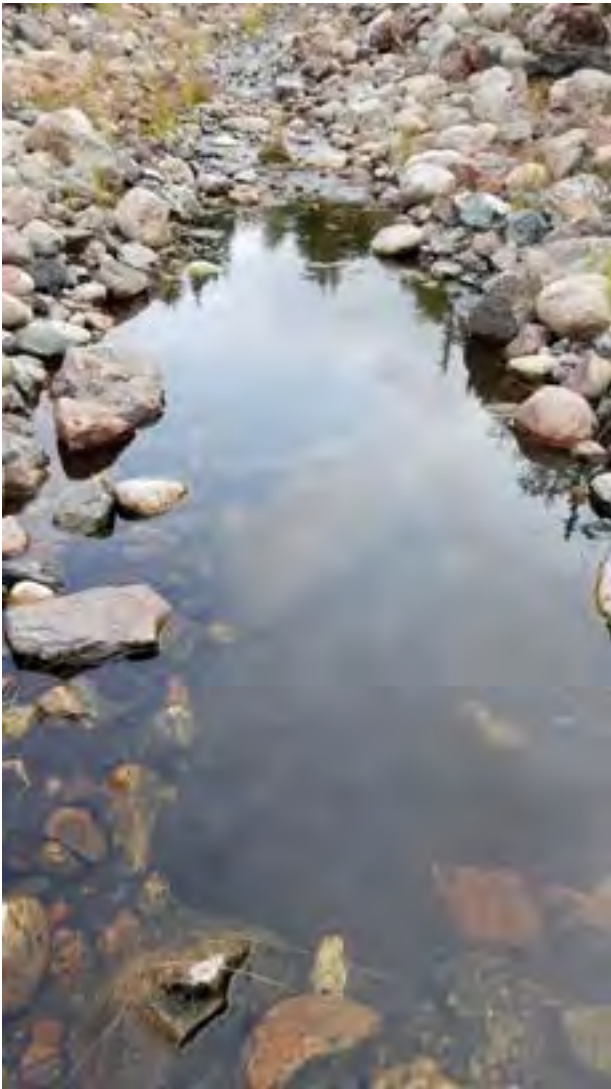
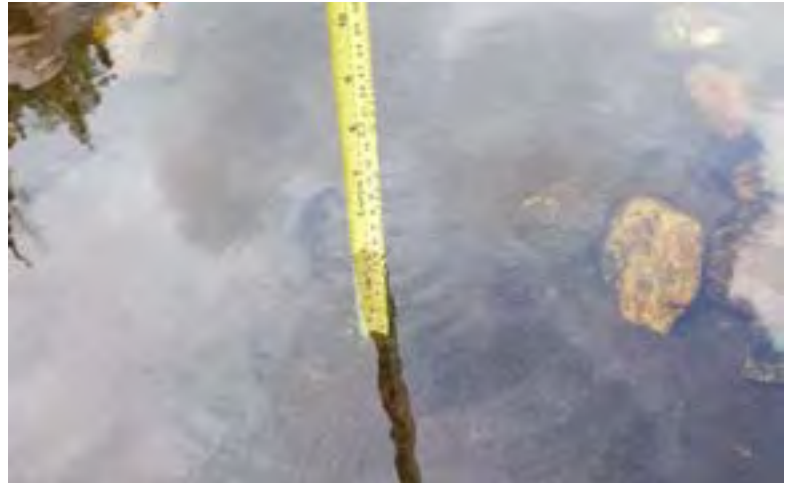
Photographs: Downstream sedimentation accumulation (Photos 6 and 7)

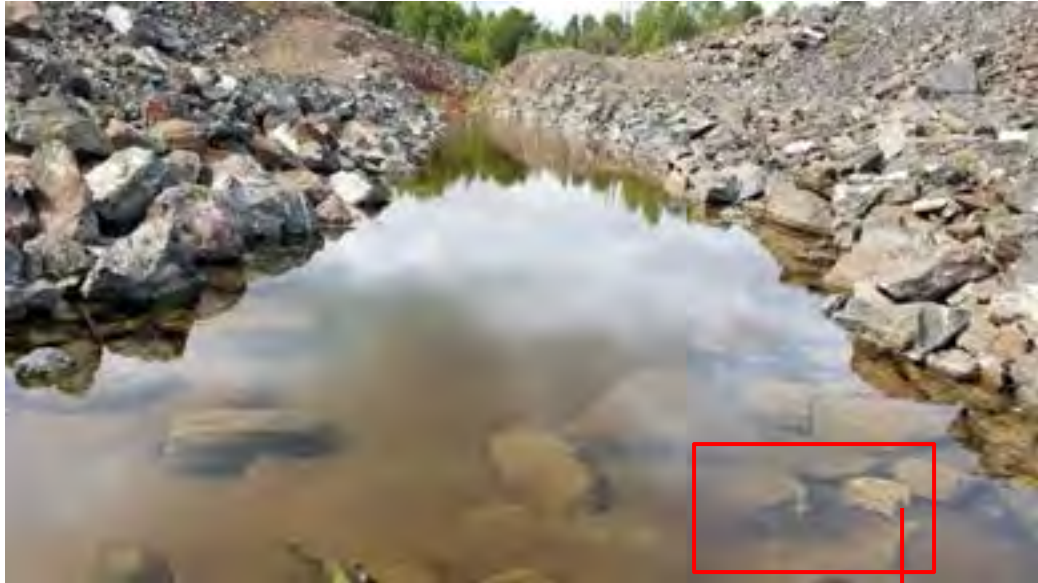
Photographs: Downstream sedimentation accumulation (Photos 10 and 11)

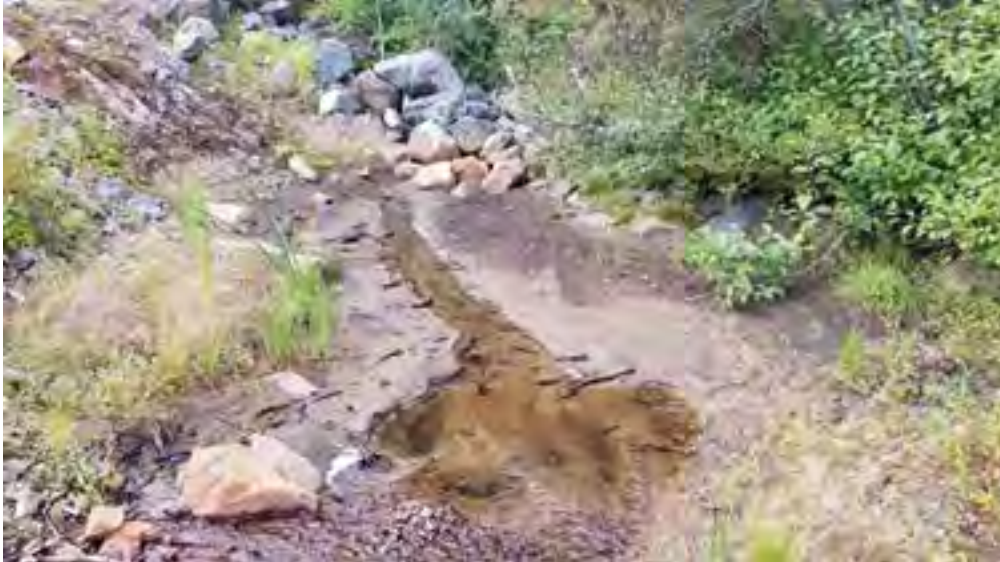
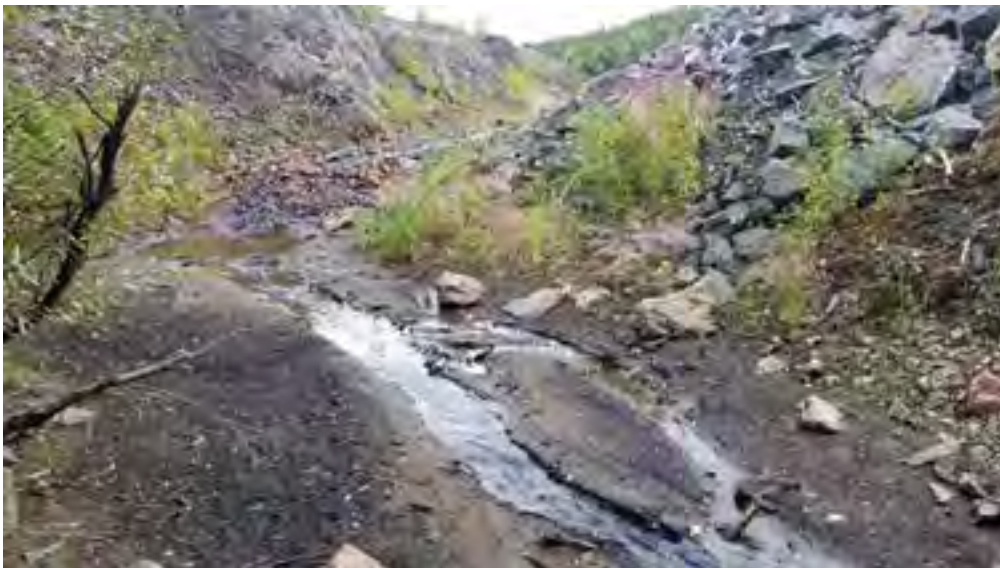
The channel outlet was observed to have sparse vegetation and heavy sedimentation (Figure 10, Photos 17 and 18). At the time of the inspection, discharge was observed to be clear and flowing at a rate of approximately 1 L/s based on the rather low flow conditions in late August 2018. No apparent change at channel outlet since the 2017 geotechnical inspection.

- 17. Channel outlet looking northwest. Sediment buildup upstream of rip rap outlet that is not restricting flow.
- 18. Channel outlet looking southeast. Sediment buildup is not restricting flow and under the flow conditions at the time of the inspection was observed to be stable (i.e. sediment was not being transported by flow).

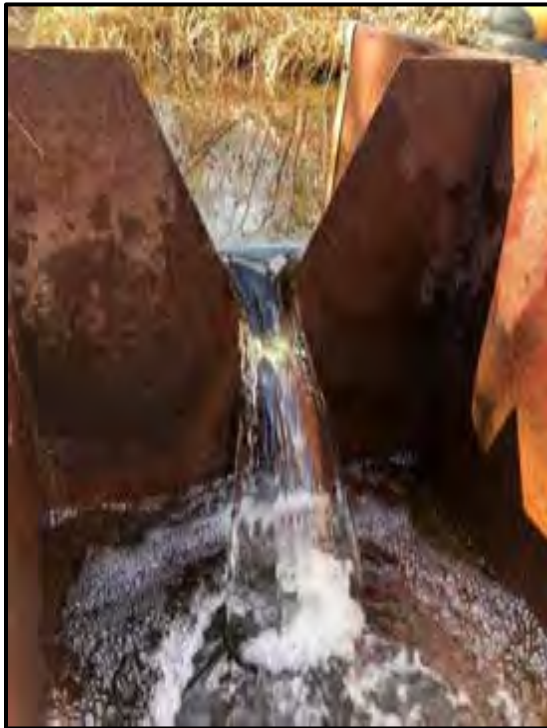
**Photo 11: TL-6– May 6, 2018**

The area known as Minewater Reservoir directs runoff towards the Fulton Drainage via a channel blasted through bedrock. A v-notch weir installed in 2011 is the monitoring station identified as TL-6. Photo 11 is from the spring field program of 2018 while Photo 12 was taken during the fall. Stage and discharge monitoring data are compiled in Table 12 and the rating curve is presented in Figure 11. The 2018 hydrograph is provided in Figure 12 with the daily average discharge data presented in Table 13.

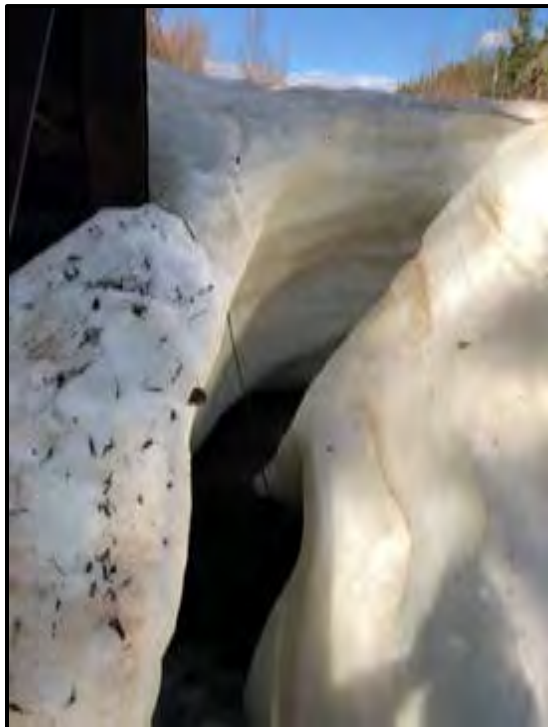
**Photo 13: TL-7– May 6, 2018**

The headwaters of TL-7 include Fulton Lake as part of the Fulton drainage but also receive water from Fookes and Marie Reservoirs which were used as tailings disposal locations during the operation of the Beaverlodge Mill in addition to receiving water from TL-6. TL-7 is also a long-term monitoring station having operated since Site closure (similar record length to AC-8). TL-7 frequently glaciates through the winter months as water free-falls over the v-notch thus impounding a large volume of ice behind the structure. The ice impoundment can take several weeks to thaw and often the datalogger is not installed until later in the year (after the passing of snowmelt runoff). In 2018, the weir was partially open during the spring field program and the datalogger was installed during that site visit (Photo 13). At that time, it was not possible to measure the flow rate. The fall field program flow condition is shown in Photo 14. The rating curve data are provided in Table 14 and shown graphically in Figure 13.

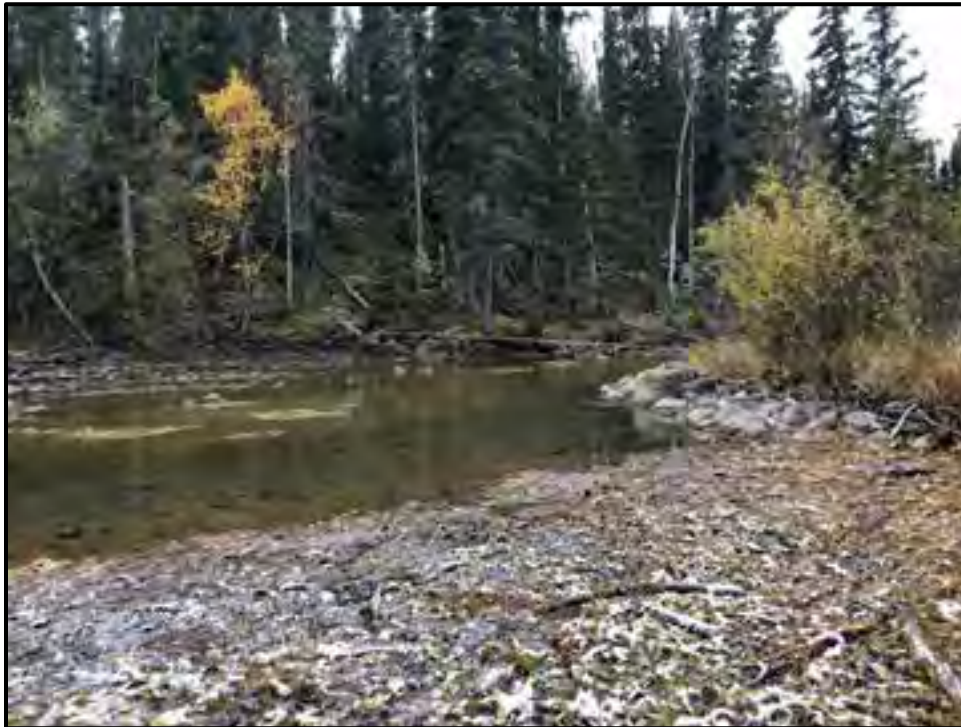
**Photo 15: BL-5 – September 30, 2018**

Station BL-5 monitors discharge at the outlet of Beaverlodge Lake. The station was visited during the 2018 fall field program (Photo 15). This location has been known to be impacted by either beaver activity, debris jam or the sudden release of debris jam; any such change to the geometry of the channel impacts the reliability of the rating curve typically evident in drifting points from the rating curve. As such, it was recommended to discontinue the preparation of an annual hydrograph at this station (MWSI, 2018). Field measurements are continued at this location and a stage datalogger remains installed should the need for water level data in Beaverlodge Lake ever be required. The summary data are presented in Table 17 and the rating curve presented in Figure 15.

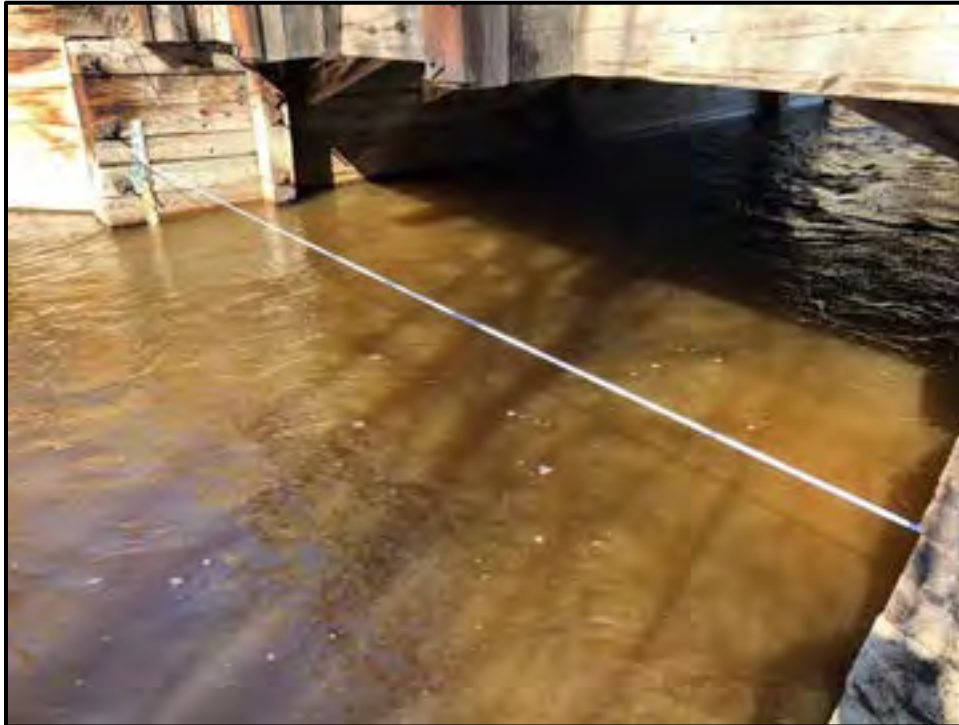
**Photo 16: CS-1 – May 6, 2018**

Station CS-1 on the Crackingstone River is located downstream of Cinch Lake which receives discharge from Beaverlodge Lake through Martin Lake. The Crackingstone River ultimately discharges to Bushell Bay of Lake Athabasca and flow monitoring occurs at a bridge crossing. Field monitoring occurred in the spring (Photo 16) and fall of 2018 (Photo 17). The measurement data for CS-1 are presented in Table 18 and the rating curve is shown in Figure 16. Figure 17 depicts the hydrograph for 2018. The daily average discharge data are presented in Table 19.

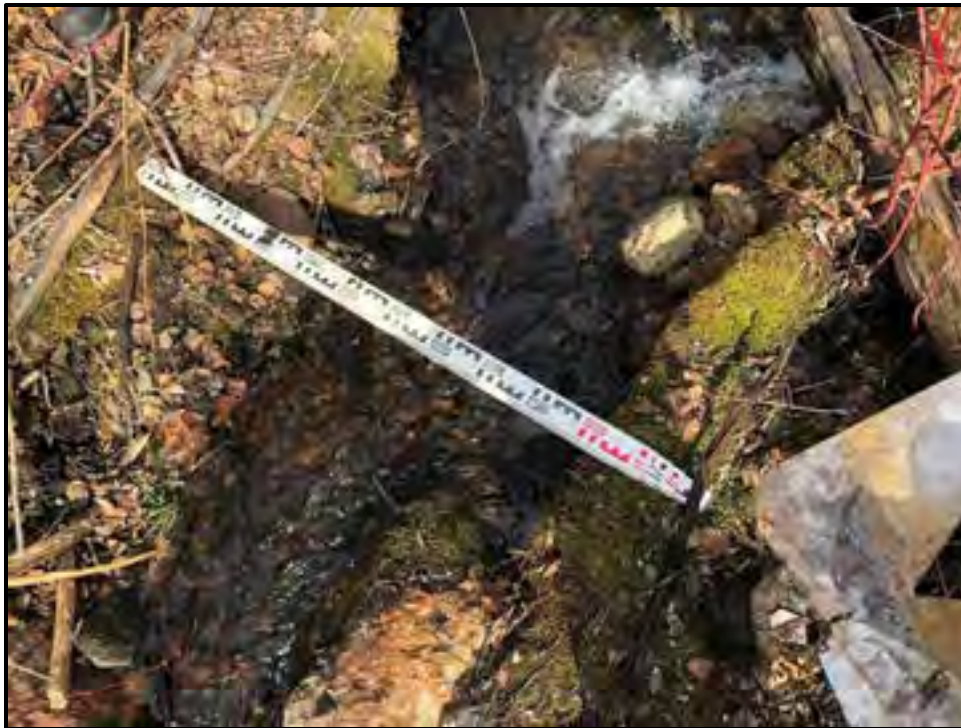
**Photo 18: Zora Outflow – May 6, 2018**

Zora Lake is upstream of Verna Lake and flows through a recently completed stream reconstruction project. Cameco requested that MWSI monitor discharge, if possible, at the outlet of Zora Lake and the subsequent inflow to Verna Lake. Measurements were completed at both stations during the spring and fall field programs. The measurement section at Zora is shown in Photo 18 and the inflow to Verna is depicted in Photo 19. During the spring, the small weir typically used to measure flow was covered in ice and a traditional measurement of stage and discharge was required. The discharge measurements at Zora outflow and Verna inflow are provided in Table 20.
