BEAVERLODGE PROJECT

Beaverlodge Project 2021 Annual Report Year 36 Transition Phase Monitoring

Prepared for:
Canadian Nuclear Safety Commission
Compliance Report for Licence: WFOL-W5-2120.1/2023
& Saskatchewan Ministry of Environment
Compliance Report: Beaverlodge Surface Lease

Prepared and Submitted by:
Cameco Corporation

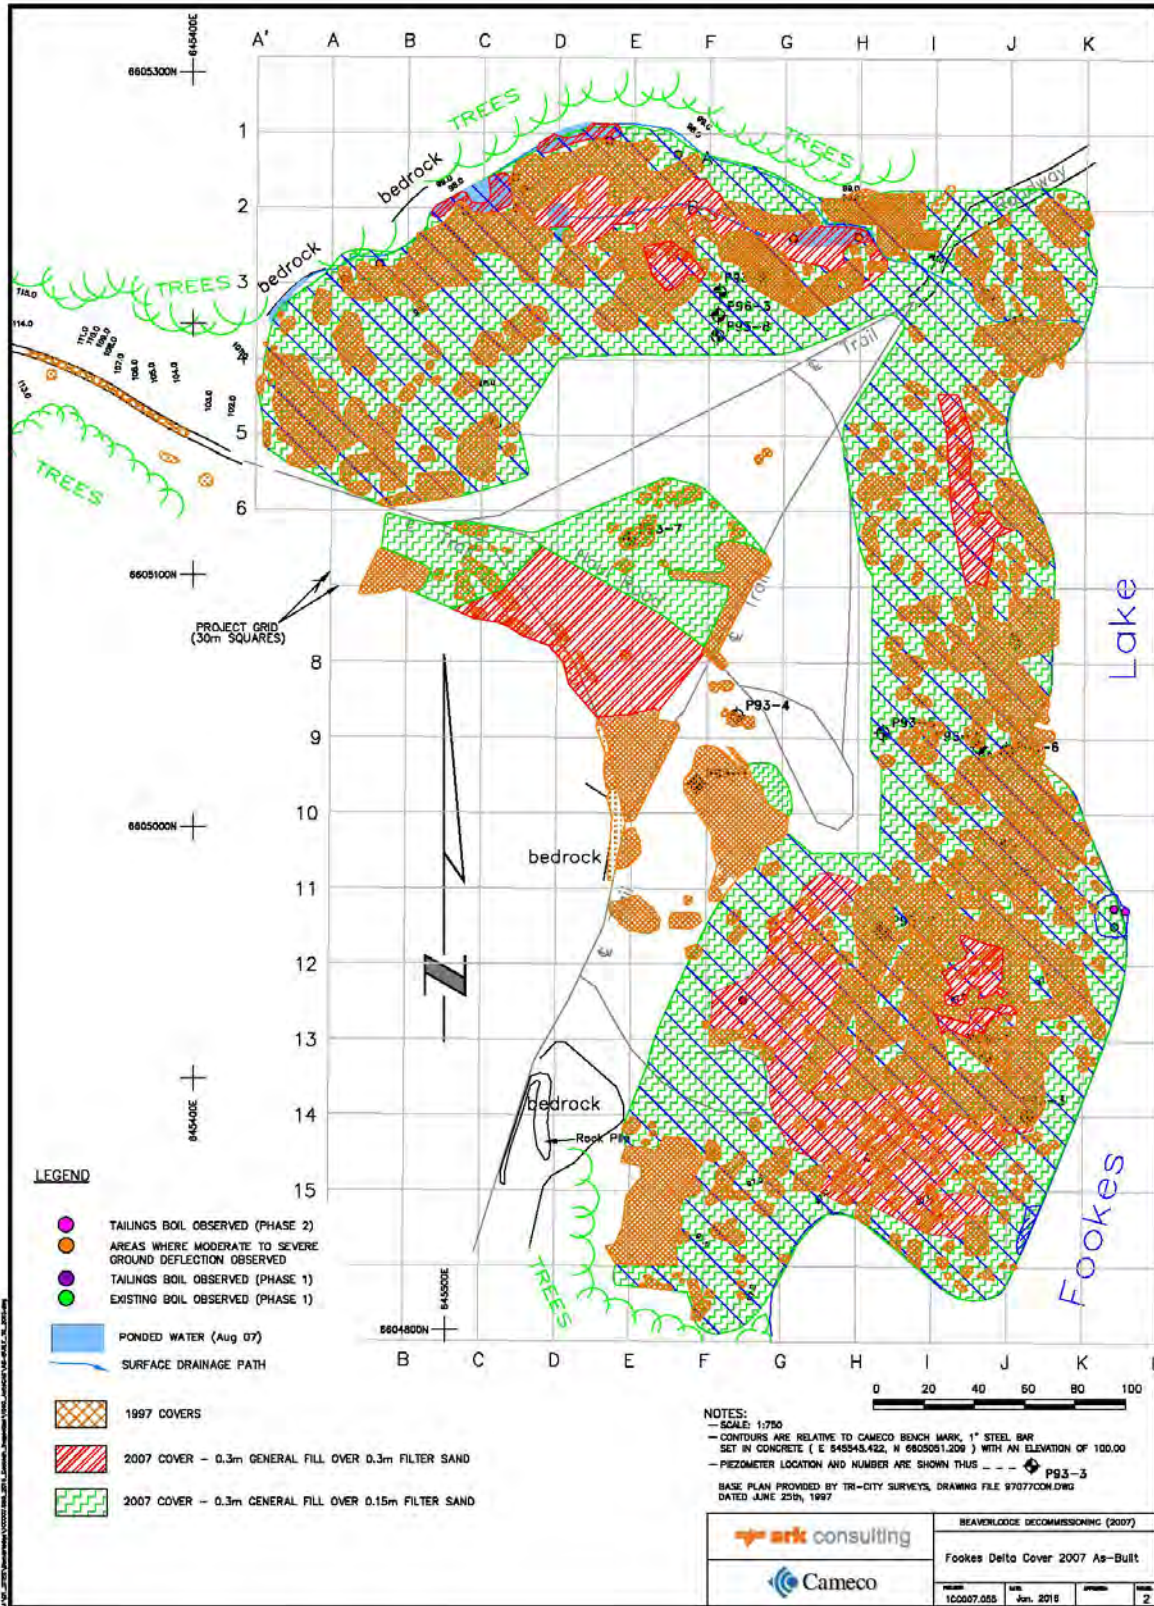
Since the earthen berms protecting the east and west access points to the Fookes Delta were repaired and reinforced in 2011 and 2012 respectively, there has not been any new evidence of passenger vehicular traffic accessing the delta. It has been noted that there are occasional quad tracks on the delta, which should not affect the integrity of the cover. Photos of the berm located on the east access point are provided in Appendix C (**Photo C8 and C9**).

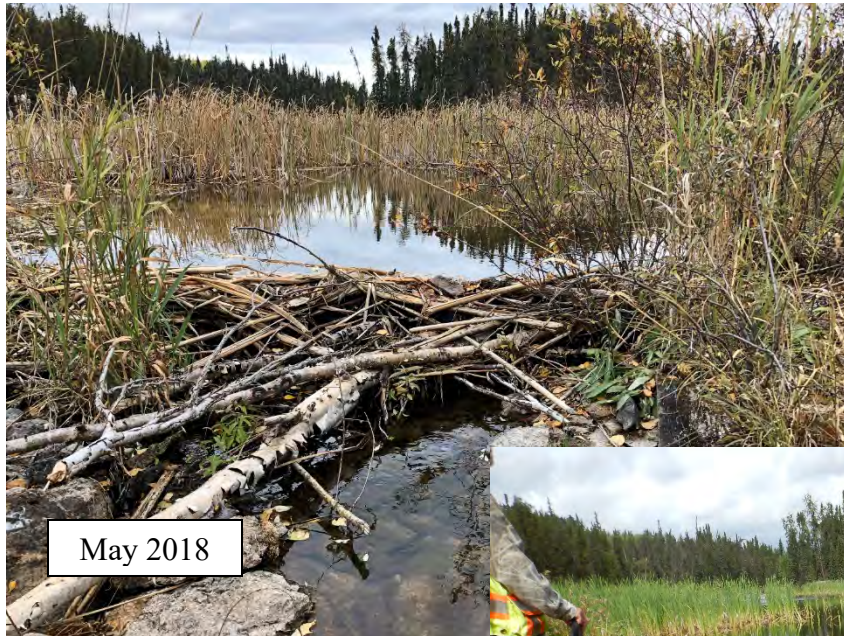
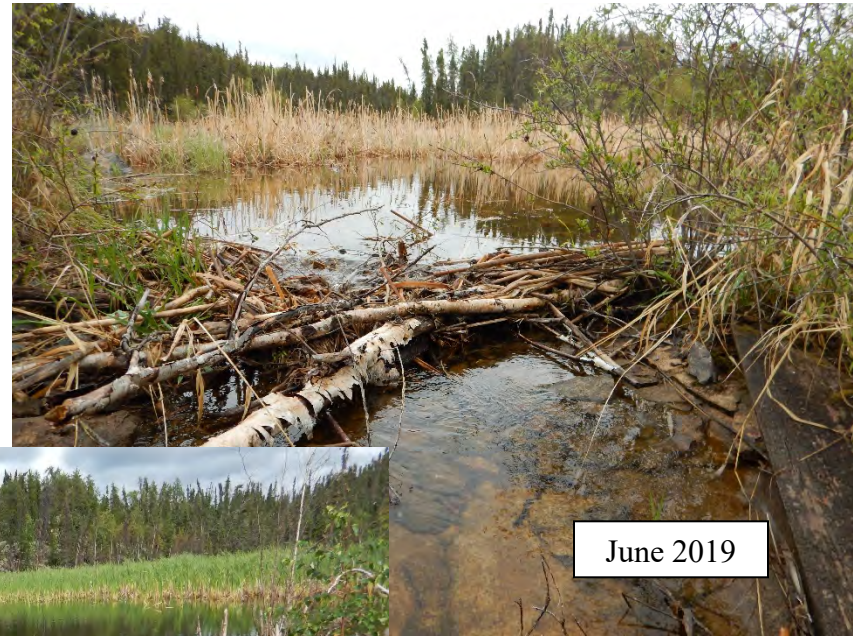
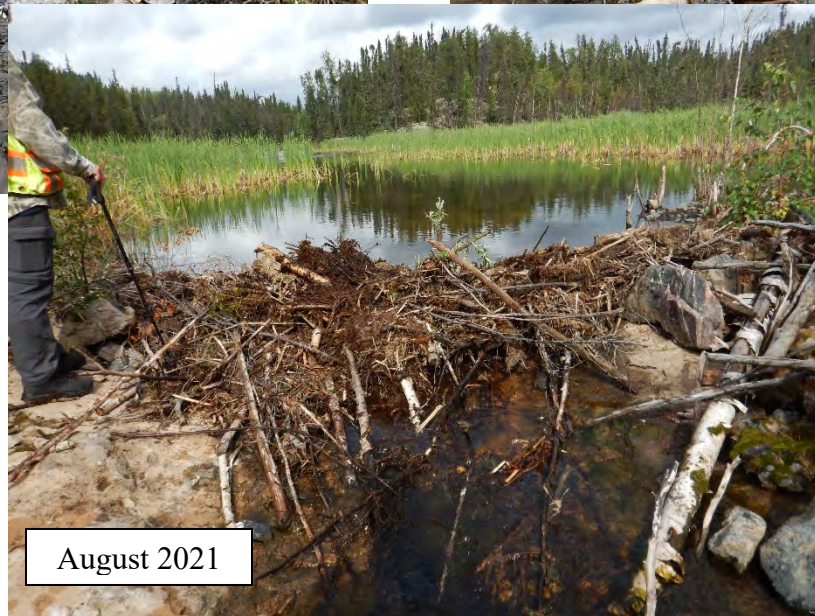
Beaver dam construction at the outlet structure for Marie Reservoir

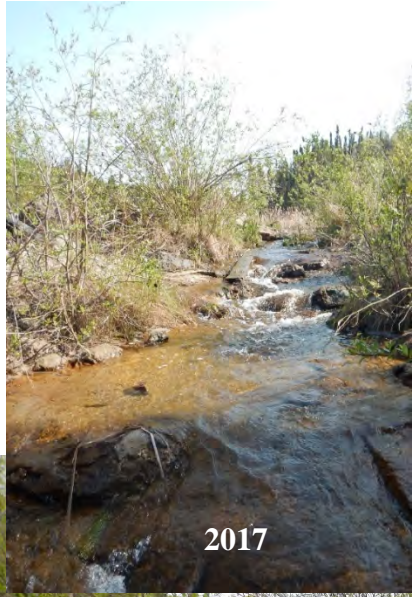
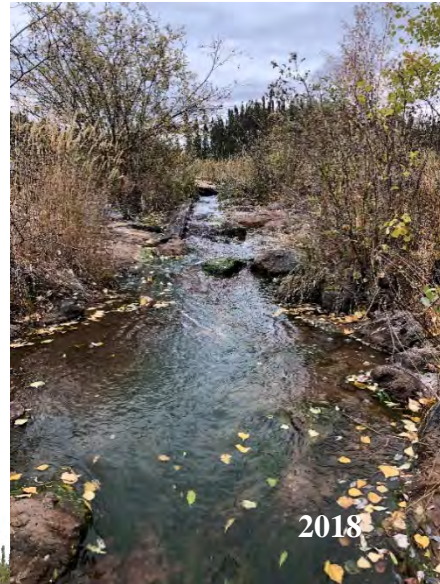
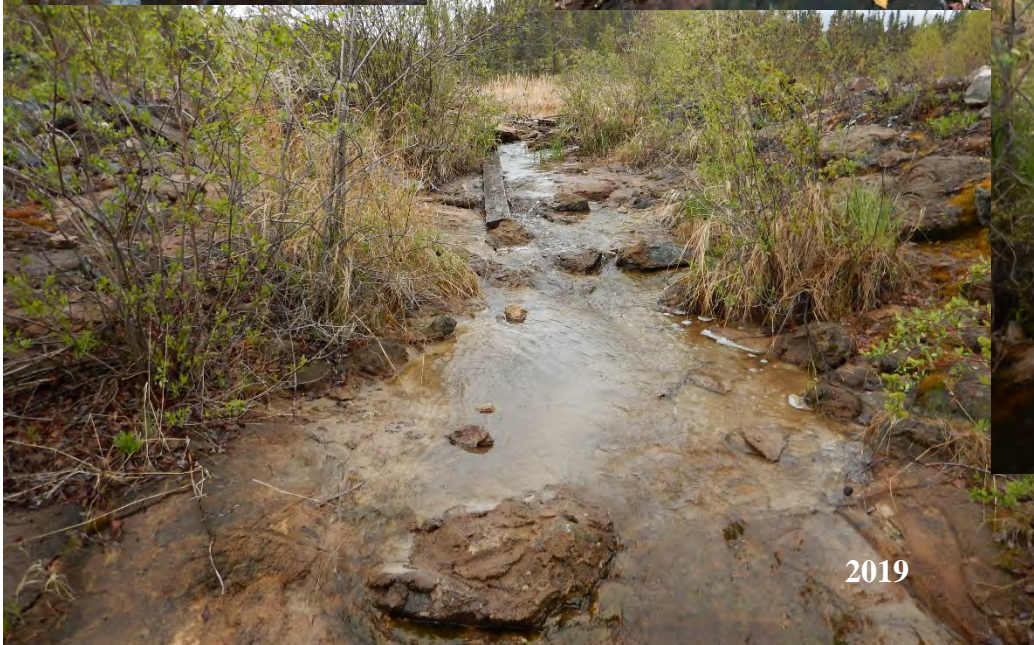
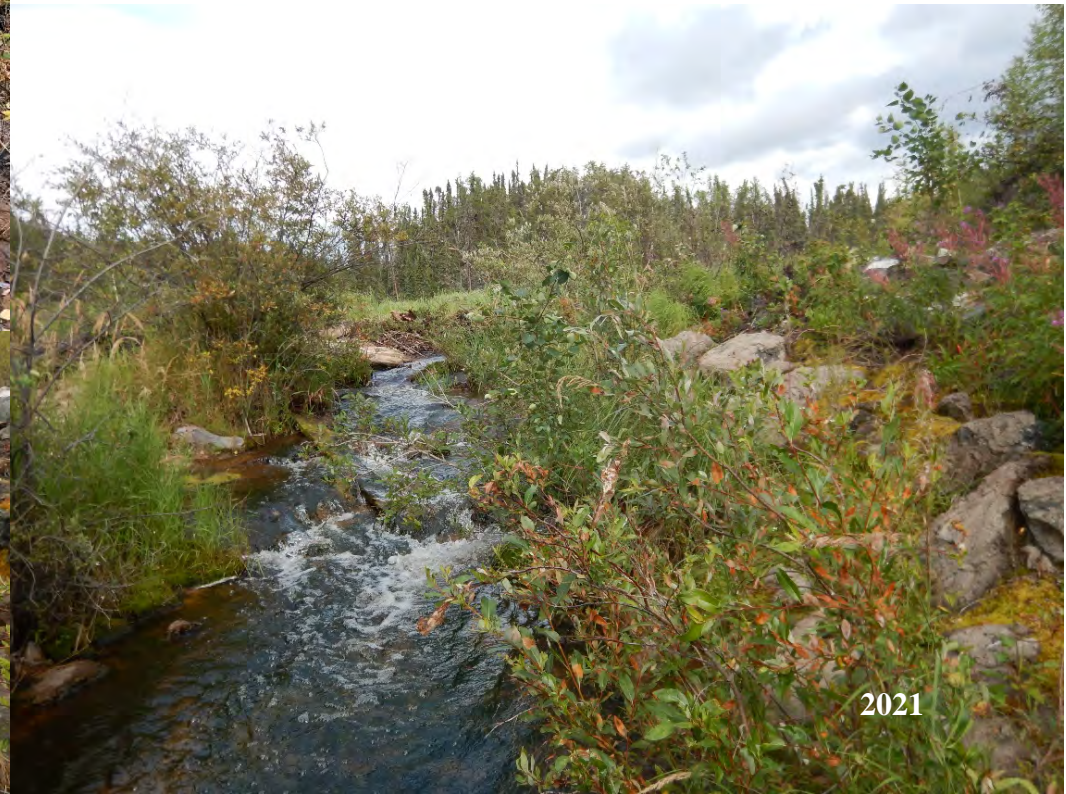
Marie Outlet Structure looking upstream

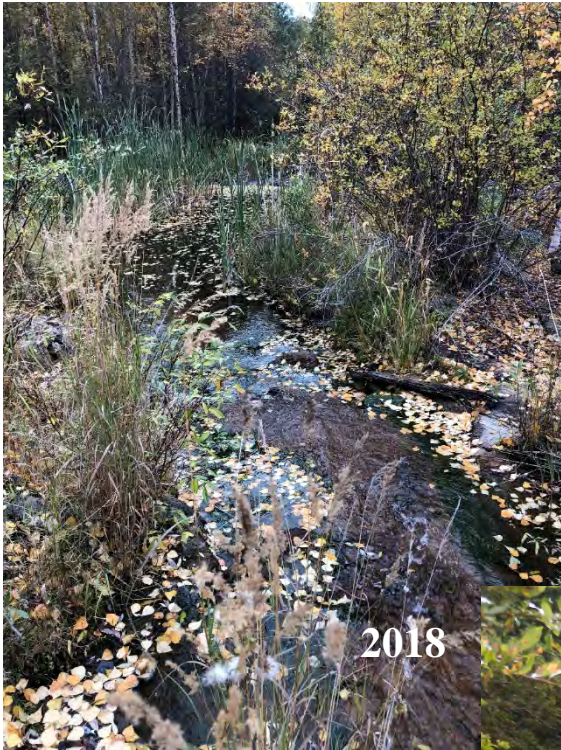
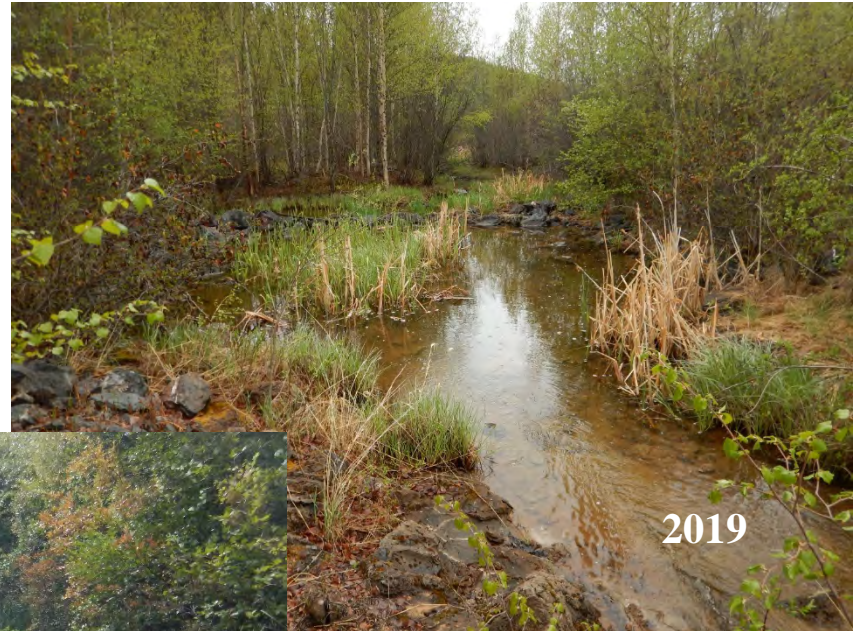
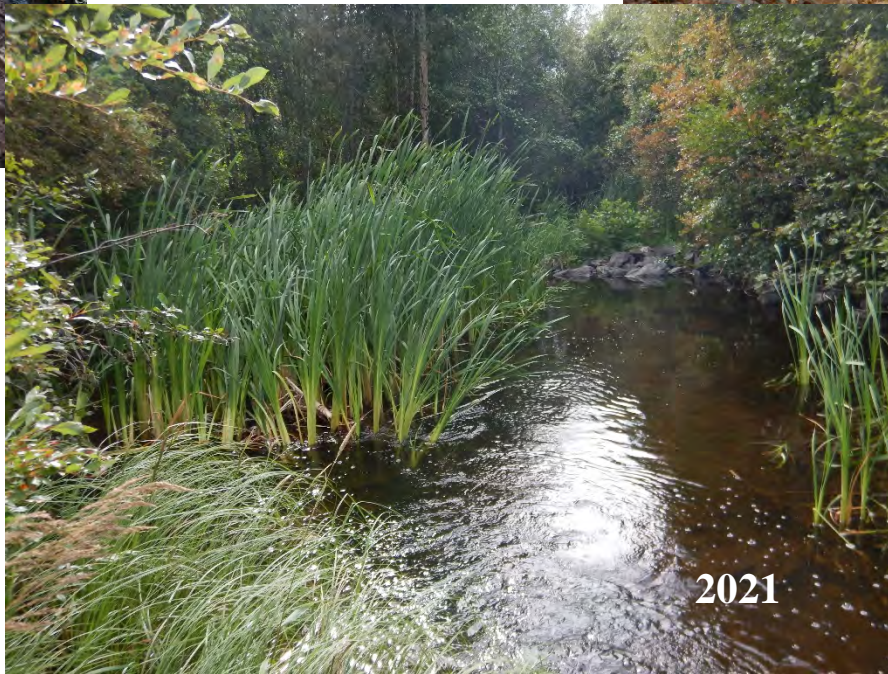
Marie Outlet Structure looking downstream

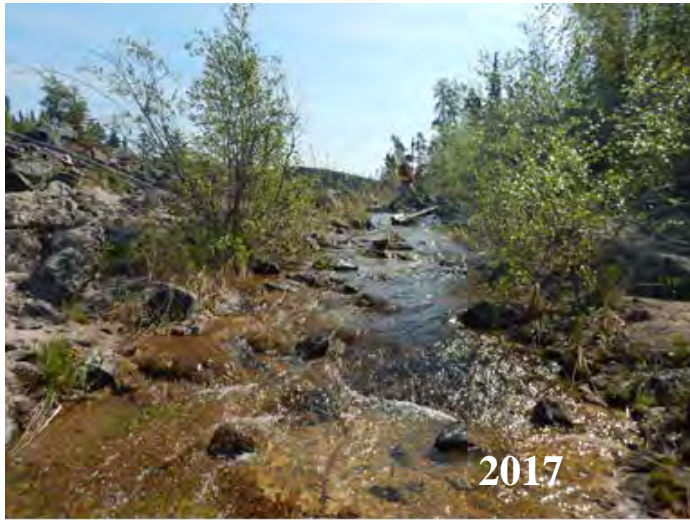
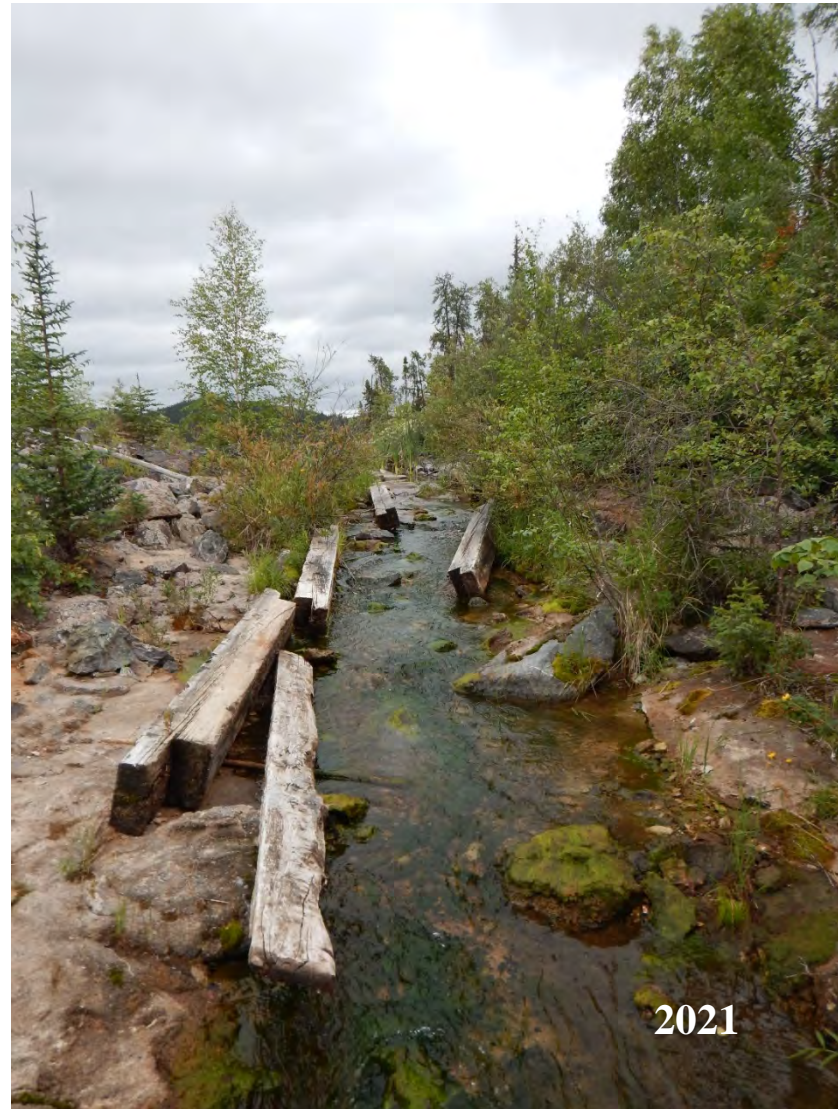
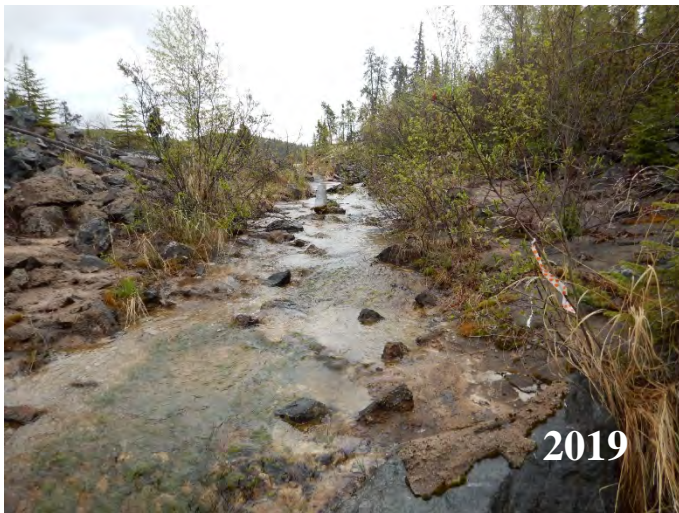
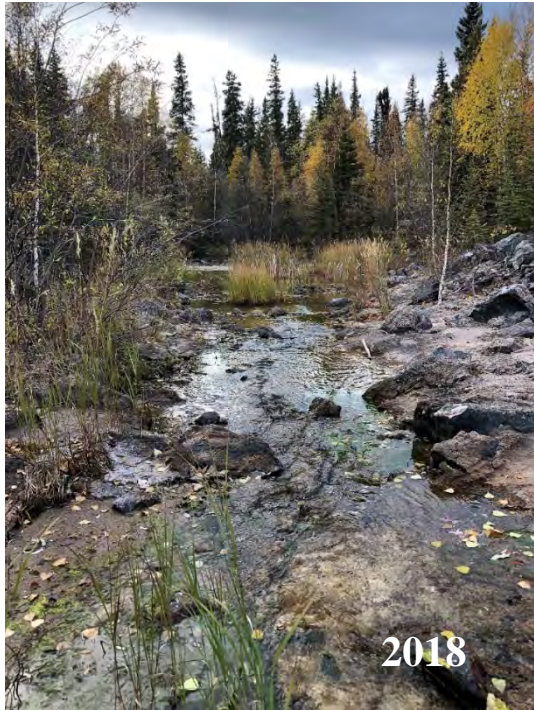
Fookes Outlet Structure looking upstream

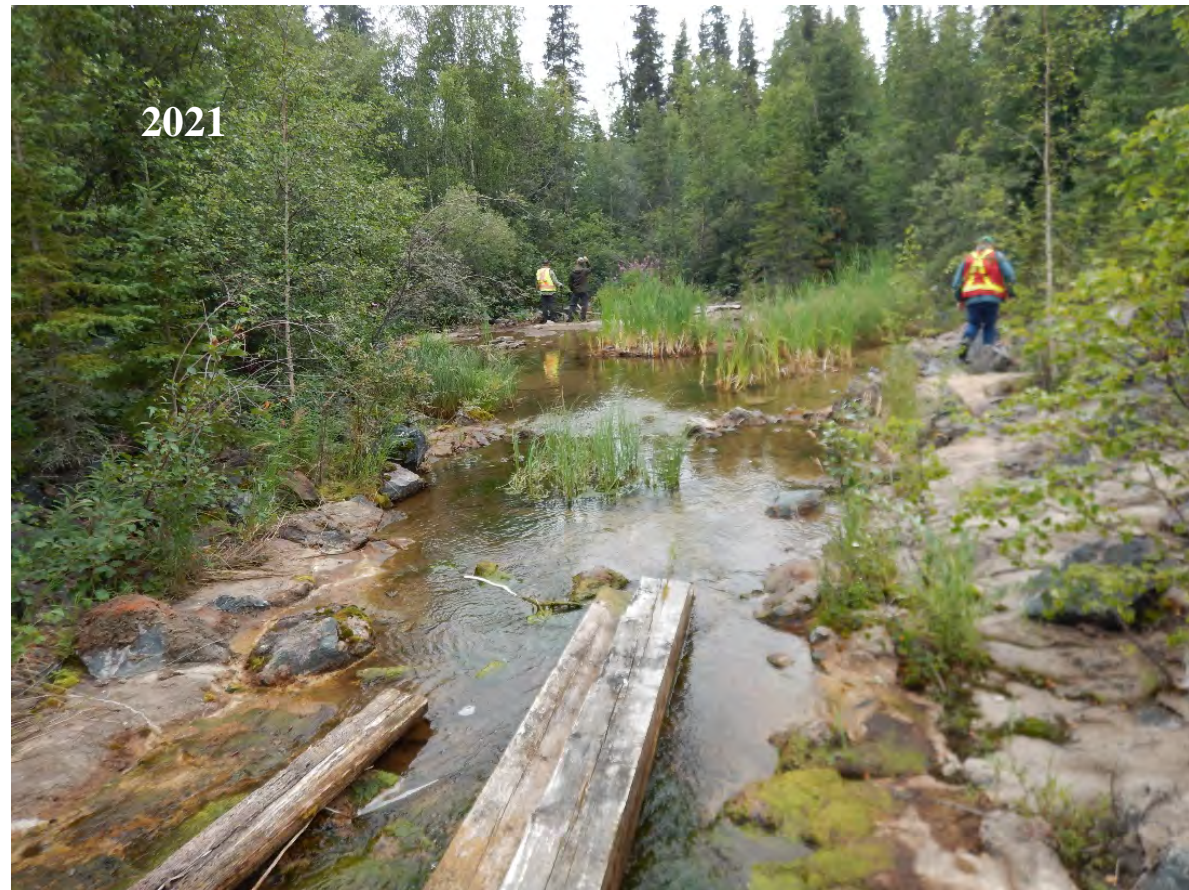
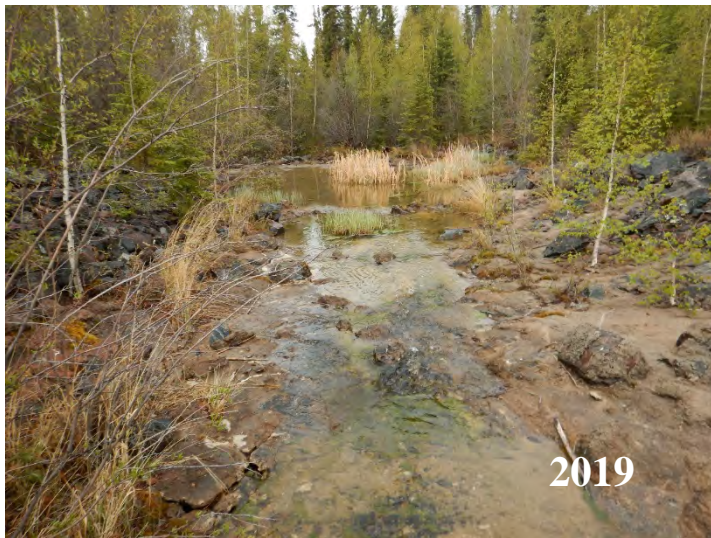
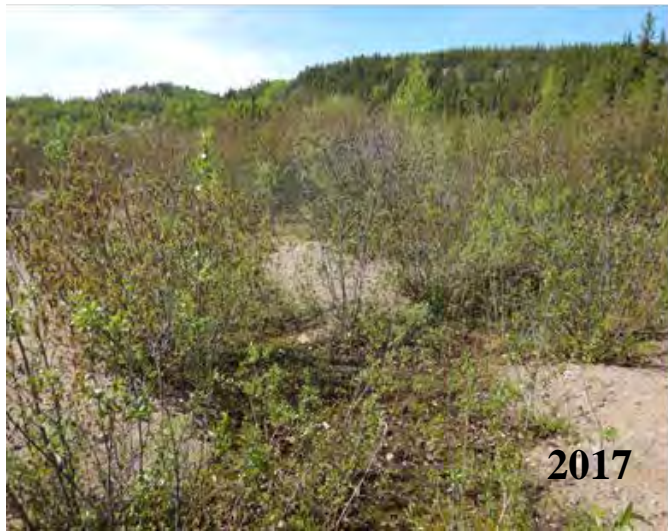
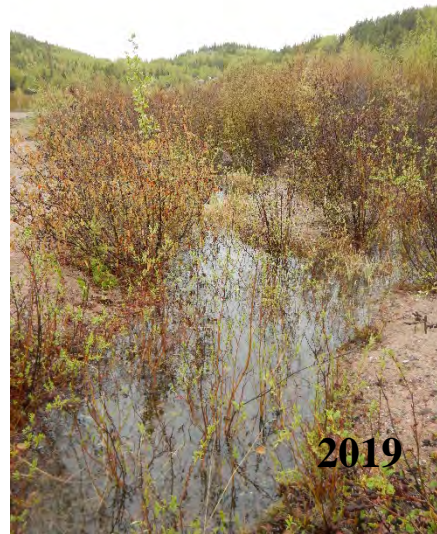
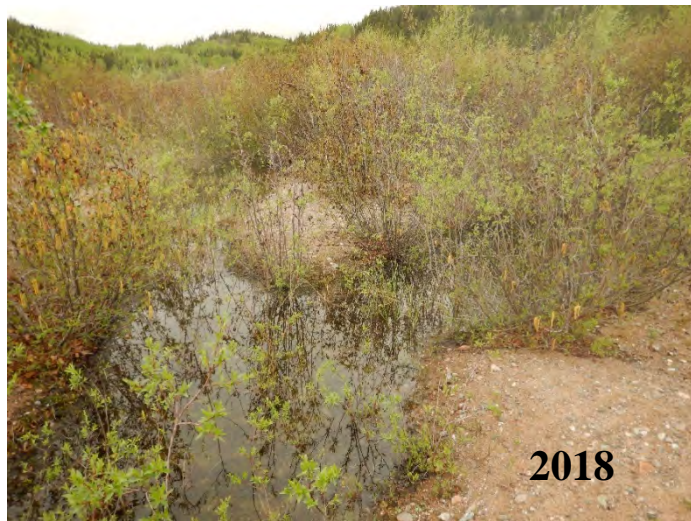
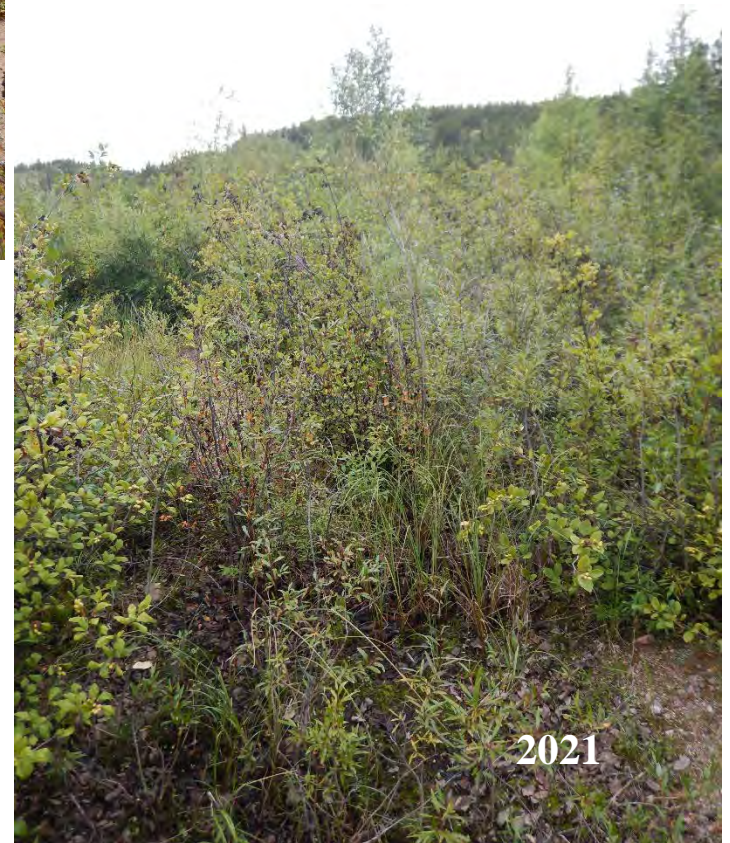
Fookes Outlet Structure looking downstream

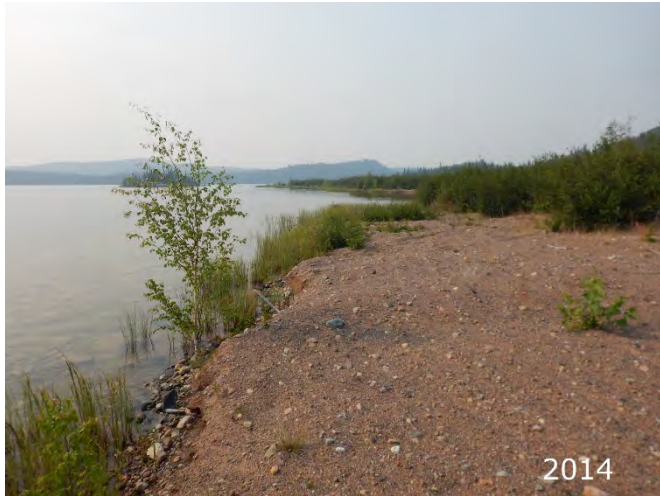
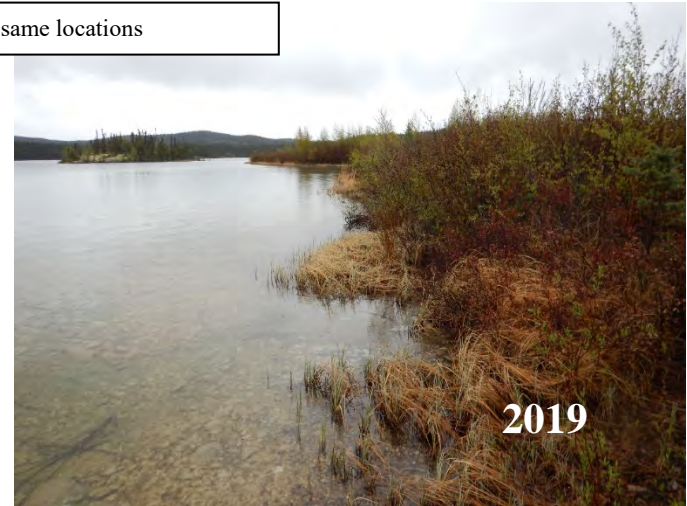
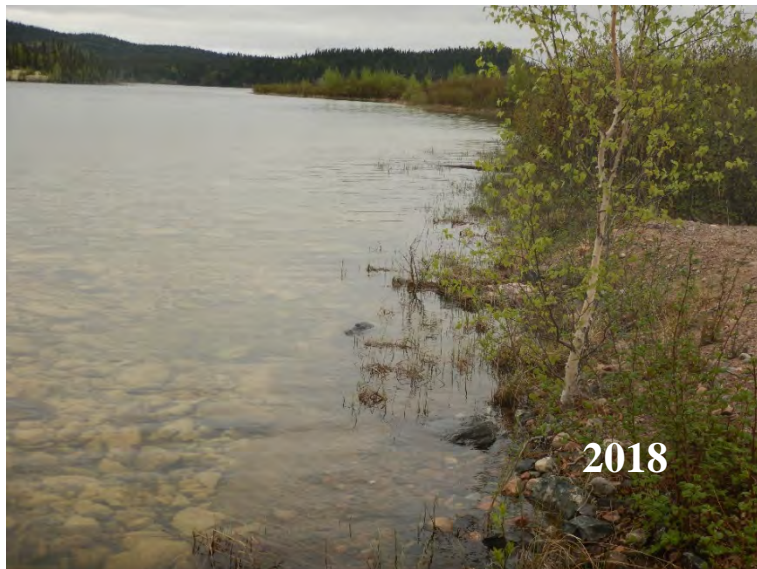
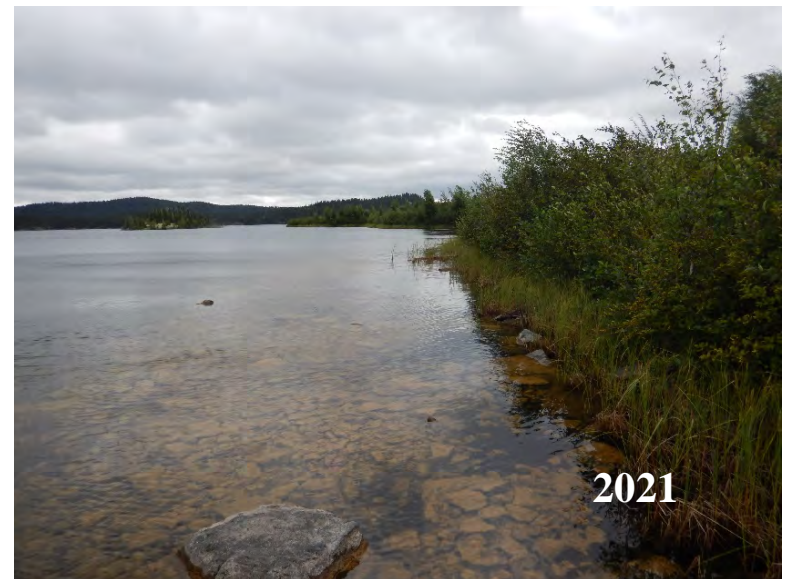
Drainage area looking NW towards access point

Note: pictures are not taken from the exact same locations

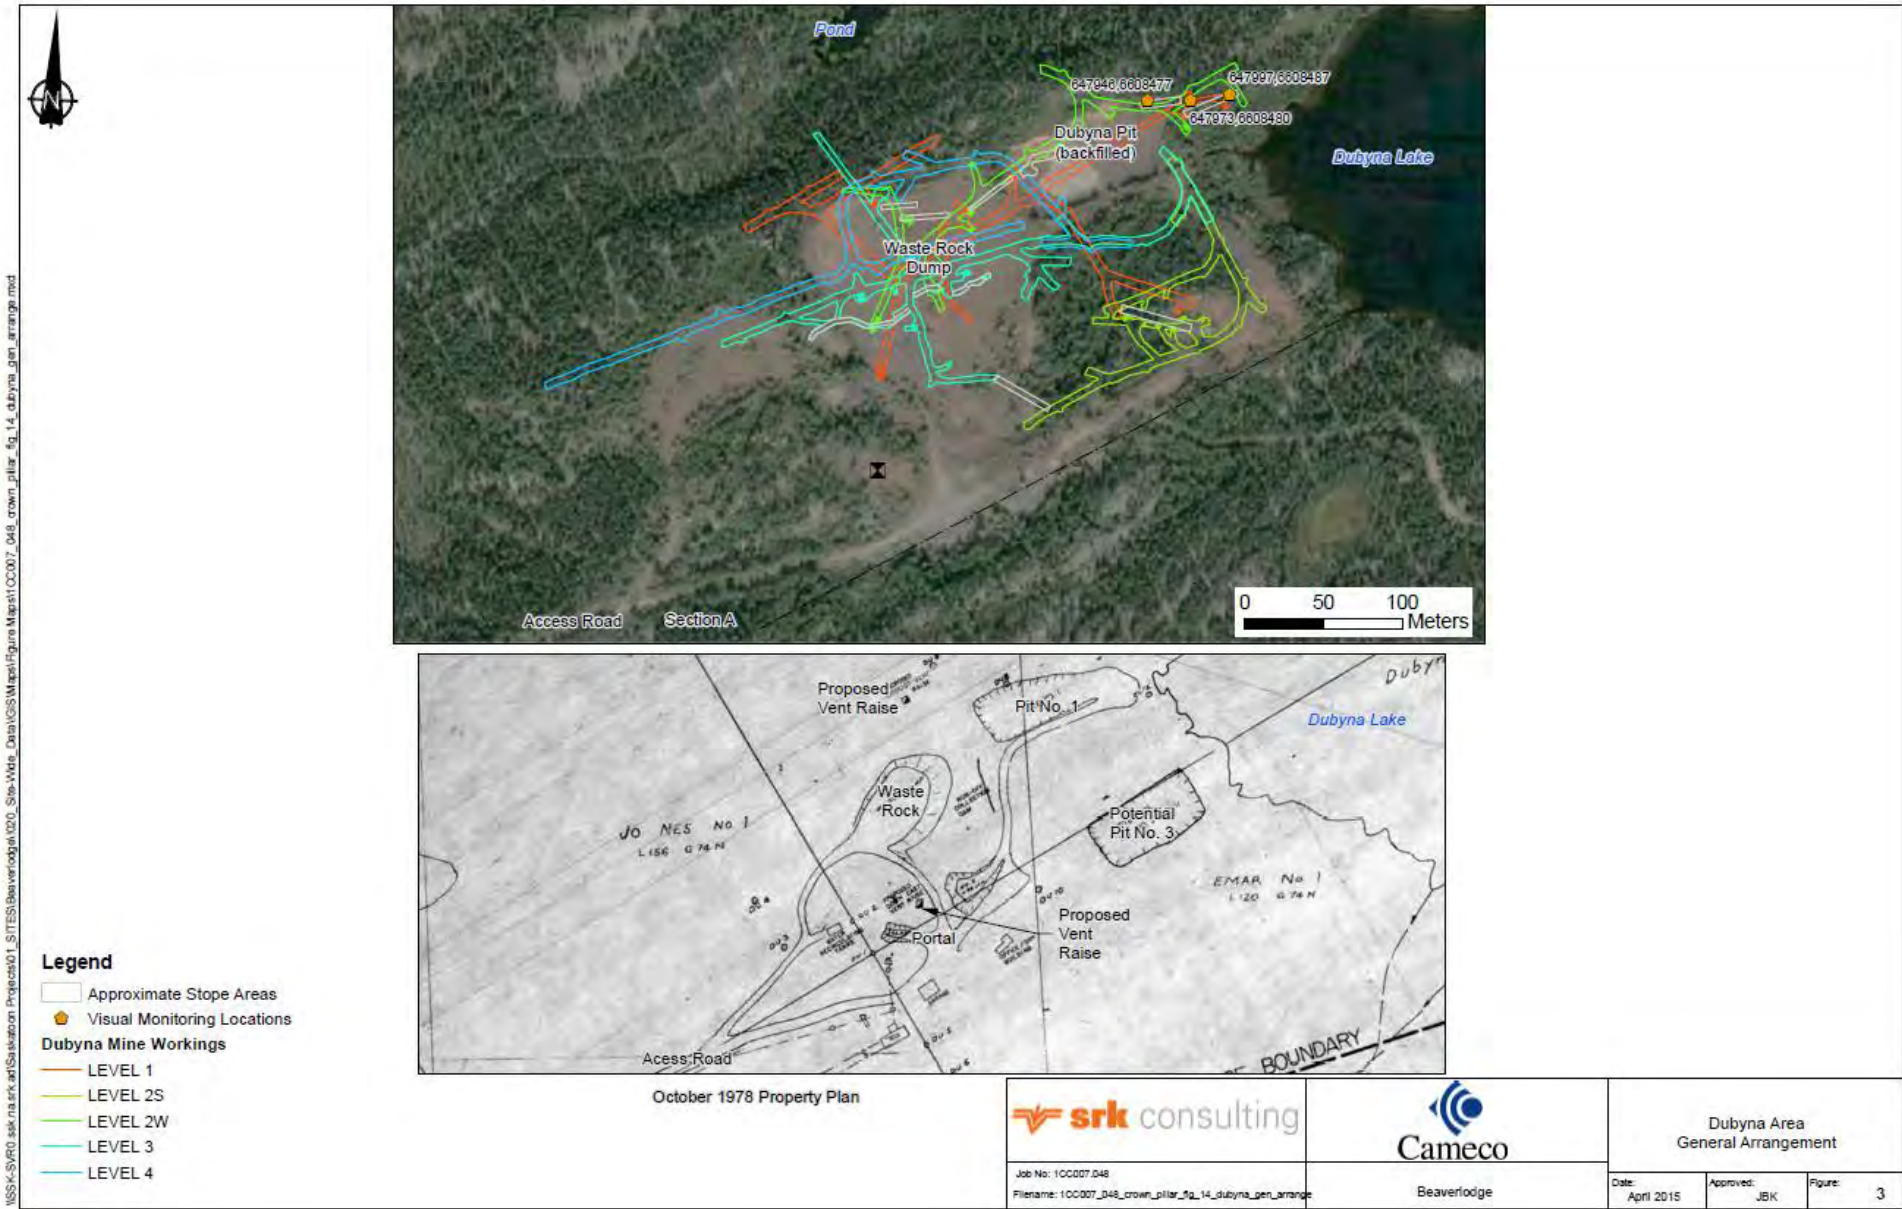
Tables 1 and 2 provide GPS points for locations associated with the Dubyna and Hab areas where visual monitoring was recommended. As shown in **Figure 3**, for the Dubyna area, the area between inspection points are expected to coincide with the Level 1 stoping area where crown pillar thicknesses would be expected to be the thinnest. As shown in **Figure 4**, for the Hab area, inspection points are expected to align roughly with the 2nd level workings where stoping of the Hab 039 Zone was conducted. **Figure 5** provides the layout of the Ace Stope Area cover along with the locations of historic subsidence observed in the area, where inspections typically focus.

The crown pillar monitoring points at Hab and Dubyna were located, and a visual walking inspection was completed at each site. The inspection involved walking between and around the points identified in Tables 1 and 2. Observations at both areas did not show any evidence of tension cracks or slumping in 2021. It should be noted that trees near the western most inspection point at Dubyna had been cleared since the 2020 geotechnical inspection was completed. This type of activity is an acceptable use of the property and was likely carried out by Uranium City residents practicing traditional activities. This does not influence the geotechnical stability of the crown pillar.

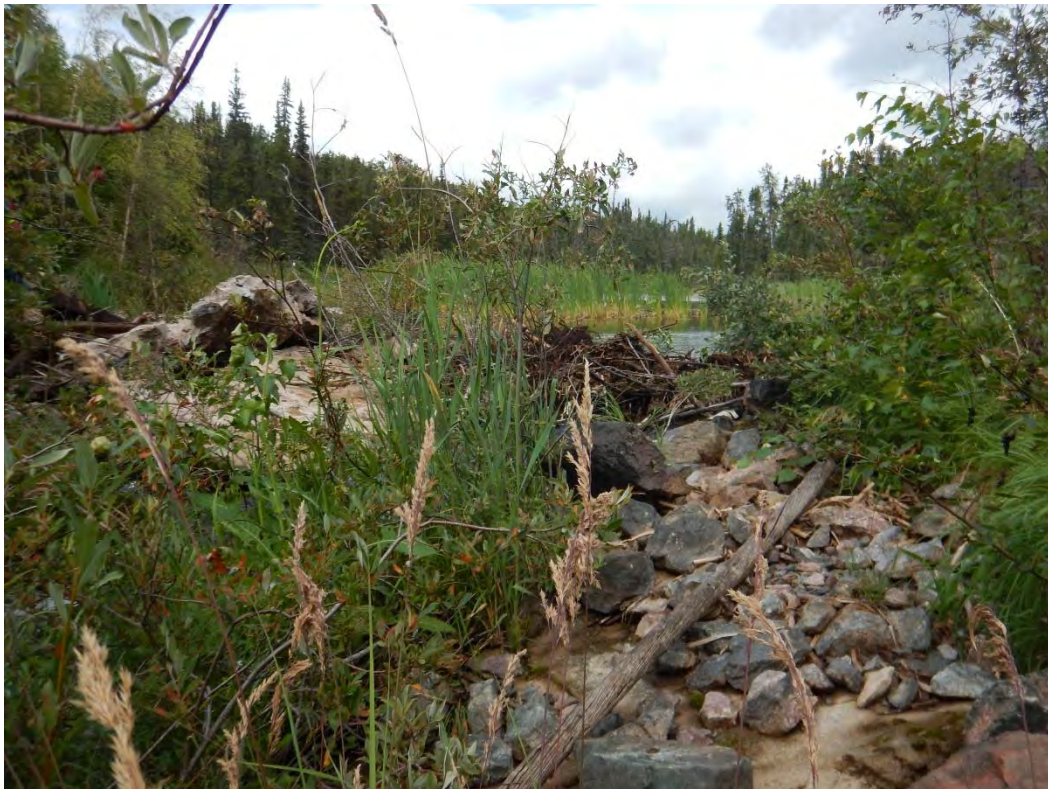
Photo A4 – Displaced grout intruded rip rap at the entrance to the spillway (far left of photo)

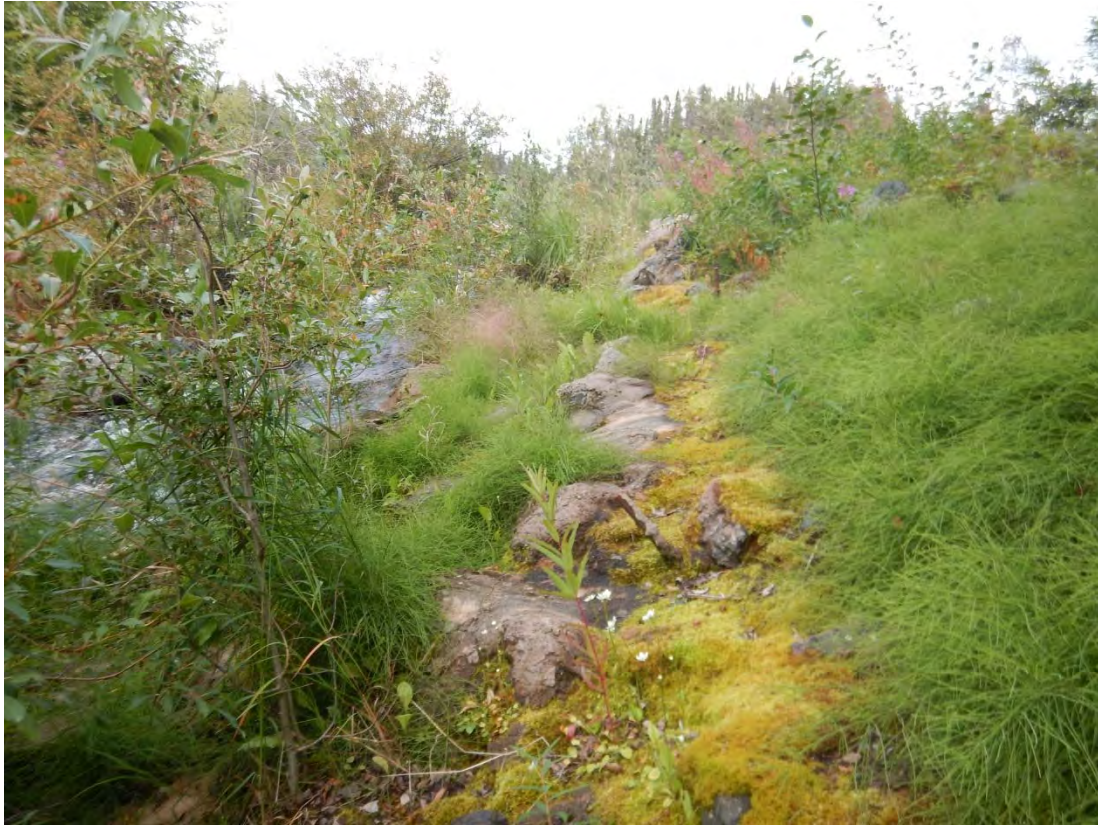
Photo A5 — Showing vegetation along the channel impacted by elevated flows during spring 2021

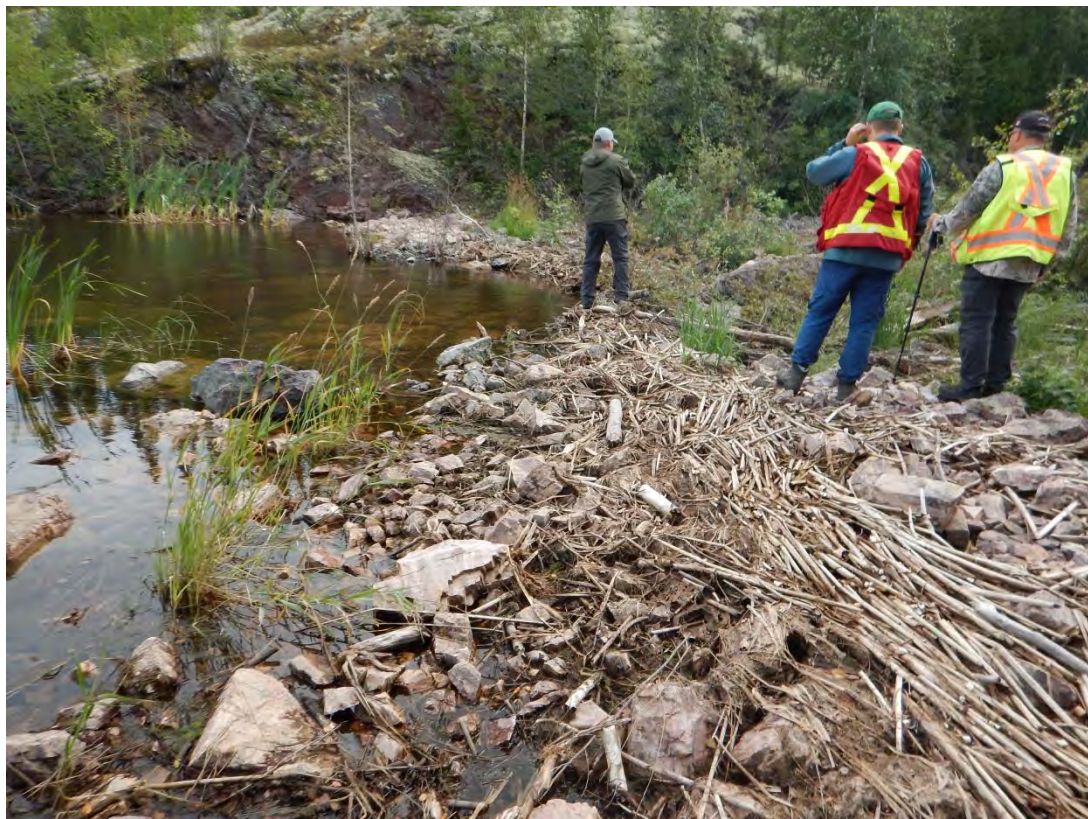
Photo A6 — Showing detritus along leading edge of embankments indicating the extent of the elevated water levels during spring 2021

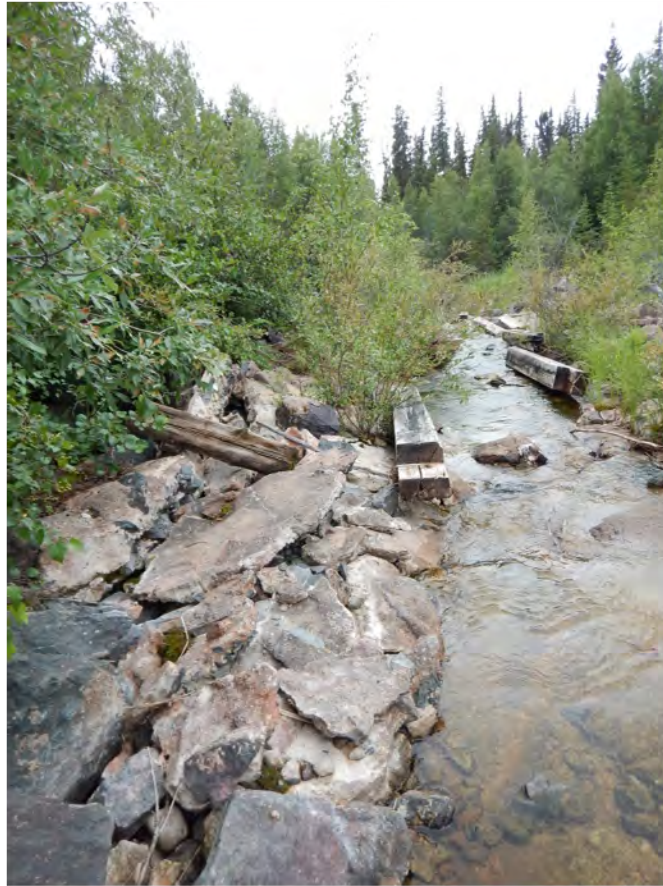
Photo B5 – Fookes Reservoir Spillway broken rip-rap on south side of channel

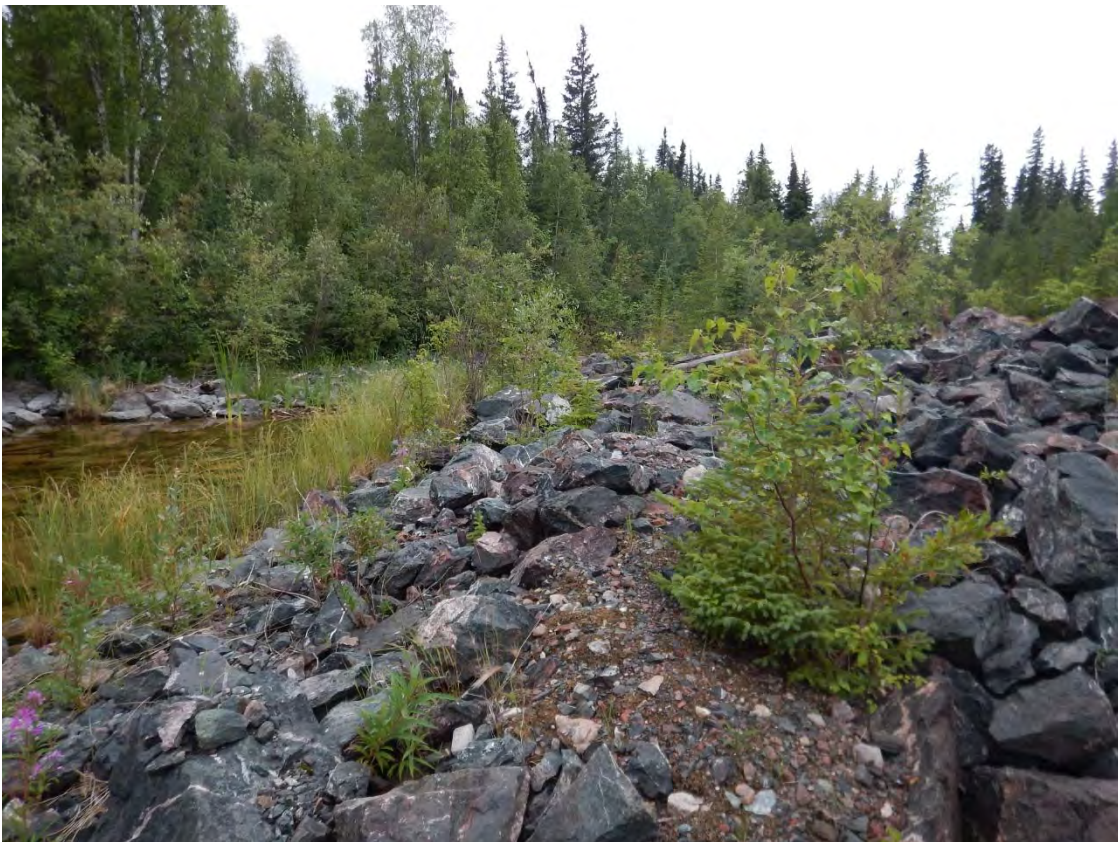
Photo B8—Fookes Outlet south embankment in good condition, looking west

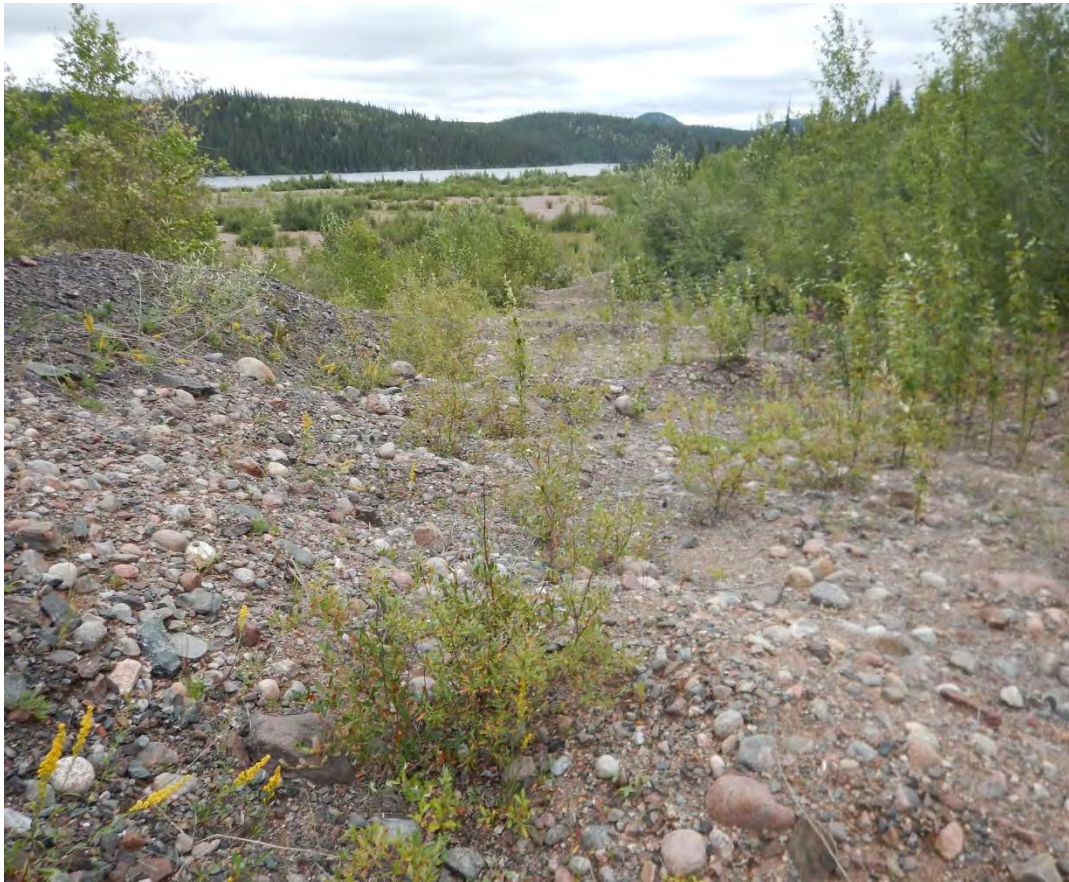
As part of the design and installation of the covers in 2005 and 2007, the area considered most vulnerable to erosion was in the area on and below the access ramp at the northwest corner of the delta (SRK, 2010). The general condition of the ramp is very good. Access to this ramp is closed off by a windrow of material at the top of the ramp. The water bars (chevrons) are performing as expected and show little sign of erosion (**Appendix C, Photo C1**).

Photo C1 – Chevrons in place on north access point to the Fookes delta looking south

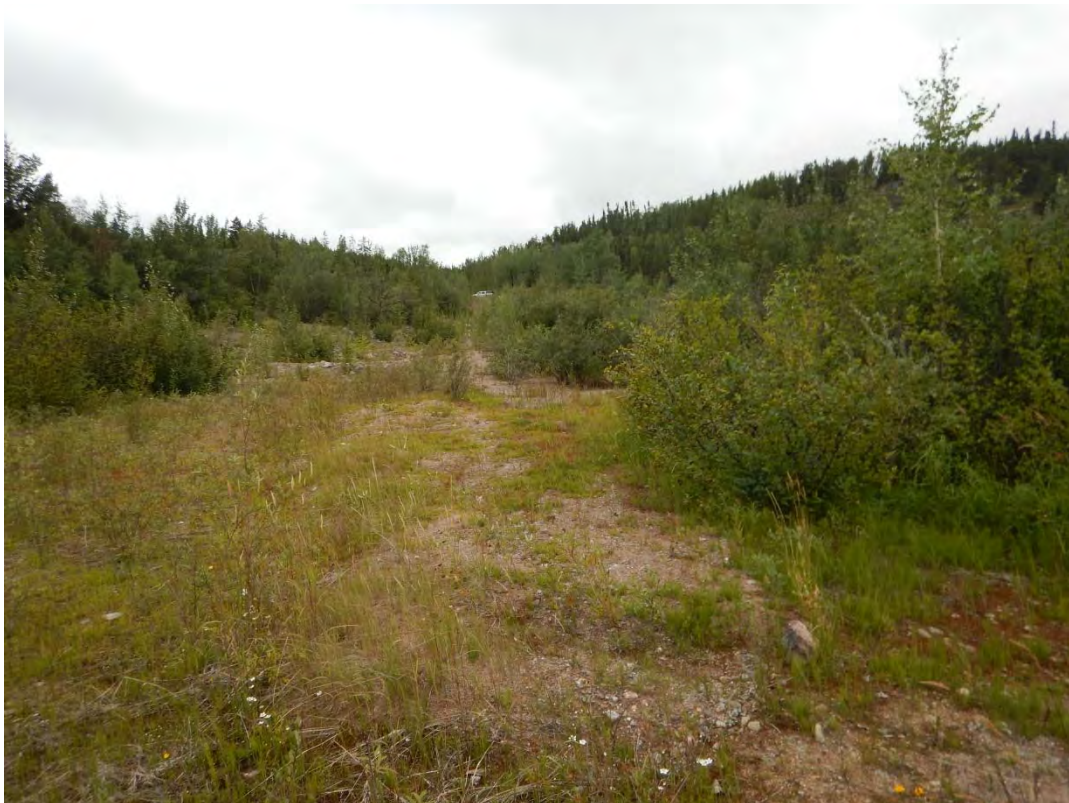
In addition to the chevrons, run-out structures were installed to carry away excessive water during extreme run-off events. These run-out structures are also in good shape with no observed additional eroded material beyond that observed during previous inspections (**Appendix C, Photo C2**).

Photo C2 – North access road looking up hill to the north from Fookes Delta
