BEAVERLODGE PROJECT

Beaverlodge Project 2021 Annual Report Year 36 Transition Phase Monitoring

Prepared for:
Canadian Nuclear Safety Commission
Compliance Report for Licence: WFOL-W5-2120.1/2023
& Saskatchewan Ministry of Environment
Compliance Report: Beaverlodge Surface Lease

Prepared and Submitted by:
Cameco Corporation

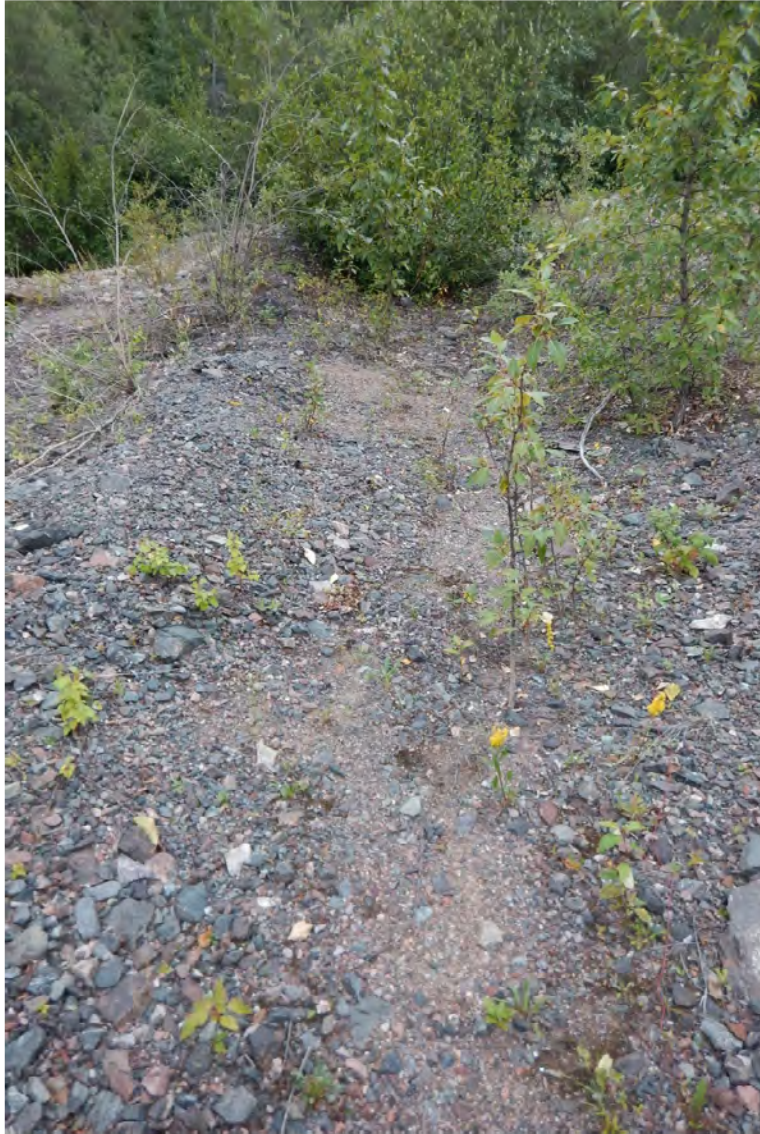
Photo C3 – Chevron run-out structure along north access road (looking east)

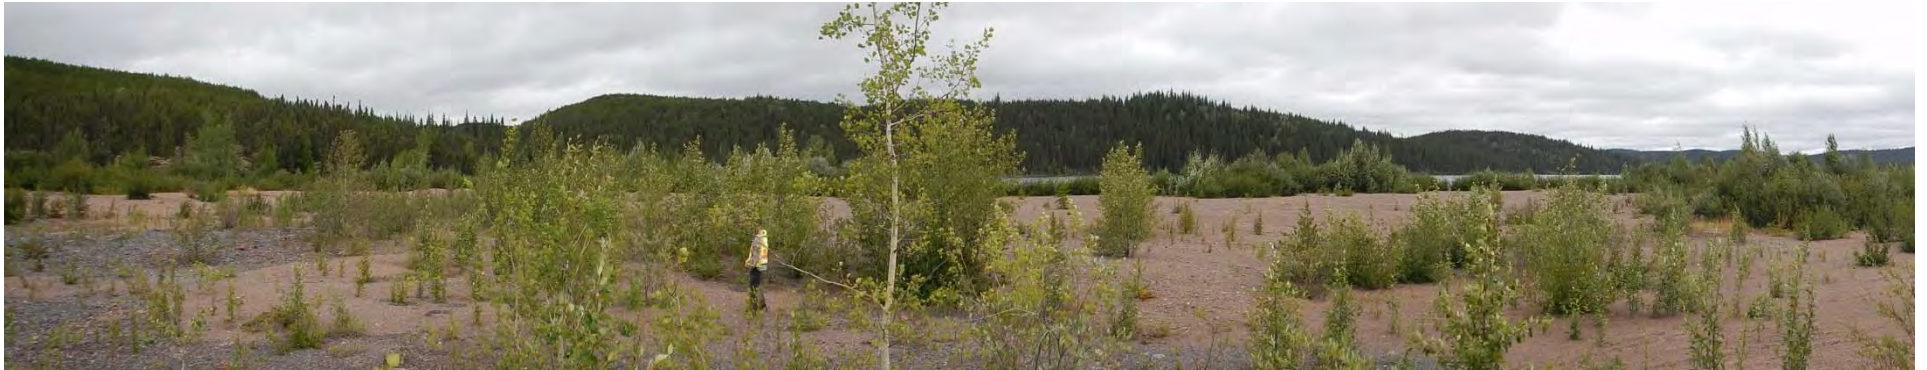
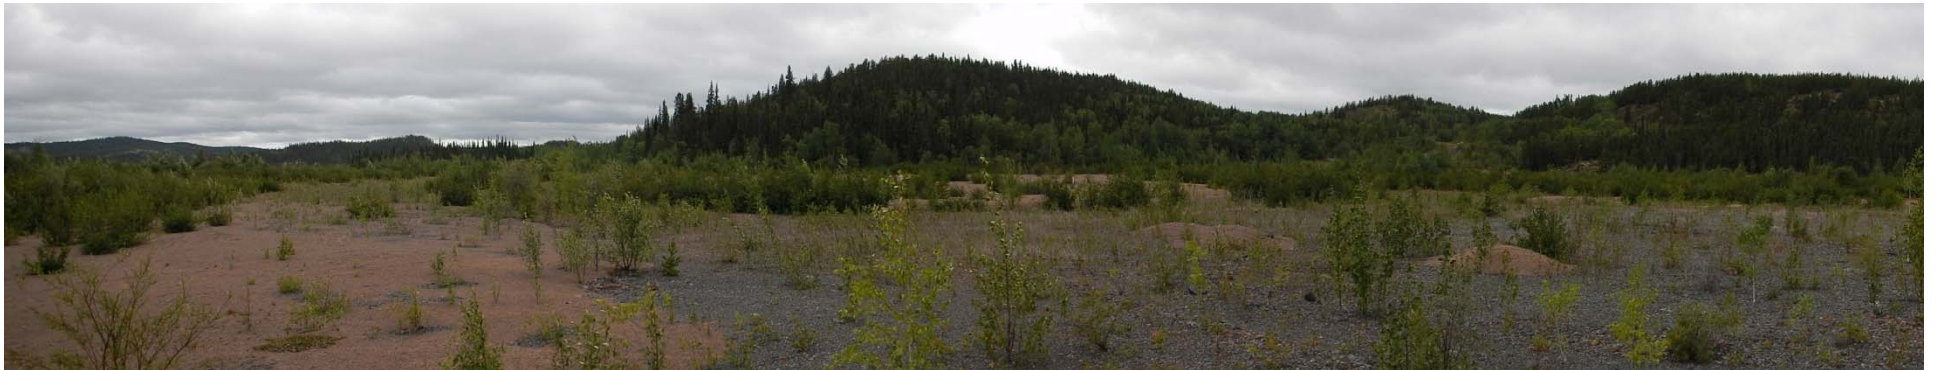
The Fookes Delta cover is in good condition and showed no signs of excessive erosion. As vegetation continues to establish on the shoreline it will provide additional armoring and increase the stability of the cover.

Photo C5a-b – Panoramic views of the Fookes cover with vegetation establishing

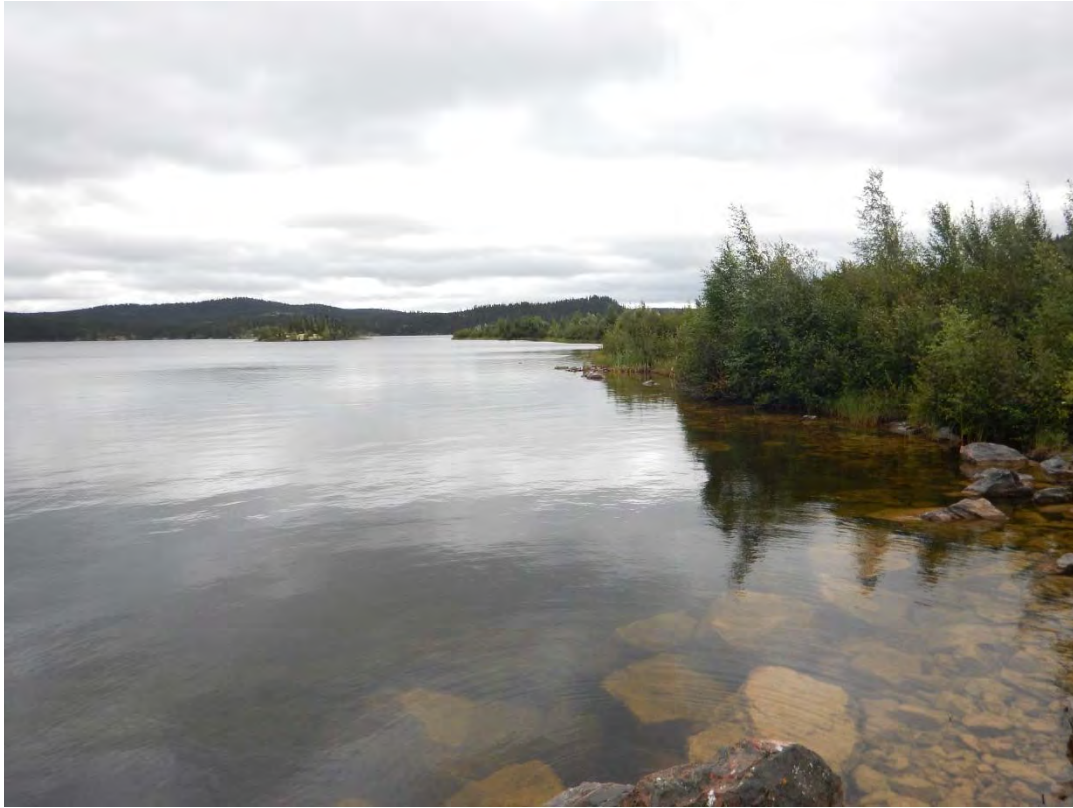
Since the earthen berms protecting the east and west access points to the Fookes Delta were repaired and reinforced in 2011 and 2012 respectively, there has not been any new evidence of passenger vehicular traffic accessing the delta. It has been noted that there are occasional quad tracks on the delta, which should not affect the integrity of the cover. Photos of the berm located on the east access point are provided in Appendix C (**Photo C8 and C9**).

Photo C8—Fookes Reservoir shoreline (looking west)

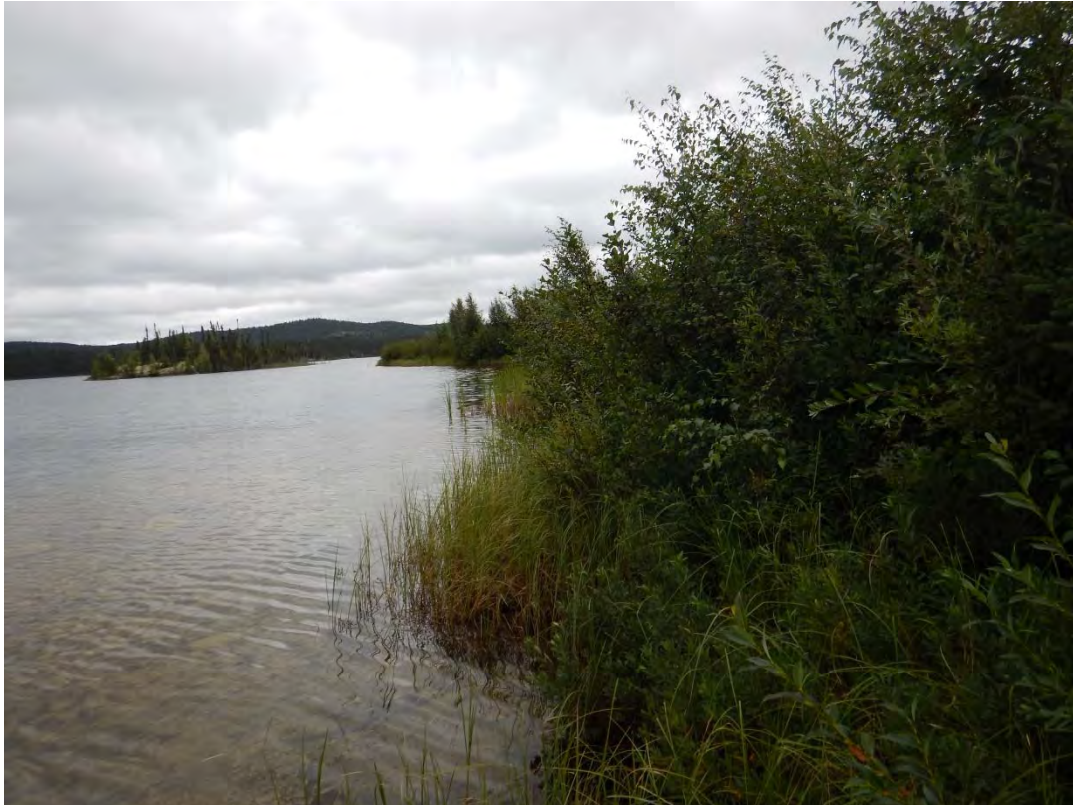
The shoreline, where the edge of the sand cover contacts Fookes Reservoir, was inspected and was in good condition, despite the water levels in Fookes Reservoir being higher than normal following freshet. Photos taken in 2021 continue to show significant vegetation coverage along the shoreline.

Photo C9—Fookes Reservoir shoreline (looking west). Note vegetation along shoreline is well established

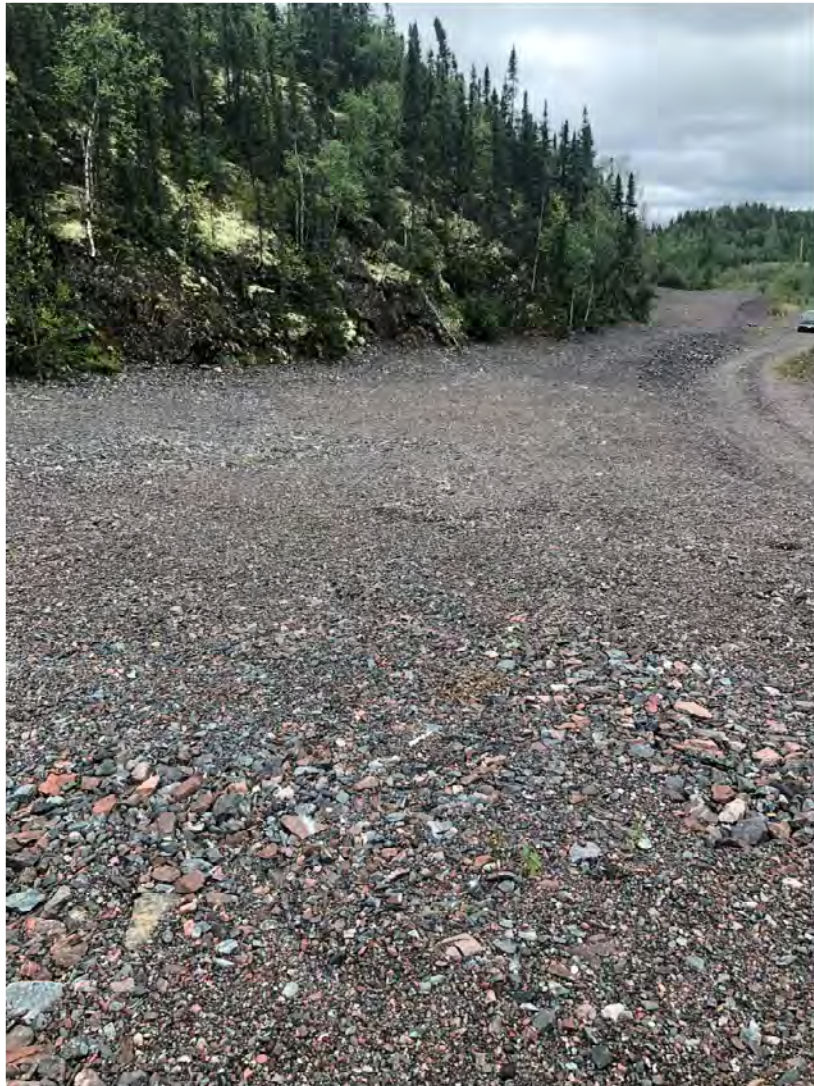
At the Ace area, the cover material over the stopes was inspected by walking the toe of the cover material, as well as the interface between the cover material and natural ground. No signs of tensions cracks or visible depressions were observed along the Ace stope cover material in 2021.

Photo D1 - View of the cover placed over Ace 201 Stope

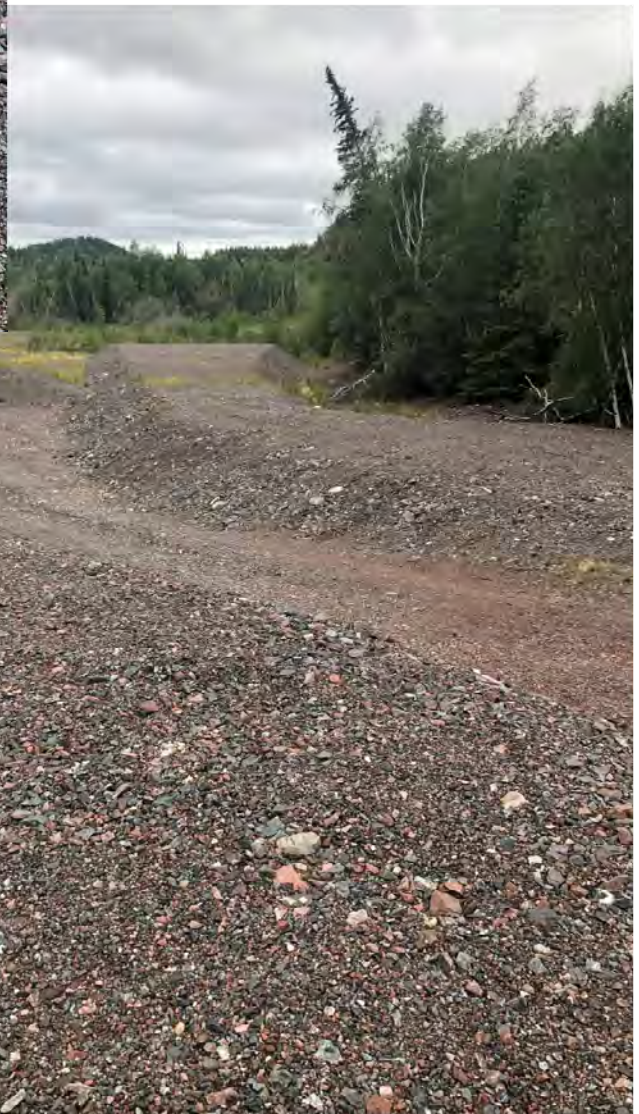
Photo D2 - view of Ace 105 and 208 Stope cover

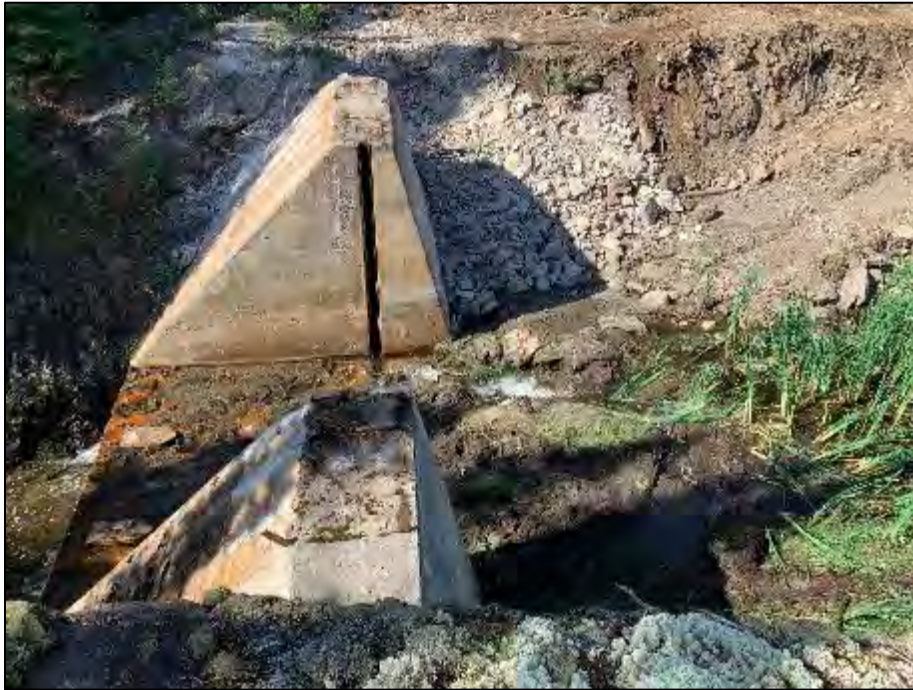
The decision was made to allow water to define a flow path through the newly exposed sediments, rather than to excavate material and develop a channel/flow path. No longer impounded, the water cut down about 30 cm into the remaining sediment until it reached the concrete sill, spread across the sill, and spilled over the concrete into the receiving channel below the TL-7 structure (Photos 3 and 4).

Photo 4. View from right bank (when facing upstream) after metal frame and stop logs were removed; note new flow path of water moving across the remaining structure (flow is from right to left)

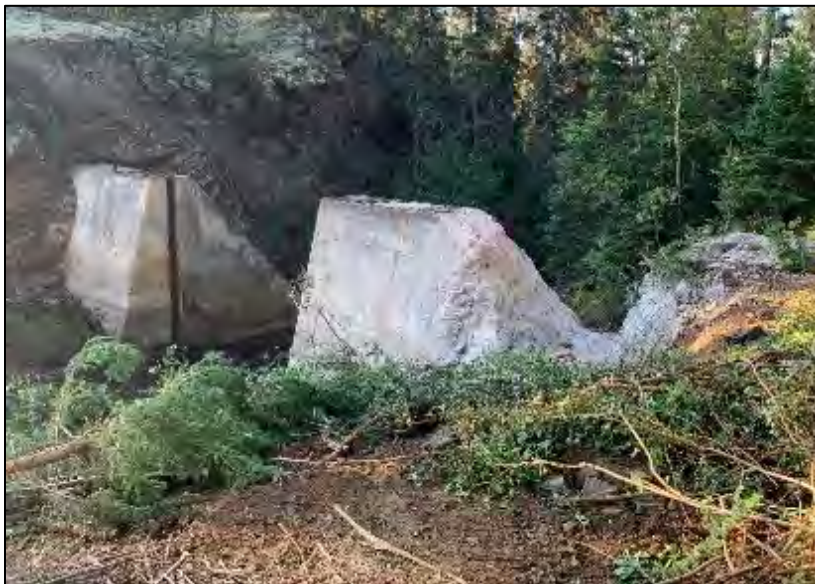
The concrete wall of the dam on the left bank (when looking upstream) had material chipped out to reduce the potential for someone to climb the dam face and walk out onto the level surface of the wall (Photo 5). Materials removed from the structure (wood, metal, and some concrete) were hauled from site using a rock truck.

Photo 5. View from left bank, showing where concrete was chipped away

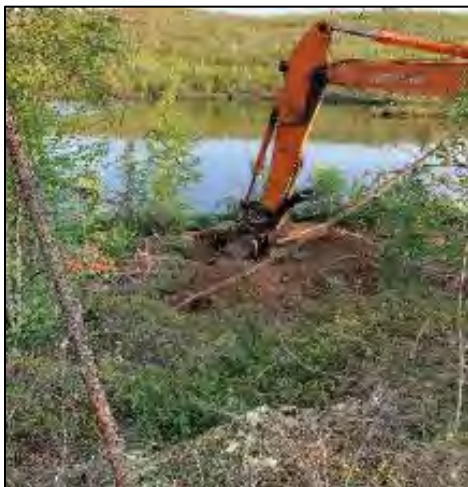
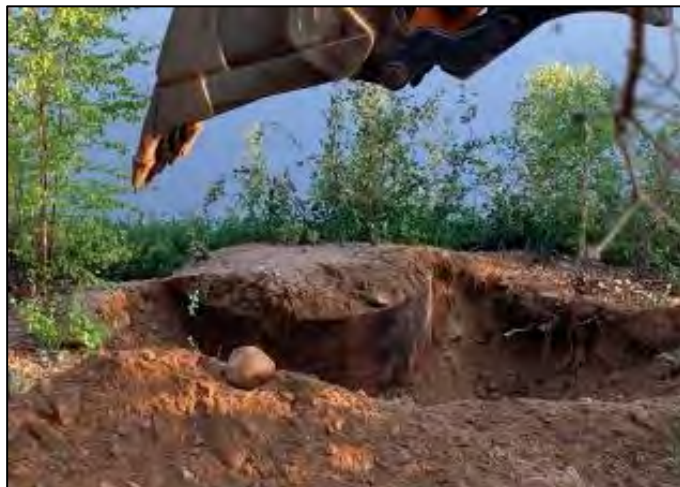
Prior to the start of work on this site, OEC assessed the shoreline in front of the metal ring and determined that installing a sediment fence properly (digging a trench and backfilling the portion of the fence that needs to be buried), would require damaging the dense vegetation that had established on top of the shoreline where the outer edge of the metal ring was, and would likely cause the soft sand material at the top of bank to fall towards the lake. In discussion with the machine operator, it was decided that machine work near the top of bank could be avoided and it would be possible to remove sand material from behind the metal ring only (i.e., as far from the shore as possible). This would allow the back area to be excavated down toward the base of the metal ring, and once a hole had been developed behind the metal – the metal would just be pulled away from the shore, rather than digging close to the lake on the shore-side of the structure (Photos 6 - 9).

Photos 6 and 7. Start of excavation behind the metal ring at Donaldson Lake

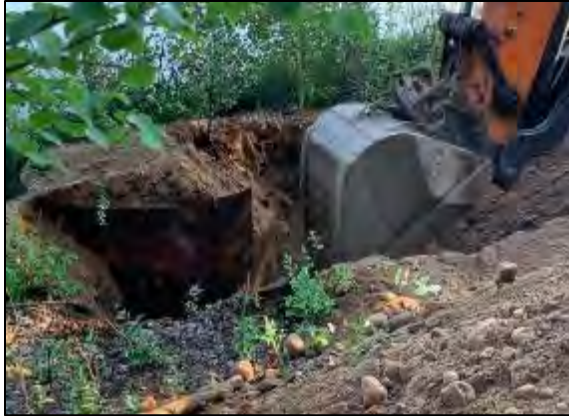
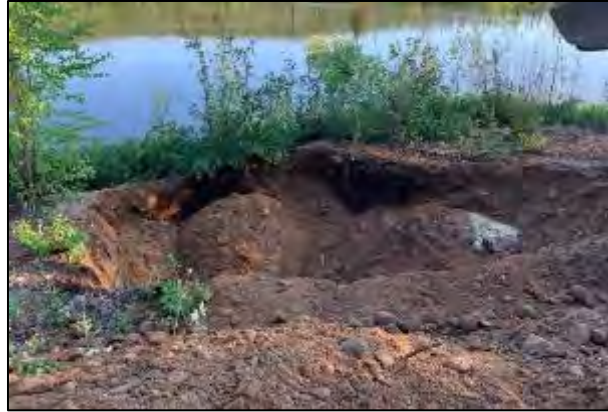
Photo 8 and 9. Further excavation behind the metal ring. It was possible to pull the ring back and avoid any excavation on the shoreline side

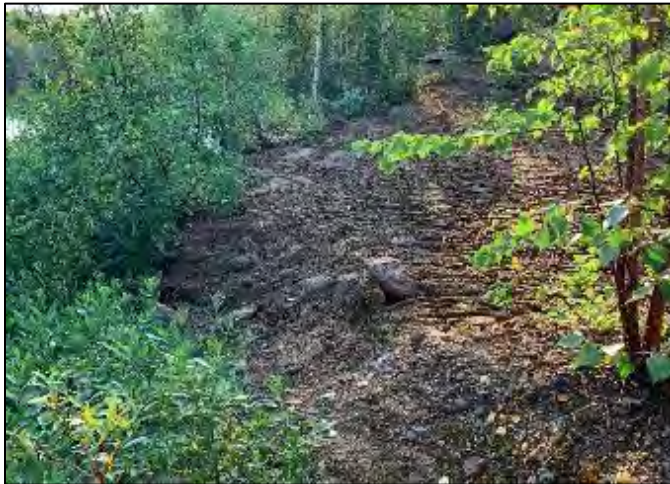
The removal of the metal ring in this manner allowed the vegetation at the top of the bank on the shoreline to remain intact, and resulted in no sediment entering the water. The hole was backfilled with local porous sand material, and packed to slope away from the lake and left to revegetate naturally (Photos 10 and 11). The slight backslope on the exposed area will reduce the likelihood that water will run directly toward the lake.

Photo 10. Looking along the shoreline from the west toward the east

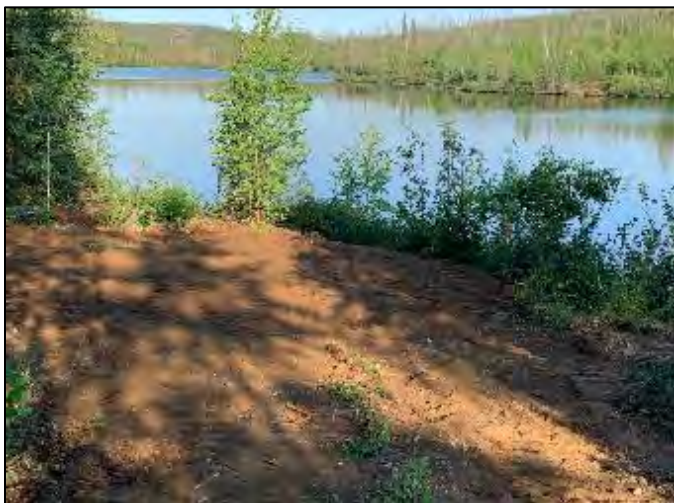
Photo 11. Looking over the excavation toward Donaldson Lake

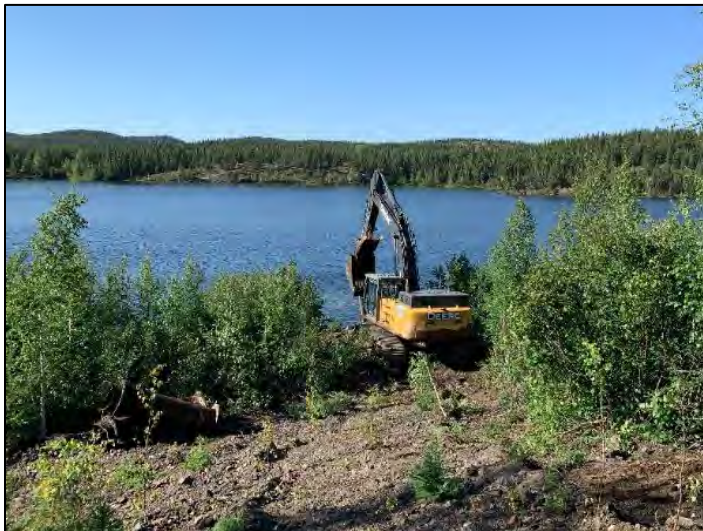
The concrete base and remaining intake pipeline associated with the pumphouse on Verna Lake were removed from the shoreline. Excavation started well back from shore, and the near shore portion of the base and in-water pipeline were removed last (Photo 12). The pumphouse foundation and associated materials (i.e., steel pipes) were removed and placed upslope behind the excavator. Once these structures had been excavated (and the area partially backfilled with the local gravel and rock removed during foundation excavation), the remaining water intake pipeline was removed.

Photo 12. Excavation of backshore portion of the pumphouse (underground water pipes on left of photo)

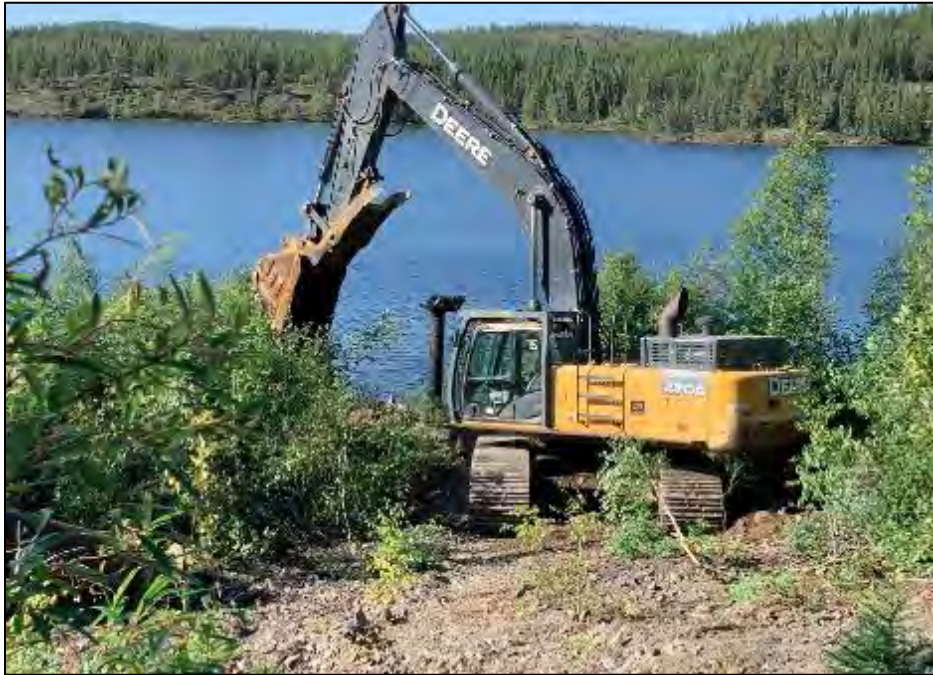
The machine operator was able to reach out with the bucket and contact the most outward edge of the intake line and get a tooth on it. This allowed for a slow and controlled pull on the intake line and caused very little sediment disturbance in the lake. As the line was pulled toward shore it crimped right at the shoreline creating a 90° vertical bend in the pipe, allowing the pipe to stand unassisted as the operator repositioned the machine and bucket / thumb (Photo 13). (The pipe was still embedded in the shoreline where the pumphouse was, which is what stabilized the pipeline while the machine was repositioned.) The operator was then able to grab the entire pipeline close to the waters' edge and peel the intake line through the shoreline material until it came out of the foundation area. The shoreline was built with introduced material (gravel/rock) and the pipeline was able to be pulled through this material with very little disturbance (Photos 14 and 15).

Photo 13. In-water portion of intake line has been pulled from the lake bed and is standing vertically in front of machine

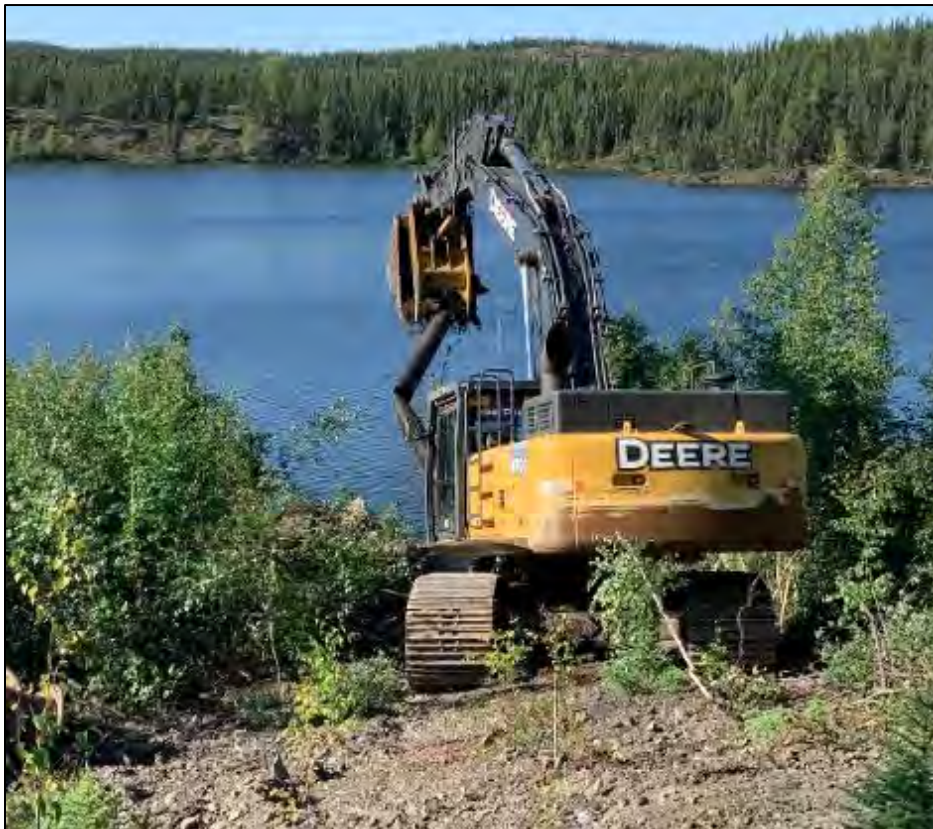
Photo 14. Remaining section of pipeline is being pulled through the shoreline

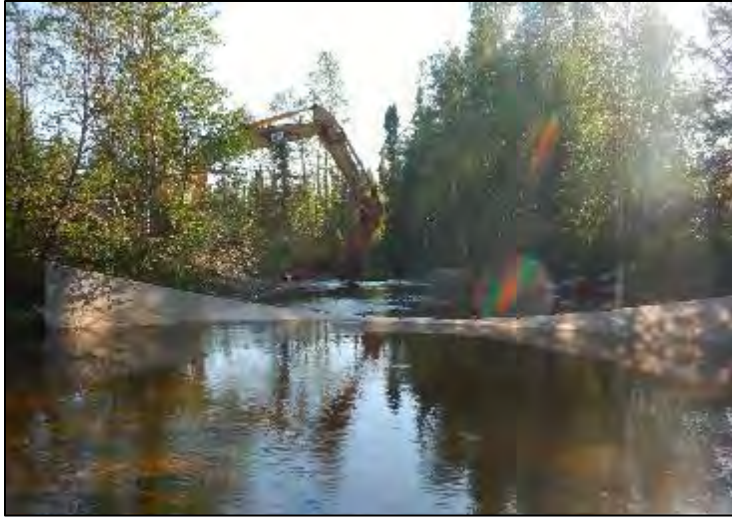
A fish blocking net was installed on the upstream side of the weir prior to the start of any work. The net was pulled from the weir in an upstream direction and tied to the shore (Photo 16). This was done to limit the likelihood of fish being present in the immediate work area. Downstream of the weir there was a significant drop in elevation at current flow volumes and fish were unlikely to be able to move upstream.

Photo 16. Net upstream of weir. Initial concrete removal to lower water levels.

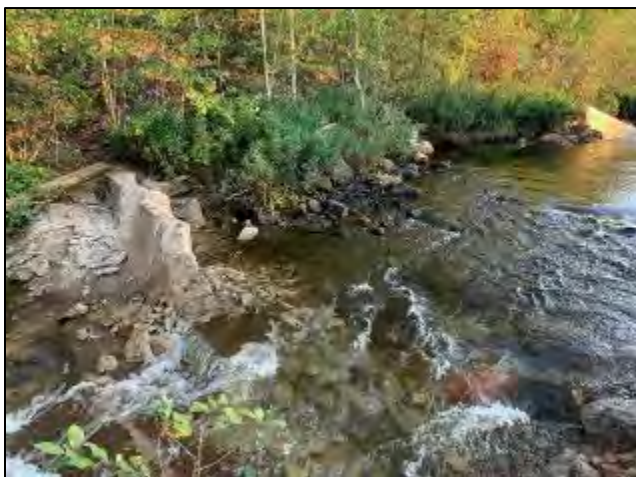
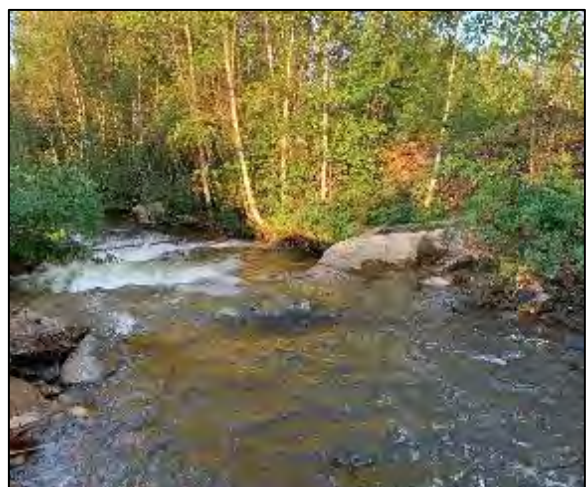
Photos 19 and 20. The main portion of the weir removed. Looking downstream and across Ace Creek

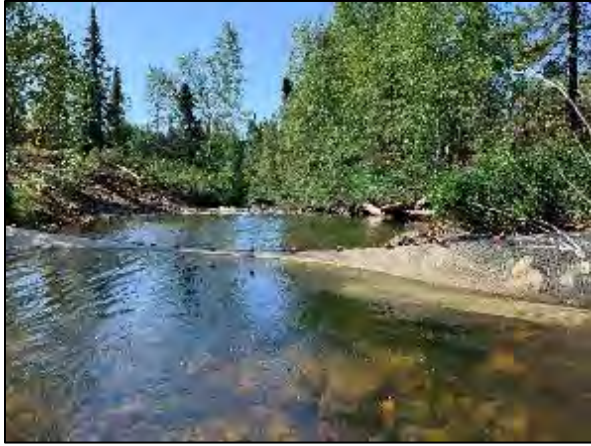
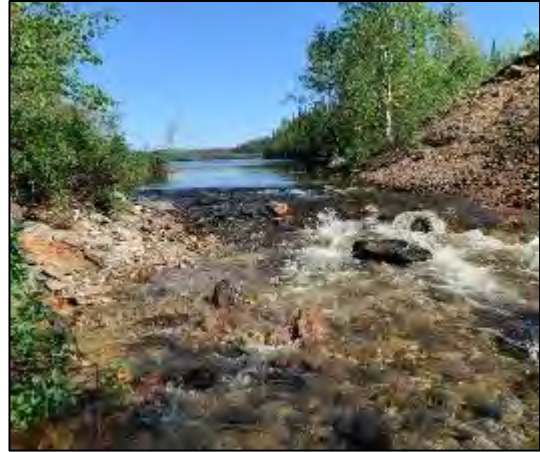
Photos 21 and 22. Just before the blocking net is removed (looking downstream), and just after the net is removed (view is upstream).

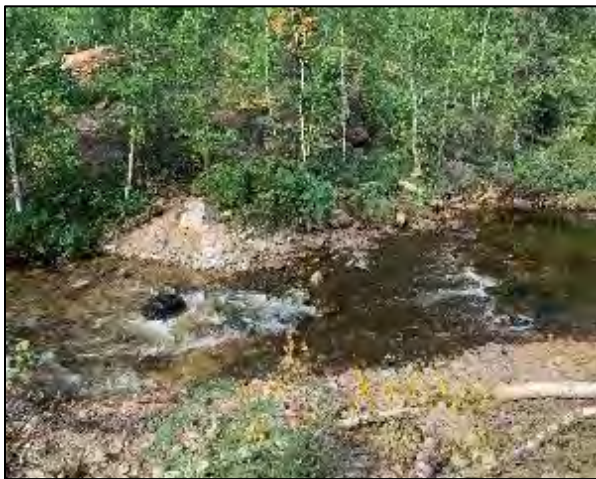
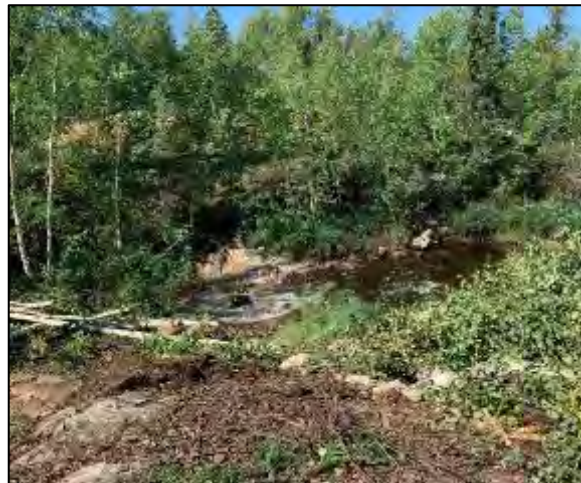
Photos 23 and 24. Looking across Ace Creek (north) after work is complete. Slash was placed on the area as the machine backed out of the work site.

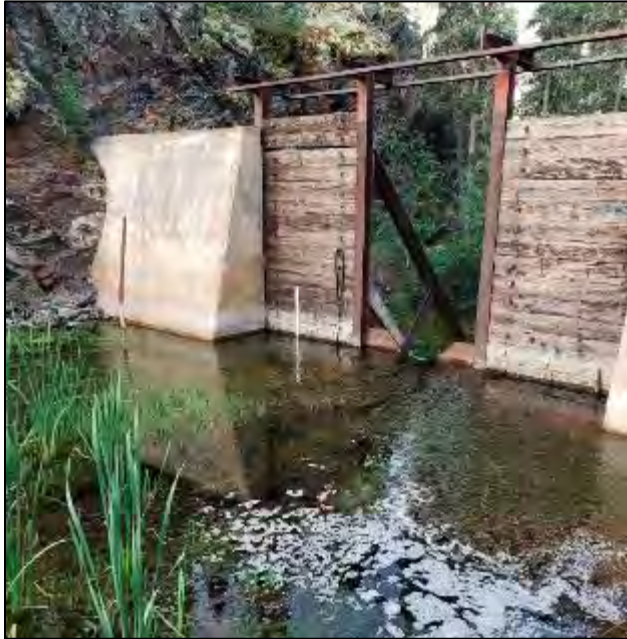
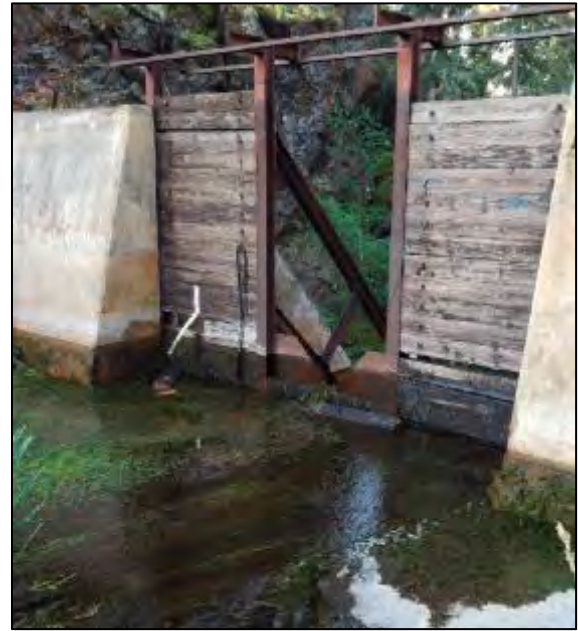
TL-7. Before and after stoplogs were moved to allow upstream to start dewatering

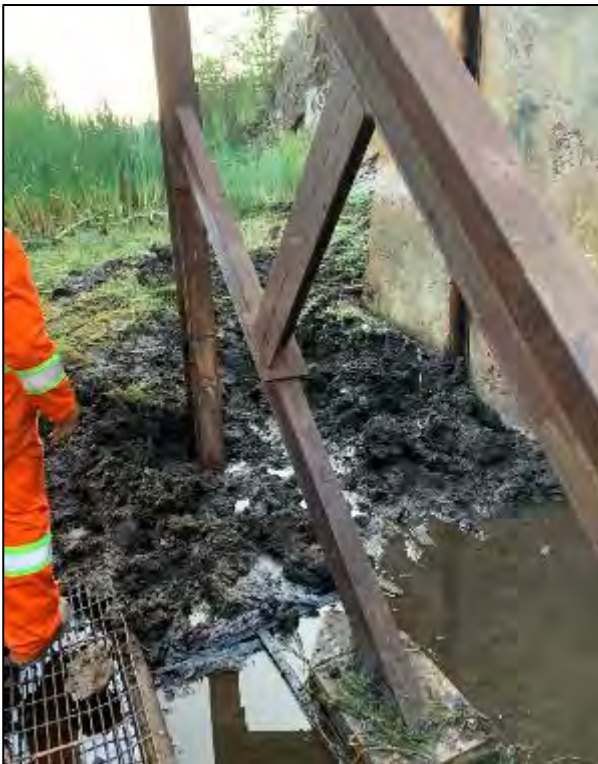
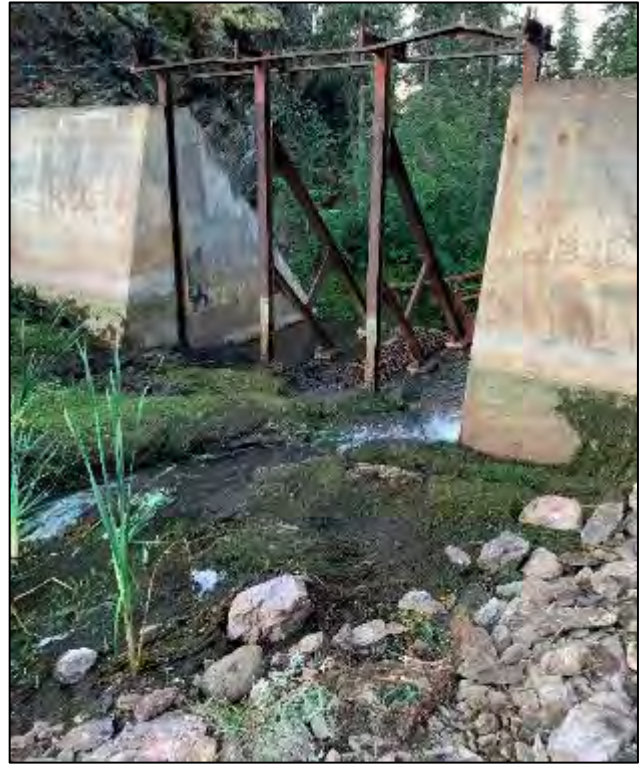
TL-7 before metal structure was cut and removed

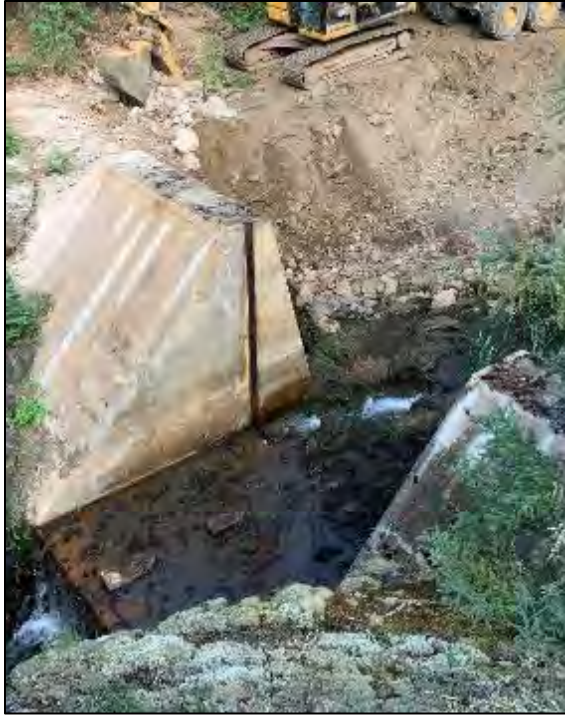
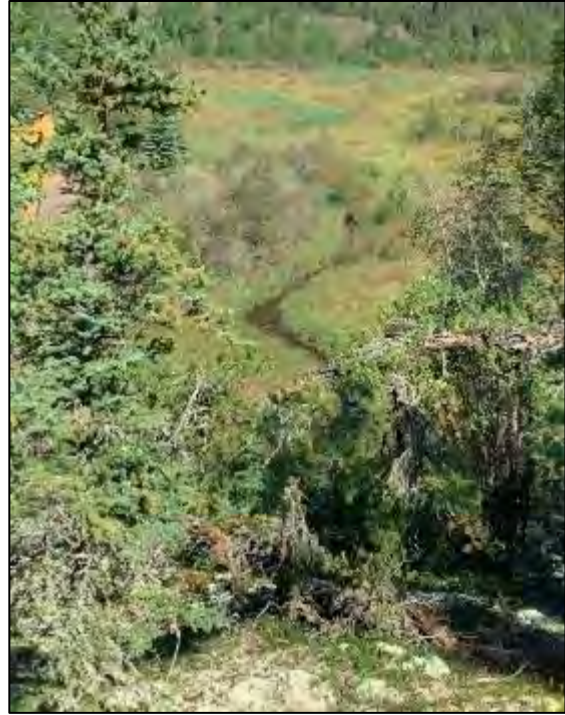
TL-7. View as start of concrete chipping starts, and existing channel from area upstream of structure

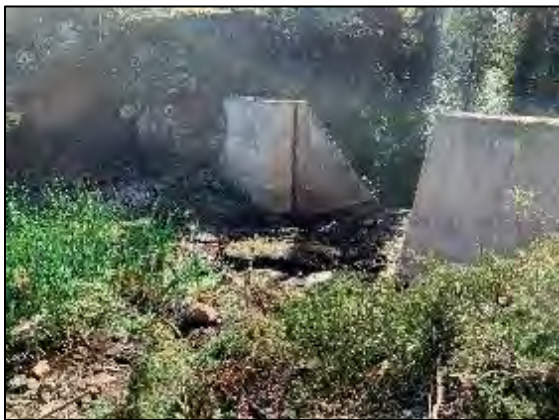
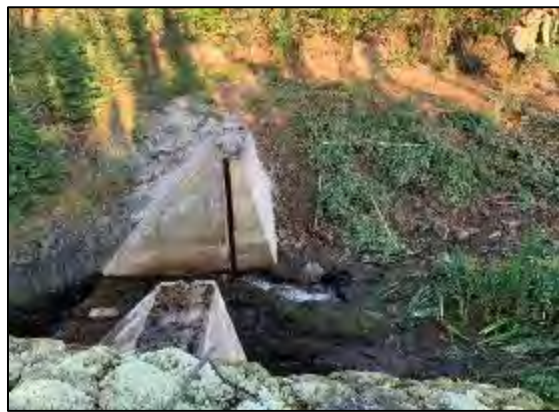
TL-7. View looking downstream before concrete chipping starts and after chipping work is complete.

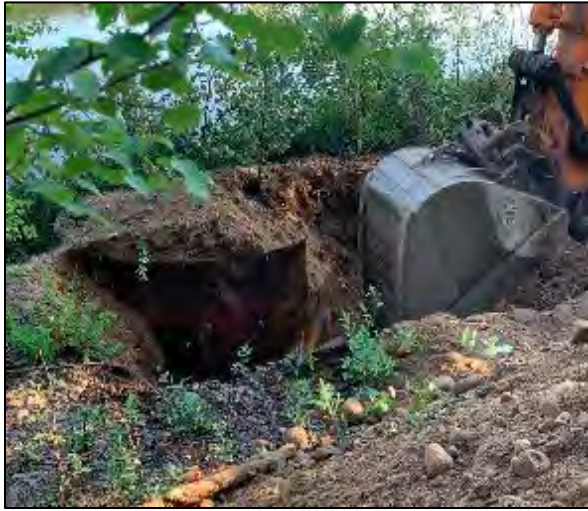
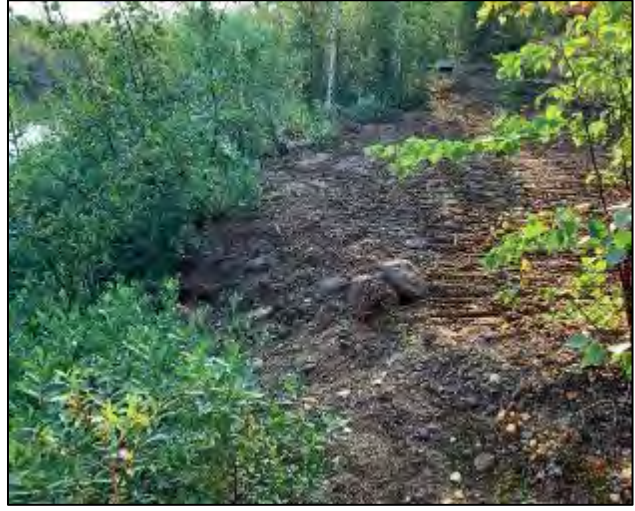
View as steel ring was excavated and as the areas was backfilled and leveled.

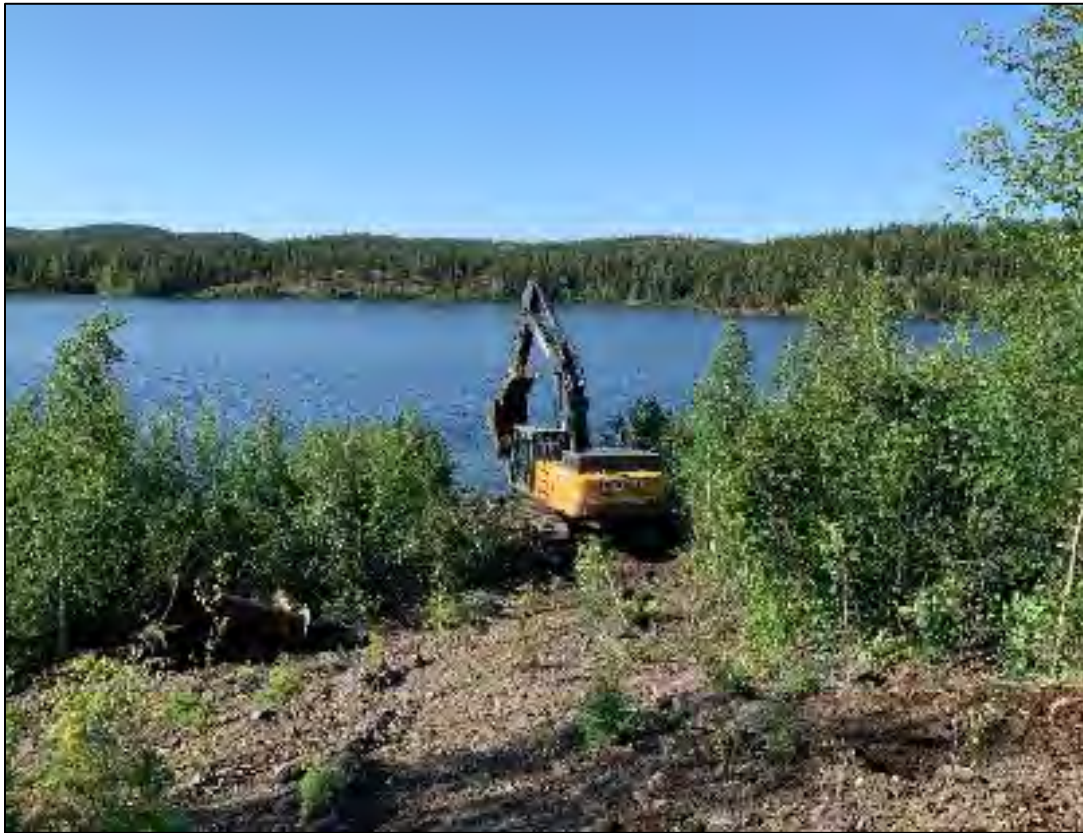
Near the start of the excavation of pumphouse materials on Verna Lake. Old pipe is on the left of the photo.

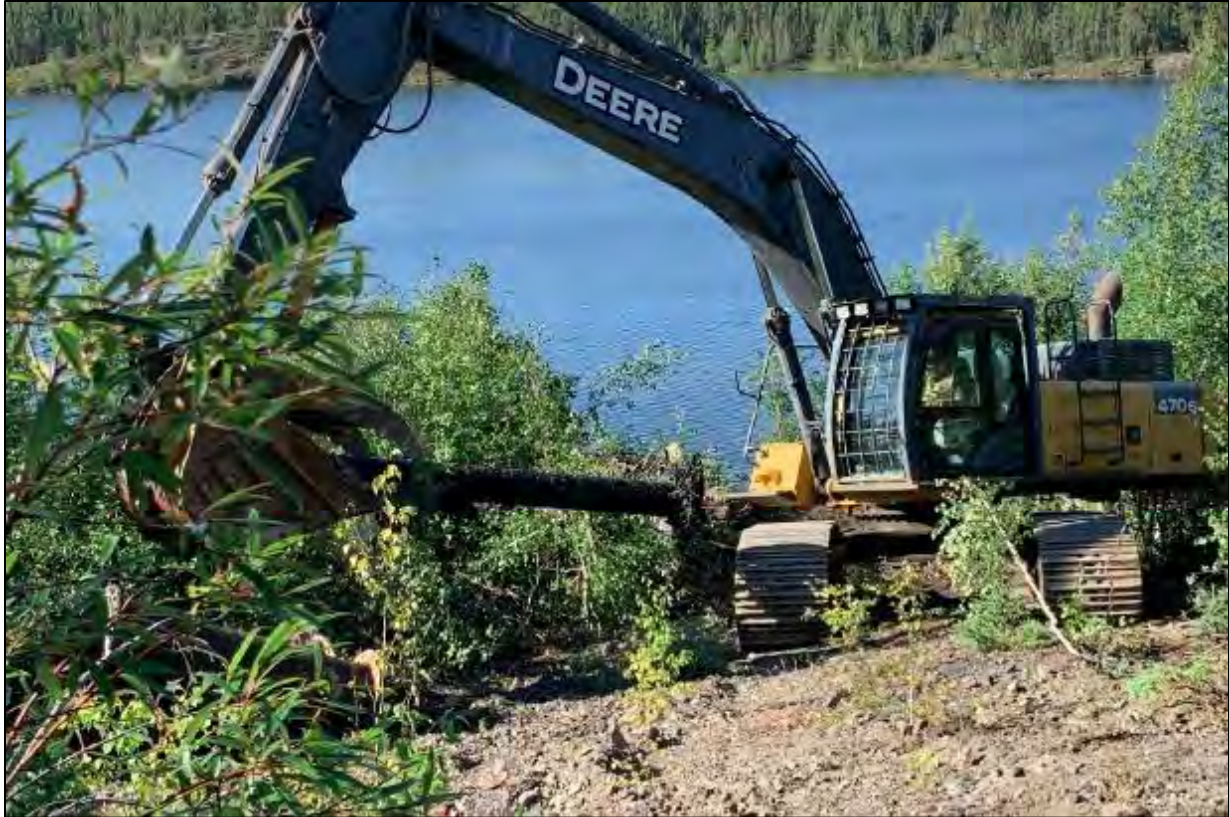
Intake from lake being moved behind excavation area.

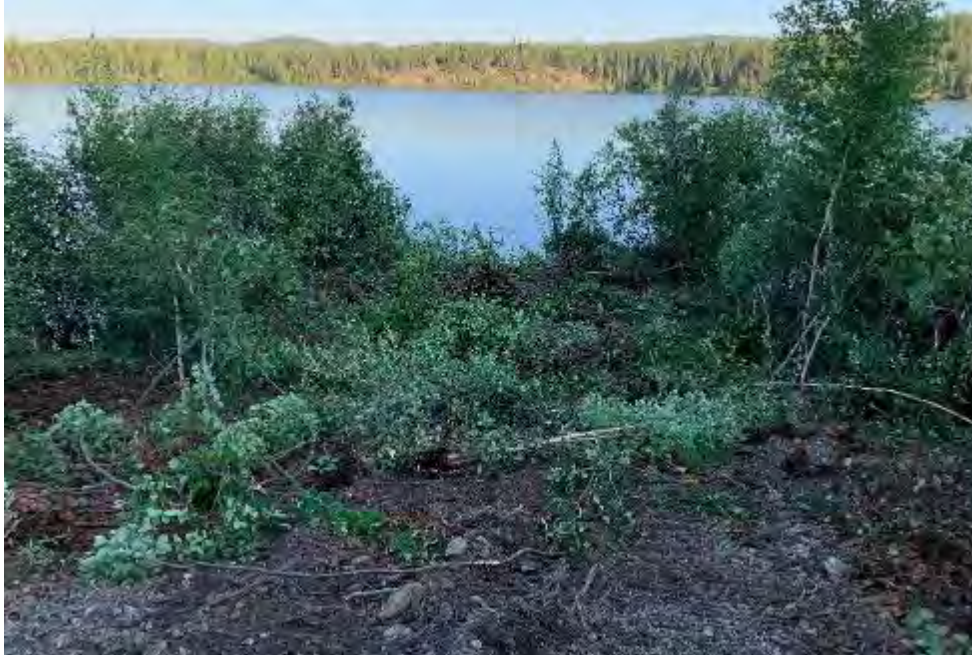
Shoreline where pumphouse was located. Slash has been placed over the backfill area

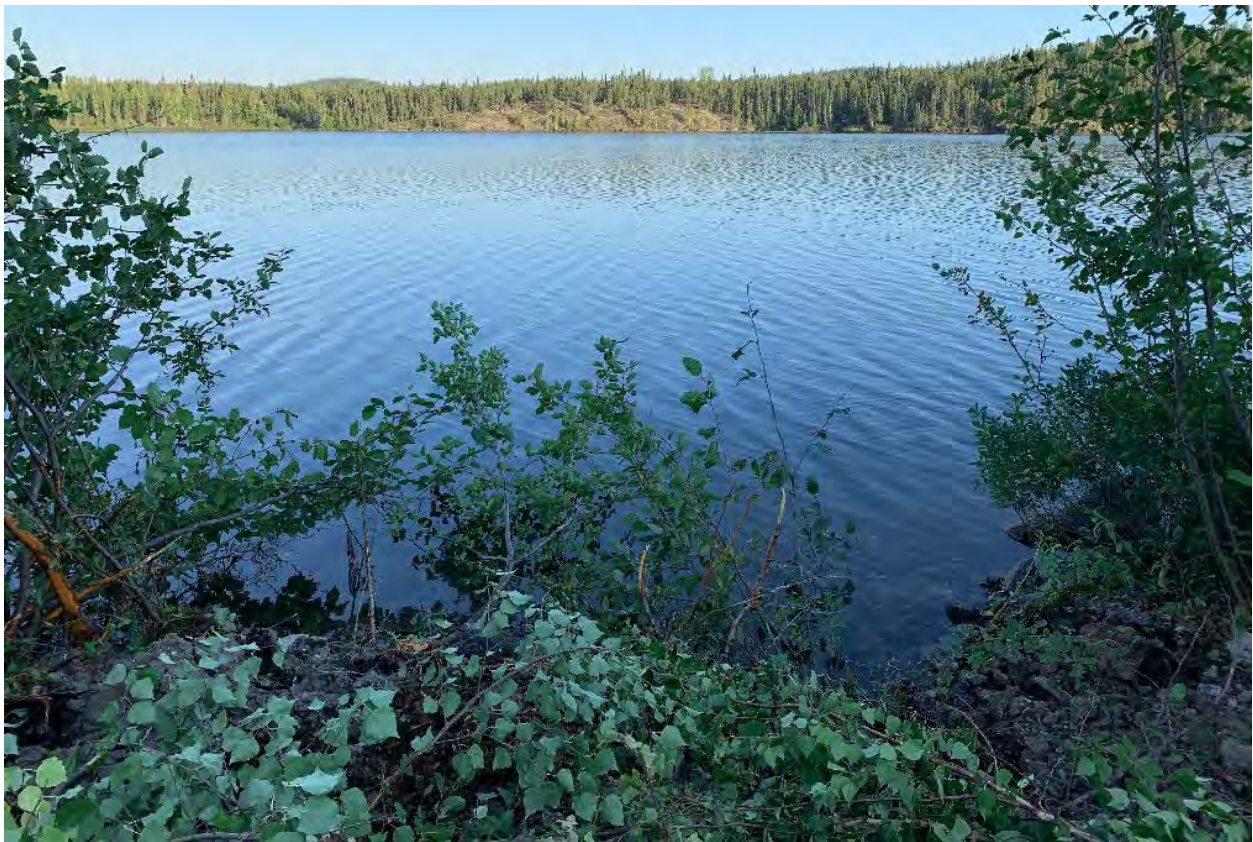
Closer view of shoreline where the pumphouse and intake line used to sit

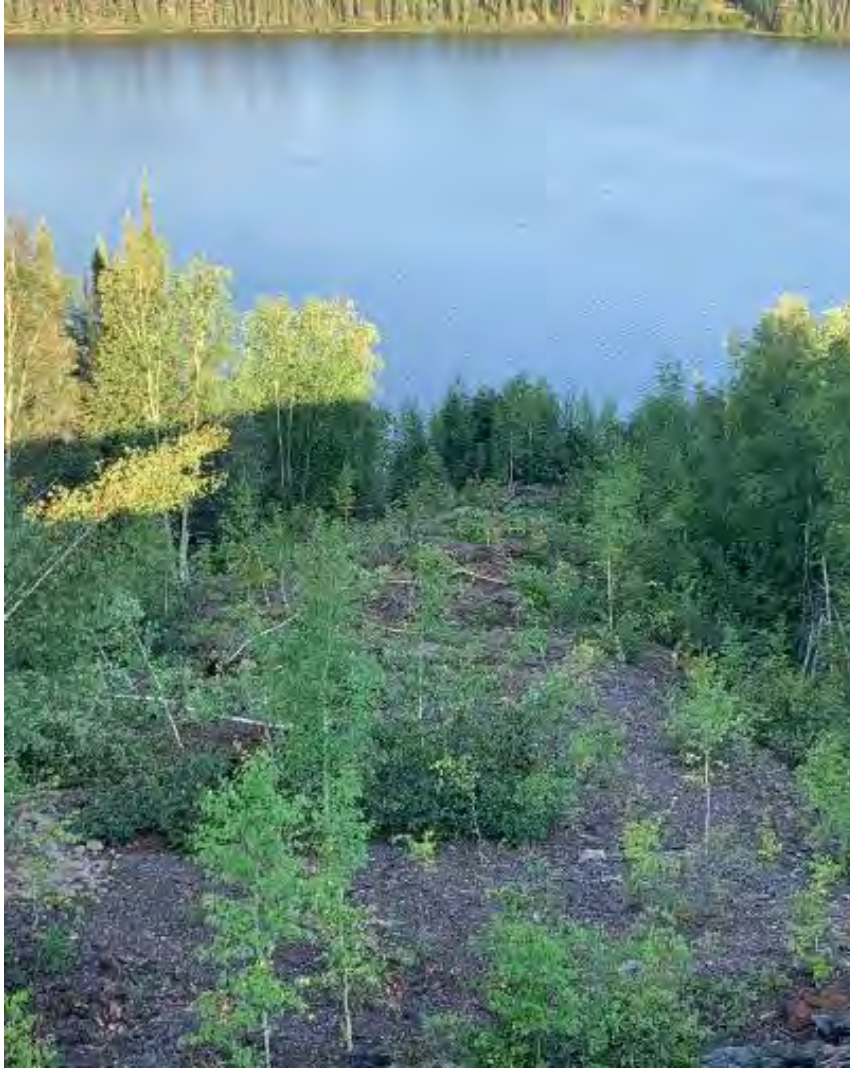
View looking down road used to access pumphouse location; slash has been pulled over driving surface

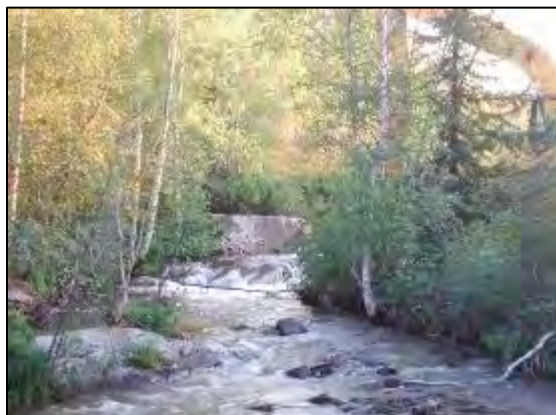
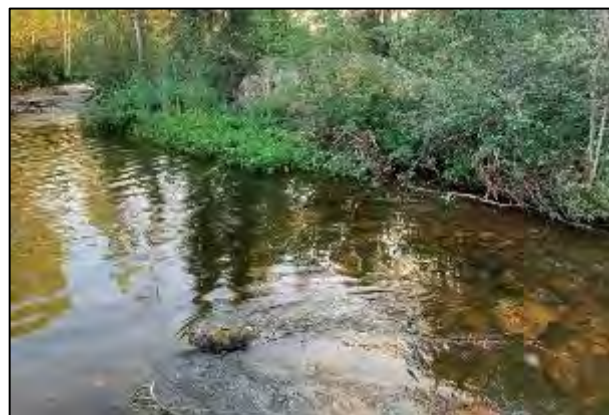
View from the 1 and 2nd downstream sample locations during a sampling effort
