BEAVERLODGE PROJECT

Beaverlodge Project 2021 Annual Report Year 36 Transition Phase Monitoring

Prepared for:
Canadian Nuclear Safety Commission
Compliance Report for Licence: WFOL-W5-2120.1/2023
& Saskatchewan Ministry of Environment
Compliance Report: Beaverlodge Surface Lease

Prepared and Submitted by:
Cameco Corporation

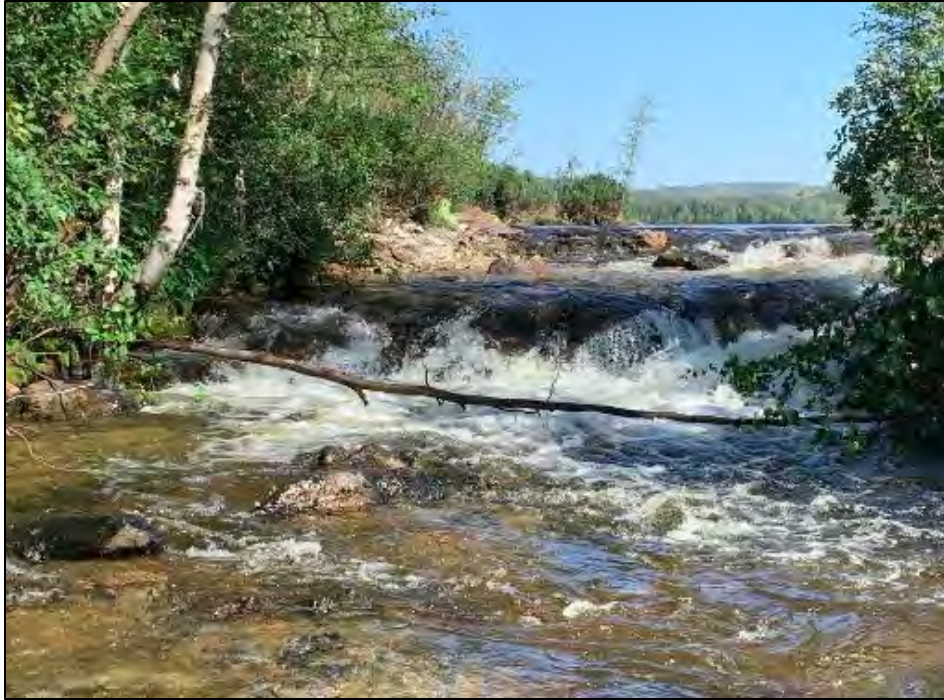
View looking upstream at completed work on Ace Creek. Rock in center channel is where the old weir was located. The small drop at the bottom of the photo is the existing bedrock drop that was below the weir.

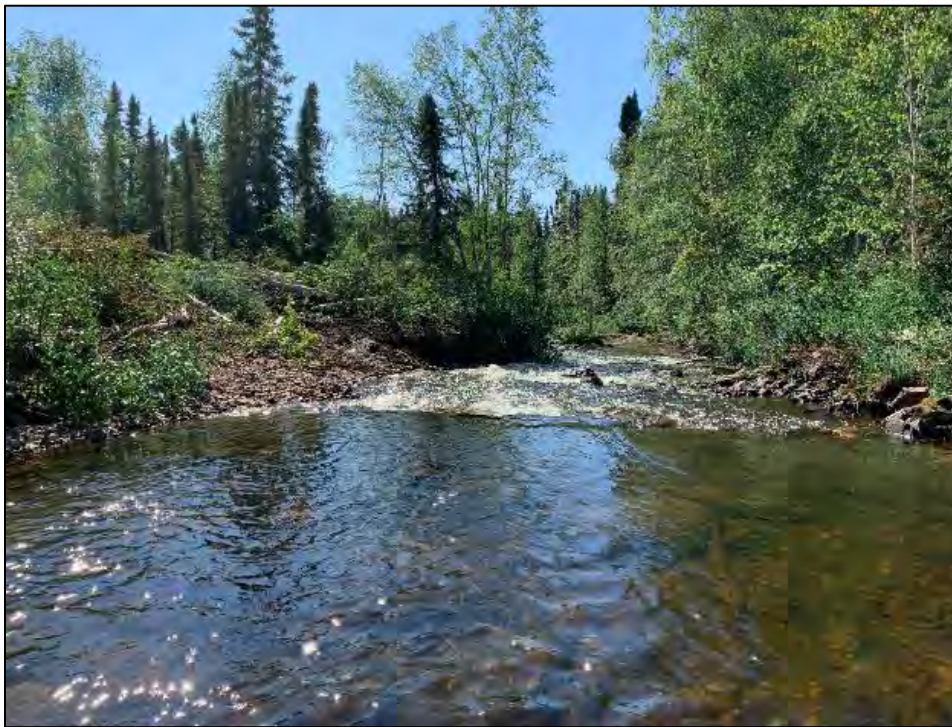
View looking downstream towards location of the former weir on Ace Creek. All work was completed from the south side of the creek (left side of photo). Slash has been placed on the slope where the machine worked.

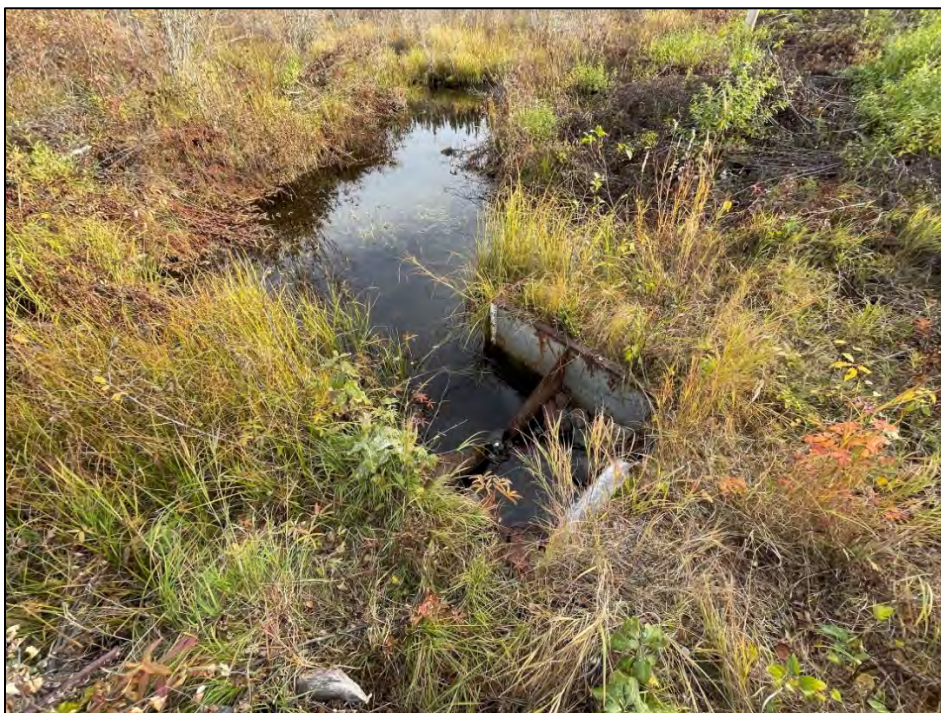
Photo 1: AC-6A – September 30, 2021

The datalogger for AC-6A could not be found in the fall field program of 2020 but was located in 2021. Data for 2020 and 2021 are presented in this report. The site was visited on September 30, 2021 (Photo 1). The rating curve data are presented in Table 2 and graphically in Figure 2. Hydrograph data are presented for 2020 in Figure 3 and Table 3 and for 2021 in Figure 4 and Table 4. Hydrograph data are estimated from the rating curve which is extrapolated beyond the highest measured point. The datalogger for AC-6A indicates that in 2021 the weir box was briefly overwhelmed twice with a maximum staff gauge equivalent of approximately 0.75 m. The height of the wingwall terminates at approximately 0.70 m staff gauge equivalent and the highest observed staff gauge reading in the rating curve is 0.486 m. As noted in the 2021 data (Figure 4 and Table 4), flow data from late May until early July are extrapolated well beyond the extents of the rating curve (maximum measured discharge of 0.0393 m³/s).

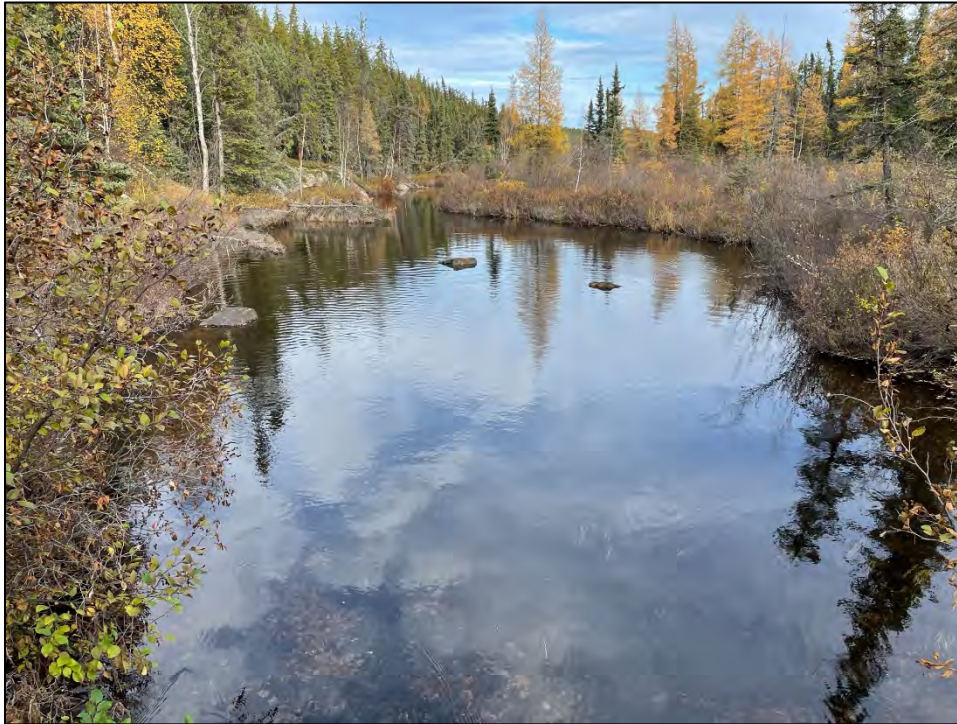
Photo 2: AC-6B – September 30, 2021

September 30, 2021 (Photo 2). Table 5 and Figure 5 present the measured flow and survey data numerically and graphically (rating curve). The rating curve for AC-6B should be interpreted with caution due to extrapolation beyond the measured range of the curve. The 2021 hydrograph is presented in Figure 6 and daily average data are provided in Table 6.

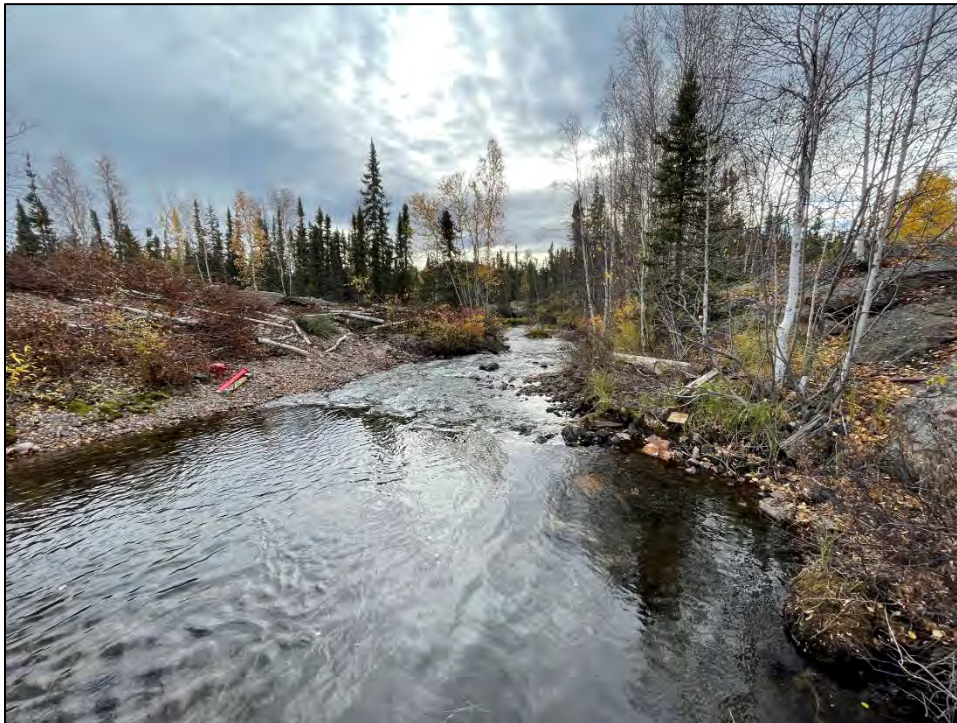
Photo 3: AC-8 – September 30, 2021

The outflow from Ace Lake has been monitored for over four decades at a concrete box weir located at the outlet of the lake (Station AC-8). In August 2021 the box weir was removed to return the lake outlet to a more natural configuration. The station was visited by NewFields during the fall program (Photo 3). Field monitoring data are provided in Table 7 and the rating curve is shown in Figure 7. The hydrograph for 2021 is presented in Figure 8. Daily average data and long-term monthly data are provided in Table 8 and Table 9, respectively.

The hydrograph is estimated from the rating curve which is extrapolated beyond the highest measured data point. According to the water level data recorder, the maximum water level was approximately 100.32 m referenced to the local benchmark (0.25 m above the highest surveyed water level). Though outflow from AC-8 tends to reflect inflow from AC-6B, NewFields believes that AC-8 daily average data more accurately reflect conditions observed in 2021. This is due to the historical data gathered at this station, with a rating curve that includes a broader range of historical discharges and a better understanding of bank geometry at this station. This is also based on previously completed hydraulic modelling at this location.

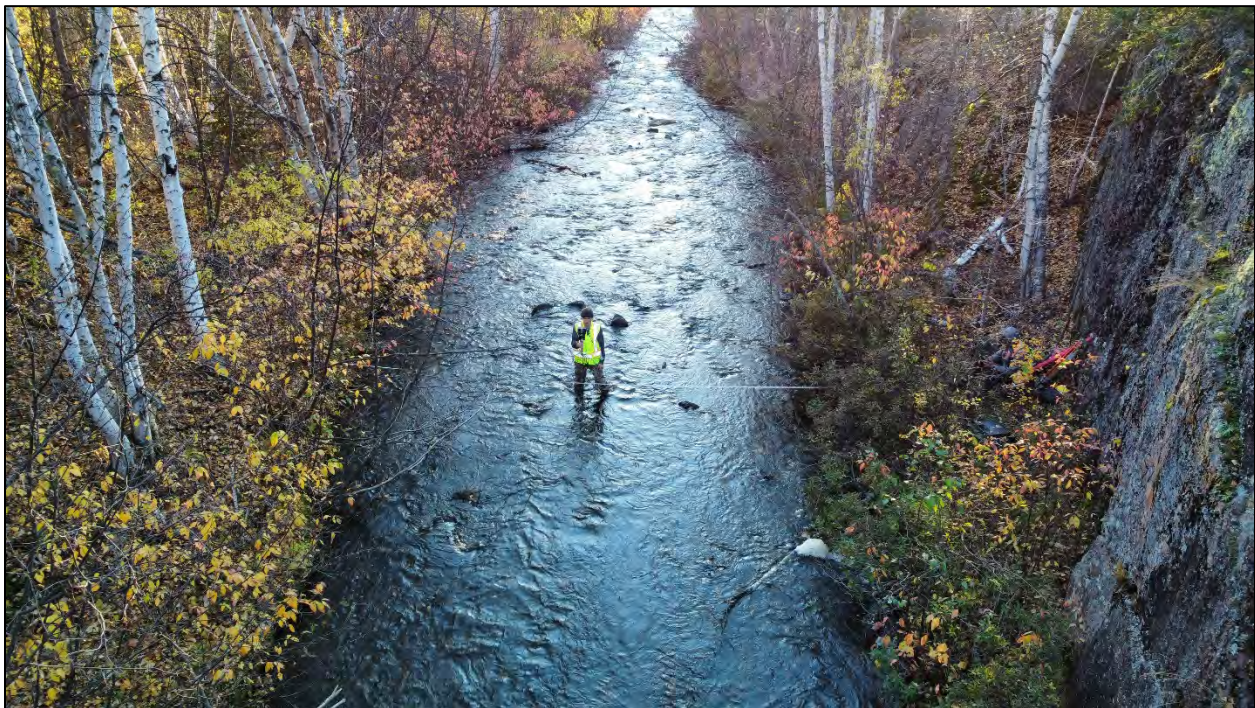
Photo 4: AC-14 – October 1, 2021

Ace Creek is monitored approximately 250 m upstream of Beaverlodge Lake at station AC-14. The site was visited on October 1, 2021 (Photo 4). Field measurement data are summarized in Table 10 and the rating curve is presented in Figure 9. The water level data recorder failed on July 5, 2021. The hydrograph is presented up to the point of data recorder failure in Figure 10 with daily average data provided in Table 11. The rating curve for AC-14 should be interpreted with caution due to extrapolation beyond the measured range of the rating curve

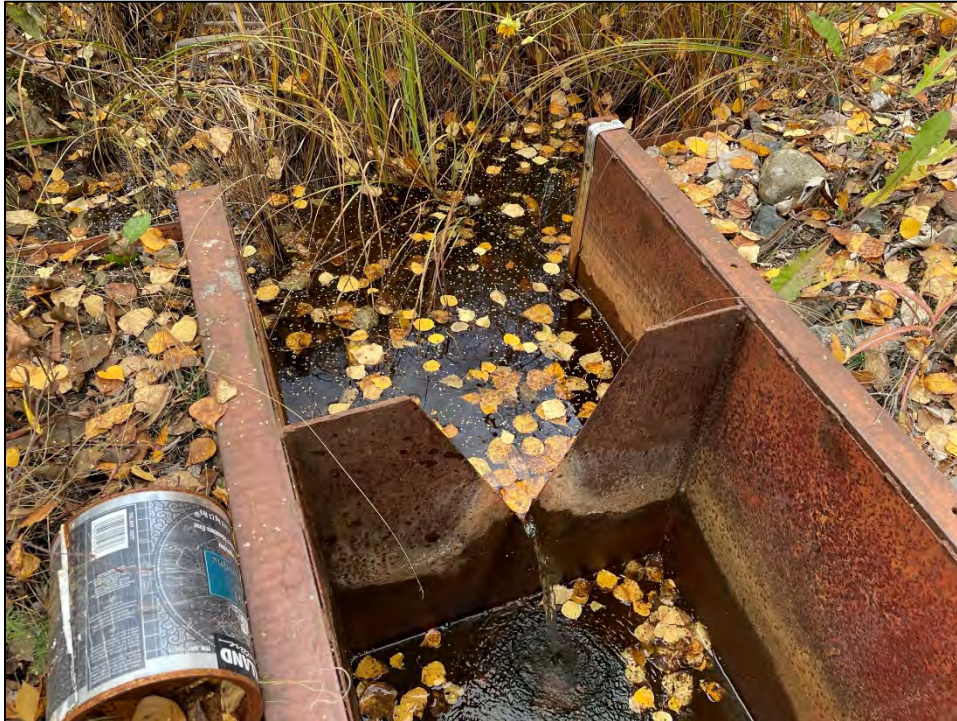
Photo 5: TL-6– September 30, 2021

was visited on September 30, 2021 (Photo 5) but no measurements were performed. Historic measurement data and the rating curve for TL-6 are presented in Table 12 and Figure 11, respectively. A water level data recorder was not installed at this station in 2021.

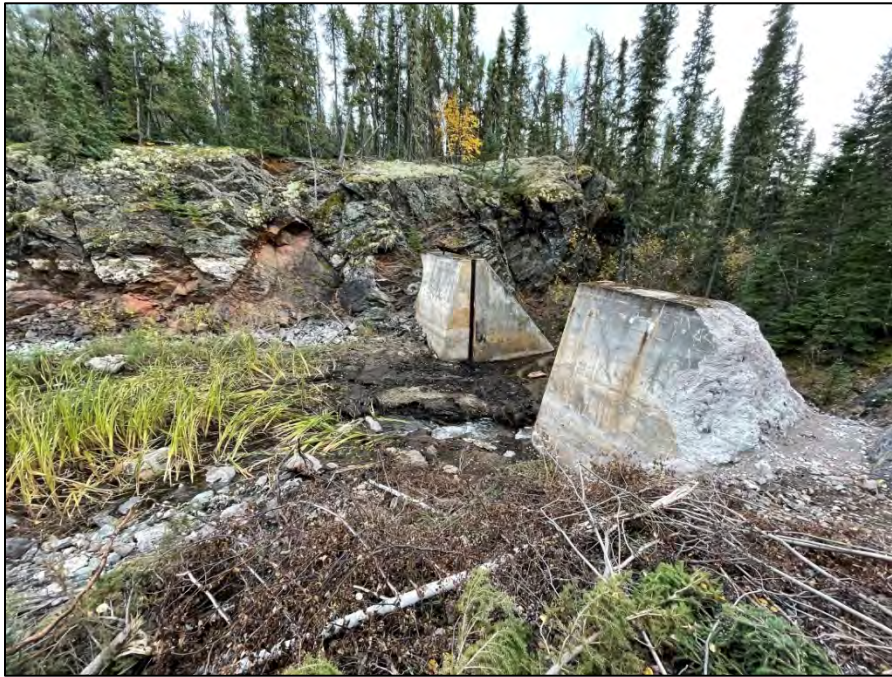
Photo 6: TL-7– September 30, 2021

The headwater of TL-7 includes Fulton Lake as part of the Fulton drainage, but also receives water from Fookes and Marie Reservoirs which were used as tailings disposal locations during the operation of the Beaverlodge Mill. TL-7 also receives flow from TL-6. TL-7 is a long-term monitoring station having operated since Site closure (similar record length to AC-8). TL-7 frequently glaciates through the winter months as water free falls over the V-notch thus impounding a large volume of ice behind the structure. A datalogger was left installed through the winter of 2020/21 and remained there until the v-notch was removed in August 2021. The station was visited on September 30, 2021 (Photo 6). Stage and discharge measurements are provided in Table 13 and the rating curve is shown in Figure 12. The hydrograph is presented up to August 26, 2021 when the weir was removed (Figure 13) with daily average discharge data provided in Table 14. Due to the brevity of 2021 data the long-term monthly averages for this station are not reported.

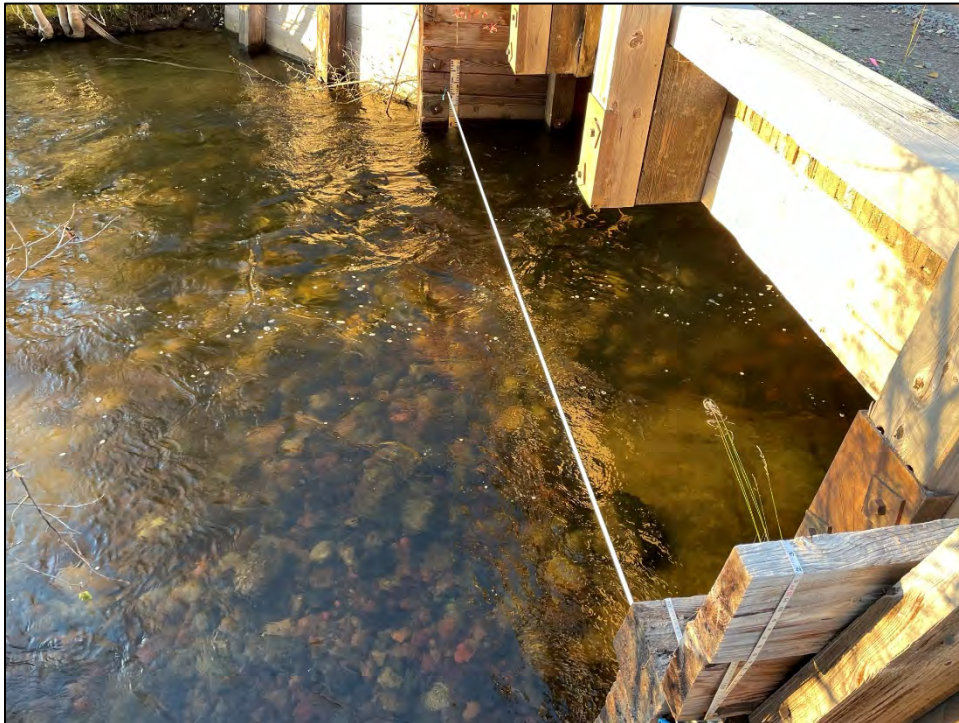
Photo 7: CS-1 – September 29, 2021

Station CS-1 on the Crackingstone River is located downstream of Cinch Lake, which receives discharge from Beaverlodge Lake through Martin Lake. The Crackingstone River ultimately discharges to Crackingstone Bay of Lake Athabasca and flow monitoring of the river occurs at a bridge crossing. The station was visited on September 29, 2021 (Photo 7). Measurement data for CS-1 are provided in Table 15 and the rating curve is shown in Figure 14. The data logger at CS-1 failed in November 2020 and no hydrograph is available for 2021.

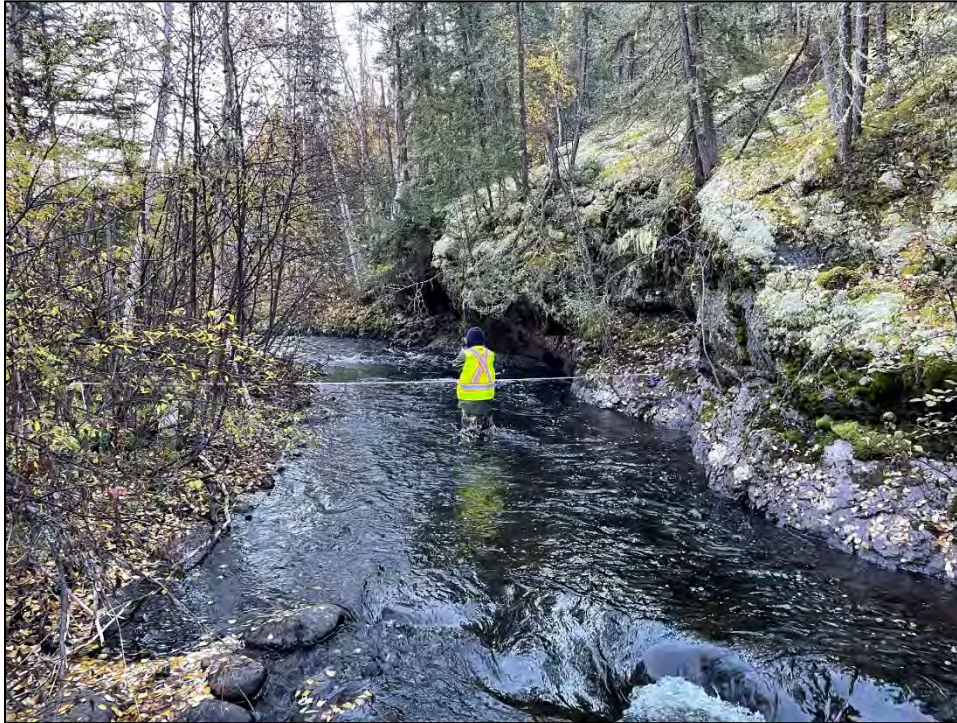
Photo 8: Fredette – September 30, 2021

In 2019, a monitoring station was added on the Fredette River below Uranium City's water supply reservoir. The station was visited on September 30, 2021 (Photo 8). Stage and discharge measurement data are provided in Table 16 and the rating curve is shown in Figure 15. The hydrograph for 2021 is provided in Figure 16 with daily average discharge data in Table 17. The water level at the Fredette River peaked at approximately 100.26 m (0.57 m above the highest recorded discharge measurement). Hydraulic geometries are insufficient to extend the rating curve for a high flow estimate. As such, extrapolated discharges should be interpreted with caution.
