# BEAVERLODGE PROJECT

## **Beaverlodge Project 2022 Annual Report Year 37 Transition Phase Monitoring**

**Prepared and Submitted by:**  
Cameco Corporation

**April 2023**

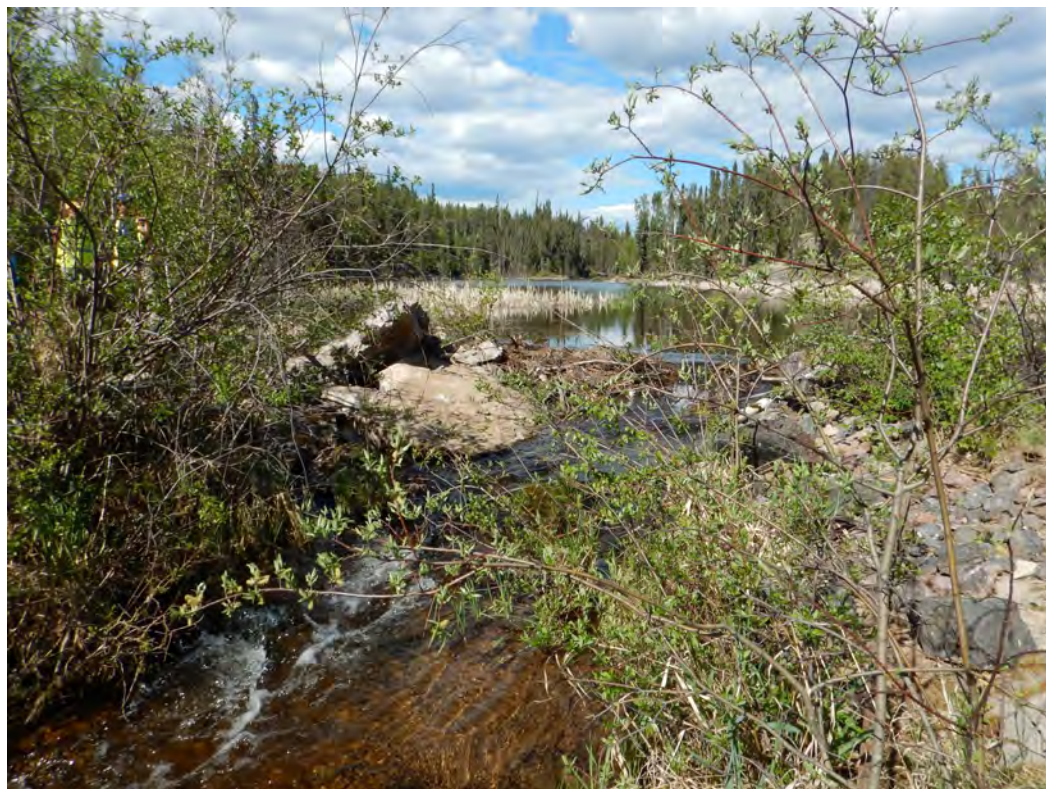
**Photo A1 – Marie Reservoir Spillway looking upstream (June 2022)**

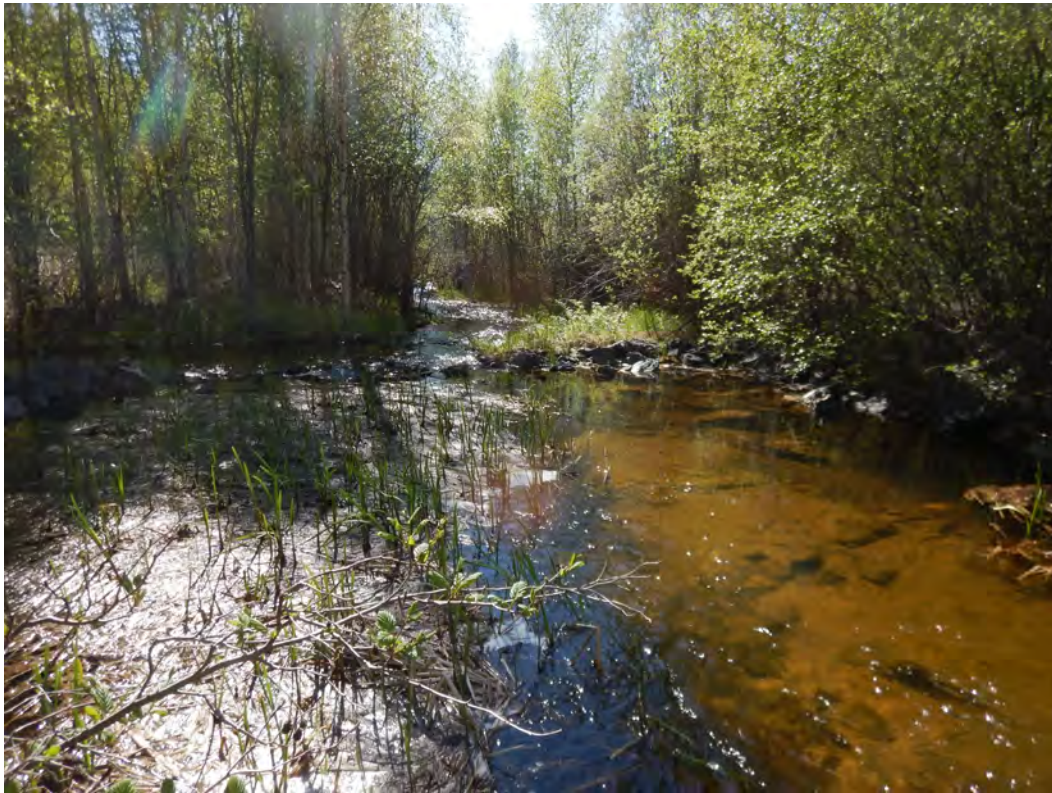
**Photo A3 – Marie Reservoir Spillway (water flowing into stilling basin) (May 2022)**

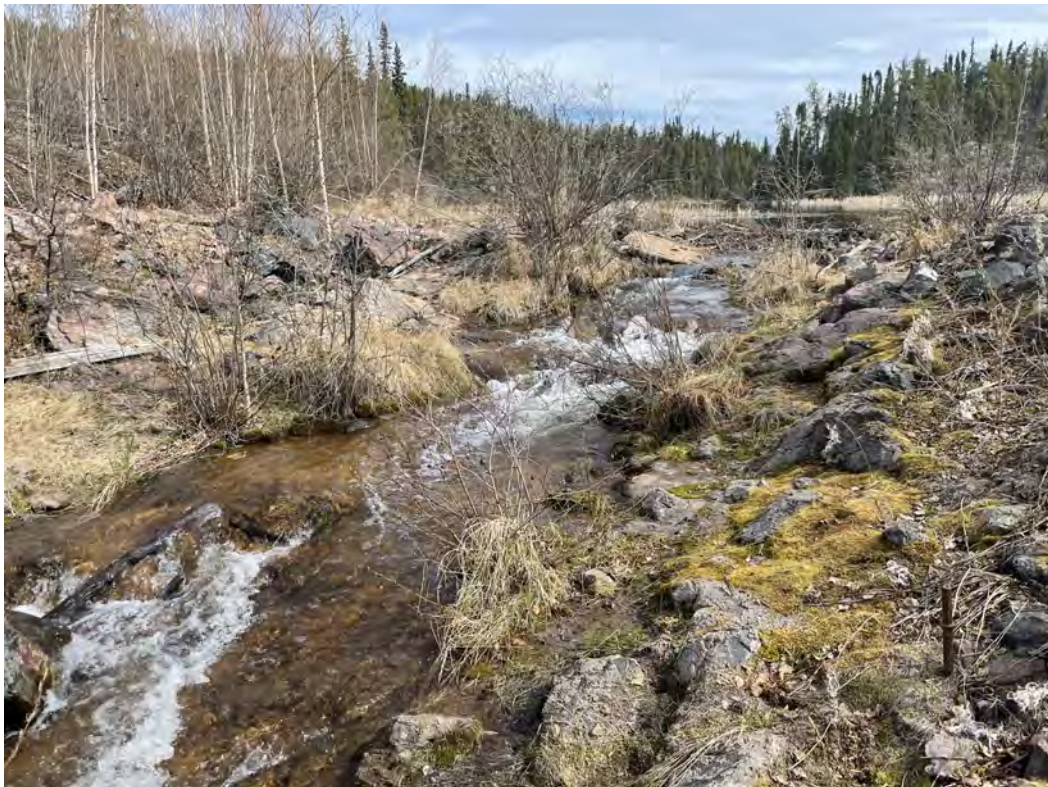
**Photo A4 – Marie Reservoir Spillway looking west (May 2022)**

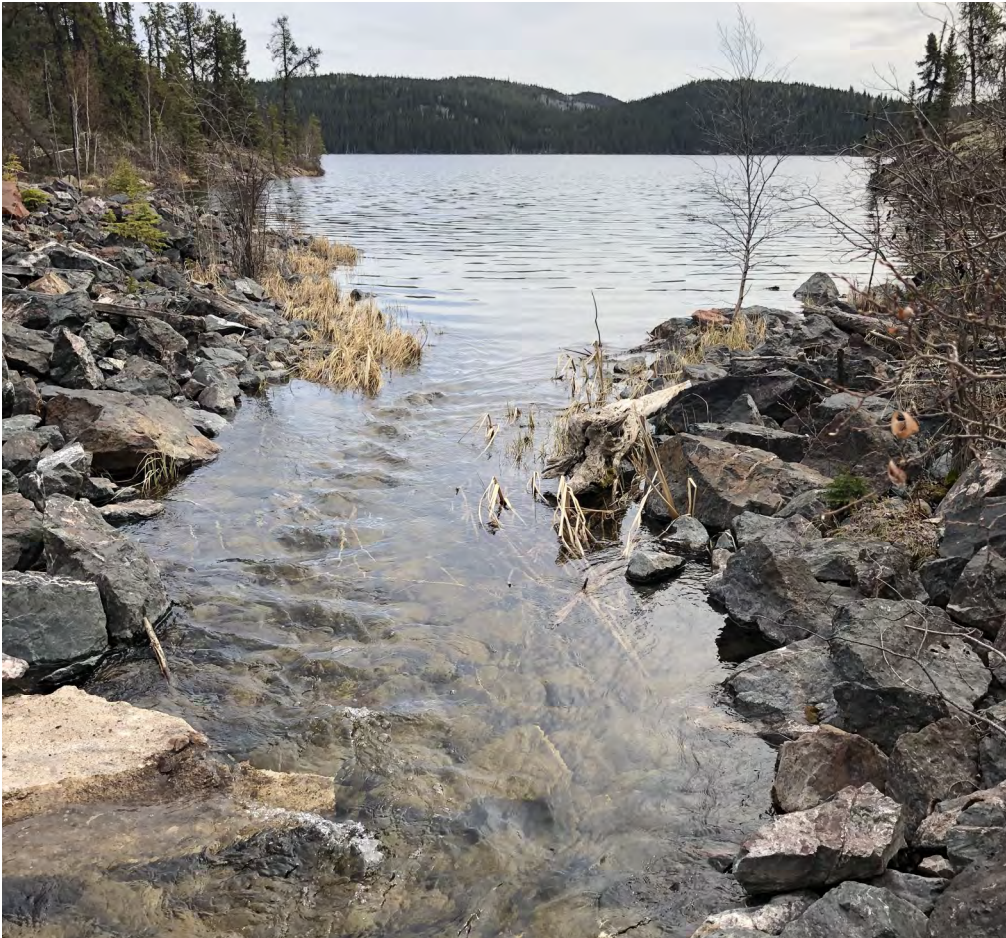
**Photo B1 – Fookes Reservoir Spillway looking into Fookes Reservoir**

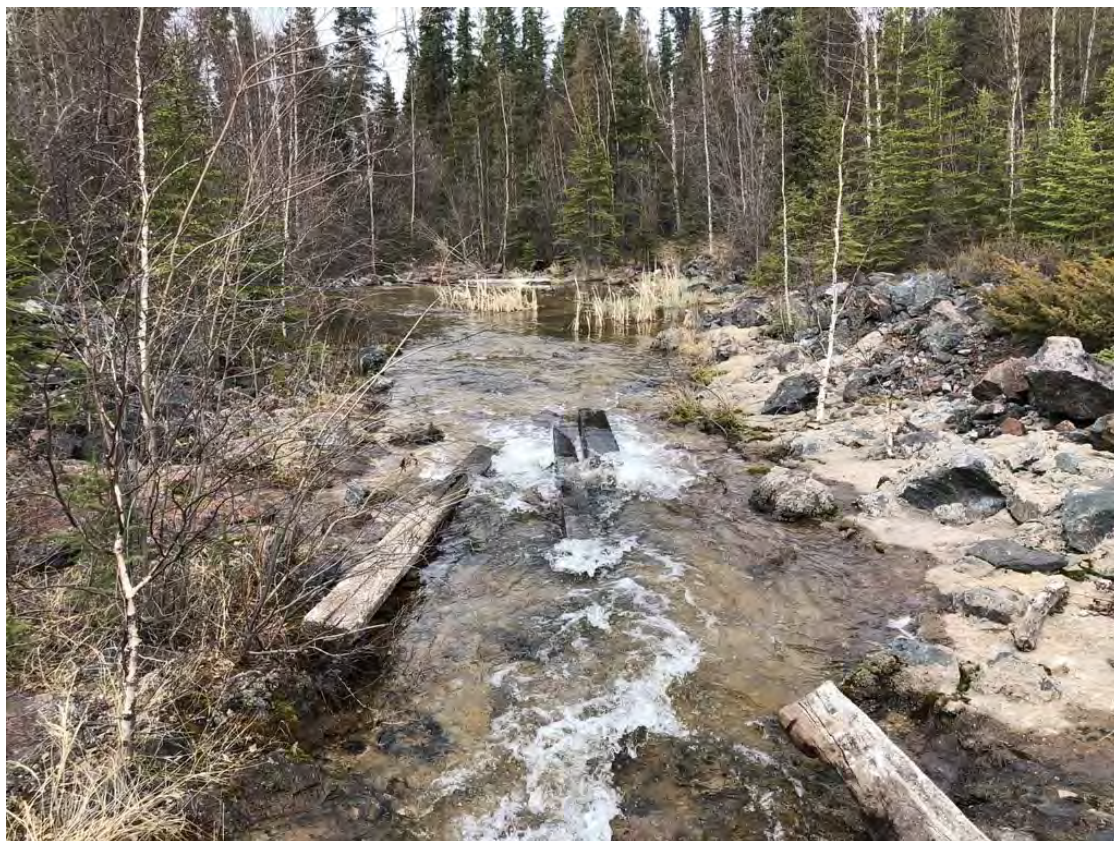
**Photo B4 – Fookes Reservoir Spillway stilling basin**

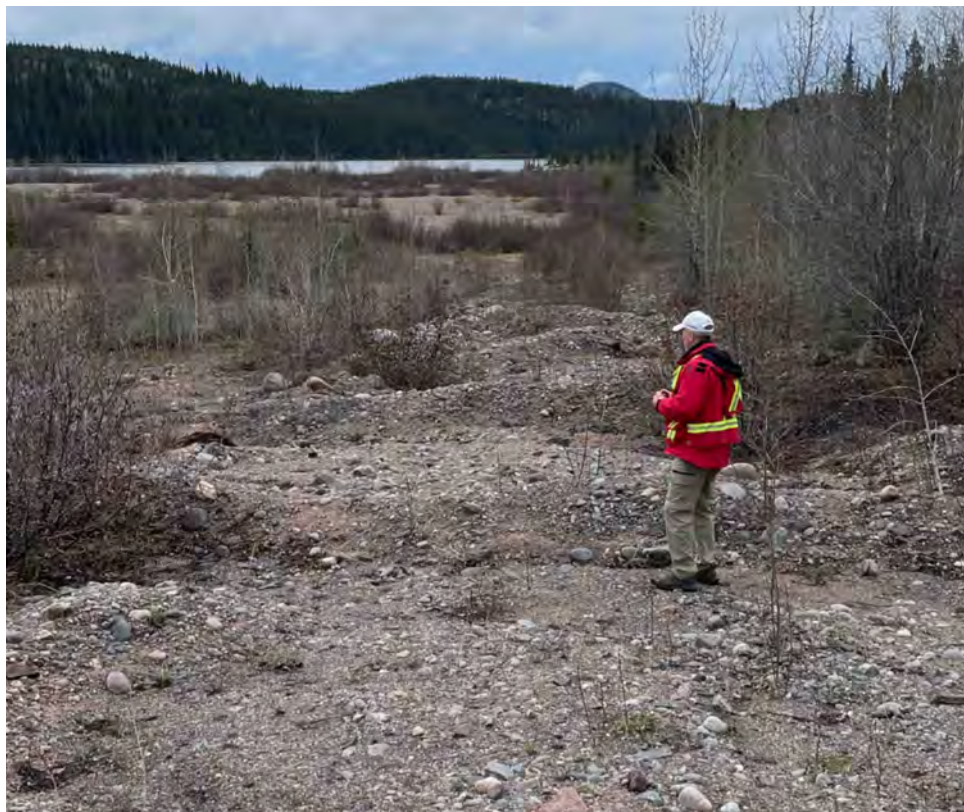
As part of the design and installation of the covers in 2005 and 2007, the area considered most vulnerable to erosion was in the area on and below the access ramp at the northwest corner of the delta (SRK, 2010). The general condition of the ramp is very good. Access to this ramp is closed off by a windrow of material at the top of the ramp, except for the small access trail to allow the remediation of the piezometer standpipes. The water bars (chevrons) are performing as expected and continue to show little sign of erosion (**Appendix C, Photo C1**).

**Photo C1 – Chevrons in place on north access point to the Fookes delta looking south (May 29, 2022)**

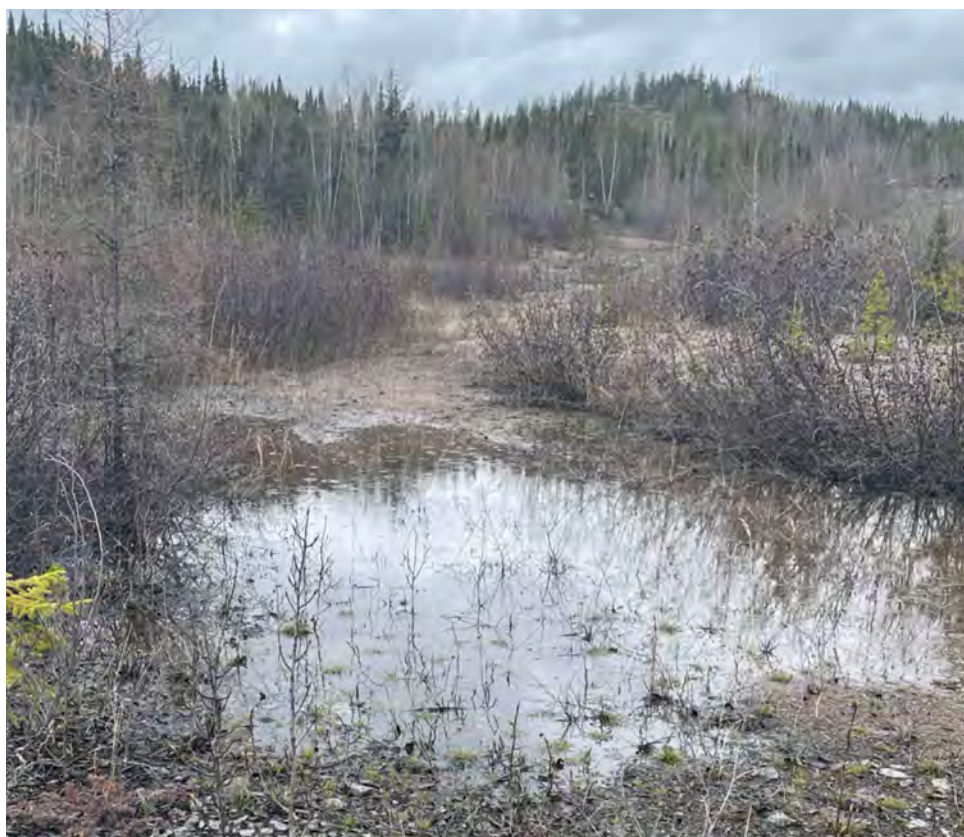
During the 2022 inspection of Fookes Delta, it was noted that the drainage area running along the north side of the delta and the drainage channel to Fookes Reservoir contained water and was performing as designed, with water present and minor amount of surface flow draining towards Fookes Reservoir (**Appendix C, Photo C6**). A small amount of ponded water was observed at the base of the north access ramp on the waste rock cover (**Appendix C, Photo C2**) due to recent snowmelt.

During the 2022 inspection it was noted that ponded water from recent snowmelt had accumulated on the exposed waste rock cover located at the base of the former access ramp. This ponded water did not result in any erosion and no tailings boils were noted.

**Photo C2 – ponded water on waste rock cover at bottom of hill near north access road during freshet (May 29, 2022)**

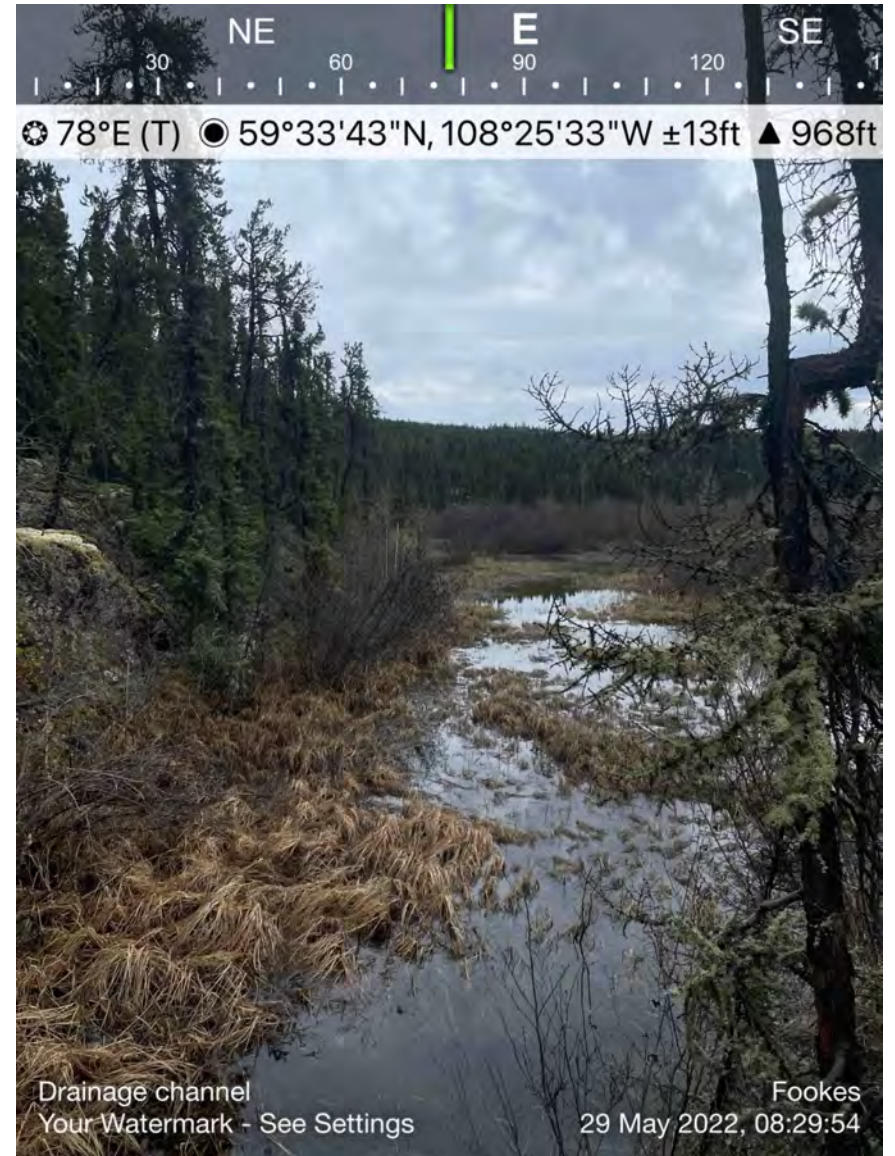
**Photo C4 – Drainage collection area on edge of Fookes Tailings Delta approximately 100m from access point**

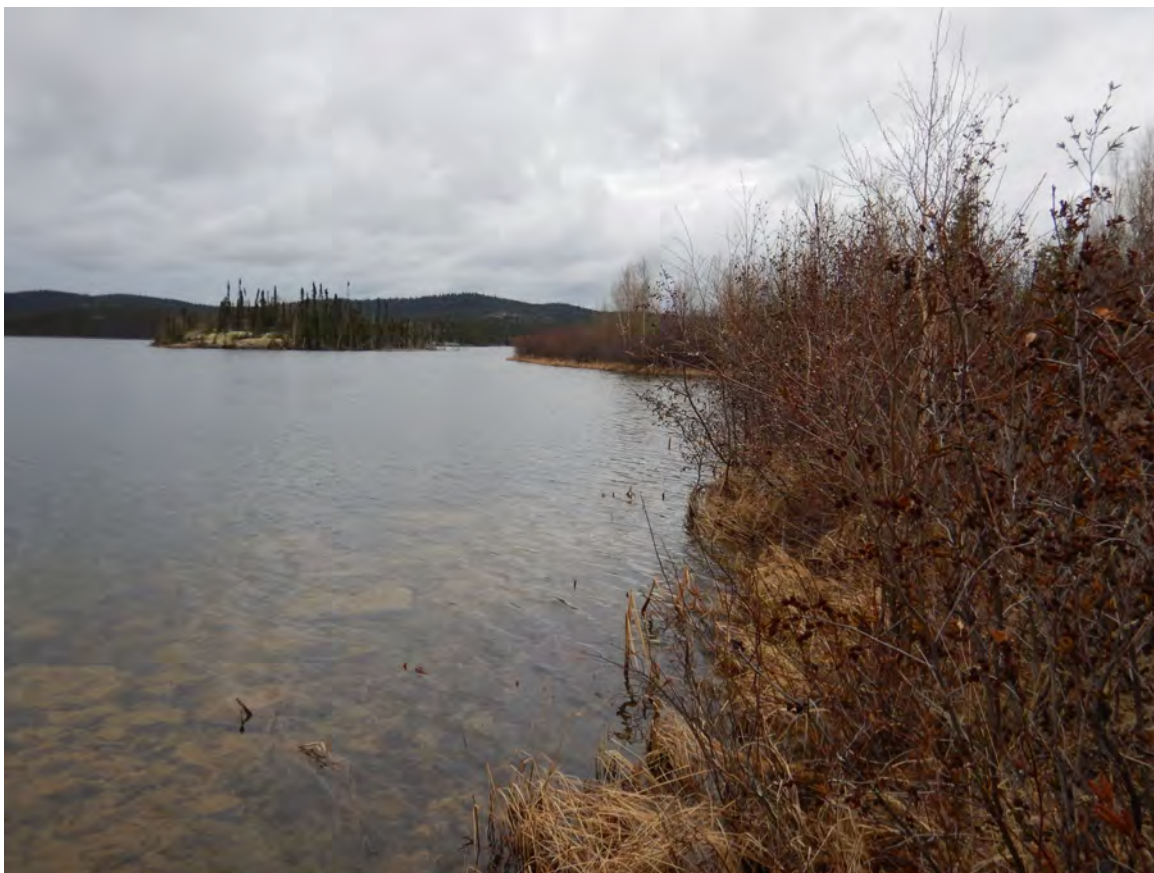
The shoreline, where the edge of the sand cover contacts Fookes Reservoir, was inspected and was in good condition, despite the water levels in Fookes Reservoir being higher during freshet. Photos taken in 2022 continue to show significant vegetation coverage along the shoreline. Note, the photos from 2022 were taken in May before the vegetation had fully leafed-out.

**Photo C9—Fookes Reservoir shoreline (looking west).**

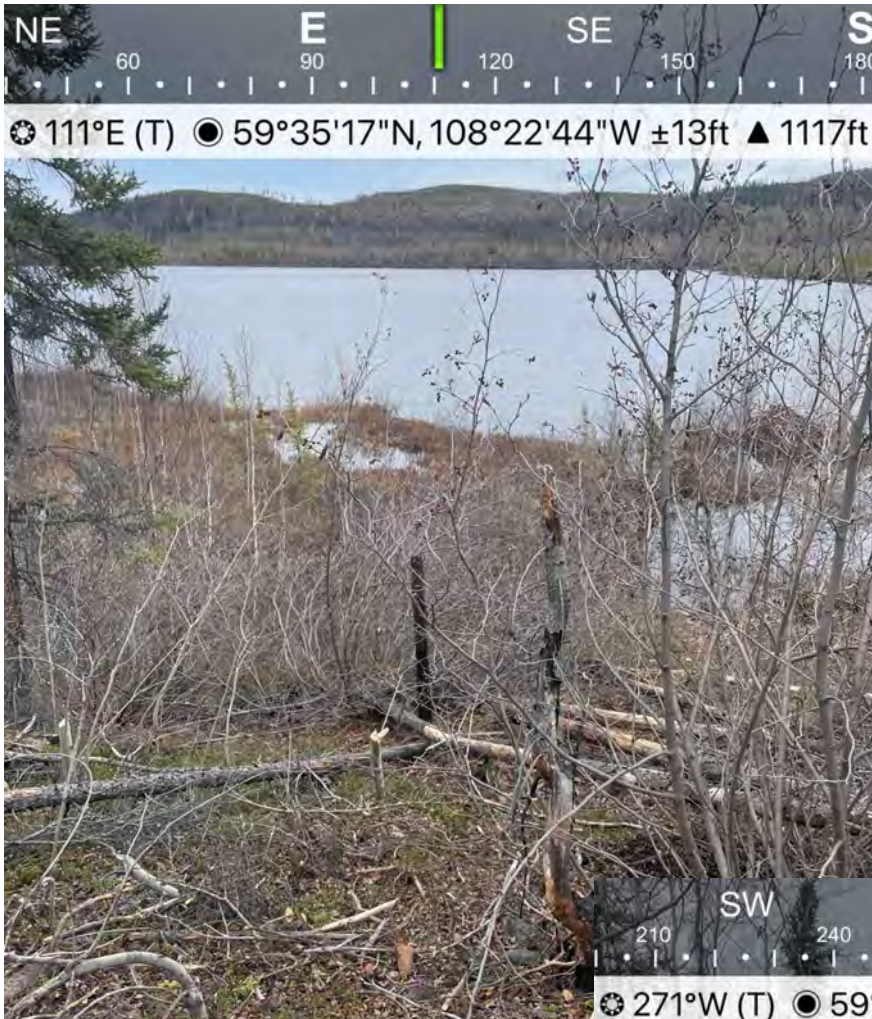
**Photo D6—Dubyna CP- 2 location  
(looking east)**

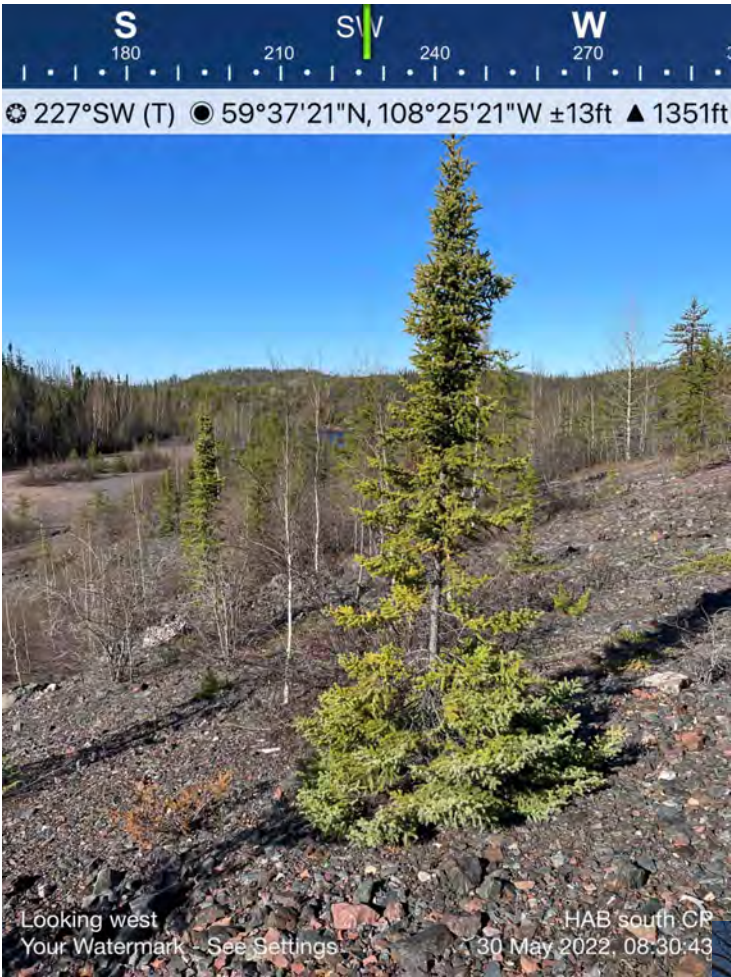
Photo D13—HAB039-04 looking west

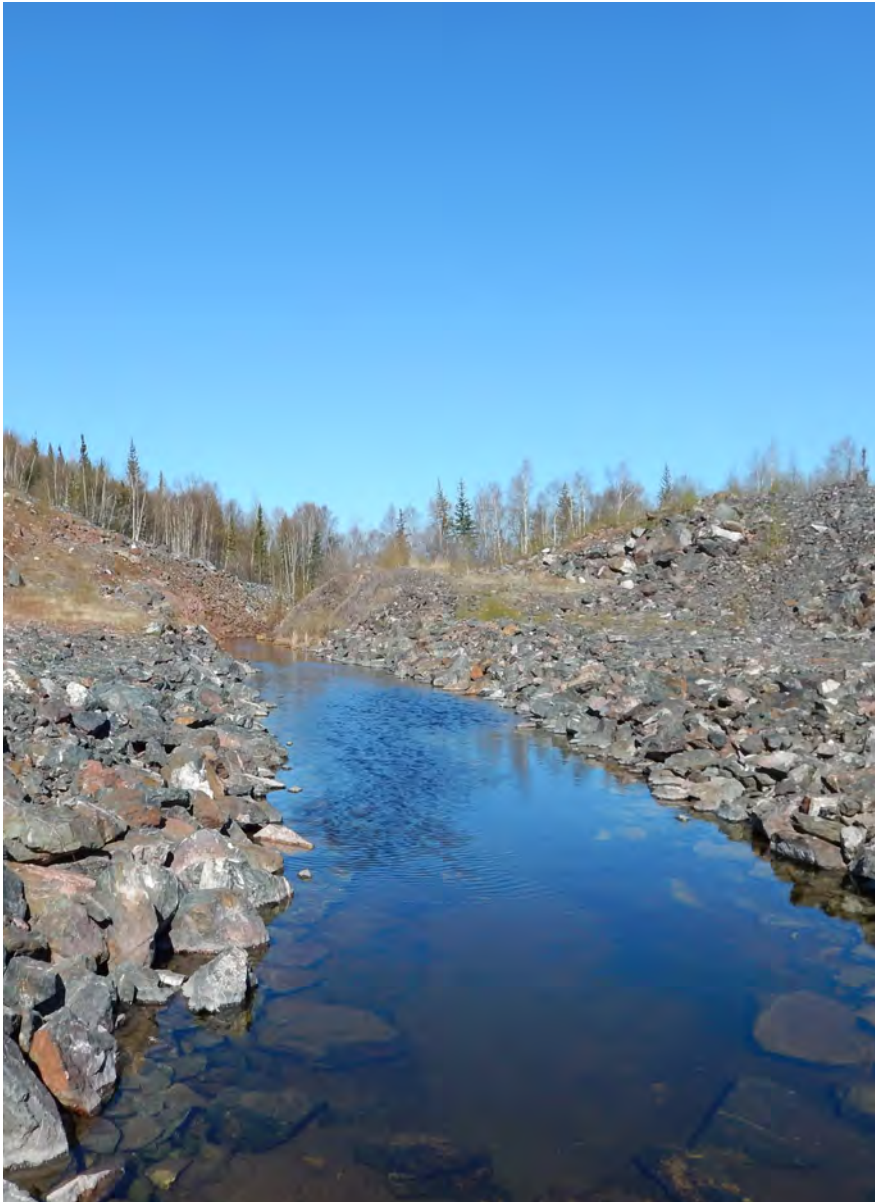
**Photo E01—View from level crossing looking downstream towards Verna Lake (May 31, 2022)**

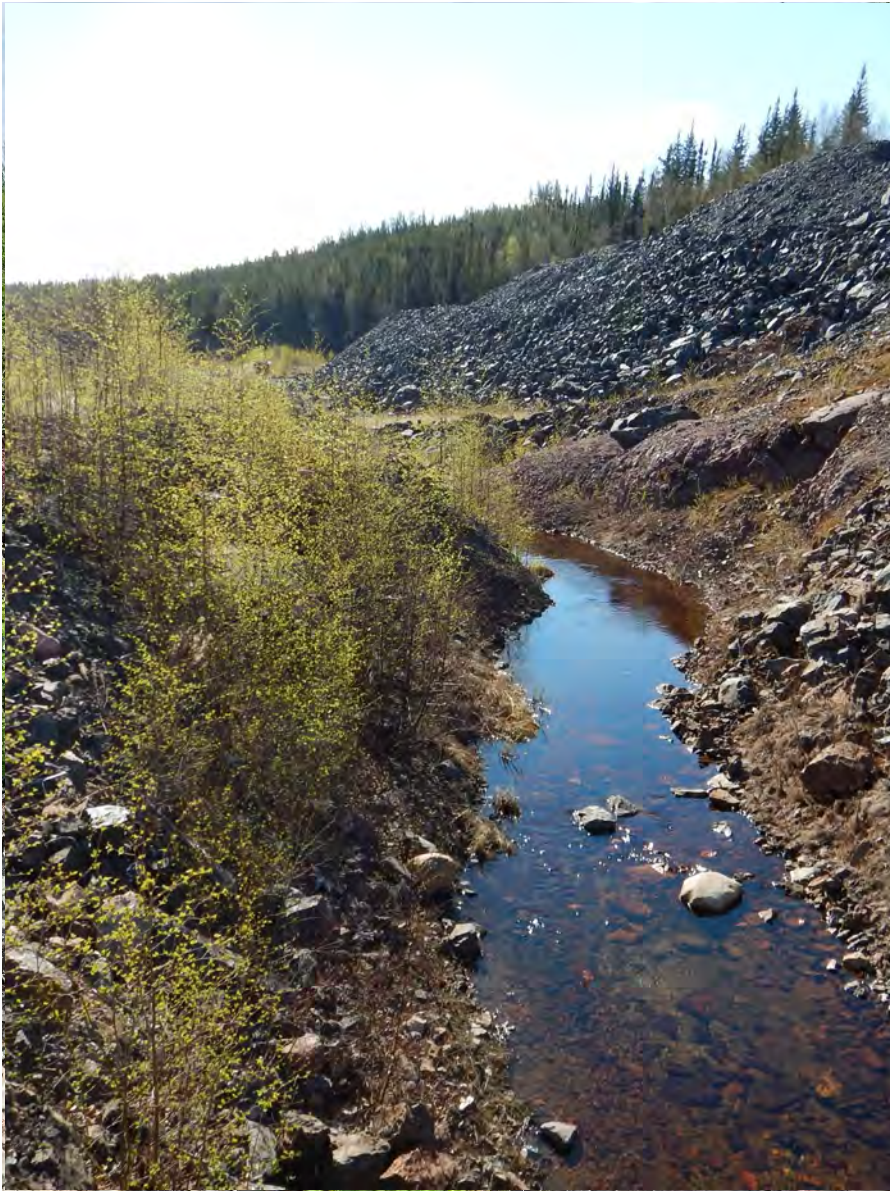
**Photo E03—View near stilling basin looking upstream (May 31, 2022)**

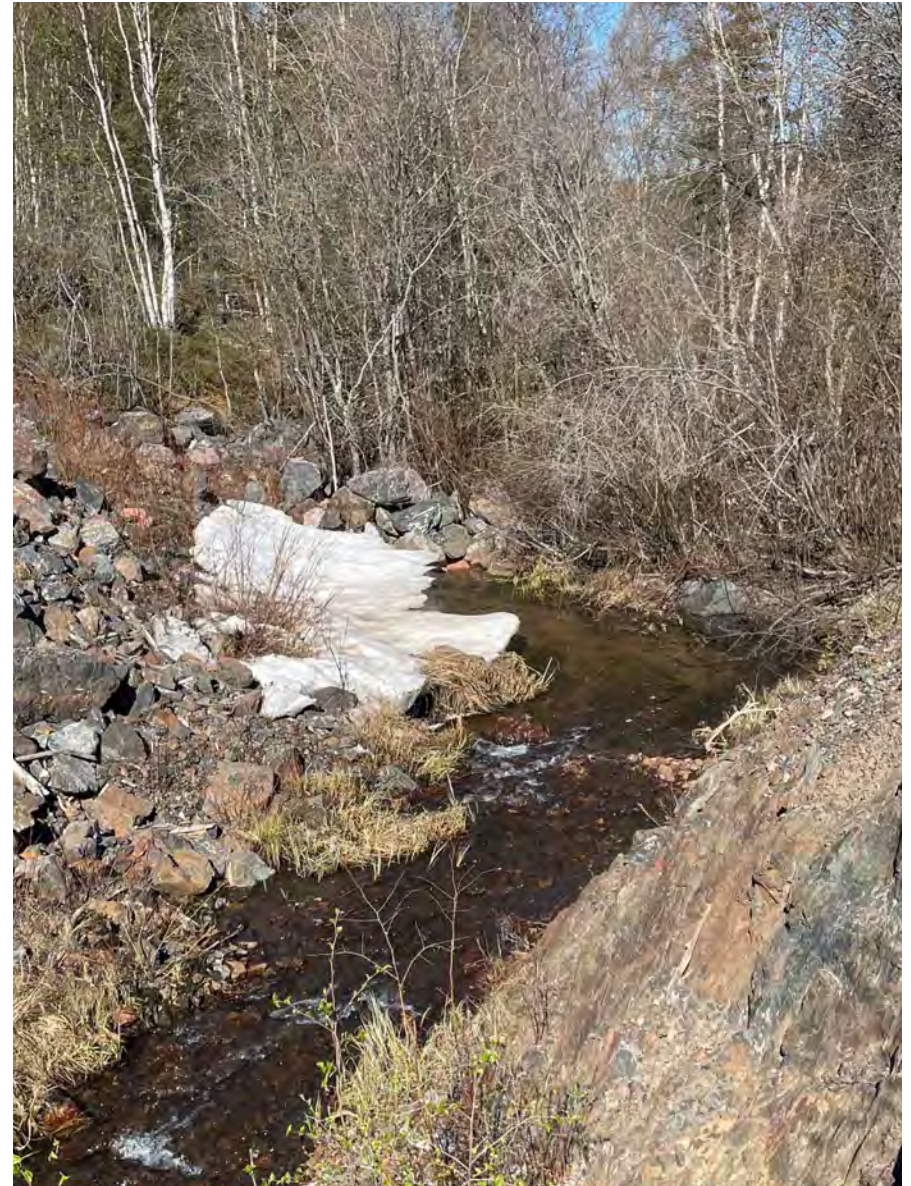
**Photo E04—View near stilling basin, looking downstream at stilling basin (May 31, 2022) Note the glaciation remaining from the late spring**

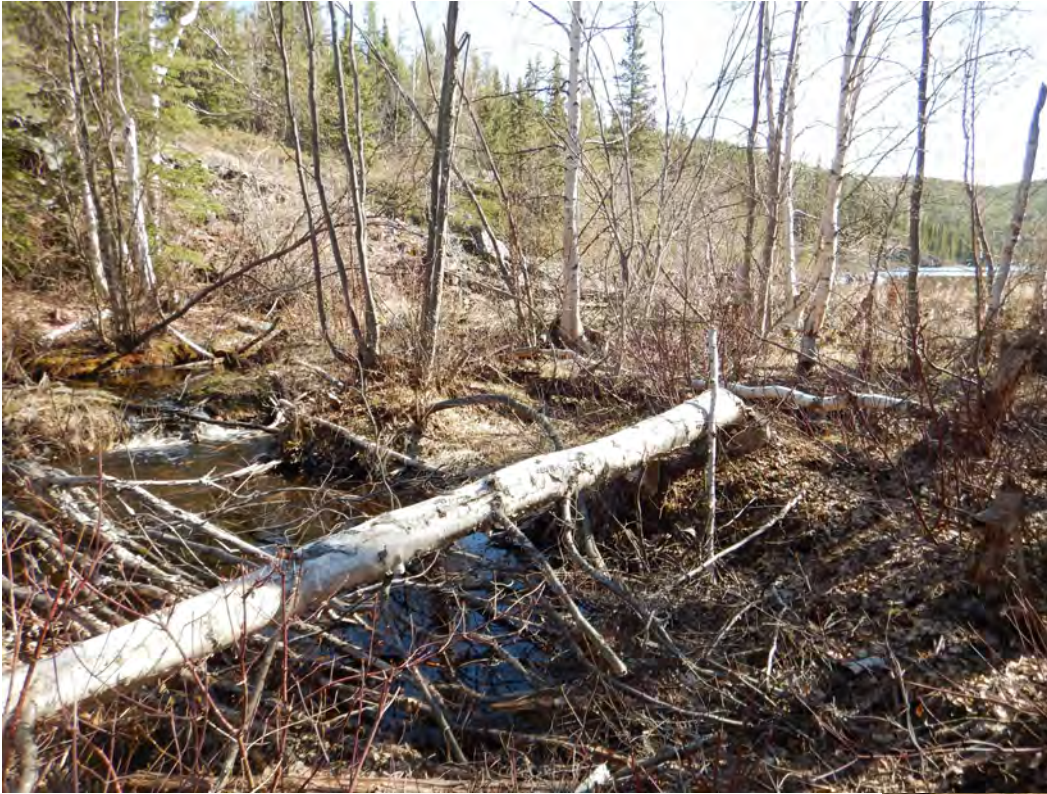
**Photo E05—View of the beaver dam at the outlet of Zora Lake, looking upstream (May 31, 2022)**

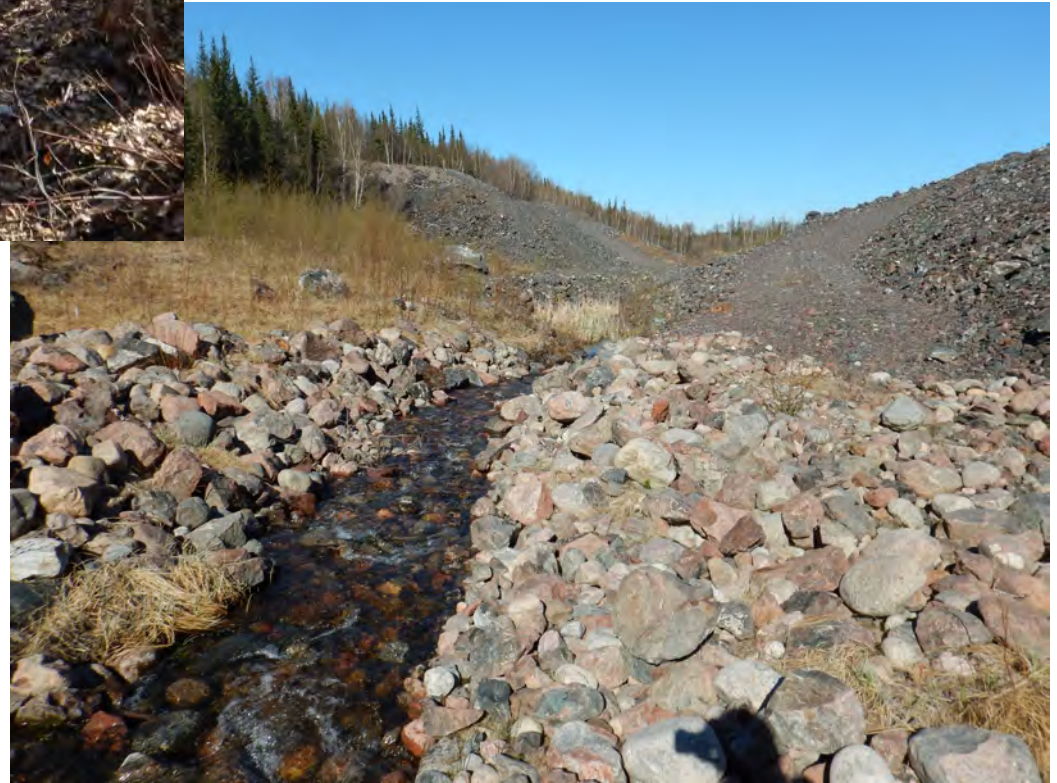
**Photo E06—View near beaver dam at outlet of Zora Lake, looking downstream (May 31, 2022)**
