Final Closure Report

Beaverlodge Properties

**URA 7, URA 1, BOLGER 1,
Tailings Management Area Properties**

NOVEMBER 2023

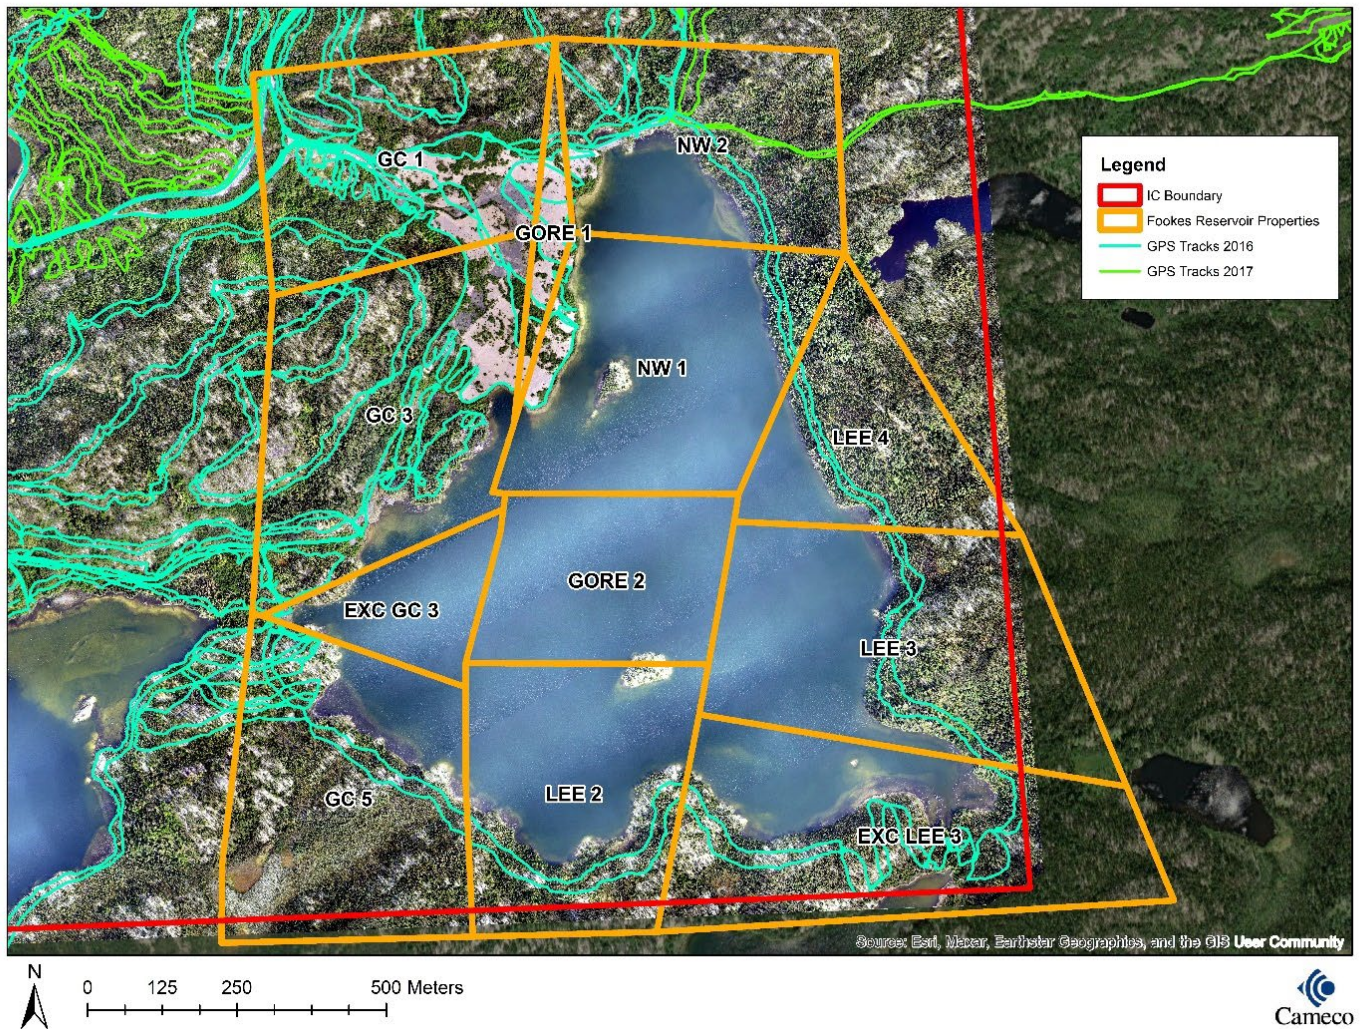
Figure 12: Fookes Reservoir Properties – Inspection Track

properties, unless safety consideration, surface features or significant vegetation prohibited access to a specific area (**Figure 12**).

As a result of this activity, the Fookes Reservoir properties meets the performance indicator of being free of debris.

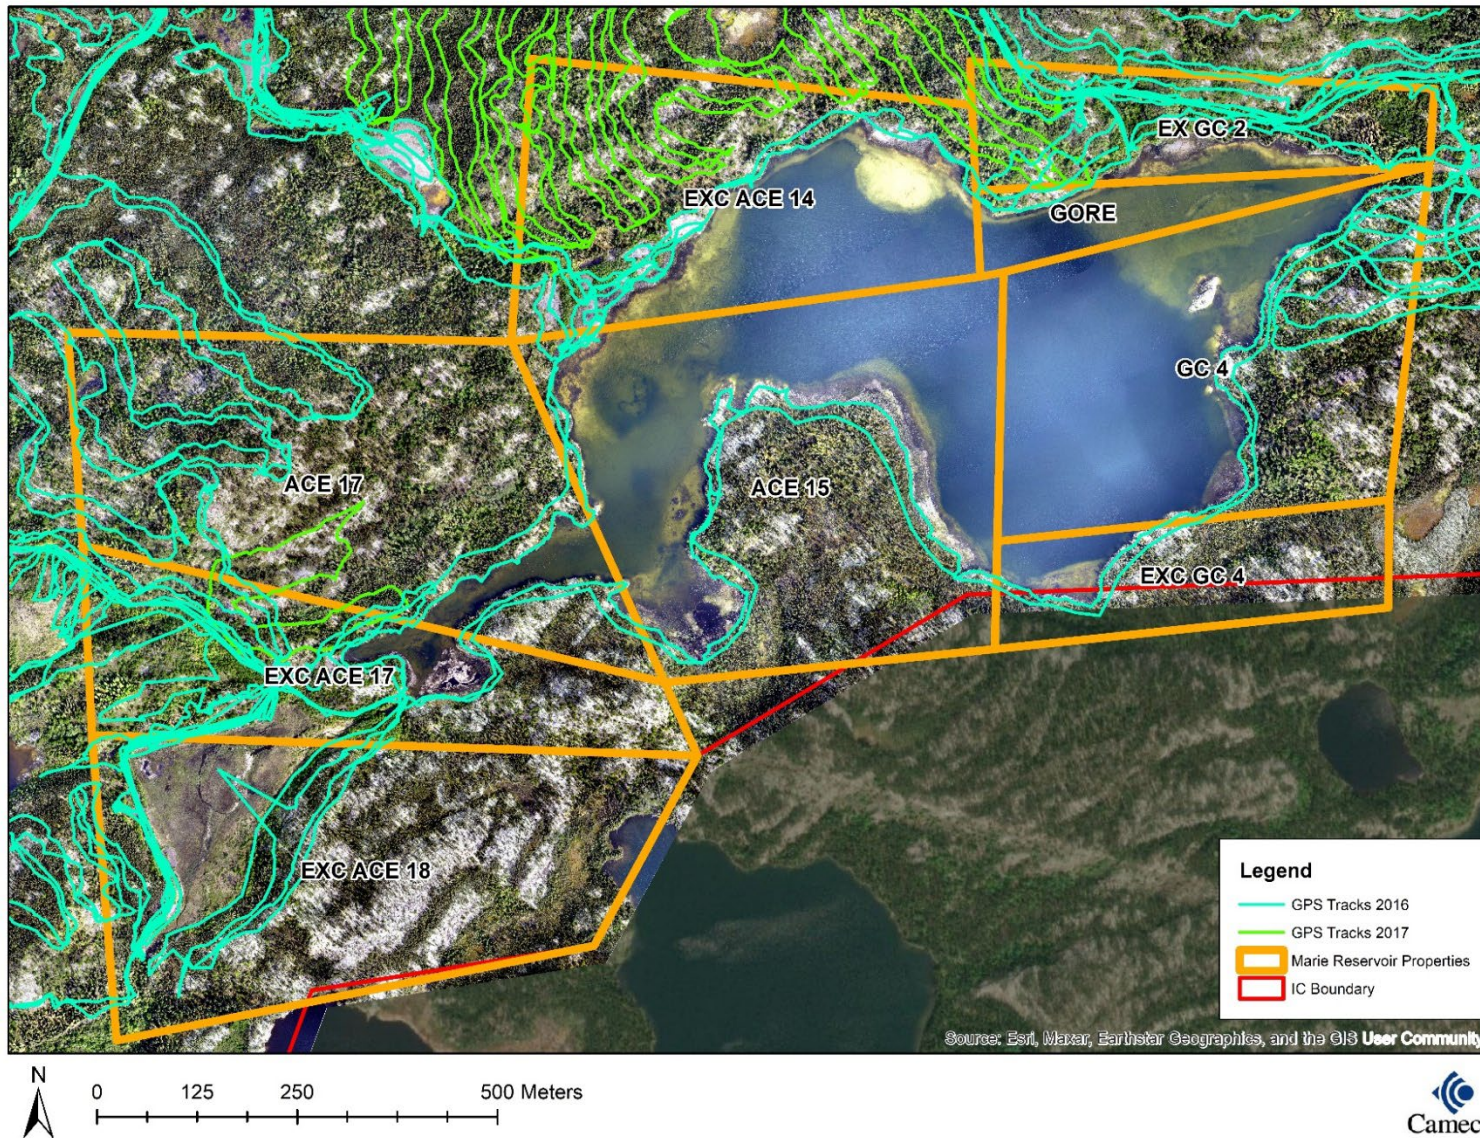
Figure 17: Marie Reservoir Properties – Inspection Track

All Beaverlodge related properties were inspected in an effort to locate historic debris not removed during initial decommissioning. During the main clean-up campaign in 2015 and 2017, GPS tracking was utilized to ensure adequate coverage of the properties, including the Marie Reservoir properties, unless safety consideration, surface features or significant vegetation prohibited access to a specific area (Figure 17).

As a result of this activity, the Marie Reservoir properties meet the performance indicator of being free of debris.

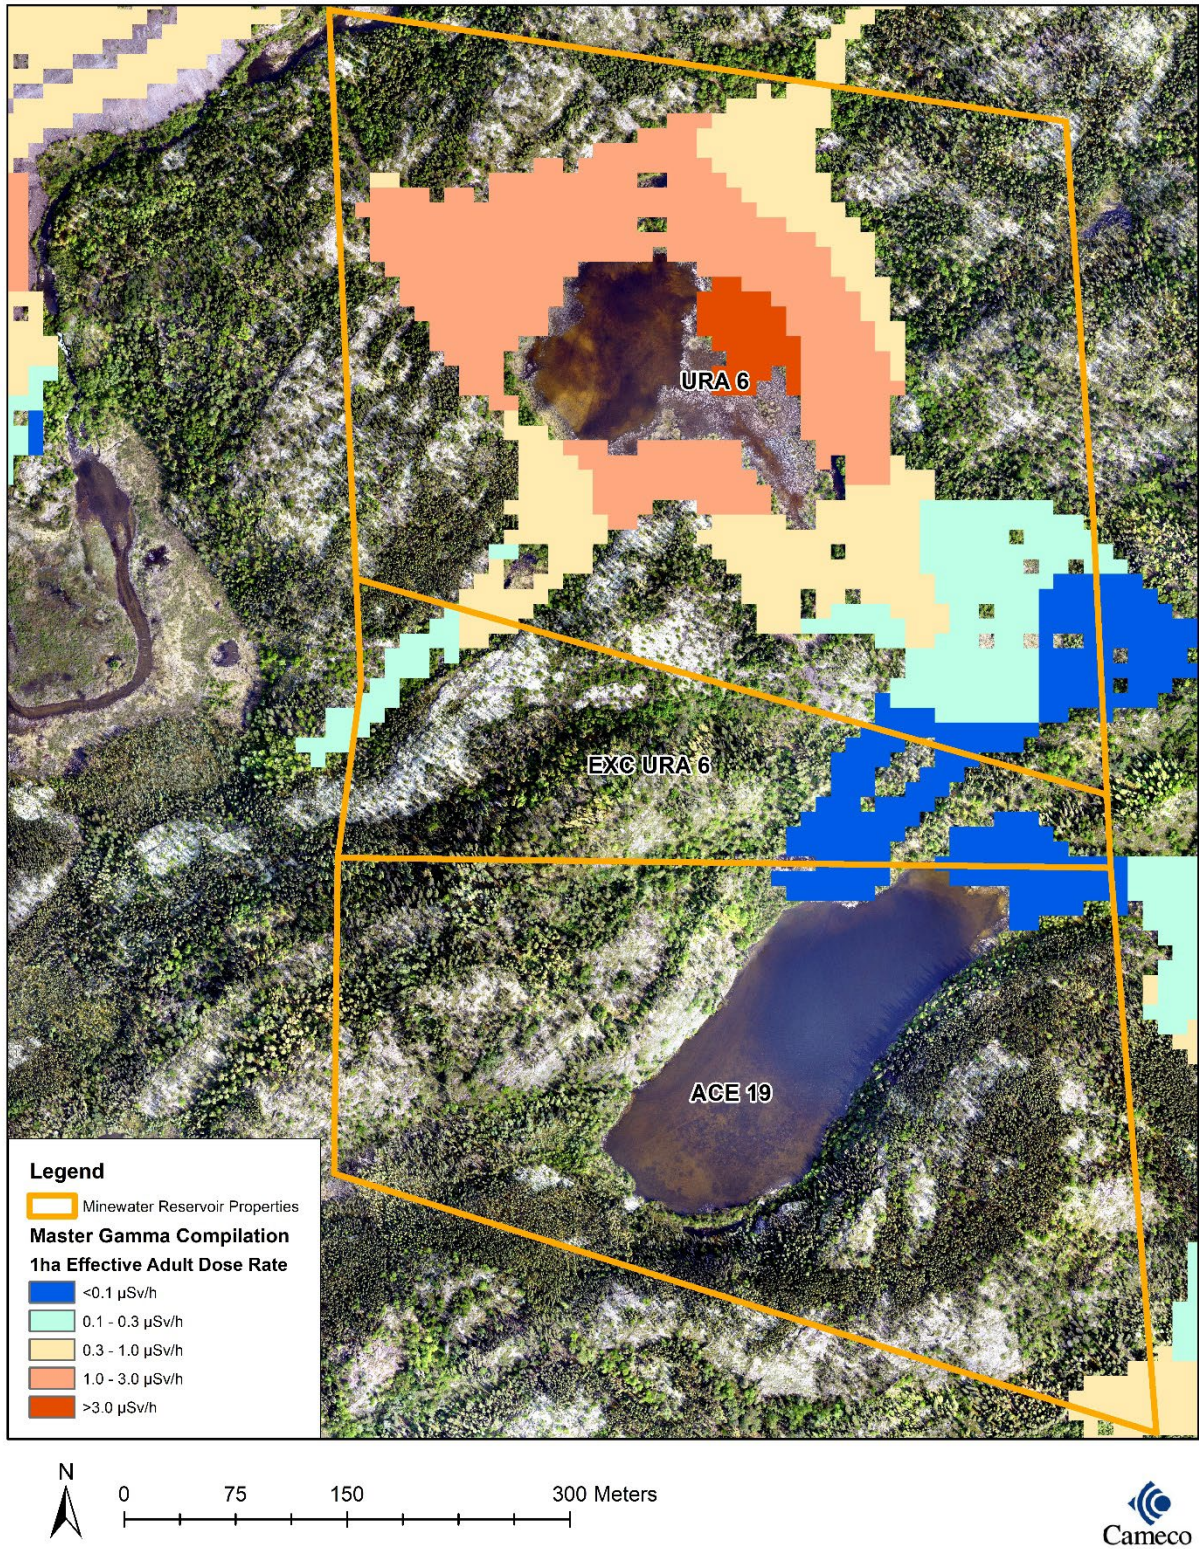
Figure 18: Incremental Gamma Radiation 1 Hectare Averages: Minewater Reservoir Properties

As shown in **Figure 18**, the surface gamma survey results for the areas downstream of Minewater Reservoir area typically ranged from $<0.1 \mu\text{Sv/h}$ to $1.0 \mu\text{Sv/h}$ above background (ARCADIS SENES 2014), which meets the *Guidelines for Northern Mine Decommissioning and Reclamation* (SkMOE 2008). The area surrounding the Minewater Reservoir itself typically measured between 1.0 and $3.0 \mu\text{Sv/h}$, with a small area on the east flank of Minewater Reservoir measuring $>3.0 \mu\text{Sv/h}$ above background. The area is difficult to access, and the area of the highest measured gamma levels is heavily vegetated. A risk-based approach was applied to evaluate potential radiation exposure risk at the property and concluded incremental dose from the properties based on the measured gamma results and the reported land use are well below the public dose criterion of 1 mSv/yr (ARCADIS 2015) and meet the Performance Indicator associated with acceptable gamma levels.

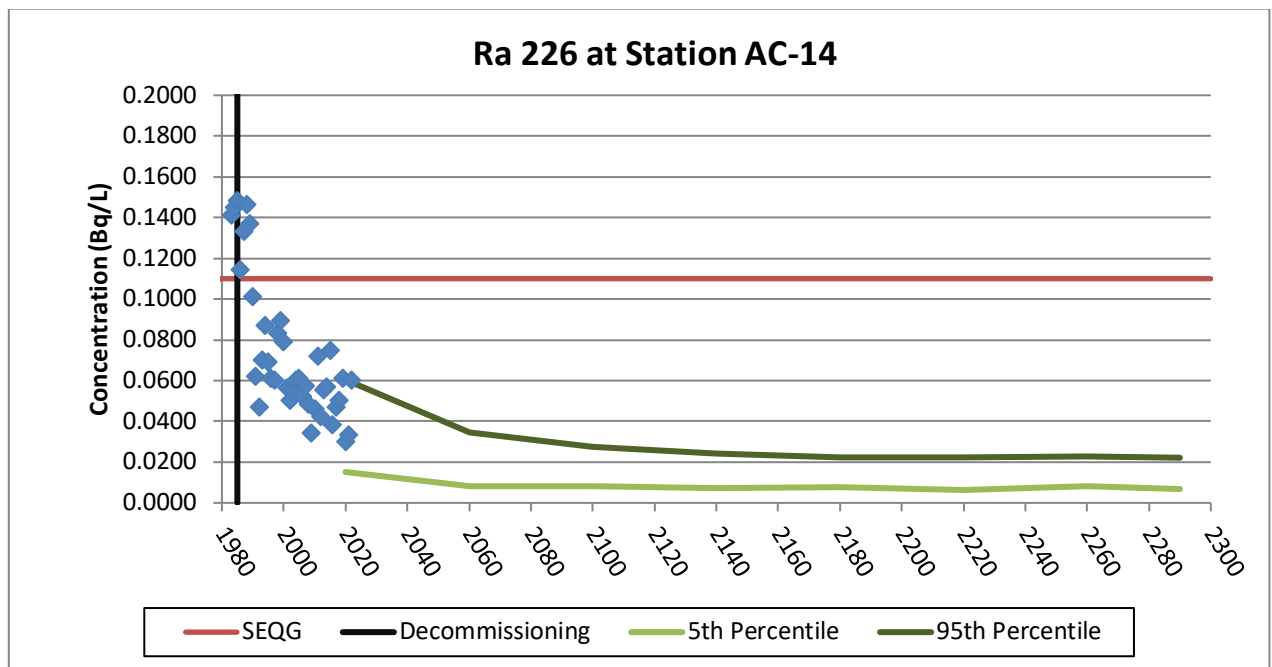
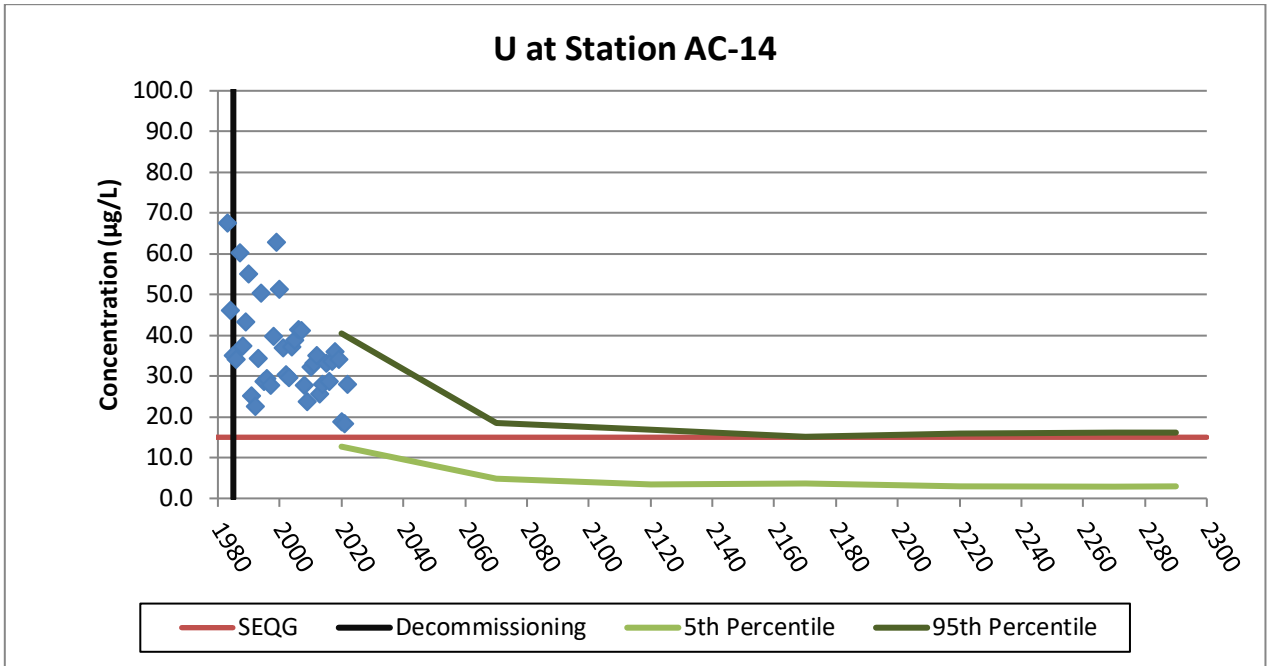
Water quality measured at AC-14 is within the modelled predictions and therefore the water quality performance indicator has been met for the URA 1 property.

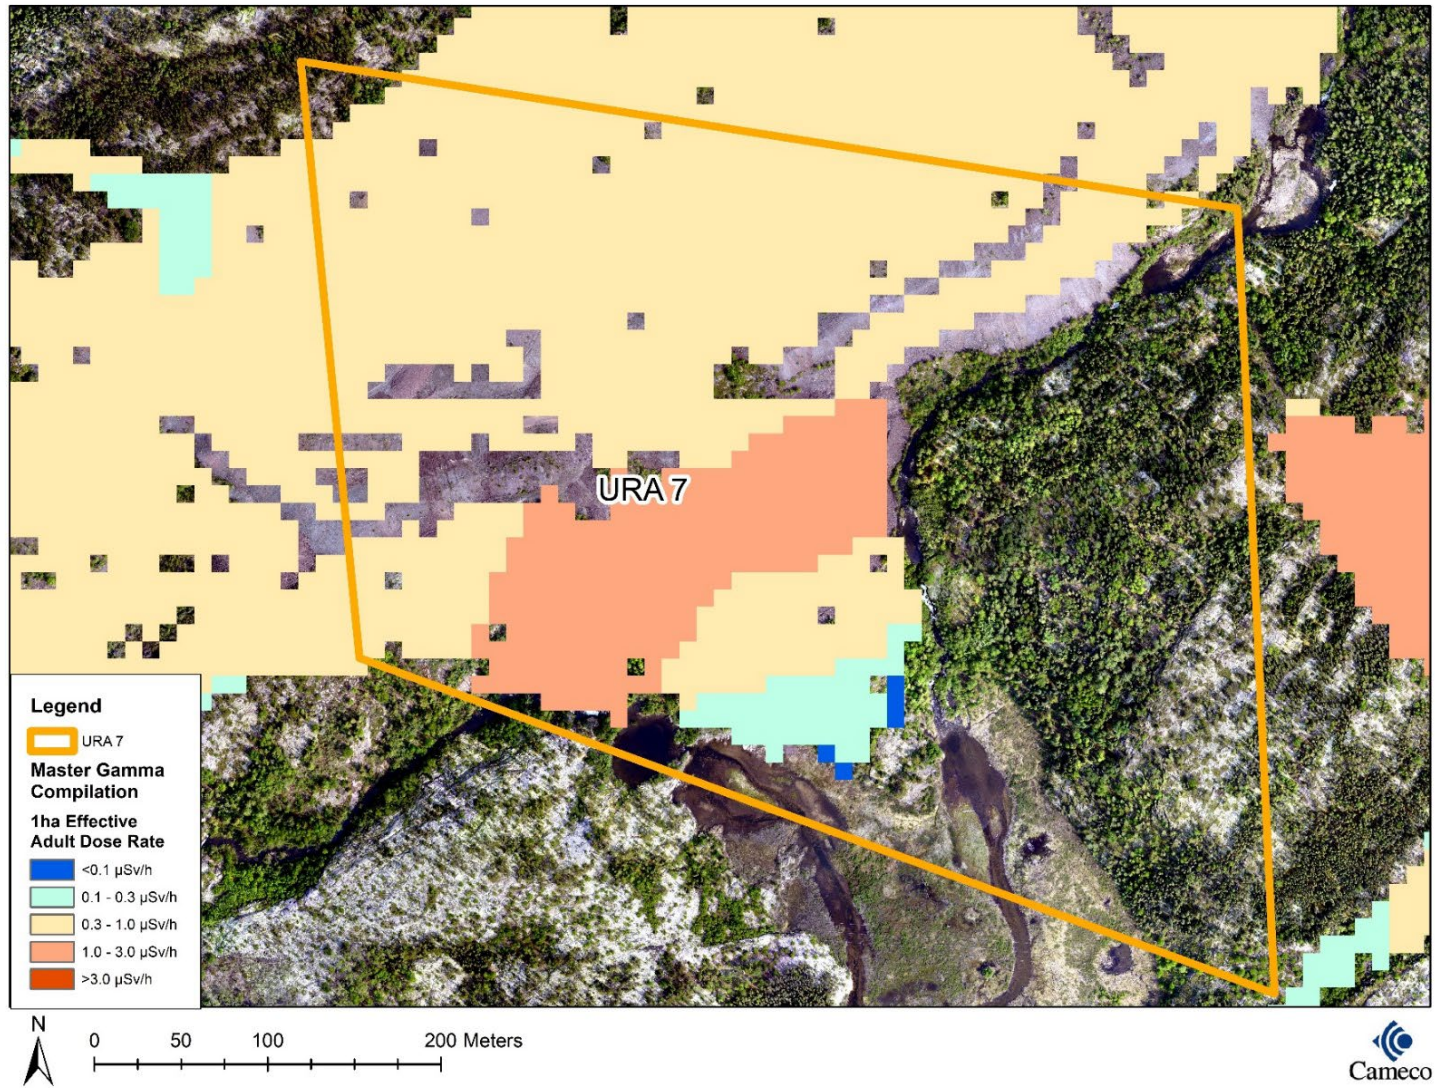
Figure 32: Incremental Gamma Radiation 1 Hectare Averages: URA 7 Property

Following the gamma survey completed in 2014 material on the URA 7 property was disturbed in the process of performing additional remediation to prepare the sites for long term stability. Material from the former sorted waste pile was removed and added as the base layer of cover material during the closure of the Lower Fay Pit (on the URA 1 property). The Former Mill Site was covered with a layer of clean waste rock, and several former mine openings were exposed to confirm their location prior to being resealed. Following completion of this additional remediation a gamma scan of these areas will be completed in May 2024 to confirm the results of the 2014 survey and risk assessment. The results of this gamma survey will be provided to the regulatory agencies once complete. The gamma results provided in **Figure 32** represent to most recent result for all areas reported.

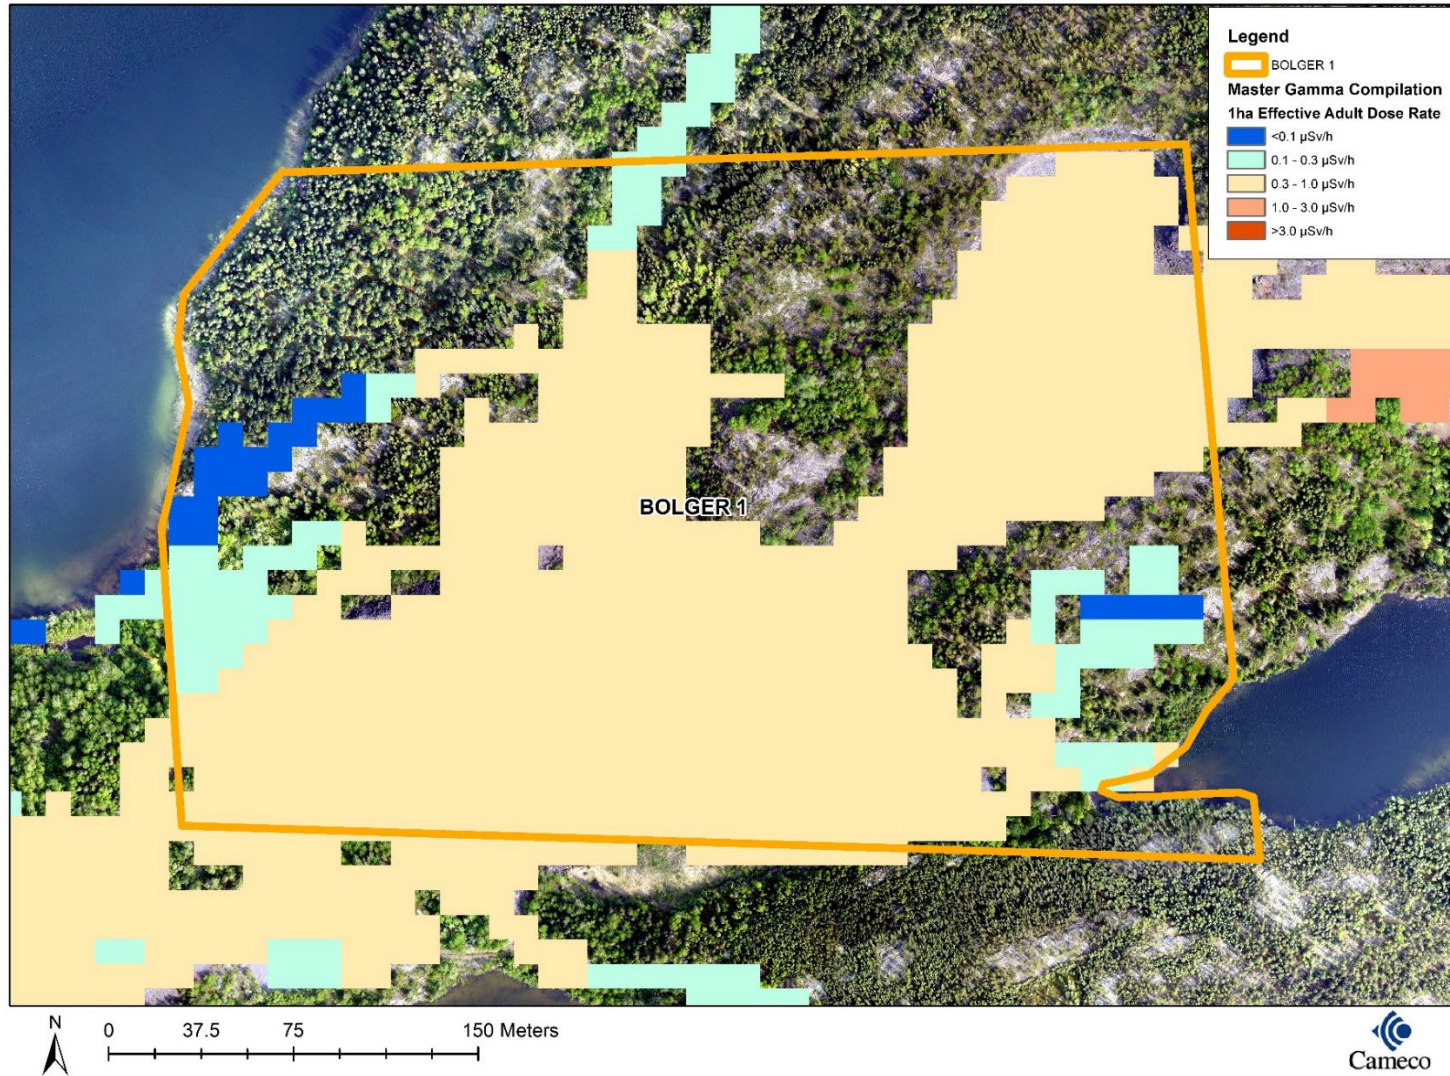
Figure 36: Incremental Gamma Radiation 1 Hectare Averages: Bolger 1 Property

As shown in **Figure 36** the entire BOLGER1 property ranged from $< 0.1 \mu\text{Sv/h}$ to $1.0 \mu\text{Sv/h}$ above background averaged over 1 ha, which meets the *Guidelines for Northern Mine Decommissioning and Reclamation* (SkMOE 2008) and meets the performance indicator associated with acceptable gamma levels.

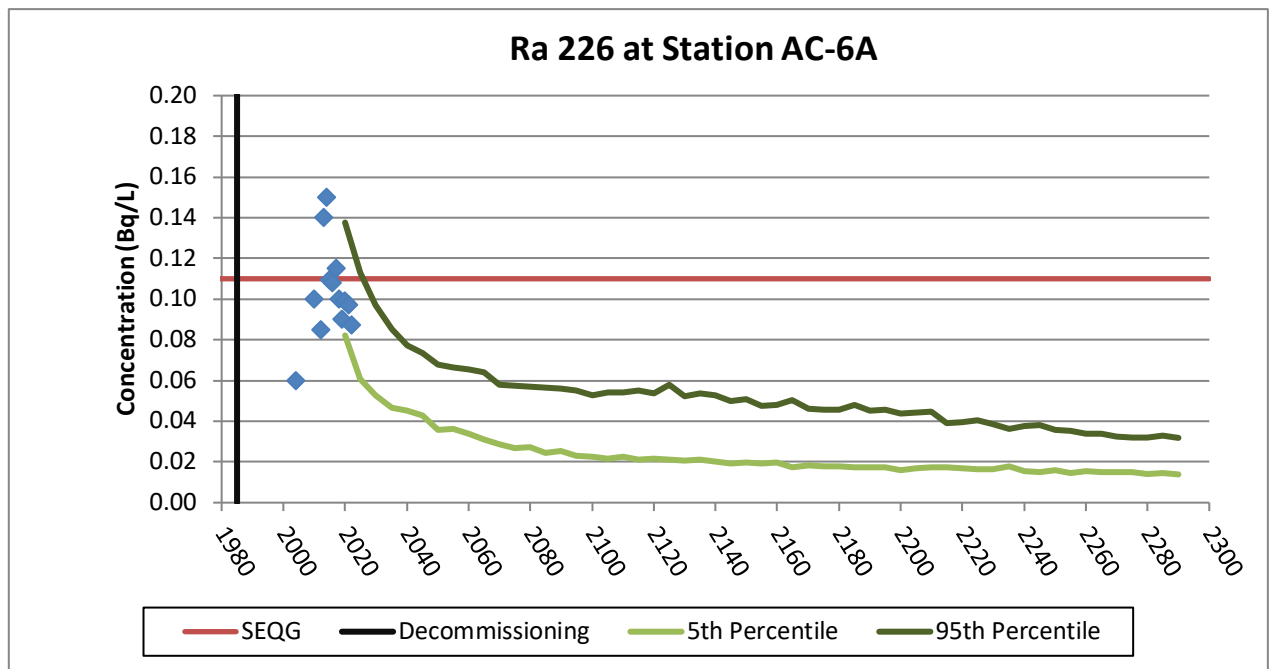
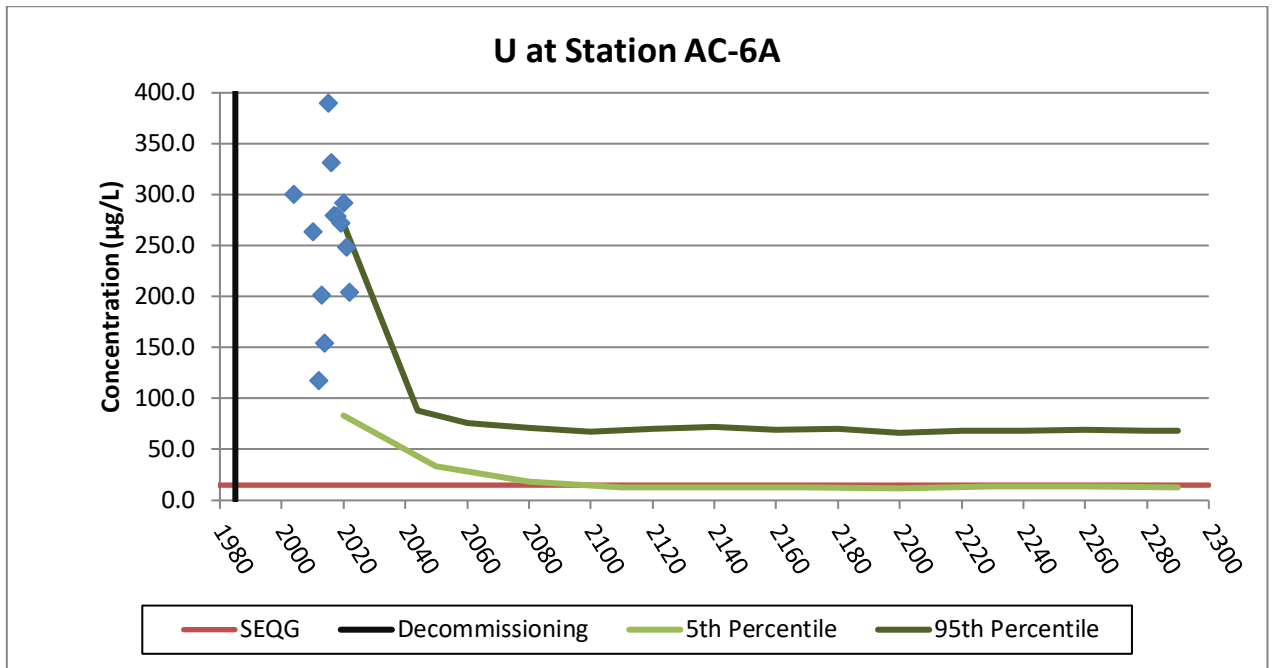
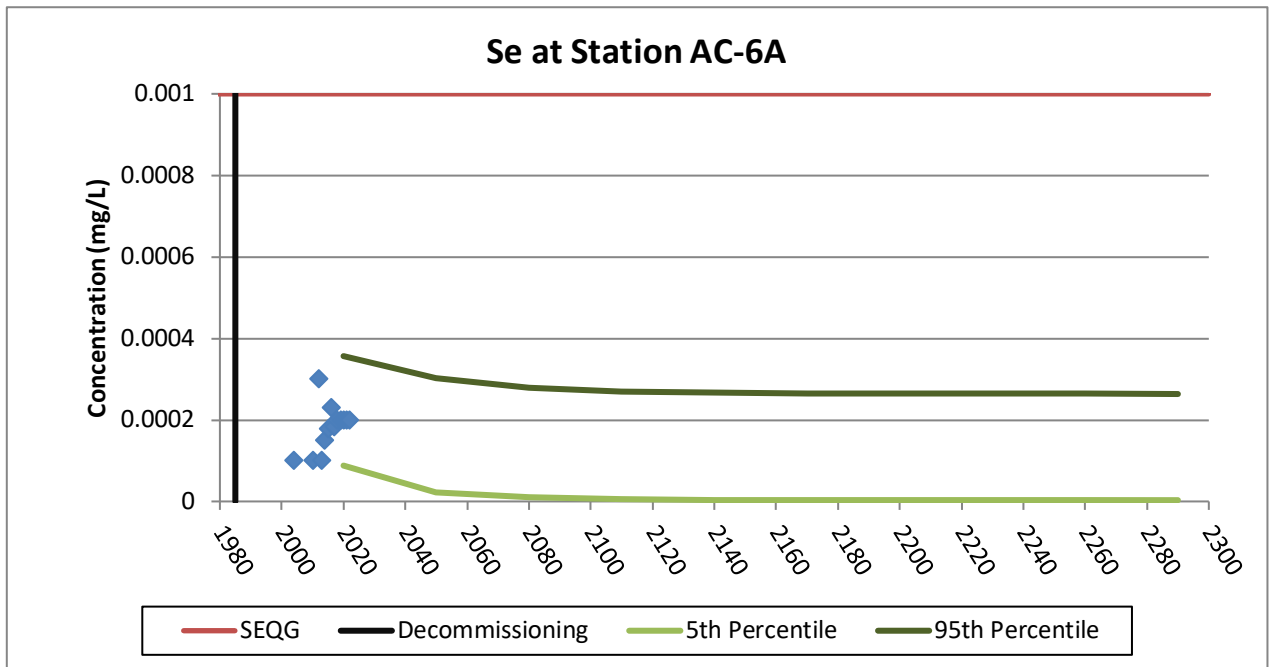
To determine if the anticipated localized benefits to Verna Lake are being achieved, water quality has been monitored at station AC-6A (located at the outflow of Verna Lake downstream of the BOLGER 1 property) and concentrations have helped inform modelled predictions. The modelled data helped establish WQ performance indicators, which CNSC Staff have deemed appropriate for evaluating the recovery of Verna Lake. The relevant water quality constituents that are assessed as part of the performance indicator include: radium-226, uranium, and selenium. As shown in **Figure 37, 38, and 39** and discussed in greater detail in the 2020 Beaverlodge ERA (CanNorth 2020a), the following observations can be made that demonstrate the Verna Lake water quality data is meeting the water quality performance indicator as defined by regulatory accepted assessment methodologies:

The BOLGER 1 property therefore meets the water quality within modelled predictions performance indicator.

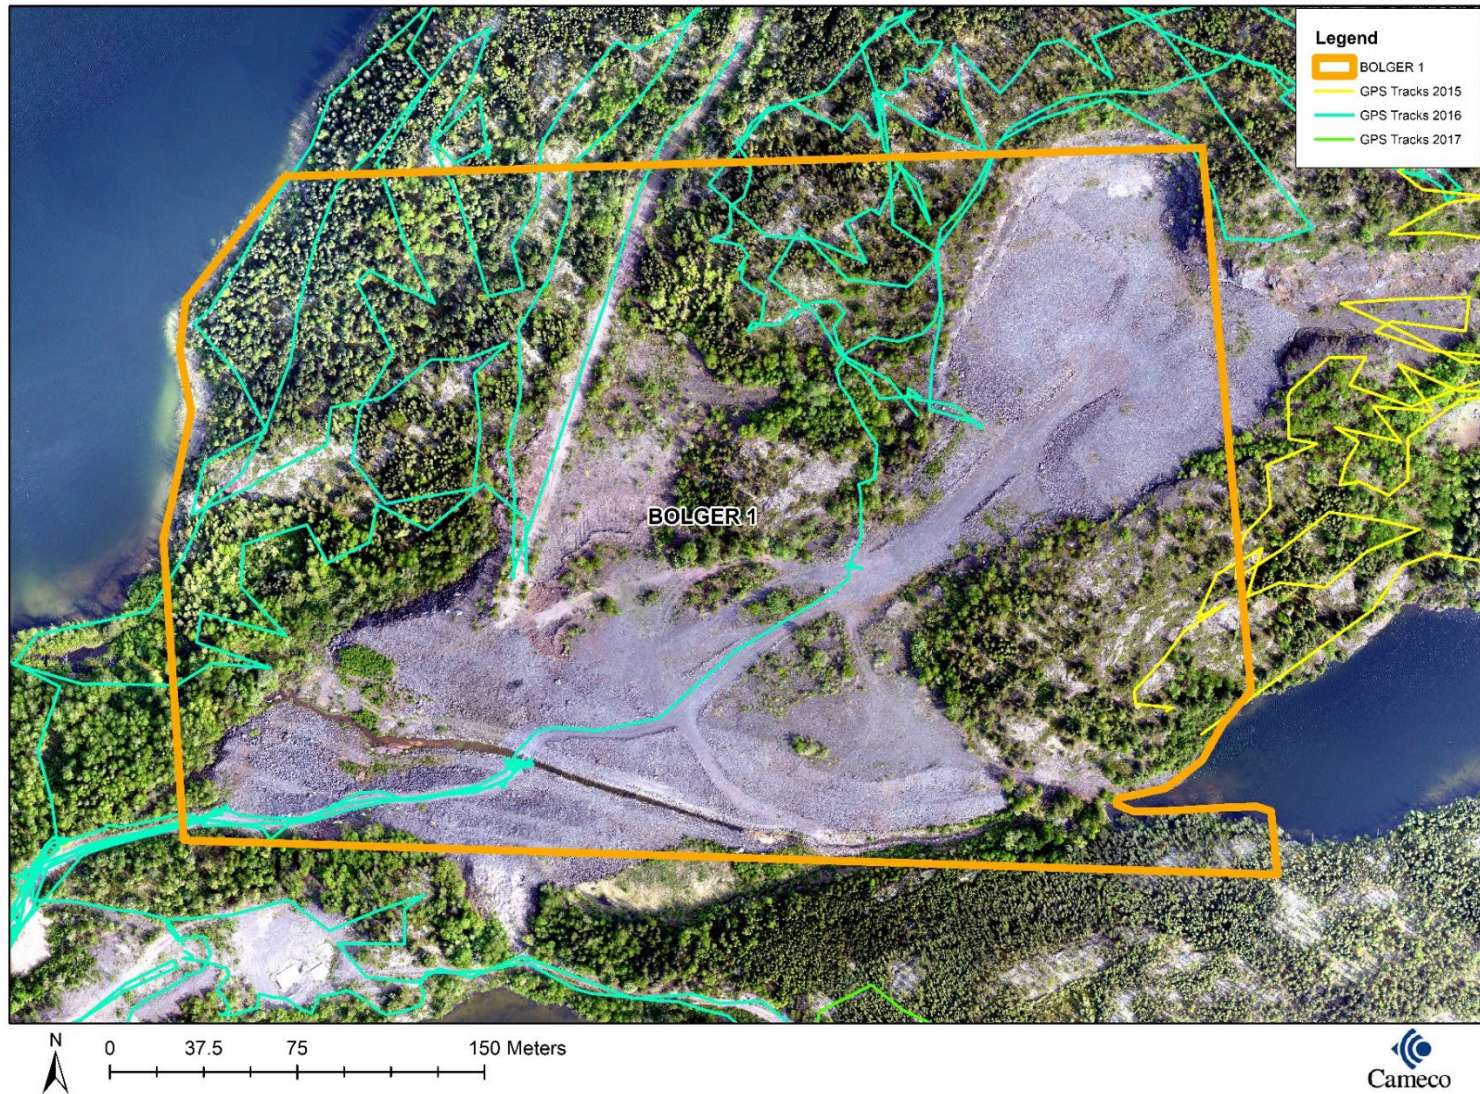
Figure 40: Bolger 1 – Inspection Track

All Beaverlodge related properties were inspected in an effort to locate historic debris not removed during initial decommissioning. During the main clean-up campaign in 2015 and 2017, GPS tracking was utilized to ensure adequate coverage of the properties, including the BOLGER 1 property, unless safety consideration, surface features or significant vegetation prohibited access to a specific area (**Figure 40**).

As a result of this activity, the BOLGER 1 property meets the performance indicator of being free of debris.

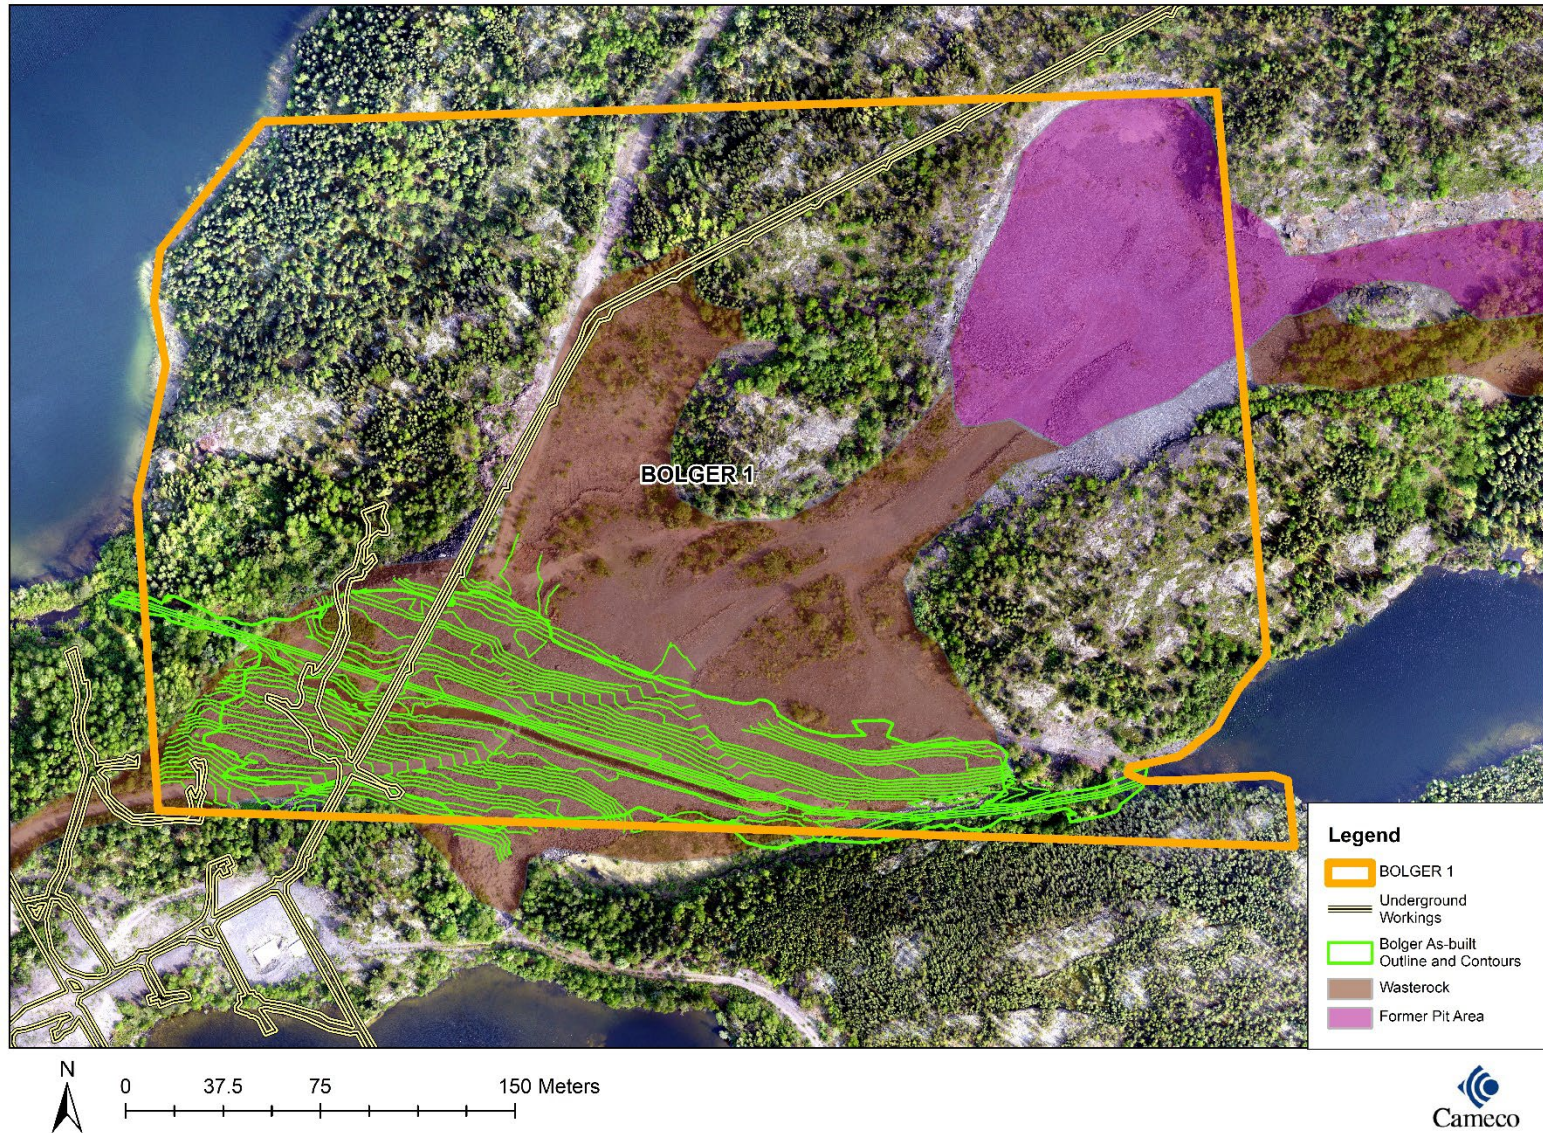
Figure 41: Bolger 1 - Site Features

Figure 41 outlines the site features associated with BOLGER 1 property. Based on the historical activities at the BOLGER 1 property, waste rock slopes will require inspection under the Province of Saskatchewan's institutional control management framework.

No aspect of the BOLGER 1 property will require maintenance under institutional control.
