Beaverlodge Project 2023 Annual Report Year 38 Transition Phase Monitoring

Prepared for:
Canadian Nuclear Safety Commission
Compliance Report for Licence: WFOL-W5-2120.0/2025
& Saskatchewan Ministry of Environment
Compliance Report: Beaverlodge Surface Lease

Prepared and Submitted by:
Cameco Corporation

March 2024

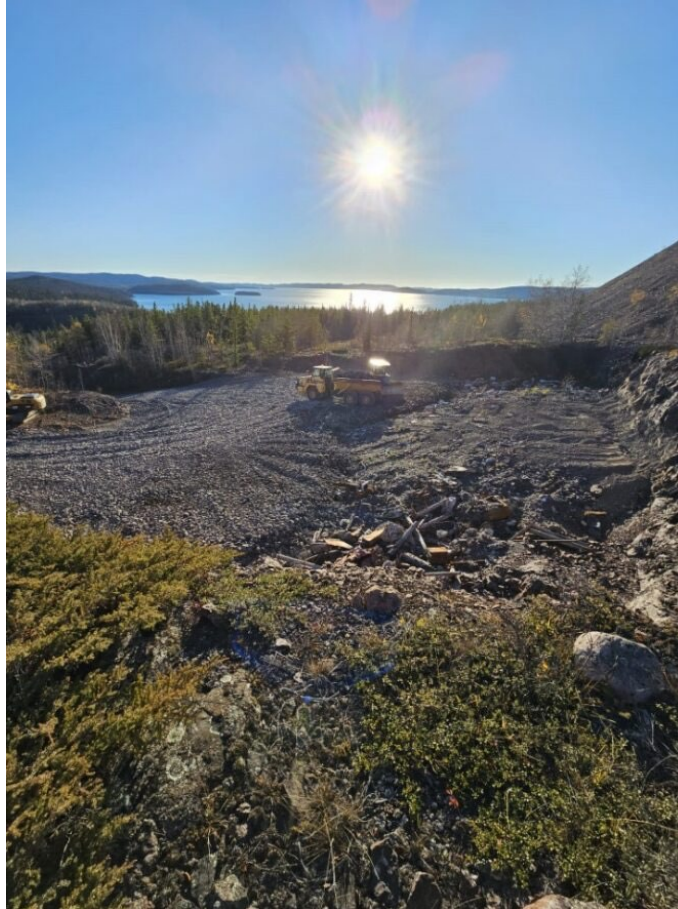
The closure of the pit was completed in October 2023 (see Photo below). The SWR and clean waste rock was placed onto the compacted debris using load, haul, dump equipment and then spread with the use of a tracked bulldozer and/or backhoe. The driving of equipment on the material further compacted the debris and incorporated the SWR into the matrix of the debris, reducing the risk of settling in the future. Cameco will conduct a gamma scan of Lower Fay Pit and the SWR pile in 2024.

Photo 2- Lower Fay Pit being covered with waste rock

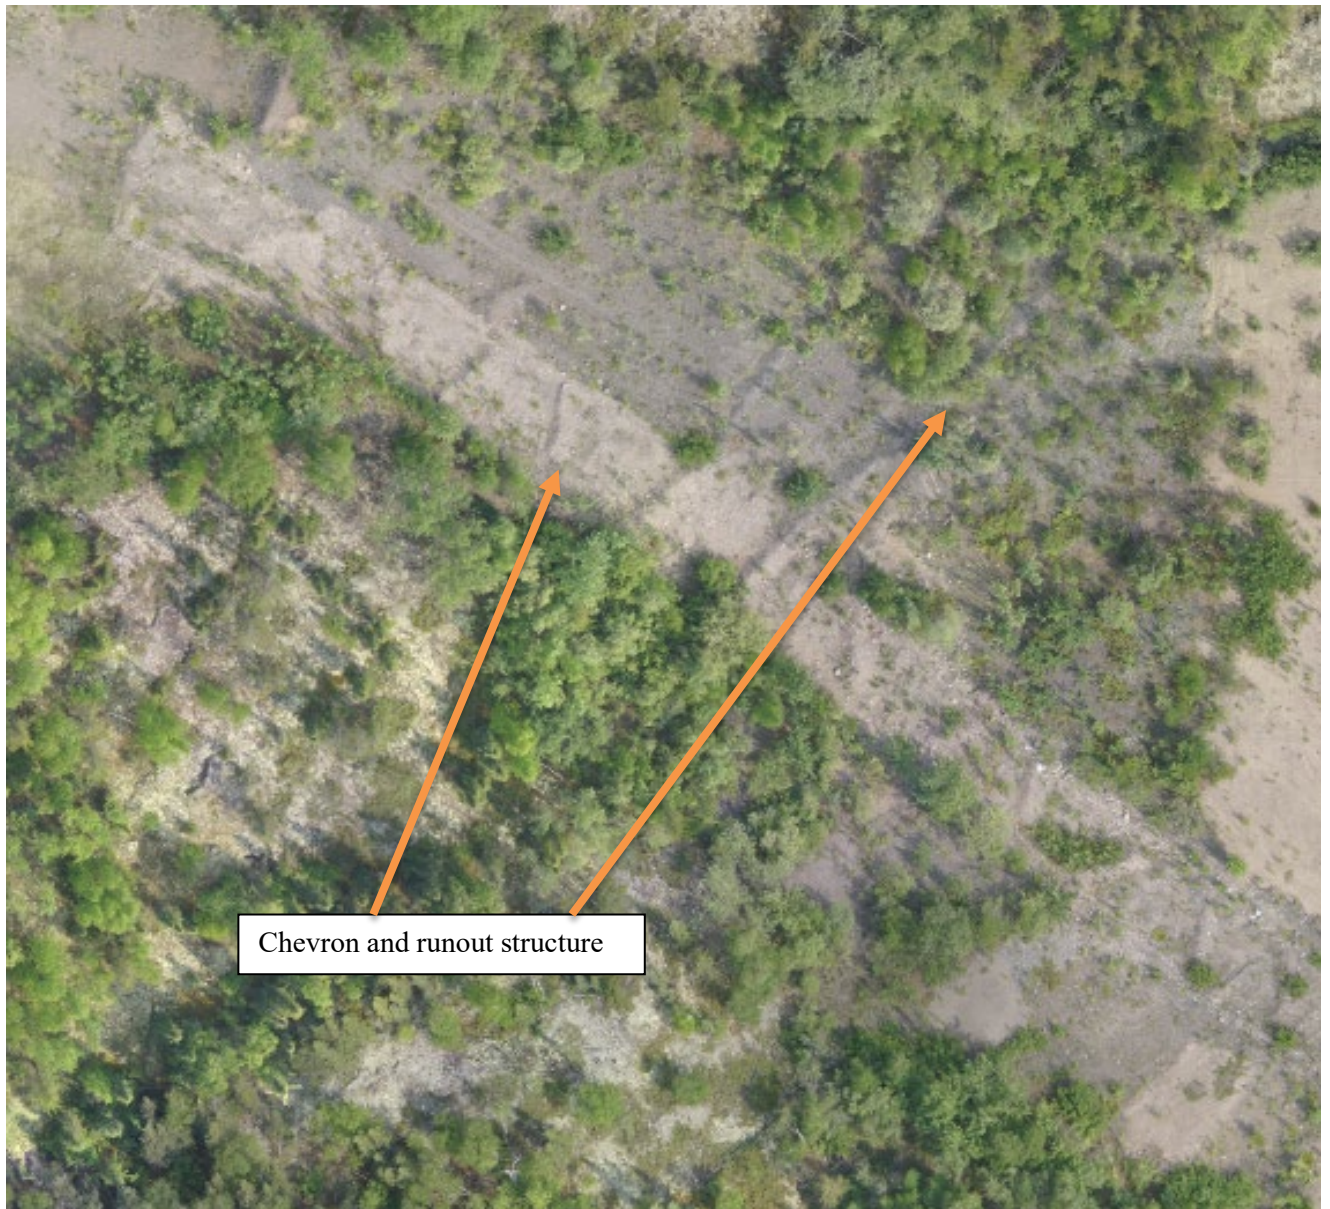
Figure 3. Fookes chevron and runout structure

As part of the design and installation of the covers in 2005 and 2007, the area considered most vulnerable to erosion was in the area on and below the access ramp at the northwest corner of the delta (SRK, 2010). The general condition of the ramp is very good. Access to this ramp is closed off by a windrow of material at the top of the ramp, except for the small access trail to allow the remediation of the piezometer standpipes. The water bars (chevrons, **Figure 3**) are performing as expected and continue to show little sign of erosion (**Appendix C, Photo C1**).

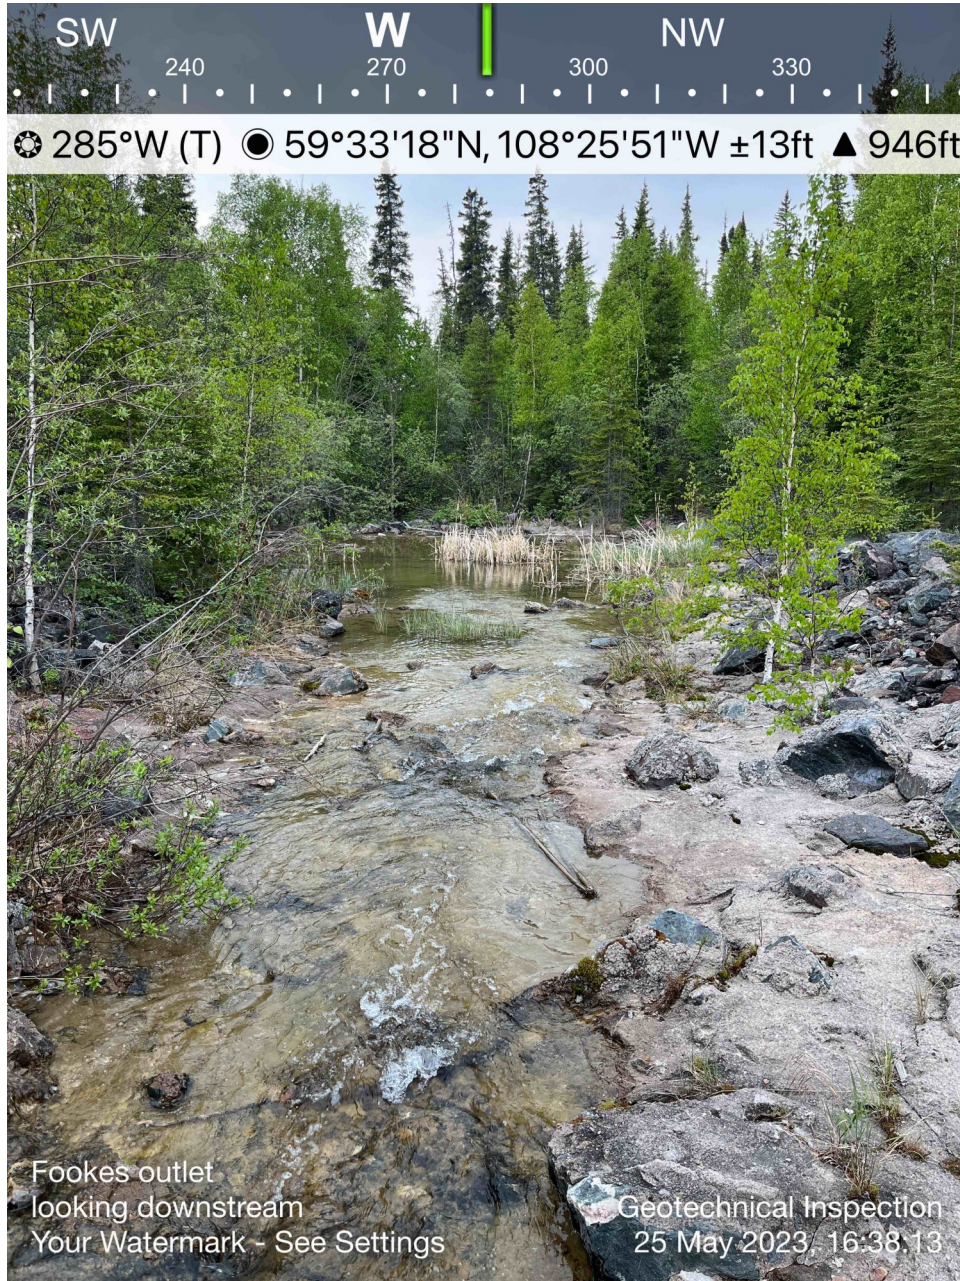
Photo B3 – Fookes Reservoir Spillway looking downstream (mid channel)

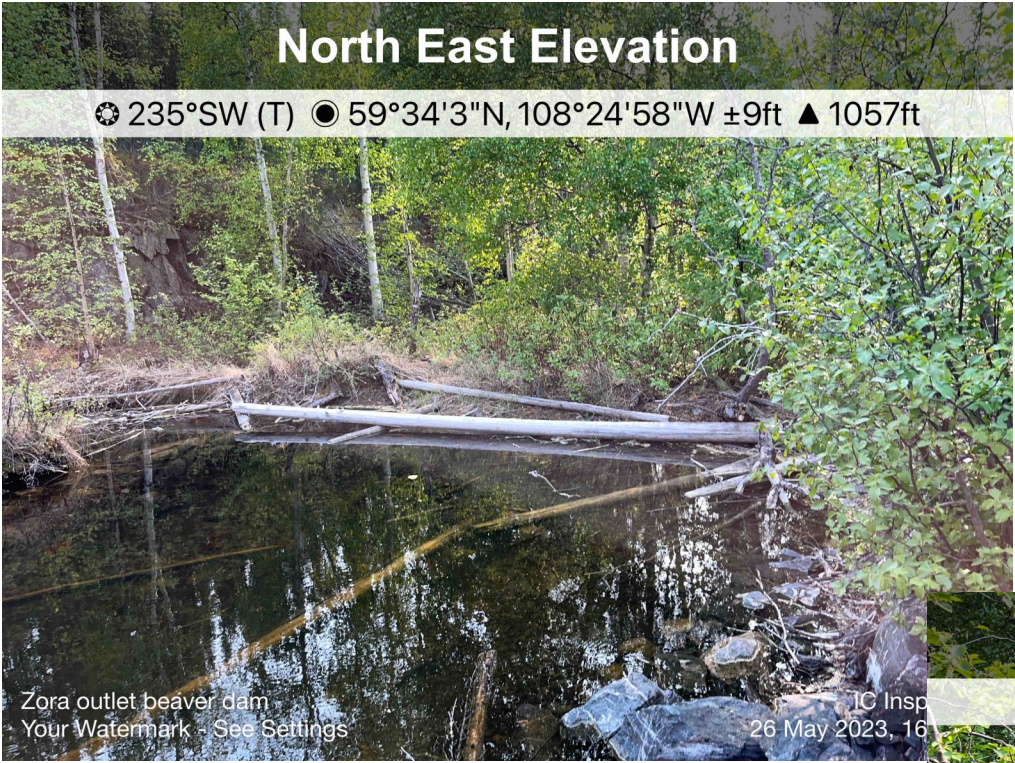
Photo E05—View of well-established beaver dam at the outlet of Zora Lake, looking downstream (May 2023)

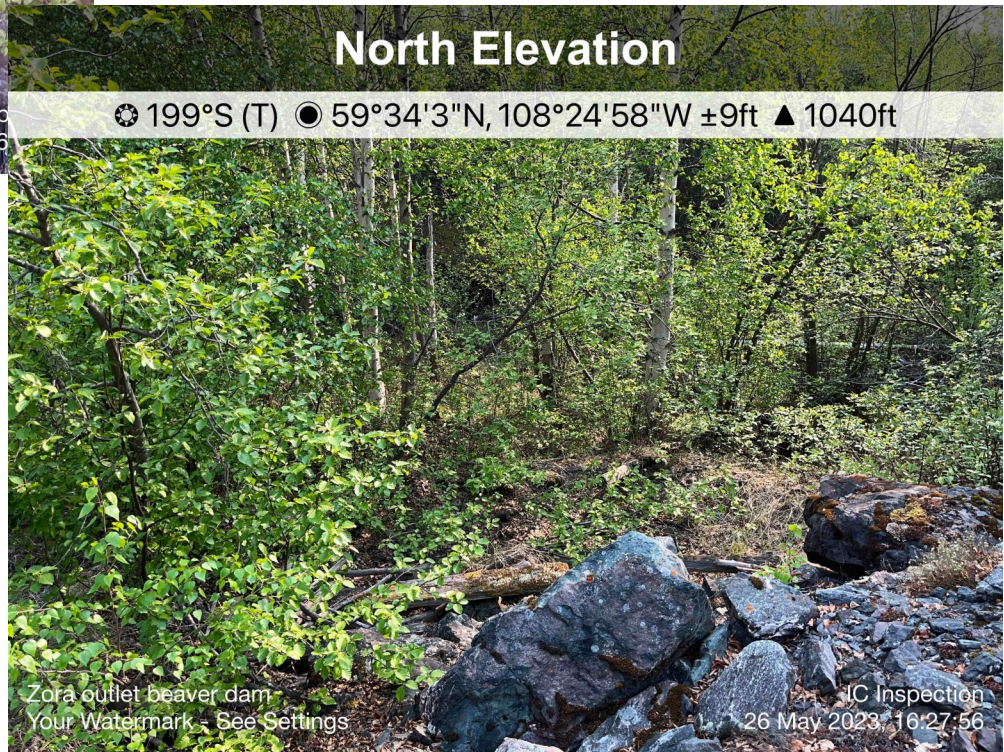
Photo E06—View near well-established beaver dam at outlet of Zora Lake, looking across Zora Creek looking south (May 2023)

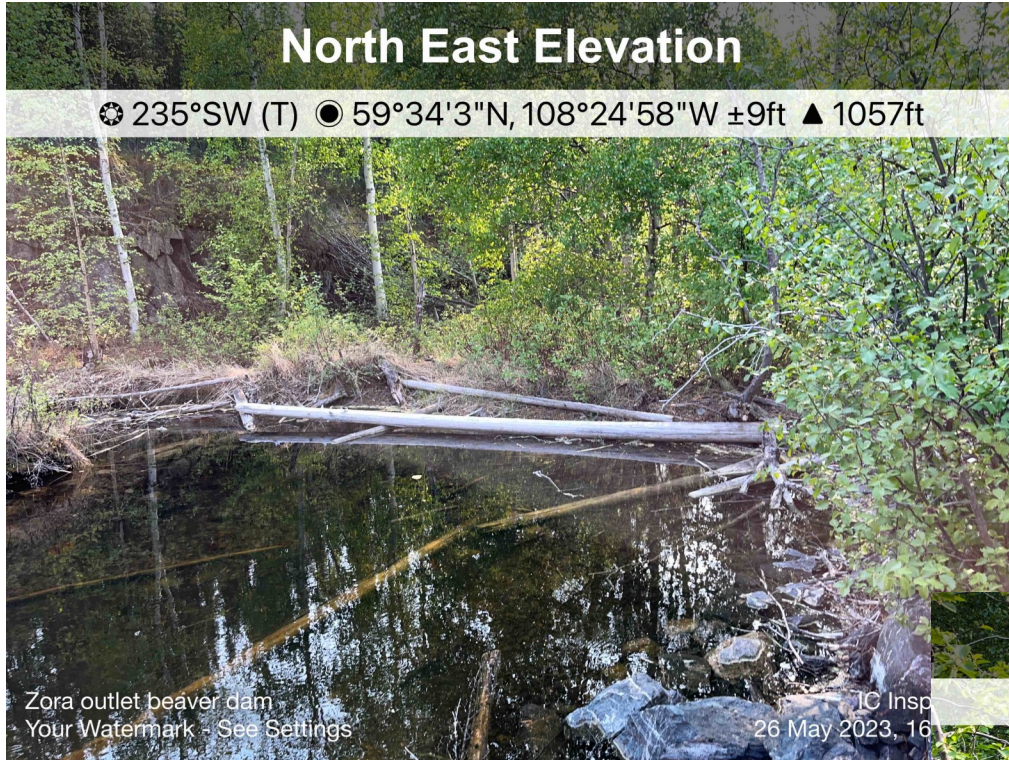
Photo E05—View of well-established beaver dam at the outlet of Zora Lake, looking downstream (May 2023)

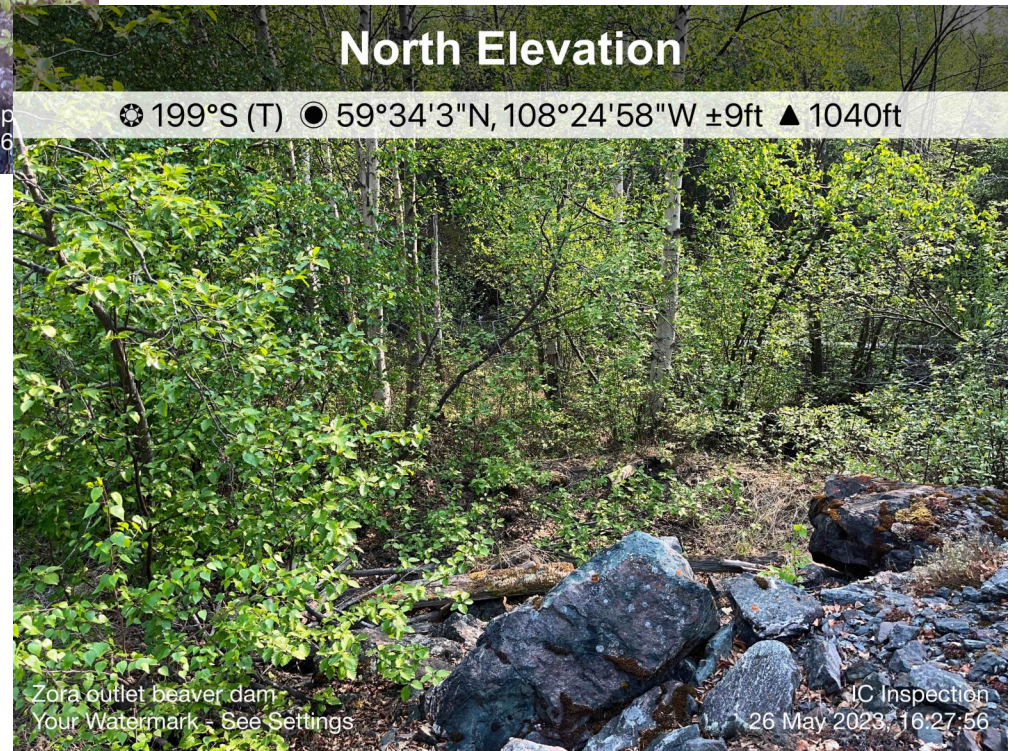
Photo E06—View near well-established beaver dam at outlet of Zora Lake, looking across Zora Creek looking south (May 2023)
