BEAVERLODGE PROJECT

Beaverlodge Project 2015 Annual Report

Year 30 Transition Phase Monitoring

Cameco Corporation

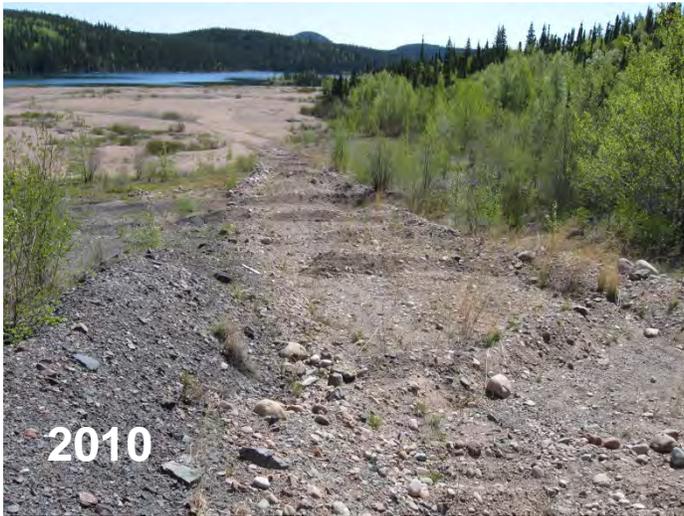
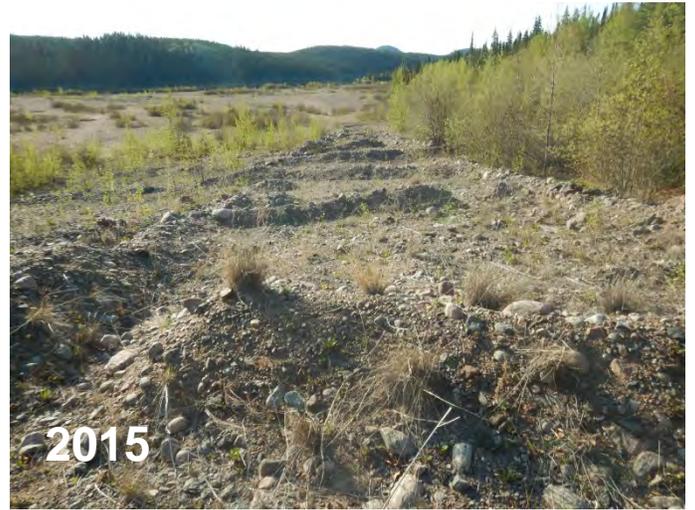
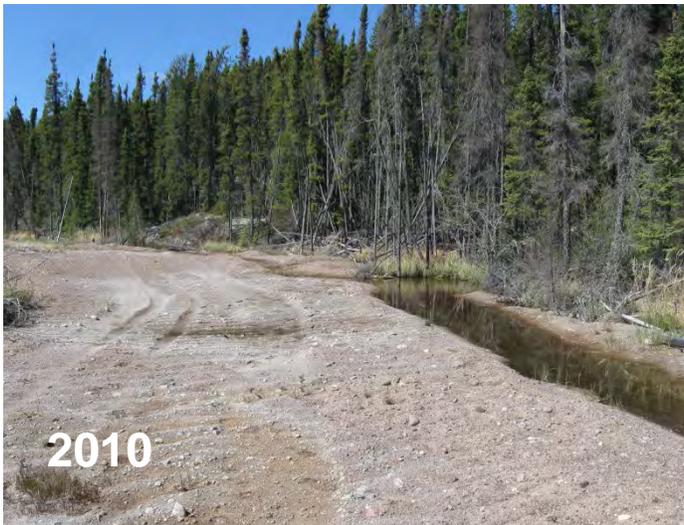
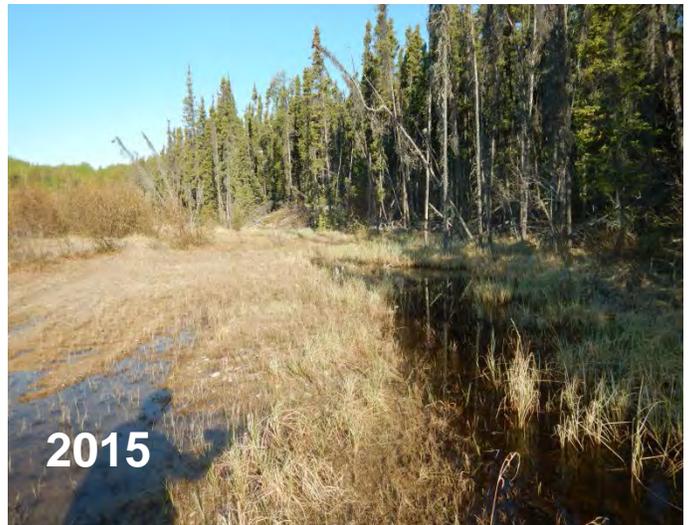
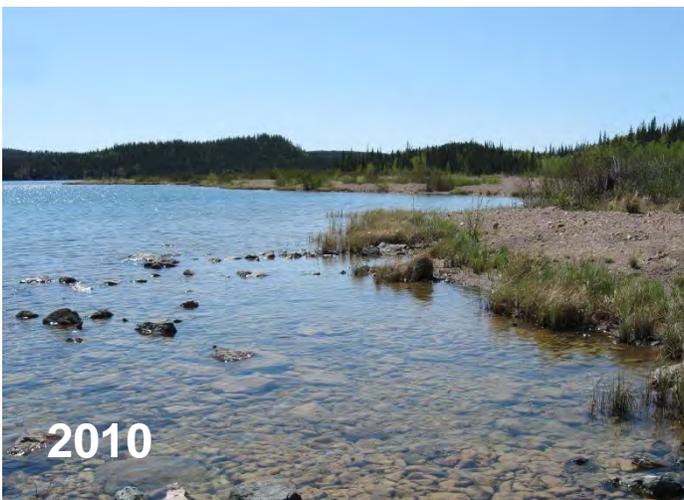
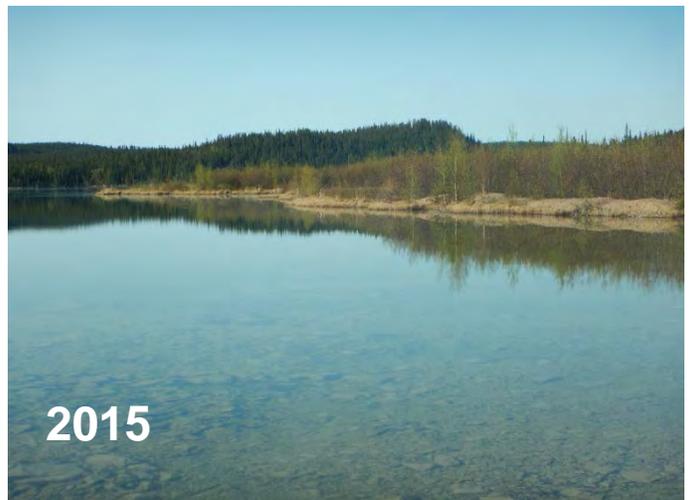
Although there are still extensive bare zones, vegetation continues to gradually spread and thicken over much of the cover (Photos 1 and 2). This is particularly evident, in the areas where “bundles” of shrubs were left in place on the 2007 cover to promote the establishment of vegetation “islands” and in areas where the water table is typically shallow, such as along the north side of the delta where drainage paths are present, and close to the Fookes Reservoir shoreline on the east side of the delta (Photo 3). The vegetation appears to be considerably more established than was the case in 2010 (Figure 3).

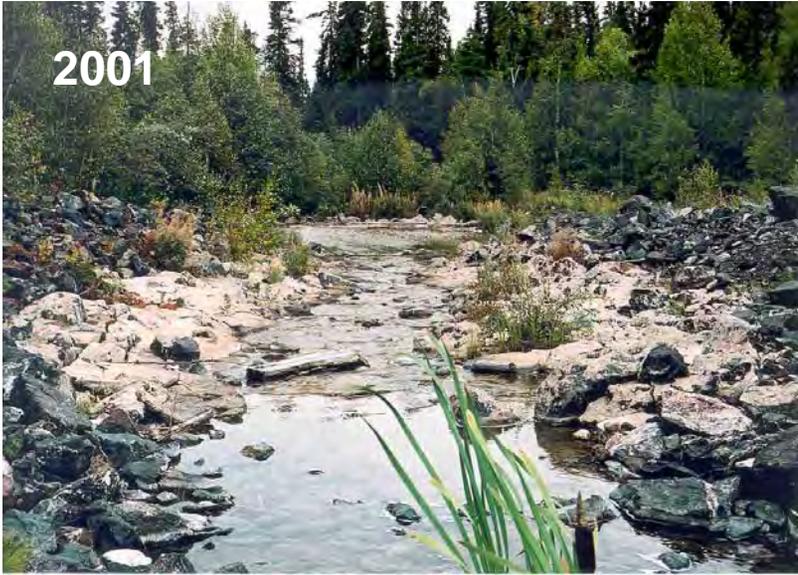
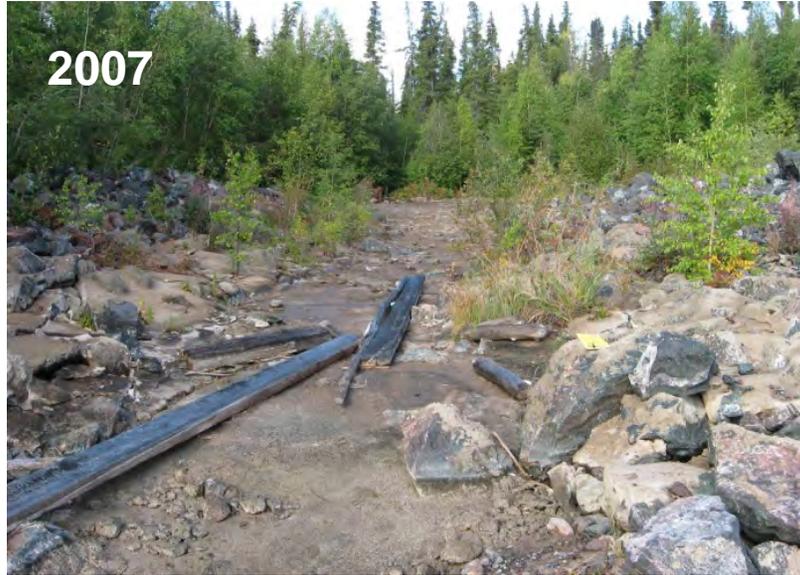
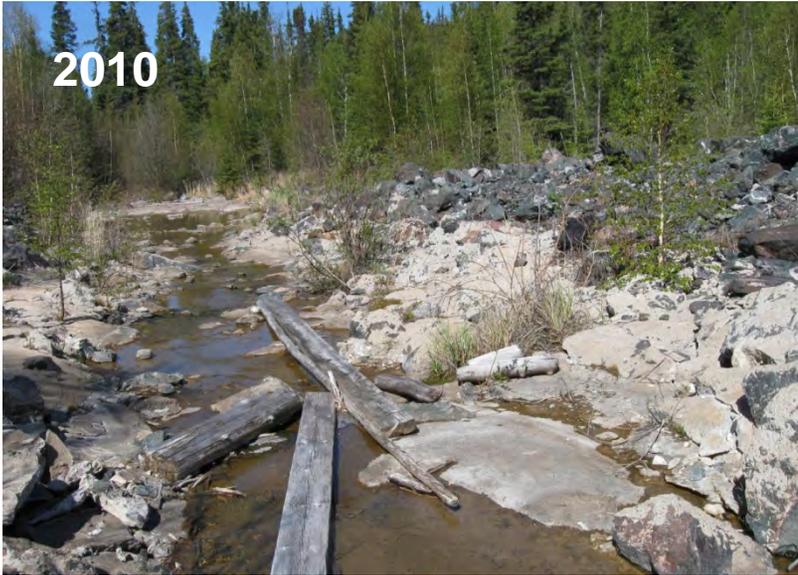
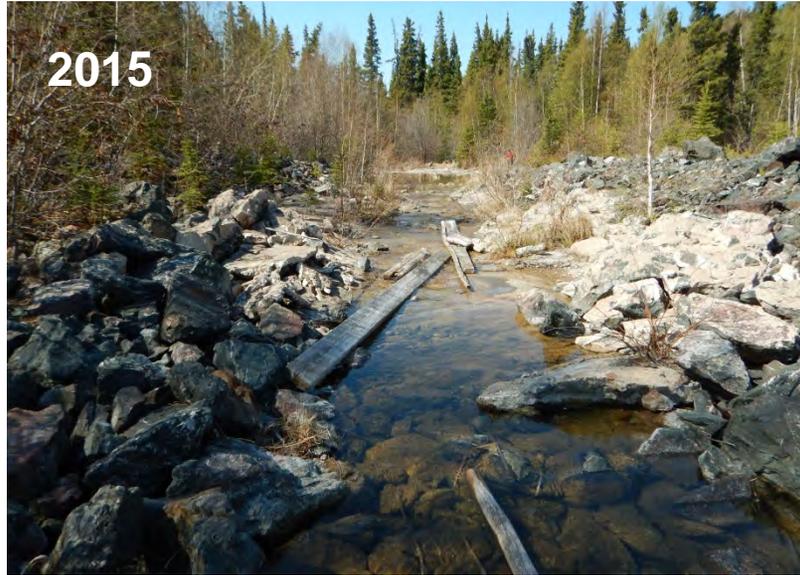
Changes in Fookes Reservoir Spillway Entrance Over Time

Observations suggest that the condition of the grout-intruded rip-rap along the length of the Fookes Reservoir outlet spillway in 2015 was very similar to its condition in 2010. The extent of the ice-jacking, with its most significant displacements located near the upper part of the spillway, i.e. on the sides of the spillway within 5 to 6 m of the spillway entrance, presented no obvious changes. Photos 13 and 15 (looking downstream) show the displaced slabs of grout-intruded rip-rap on the left side of the outlet spillway. Figure 4 provides an indication of how ice-jacking has progressed based on photos from inspections since 2001. The base of the channel does not show any signs of significant displacement.

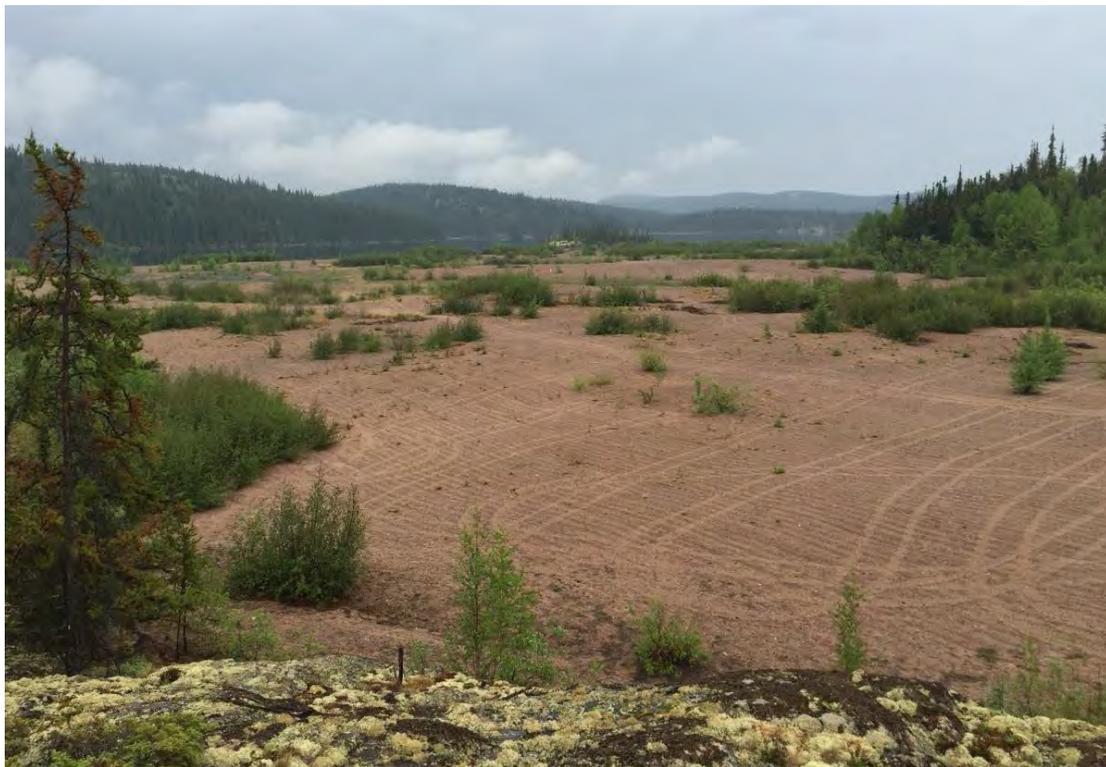
Photo 2: Looking southeastward across the delta cover on June 9, 2015. Note the vegetation "islands" that have formed.

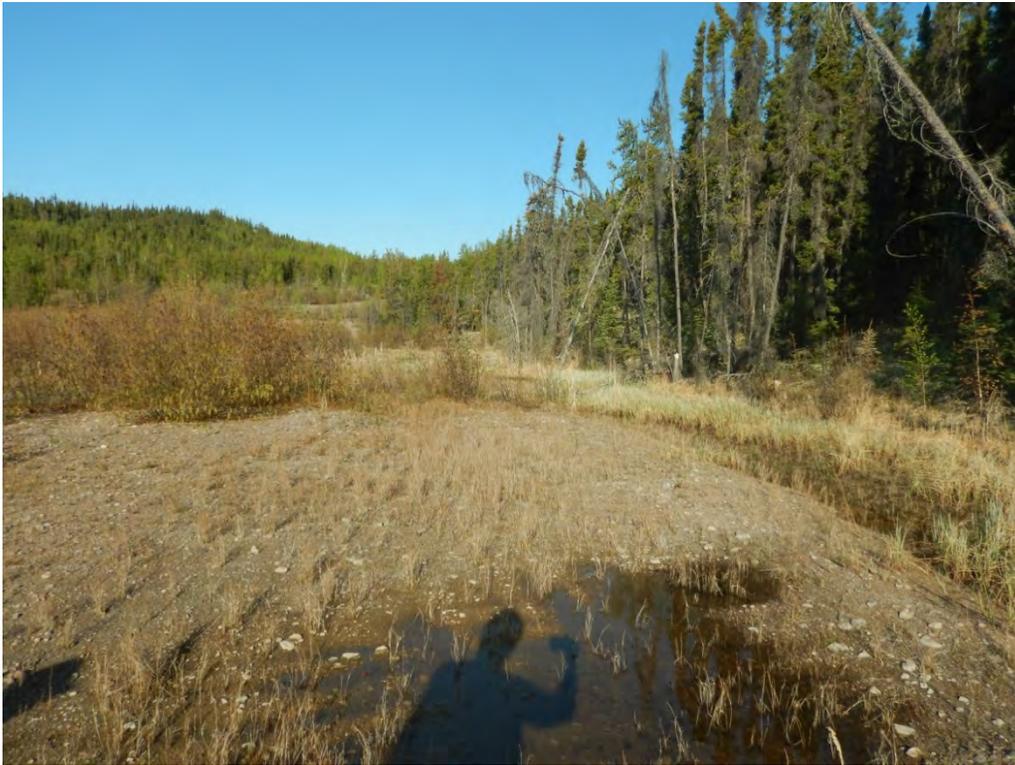
Photo 3: Looking southwestward along the upstream segment of the diversion ditch that runs along the north limit of the cover area on May 24, 2015. Access ramp is visible in the distance.

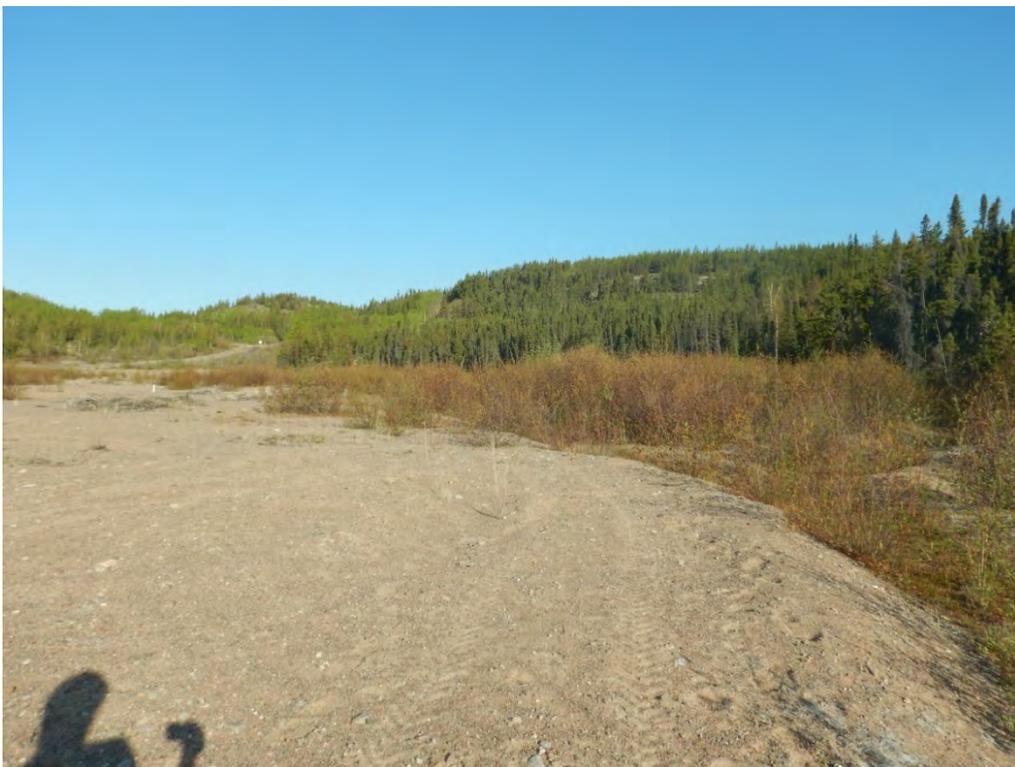
Photo 4: Photo 3: Looking westward along the middle segment of the diversion ditch that runs along the north limit of the cover area on May 24, 2015. Access ramp is visible in the distance.

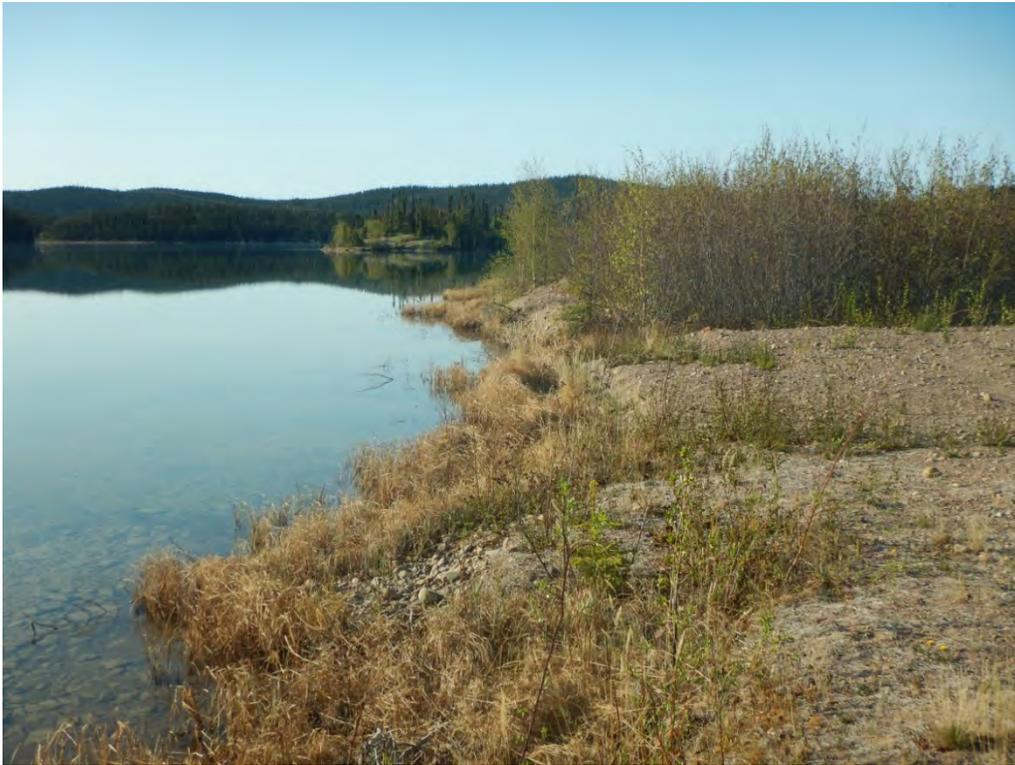
The edge of the cover, where it contacts Fookes Reservoir, was inspected with a view to evaluating the degree of erosion along the shore. A nominal amount of erosion from wave action was evident along the cover edge in 2010. In particular, sand from the cover in some areas had been transported a nominal distance into the reservoir as a submerged, very narrow, thin, fan-like deposit. This fan-like deposit typically extends into the reservoir up to a metre (Photo 10), though at one 6 m wide location, the sand extends about 3 to 4 m into the reservoir. In 2010, grasses and some shrubs were growing in this littoral sandy material. In 2015, it appears the vegetation continues to establish itself in this shoreline area and, as expected, has stabilized the edge of the sand/gravel cover. Given the size (and fetch limitation) of this reservoir, as well as the continued growth of vegetation along the delta shoreline, the risk that significant erosion will occur at the margin of the water/cover is considered negligible.

Photo 5: Looking southward along the shoreline in the northern part of the cover area on May 24, 2015.

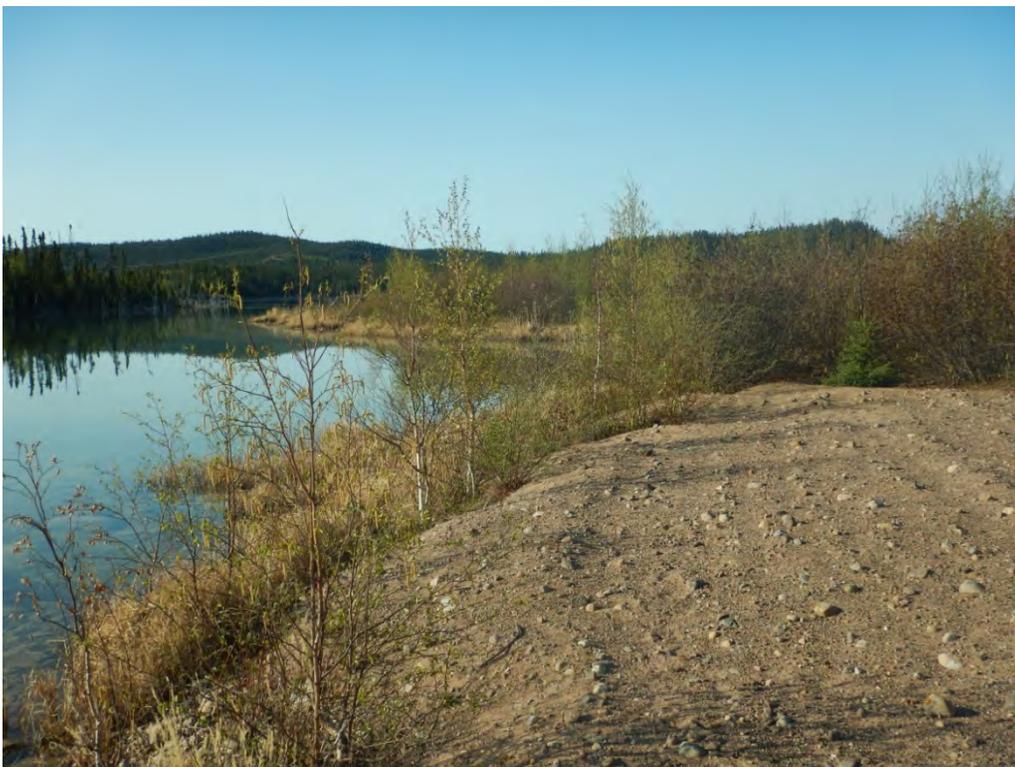
Photo 6: Looking southward along the shoreline in the northern part of the cover area on May 24, 2015.

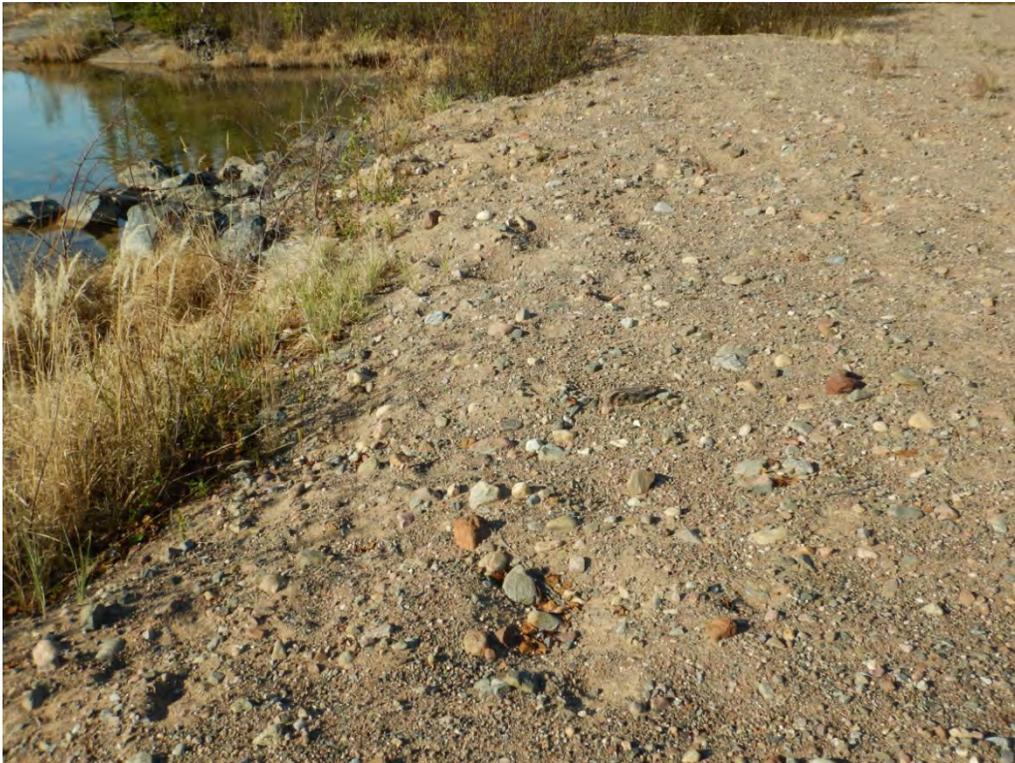
Photo 7: Looking southward at small depressions in the cover near the shoreline in the southern part of the cover area on May 24, 2015.

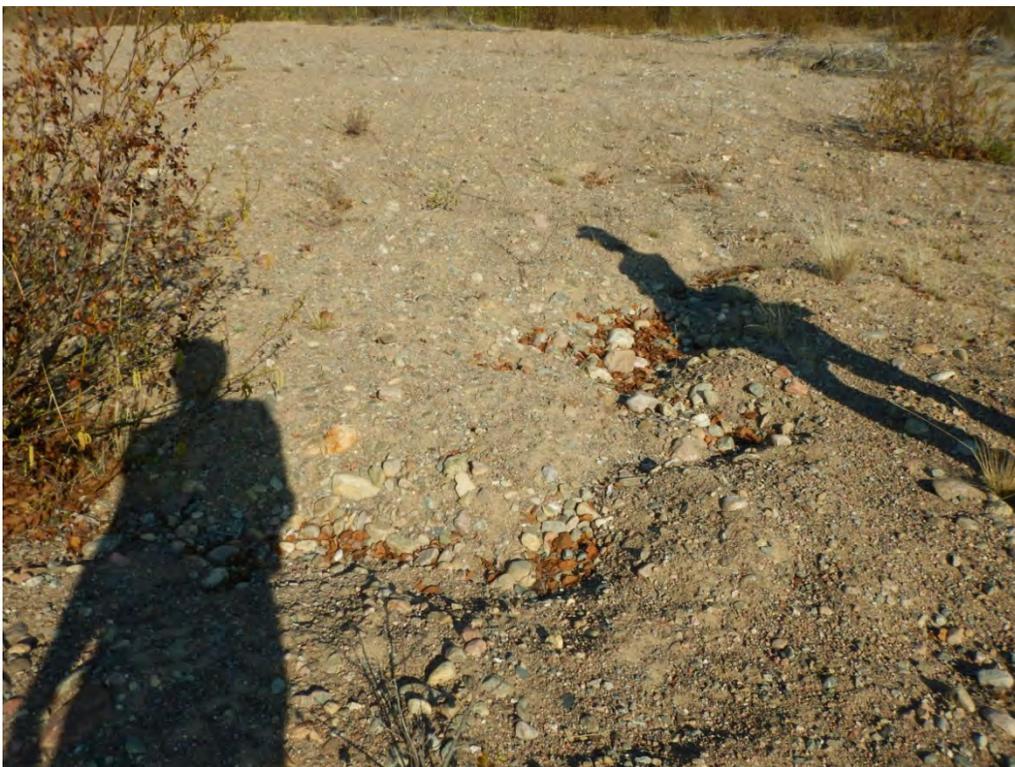
Photo 8: Looking westward, from close to the shoreline, where small depressions in the southern part of the cover have coalesced. Photo taken on May 24, 2015.

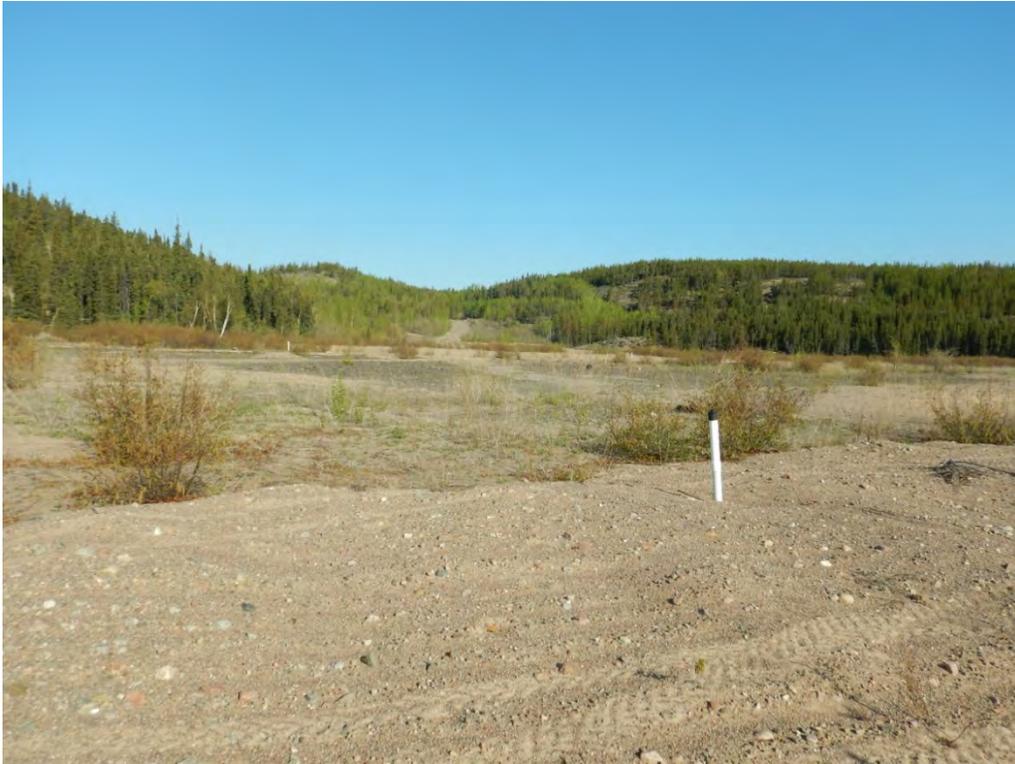
Photo 9: Looking westward across the central part of the cover, towards the access ramp, on May 24, 2015. The white pipe is the “housing” for a piezometer cable.

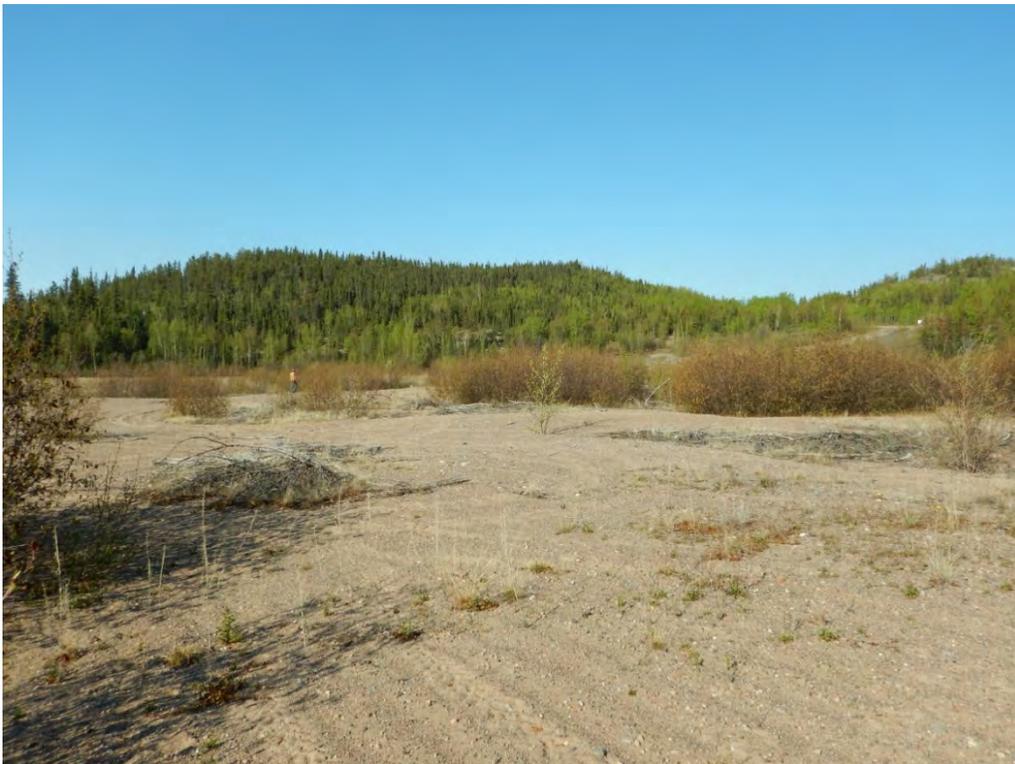
Photo 10: Looking southwestward across the central part of the cover on May 24, 2015. The access ramp is visible in the top right corner of the photograph.

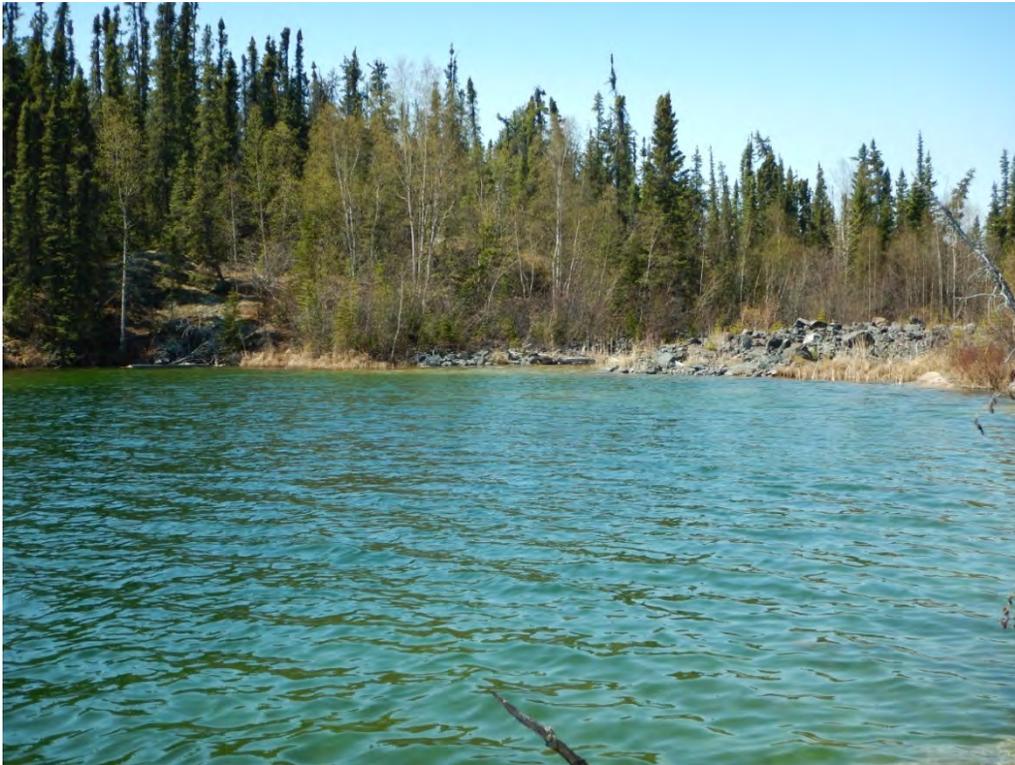
Photo 11: Looking southwest towards the upstream end of the Fookes Reservoir outlet spillway on May 21, 2015.

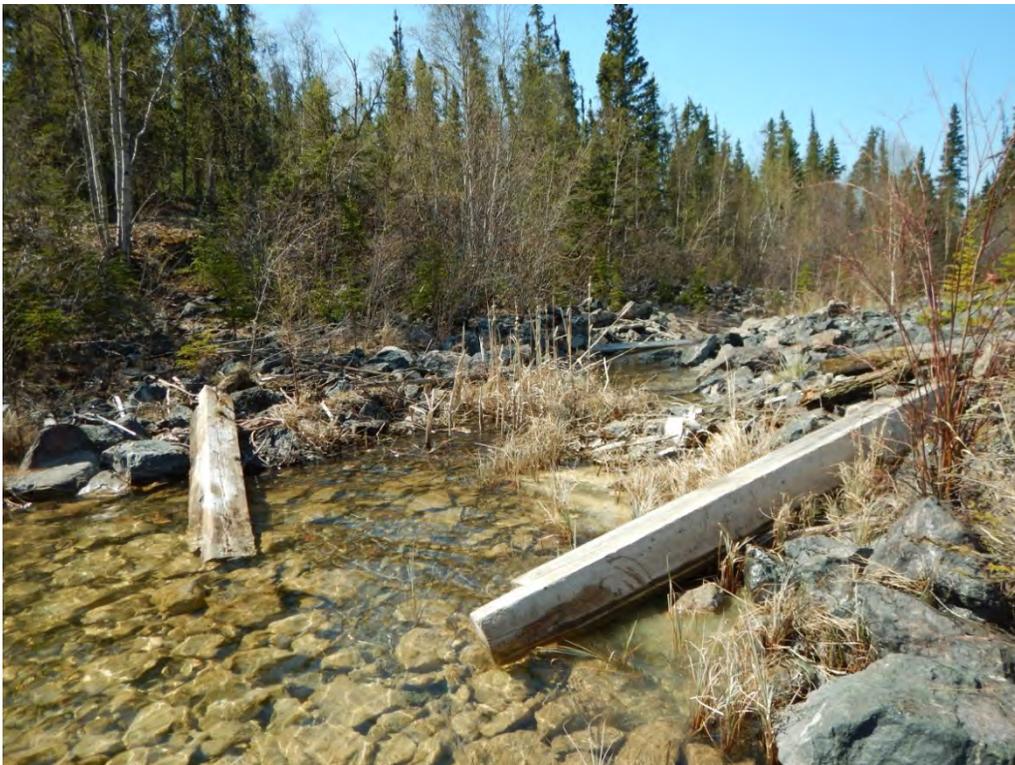
Photo 12: Close-up view of the upstream end of the outlet spillway on May 21, 2015.

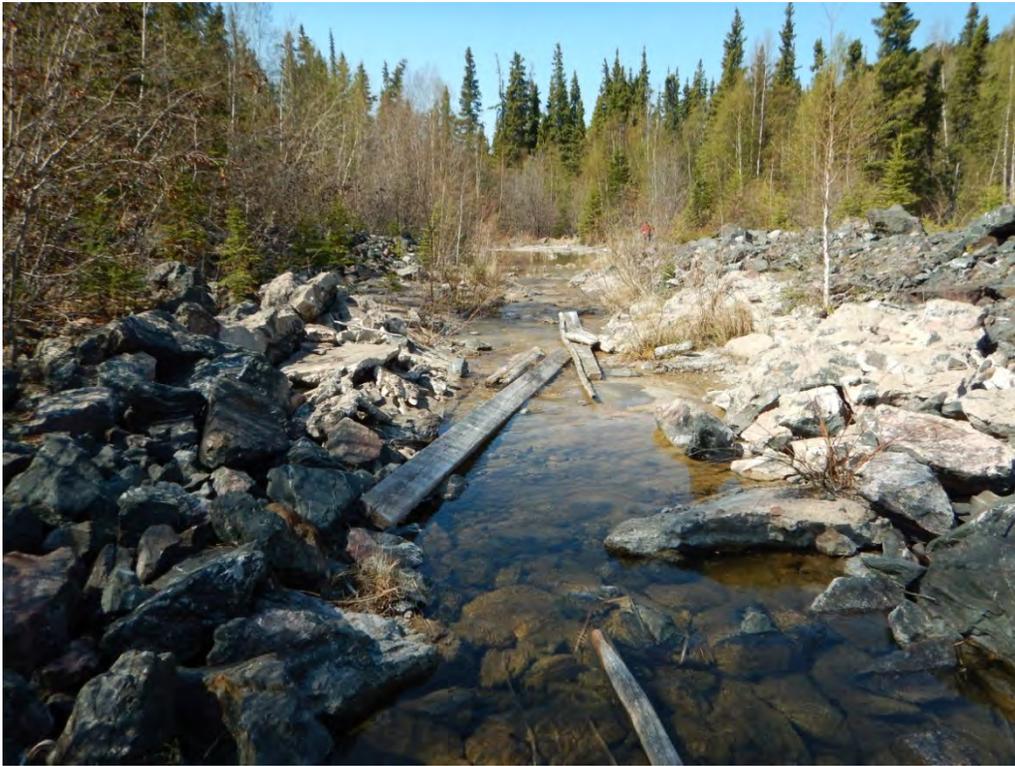
Compared to the upper part of the spillway (Photos 13 through 15), the middle and lower parts of the spillway (Photos 16 and 18) remain in much better condition. These areas have numerous cracks but there are no obvious changes to the cracks since 2010, nor is there significant evidence of ice-jacking. Vegetation continues to gradually develop a foothold in the cracks in the grout-intruded rip-rap along the spillway (Photos 13 to 18).

Photo 13: Looking downstream along the outlet spillway showing the ice-jacked slabs of grout-intruded rip-rap on the sides of the spillway. Photo taken on May 21, 2015.

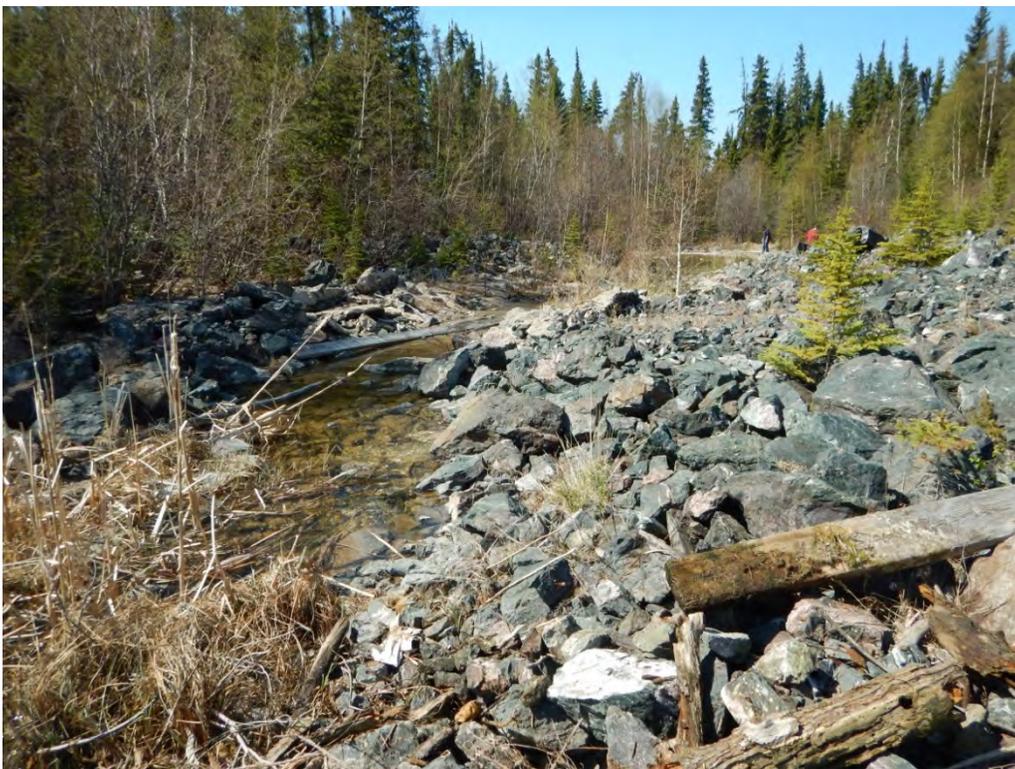
Photo 14: Similar view to Photo 13, taken on May 21, 2015. The stilling basin is visible in the distance.

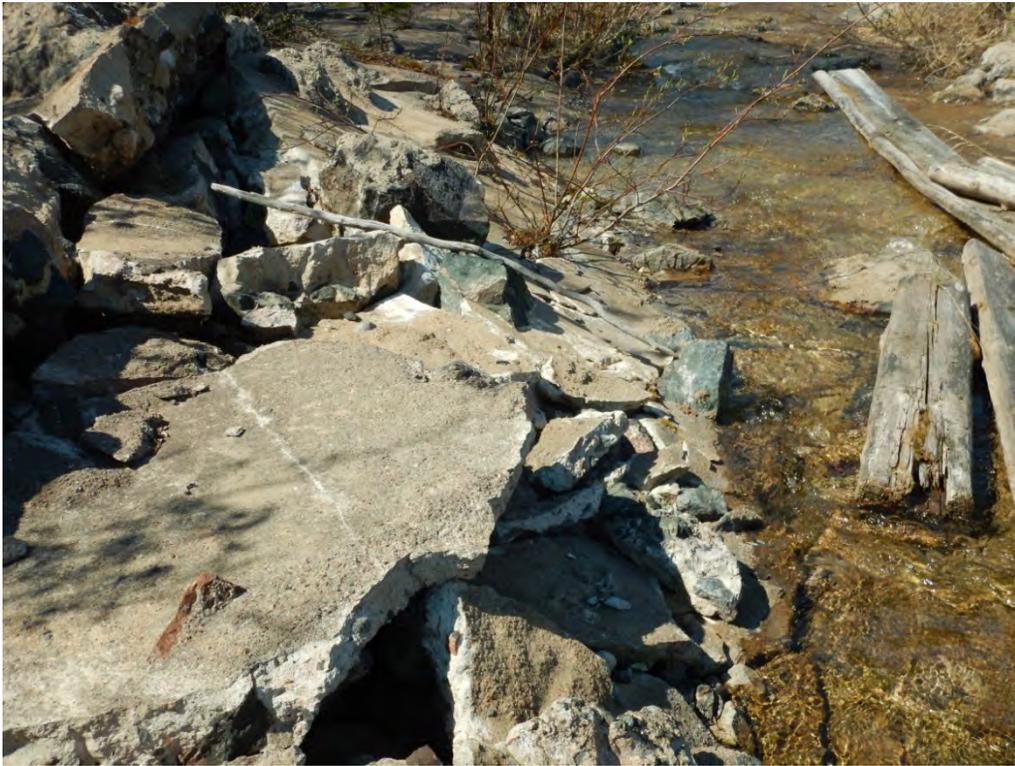
Photo 15: Close-up view of the ice-jacked slabs of grout-intruded rip-rap on the left side of the spillway. Photo taken on May 21, 2015.

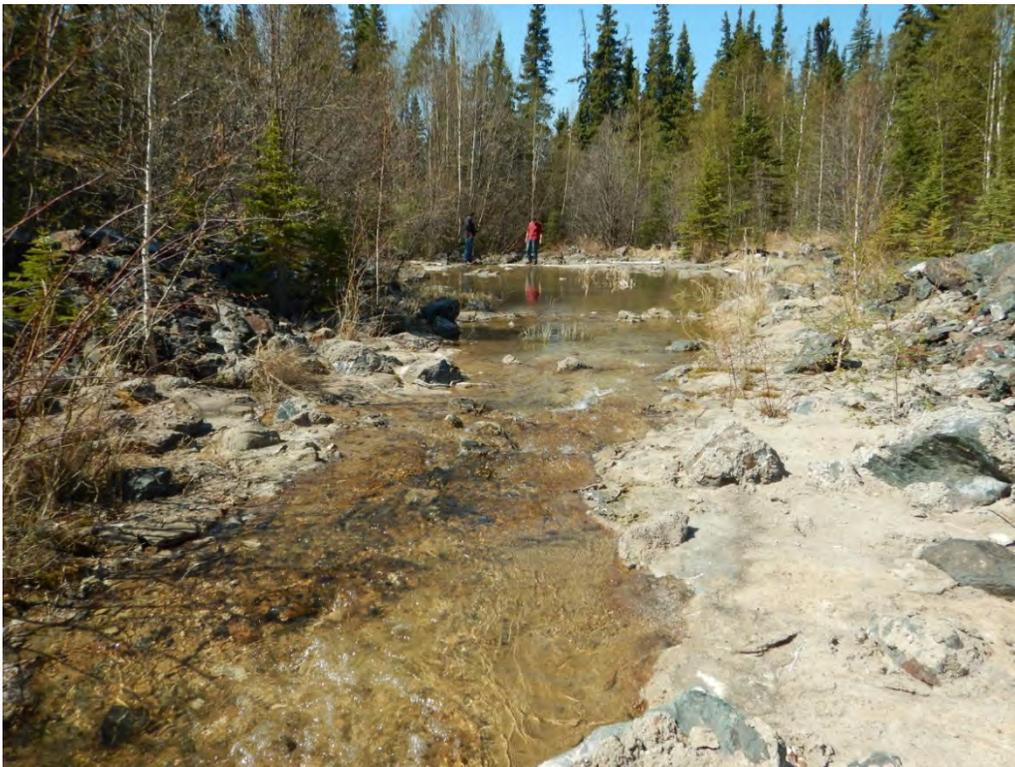
Photo 16: Photo looking downstream, taken near the middle segment of the outlet spillway, on May 21, 2015. The stilling basin is visible in the distance.

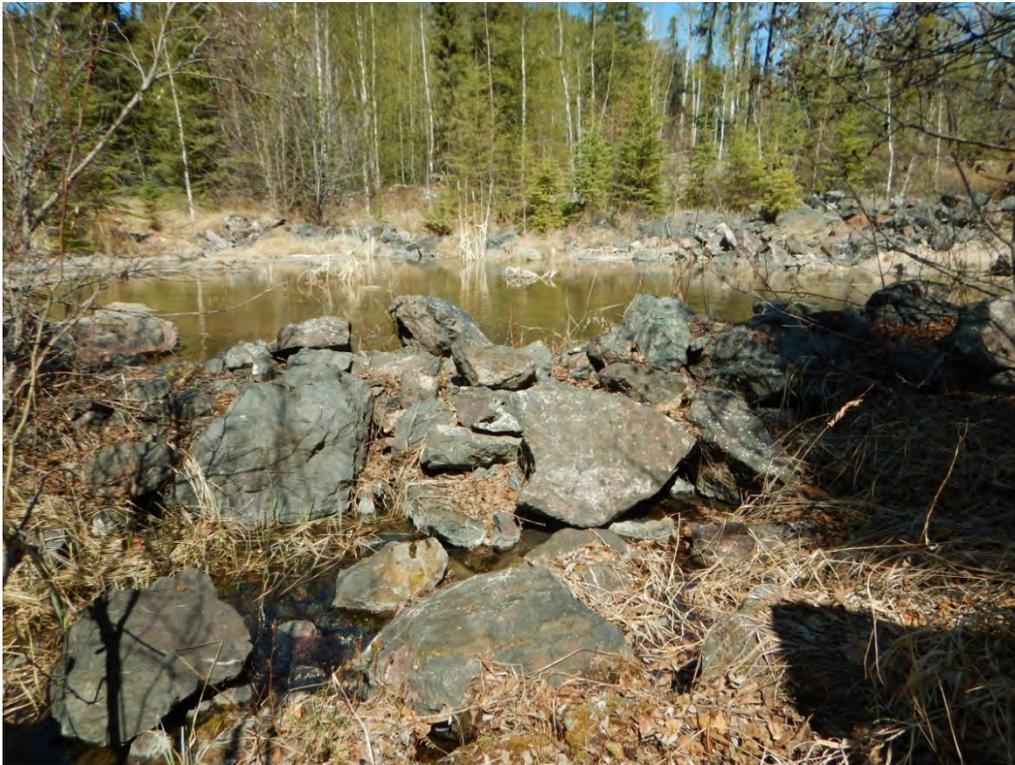
Photo 17: Looking upstream across the edge of the stilling basin at the location where most of the water leaves the basin.

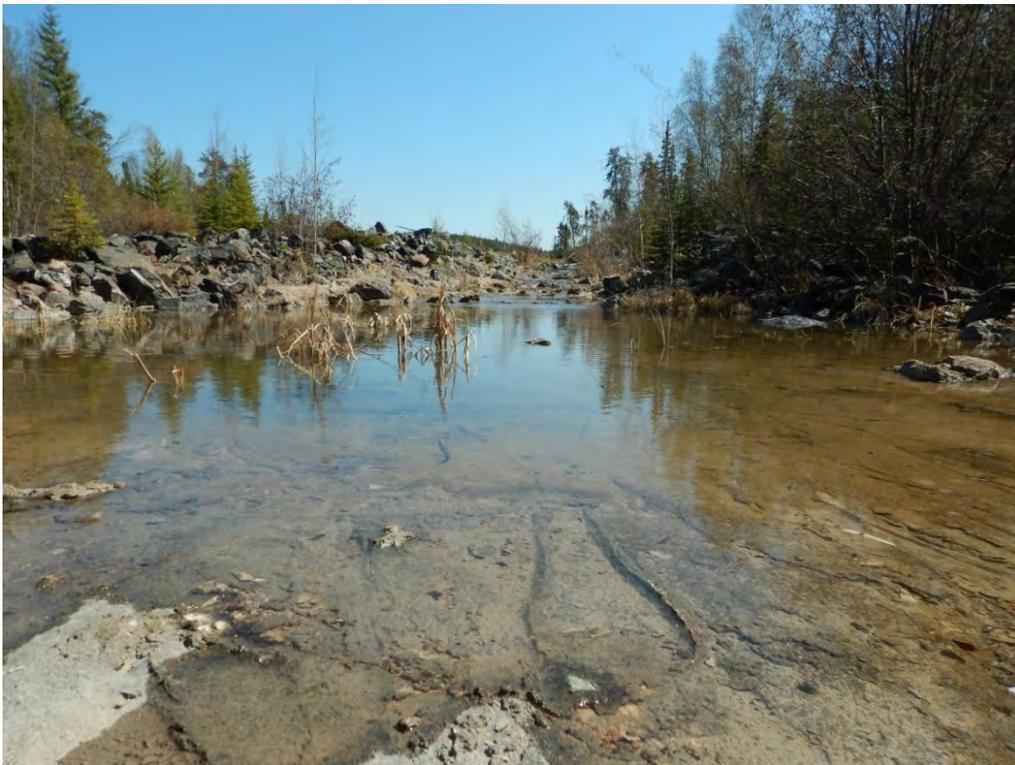
Photo 18: Looking up the outlet spillway from the stilling basin on May 21, 2015.

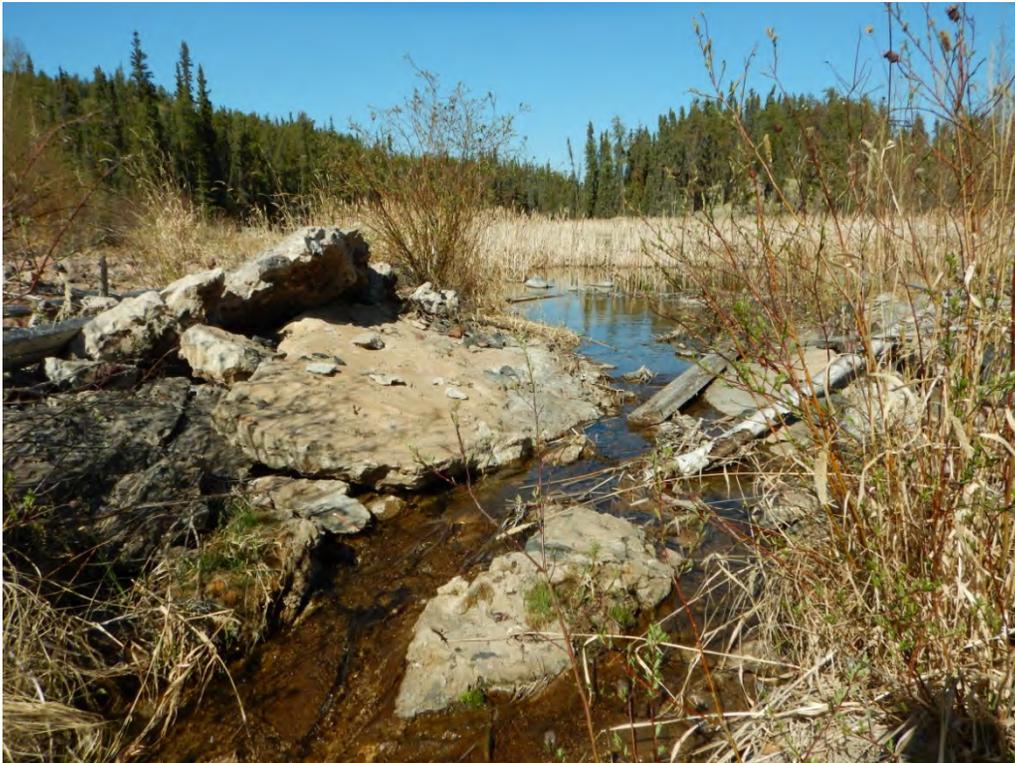
Observations indicate the Marie Reservoir outlet spillway has, in general, changed little since 2004. The grout-intruded rip-rap is relatively intact except near the spillway entrance where one large block slab and several smaller ones on the right side of the spillway (looking downstream) continued to displace incrementally due to ice-jacking (Photos 19 to 21). The ice-jacking has been evident since 2004 but, as shown in Figure 5, one of the ice-jacked slabs, which was “supporting” another slab in 2010, appears to have settled noticeably by 2015.

The beaver dam observed at the entrance to the Marie Reservoir outlet spillway in May 1997 was removed prior to the 1998 inspection. It appeared during the 1998 inspection that the beavers were starting to build another dam but, by the time of the 2001 inspection, only some remnant branches were evident. No beaver dam was evident at the entrance to the outlet spillway in 2004, 2007, 2010 or in 2015 (Photos 19 and 21).

Photo 19: Looking at ice-jacked slabs of grout-intruded rip-rap on the right side of the Marie Reservoir outlet spillway, near its upstream end on May 24, 2015.

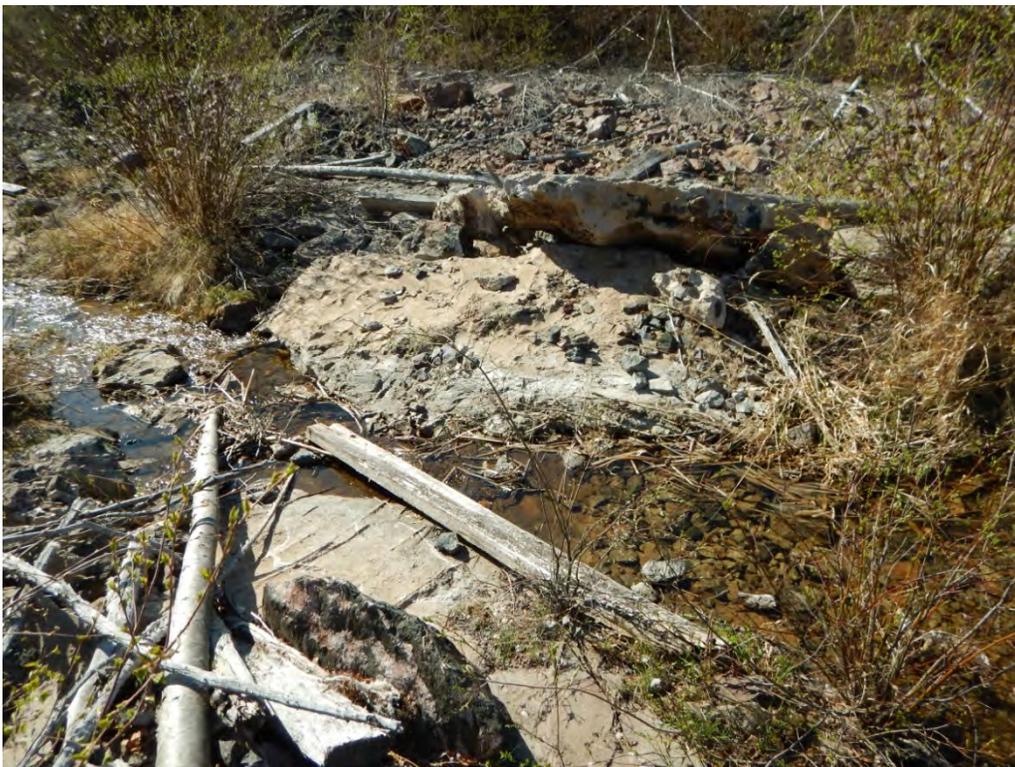
Photo 20: Looking across the spillway at the same ice-jacked slabs shown on Photo 19. Photo taken on May 24, 2015.

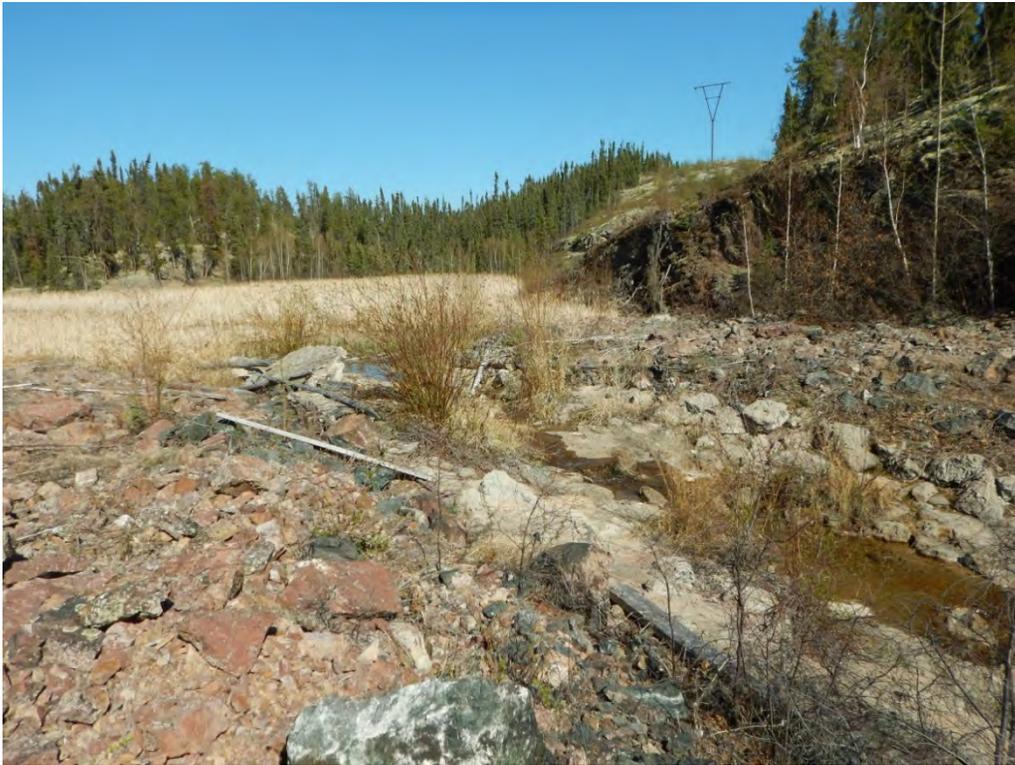
Photo 21: Looking upstream near the upstream end of the outlet spillway on May 24, 2015. The ice-jacked slabs of the grout-intruded rip-rap are visible at the entrance.

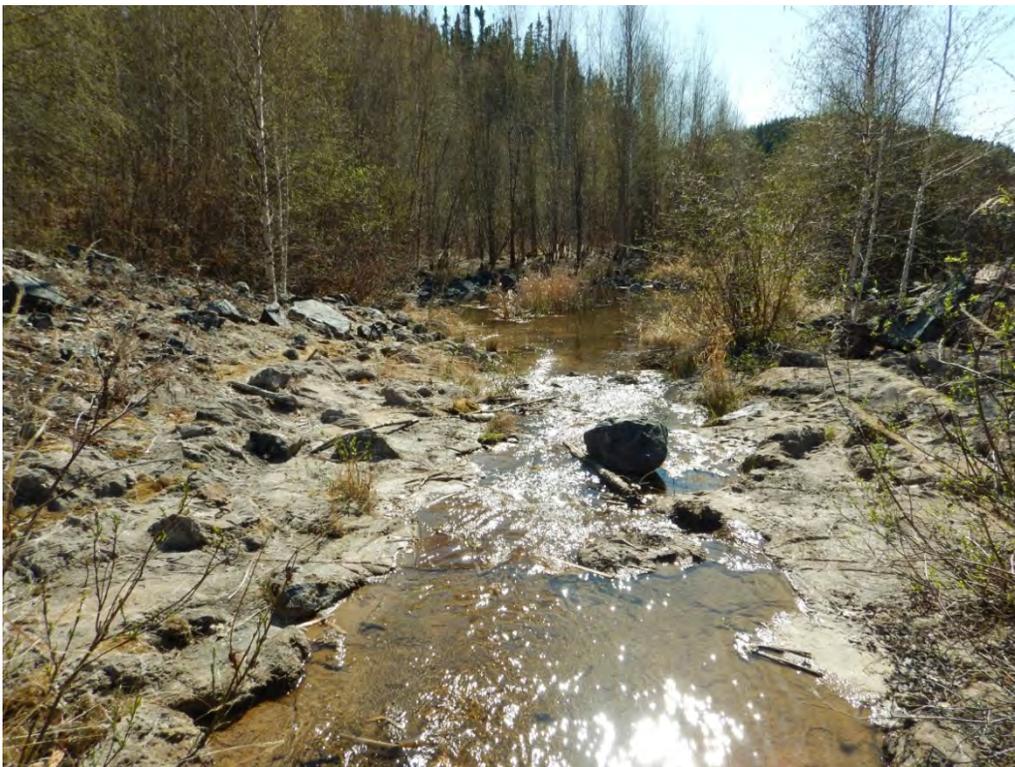
Photo 22: Looking downstream along the outlet spillway on May 24, 2015. The stilling basin is visible in the distance.

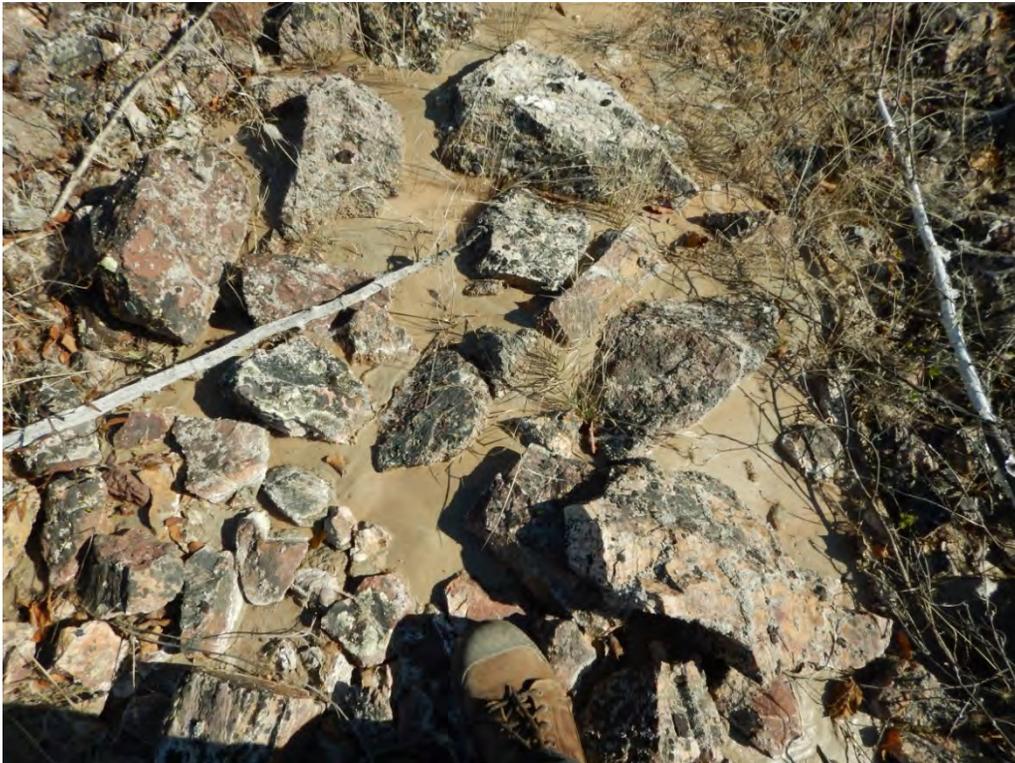
One unusual feature evident in 2015, and not previously observed, was a zone of very spongy ground to the left of the spillway, very close to the spillway inlet (Photos 23 and 24). The spongy area was about 4 m by 2 m and was characterized by waste rock overlying what appeared to be grey, clayey silt; the silt appears to have worked its way to surface and was visible over a portion of the spongy ground. The silt classification was based on the fact that this material was highly

Photo 23: Looking at the grey, clayey silt coinciding with the spongy area on the left side of the outlet spillway, near its upstream end. Photo taken on May 24, 2015.
