BEAVERLODGE PROJECT

Beaverlodge Project 2015 Annual Report

Year 30 Transition Phase Monitoring

Cameco Corporation

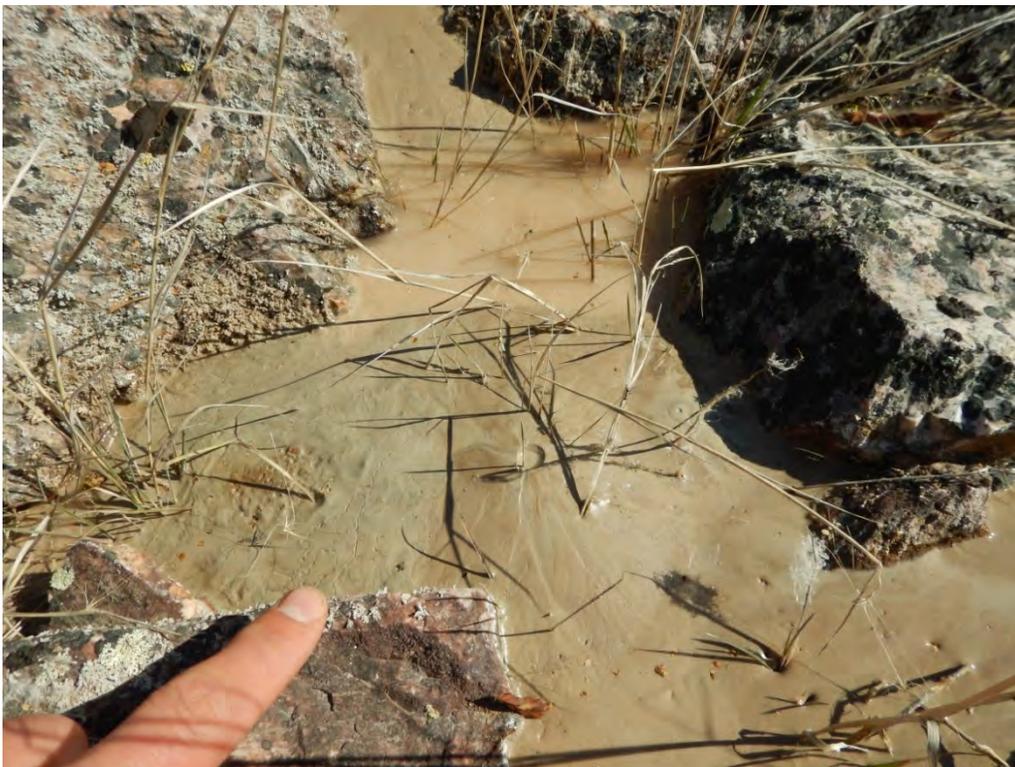
One unusual feature evident in 2015, and not previously observed, was a zone of very spongy ground to the left of the spillway, very close to the spillway inlet (Photos 23 and 24). The spongy area was about 4 m by 2 m and was characterized by waste rock overlying what appeared to be grey, clayey silt; the silt appears to have worked its way to surface and was visible over a portion of the spongy ground. The silt classification was based on the fact that this material was highly

Photo 24: Close-up of the grey, clayey silt shown in Photo 23 on May 24, 2015. Note the boil-like feature in the center of the photo.

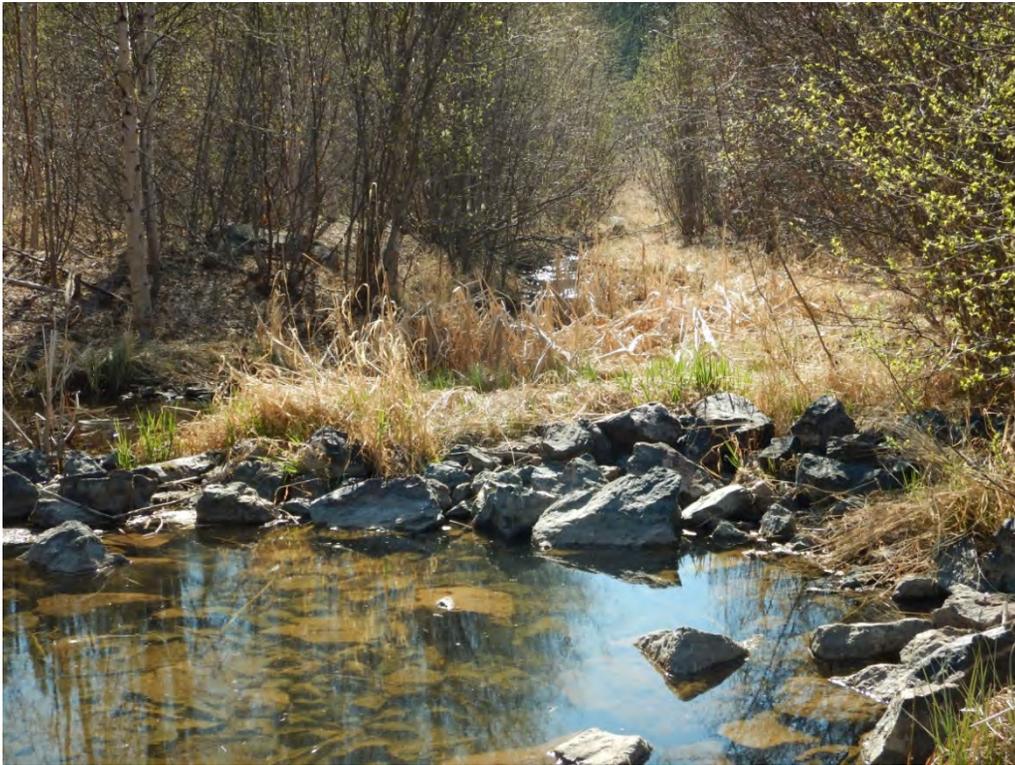
Photo 25: Looking at the downstream edge of the stilling basin on May 24, 2015. The natural creek is visible downstream side of the basin.

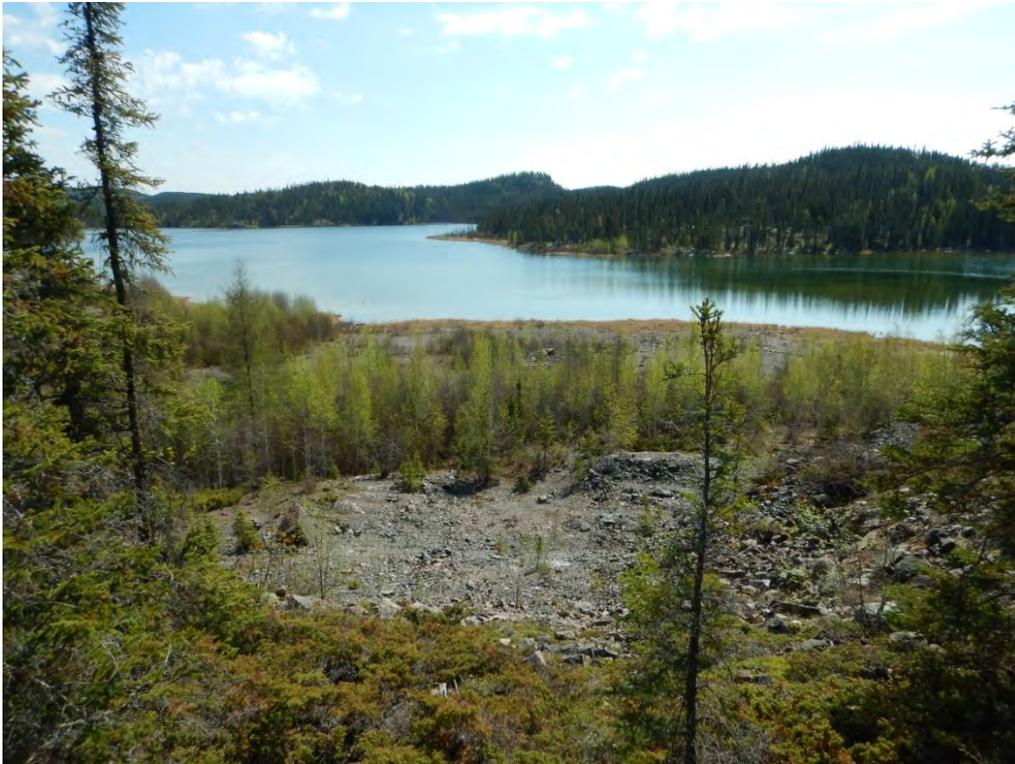
Most of the Marie Reservoir west delta is covered by rock fill provided from three quarries which were developed immediately above the delta (one of the quarries is visible in the foreground of Photo 26). Small trees, shrubs and some grasses are present on some parts of the cover (Photos 26, 27, 29 and 32).

Photo 26: Looking southeastward across the Marie Reservoir west delta area on May 24, 2015. The water body is Marie Reservoir.

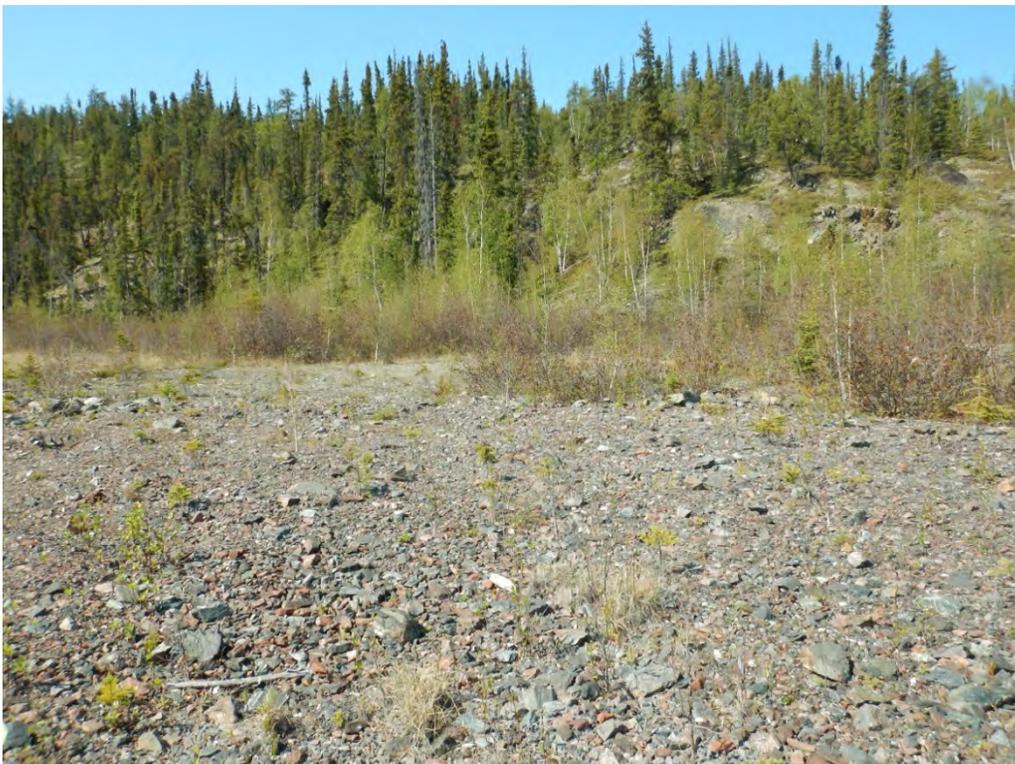
Photo 27: Looking northwestward across west delta area on May 24, 2015.

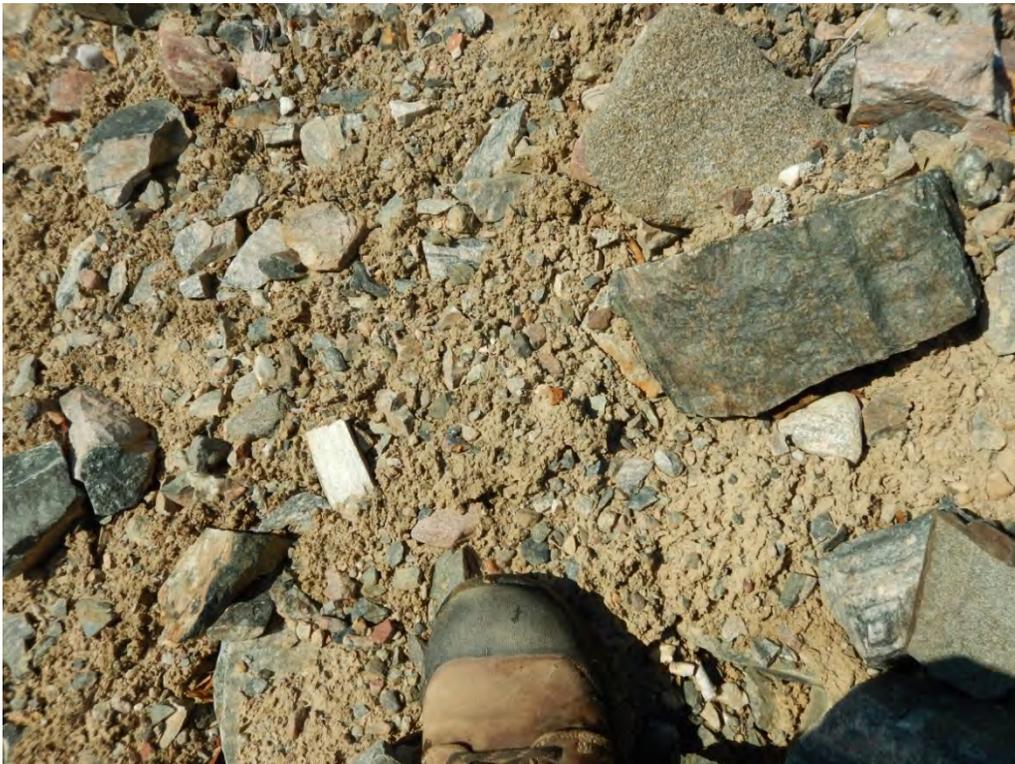
squeezed up through the rock fill (Photos 28 to 31) and/or the tailings immediately below the cover can be easily “pumped” by the cyclic application of foot pressure. Salts are evident on the surface of some of these exposed tailings (Photos 29 to 31). Notwithstanding the presence of exposed tailings at a number of locations, the condition of the cover over the rest of the west delta is generally good.

Photo 28: Typical exposure of tailings which day-lighted through the rockfill cover on the west delta area, likely prior to the 2004 geotechnical inspection. Photo taken on May 24, 2015.

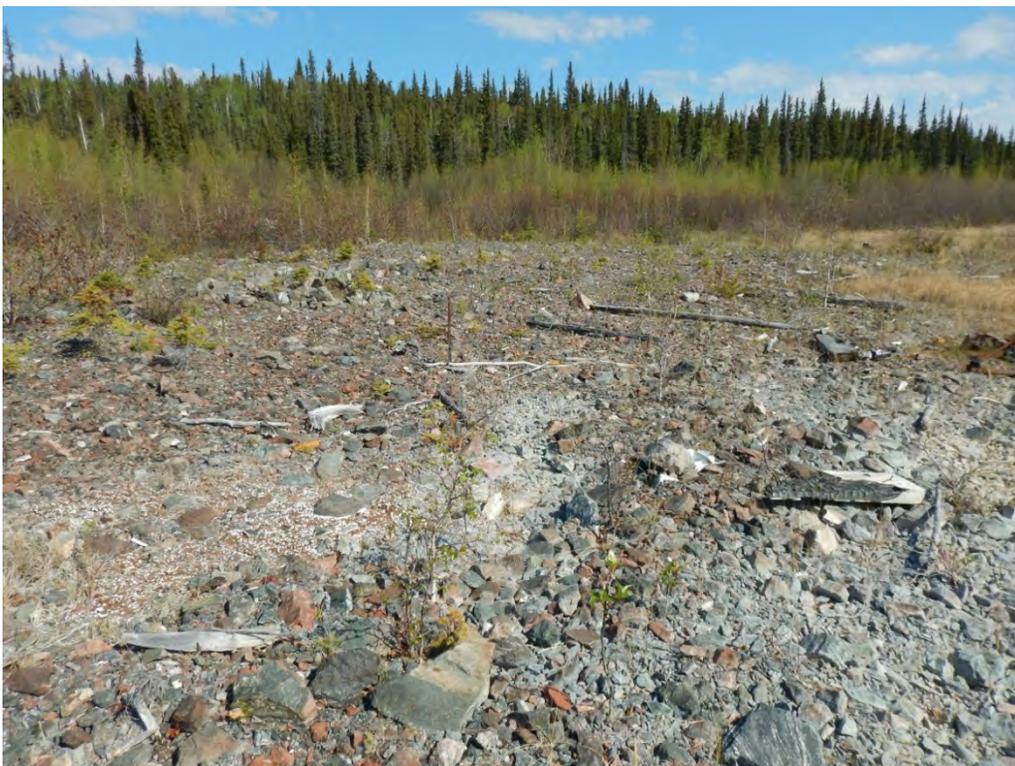
Photo 29: Another area on the cover where tailings have day-lighted. Salts are evident on the surface of the tailings (see close-ups on Photos 30 and 31). Photos taken on May 24, 2015.

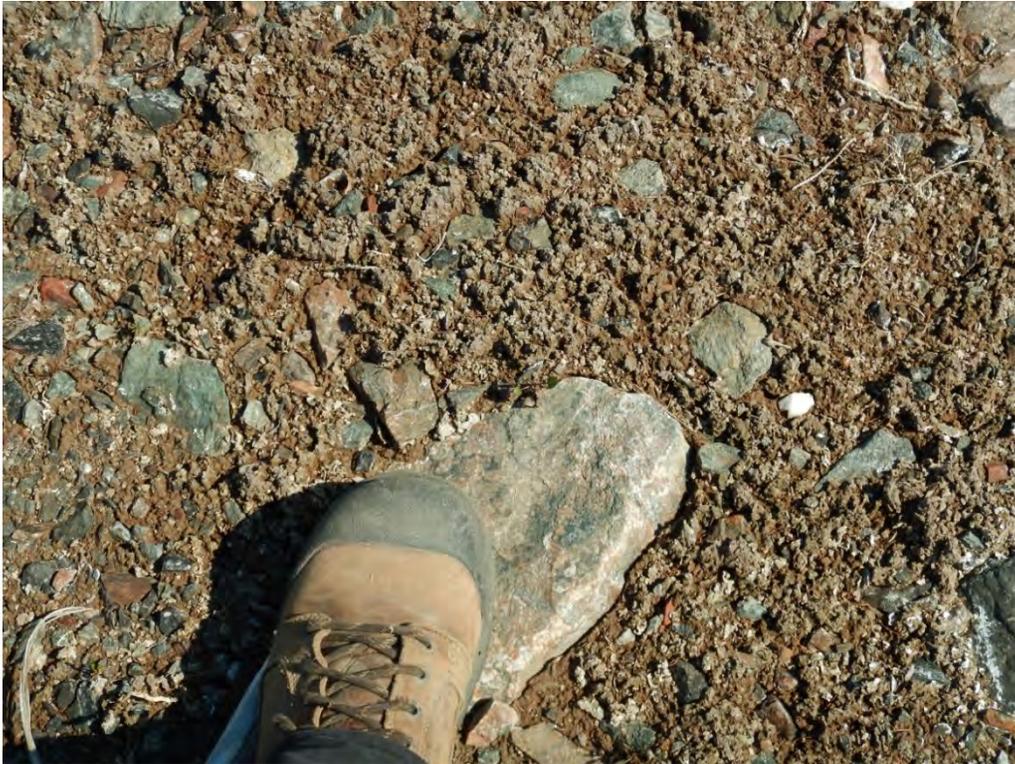
Photo 30: Close-up of the exposed tailings shown in Photo 29.

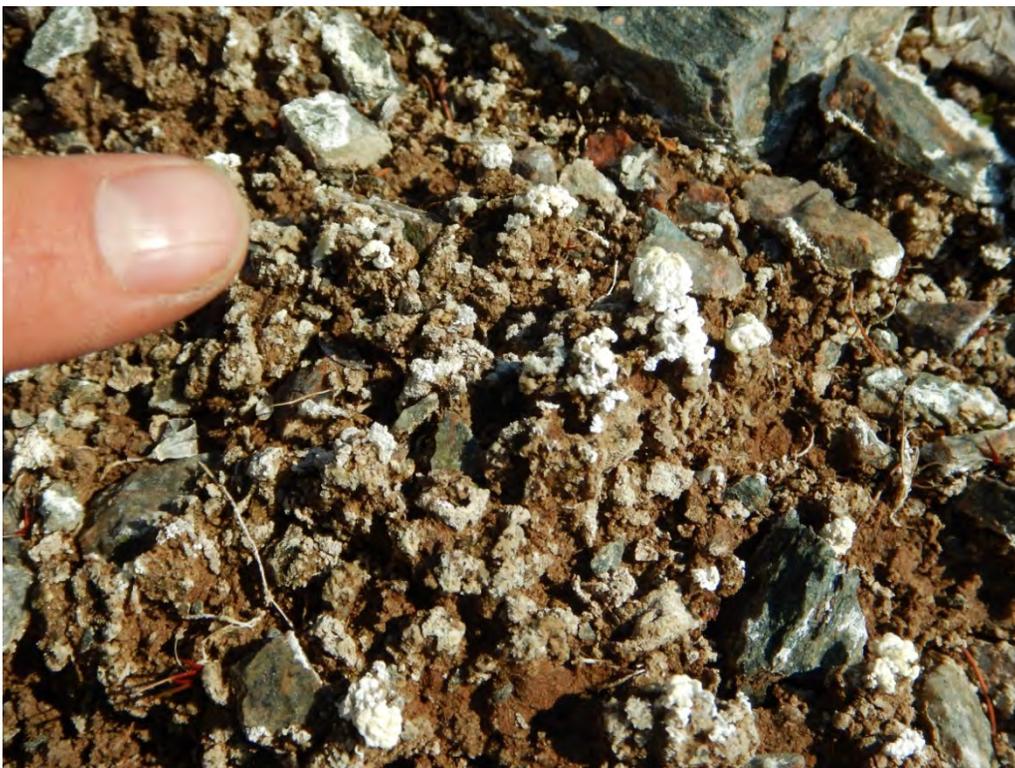
Photo 31: Close-up of salts visible on the surface of exposed tailings on the west delta area.

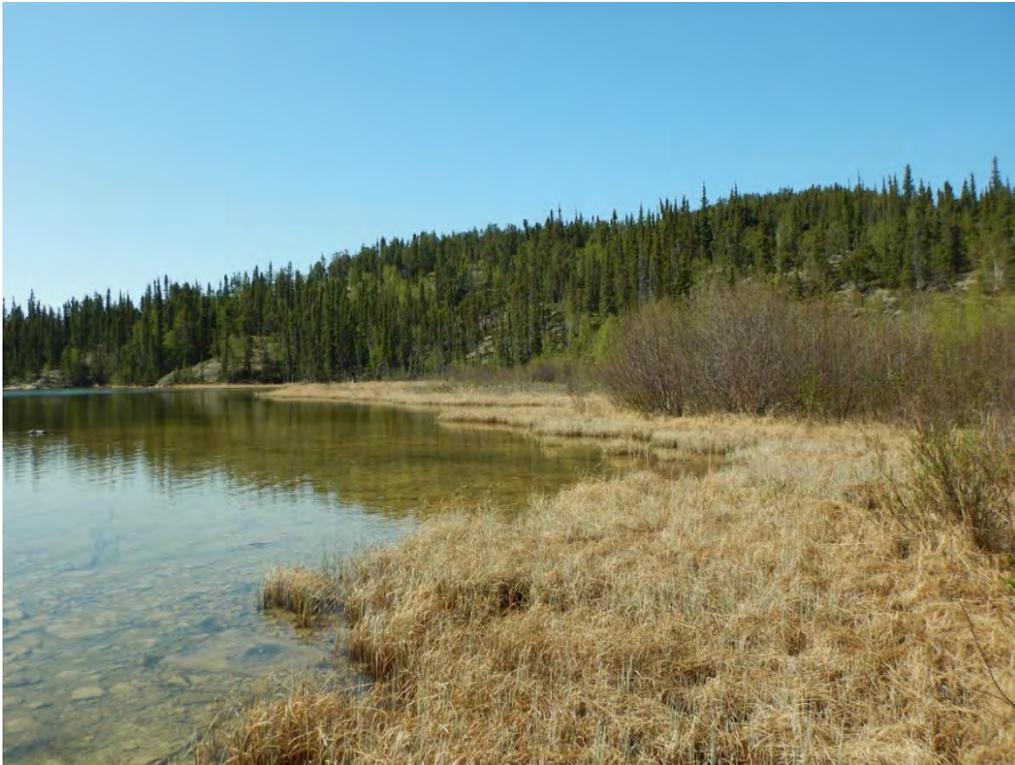
Photo 32: Looking westward along the shoreline of the west delta cover. Rockfill cover is visible below the water surface. Photo taken on May 24, 2015.

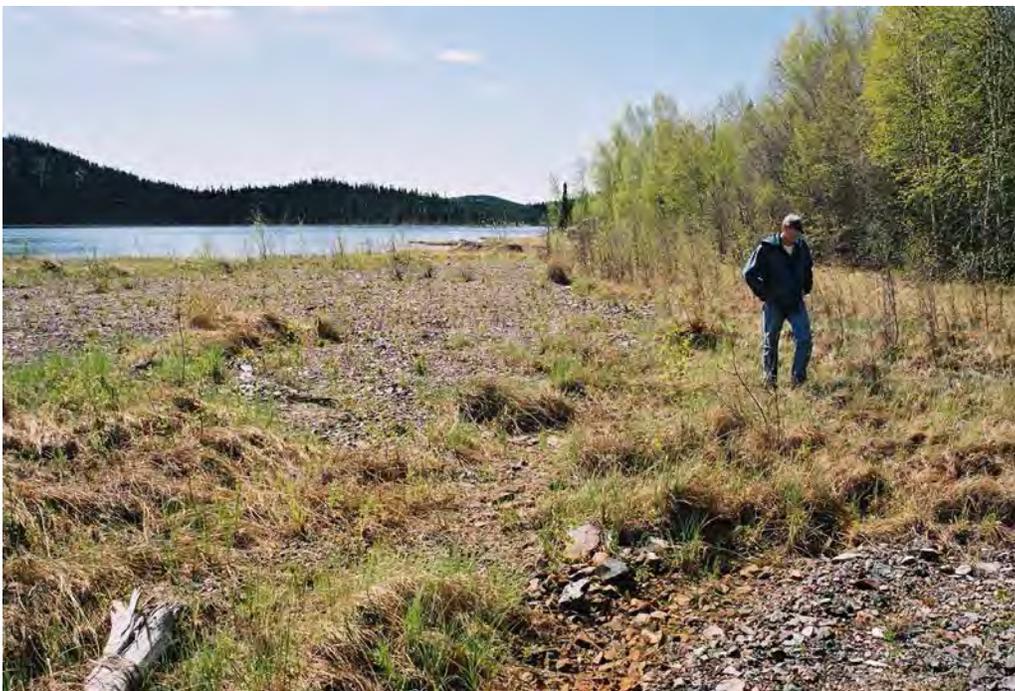
The Marie Reservoir east delta is much smaller than the Marie Reservoir west delta. Rock fill covers the delta (Photo 33); grasses and small shrubs are present on some parts of the cover. The condition of the cover is generally good despite the fact that tailings have come up through the rock fill at a few isolated locations.

Photo 33: Looking westward along the shoreline of the east delta cover on June 20, 2004.

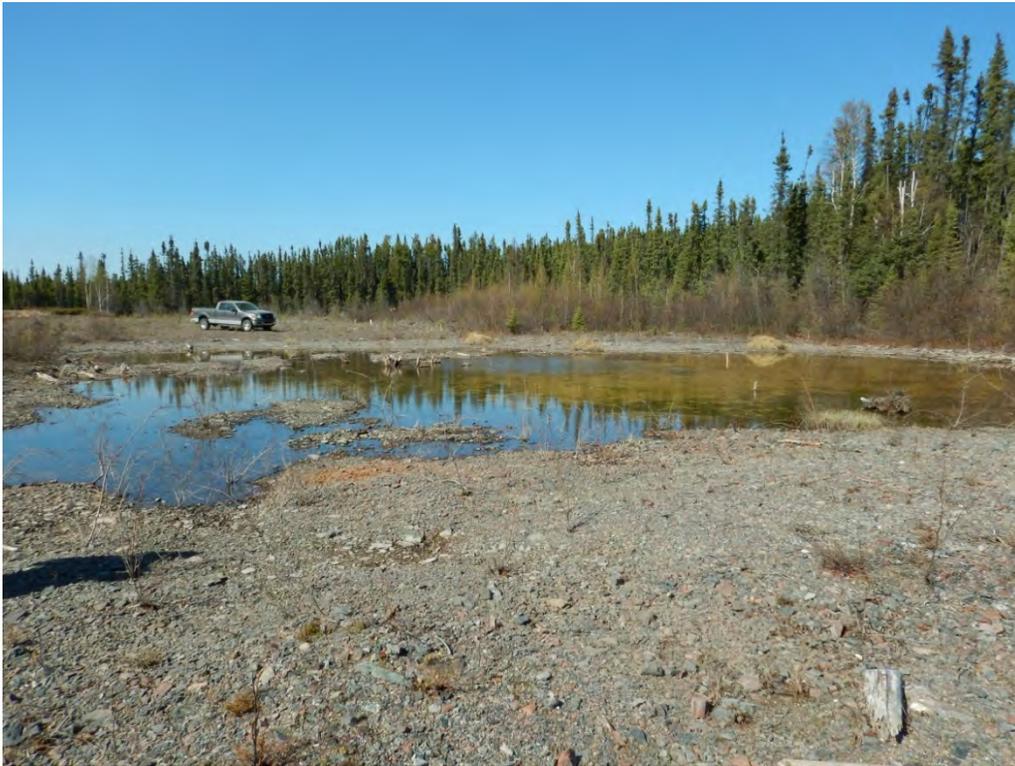
There was also a small diameter shallow pond near the south end of catchment area III (Photos 34 to 36). The mud line of a previous pond level was about 82 m wide at its widest point and 95 m wide in a north-south direction, much larger than the pond area at the time of the visit.

Photo 34: Looking northward across the pond area at the south end of Ace Creek catchment area III on May 20, 2015.

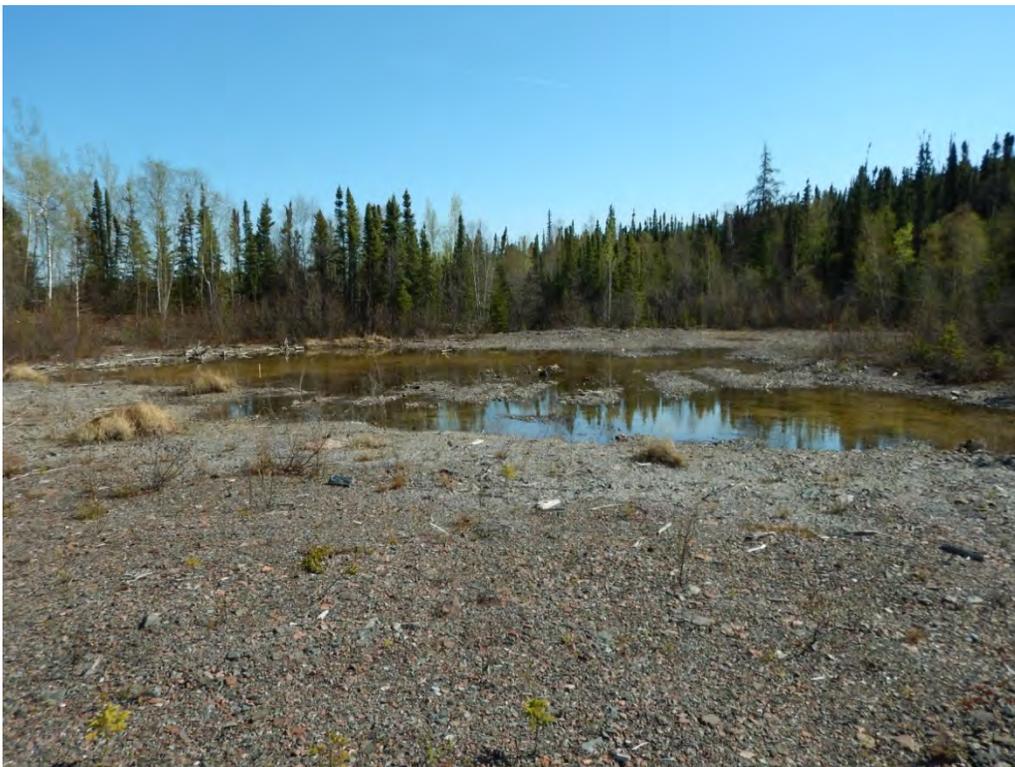
Photo 35: Looking southward across the pond area at the south end of Ace Creek catchment area III on May 20, 2015. Surface drainage would flow to the right, towards the background.

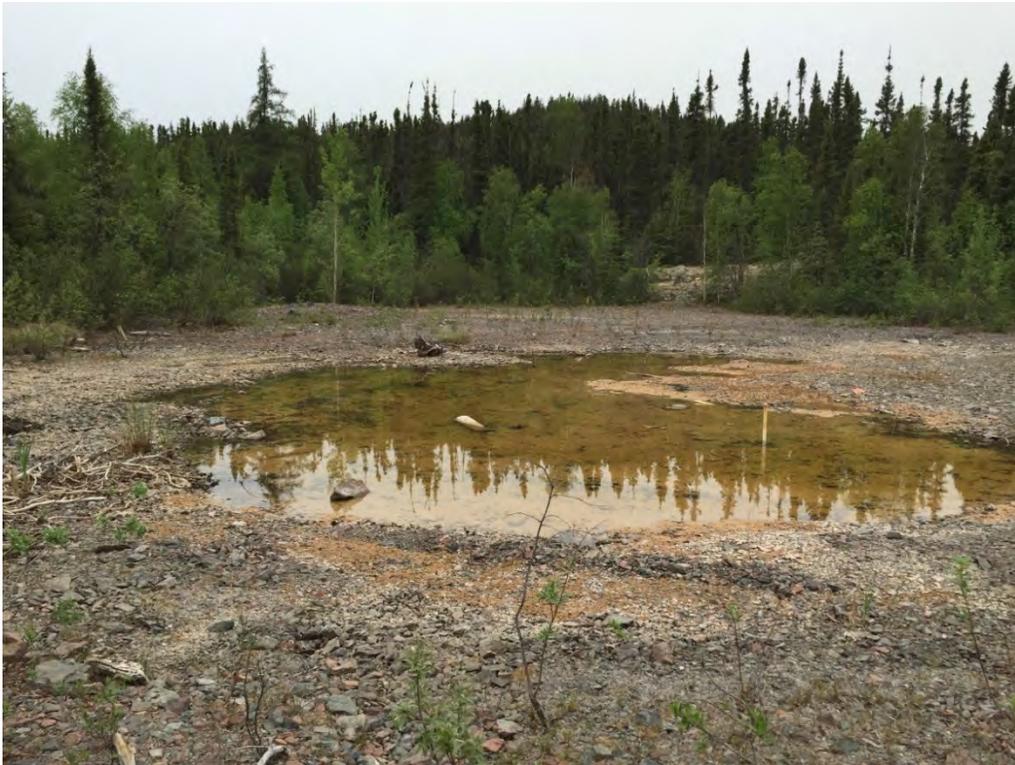
Photo 36: Looking southwestward across the pond area at the south end of Ace Creek catchment area III on June 9, 2015. Note the pond size compare to Photo 39.

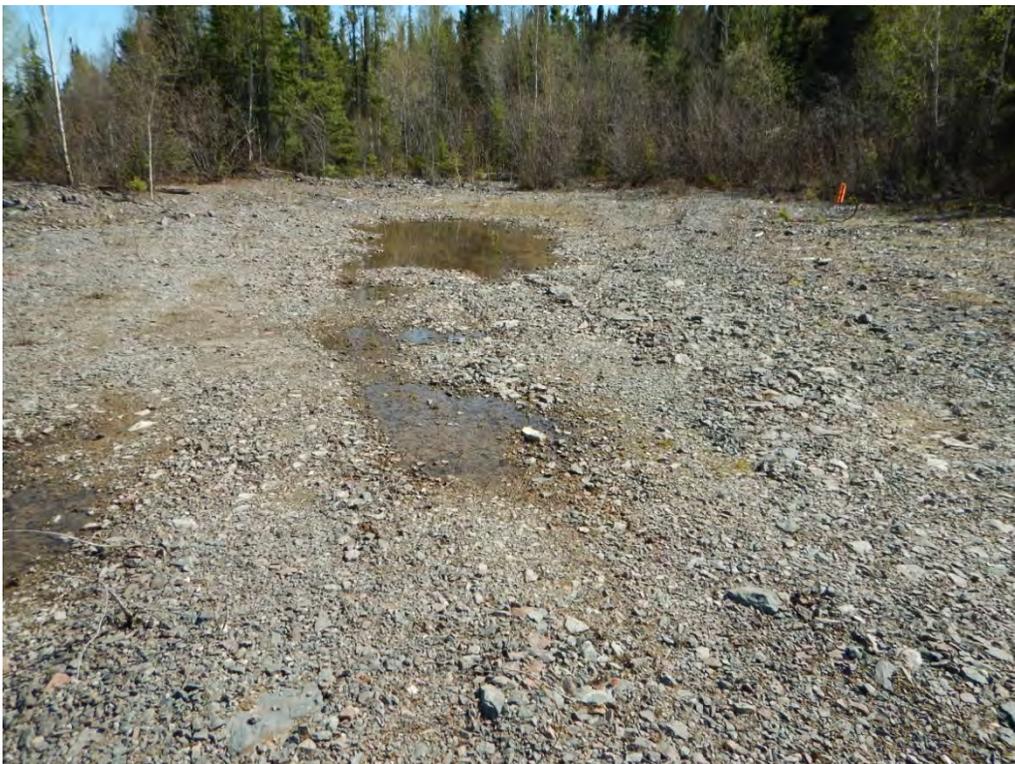
Photo 37: Looking southward to the surface drainage where surface drainage would naturally flow. Photo taken on May 20, 2015.

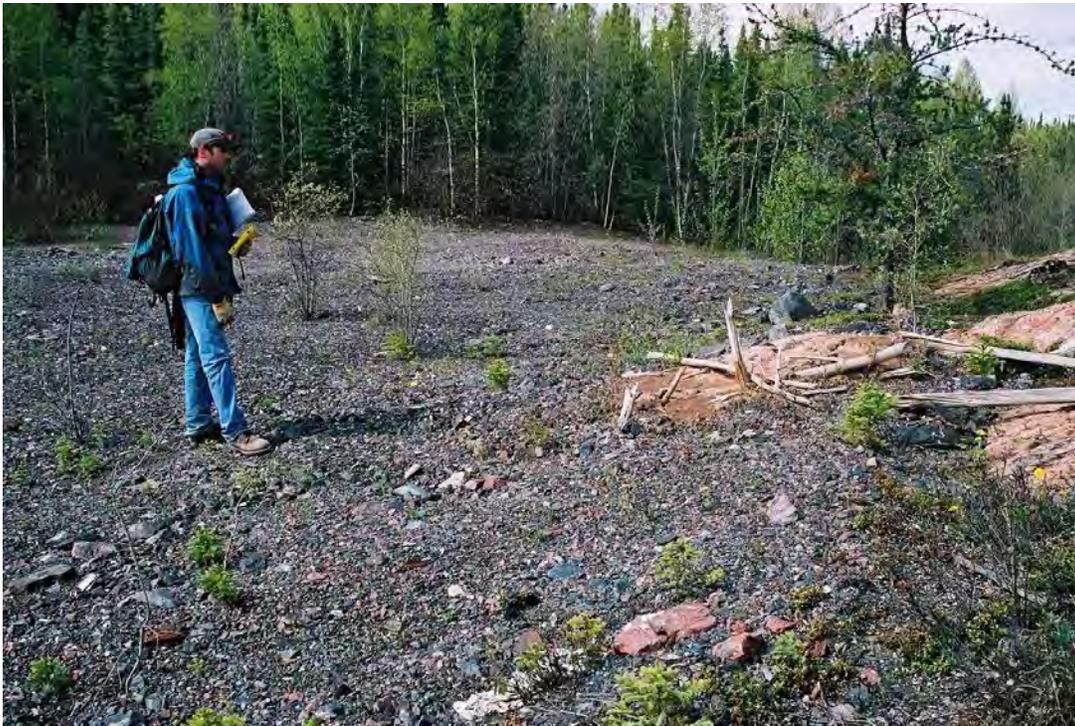
Over the rest of the cover, there are occasional small exposures of tailings that have come up through the waste rock. One of these exposures occurs immediately adjacent to a bedrock outcrop. A comparison of the exposed tailings in 2004 (Photo 38) with the same tailings in 2015 (Photo 39) indicate there has been no obvious change in the volume of exposed tailings.

Photo 38: View of a tailings exposure at the north end of Ace Creek catchment area III (same location as shown in Photo 39). Photo taken on June 20, 2004.

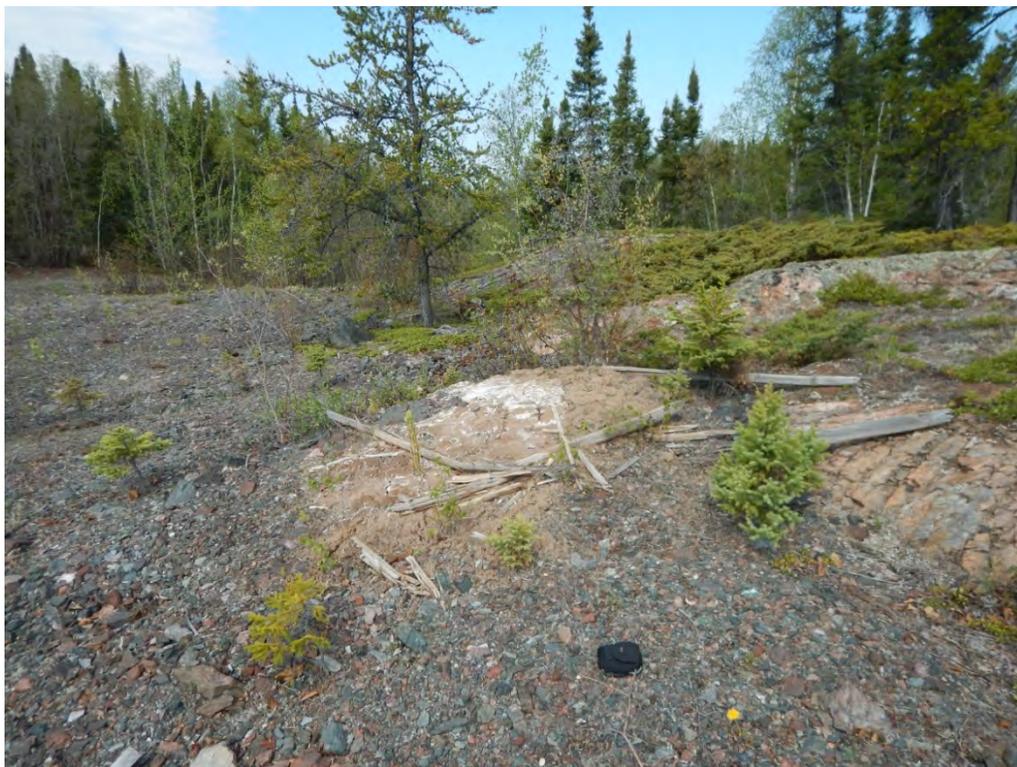
Photo 39: View of the same tailings exposure shown in Photo 38, 11 years later. Photo taken on May 20, 2015.
