BEAVERLODGE PROJECT

Beaverlodge Project 2020 Annual Report Year 35 Transition Phase Monitoring

Prepared for:
Canadian Nuclear Safety Commission
Compliance Report for Licence: WFOL-W5-2120.0/2023 &
Saskatchewan Ministry of Environment
Compliance Report: Beaverlodge Surface Lease

Prepared and Submitted by:
Cameco Corporation

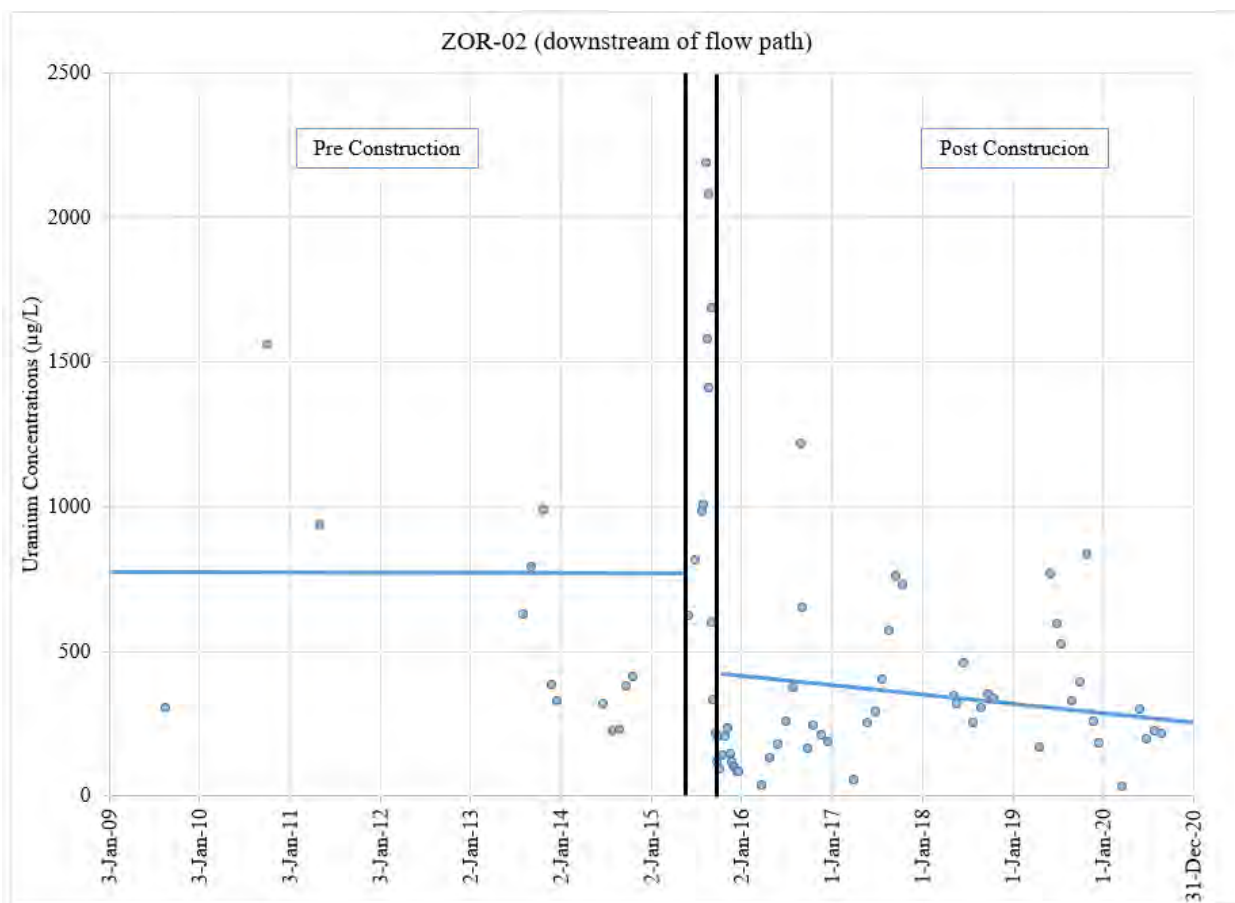
Figure 4.3-9 - ZOR-02 Uranium Concentrations Pre and Post Construction

Figure 4.3-9 shows the results of water sample data collected at ZOR-02 through the various phases of pre-construction, construction and post construction. Also provided are general trend lines showing the relative improvement in water quality post-construction. The Pre-Construction trend line is the overall average U concentration for that period, while the Post-Construction is a linear trend line created using the annual U concentration averages.

The fluctuations in U concentrations observed through construction and following construction are reflected in the concentration of U measured at AC-6A which increased, as expected, immediately following construction but has seen some improvement in subsequent years. Uranium concentrations measured at the monitoring station AC-8 located in Ace Lake (immediately downstream) have remained below the SEQG since 2012. A summary of annual mean U and ^{226}Ra data from 2010 to 2020 at ZOR-02, AC-6A, and AC-8 is presented in **Table 4.3-3**. As AC-6A flows into Ace Lake, data from the outlet of Ace Lake (AC-8) is presented for reference.

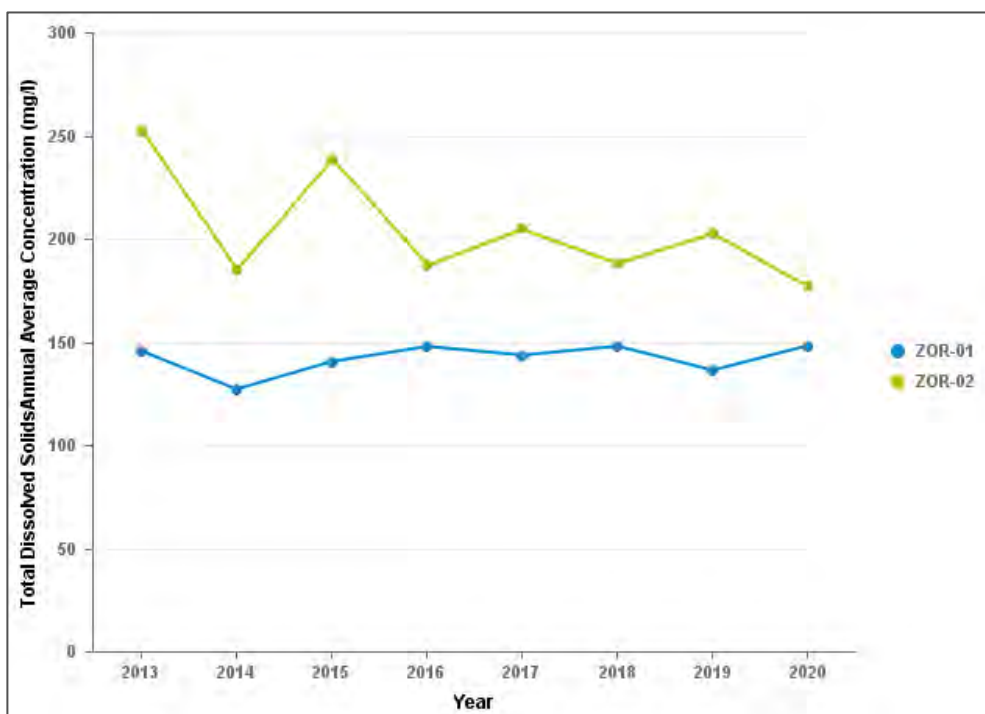
Figure 10: Water Quality Monitoring Data in the Drainage Channel

As previously noted, Cameco has continued to monitor water quality in the Drainage Channel and a brief summary is provided below in order to augment the geotechnical inspection. Upstream of the Drainage Channel (station ZOR-01), total dissolved solids (TDS) concentrations have remained stable with an annual average value hovering below 150 mg/l since 2013 (Figure 10). At the outlet of the Drainage Channel, TDS annual average concentrations show a peak during channel construction in 2015 and have since declined to hover around 200 mg/l (Figure 10). Additionally, Figure 11 shows the annual average uranium concentrations collected at the channel outlet (station ZOR-02) through the various phases of pre-construction, construction and post construction. Also provided are general trend lines showing the relative improvement in water quality post-construction.

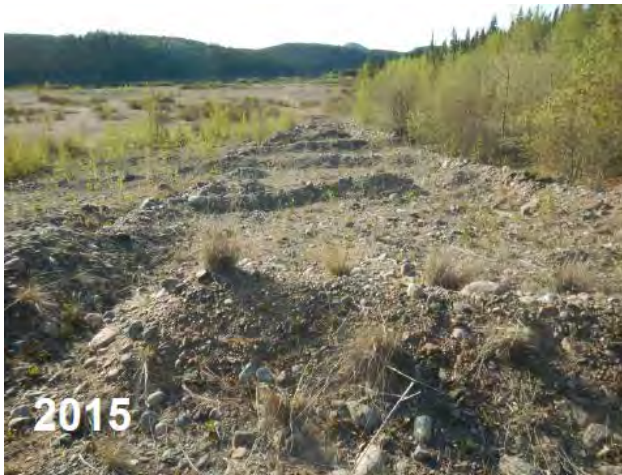
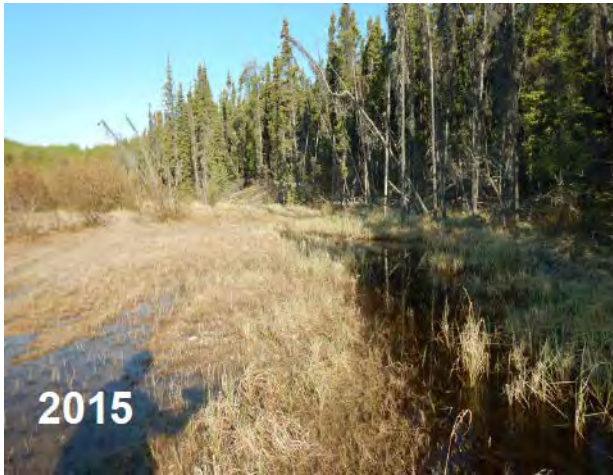
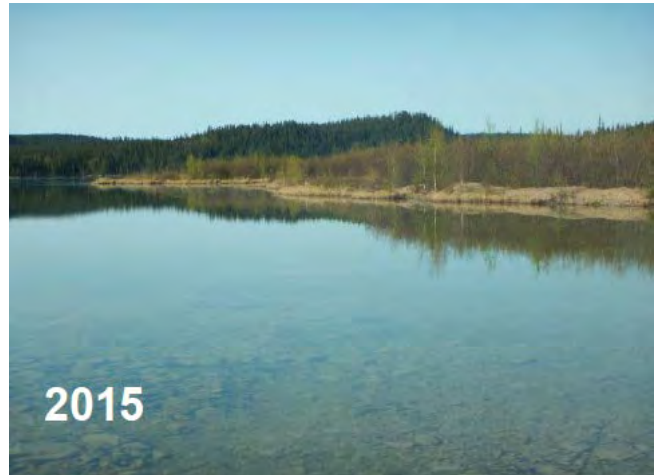
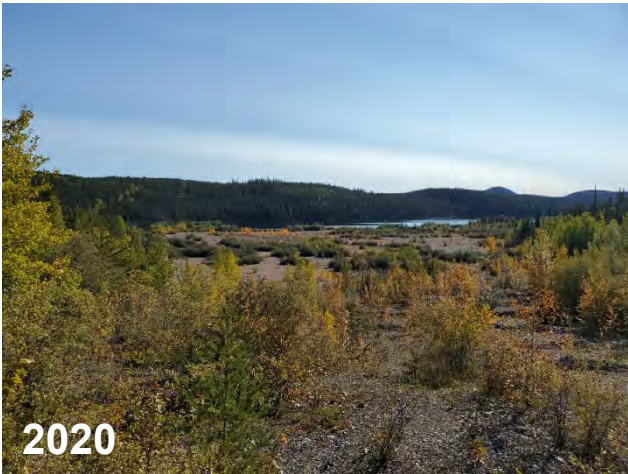
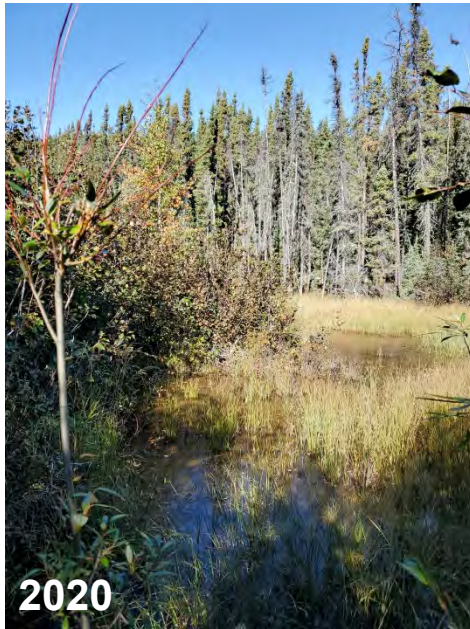
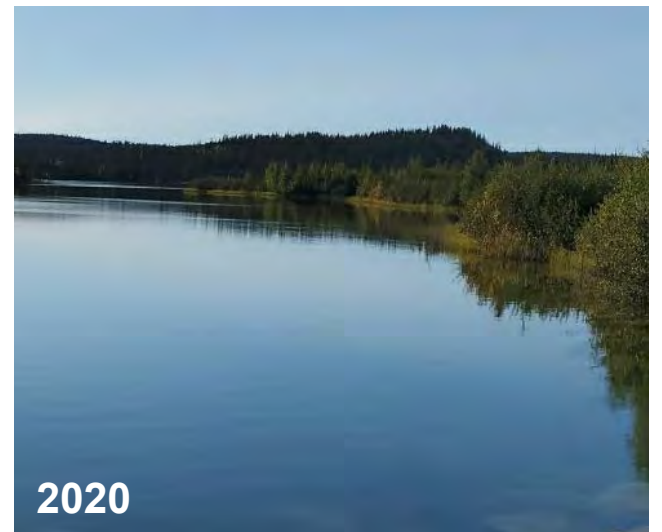
2020 Geotech Inspection		
		Changes in Vegetation at Fookes Reservoir Cover Over Time		
Job No: 1CC007.067 Filename: BL_1CC007.067	Beaverlodge Mine Site	Date: October 2020	Approved: CCS	Figure: 4

Although there are still bare zones, vegetation continues to gradually spread and thicken over much of the cover (Photos 1 and 2). This is particularly evident, in the areas where “bundles” of shrubs were left in place on the 2007 cover to promote the establishment of vegetation “islands” and in areas where the water table is typically shallow, such as along the north side of the delta where drainage paths are present, and close to the Fookes Reservoir shoreline on the east side of the delta (Photo 3). The vegetation appears to be considerably more established than what was observed in 2015 (Figure 4).

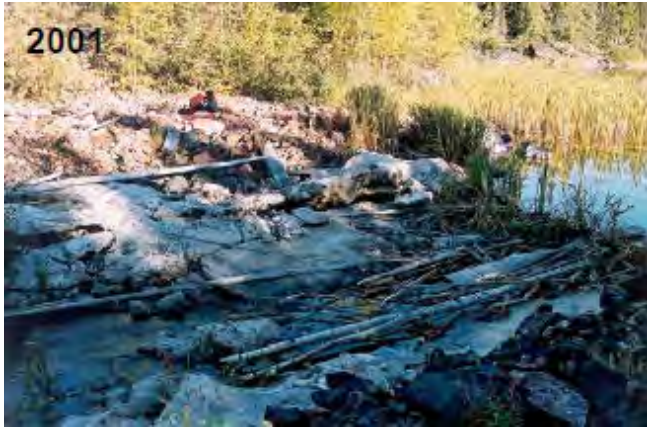
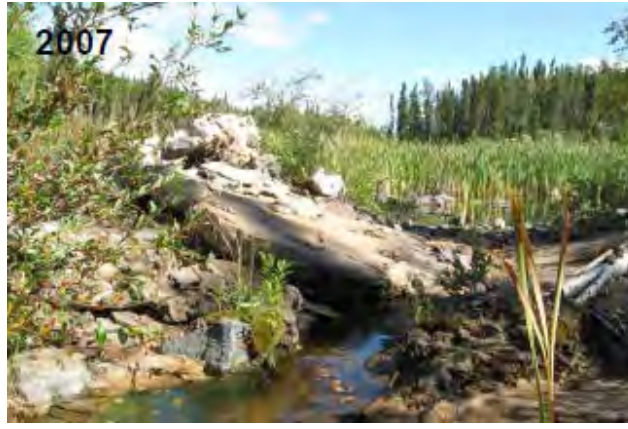
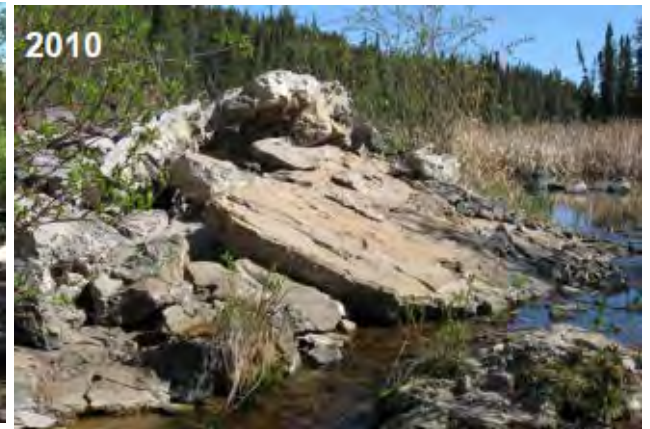
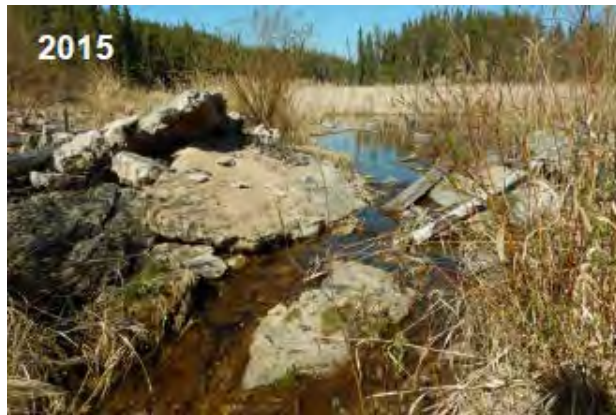
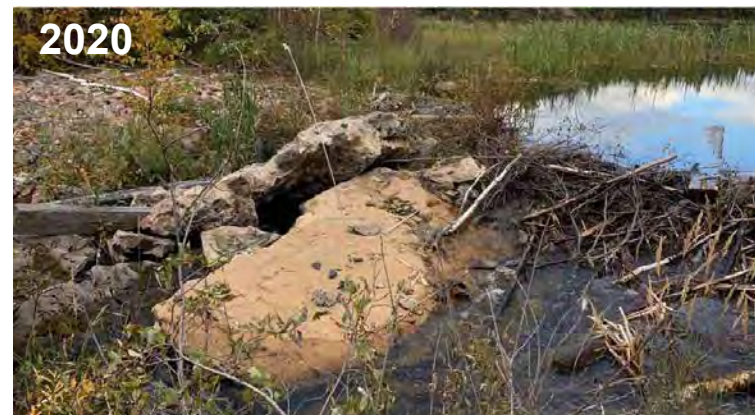
2020 Geotech Inspection		
		Changes in Marie Reservoir Outlet Spillway Over Time		
Job No: 1CC007.067 Filename: BL_1CC007.067	Beaverlodge Mine Site	Date: October 2020	Approved: CCS	Figure: 7

Observations indicate the Marie Reservoir outlet spillway has, in general, changed little since 2004. The grout-intruded rip-rap is relatively intact except near the spillway entrance where one large block slab and several smaller ones on the right side of the spillway (looking downstream) continued to displace incrementally due to ice-jacking (Photos 23 to 25). The ice-jacking has been evident since 2004 but, as shown in Figure 7, one of the ice-jacked slabs, which was “supporting” another slab in 2010, appears to have settled noticeably by 2015 and this was again confirmed in 2020.

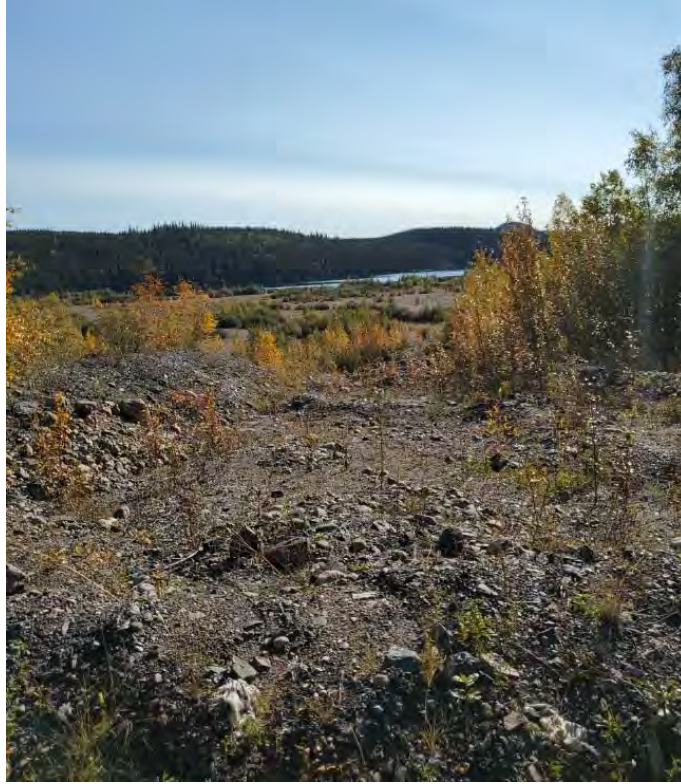
Photo 1: Looking south-eastward, down the access ramp towards the central part of the delta cover on September 17, 2020. The water bars, visible on the access ramp, manage the runoff down the ramp. The extent and height of the cover vegetation has continued to increase.

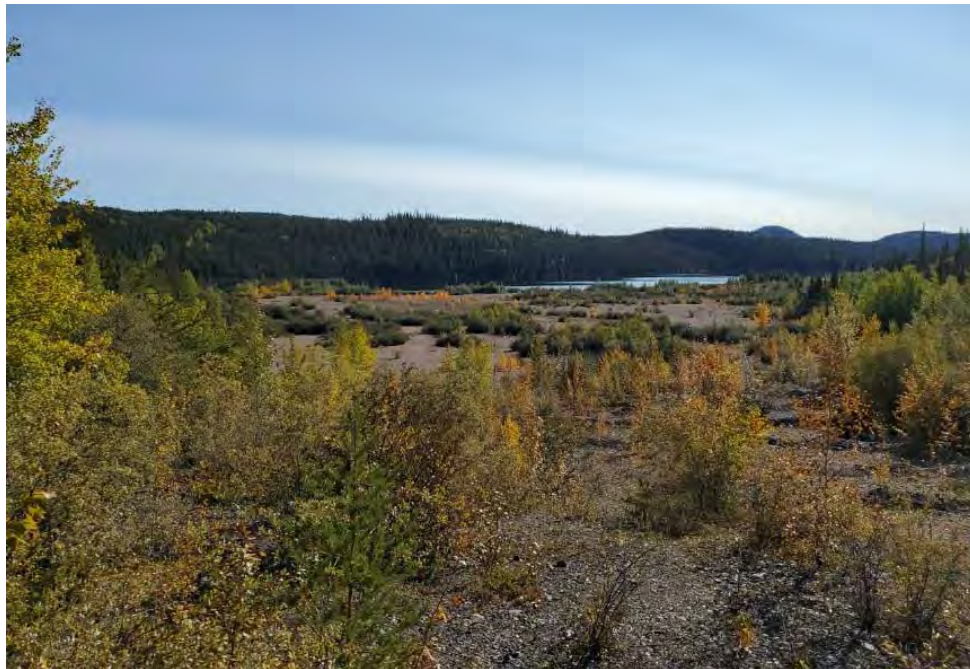
Photo 2: Looking eastward across the delta cover on September 17, 2020. There has been a significant increase in the amount of cover vegetation associated with the previously established “islands”.

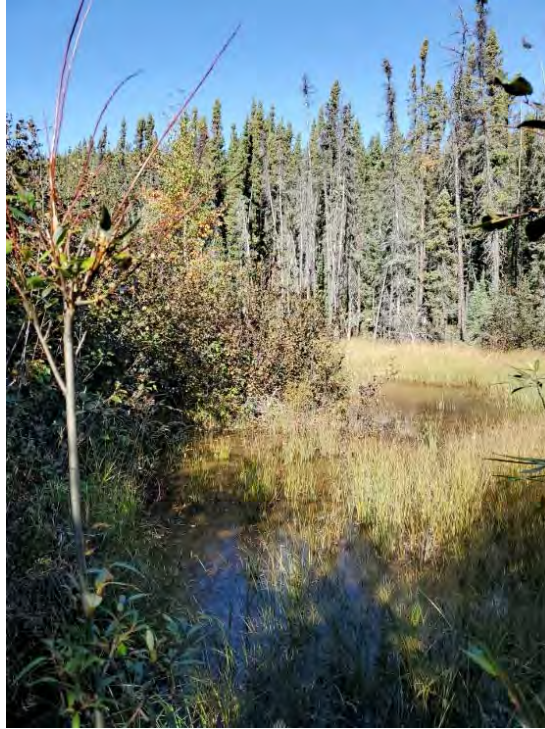
Photo 3: Looking northwest along the upstream segment of the diversion ditch that runs along the north limit of the cover area on September 17, 2020. There has been a significant increase in the cover vegetation along the northern edge of the Fookes Reservoir Delta.

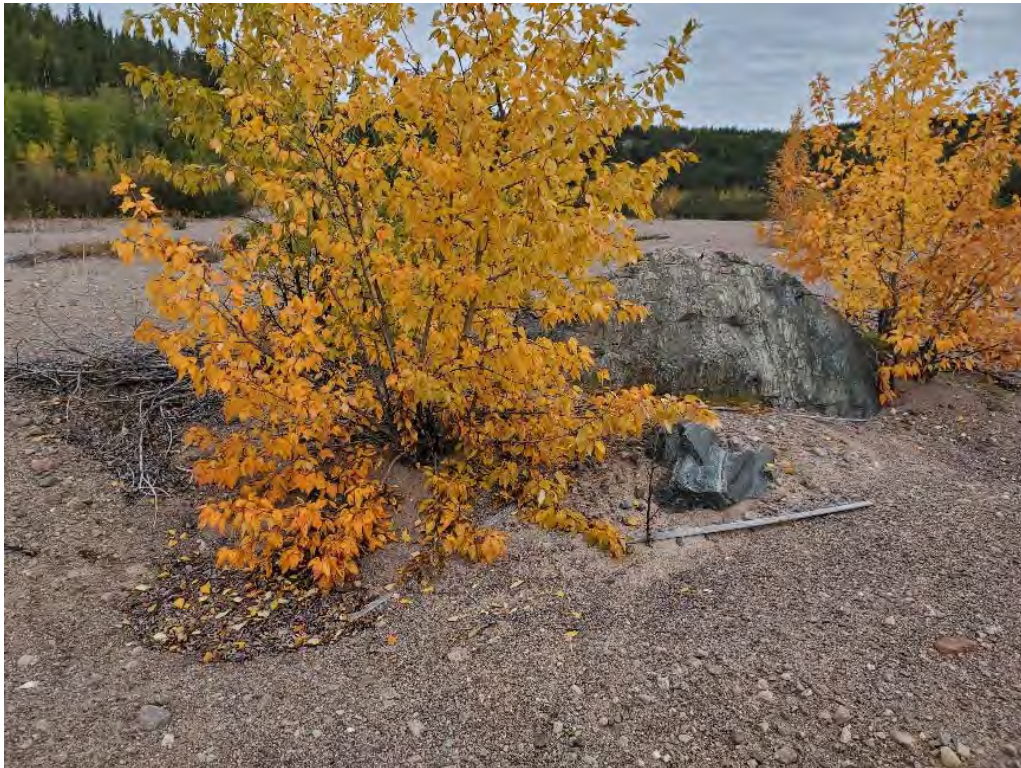
Photo 6: Looking westward at the small depressions in close proximity to the shoreline along the southern part of the cover area on September 16, 2020.

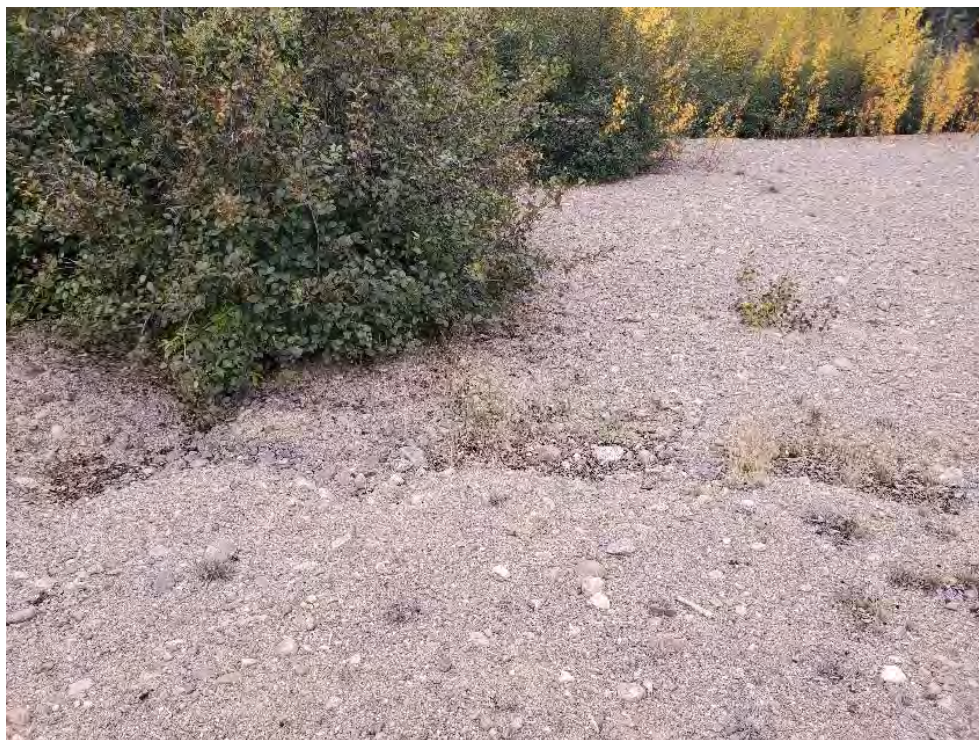
Photo 7: Looking westward, from close to the shoreline, where small depressions in the southern part of the cover area have coalesced. Photo was taken on September 16, 2020.

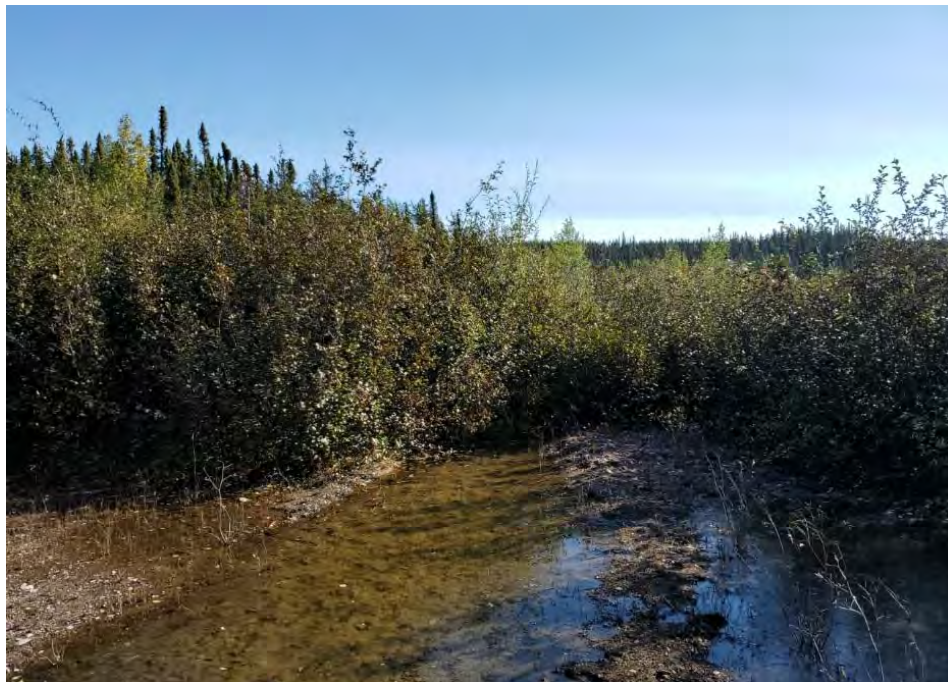
Photo 12: Similar view as in Photo 11, showing the depth of water in the ditch. Photo taken on September 17, 2020.

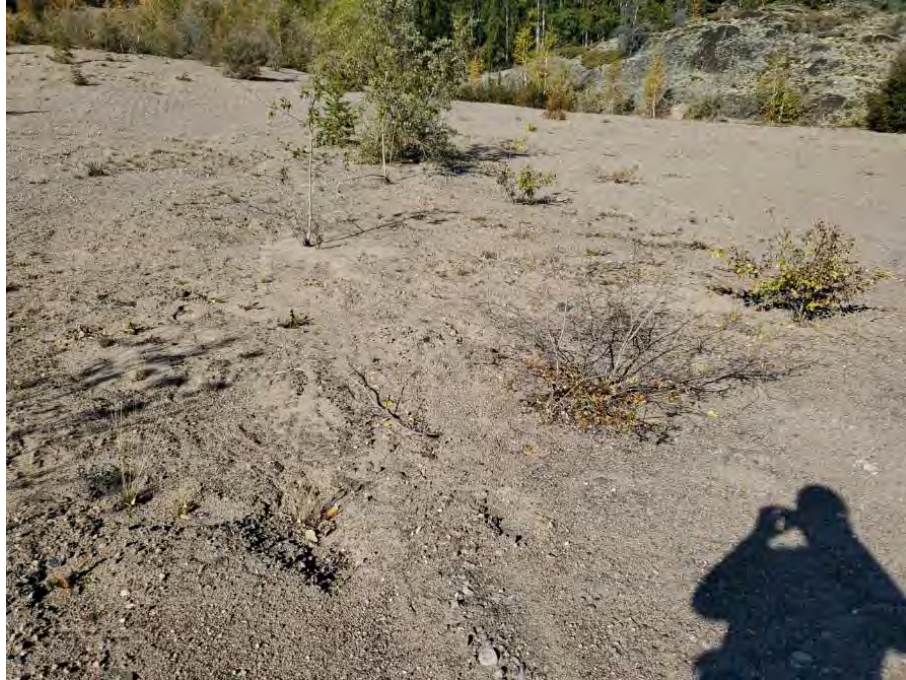
Photo 13: Facing northwest along the northern edge of the delta where surface depressions are evident. Photo taken on September 17, 2020.

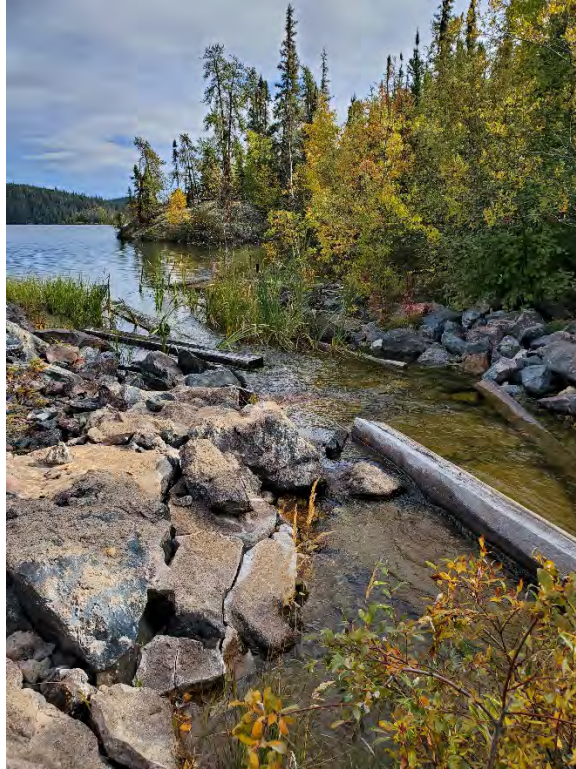
Photo 17: Looking upstream along the outlet spillway showing the ice-jacked slabs of grout-intruded rip-rap on the sides of the spillway. Photo taken on September 16, 2020.

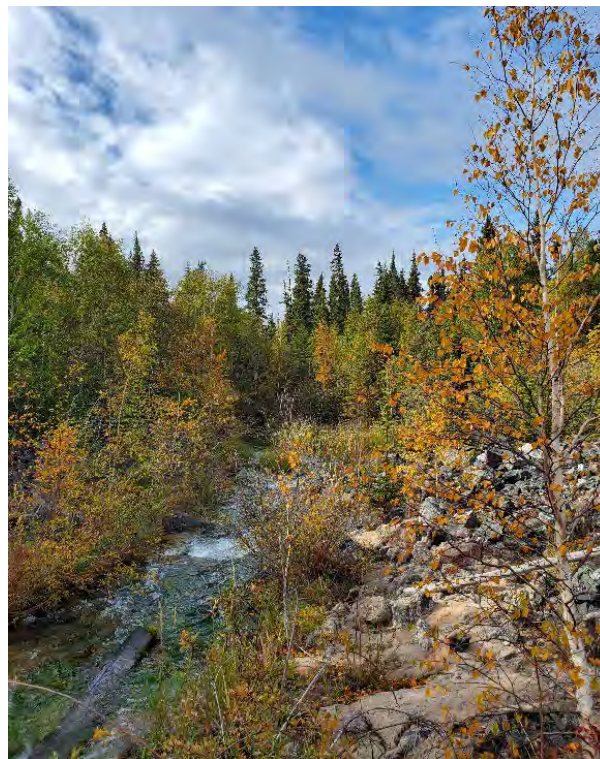
Photo 18: Similar view to Photo 17, taken September 16, 2020. The stilling basin is visible in the distance.

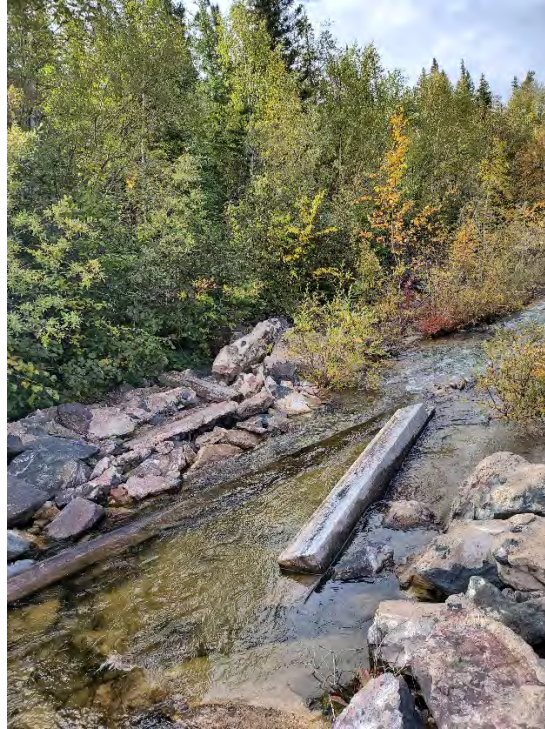
Photo 19: Close-up view of the ice-jacked slabs of grout-intruded rip-rap on the left side of the spillway, facing downstream. Photo taken on September 16, 2020.

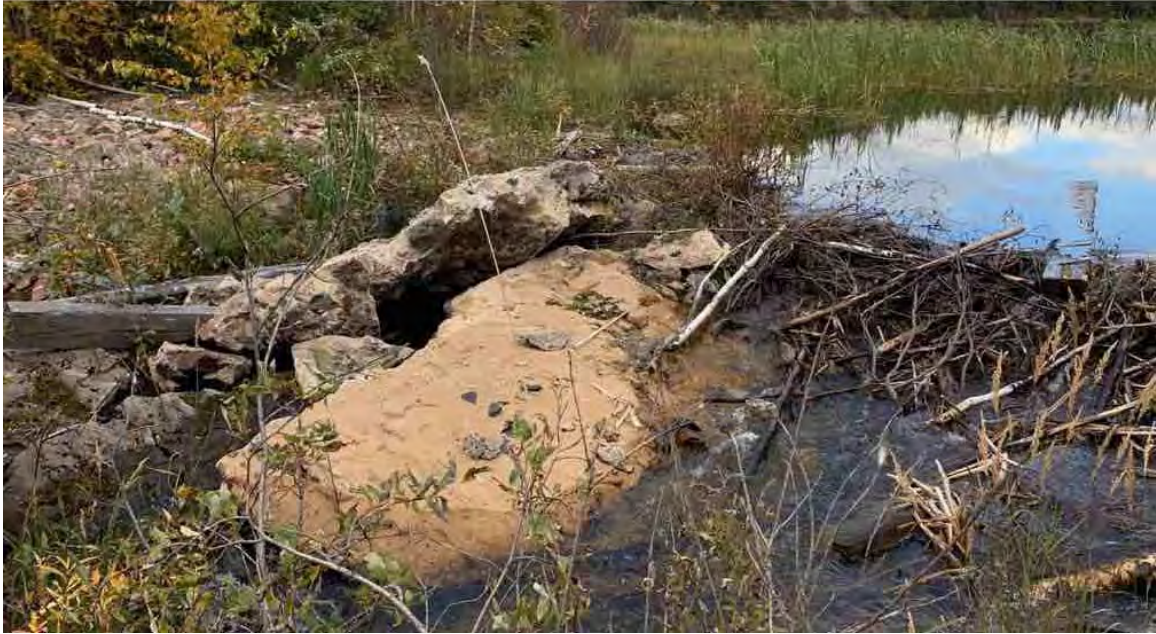
Photo 23: Looking at the ice-jacked slabs of grout-intruded rip-rap on the right side of the Marie Reservoir outlet spillway, near its upstream end on September 16, 2020. Beaver dam is visible immediately to the right of the slabs.

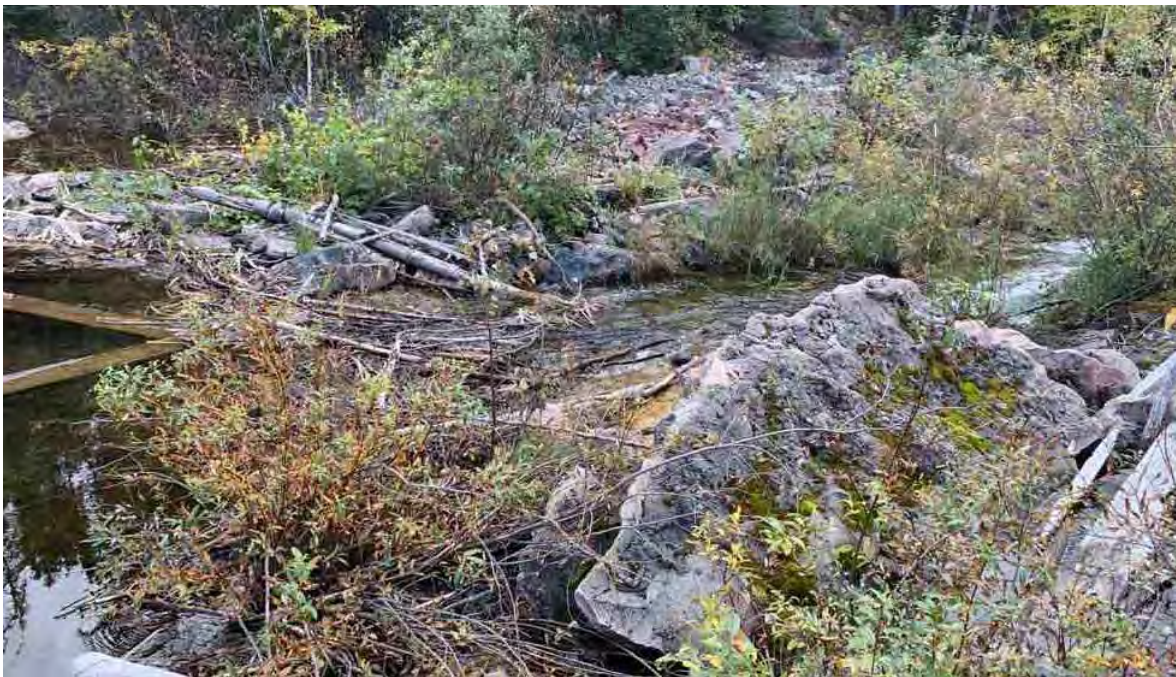
Photo 24: Looking downstream in a southeastern direction at the same ice-jacked slabs shown in Photo 23. Photo taken on September 16, 2020. Note the water level difference on either side of the beaver dam.

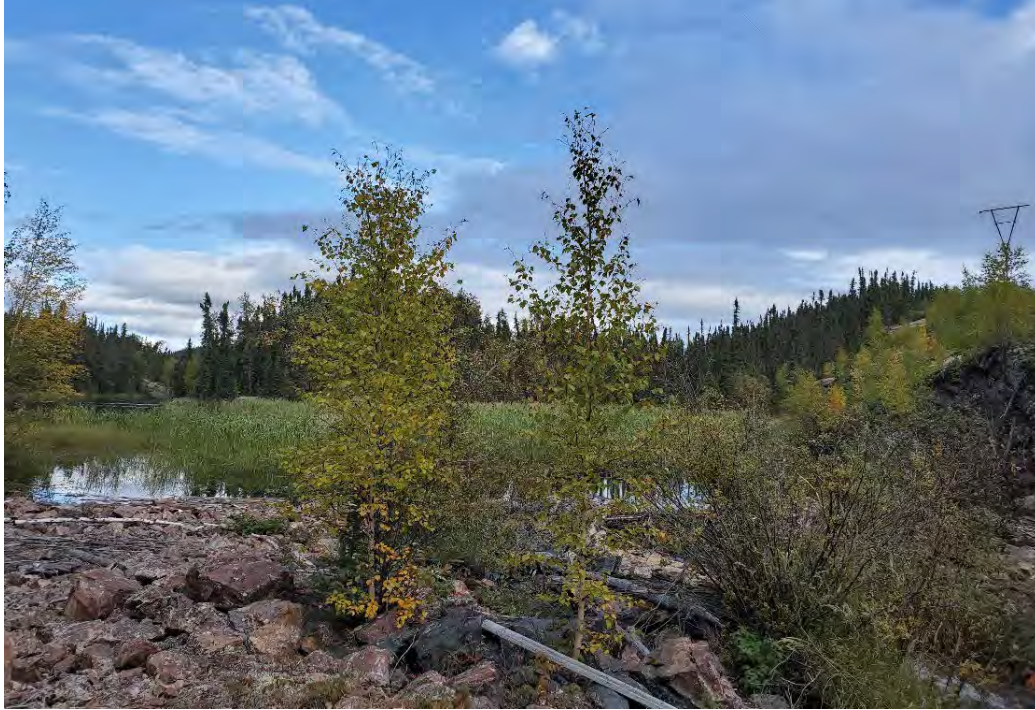
Photo 25: Looking upstream near the upstream end of the outlet spillway on September 17, 2020. The ice-jacked slabs of the grout-intruded rip-rap are visible at the entrance.

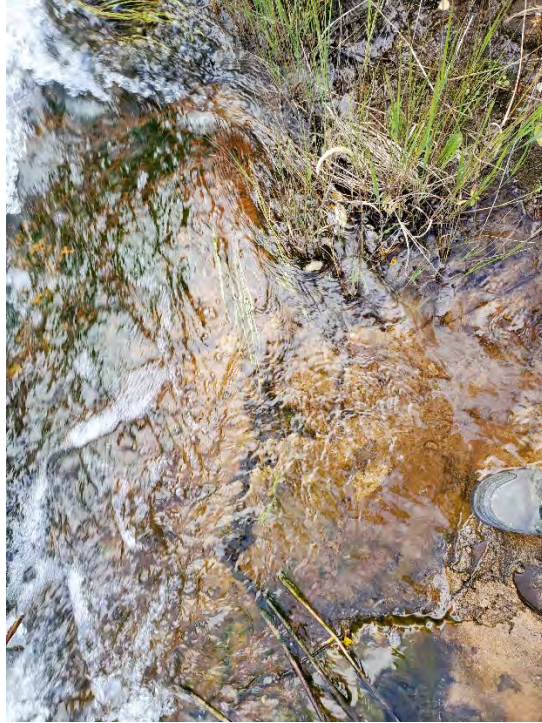
Photo 27: Close-up view of the stream. No clayey silt material is visible. Photo taken on September 17, 2020.

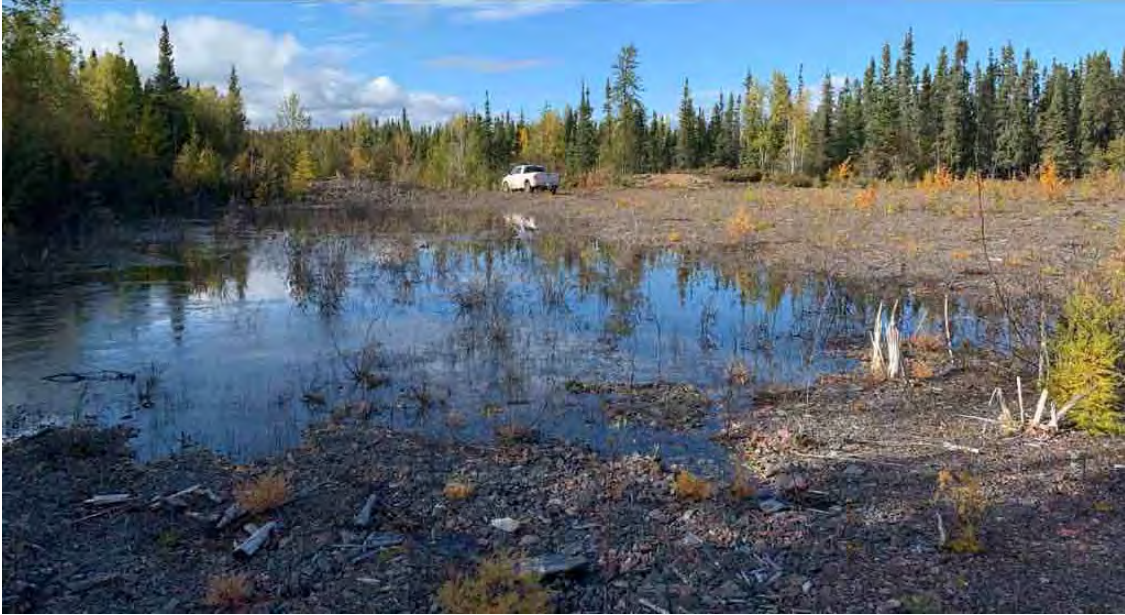
Catchment area III is largely covered by waste rock (Photos 35 to 39). Water was ponding on the west side of catchment area III (Photos 35, 36 and 38), near its discharge point at the southwest limit of the area.

Photo 35: Looking northward across the pond area at the south end of Ace Creek catchment area III on September 16, 2020.

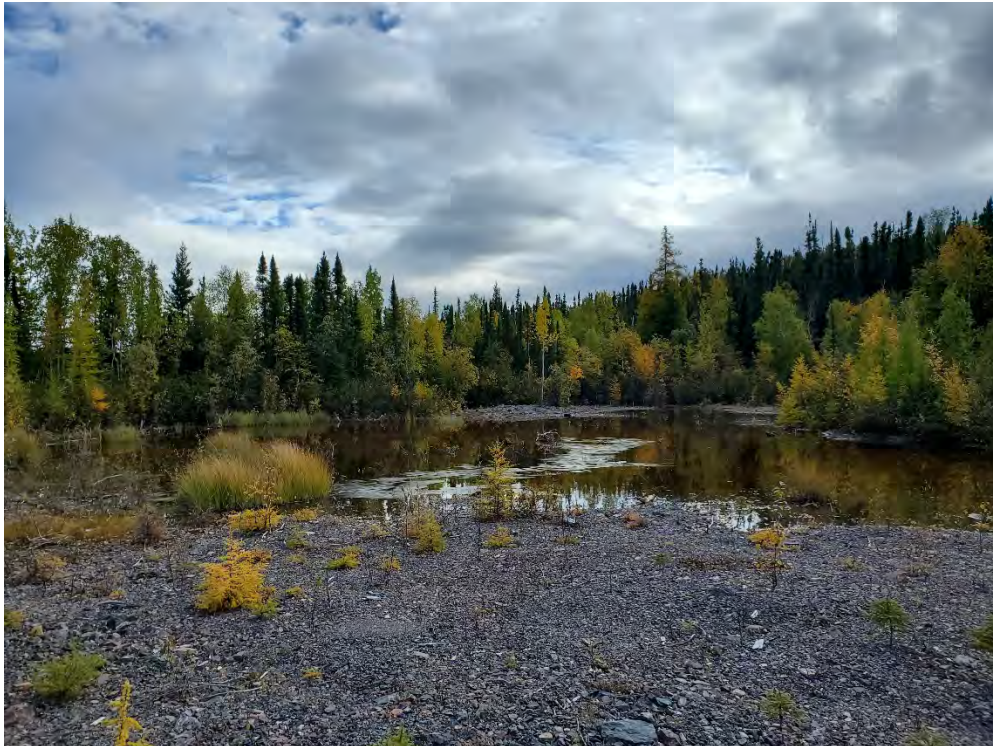
Photo 36: Looking southward across the pond area at the south end of Ace Creek catchment area III on September 16, 2020. Surface drainage would flow to the right, towards the background.

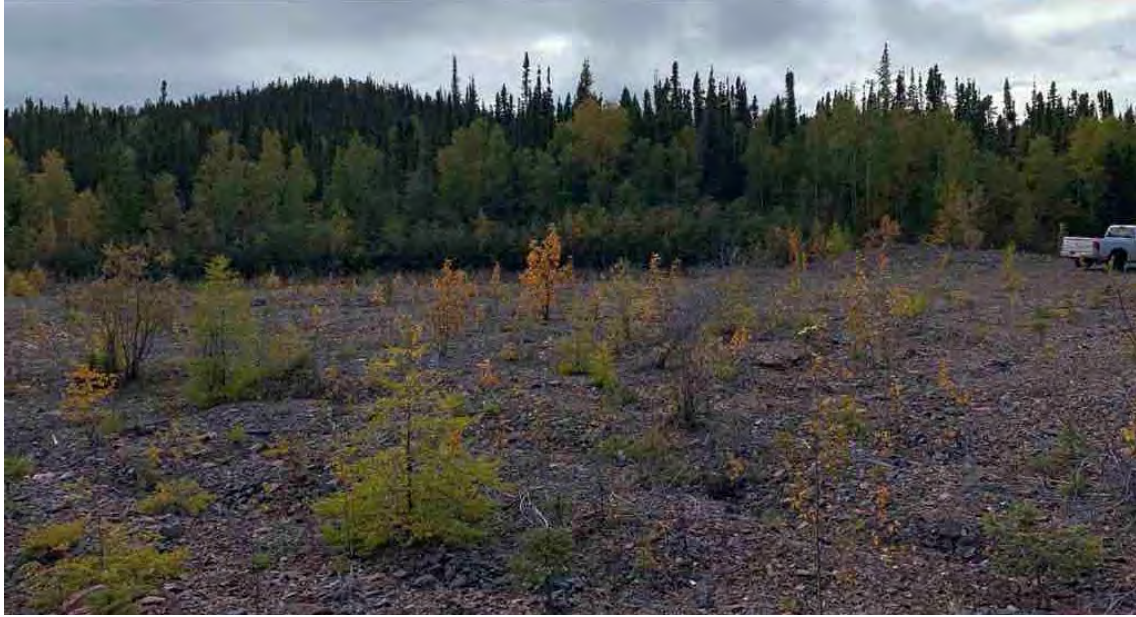
Photo 37: Looking southwestward across the area at the south end of the Ace Creek catchment area III on September 16, 2020. No pond visible in this area.

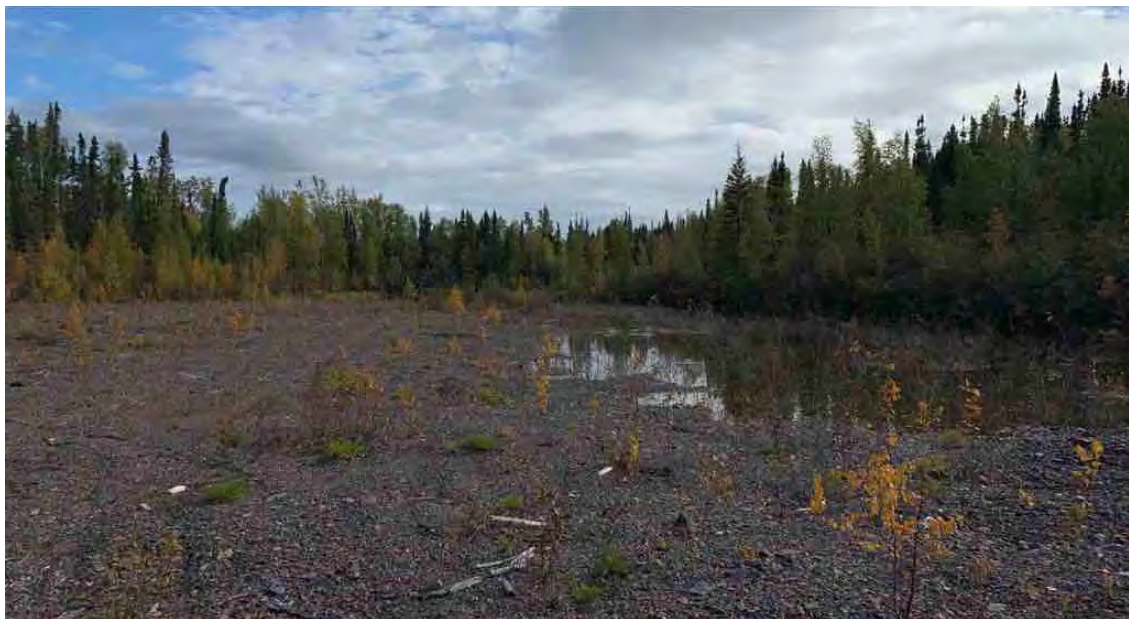
Photo 38: Looking southeast to the surface drainage where surface drainage would naturally flow. Photo taken on September 16, 2020.

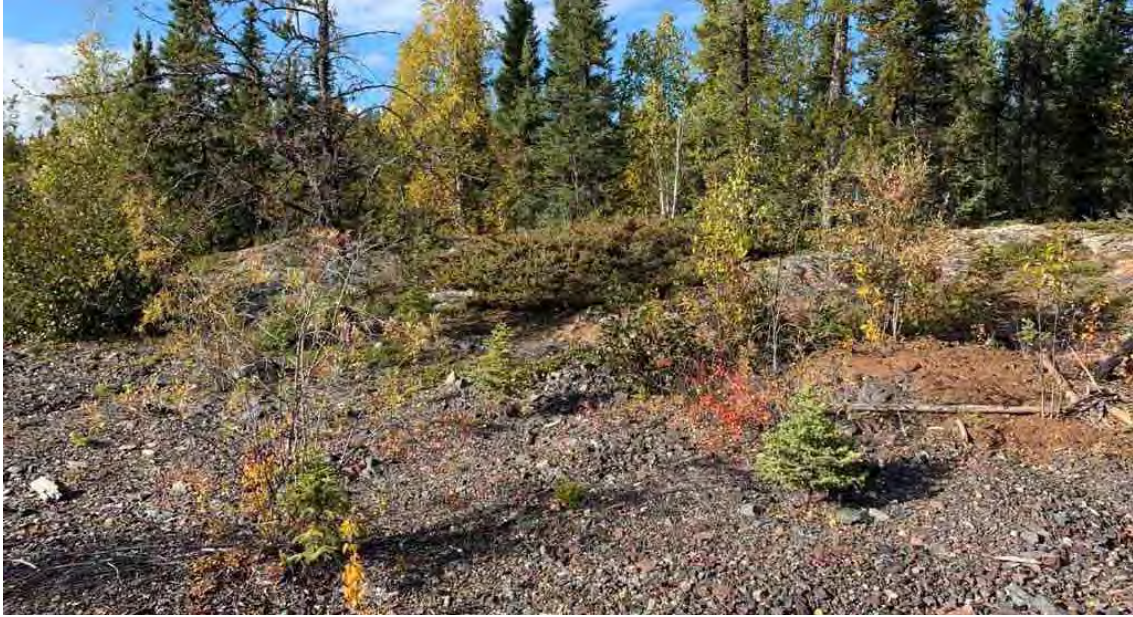
Photo 39: View of the tailings exposure at the north end of Ace Creek catchment area III. Photo taken on September 16, 2020.

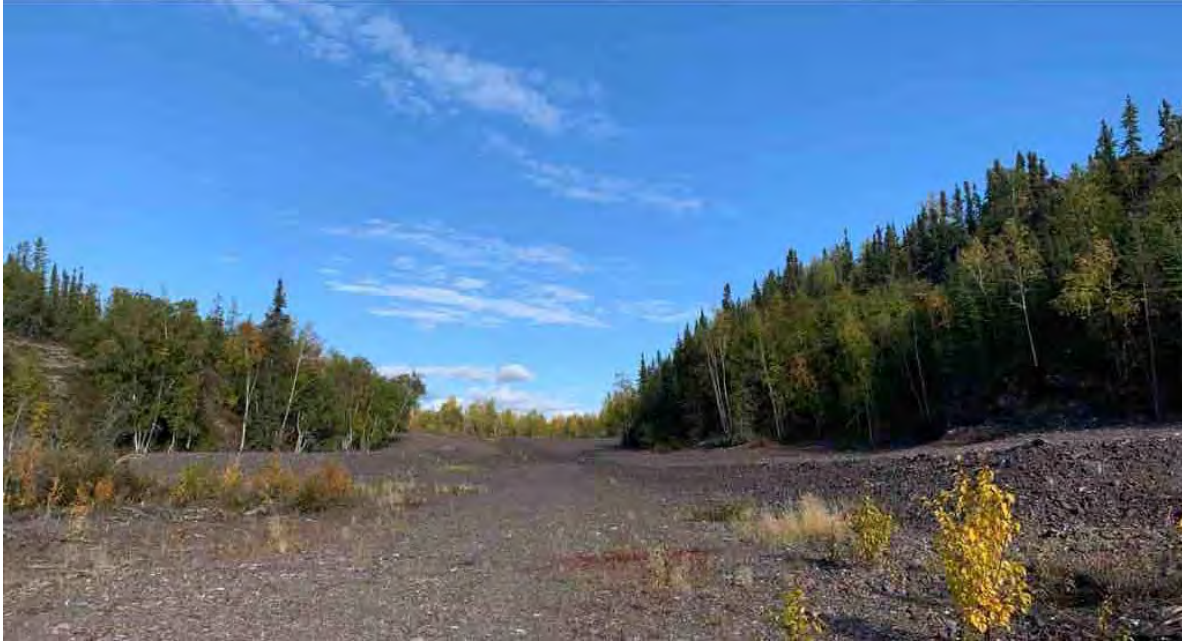
Photo 42: Looking eastward across the Ace Stope Area. Photo taken September 16, 2020.

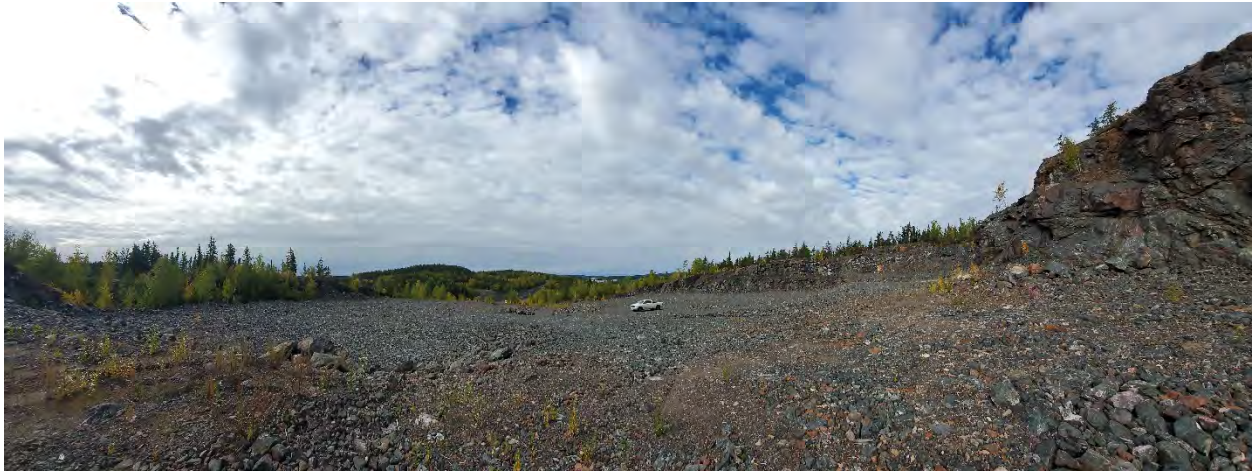
Photo 45: Looking southwest along the Bolger Pit, in the direction of the Drainage Channel. Photo taken September 17, 2020.

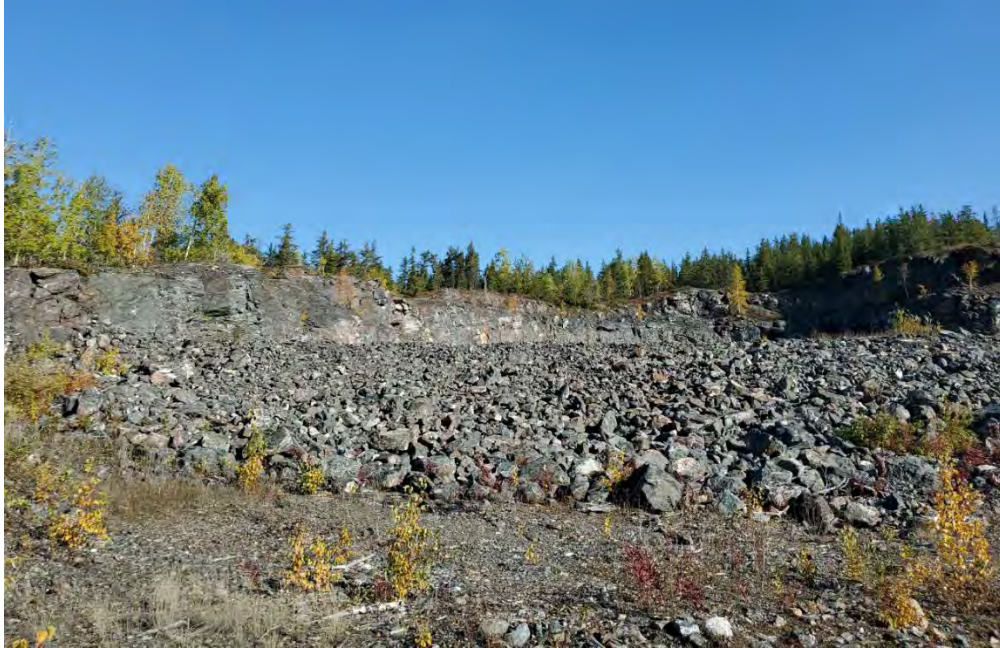
Photo 47: Looking north towards the Bolger Pit, the berms are still intact. The pit walls are visible in the background of this photo. Photo taken September 17, 2020.

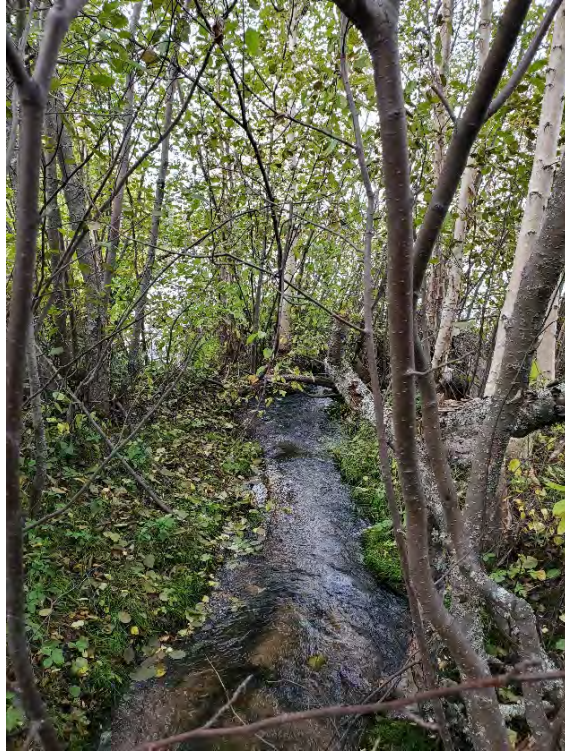
The outlet of the Drainage Channel is shown in Photos 54 and 55. Vegetation covers the area surrounding the channel and no fines were identified within the channel.

Photo 54: Looking west-northwest (downstream) along the Drainage Channel near the inlet to Verna Lake. Photo taken September 17, 2020.

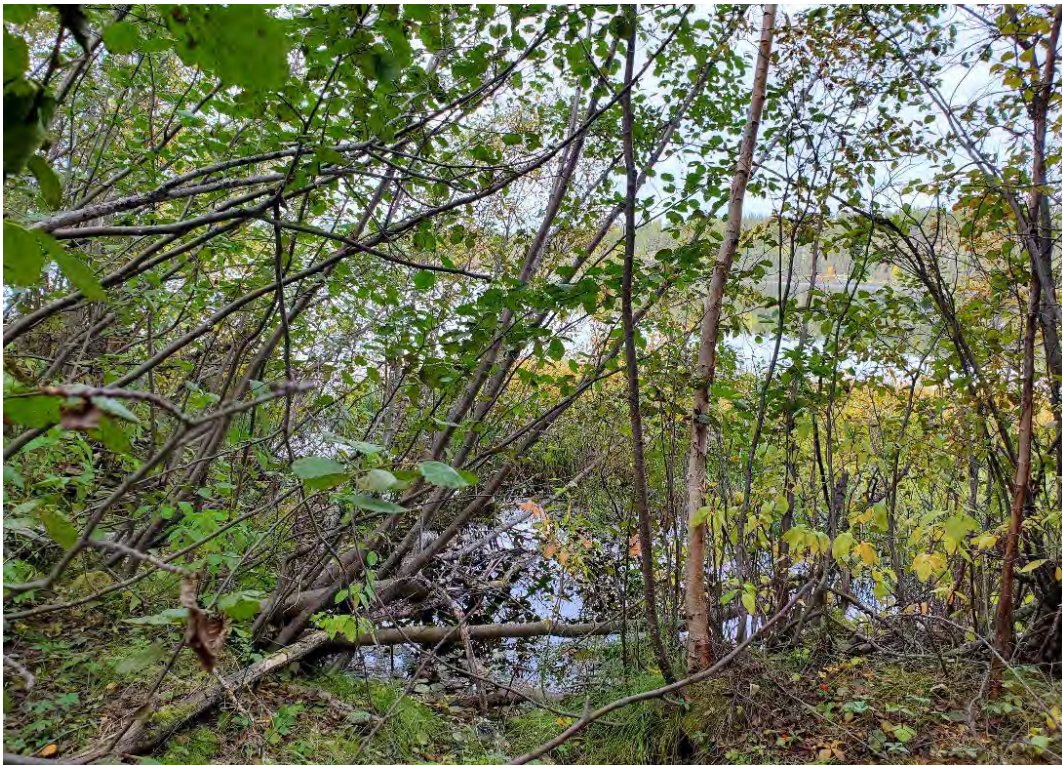
Photo 55: Looking west-northwest, at the inlet to Verna Lake. Photo taken September 17, 2020.
