BEAVERLODGE PROJECT

Beaverlodge Project 2020 Annual Report Year 35 Transition Phase Monitoring

Prepared for:
Canadian Nuclear Safety Commission
Compliance Report for Licence: WFOL-W5-2120.0/2023 &
Saskatchewan Ministry of Environment
Compliance Report: Beaverlodge Surface Lease

Prepared and Submitted by:
Cameco Corporation

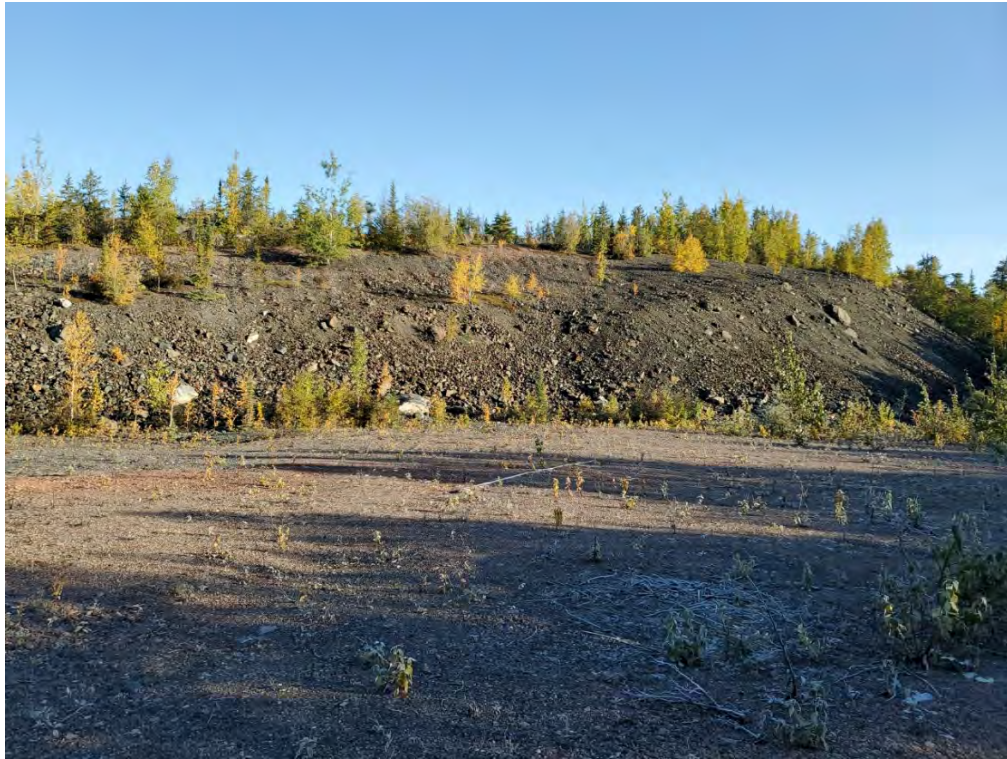
Photos 56 to 62 show the monitoring locations at the Hab area. No evidence of significant tension cracks or observable changes in ground elevation was observed at this area.

Photo 56: Looking north towards the Hab area. Photo taken September 17, 2020.

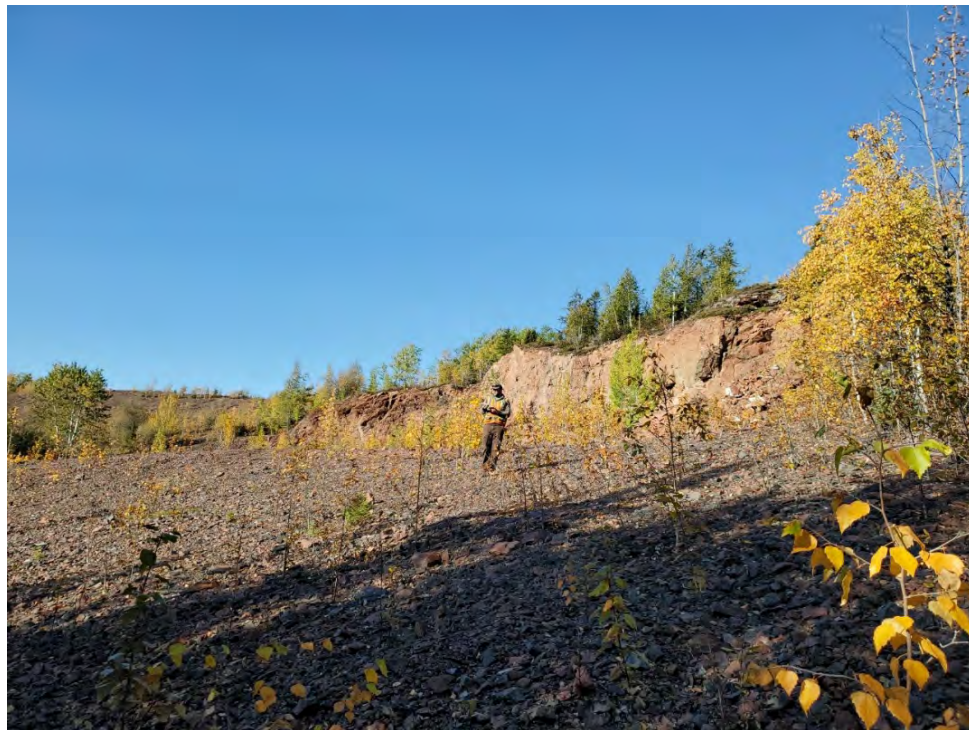
Photos 63 to 67 show the monitoring locations at the Dubyna area. No evidence of significant tension cracks or observable changes in ground elevation was observed at this area. However, minor surface depressions were identified in close proximity to the DUB-01 location (Photo 65).

Photo 63: Looking west towards the Dubyna area. Photo taken September 17, 2020.

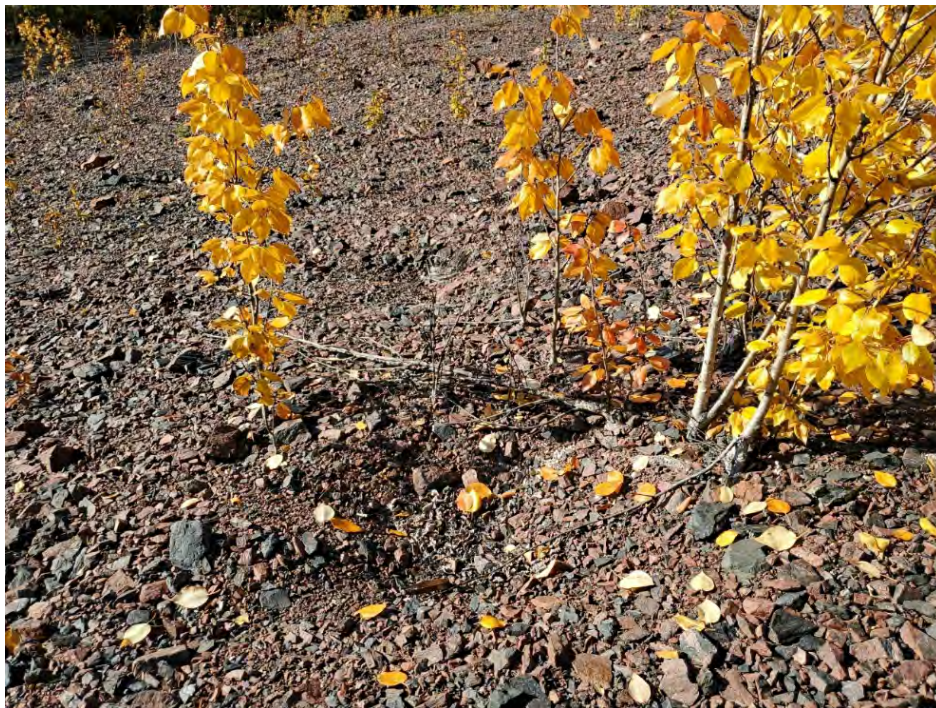
Photo 65: Looking southwest at the DUB-01 monitoring location. Minor surface depressions identified. Photo taken September 17, 2020.

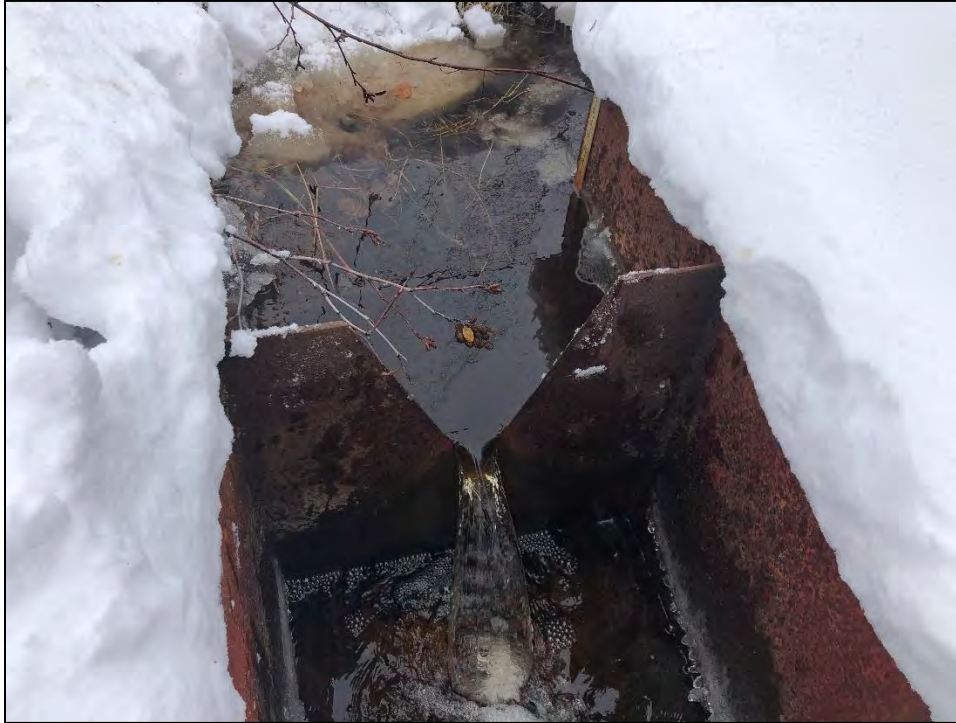
Photo 8: TL-6– October 15, 2020

The area known as Minewater Reservoir directs runoff towards the Fulton Drainage via a channel blasted through bedrock. A v-notch weir installed in 2011 is the monitoring station identified as TL-6. Photo 8 is from the fall field program. Stage and discharge monitoring data are compiled in Table 10 and the rating

The sensor for TL-6 was installed into snow and ice on May 1 by a local resident. Based on the logger data MWSI believes that the snow and ice were cleared of the notch on May 5. The logger functioned until August 22 until it seems to have malfunctioned and no data are available after that time for this station. This logger will be inspected and repaired or replaced prior to its reuse.

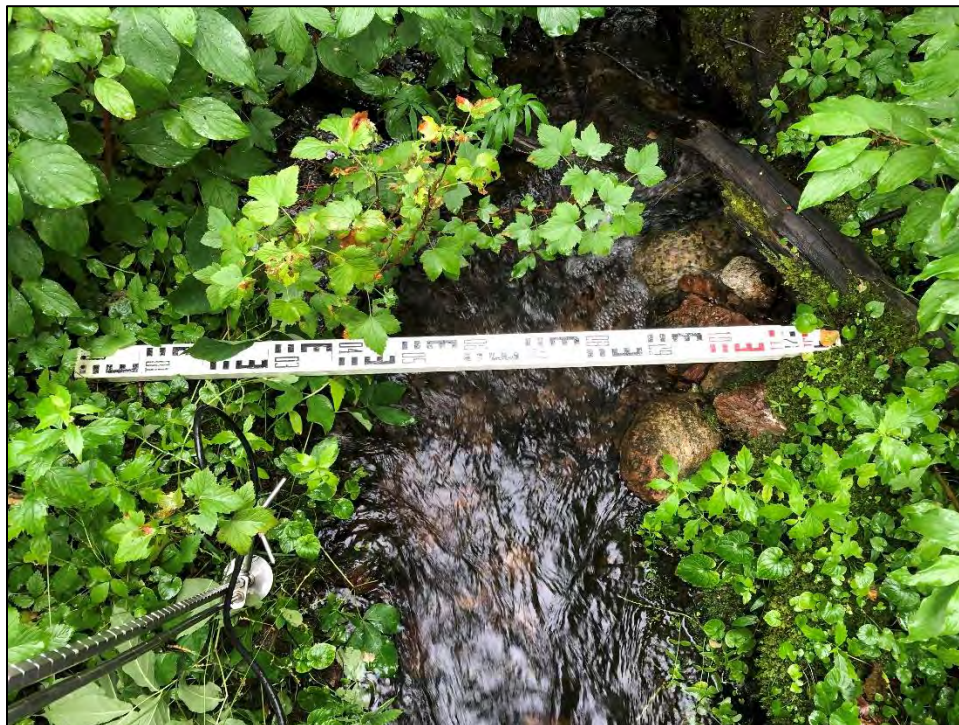
Photo 13: Zora Outflow – August 13, 2020

measurement section at Zora is shown in Photo 13 and the inflow to Verna is depicted in Photo 14. The discharge measurements at Zora outflow and Verna inflow are provided in Table 17.
