# BEAVERLODGE PROJECT

## Beaverlodge Mine Site

### Path Forward Report

**December 2012**

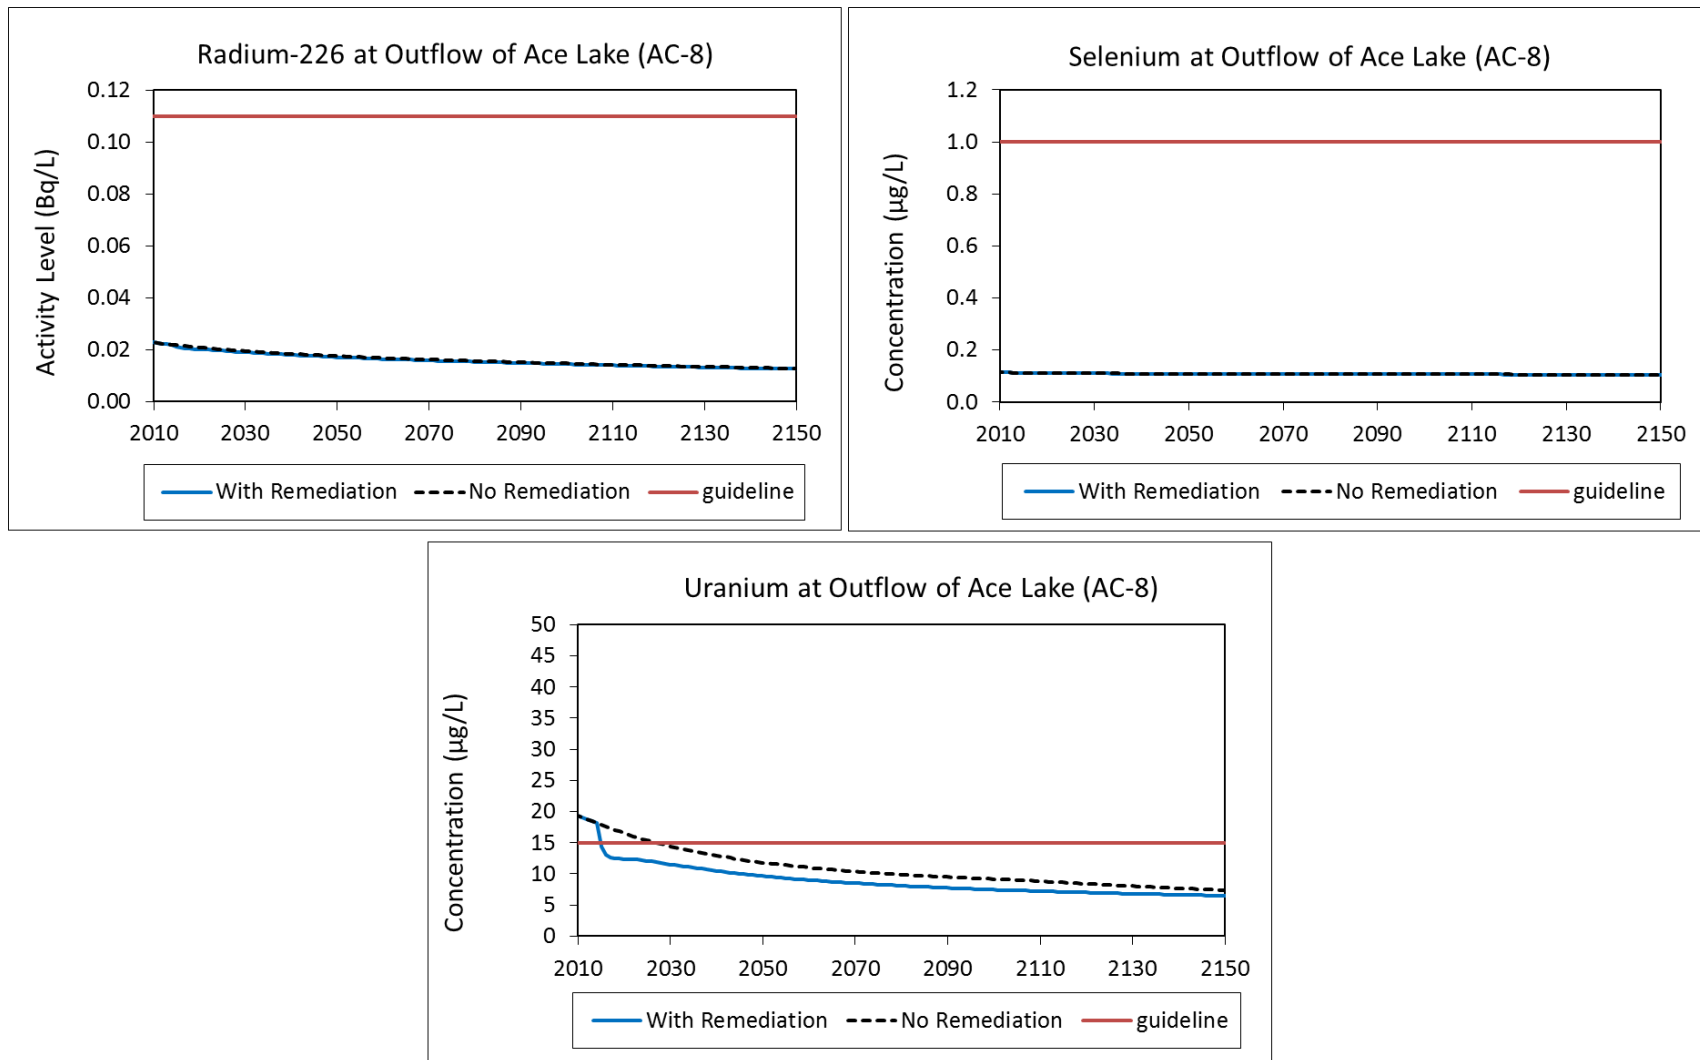
**Figure 2.2-3 Ace Lake Water Quality Predictions (Divert Schmoor Lake Outflow)**

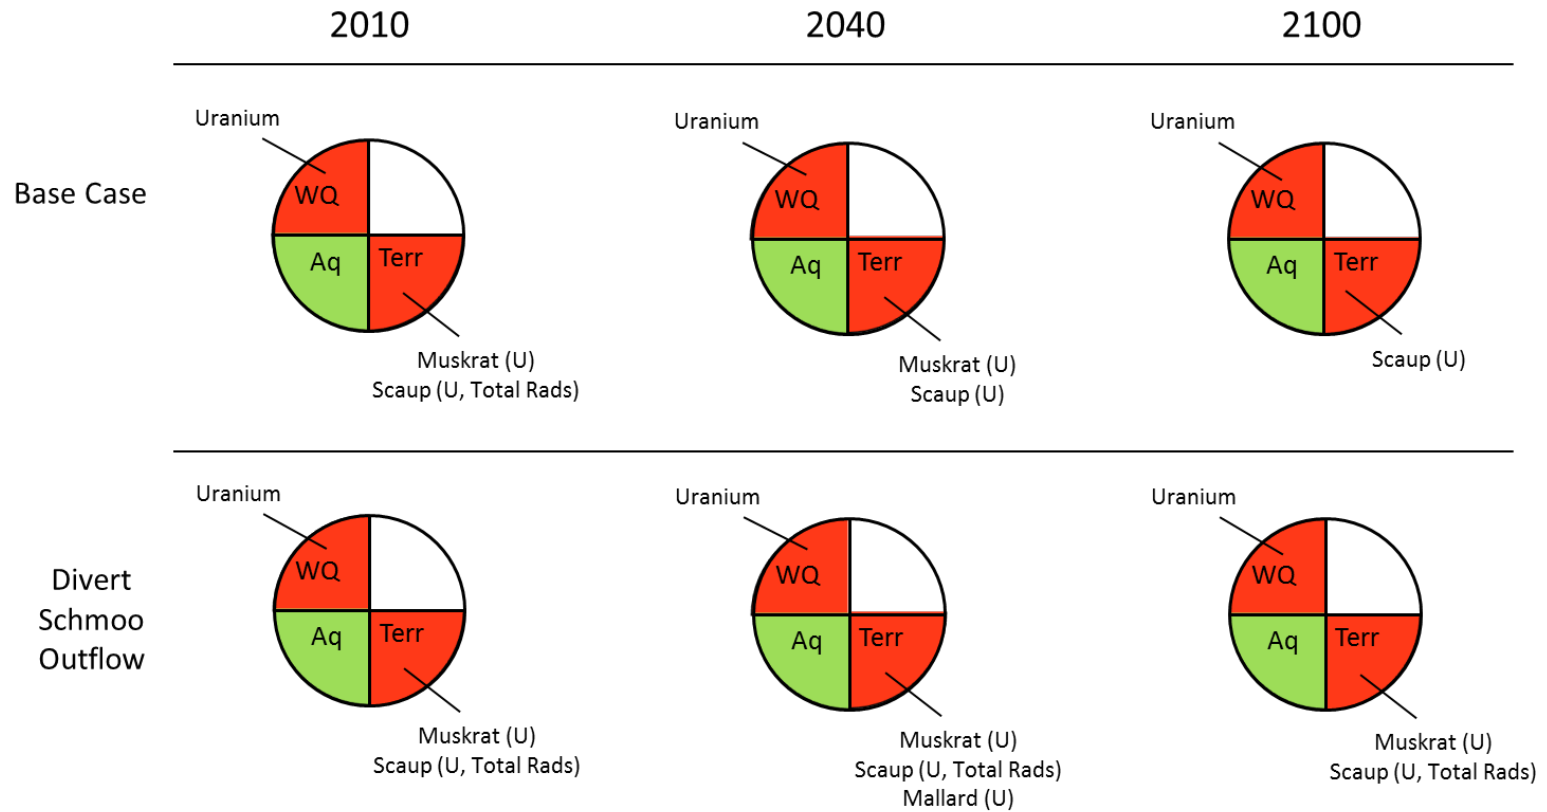
**Figure 2.2-4 Summary of Outcomes in Dubyna Lake (Divert Schmoor Lake Outflow)**

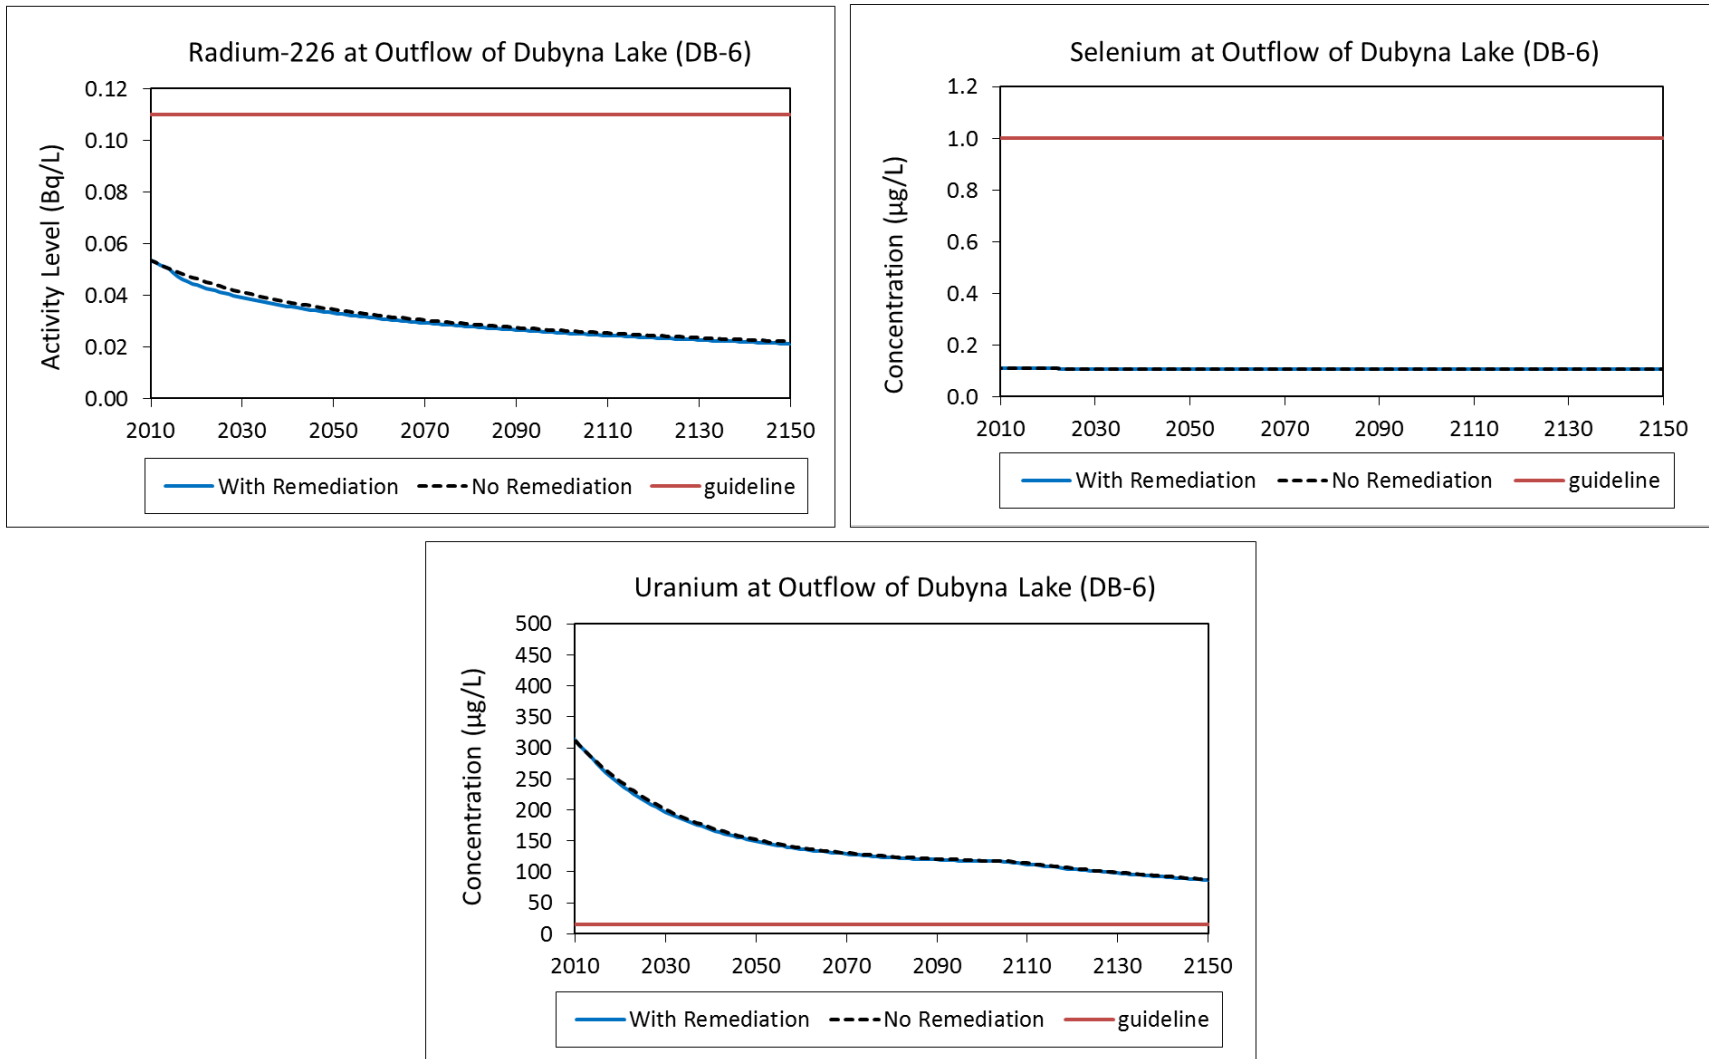
**Figure 2.2-6 Dubyna Lake Water Quality Predictions (Cover Dubyna Waste Rock)**

Predicted water quality in the immediate area as well as downstream over the 2010-2150 period is shown in Figures 2.2-6 and 2.2-7. Almost no change to the predicted water quality is seen in Dubyna or Ace lakes as a result of this activity. It should be noted that water quality in Ace Lake without any remedial activities is predicted to be below the applicable guidelines with the exception of uranium in the first few years. A summary of the predicted exceedances of water quality guidelines and SI benchmarks for the considered receptors are shown in Figures 2.2-8 and 2.2-9 for Dubyna and Ace lakes as compared to the base case, with no remediation. As can be seen, implementation of this remedial measure does not change the exceedances predicted in Dubyna or Ace lakes. Risks to receptors utilizing Ace Lake were predicted to be below the applicable SI benchmarks with and without the application of this cover. The results presented

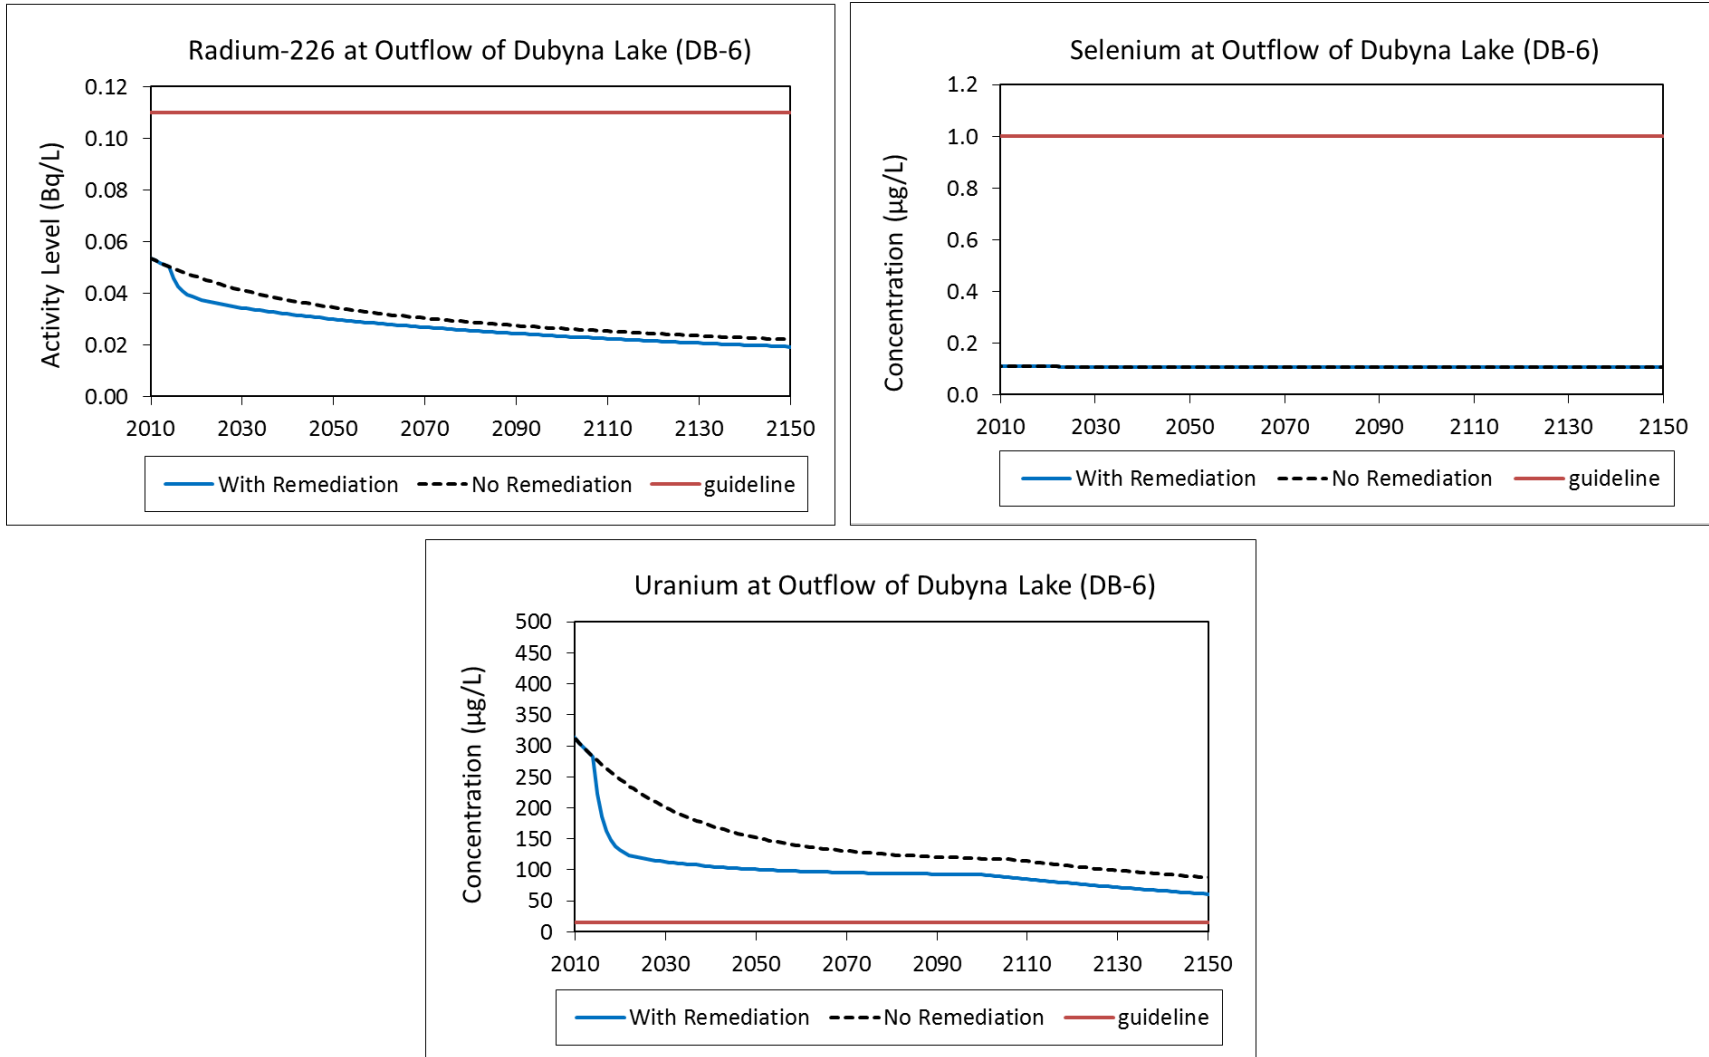
**Figure 2.2-10 Dubyna Lake Water Quality Predictions (Plug Dubyna Area Boreholes)**

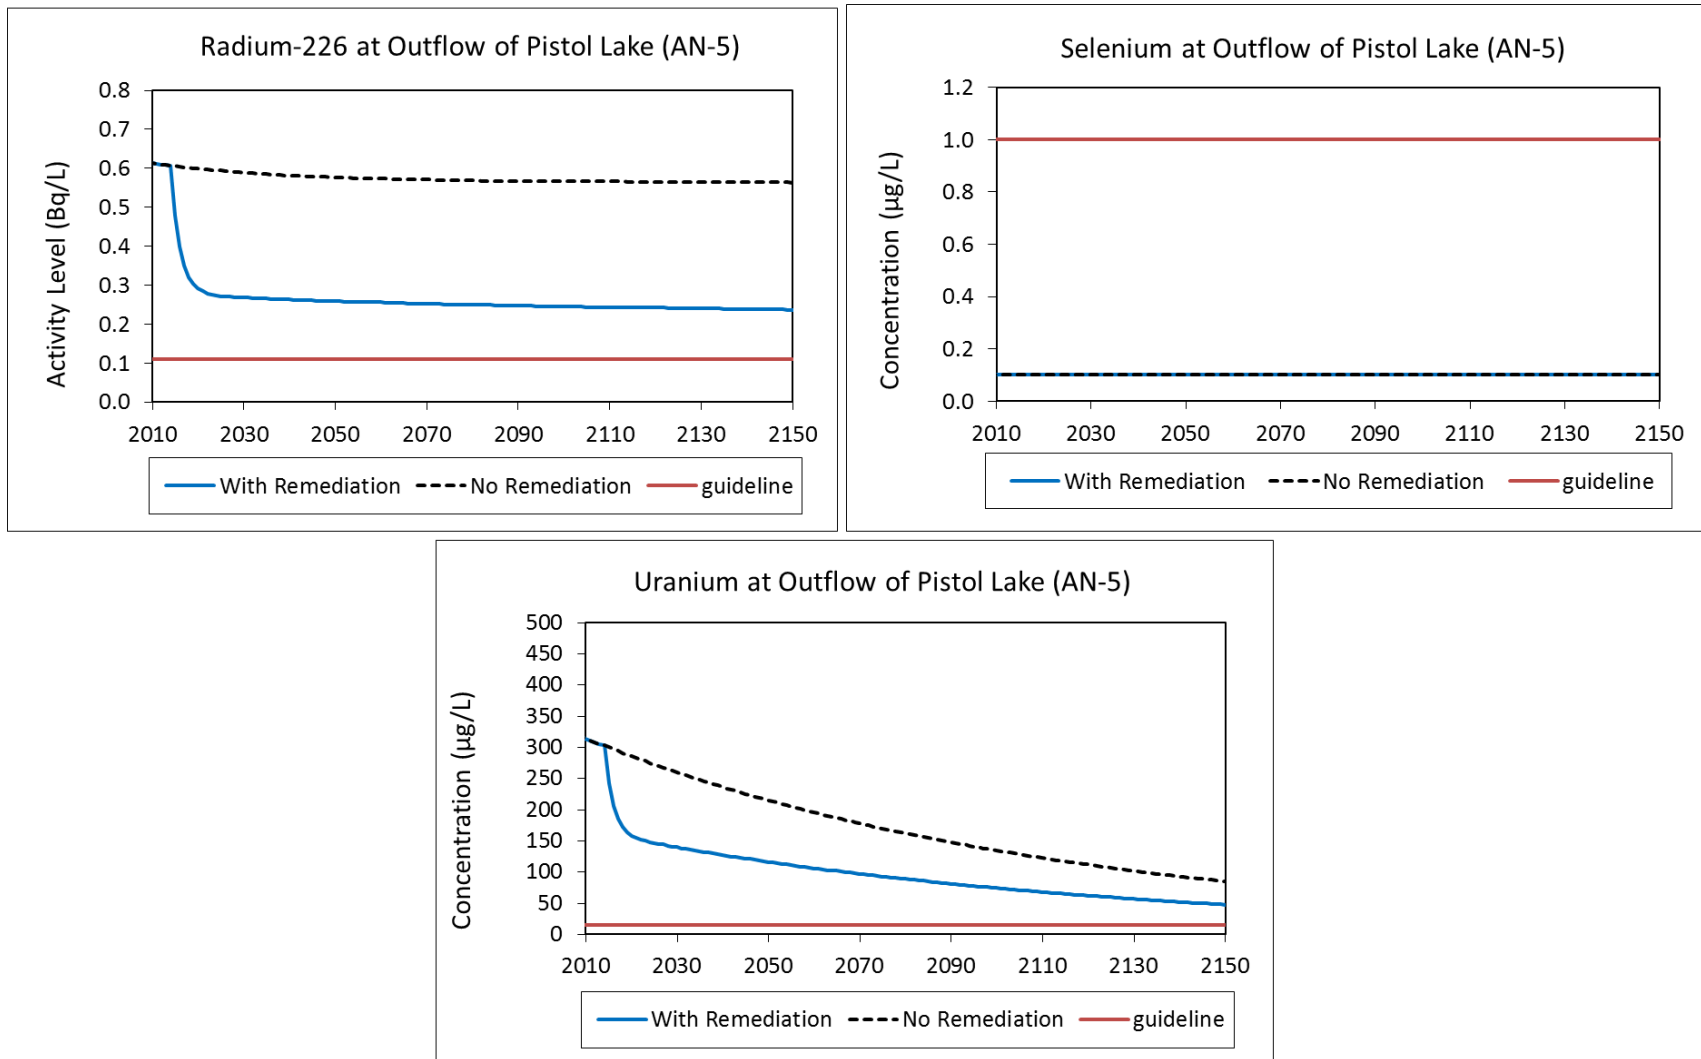
**Figure 2.3-2 Pistol Lake Water Quality Predictions (Divert Beatrice Lake Outflow)**

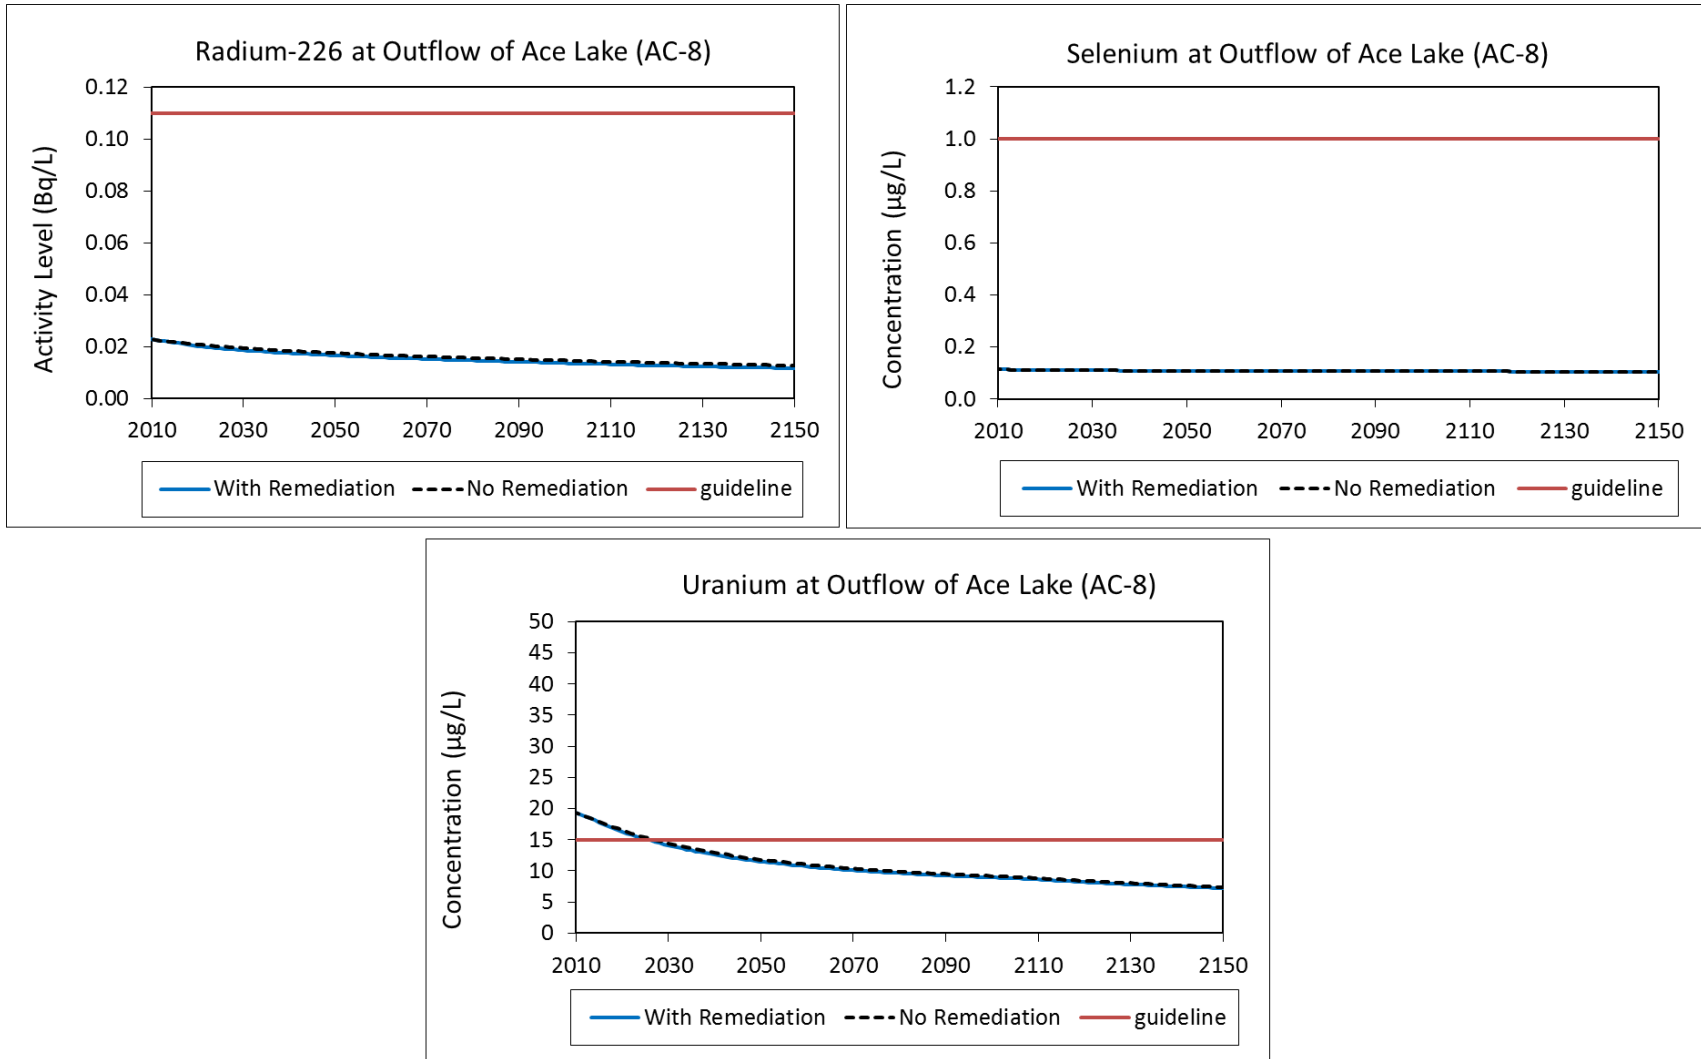
**Figure 2.3-4 Ace Lake Water Quality Predictions (Divert Beatrice Lake Outflow)**

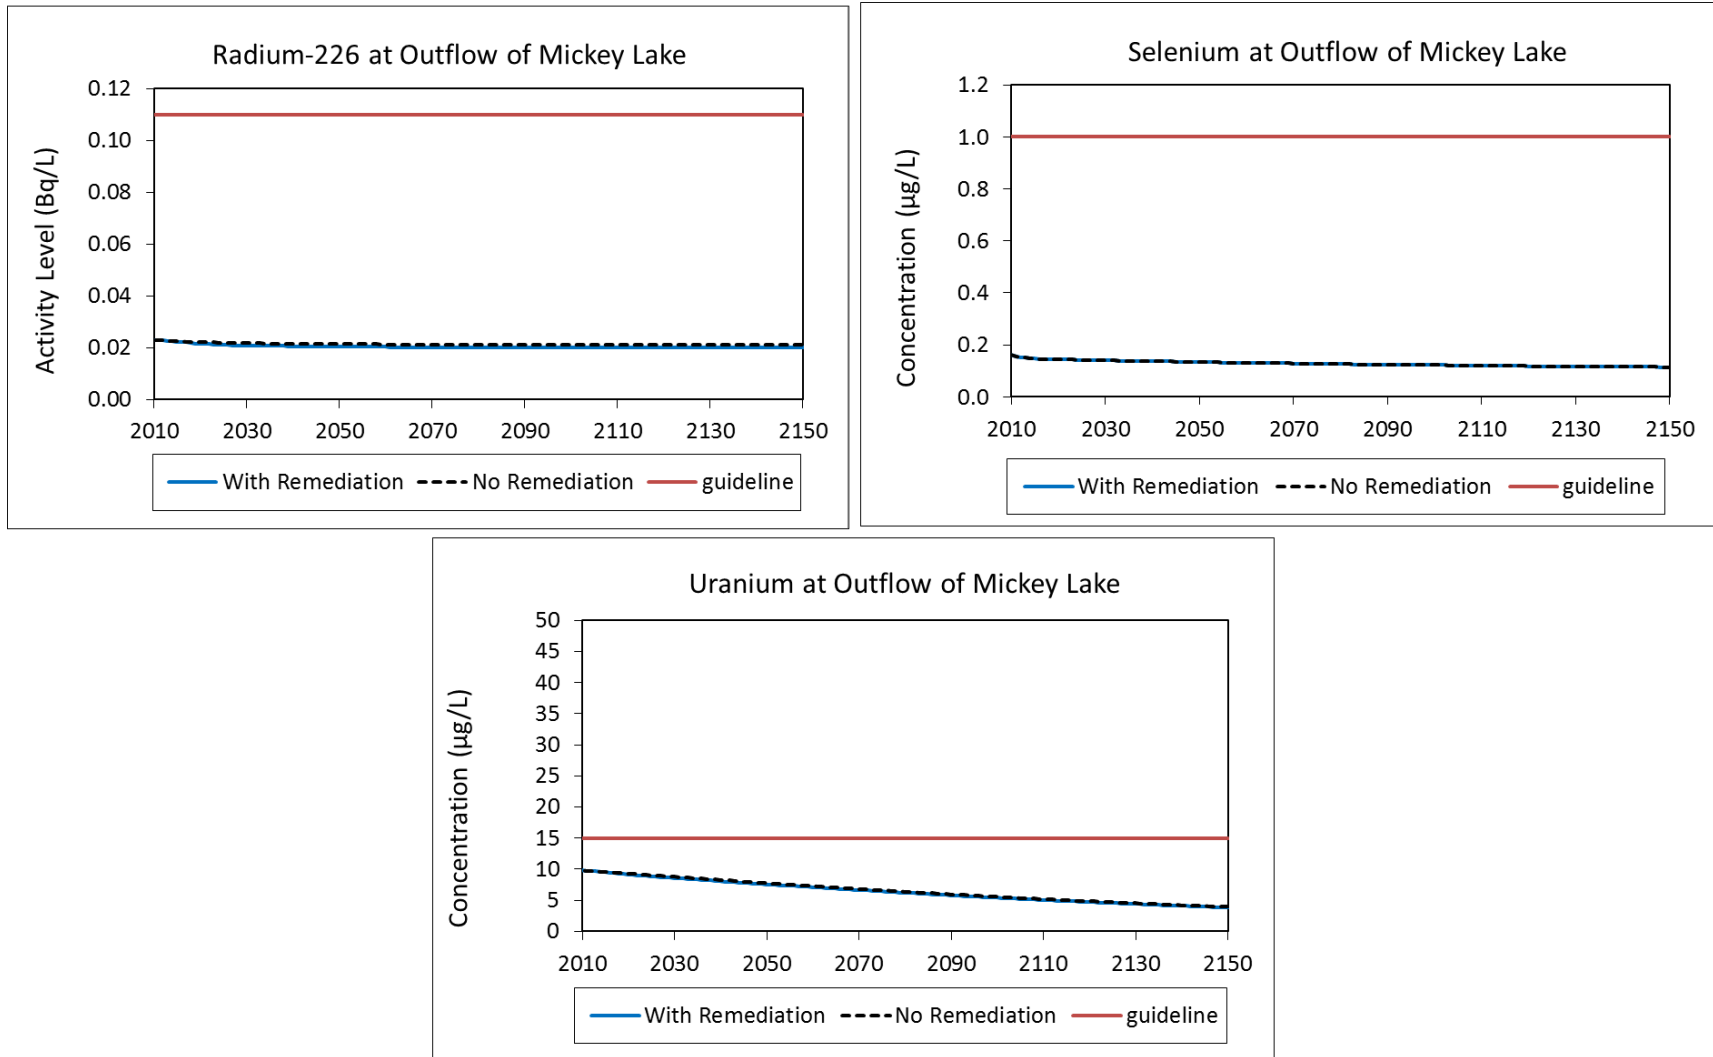
**Figure 2.3-8 Mickey Lake Water Quality Predictions (Reshape and Cover Waste Rock)**

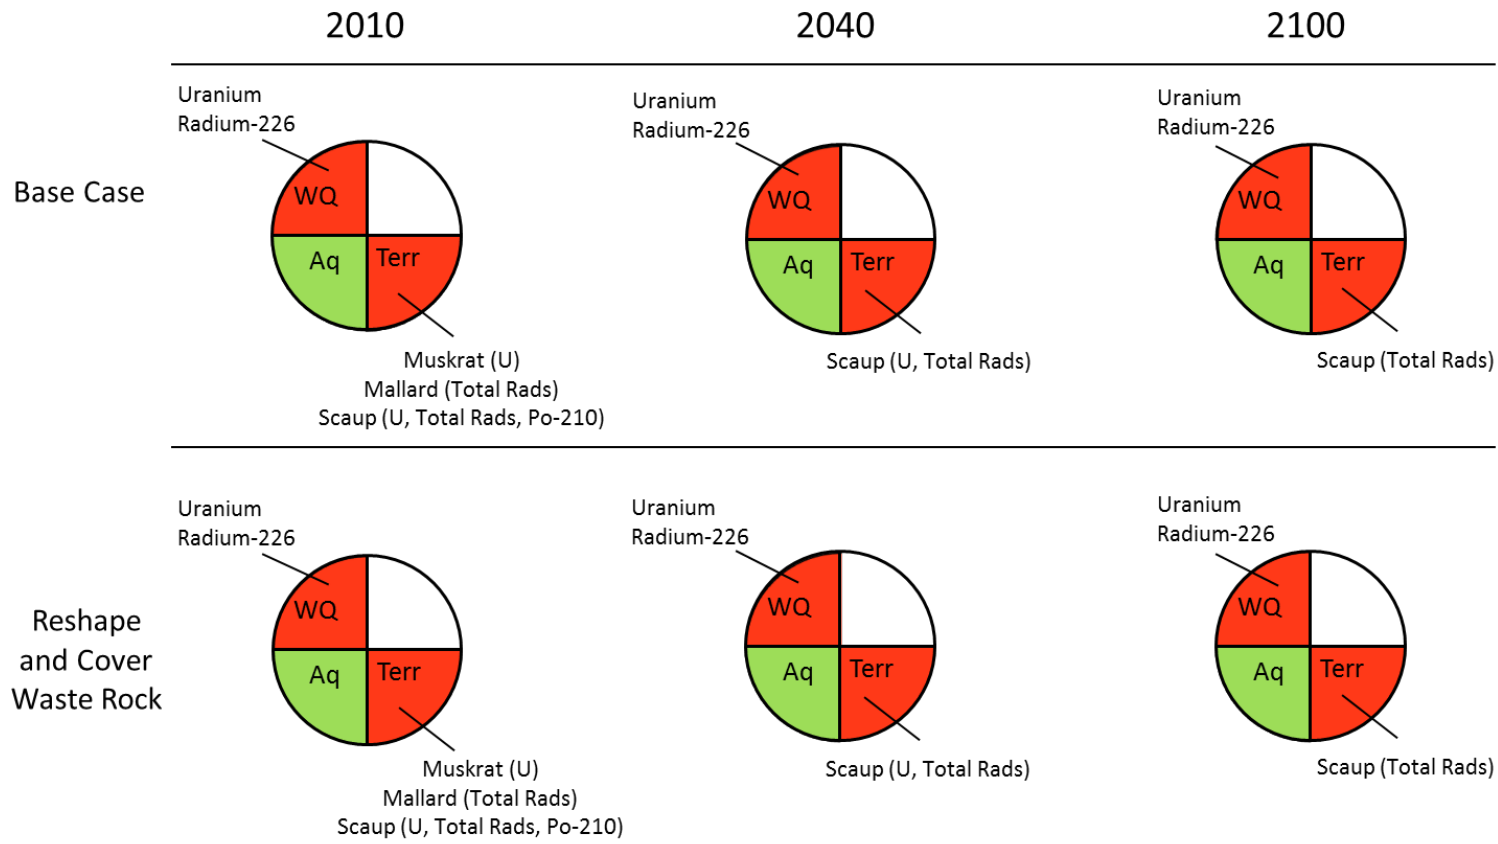
**Figure 2.3-10 Summary of Outcomes in Pistol Lake (Reshape and Cover Waste Rock)**

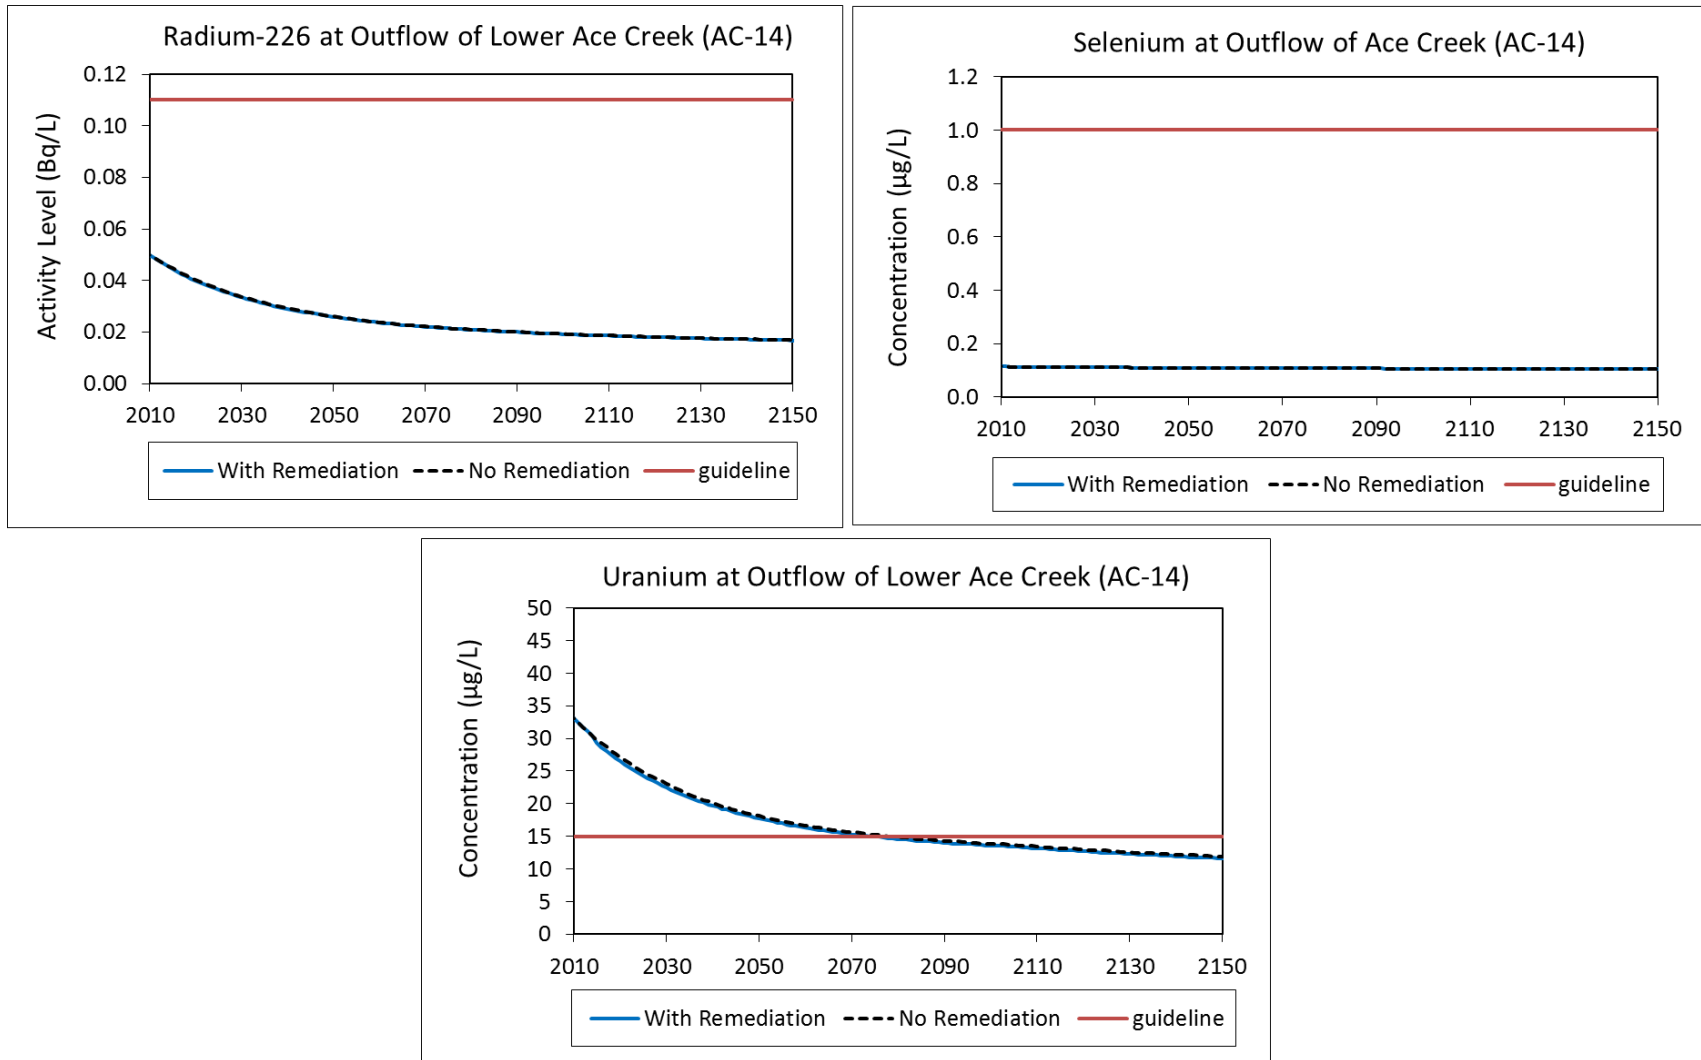
**Figure 2.5-2 Lower Ace Creek Water Quality Predictions (Reshape and Cover Fay Waste Rock Pile)**

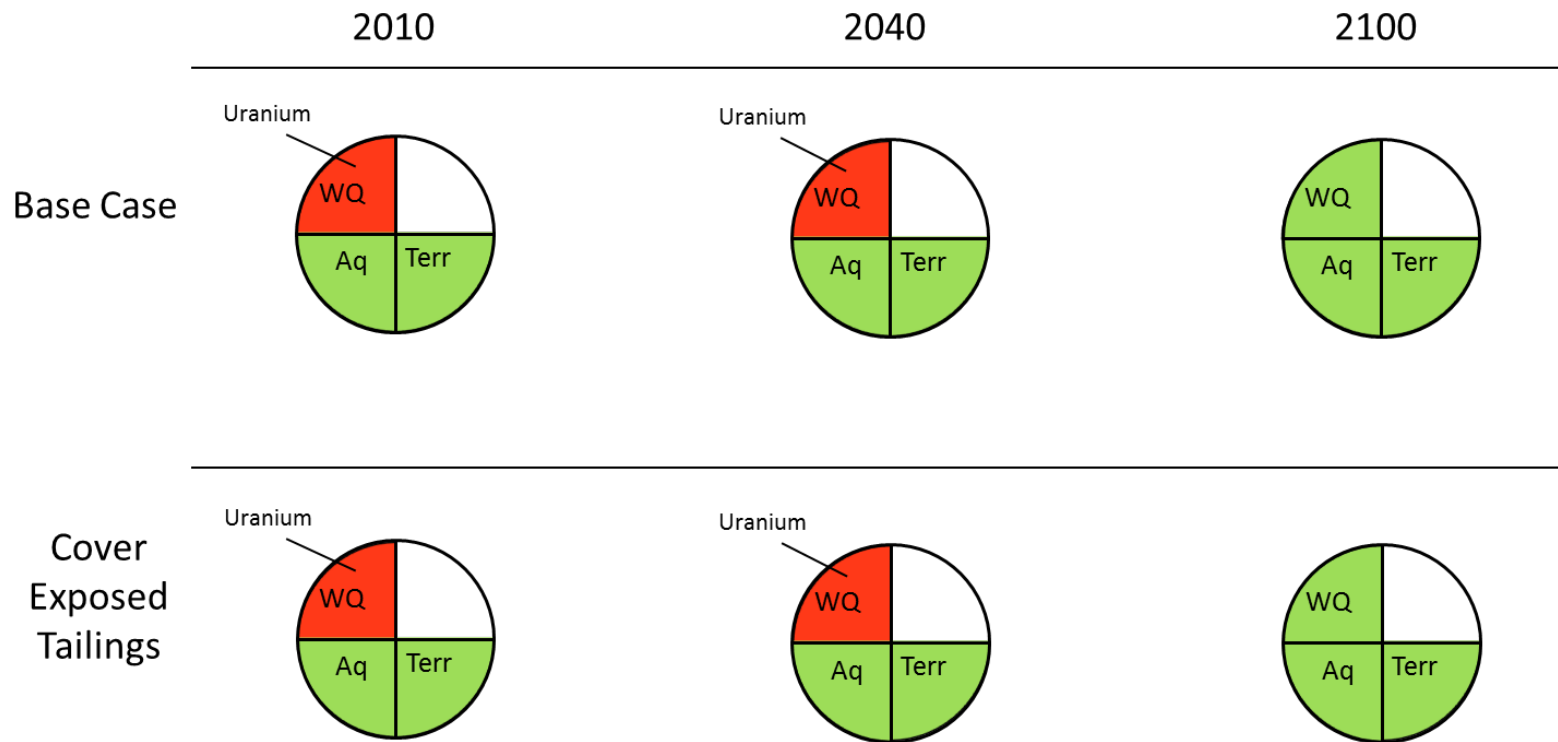
**Figure 2.5-8 Summary of Outcomes in Lower Ace Creek (Cover Exposed Tailings)**

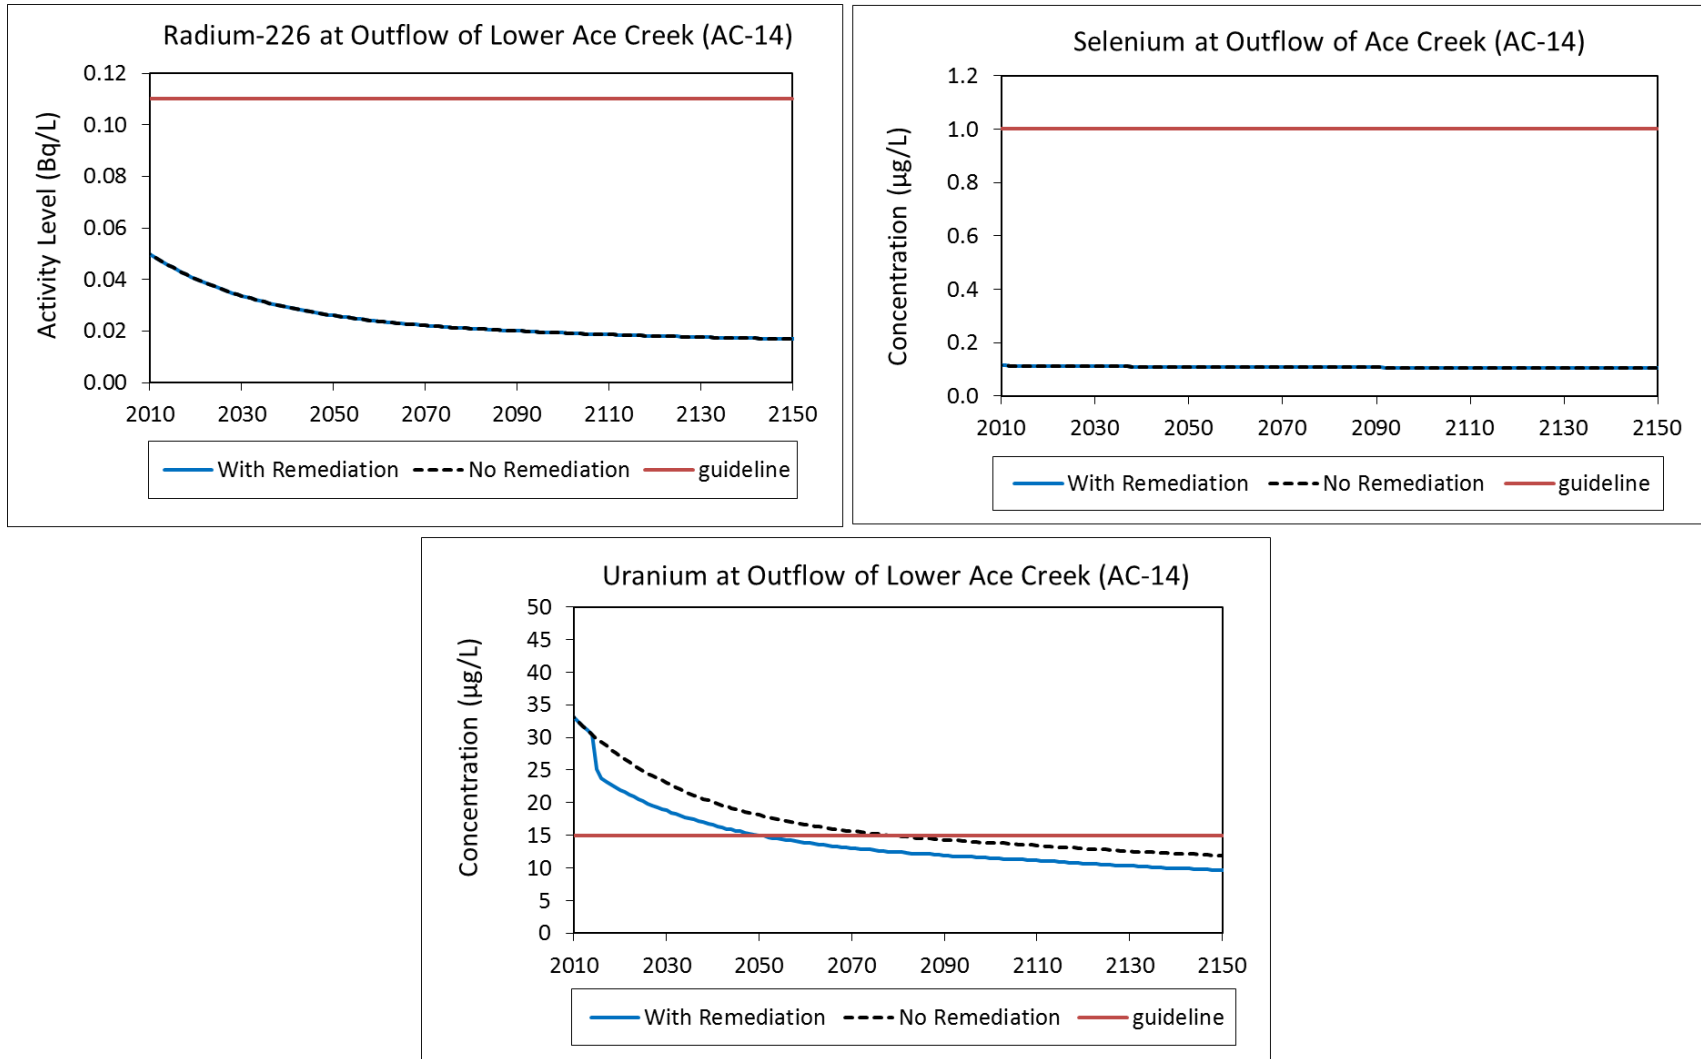
**Figure 2.5-10 Lower Ace Creek Water Quality Predictions (Treat Mill Seep for U Removal)**

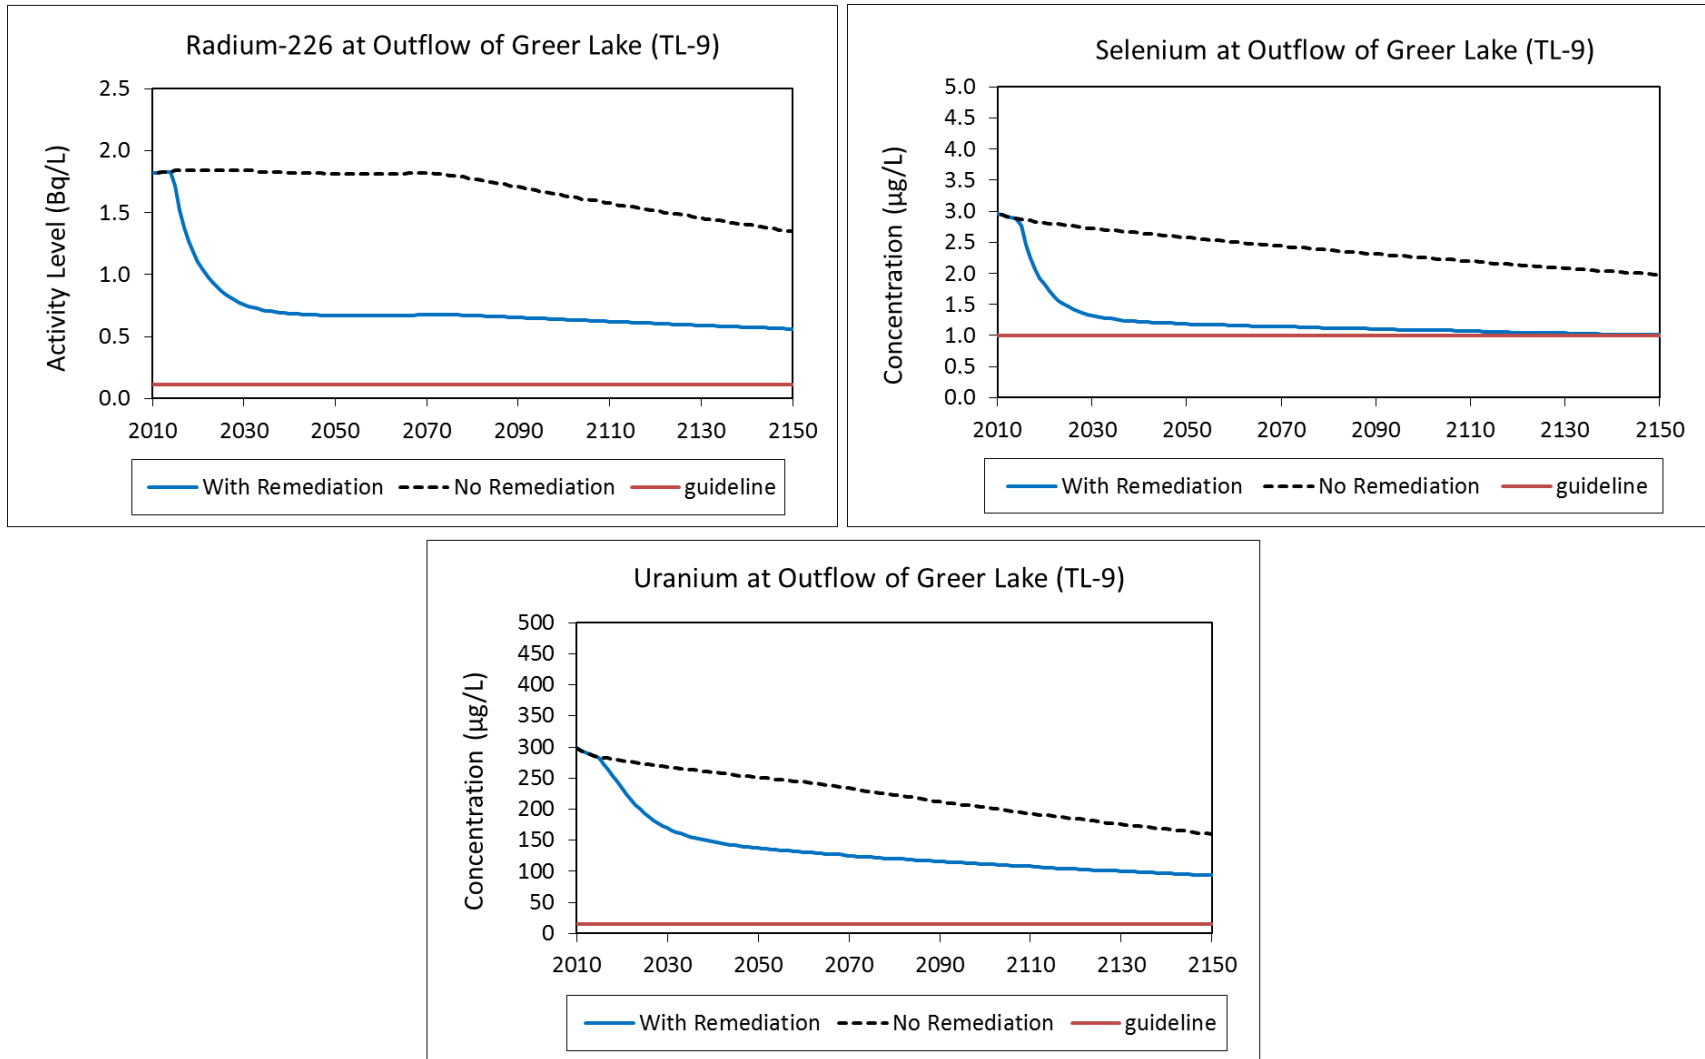
**Figure 2.6-16 Greer Lake Water Quality Predictions (Cover Fulton Creek Sediments)**

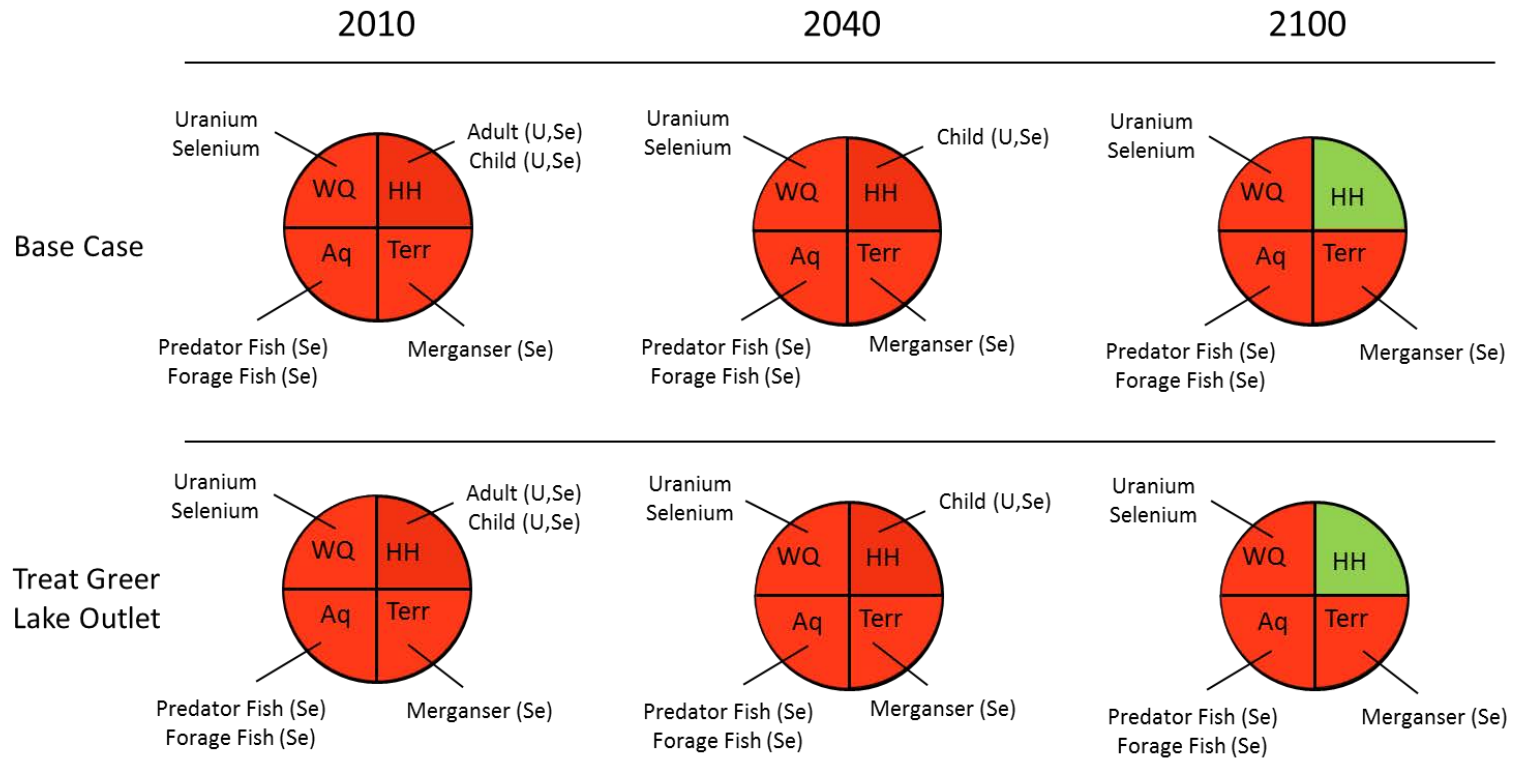
**Figure 2.6-31 Summary of Outcomes in Beaverlodge Lake West (Water Treatment at Greer Lake Outlet)**
