CNSC Commission Member Document (CMD)

Request for a Licensing Decision: Amend the Beaverlodge Waste Facility Operating Licence to allow removal of 18 properties from CNSC licensing

Cameco Corporation

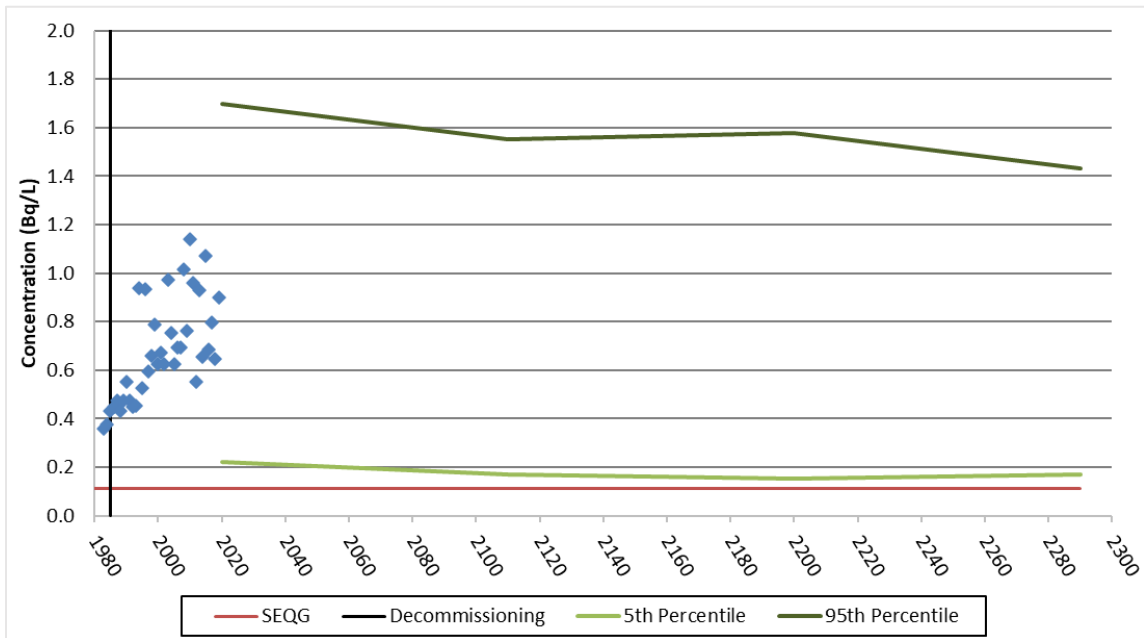
Figure 3.1-2: Radium-226 concentrations and predictions at station AN-5.

Water quality measured at the outflow of Pistol Lake (Station AN-5) compared to modelled predictions is a performance indicator associated with the decommissioned HAB 1, HAB 2 and EXC 1 properties. The relevant water quality constituents assessed as part of this performance indicator include, radium-226, uranium and selenium. As shown in Figures 3.1-2, 3.1-3 and 3.1-4, measured concentrations of these parameters fall within the range of modelled predictions for AN-5.

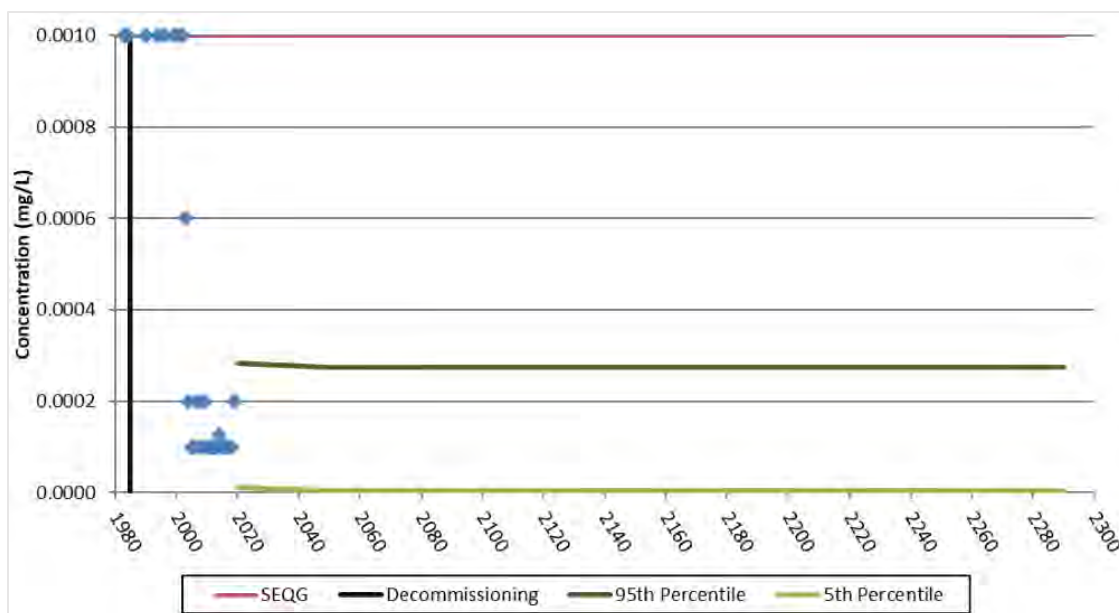
Figure 3.1-4: Selenium (Se) concentrations and predictions at station AN-5.

*Note: Prior to 2000, the detection limit for Se was 0.001 mg/L and post 2000 it has been 0.0001 mg/L.

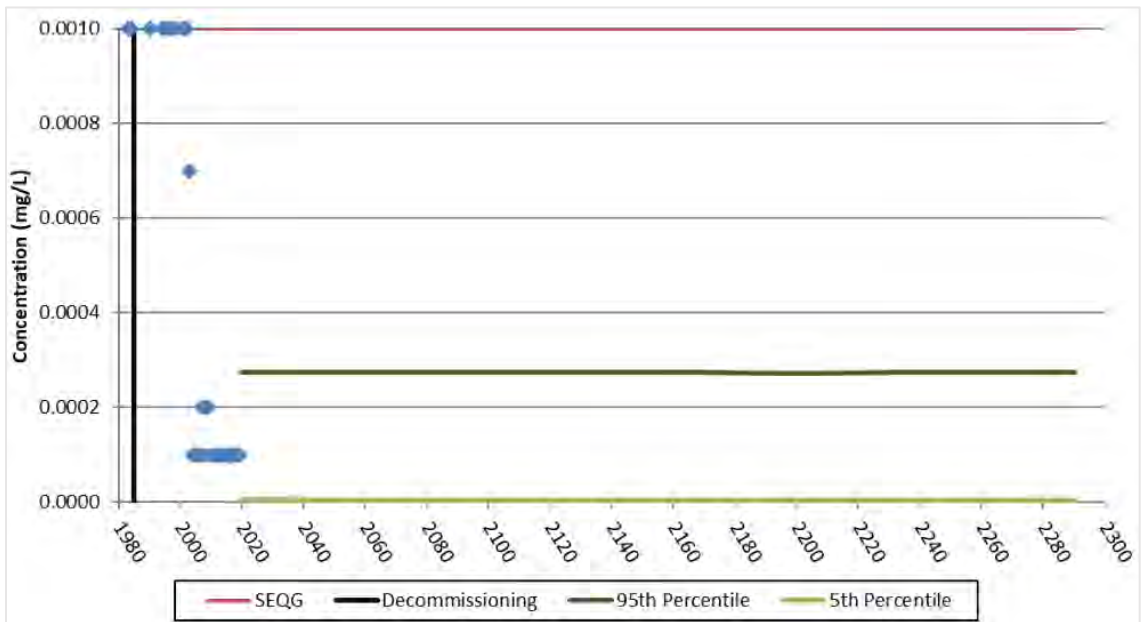
Figure 3.2-4: Selenium (Se) concentrations and predictions at station DB-6.

Water quality measured at Dubyna Creek (Station DB-6), located immediately downstream of Dubyna Lake, compared to modelled predictions is a performance indicator associated with the decommissioned EMAR 1 property. The relevant water quality constituents assessed as part of this performance indicator include, radium-226, uranium and selenium. As shown in Figures 3.2-2, 3.2-3 and 3.2-4, measured concentrations of these parameters fall within the range of modelled predictions for DB-6.

*Note: Prior to 2000, the detection limit for Se was 0.001 mg/L and post 2000 it has been 0.0001 mg/L.

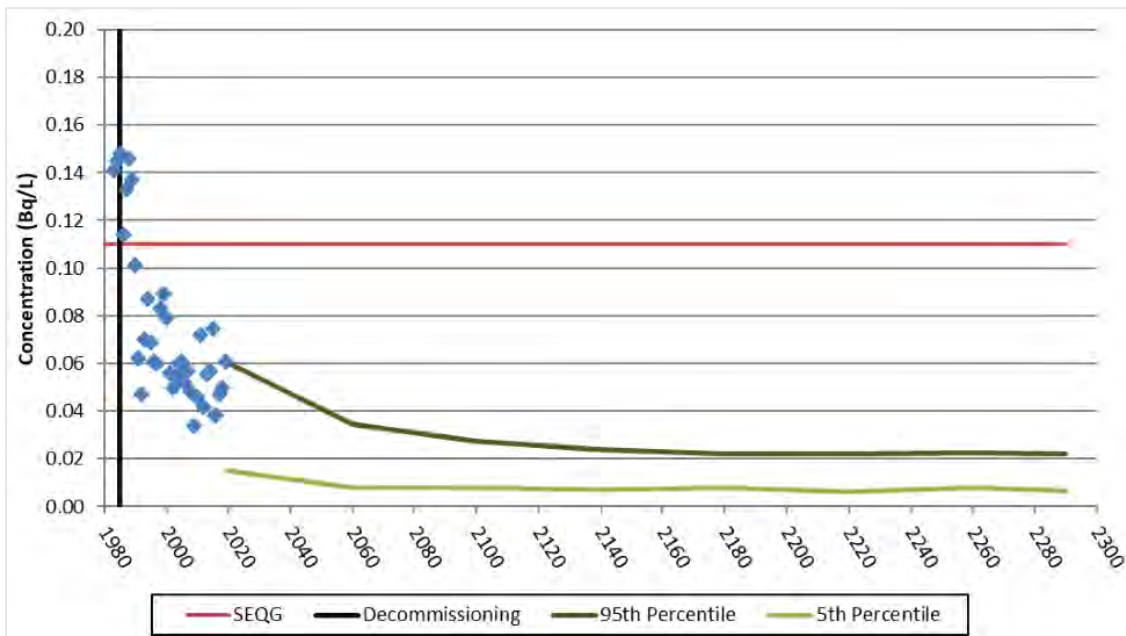
Figure 3.3-2: Radium concentrations and predictions at station AC-14.

Seeps originating at the base on the Fay waste rock pile on the URA 7 property (not subject to this request) extend to EXC URA 7. Water quality measured at the outlet of Lower Ace Creek (station AC-14) compared to modelled predictions is a performance indicator associated with the decommissioned EXC URA 7 and URA FR properties. The relevant water quality constituents assessed as part of this performance indicator include, radium-226, uranium and selenium. As shown in Figures 3.3-2, 3.3-3 and 3.3-4, measured concentrations of these parameters fall within the range of modelled predictions for AC-14.

- Radium-226 and selenium levels in Lower Ace Creek are within the modelled range and are expected to remain low (e.g., below applicable surface water guideline levels) over the long-term
- Uranium concentrations in Lower Ace Creek are within the modelled range and are expected to continually decline over time
