## **CNSC Commission Member Document (CMD)**

**CMD: 19-H6.1**

# **Cameco Corporation**

**Request for a Licensing Decision: Amend the Beaverlodge Waste Facility Operating Licence to allow removal of 20 properties from CNSC licensing**

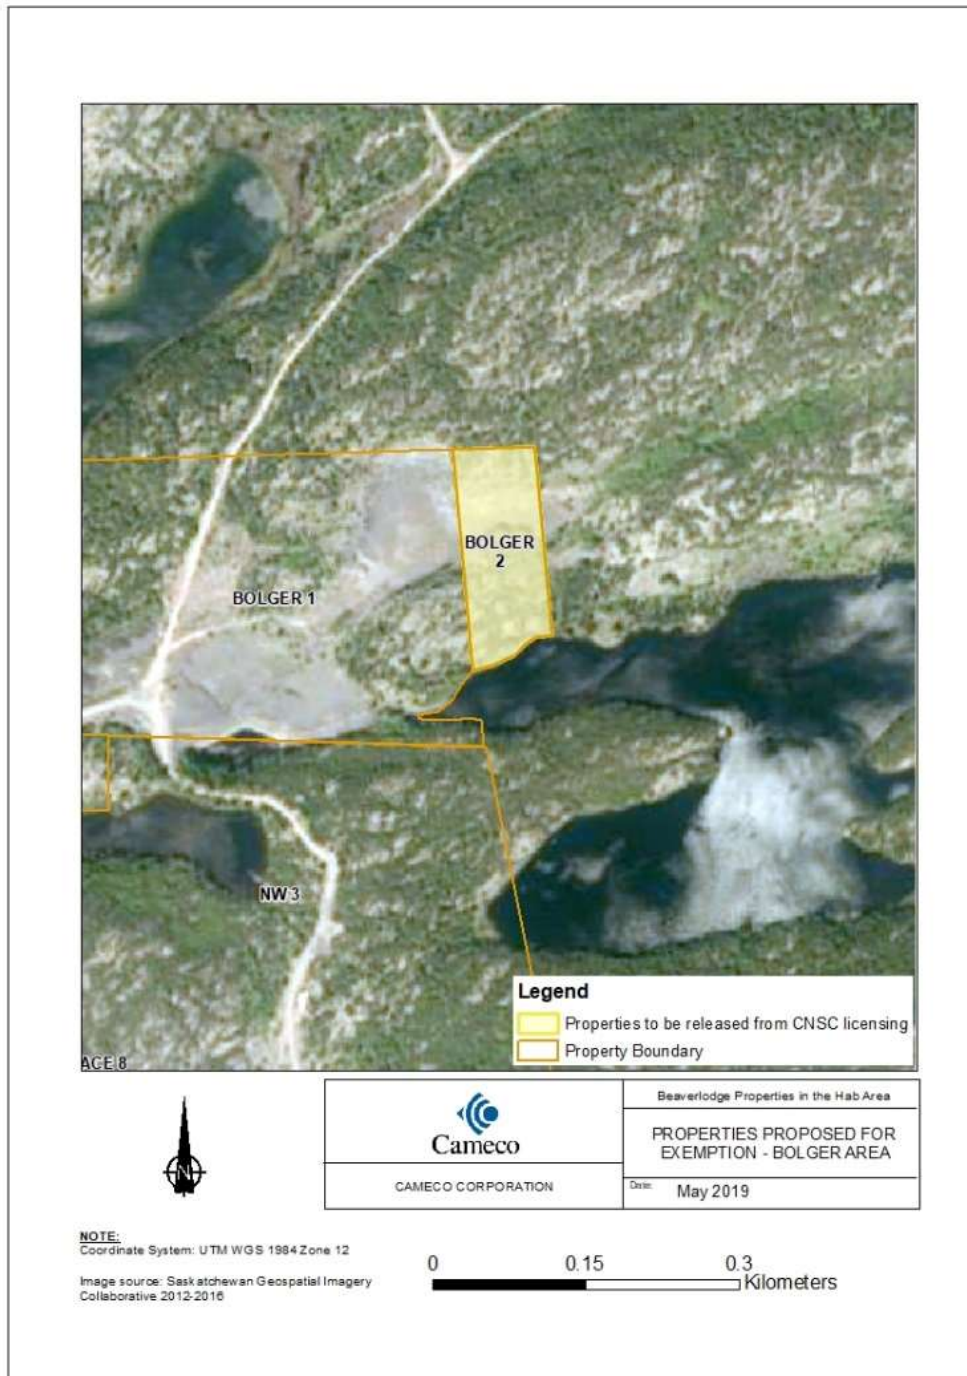
*Figure 3.3-1 BOLGER 2 property boundaries.*

The BOLGER 2 property consists of a 1.6 hectare parcel of land located on the former Verna/Bolger satellite mine area (Figure 3.3-1). The BOLGER 2 property contains a small open pit, identified as the Bolger "spur pit". The spur pit is located adjacent to the

main Bolger Pit, but terminated at a higher elevation. No decommissioning waste was disposed of within the spur pit on the BOLGER 2 property. There is also a small amount of waste rock associated with the BOLGER 2 property. Waste rock characterization has been completed and demonstrates that the waste rock has a low potential for acid generation. In addition, visual observation and monitoring has not indicated any conditions or impacts that would be attributed to acid generation.

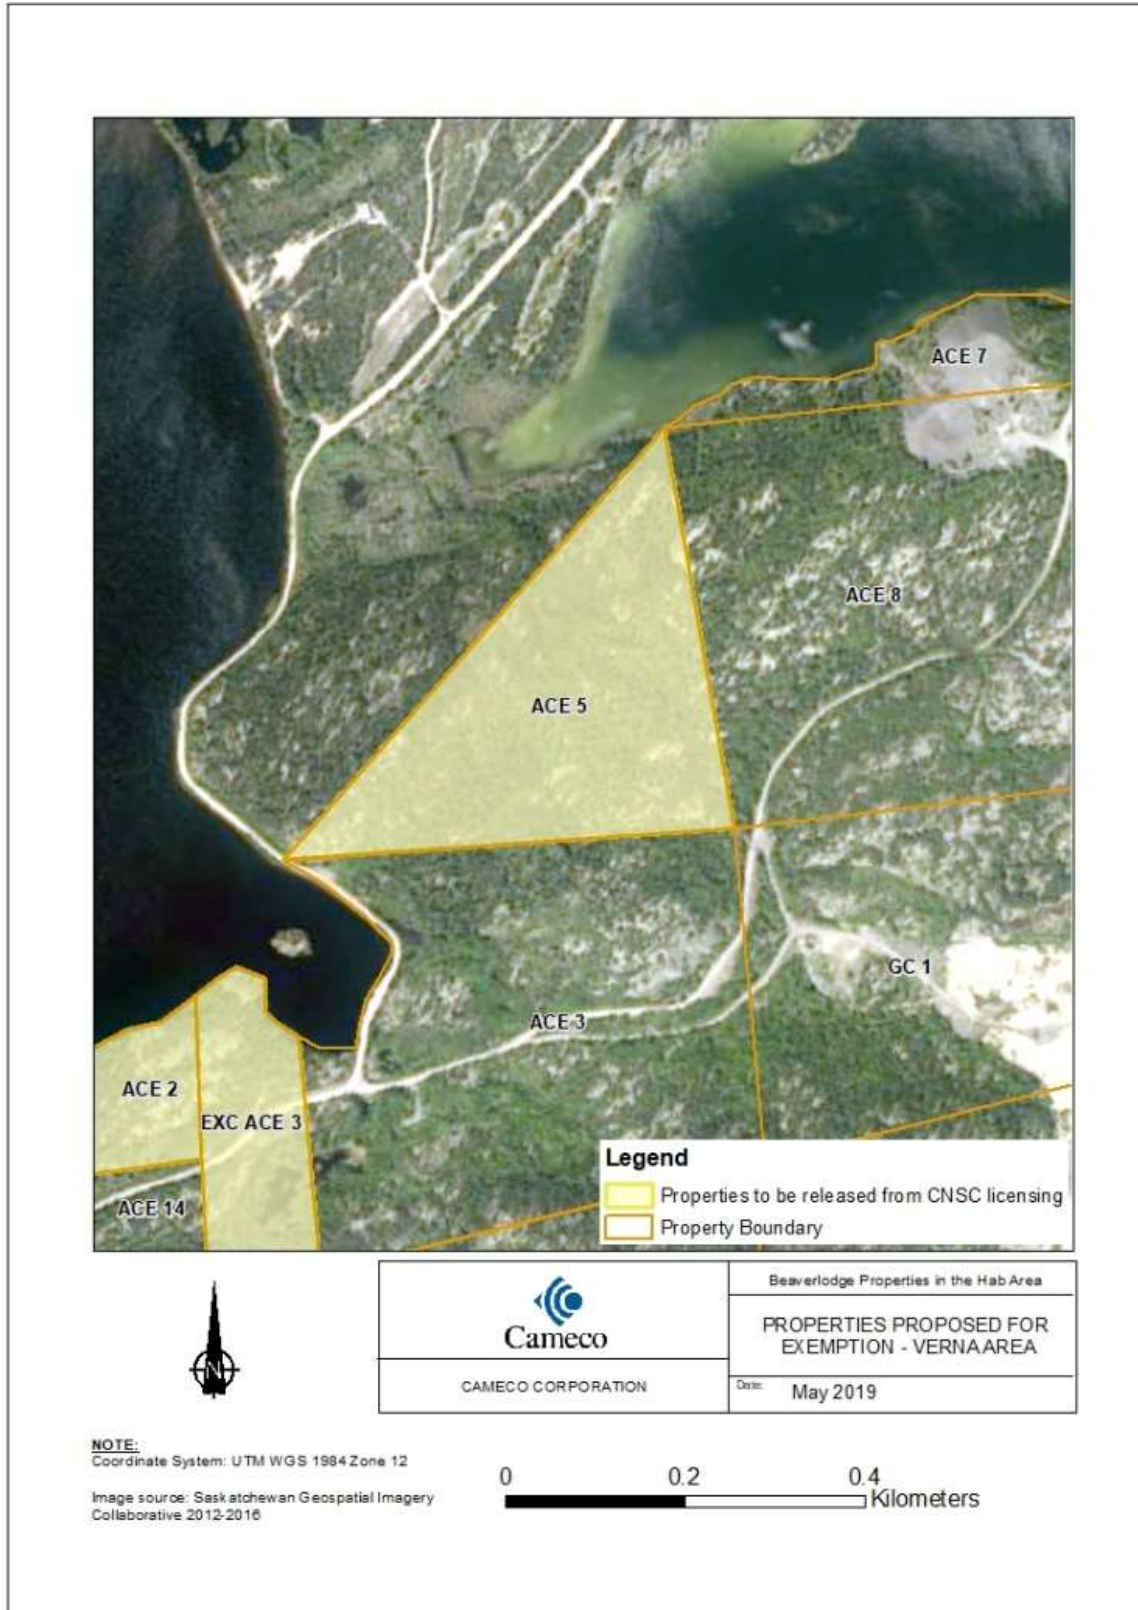
Figure 3.3-2 ACE 5 property boundaries.

The ACE 5 property consists of an 11.3 hectare parcel of land located between Ace Lake and the Verna site (Figure 3.3-2). The ACE 5 property hosted two separate utility corridors/lines: the main powerline from the Fay site crossed the corner of Ace Lake and traveled directly over the hill to the Verna powerhouse, and a communication line, which also crossed the corner of Ace Lake and traveled directly over the hill to the Verna powerhouse. The property does not contain any roads or any other infrastructure or disturbance.

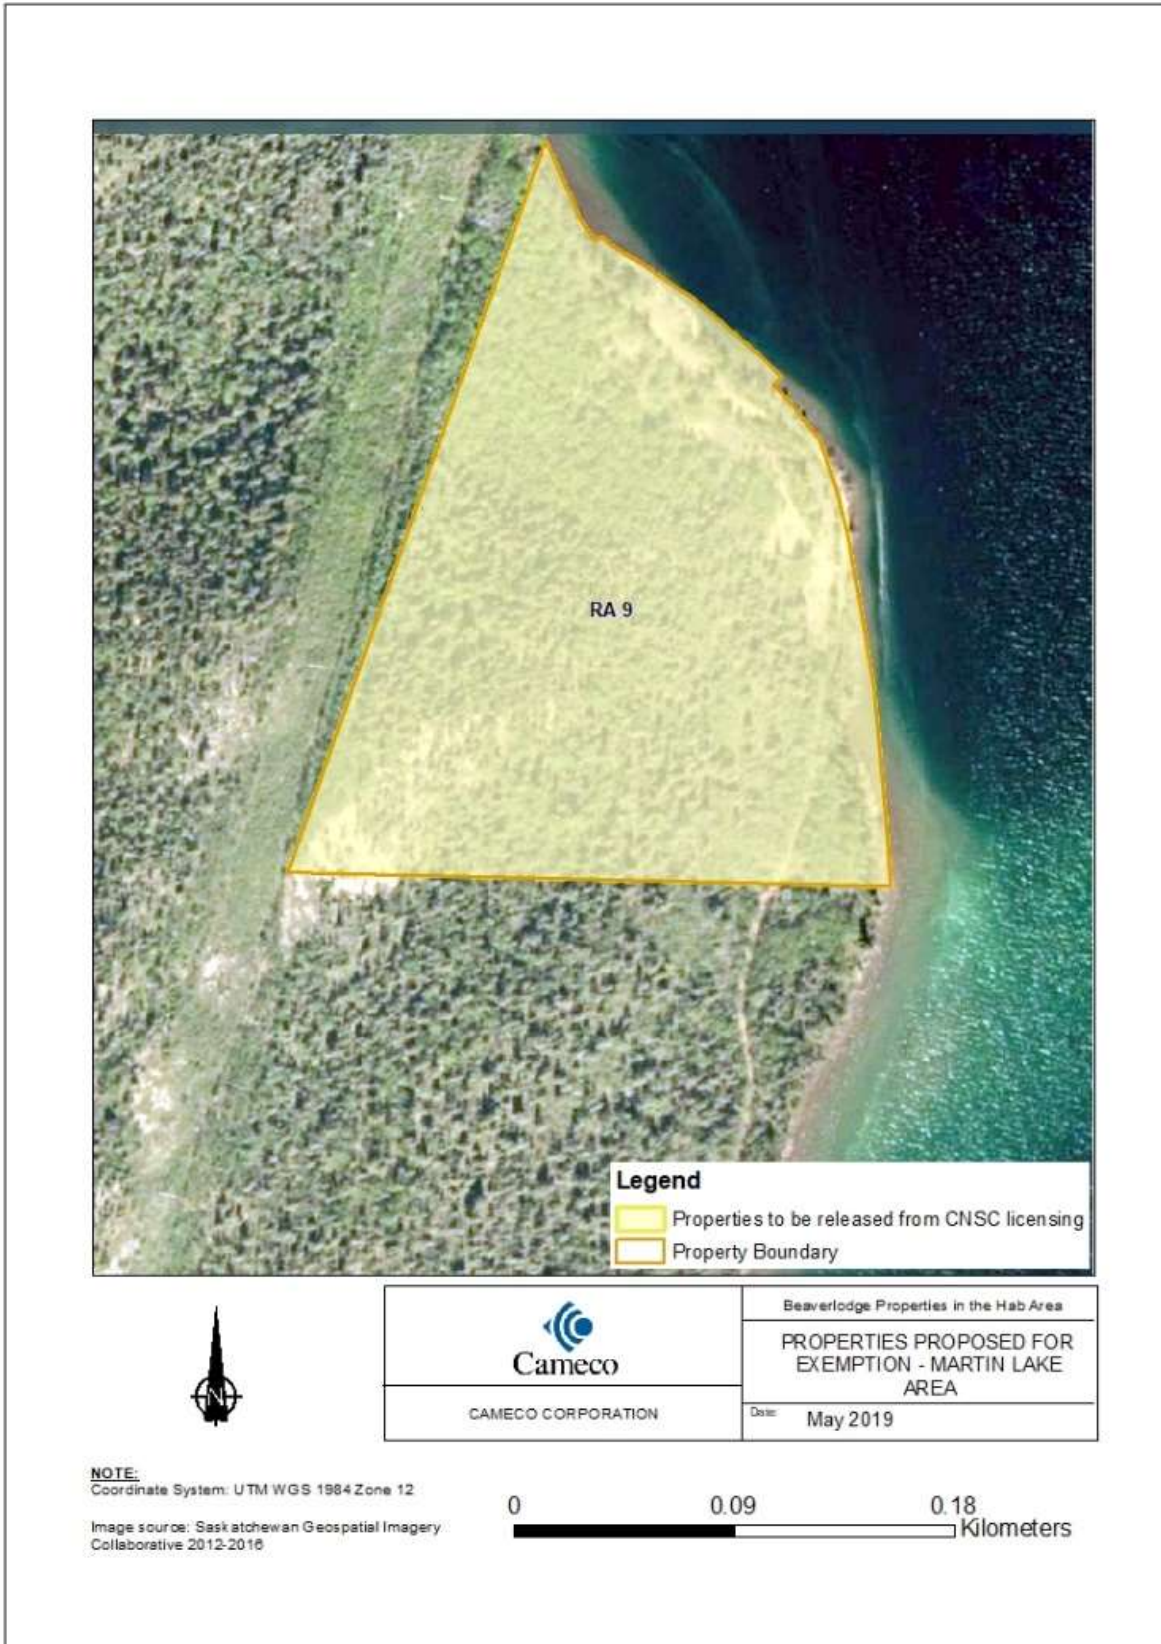
*Figure 3.5-2 RA 9 property including proposed IC boundary.*

The RA 9 property consists of a 4.5 hectare parcel of land located along the western shoreline of Padget Bay of Beaverlodge Lake (Figure 3.5-1). The RA 9 property contains an adit that has been backfilled with waste rock to prevent access to the mine workings. A geotechnical assessment of the crown pillar located between properties RA 6 and RA 9 concluded no immediate subsidence or safety risk is expected and no additional investigations or remediation related to the crown pillars in this area are expected to be required due to the thickness of the crown pillars and depth to the underground workings below this area (SRK 2015).

Also located on the property is waste rock associated with the mine development. The waste rock pile is located in the area between the adit opening and the shoreline of the lake, but does not encroach on Beaverlodge Lake. Waste rock characterization has been completed and demonstrates that the waste rock has a low potential for acid generation. In addition, visual observation and monitoring has not indicated any conditions or impacts that would be attributed to acid generation.
