**Beaverlodge: Year 31 Transition Phase Monitoring Annual Report (2016)**

## Beaverlodge Project 2016 Annual Report Year 31 Transition Phase Monitoring

**March 2017**

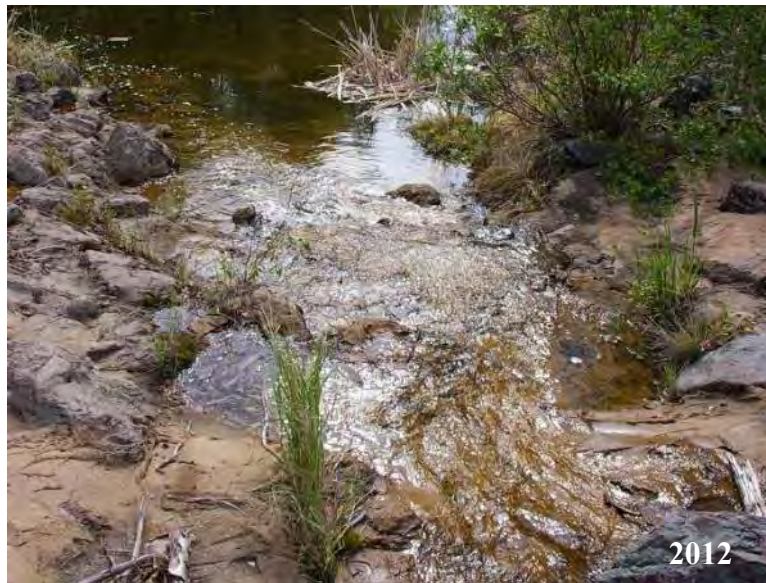
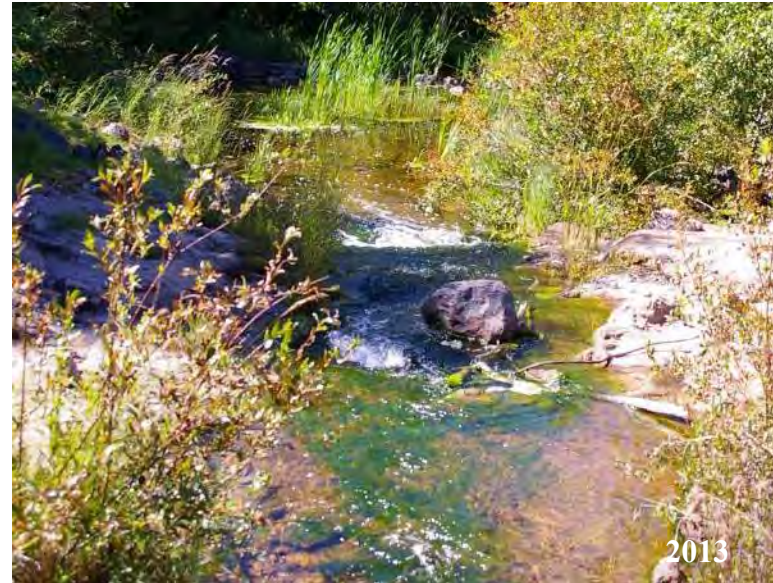
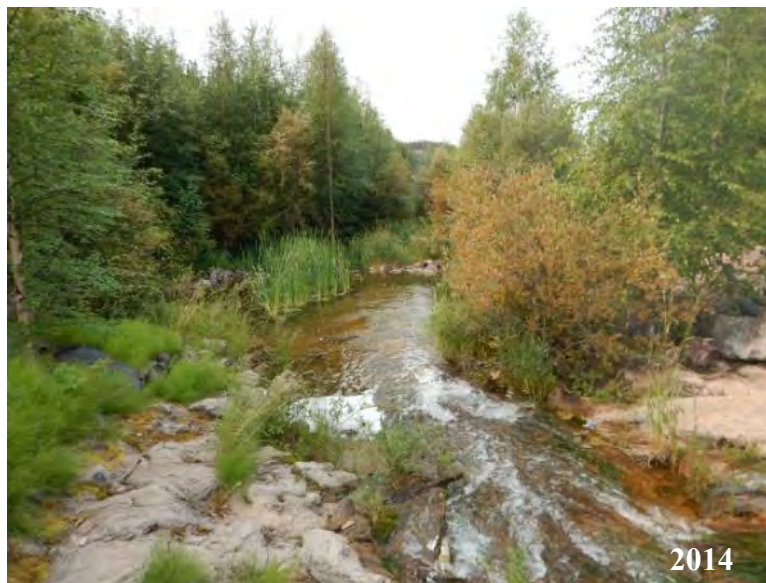
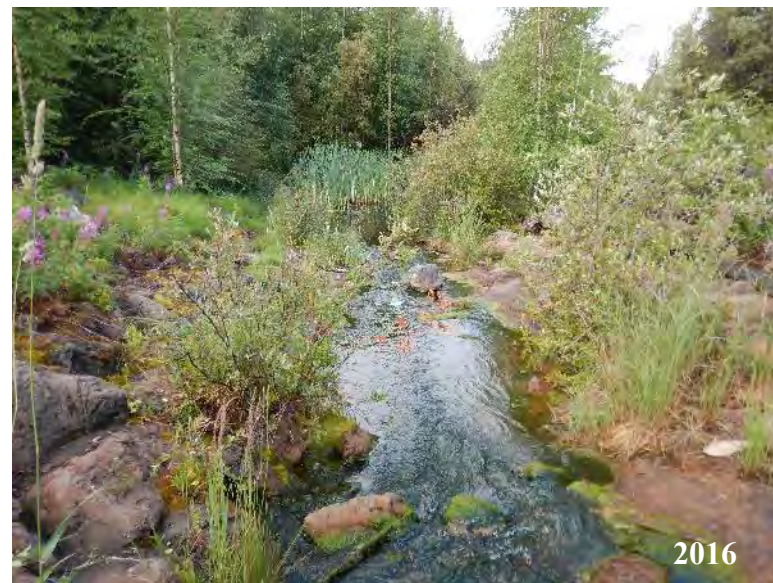
Photos taken during the July and September 2016 inspections provide photographic record of the condition of the Marie Reservoir spillway channel and are attached in [Appendix A](#). The spillway remains in a similar condition as observed in previous inspections.

Marie Outlet Structure looking upstream

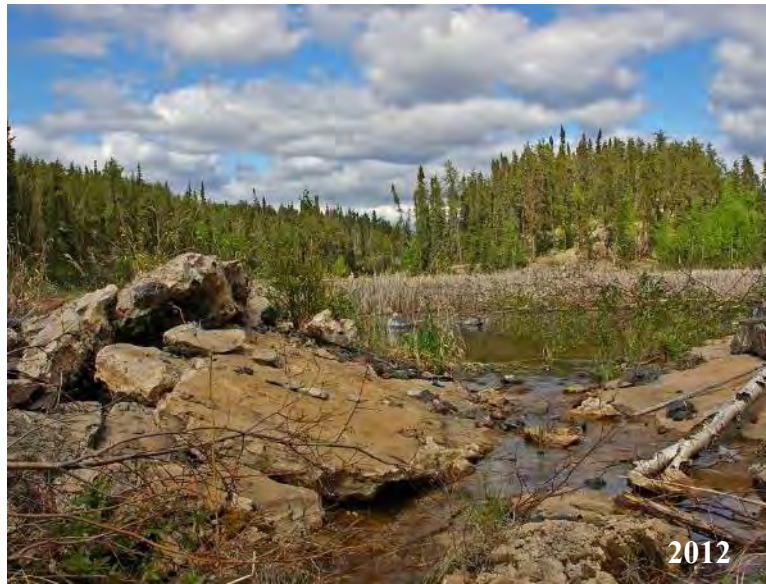
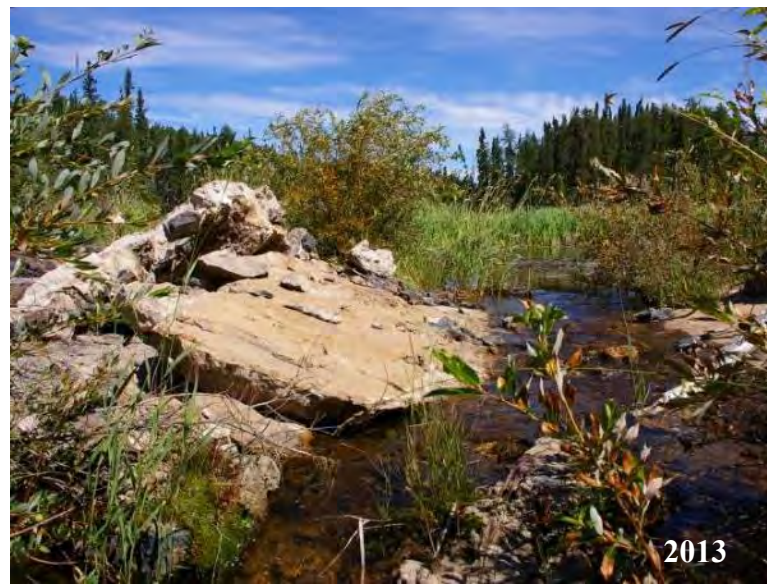
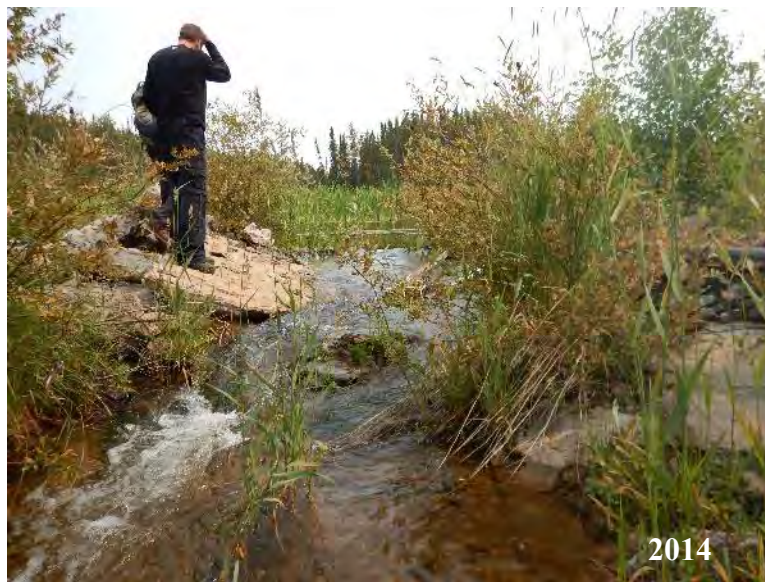
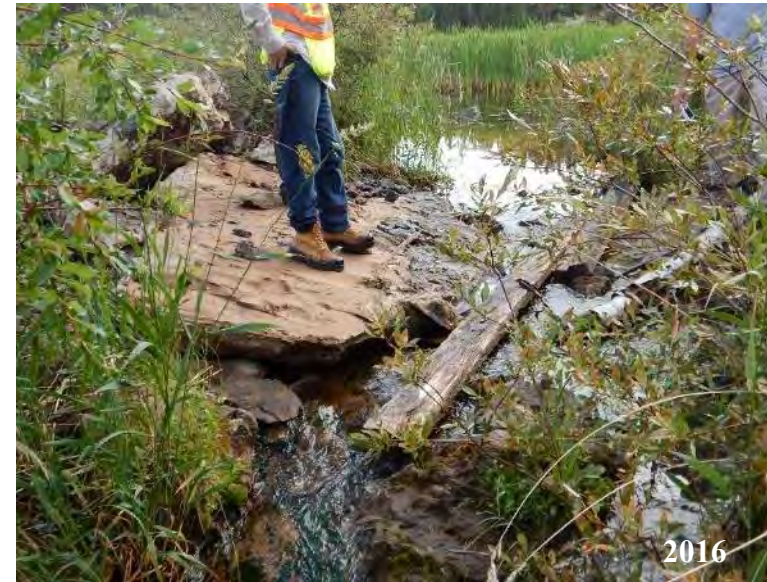
Despite the noted increased flows observed at the outlet of Marie Reservoir there is no evidence that water has overtopped the rip-rap in this area. Photographic evidence comparing the last four internal inspections show loose stones on the frost-heaved block of grout intruded rip-rap have not moved from year to year. Photographic comparison to previous inspection photos is provided in [Section 4.0](#).

Marie Outlet Structure looking downstream

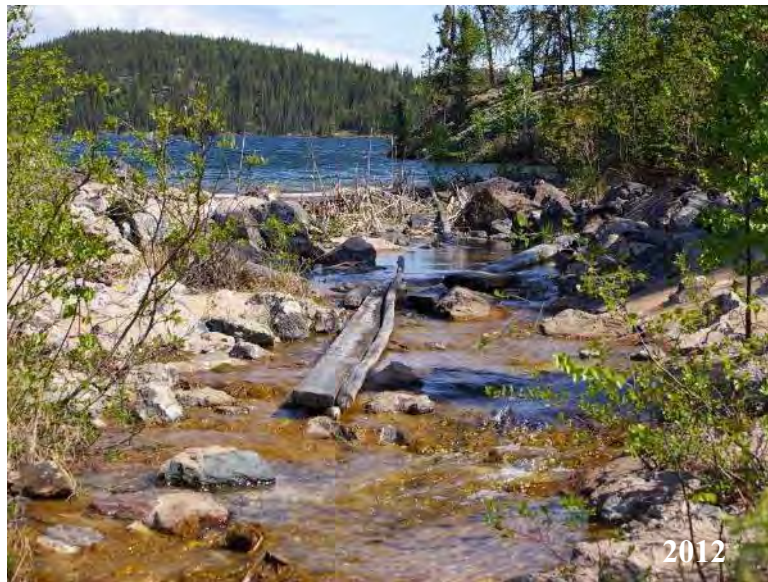
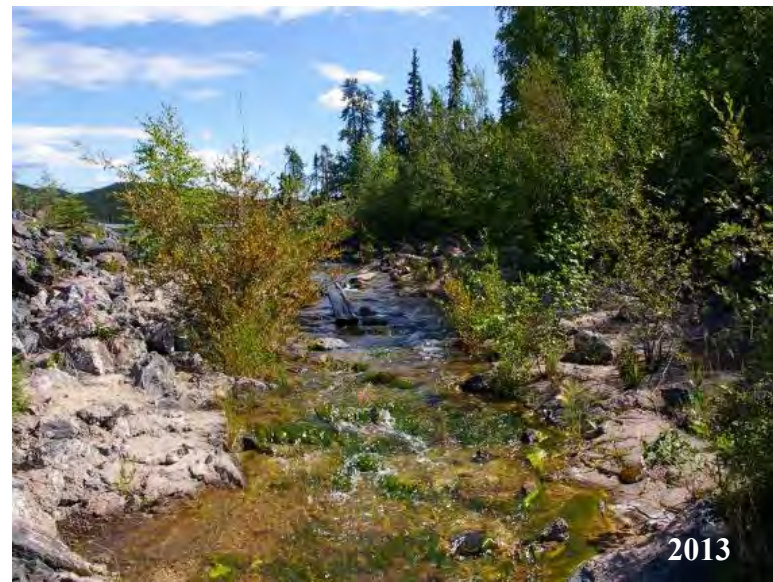
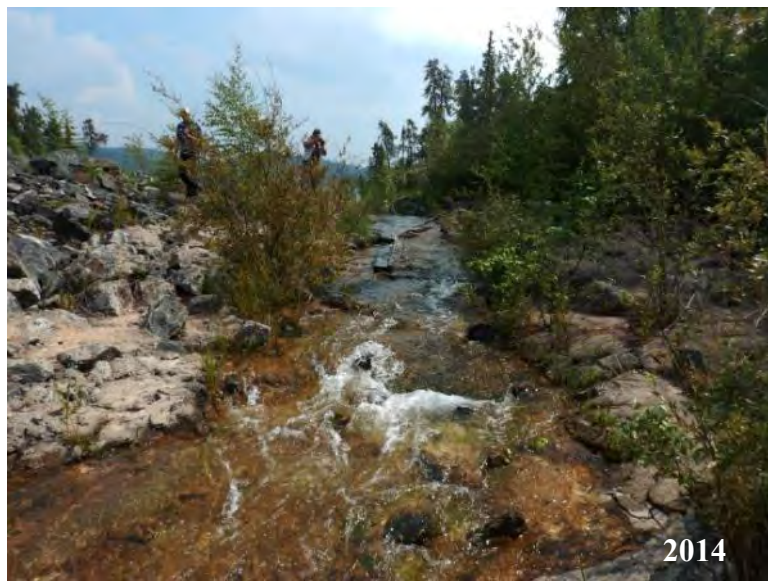
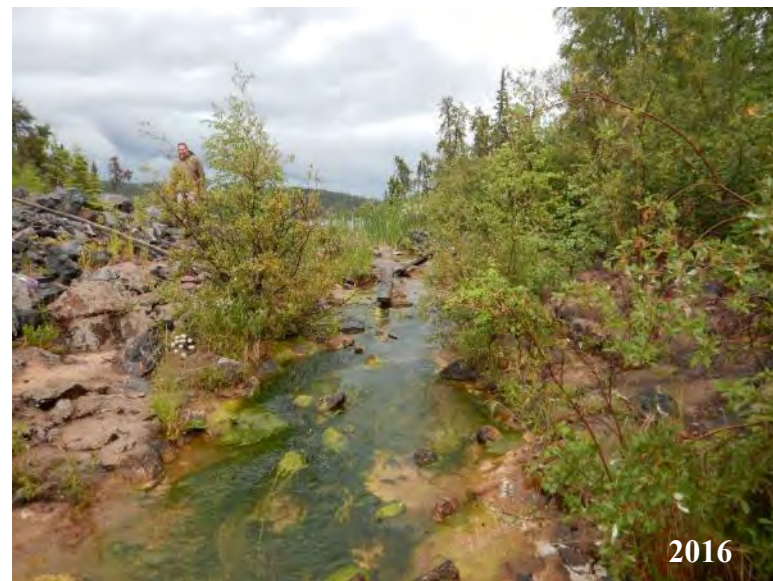
It should be noted that cracking and displacement of the grout-intruded rip-rap was anticipated in the original design and does not affect the performance of the outlet spillway. The grout that was intruded into the rip-rap is meant to serve purely as a binding agent to increase the effective block size of the rip-rap, allowing it to more effectively resist erosion. It has been acknowledged by SRK that additional cracking and grout degradation will occur with time (*SRK 2016*).

**Marie Reservoir Outlet Structure – Ice jacked block of grout intruded rip-rap**

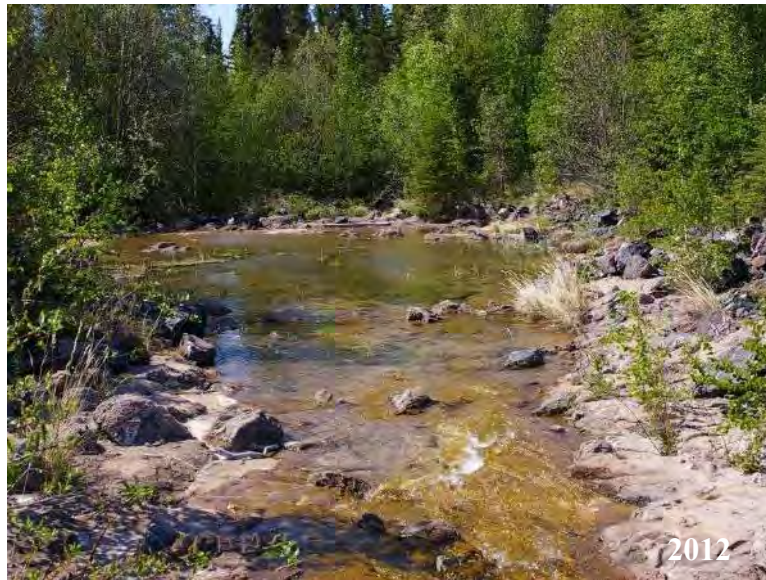
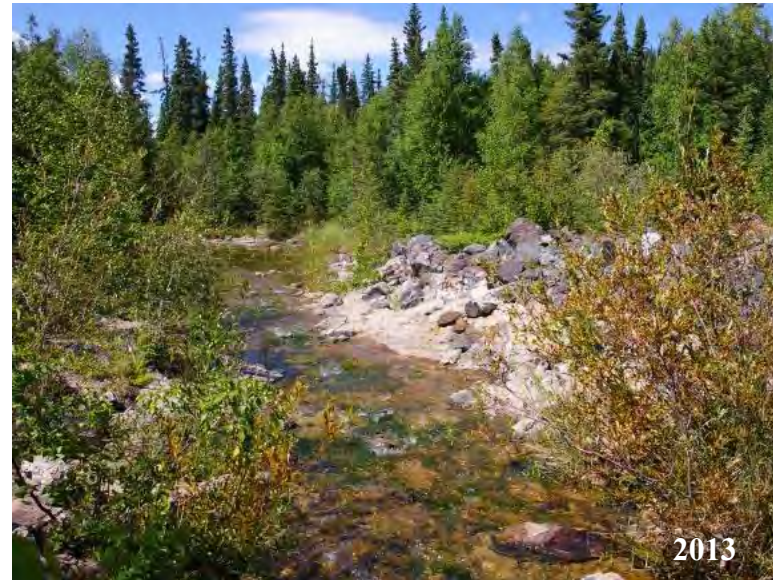
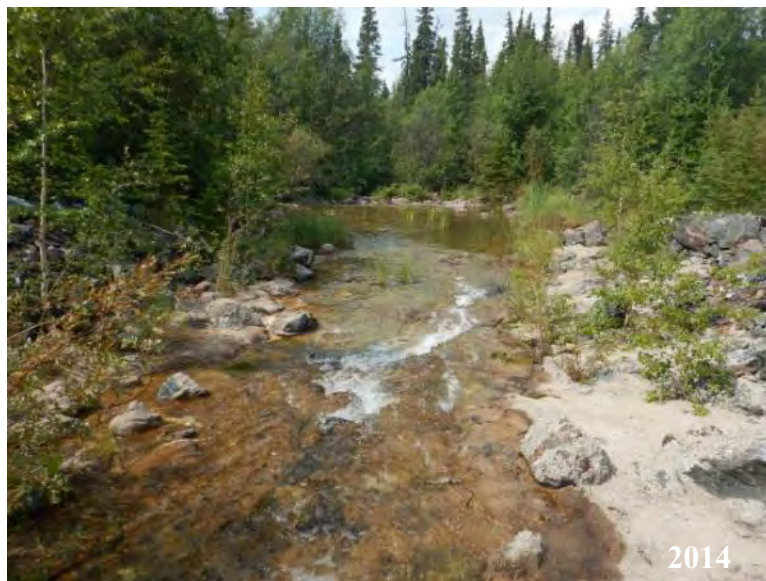
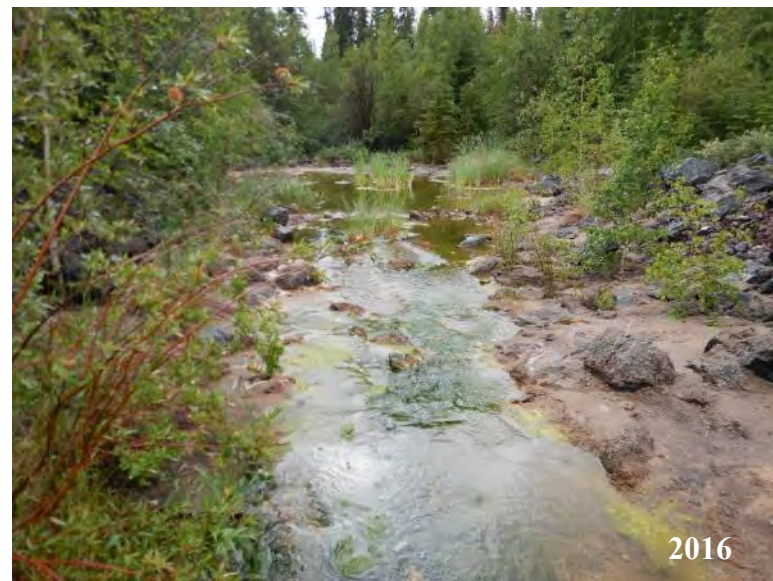
Similar to the Marie Outlet, SRK Consulting also identified that the grout-intruded rip-rap along the length of the Fookes Reservoir outlet spillway shows signs of cracking. In addition, there has been some ice-jacking, with the most significant displacements located near the upper part of the spillway, i.e., on the sides of the spillway, within 5 to 6 m of the spillway entrance ([Photo B7](#)). The base of the channel does not show signs of displacement, and the middle to lower parts of the spillway remain in good condition. SRK noted during the 2015 inspection that the spillway continues to operate satisfactorily.

**Fookes Outlet Structure looking upstream**

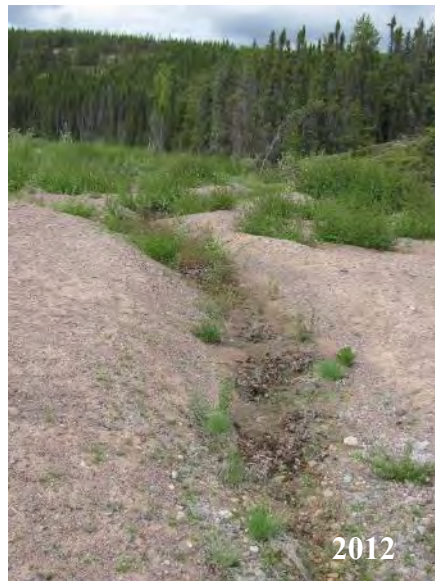
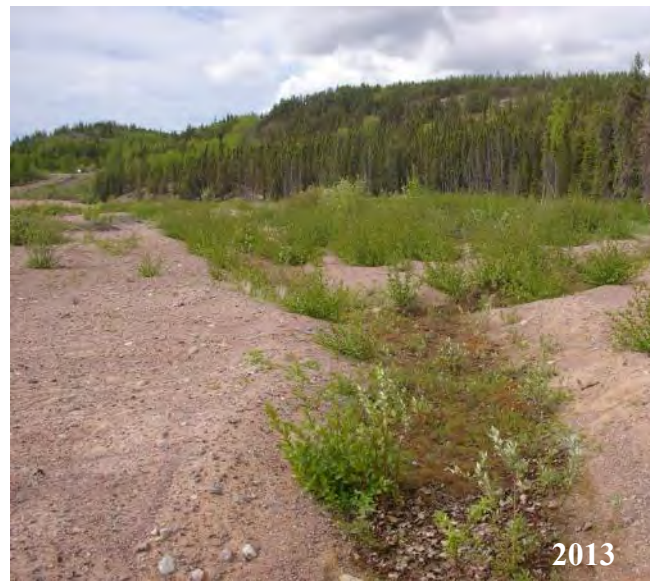
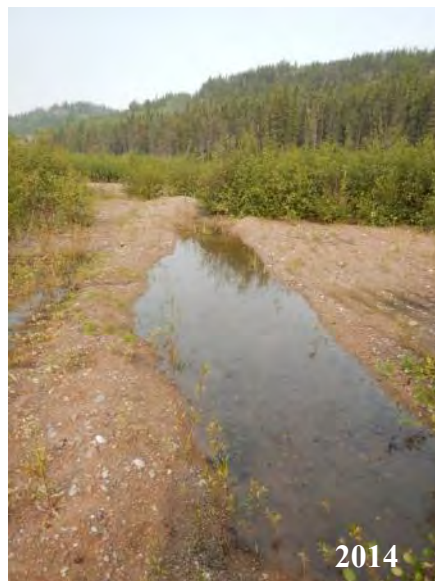
**Fookes Outlet Structure looking downstream**

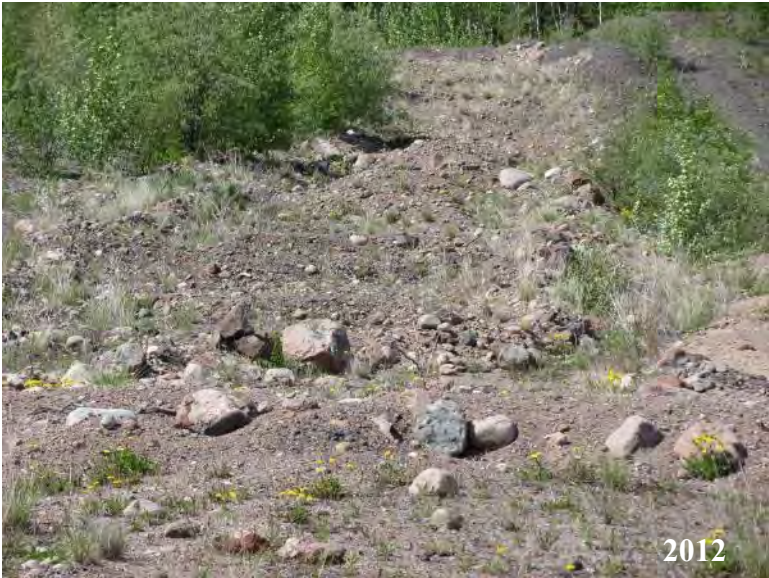
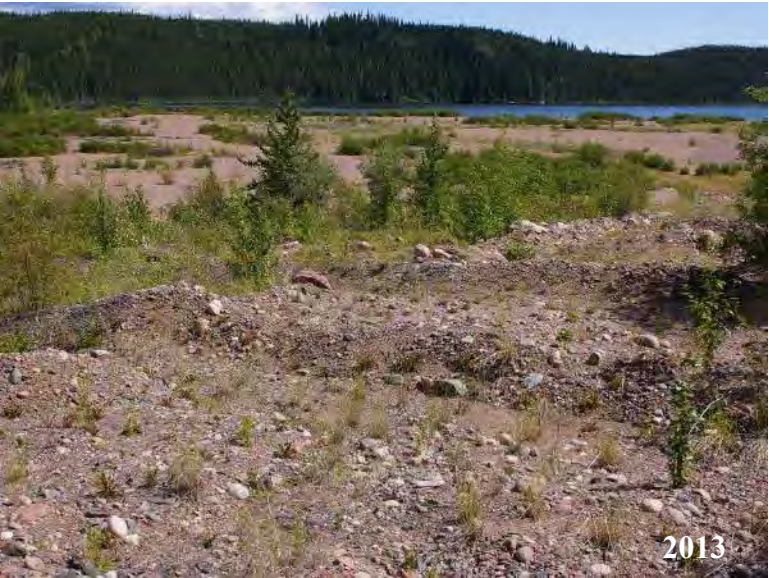
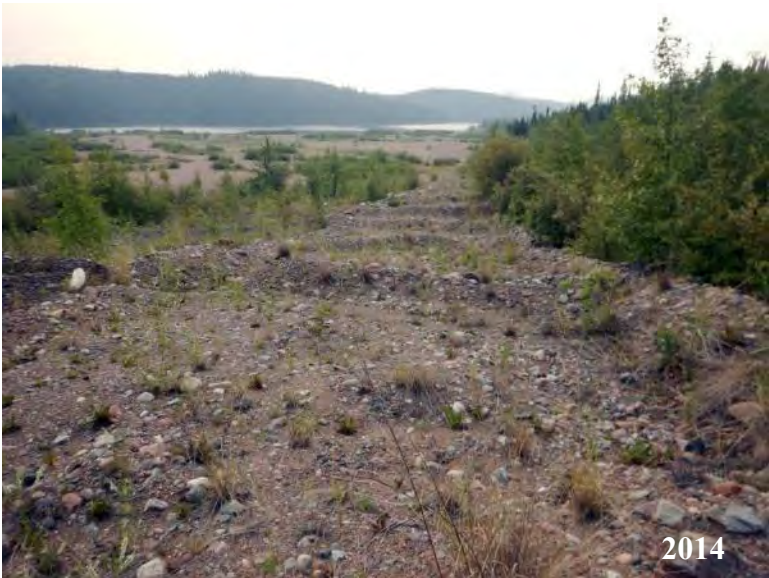
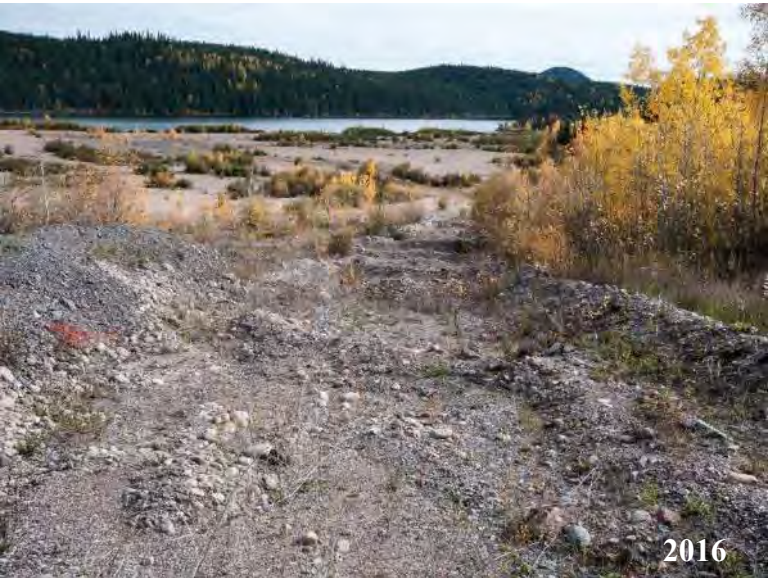
As mentioned previously Fookes Reservoir water levels are higher than past years and there is more standing water in the drainage areas of the delta than have been observed in the past. Despite the elevated water table the sand cover was in good condition and showed no signs of excessive erosion. [Photo C10a](#) shows a picture of the shoreline where the water level meets the sand cover. A small amount of erosion of the sand cover can be seen due to wave action, which is to be expected. It is not anticipated that this small amount of erosion will affect the performance of the sand cover. As vegetation continues to establish on the shoreline it will provide additional armoring and increase the stability of the cover.

**Fookes cover with vegetation growth**

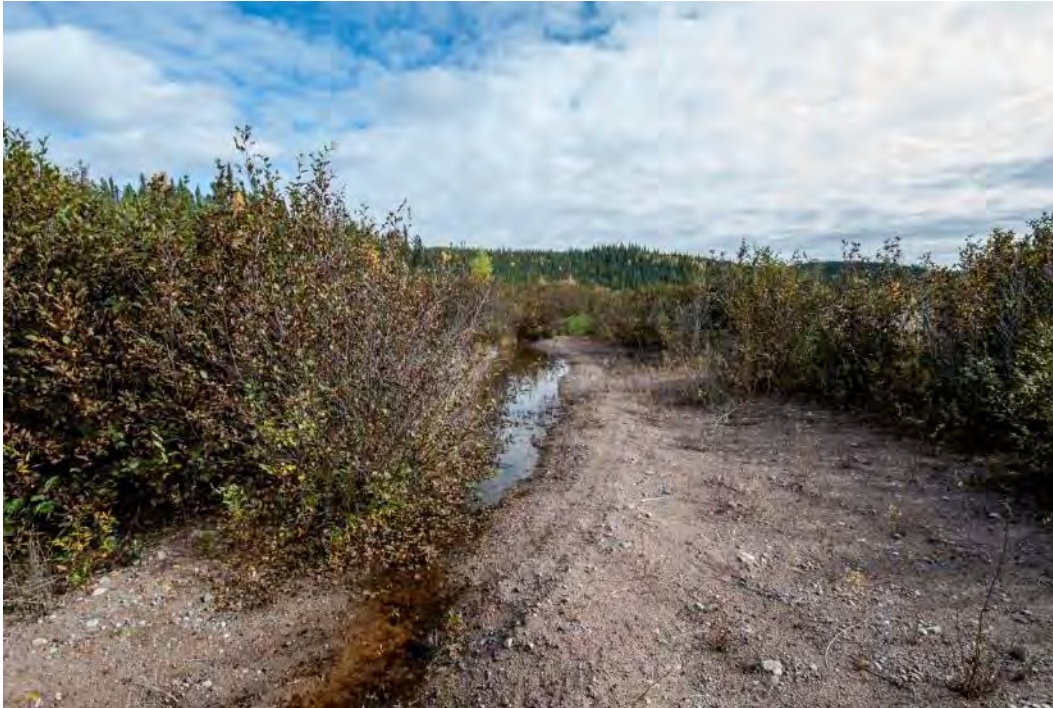
**Photo C1 – Drainage collection area on NE edge of Fookes Tailings Delta (looking SE)**

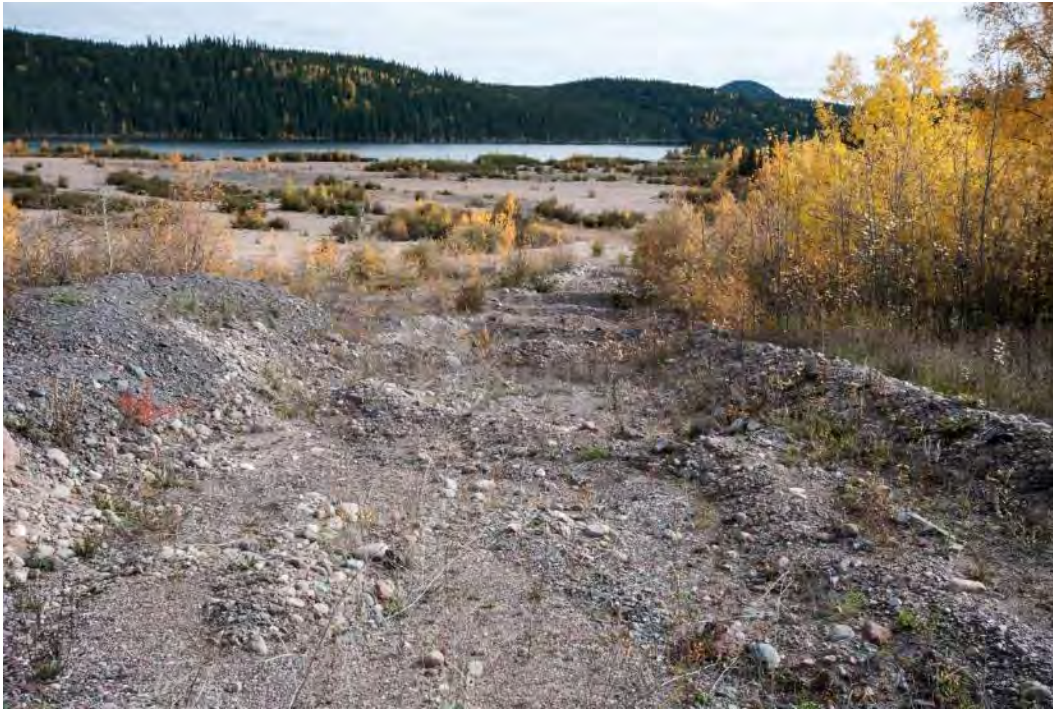
As part of the design and installation of the covers in 2005 and 2007, the area considered most vulnerable to erosion was in the area on and below the access ramp at the northwest corner of the tailings delta (*SRK 2010*). The general condition of the ramp is very good. Access to this ramp is closed off by a windrow of material at the top of the ramp. The

**Photo C3 – Chevrons in place on north access point to the Fookes delta**

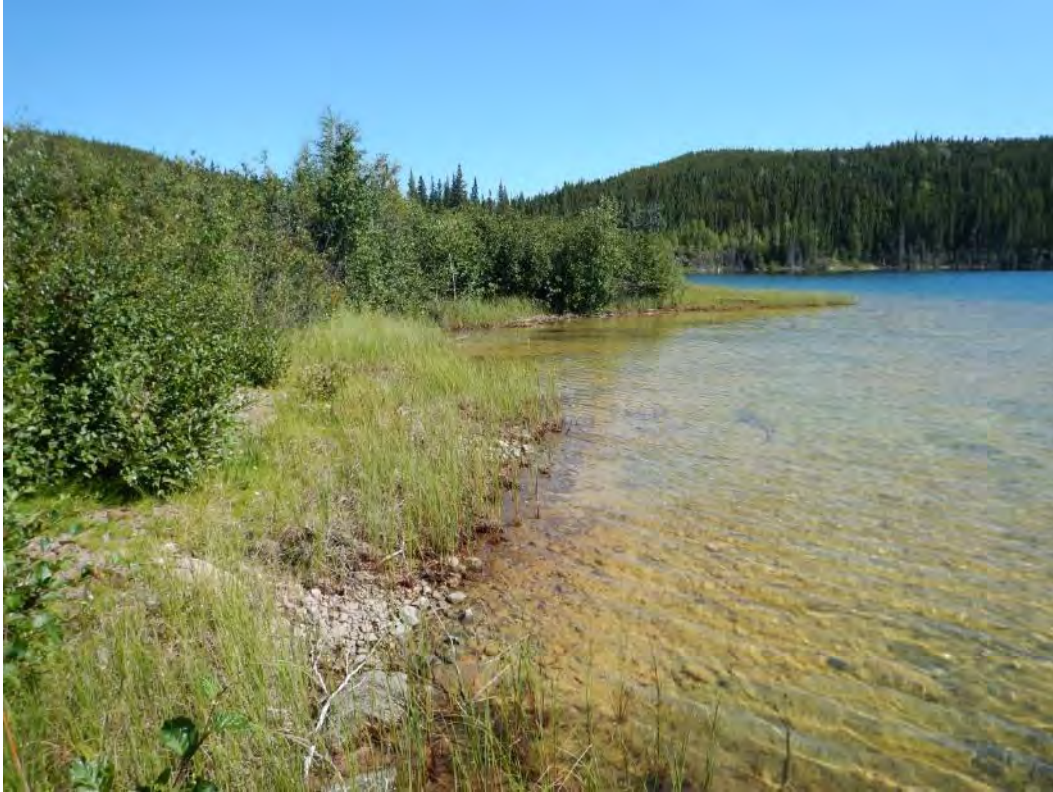
**Photo C8 – View of the East Fookes shoreline looking N**

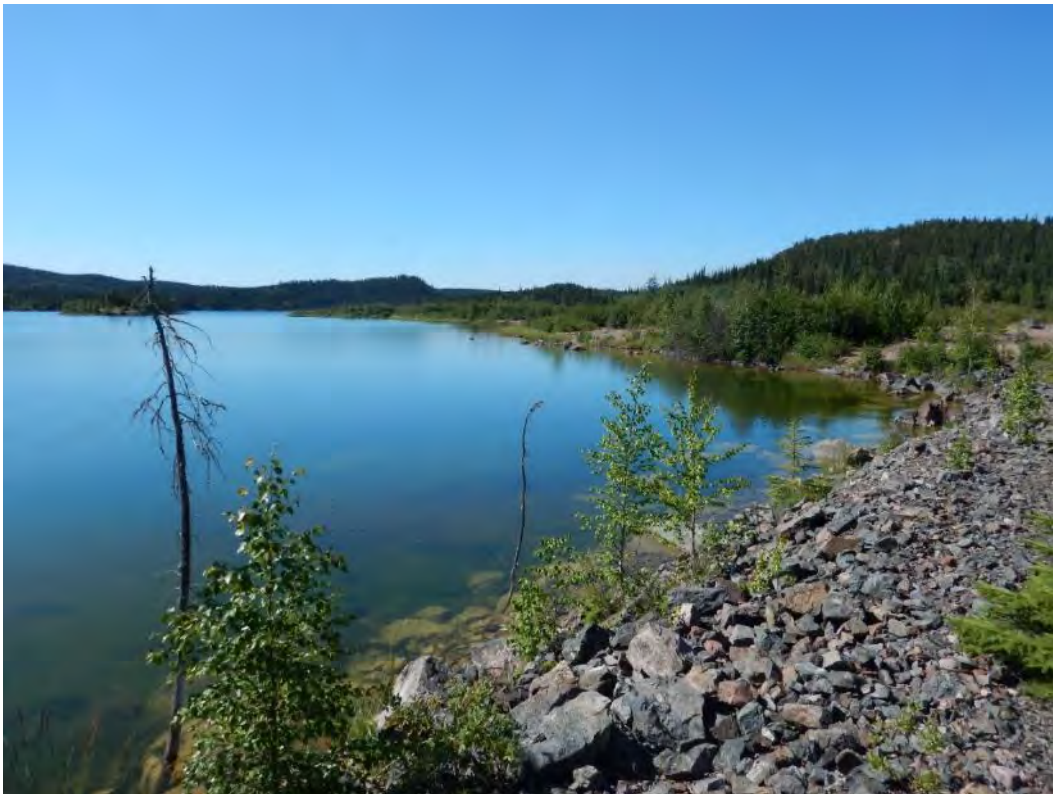
**Photo C9 – View of the Fookes shoreline looking S**

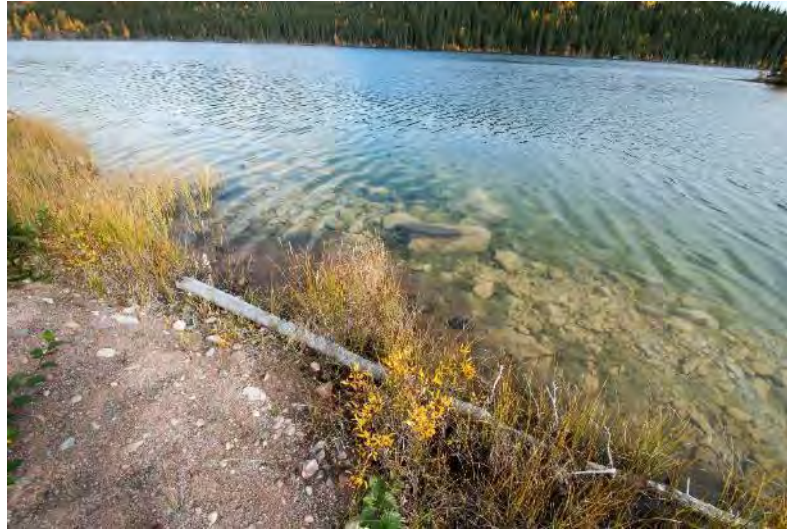
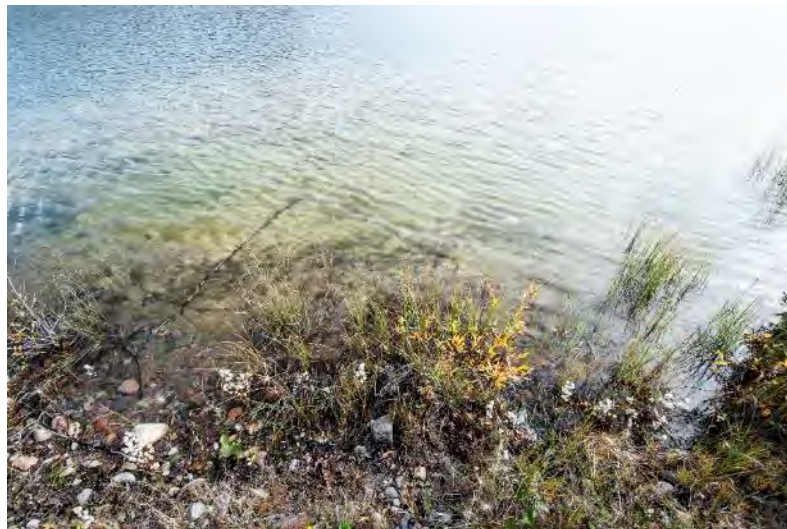
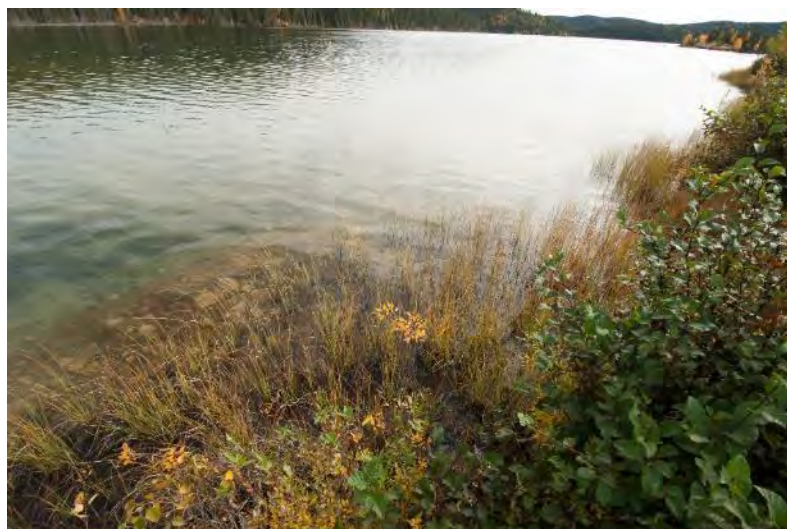
**Photo C10a-c – Additional photos of the shoreline showing established vegetation**

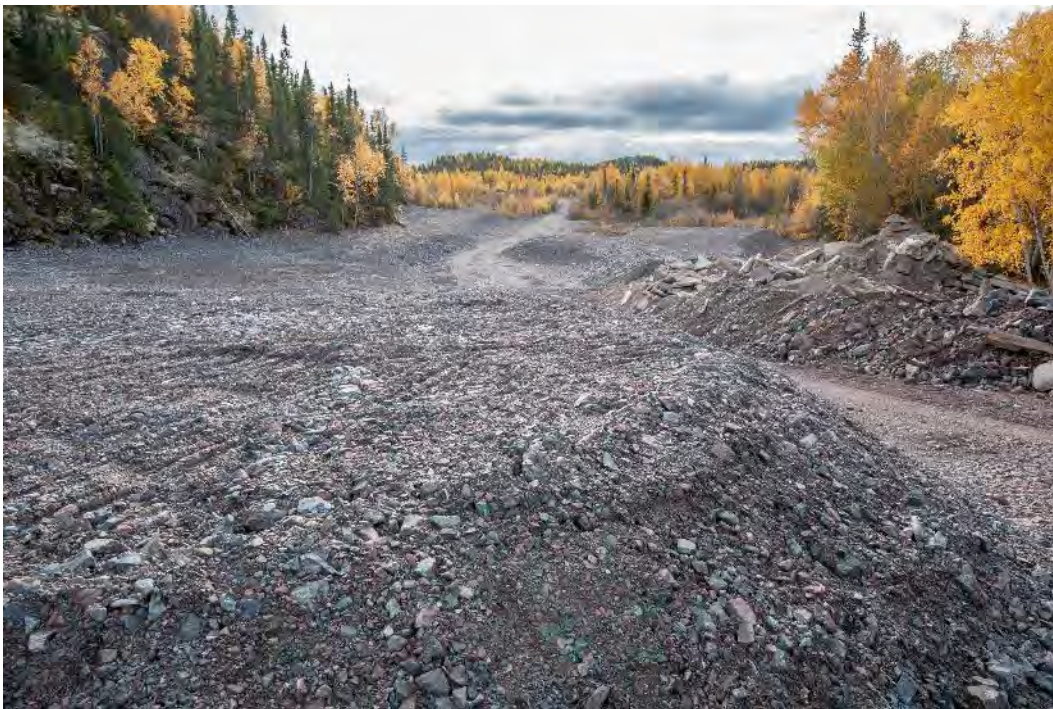
**Photo D2 - Close up view of the 208 stope cover**

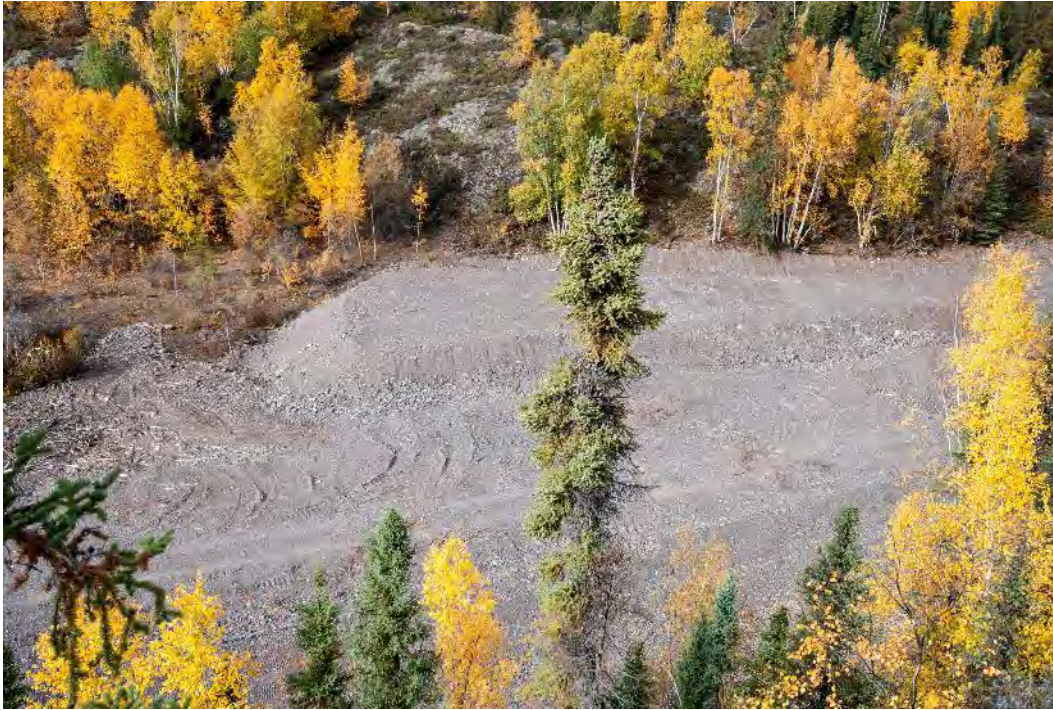
**Photo D3 – View of the 103 and 201 Stope cover**

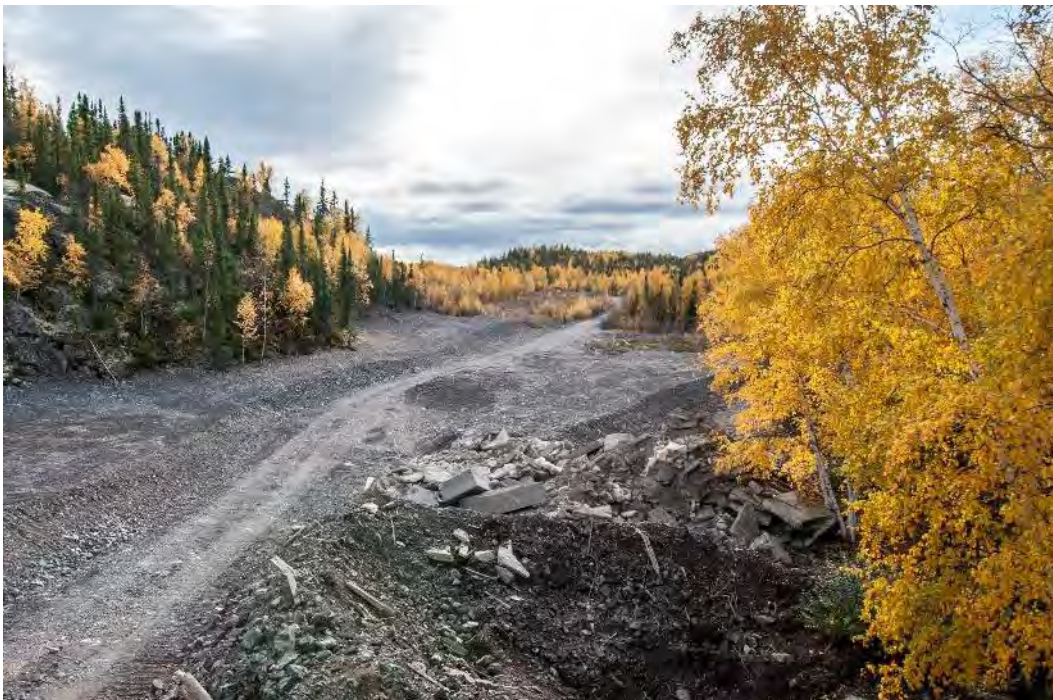
**Photo D4 – View looking SW with 201 Stope cover in the background**

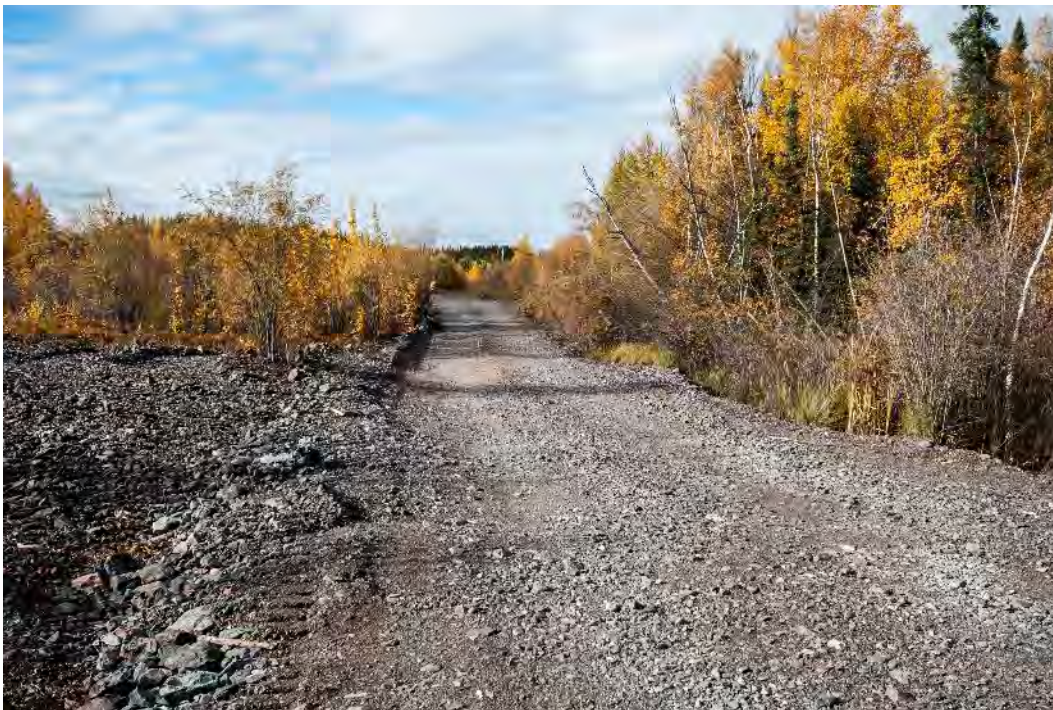
**Photo D6 – View of the road over the hummocky area looking SW**

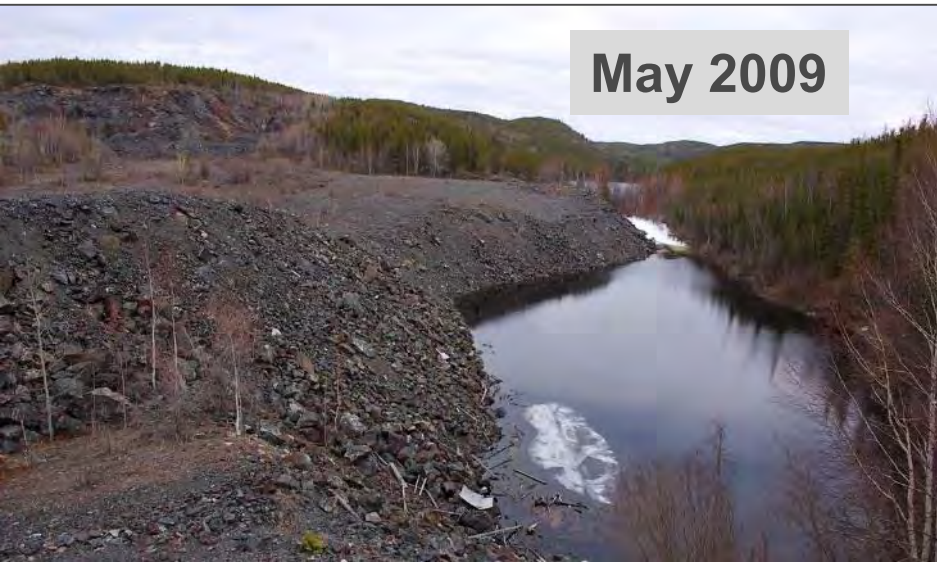
May 2009 - Ice inside waste rock pile impedes flow from Zora Lake

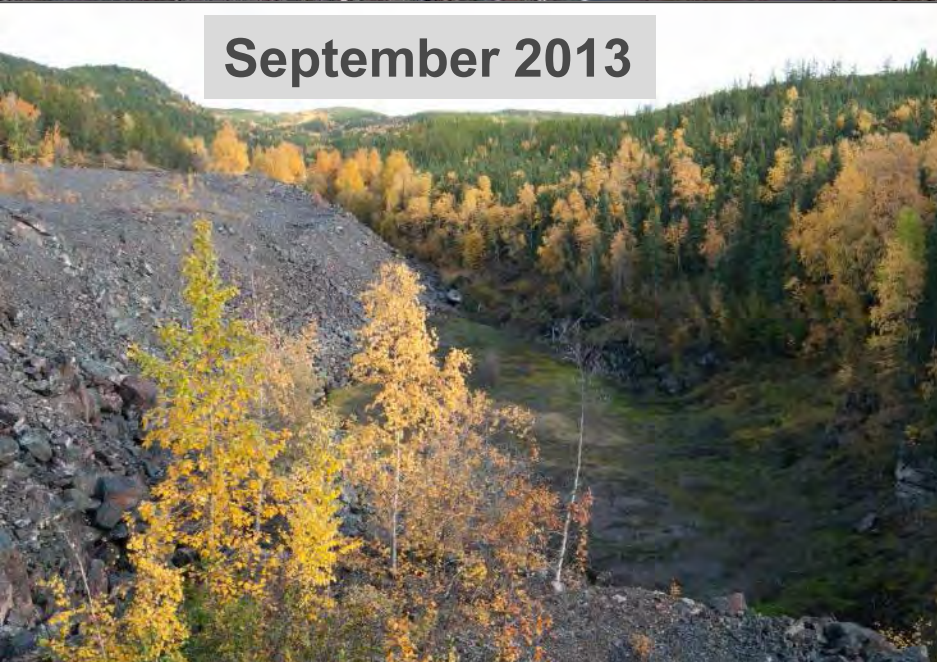
September 2013 – Ice in waste rock pile melts allowing backed up water to flow

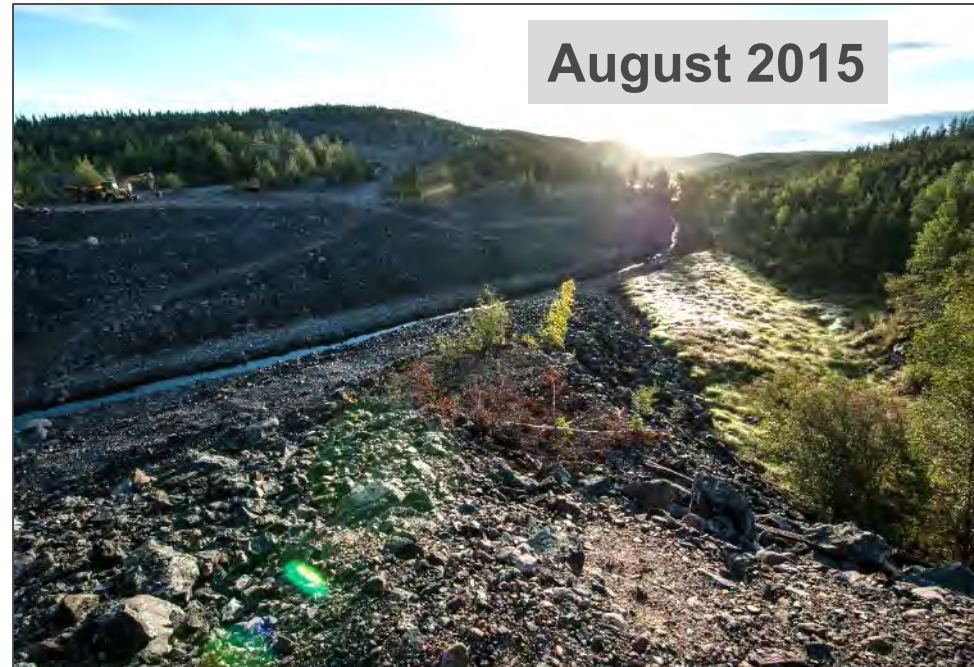
August 2015 – completed channel allows water to flow unimpeded from Zora to Verna Lake

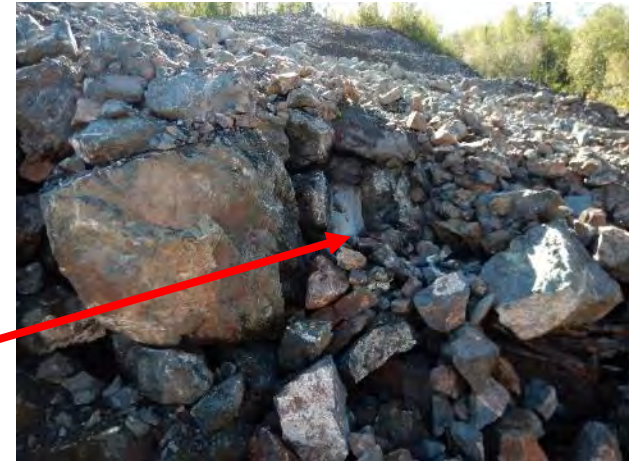
Ice block in waste rock  
August 2016

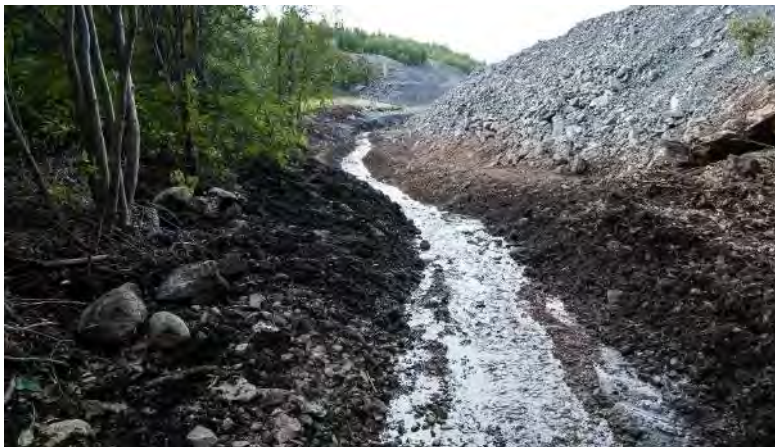
2015 – following  
excavation of the channel

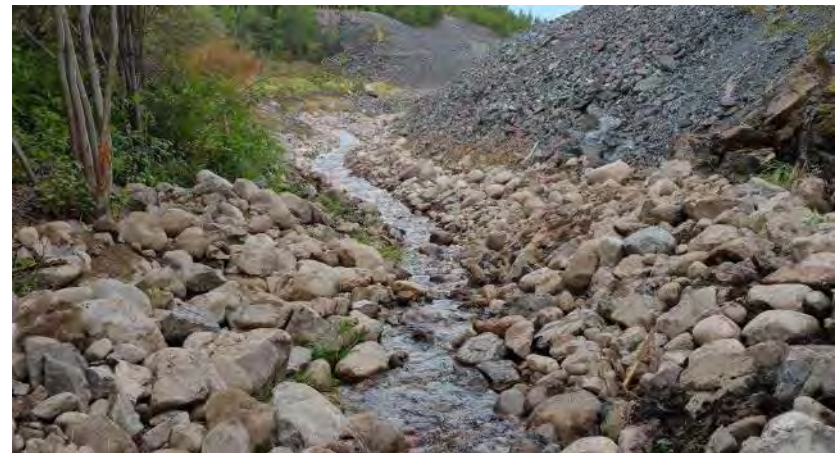
2016 – following the  
placement of rip-rap

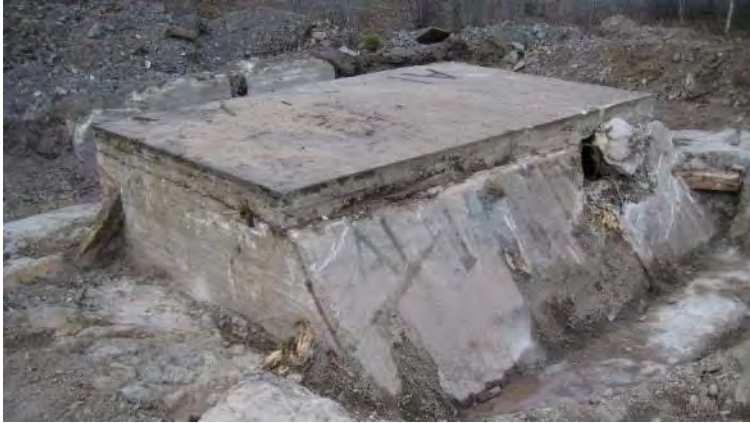
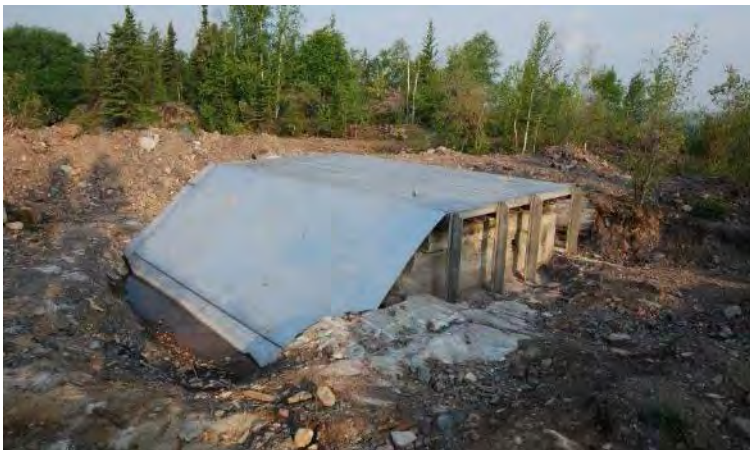
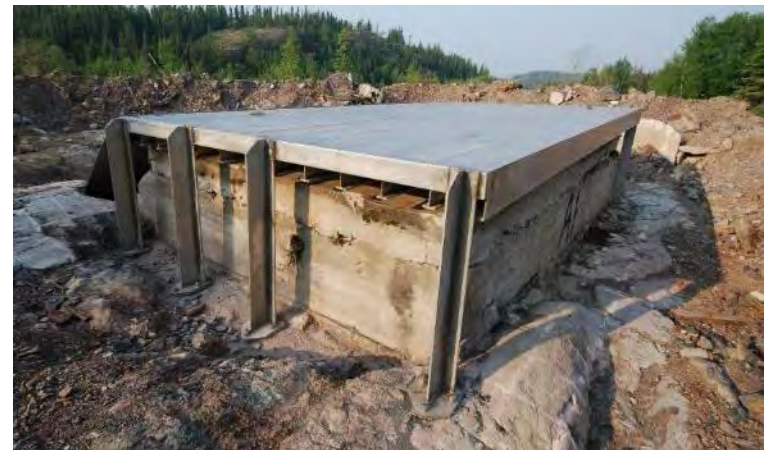
## Ace Shaft

- Exposed buried concrete cap and collar poured on bedrock
- Measured in 2015
- Fabricated cap and installed in 2016

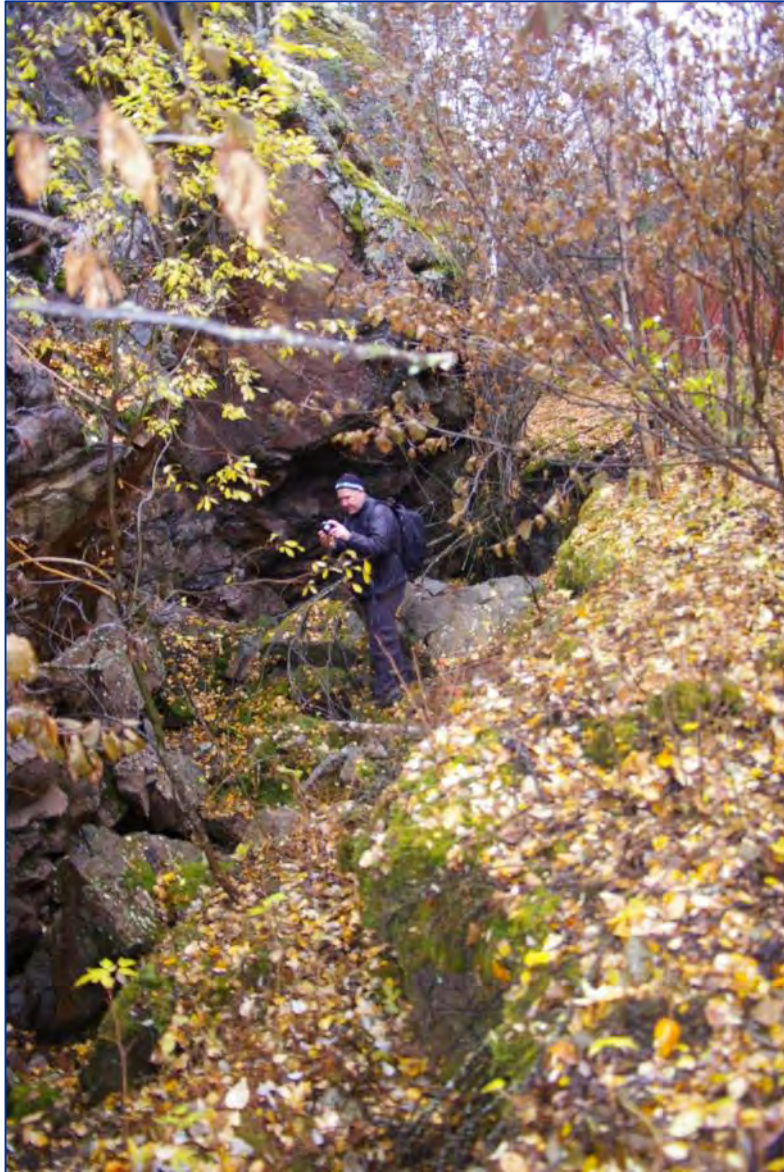
- 2013 noticed an area where slumping had occurred
  - Applied a sand cover with the intention to monitor the area for additional slumping
