**Beaverlodge: Year 31 Transition Phase Monitoring Annual Report (2016)**

## Beaverlodge Project 2016 Annual Report Year 31 Transition Phase Monitoring

**March 2017**

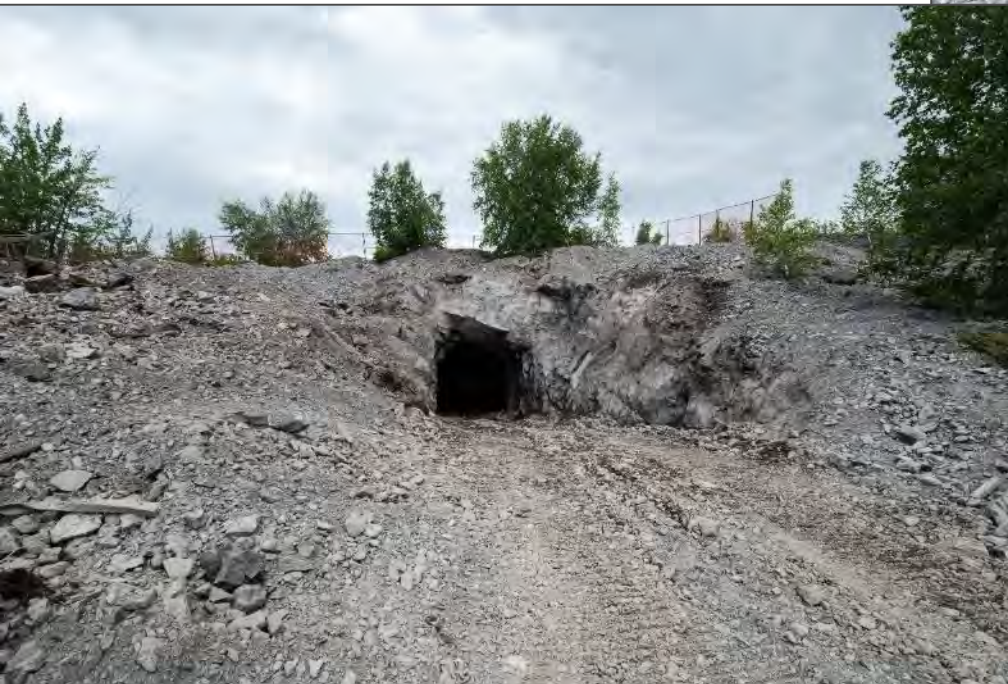
Adit exposed

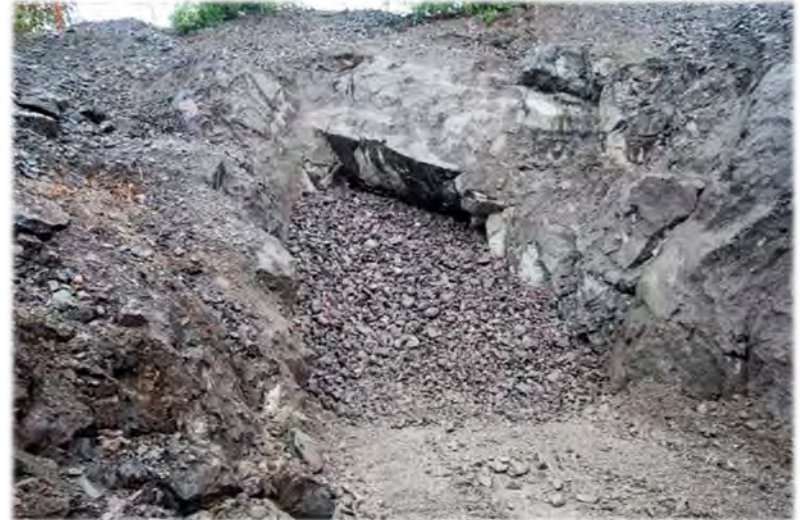
Waste rock packed to top of opening

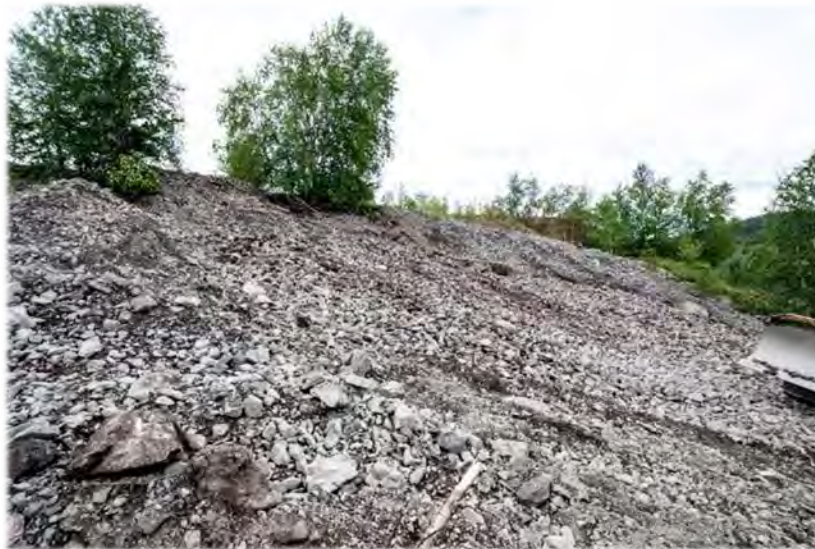
Project completed

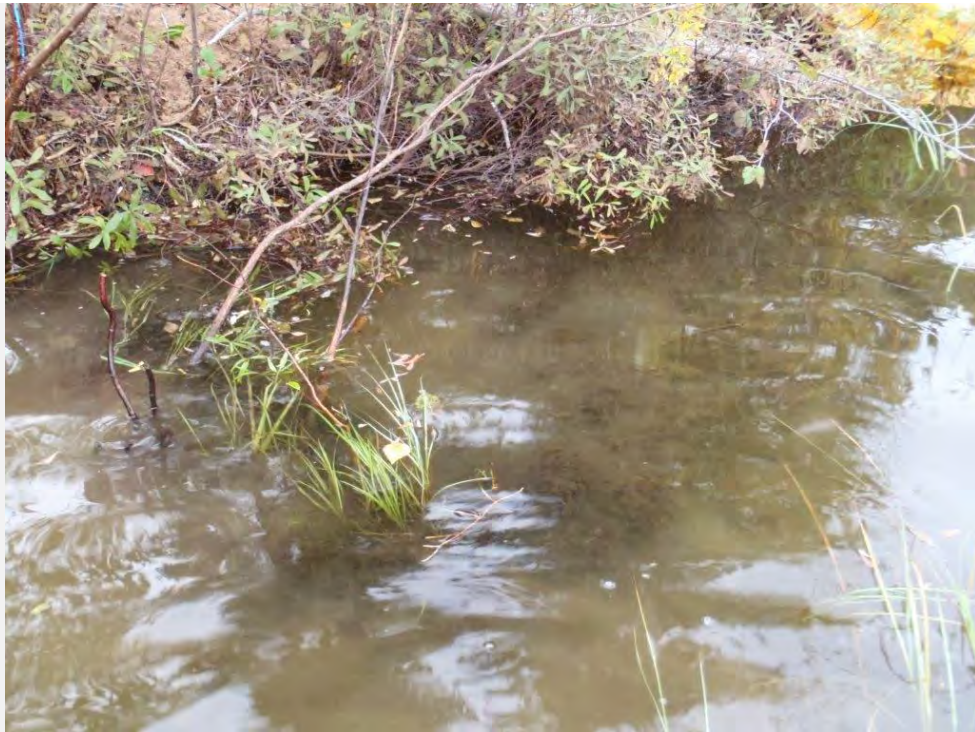
The turbidity curtain was removed from Verna Lake by hand. It should be noted that there was a considerable amount of silt accumulated along the inside edge of the turbidity curtain prior to its removal. Care was taken to minimize its disturbance; however, as the bottom of the curtain was keyed in using sandbags, much of this silt was re-suspended into the water column during removal of the curtain (Appendix A, Photo 2). Turbidity measurements were taken inside the turbidity barrier before and after removal of the curtain. Turbidity inside the barrier measured 0.99 NTU just prior to the curtains' removal; two hours later, turbidity measured 7.07 NTU. Turbidity was also measured outside of the barrier after removal of the turbidity curtain and was recorded at 0.74 NTU, indicating that the barrier was successful in isolating the turbid water from the rest of Verna Lake (Appendix A, Photo 3).

Photo 2. Photo showing re-suspension of silt and sediment in Verna Lake during removal of the inner turbidity curtain, September 2016.

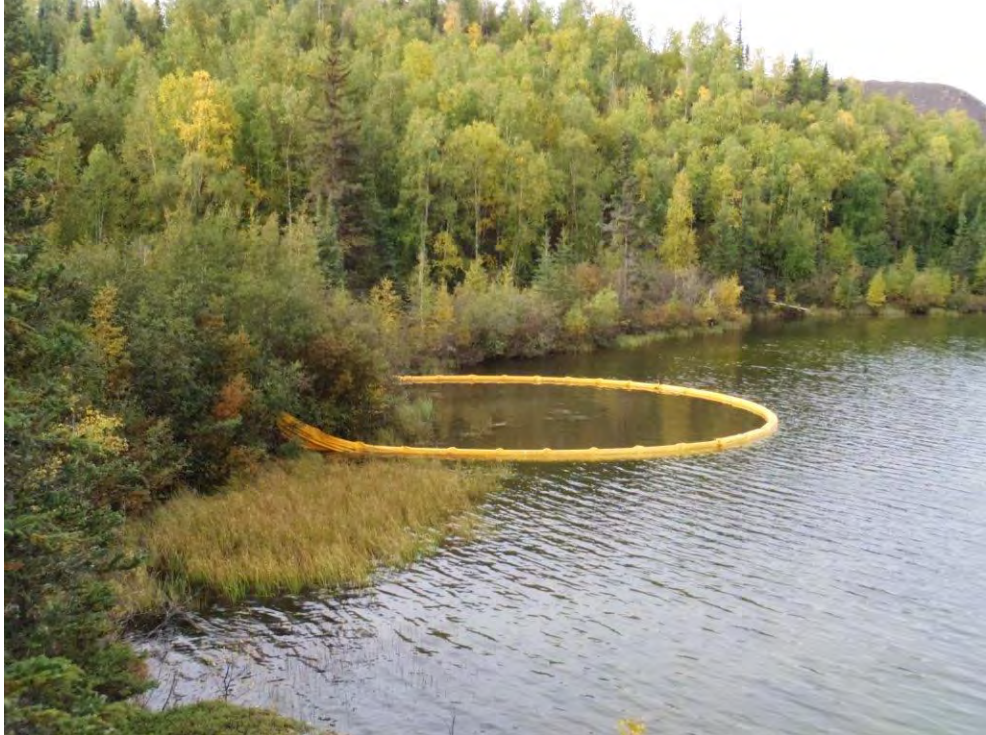
Photo 3. Photo showing an upland view of the outer turbidity barrier in Verna Lake, September 2016.

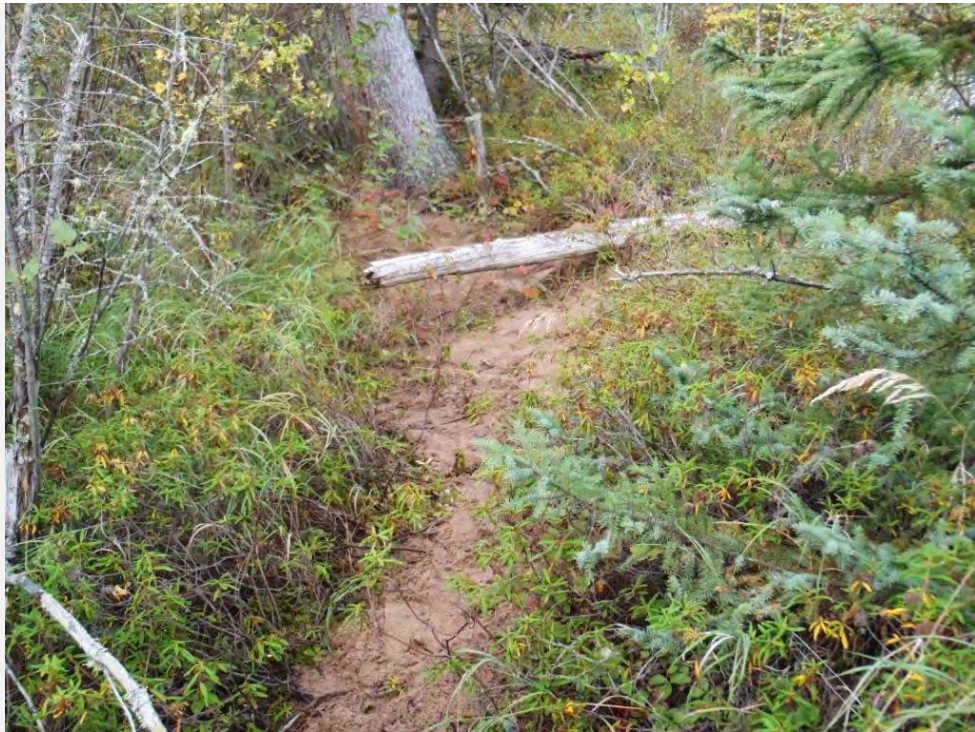
Additionally, any materials that were placed into Verna Lake during the installation of the turbidity curtain, including ropes and sandbags, were removed from the water and disposed of appropriately. In some cases, material from sandbags that had degraded due to sun exposure was disposed of in upland vegetation immediately adjacent to the turbidity curtain (Appendix A, Photo 4), since these sandbags could not be easily moved; otherwise, the sandbags were transported across the lake and the material disposed of at the location where it was originally collected. Additional sections of sediment fence that were installed along the creek were also removed and disposed of, along with any materials that were used to reinforce them (i.e., sandbags; Appendix A, Photos 5 to 8).

Photo 4. Photo showing an example of sandbags being spoiled along the upland/shoreline of Verna Lake, September 2016.

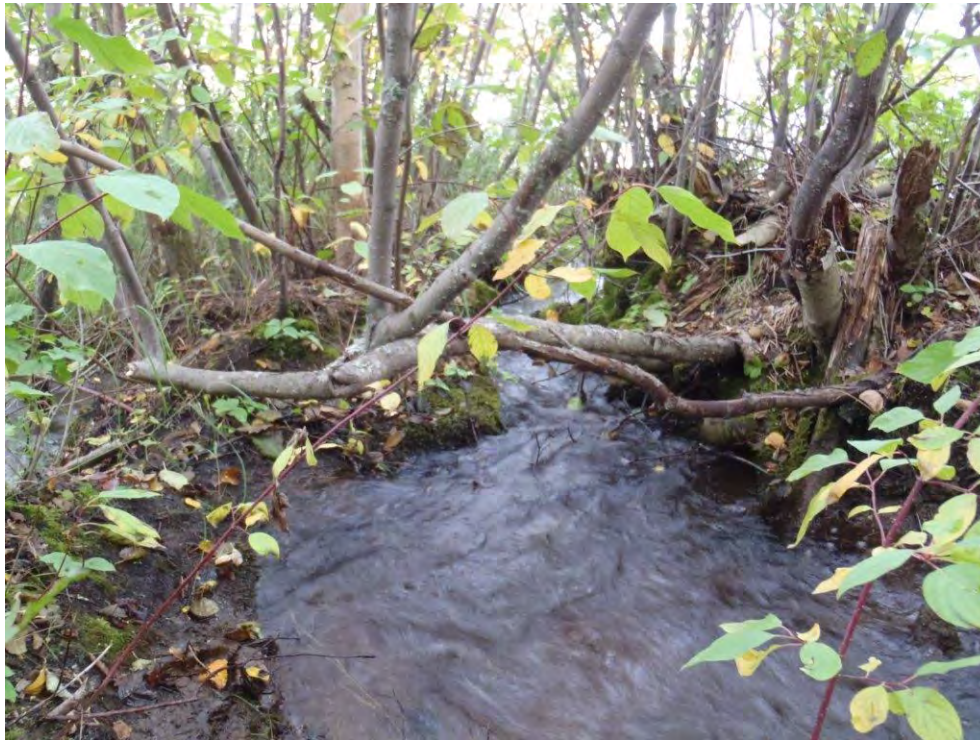
Photo 6. Photo showing Zora Creek following removal of sediment fence and sandbags, September 2016.

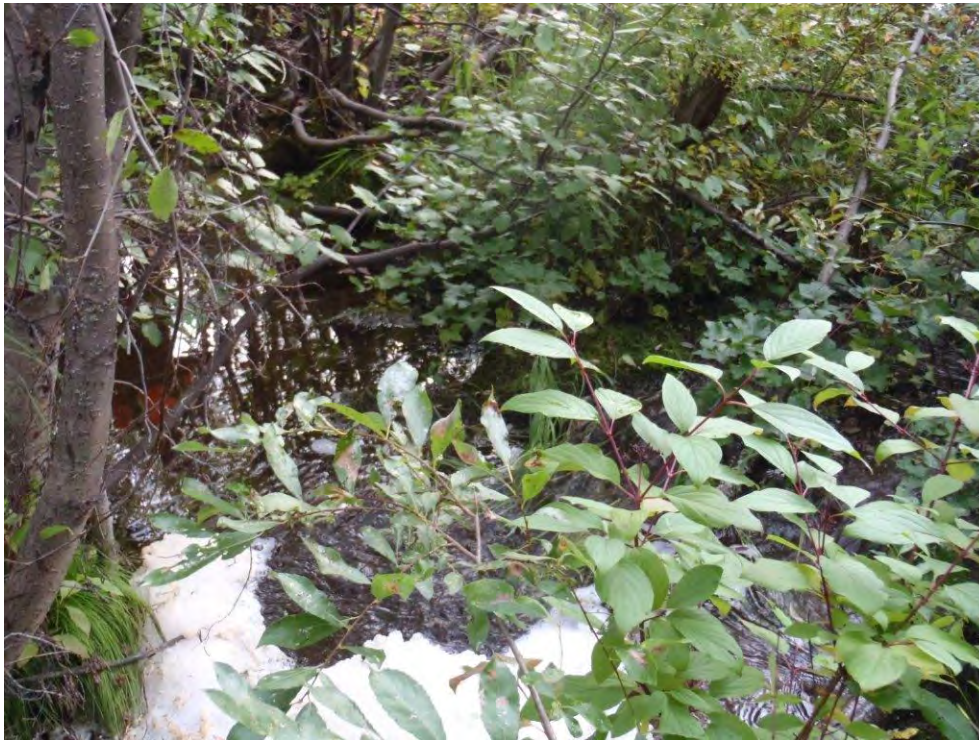
Photo 8. Photo showing Zora Creek following removal of sediment fence and sandbags, September 2016.

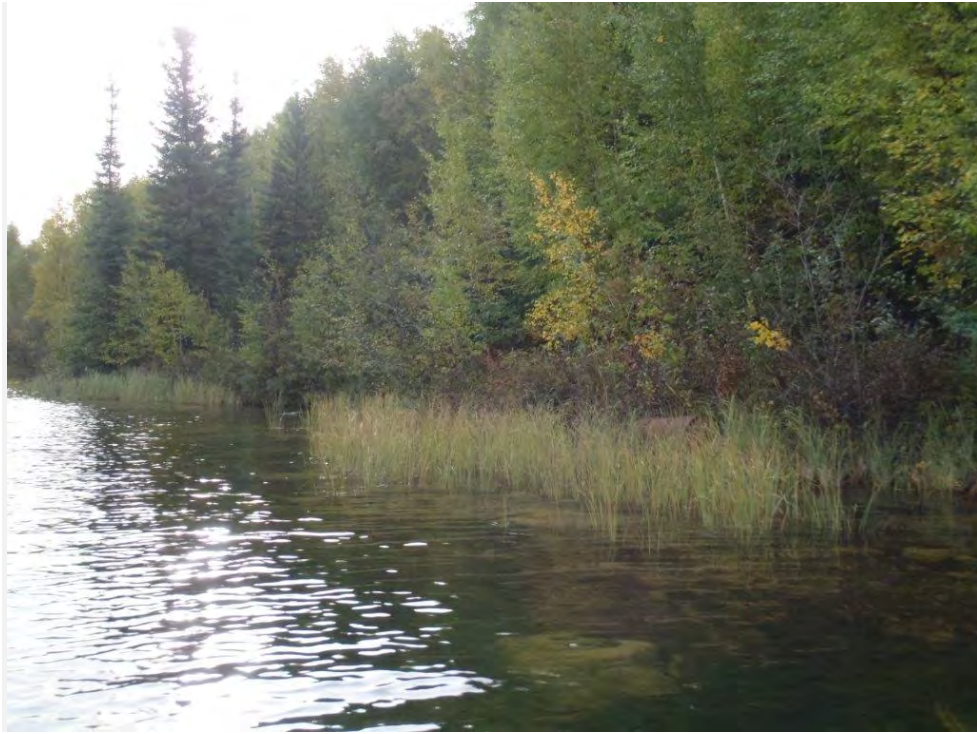
Photo 9. Photo of Habitat Section 1 in Verna Lake, September 2016.

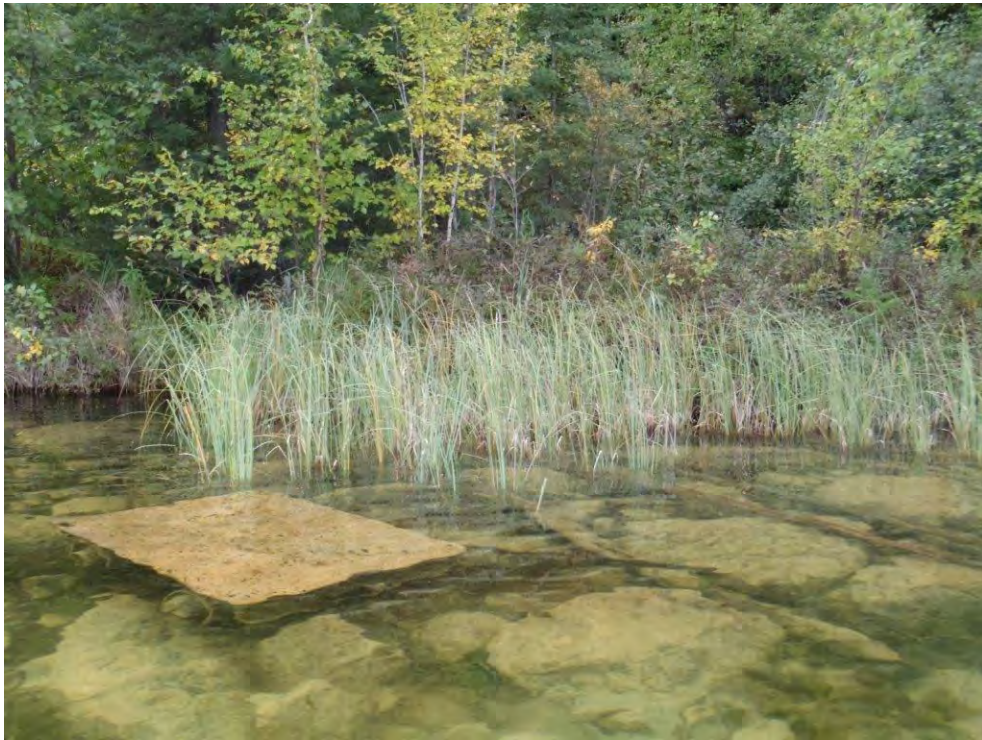
Photo 10. Photo of Habitat Section 1 in Verna Lake, September 2016.

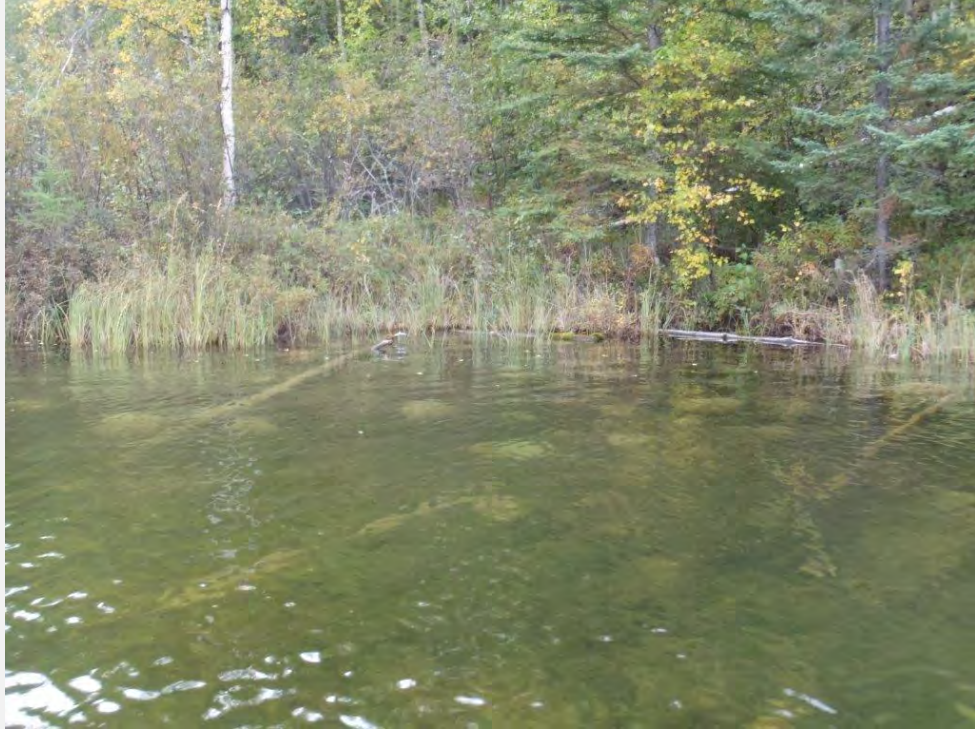
Photo 11. Photo of Habitat Section 2 in Verna Lake, September 2016.

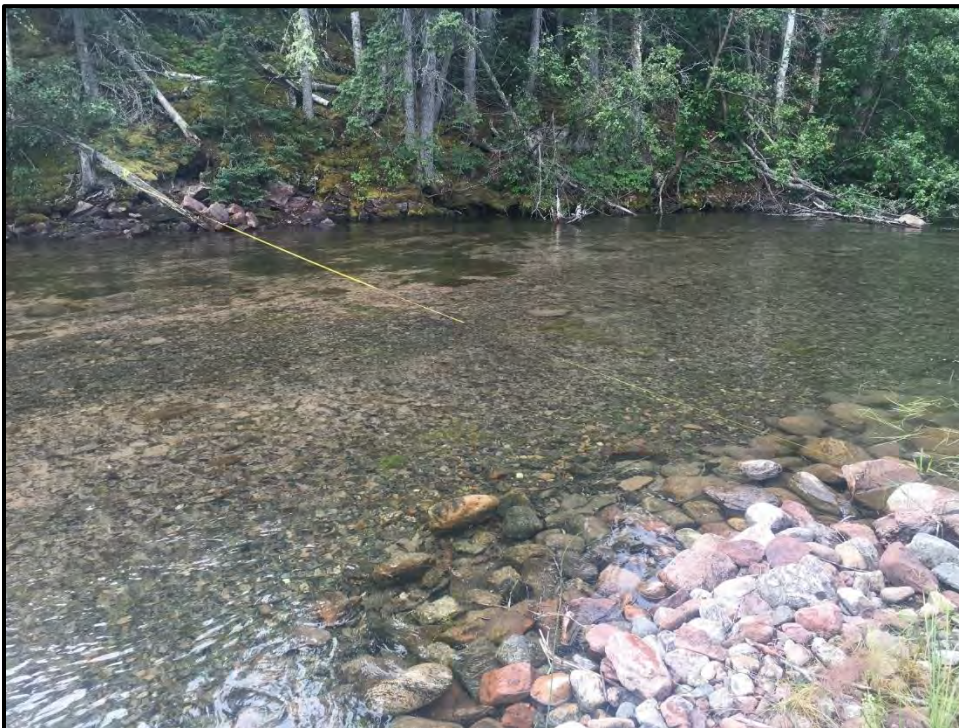
**Photo 16: BL-5 – August 11, 2016**

The station BL-5 monitors discharge at the outlet of Beaverlodge Lake. The station was not visited until August, 2016 due to spring ice conditions. Summer and fall field program photos are shown as Photo 16 and Photo 17, respectively. This location has been known to be impacted by either beaver activity, debris jam or the sudden release of debris jam; any such change to the geometry of the channel impacts the reliability of the rating curve typically evident in drifting points from the rating curve. The 2016 reporting year again experienced a shift in the rating curve requiring re-assessment of the rating curve for estimation of the hydrograph. For 2016, the water level data in the rating curve are referenced from the location of the datalogger rather than the measurement cross-section. The summary data are presented in Table 18 and the rating curve presented in Figure 16. The 2016 hydrograph is shown in Figure 17 and the daily average discharge data are provided in Table 19.

It is MWSI's understanding that at this location, the stream alignment between Beaverlodge and Martin Lakes, was historically used to transport infrastructure and potentially personal from Uranium City to the mine site prior to construction of the road. There is some evidence that part of the infrastructure between the two lakes may be partially responsible for the shifts in the rating curve as it degrades over time. It may be worth considering removal of some of this infrastructure during the 2017 field season in an attempt to restore the hydraulic geometry at this cross-section to a more stable condition.

MWSI believes that the drifting rating curve at BL-5 is a function of the debris jams located immediately downstream of the measurement cross-section and their degrading states. It may be possible to improve the hydraulics of the channel by removing some of this debris. The level of effort required to complete this task can be assessed upon request and incorporated into field work in 2017.

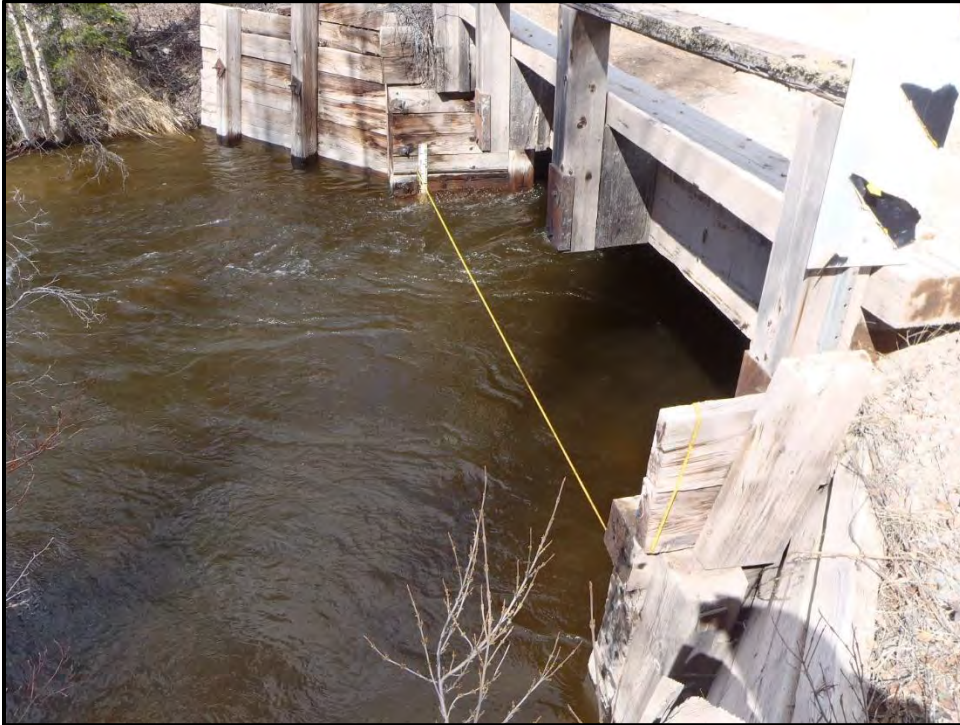
**Photo 18: CS-1 – May 5, 2016**

The Crackingstone River is located downstream of Cinch Lake which receives discharge from Beaverlodge Lake. The Crackingstone River ultimately discharges to Bushell Bay of Lake Athabasca and flow monitoring occurs at a bridge crossing. Field monitoring occurred in the spring (Photo 18) and fall (Photo 19) of 2016. The measurement data for CS-1 are presented in Table 20 and the rating curve is
