# BEAVERLODGE PROJECT

## **Beaverlodge Project 2022 Annual Report Year 37 Transition Phase Monitoring**

**Prepared and Submitted by:**  
Cameco Corporation

**April 2023**

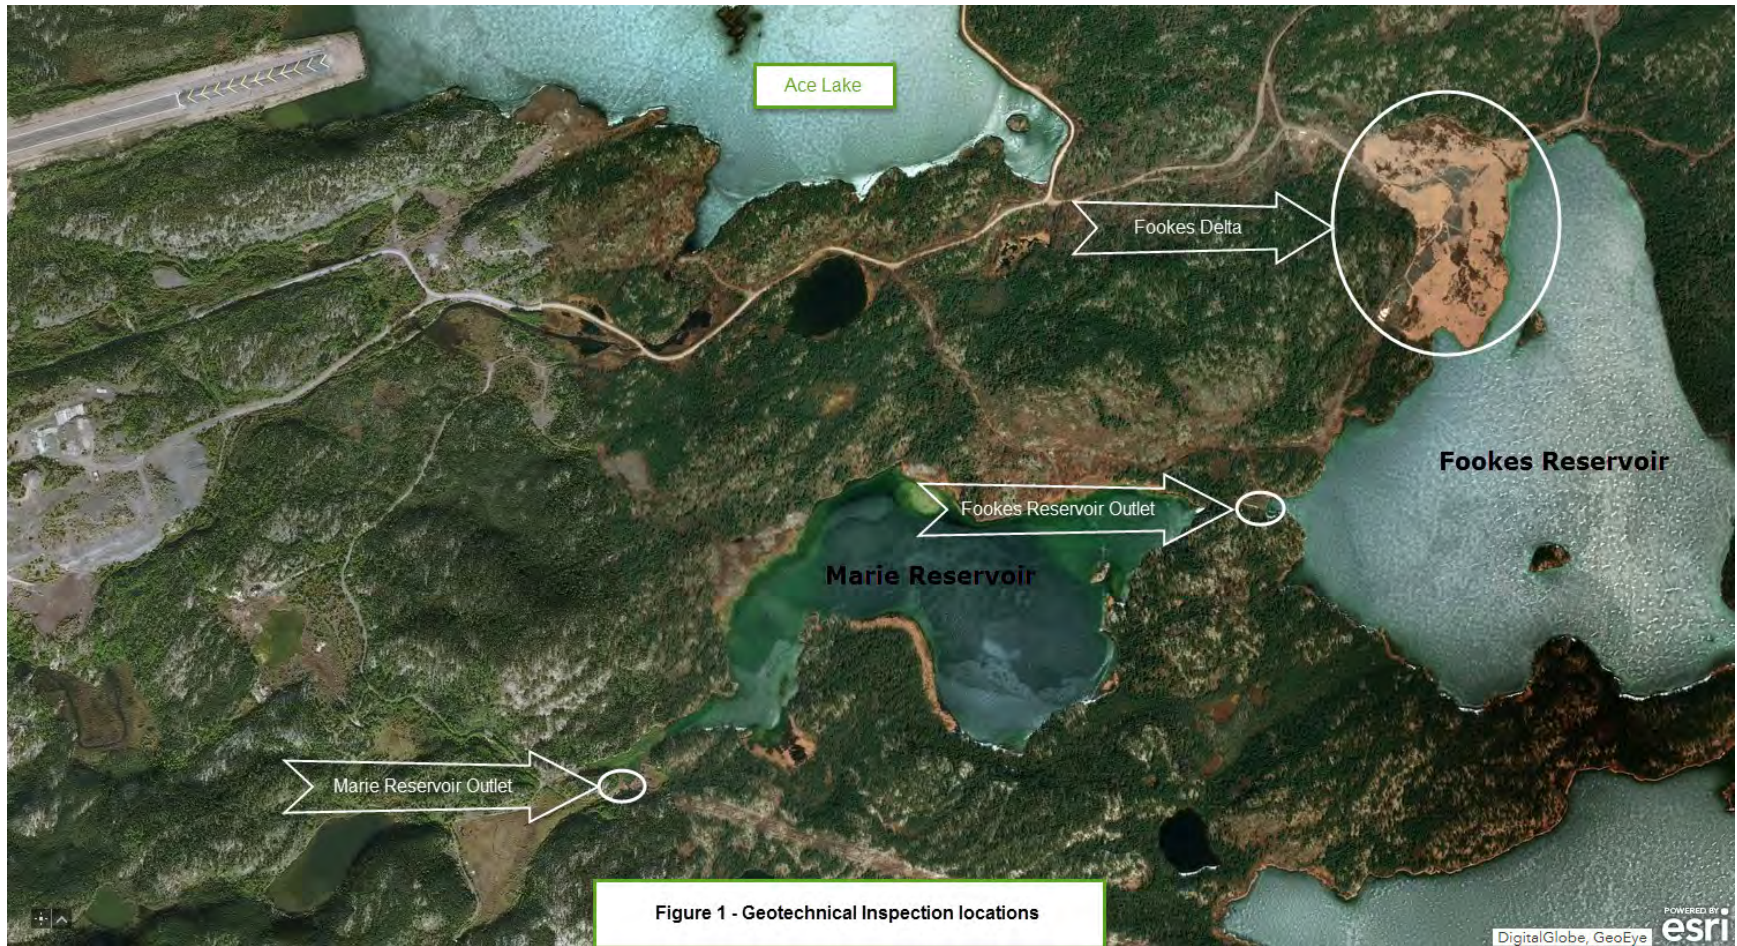
Figure 1 - Geotechnical Inspection locations

**Figure 1** provides the locations of the Fookes Delta and the outlet structures. Additional details are provided in **Section 5.0**, including **Figures 3**, **Figure 4**, and **Figure 5**, which provide the locations of applicable crown pillar monitoring.

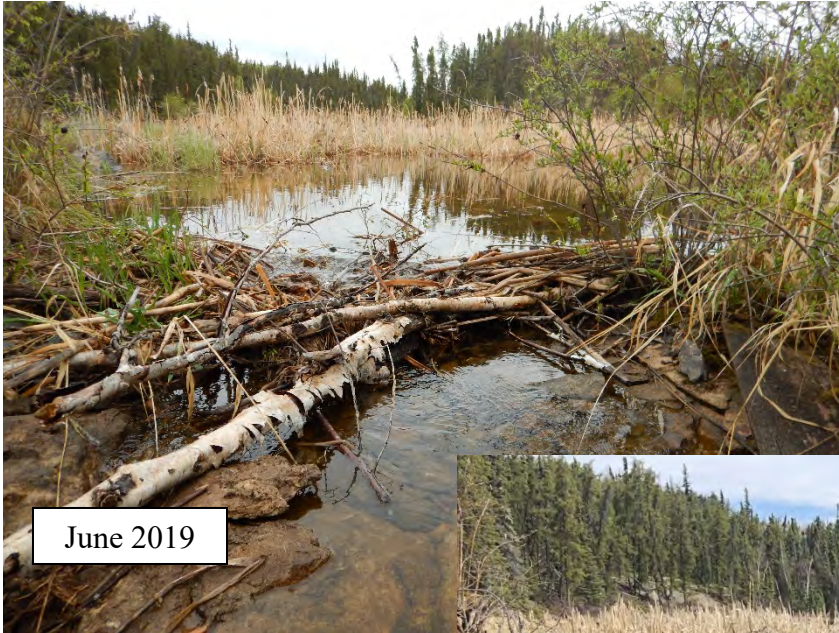
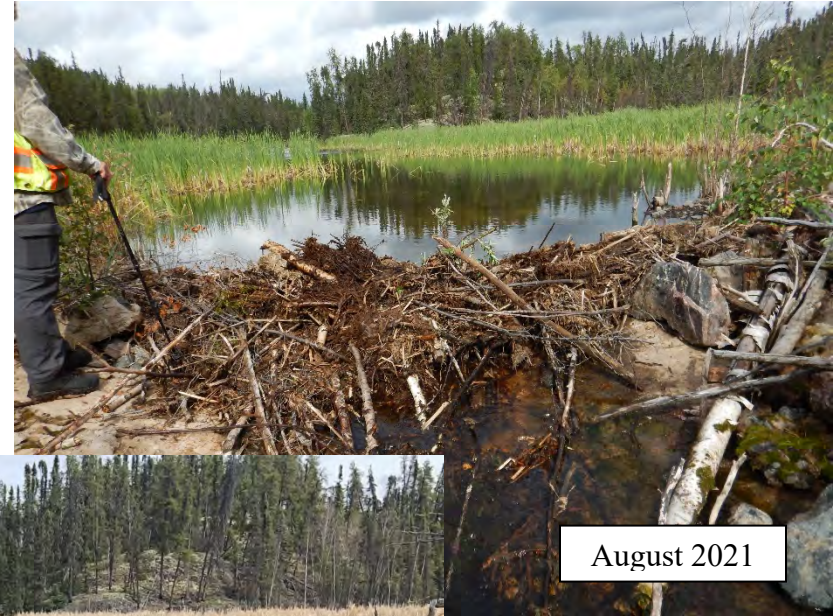
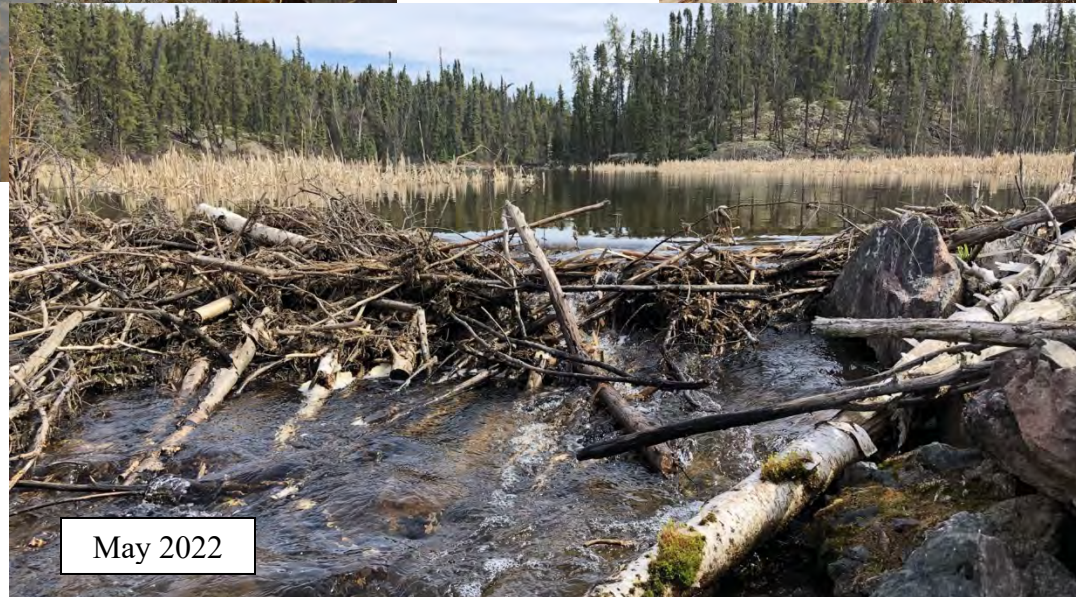
### Beaver dam construction at the outlet structure for Marie Reservoir

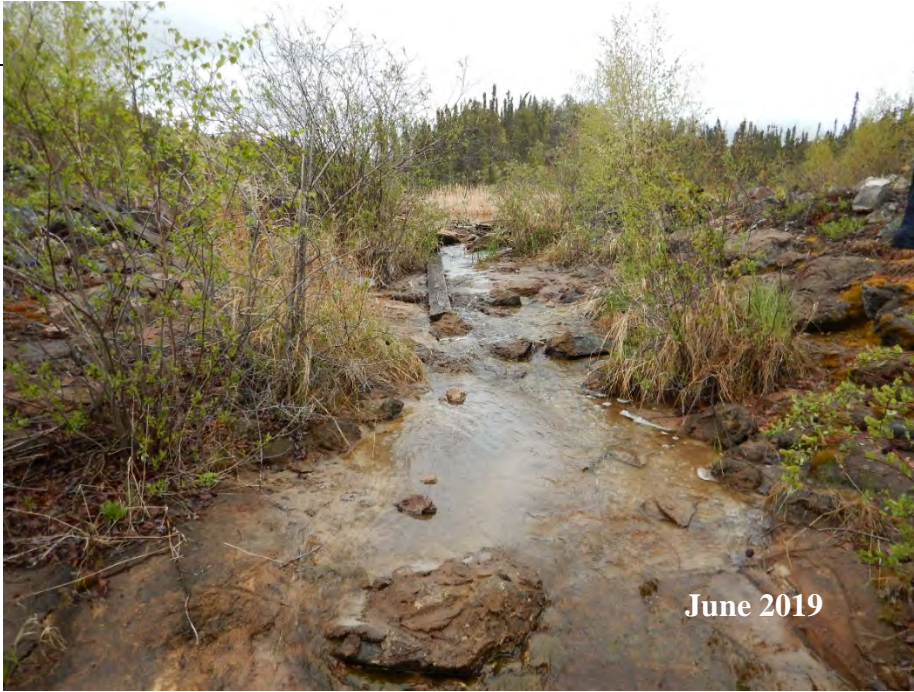
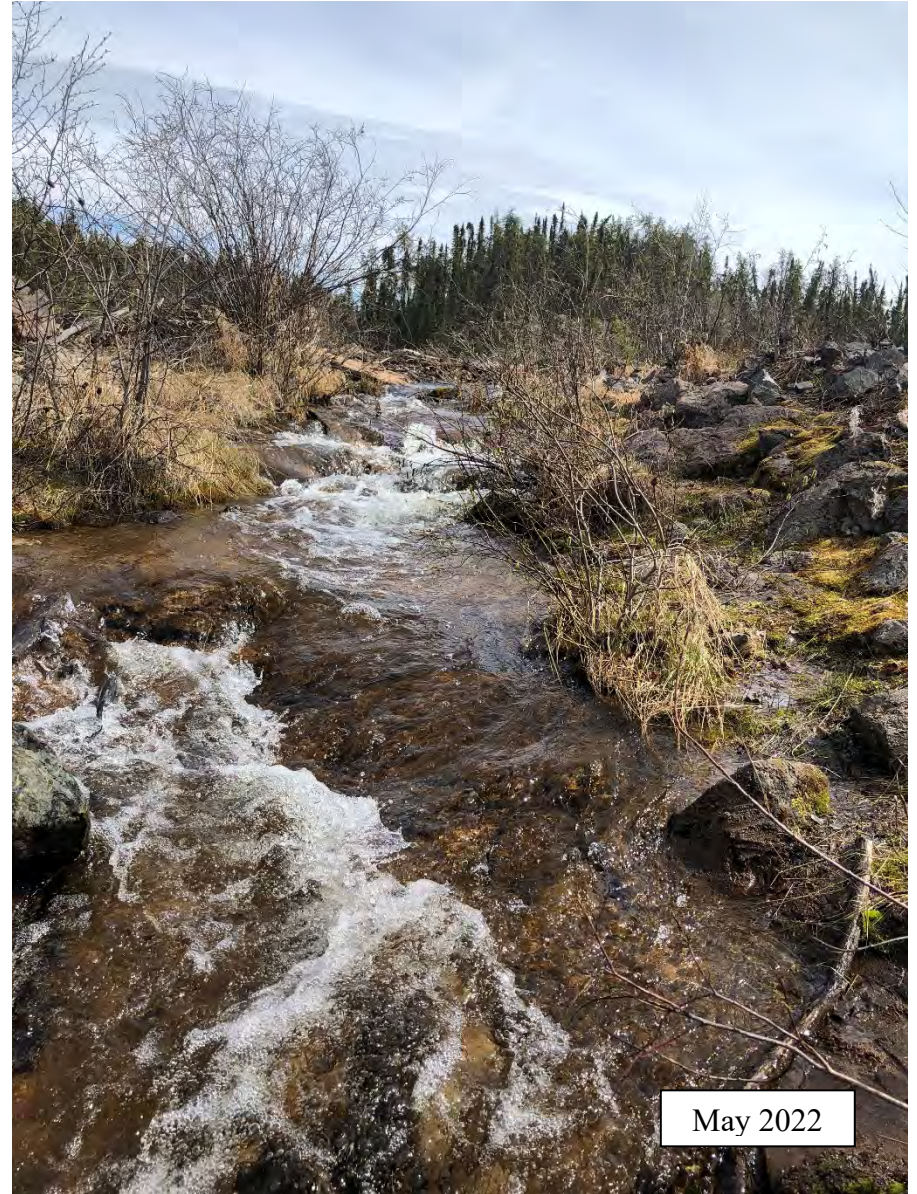
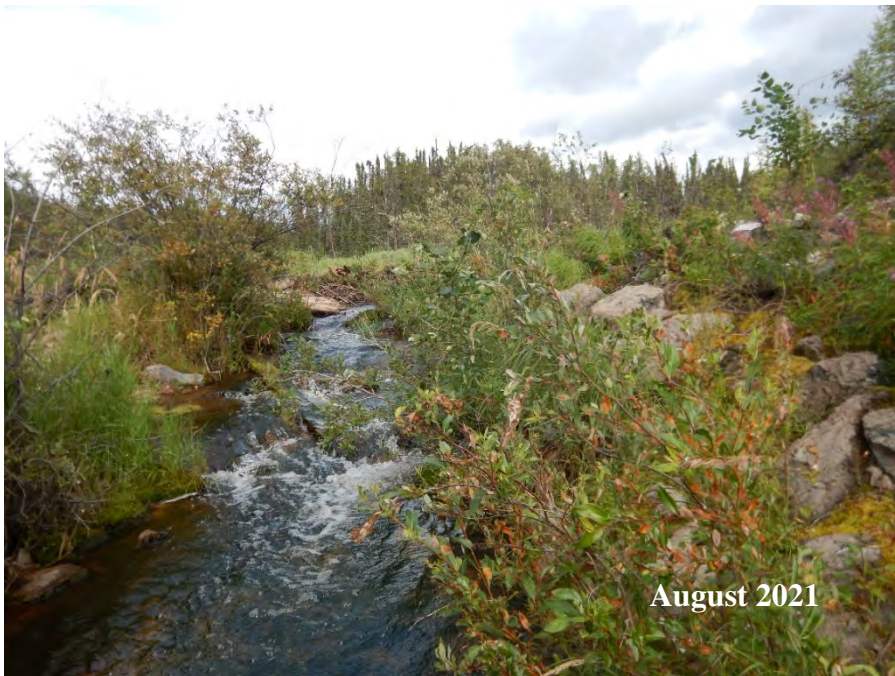
### Marie Outlet Structure looking upstream

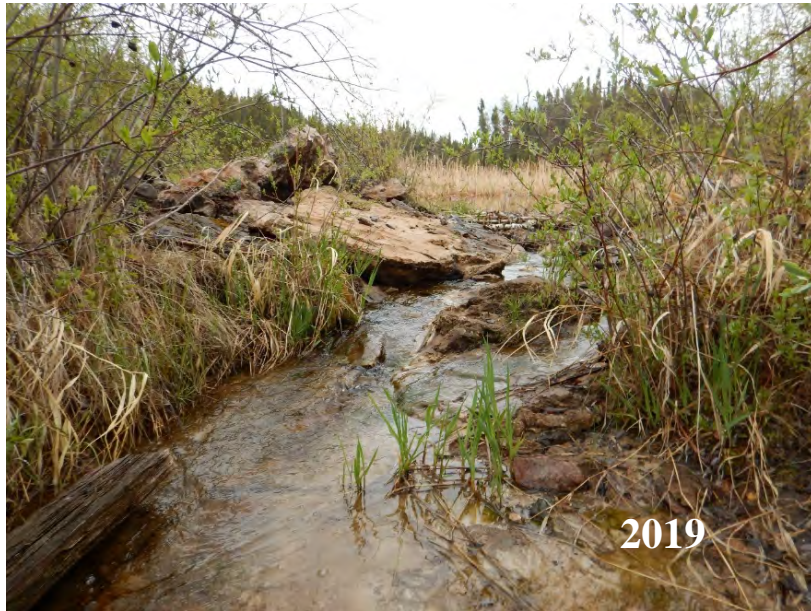
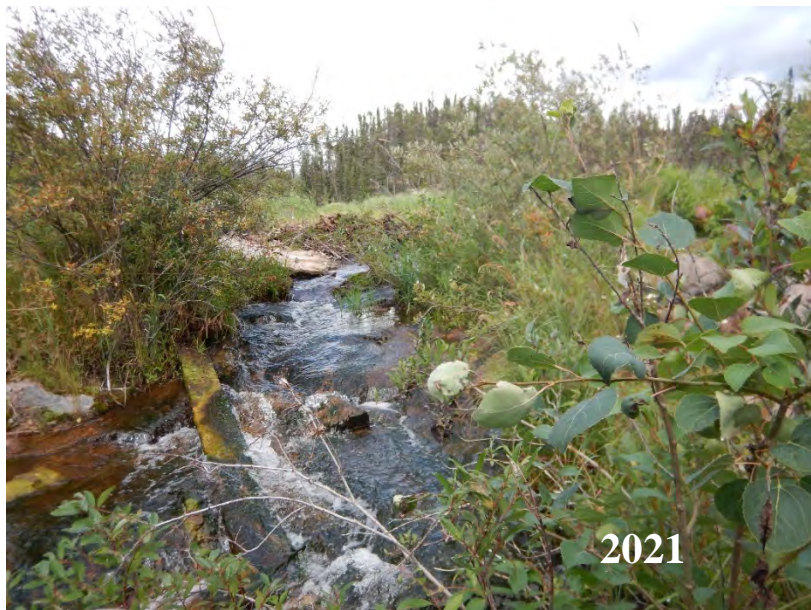
**Marie Reservoir Outlet Structure**  
**– Ice jacked block of grout intruded rip-rap**

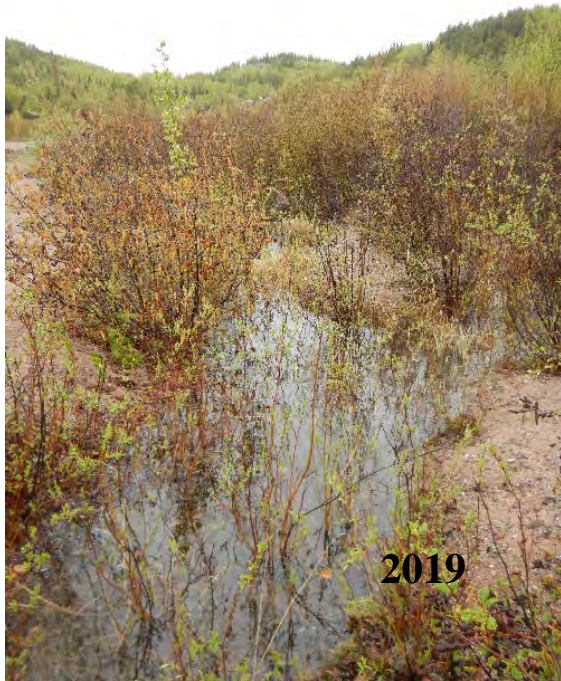
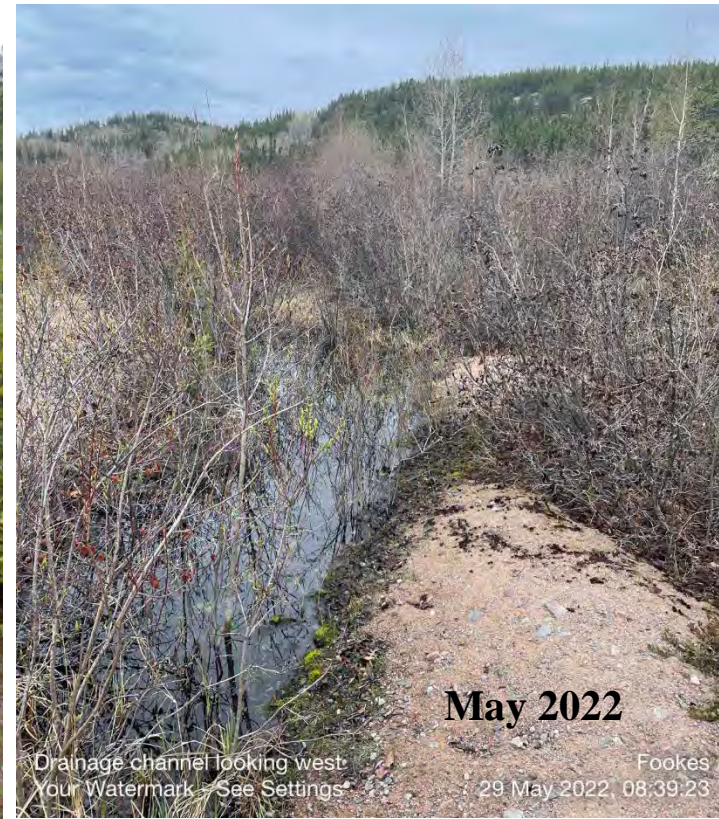
**Drainage area looking NW towards access point on hill**

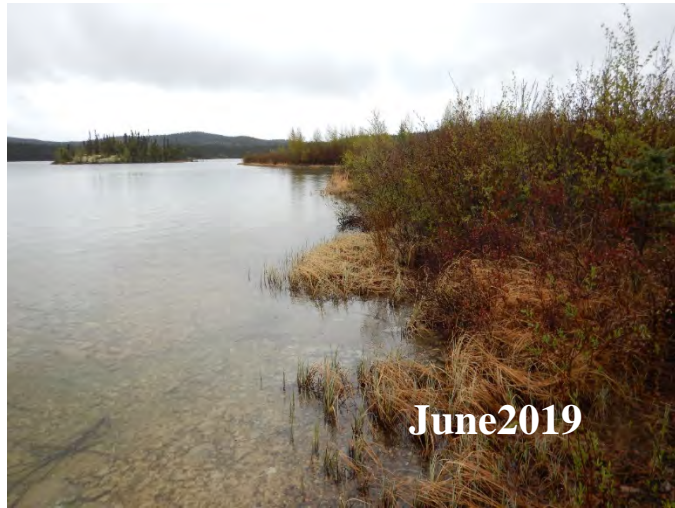
**Fookes Cover Shoreline**

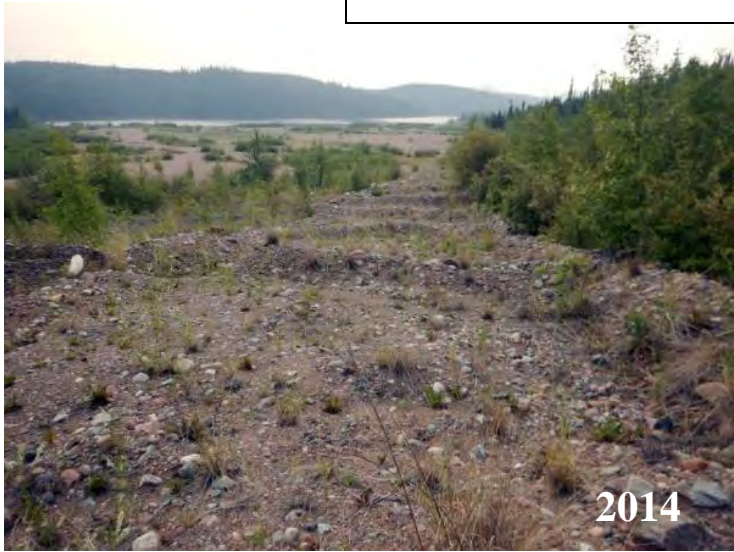
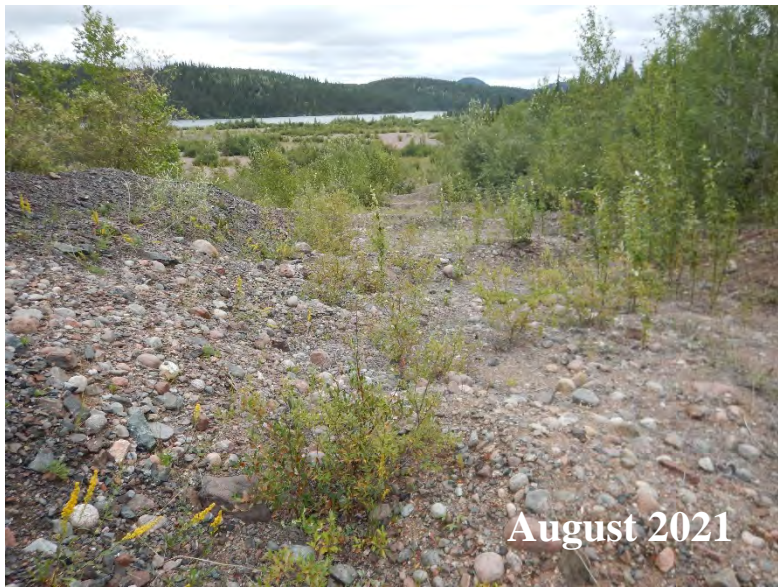
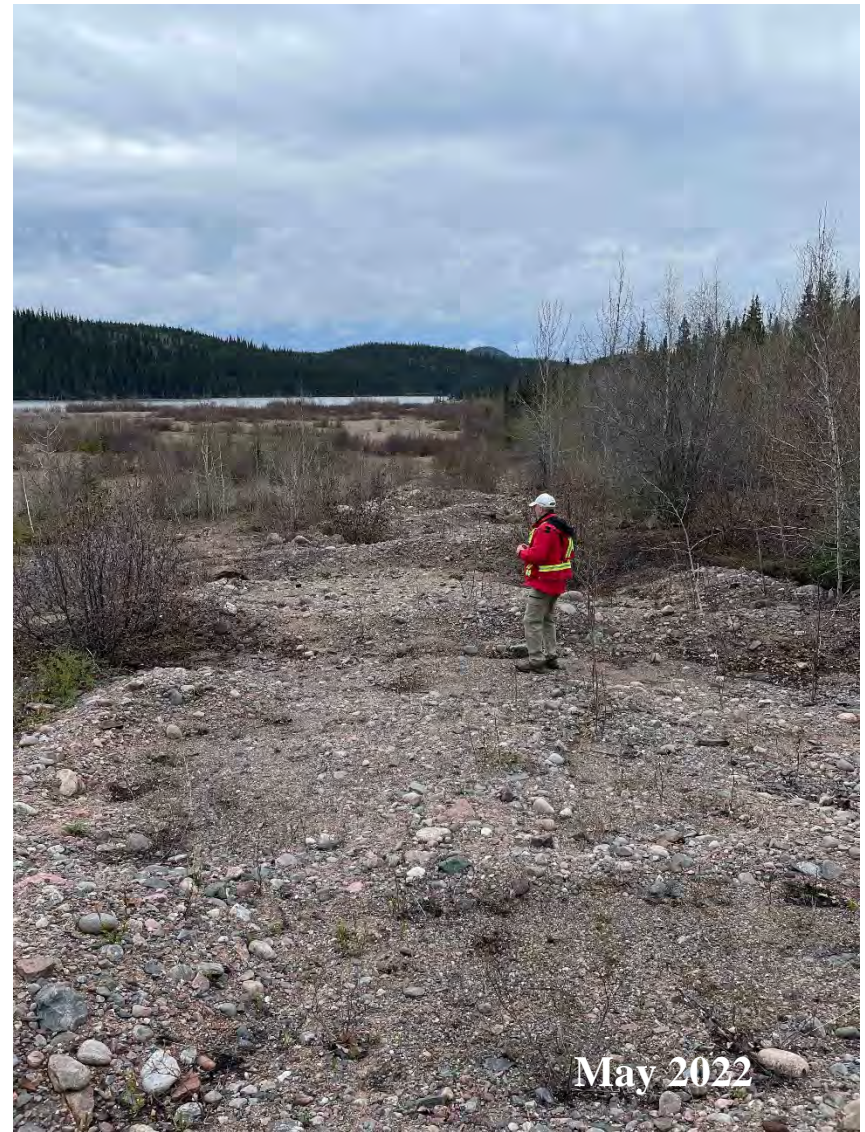
**Chevrons in place on north access point to the Fookes Delta**

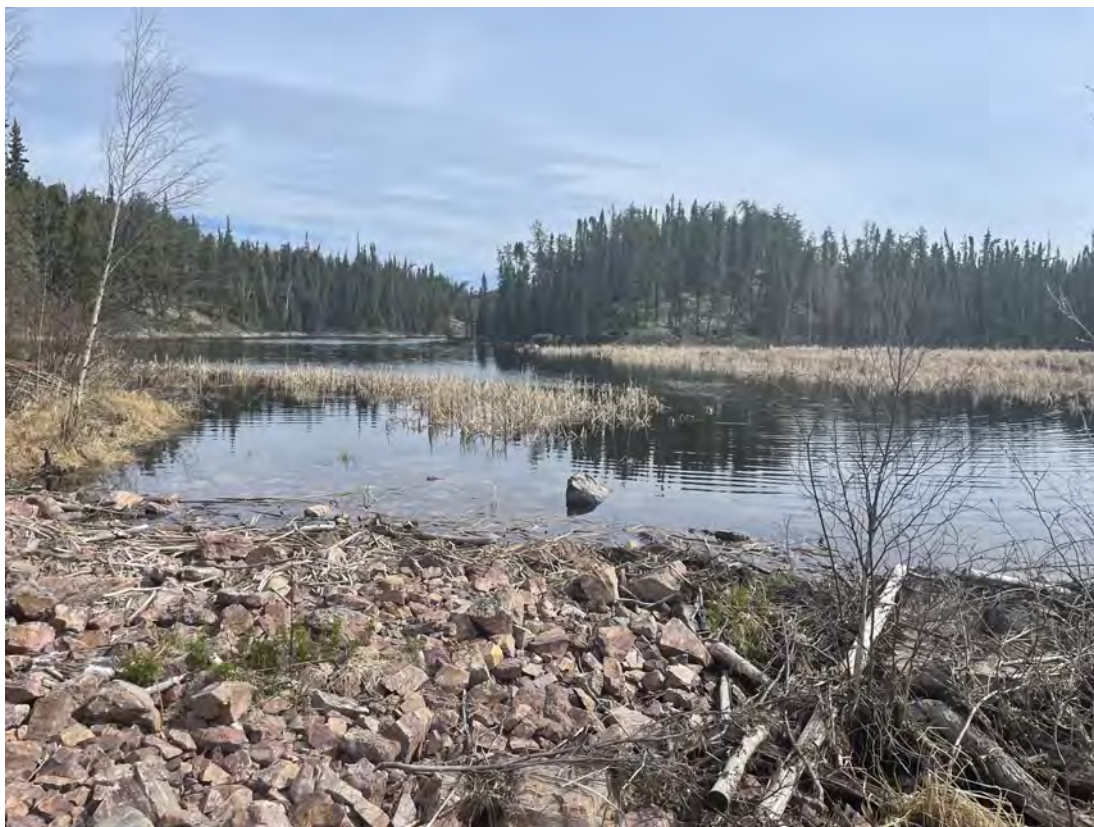
**Photo A5 — Showing detritus along leading edge of embankments indicating the extent of the elevated water levels during spring 2021. Appeared similar in 2022**

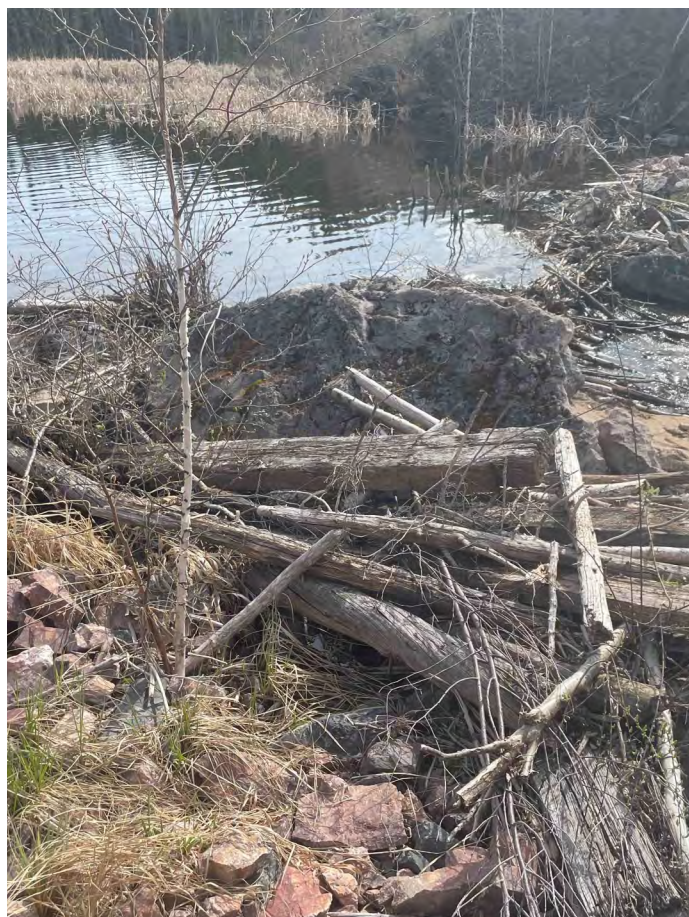
**Photo A6 — Showing debris and dimensional lumber along edges ice-jacked block of rip-rap along the edge of the Marie Reservoir channel. Dimensional lumber was removed in June 2022.**

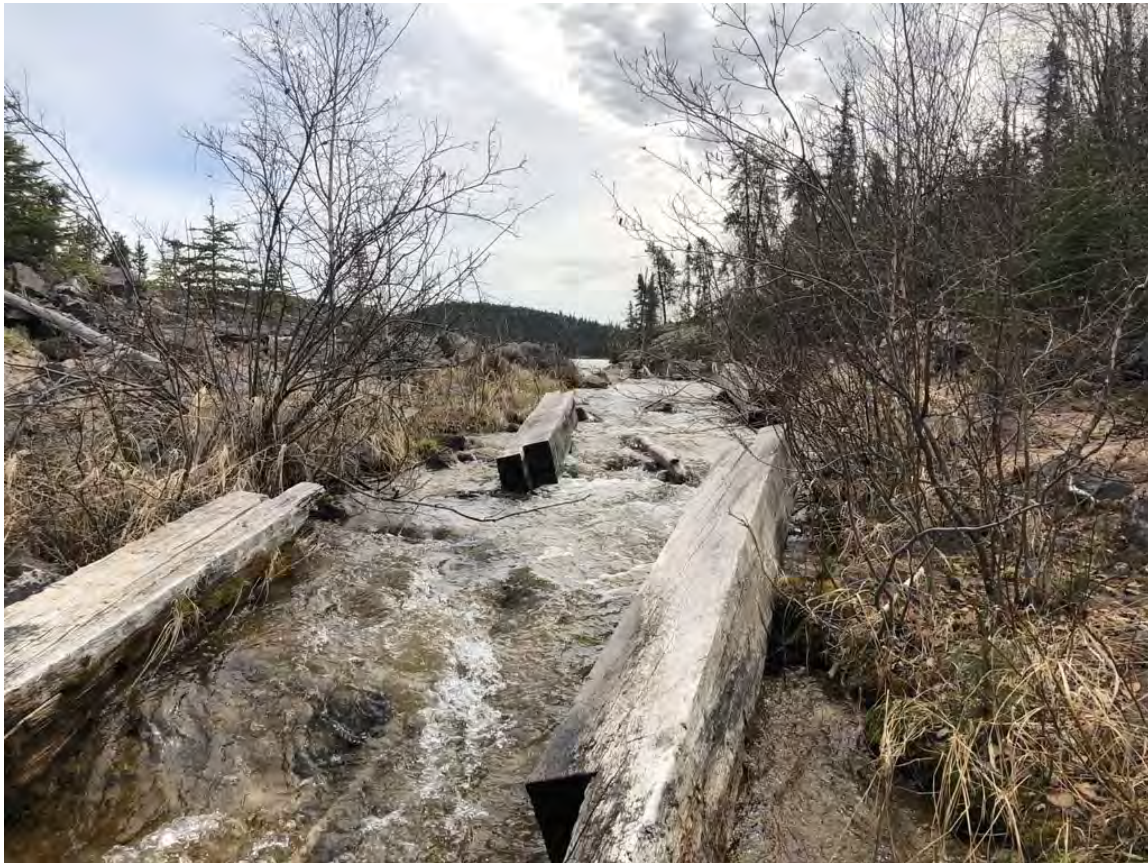
**Photo B2 – Fookes Reservoir Spillway looking upstream (near mouth)**

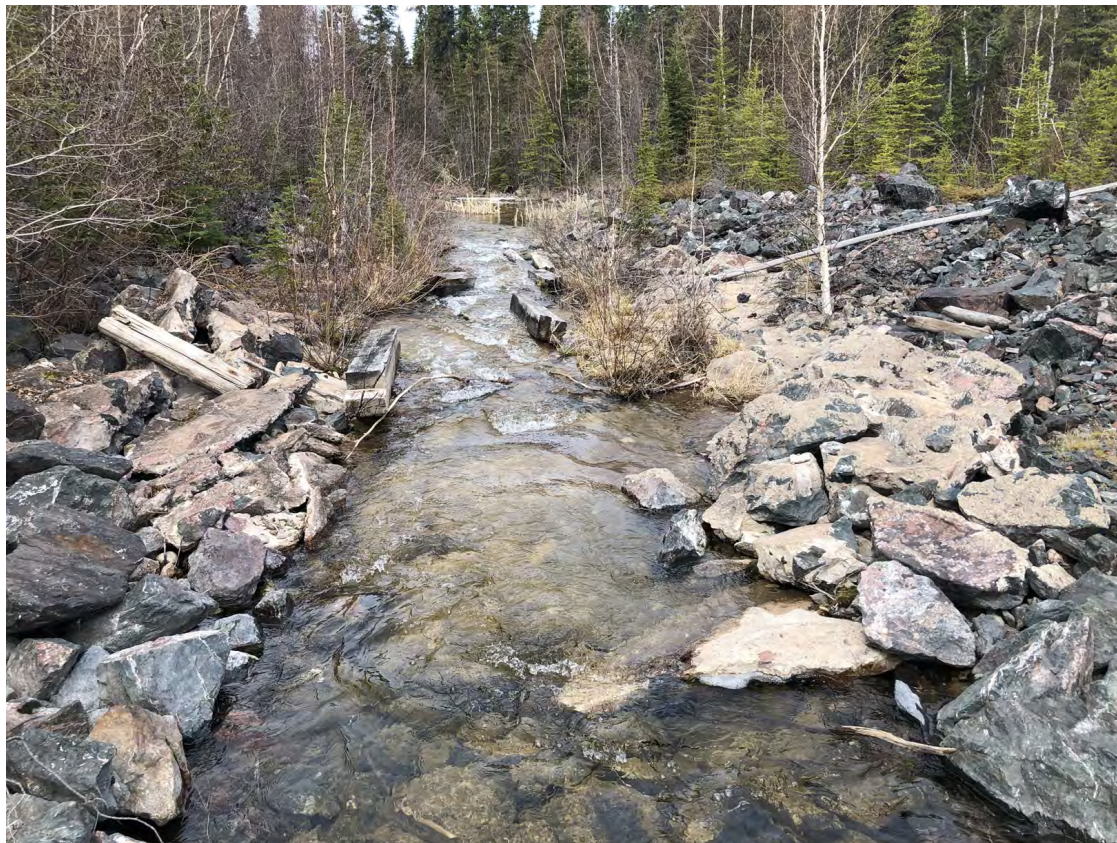
**Photo B3 – Fookes Reservoir Spillway looking downstream (mid channel)**

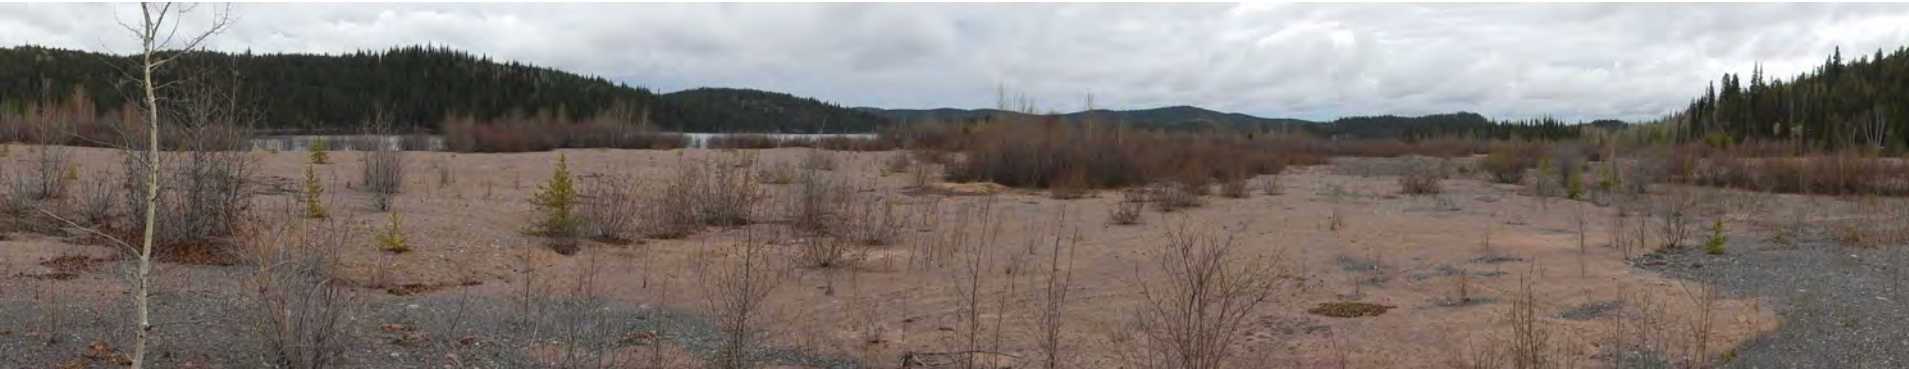
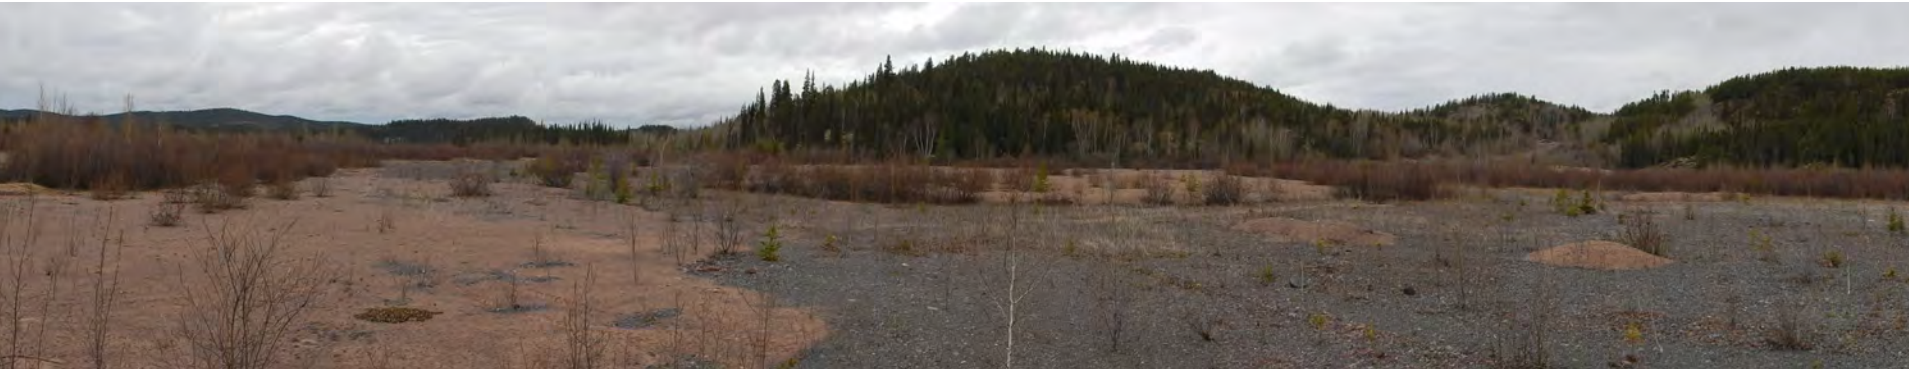
Generally, the cover was in good condition showing no areas of excessive erosion, despite greater than normal precipitation and the elevated water levels seen in Fookes Reservoir over the past number of years, discussed in Section 2.4. The east and west berms were in good condition with no evidence they have been breached by vehicular traffic. A small access trail was located adjacent to the north berm to allow all-terrain vehicle (ATV) access to facilitate removal of piezometer standpipes on the delta as the property is being prepared for transfer to the IC program. As a result, some localized ATV traffic was noted in on the Fookes Delta cover in 2022. Vegetation is well established within 50 m of the shoreline and the engineered drainage structures. Vegetation continues to gradually encroach and thicken over much of the delta.

**Photo C5a-b – Panoramic views of the Fookes cover (Photos taken May 29, 2022) vegetations is yet to leaf-out**

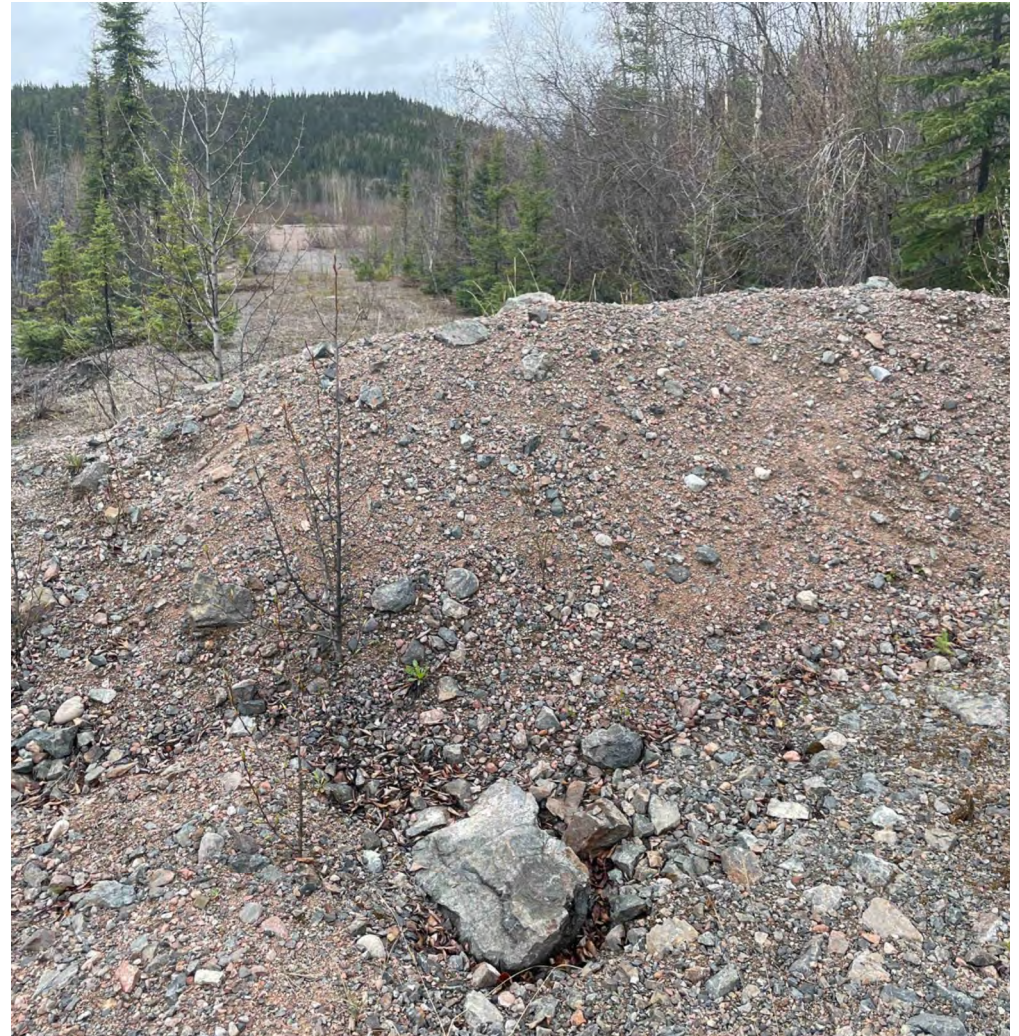
**Photo C6 – View of vegetation establishing along drainage channel, water in channel (May 29, 2022)**

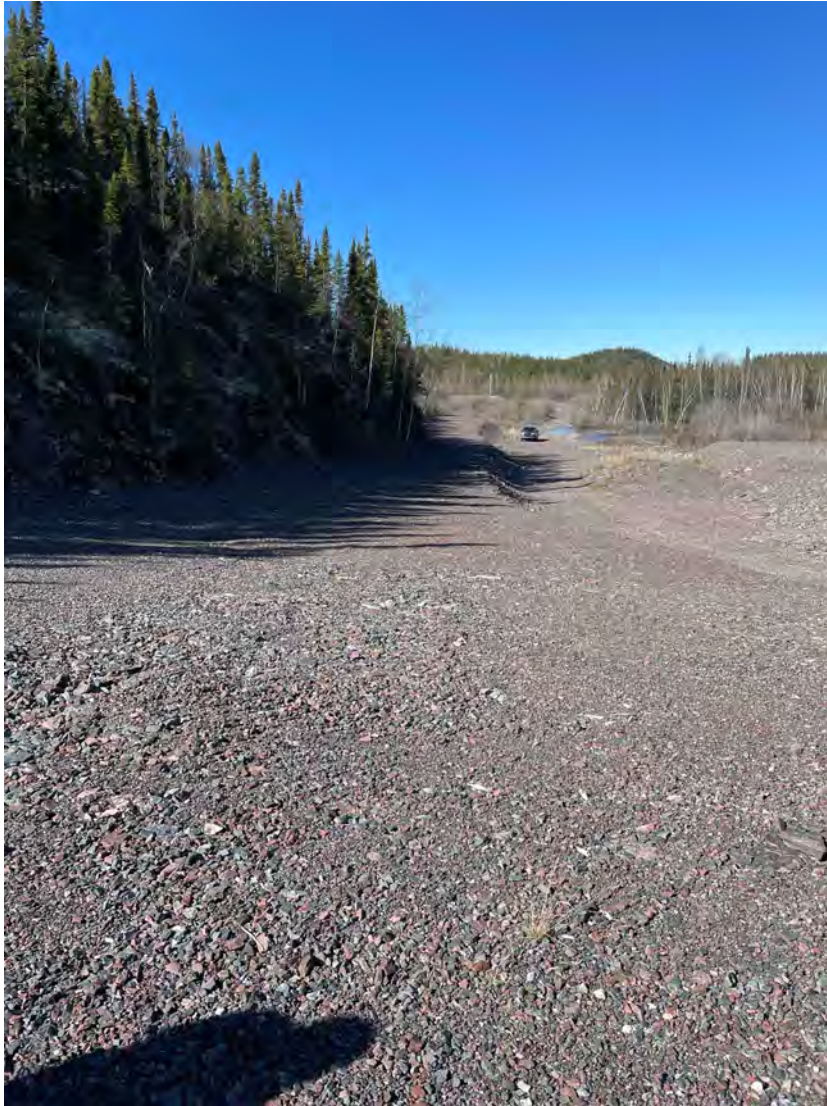
At the Ace area, the cover material over the stopes was inspected by walking the toe of the cover material, as well as the interface between the cover material and natural ground. No signs of tension cracks or visible depressions were observed along the Ace stope cover material in 2022.

**Photo D1 - View of the cover placed over Ace 201 Stope**

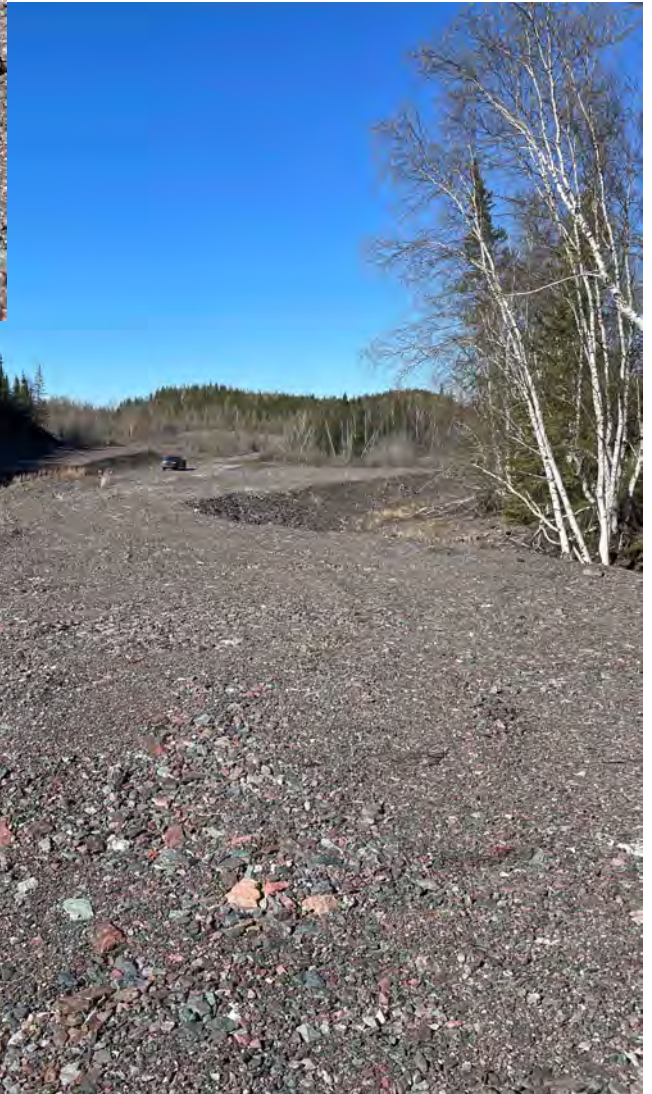
**Photo D2 - view of Ace 105 and 208 Stope cover**

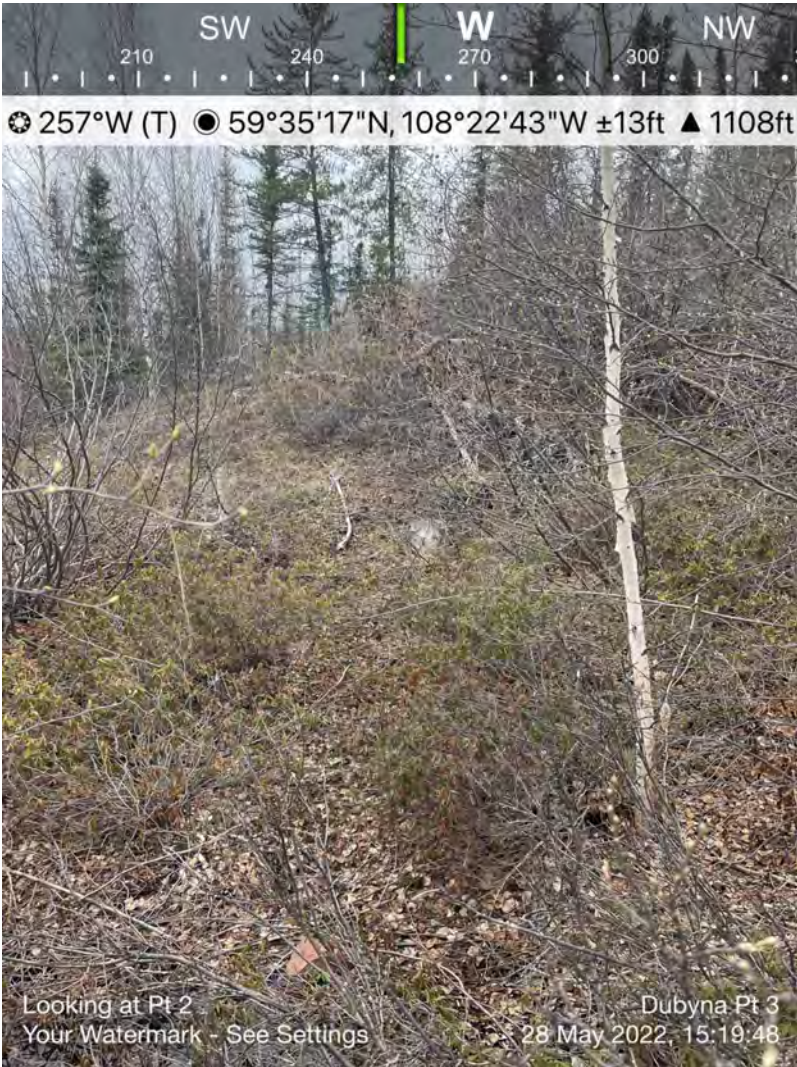
**Photo D8—Dubyna CP– 3 location (looking west)**

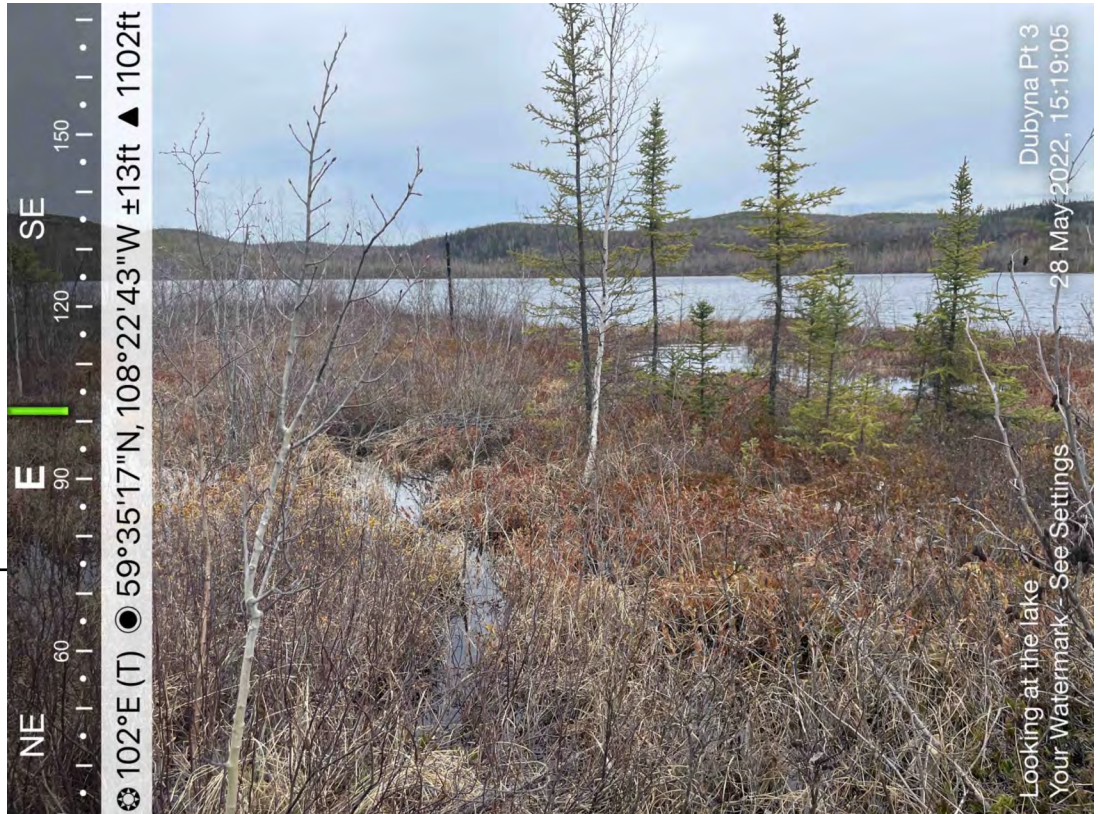
**Photo D9—Dubyna CP– 3 location (looking east to Dubyna Lake)**

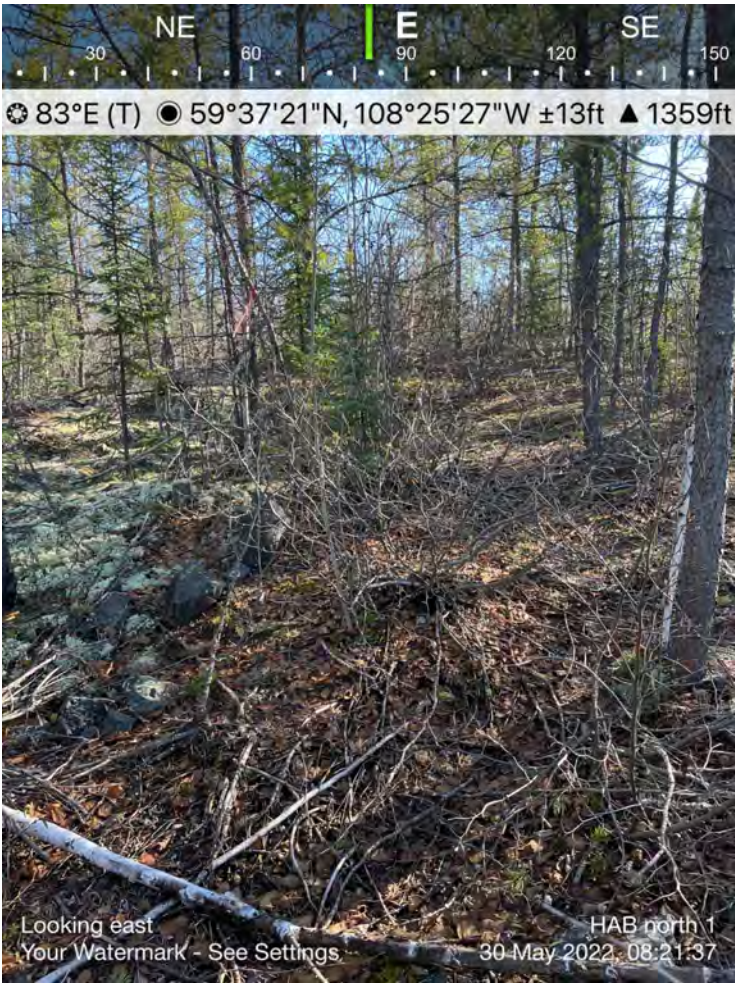
**Photo D10—HAB039-01 location (looking east)**

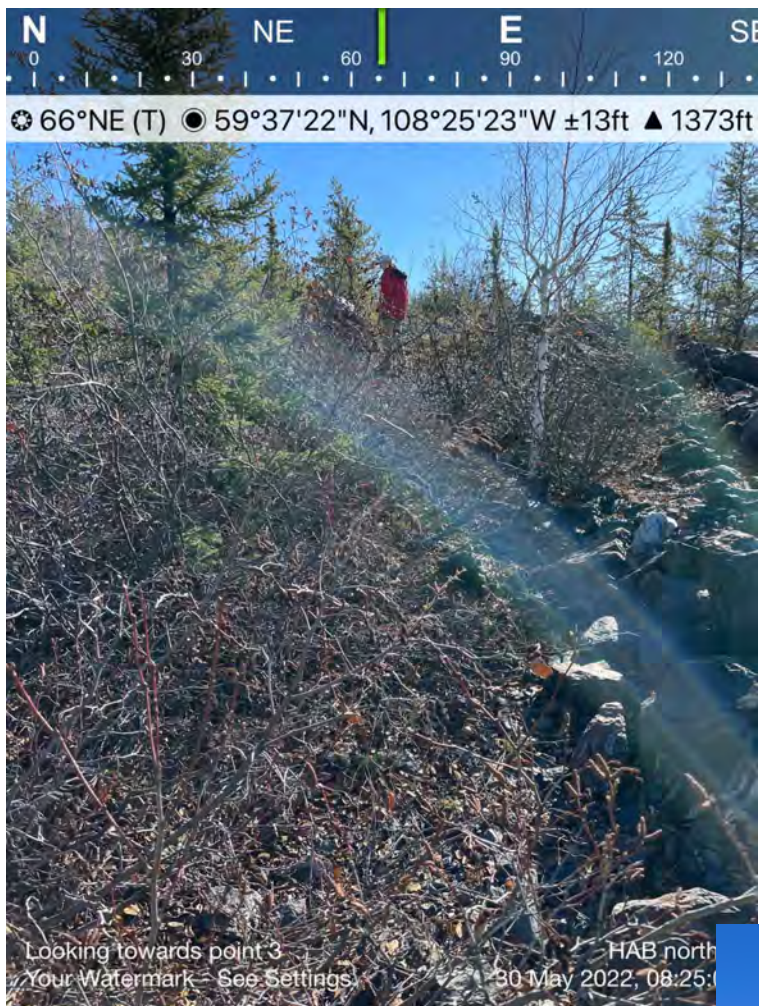
**Photo D12—HAB039-02 location (looking east)**

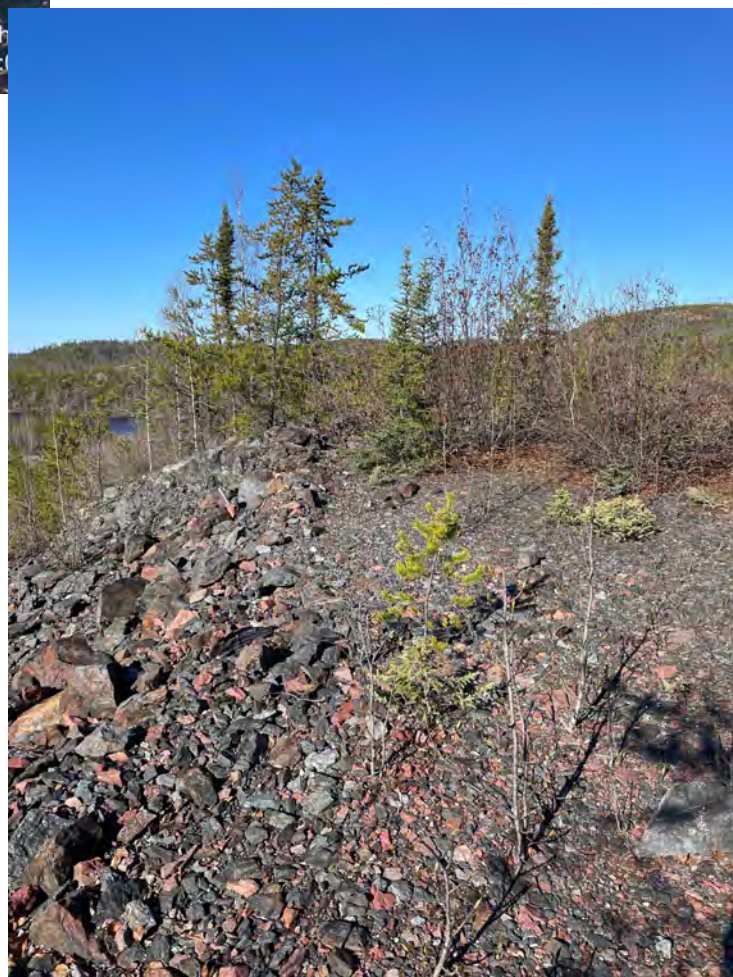
**Photo D13—HAB039-03 looking west**

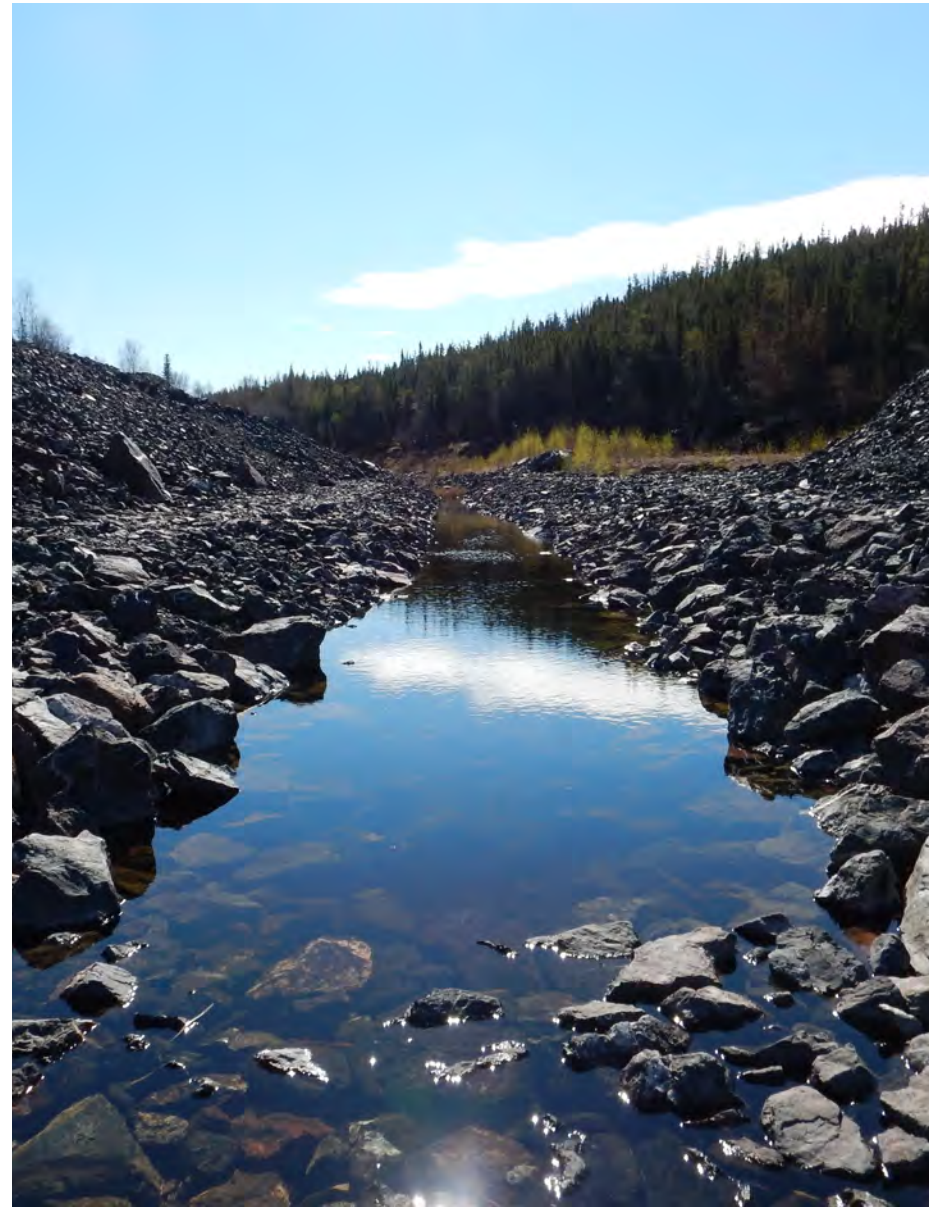
**Photo E02—View from level crossing looking upstream towards Zora Lake (May 31, 2022)**
