Beaverlodge Project 2023 Annual Report Year 38 Transition Phase Monitoring

Prepared for:
Canadian Nuclear Safety Commission
Compliance Report for Licence: WFOL-W5-2120.0/2025
& Saskatchewan Ministry of Environment
Compliance Report: Beaverlodge Surface Lease

Prepared and Submitted by:
Cameco Corporation

March 2024

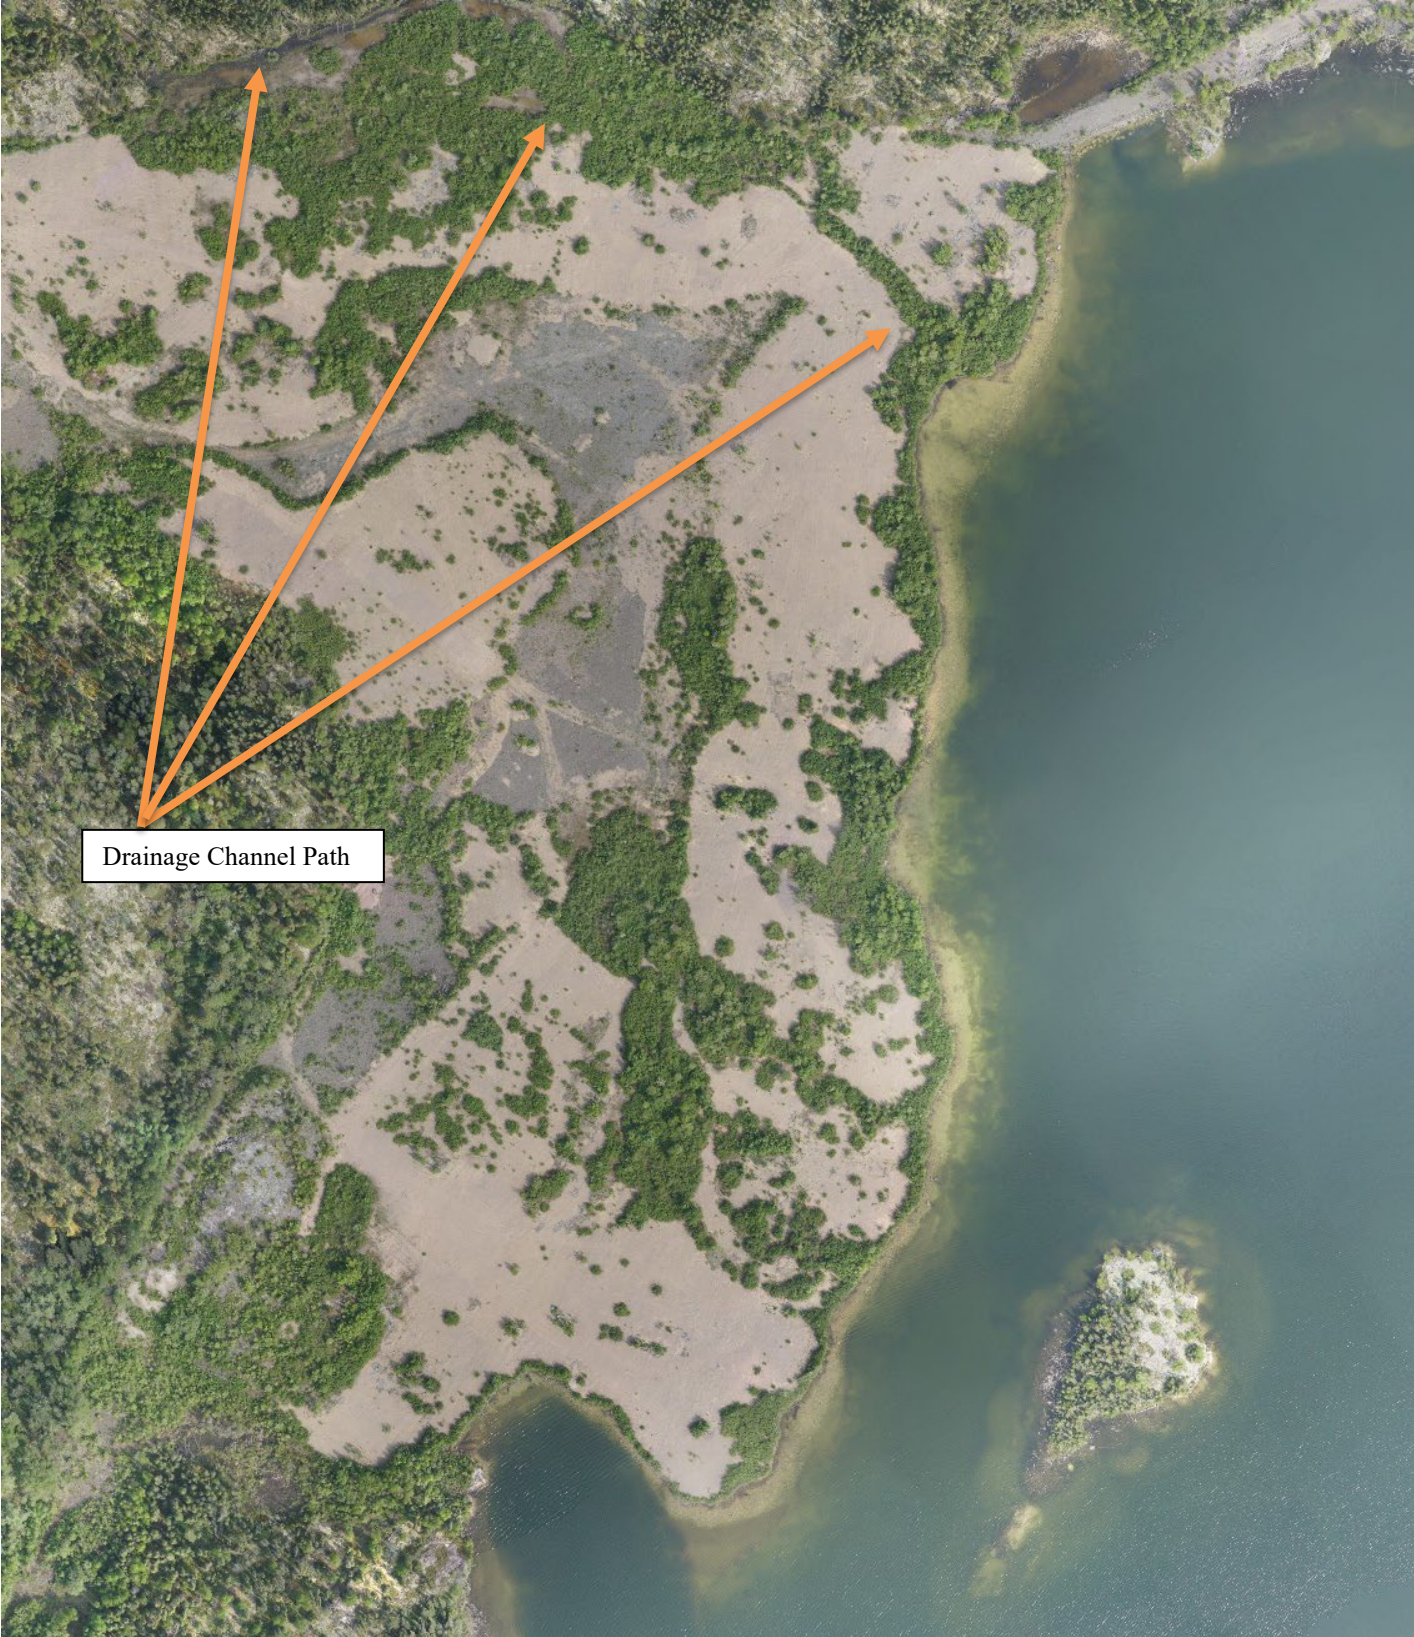
Figure 2. Fookes Overview

Historically, the area along the northeast side of the Fookes Delta has contained standing water. The Fookes Delta cover in this area was purposefully graded to establish an overall preferential gradient towards Fookes Reservoir. **Figure 2** provides an overview of the cover design (SRK, 2008), with the surface drainage paths outlined. As per the SRK design for the Fookes cover, the northern drainage ditch area of the delta was never intended to provide fully channelized flow to Fookes Reservoir. As a result, some ponding in higher precipitation years was anticipated and may be expected to occur.

The 2023 inspection showed that water is being captured in the drainage channels as per design and there is no evidence of any significant erosion of the cover. The drainage channel continues to vegetate heavily as can be seen in the photos in Section 4 and **Figure 2**.

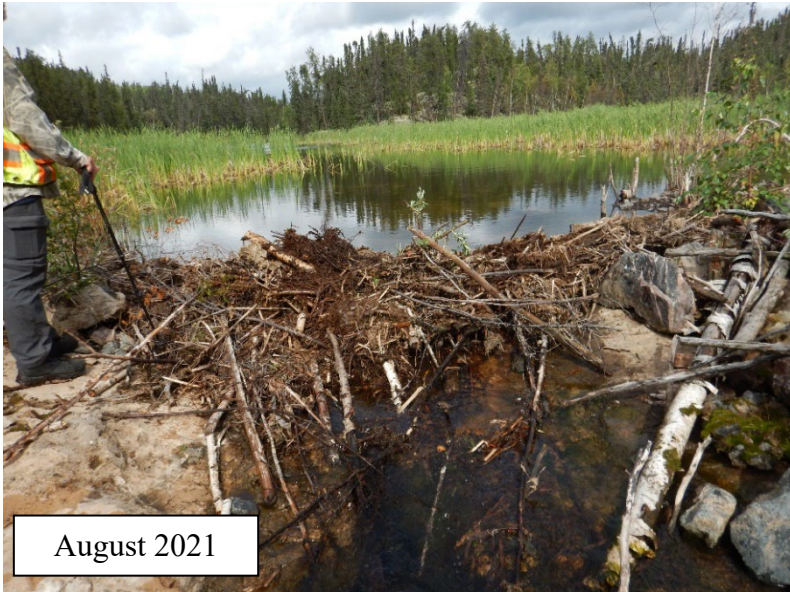
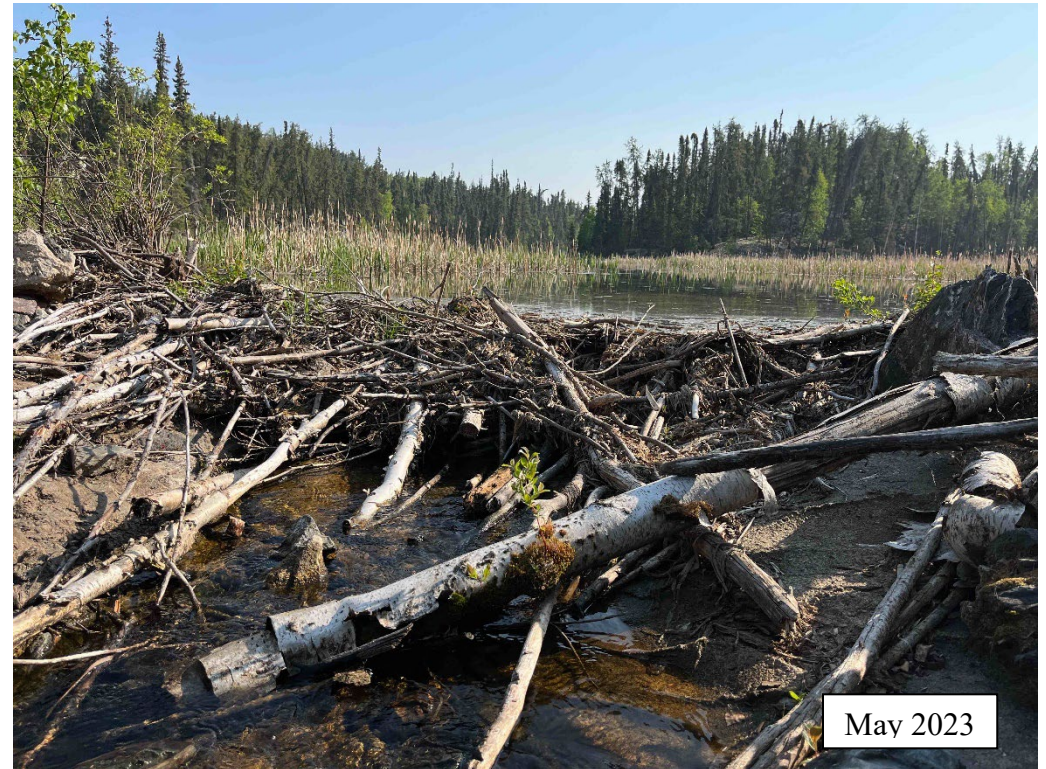
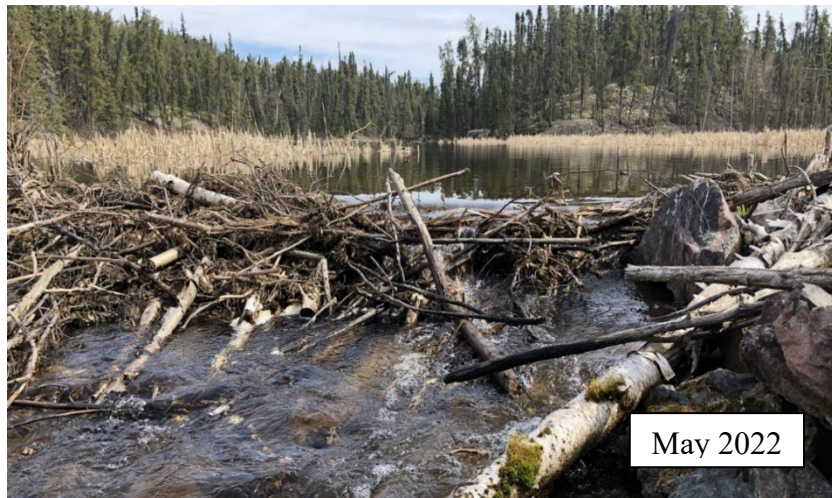
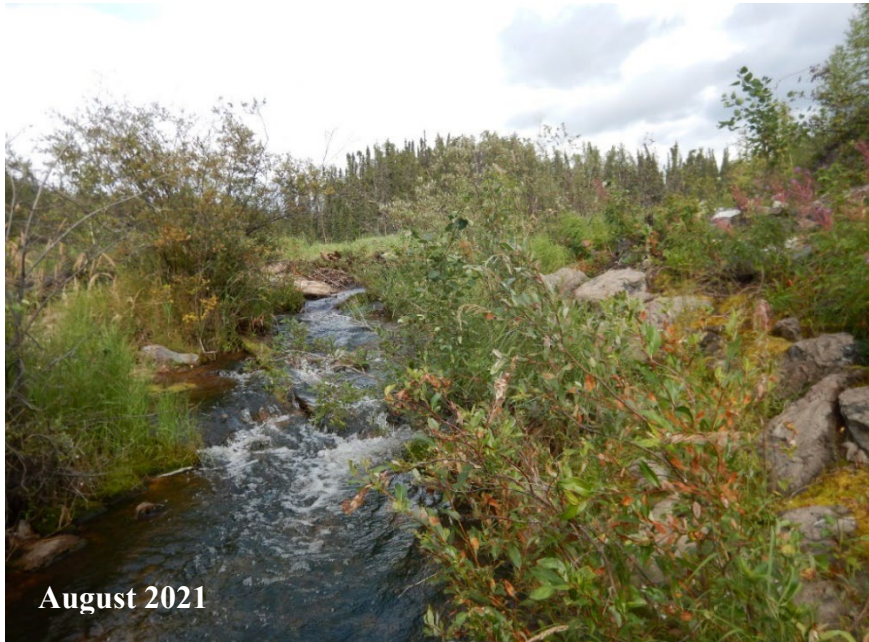
Beaver dam construction at the outlet structure for Marie Reservoir

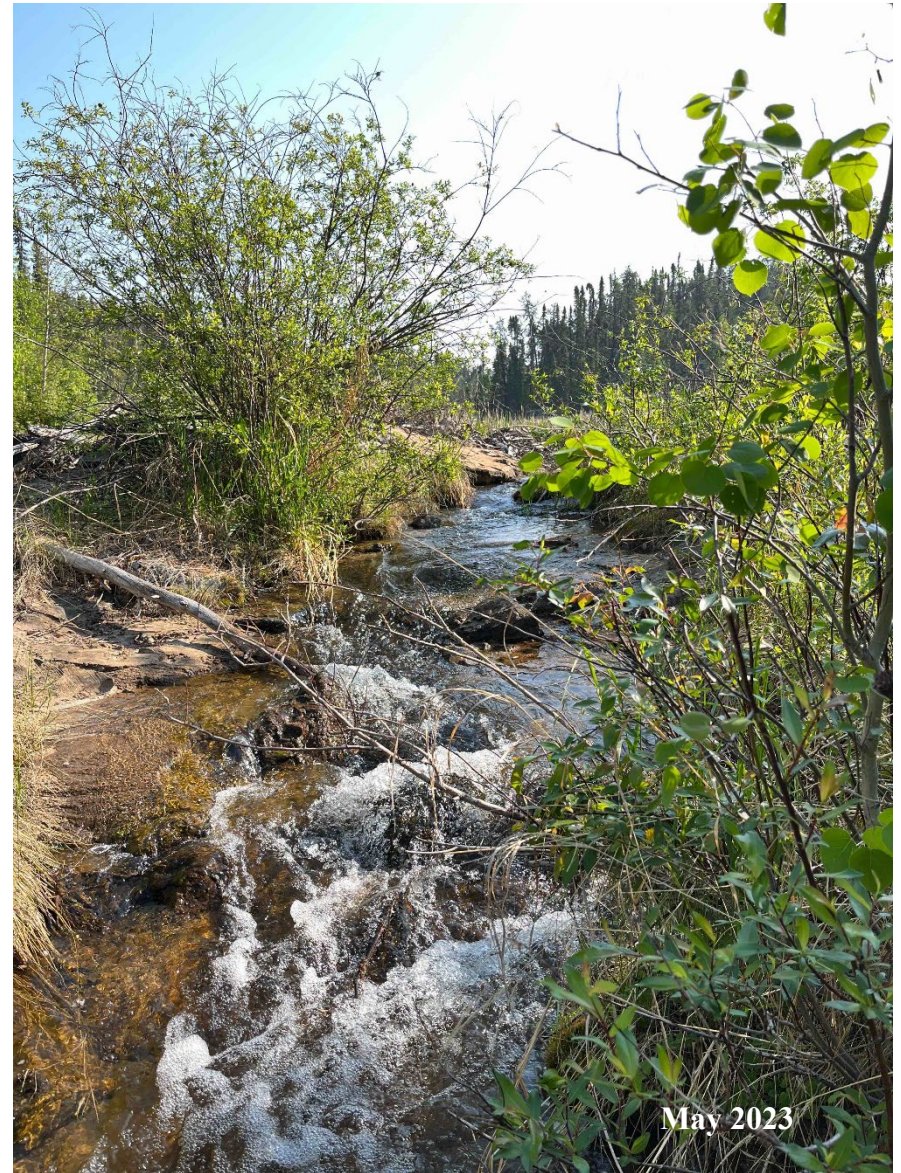
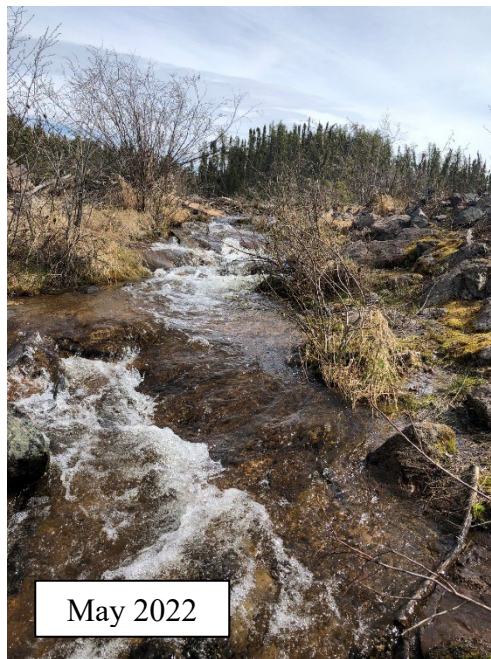
Marie Outlet Structure looking upstream

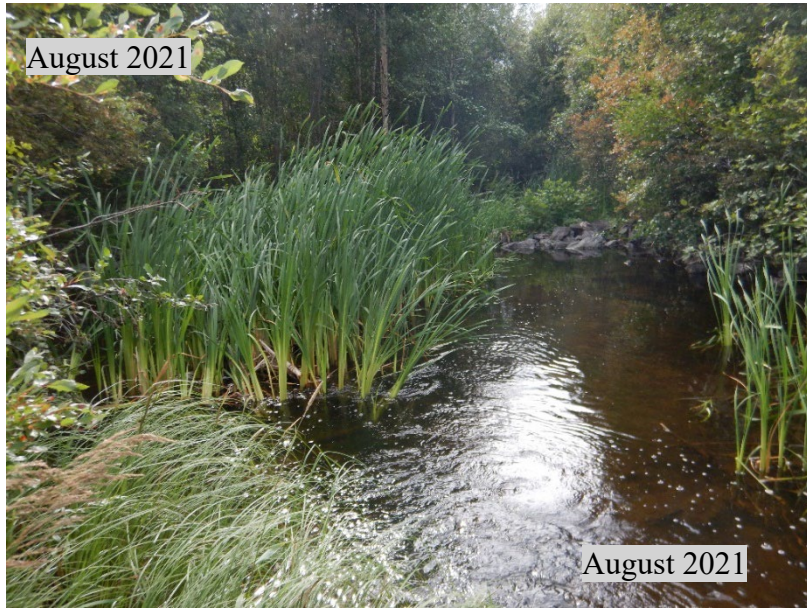
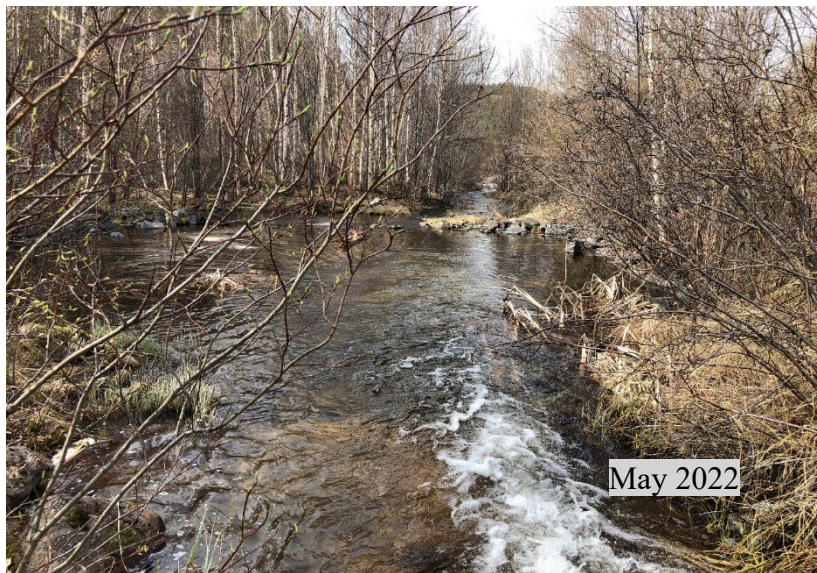
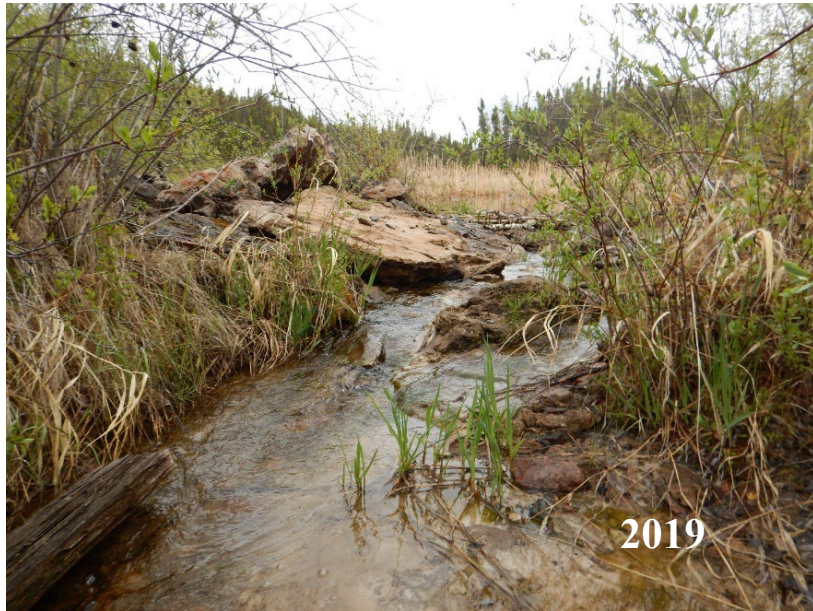
Marie Outlet Structure looking downstream

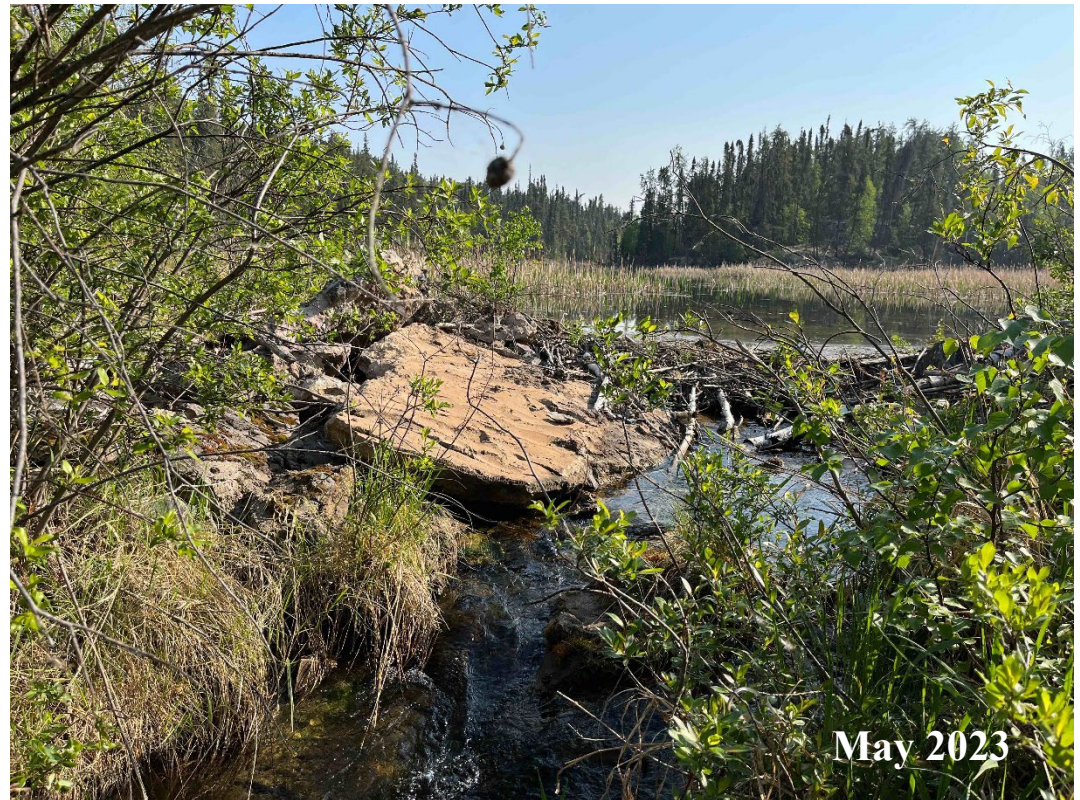
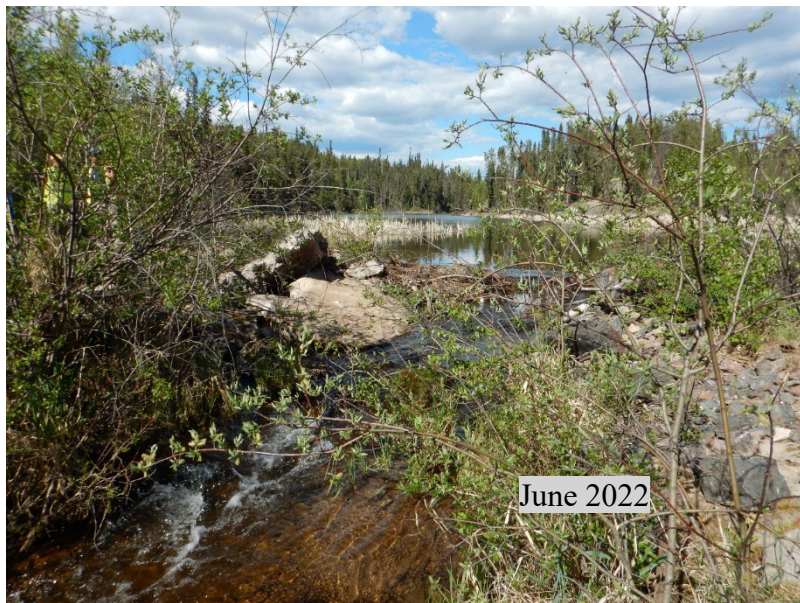
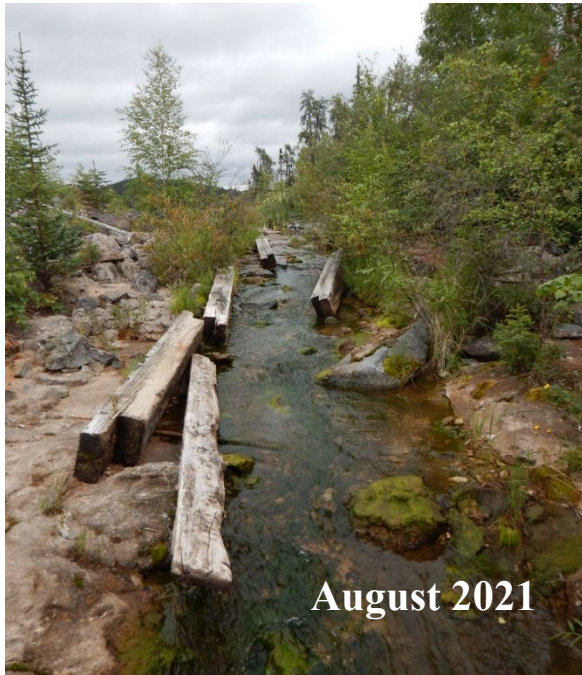
Marie Reservoir Outlet Structure
– Ice jacked block of grout intruded rip-rap

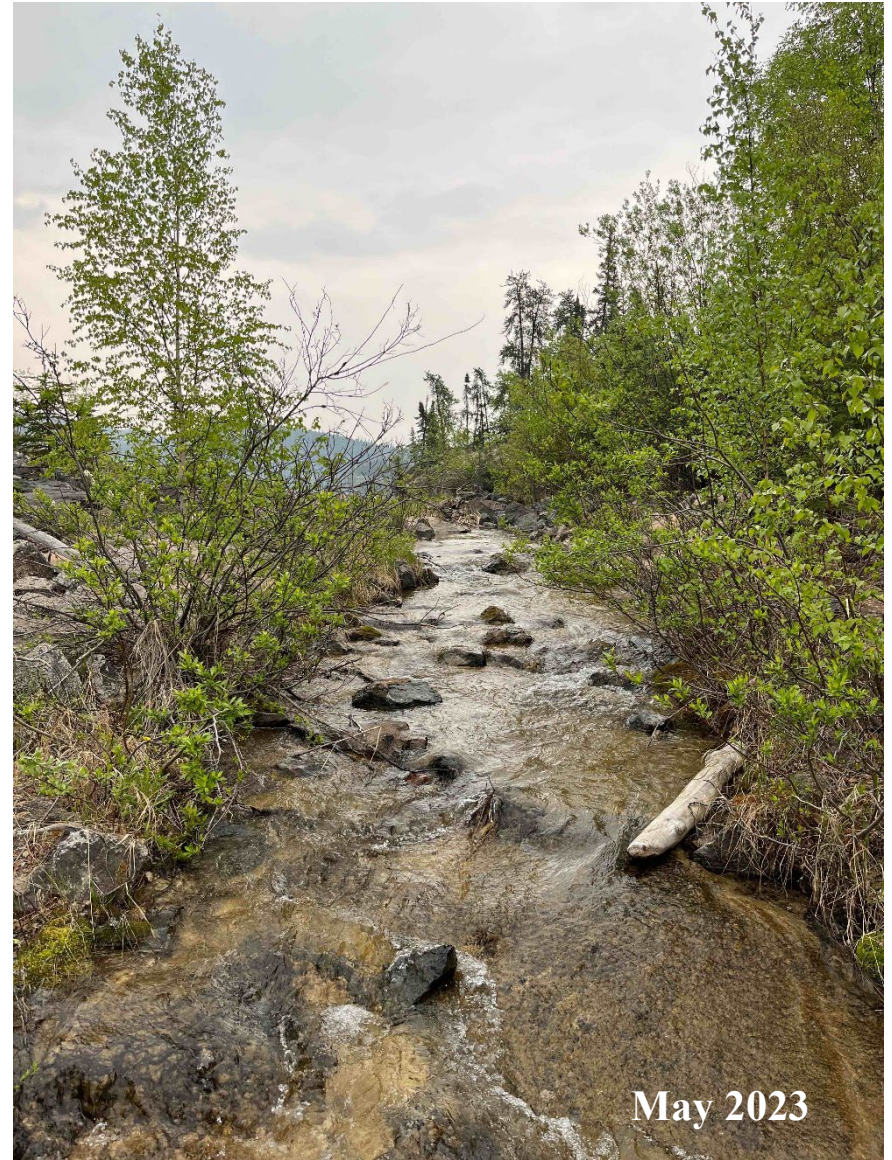
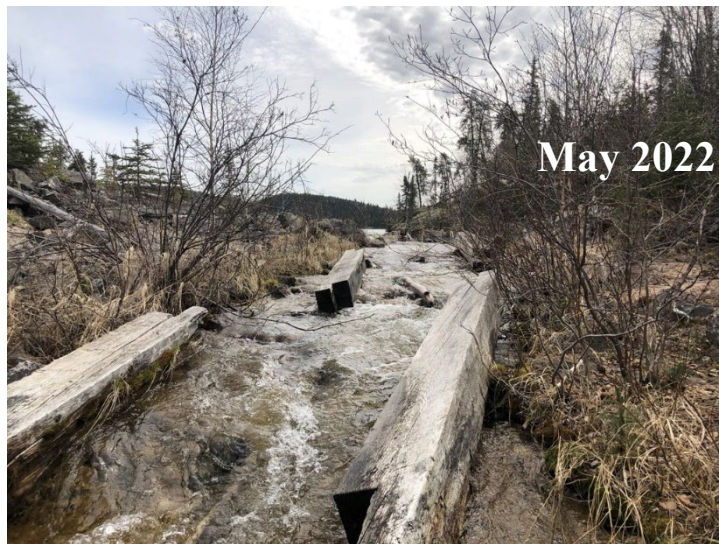
Fookes Outlet Structure looking upstream

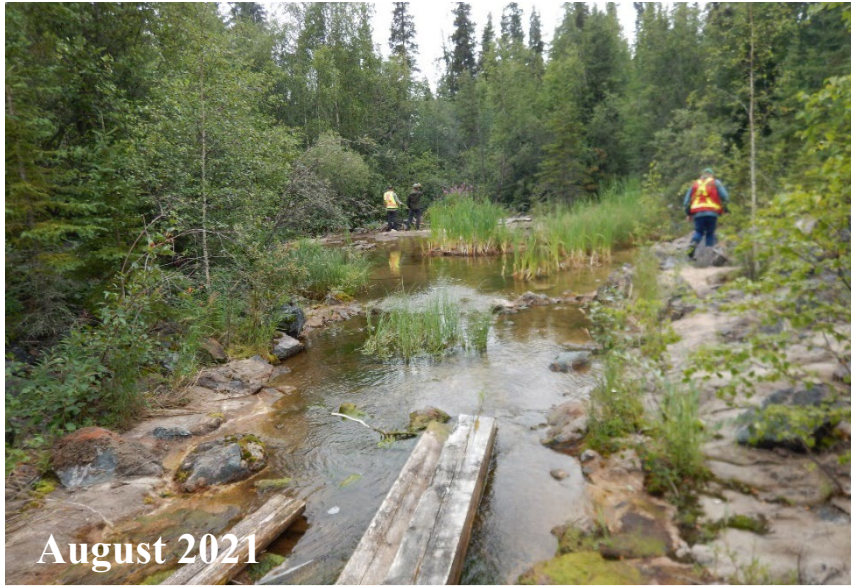
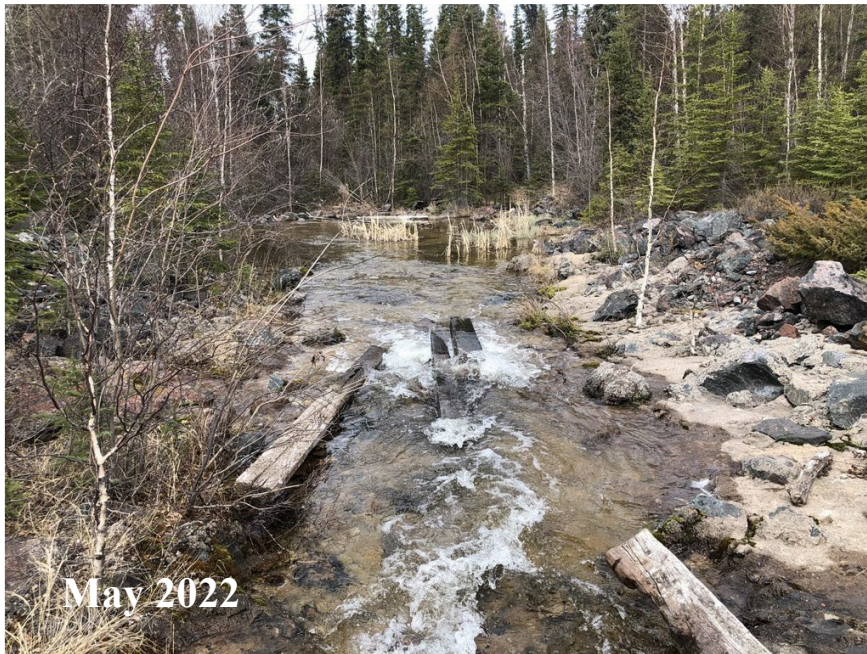
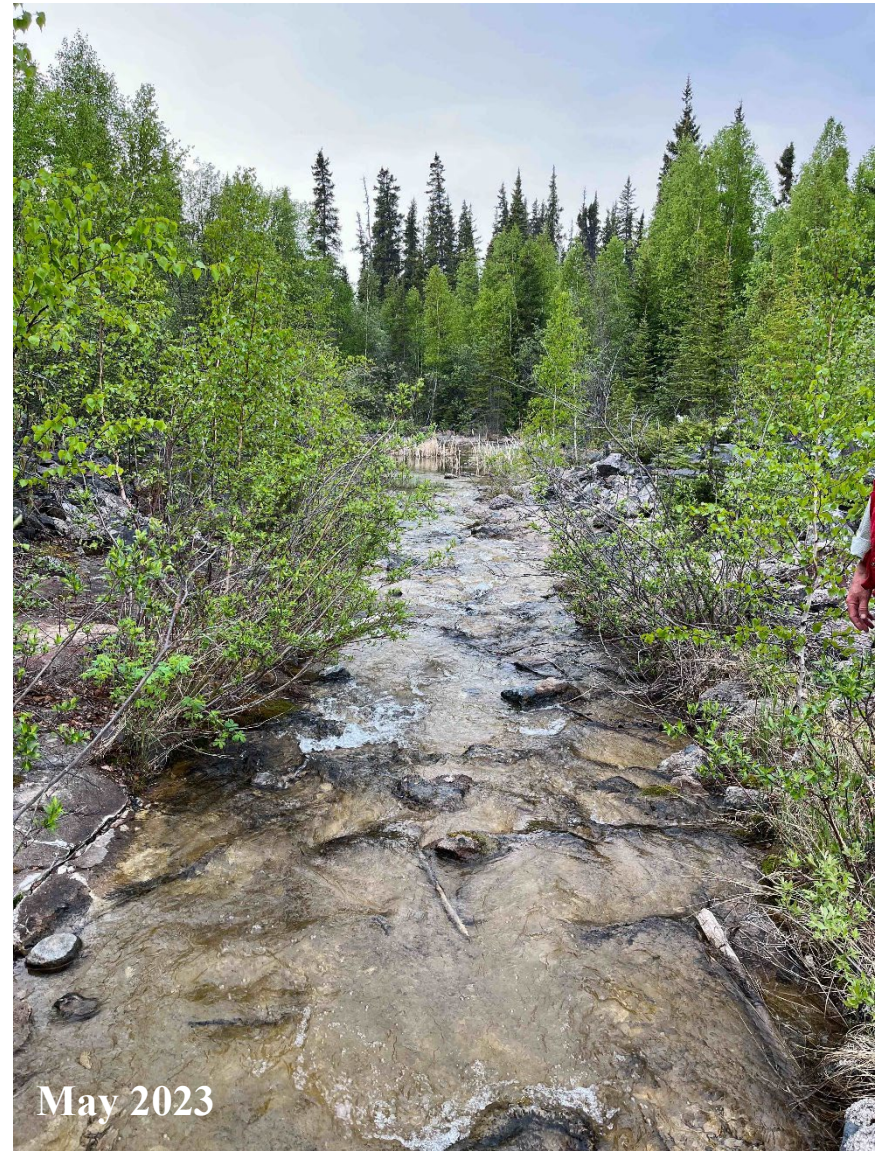
Fookes Outlet Structure looking downstream

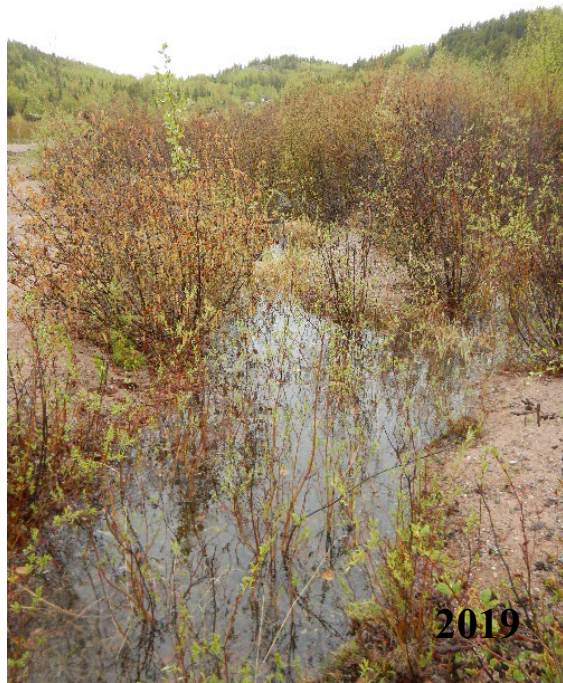
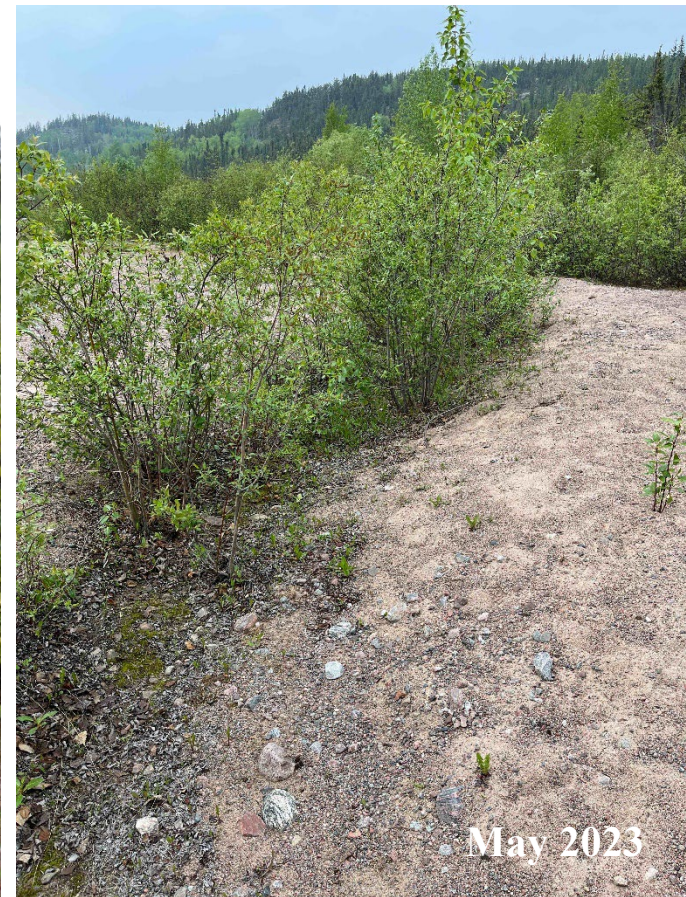
Drainage area looking NW towards access point on hill

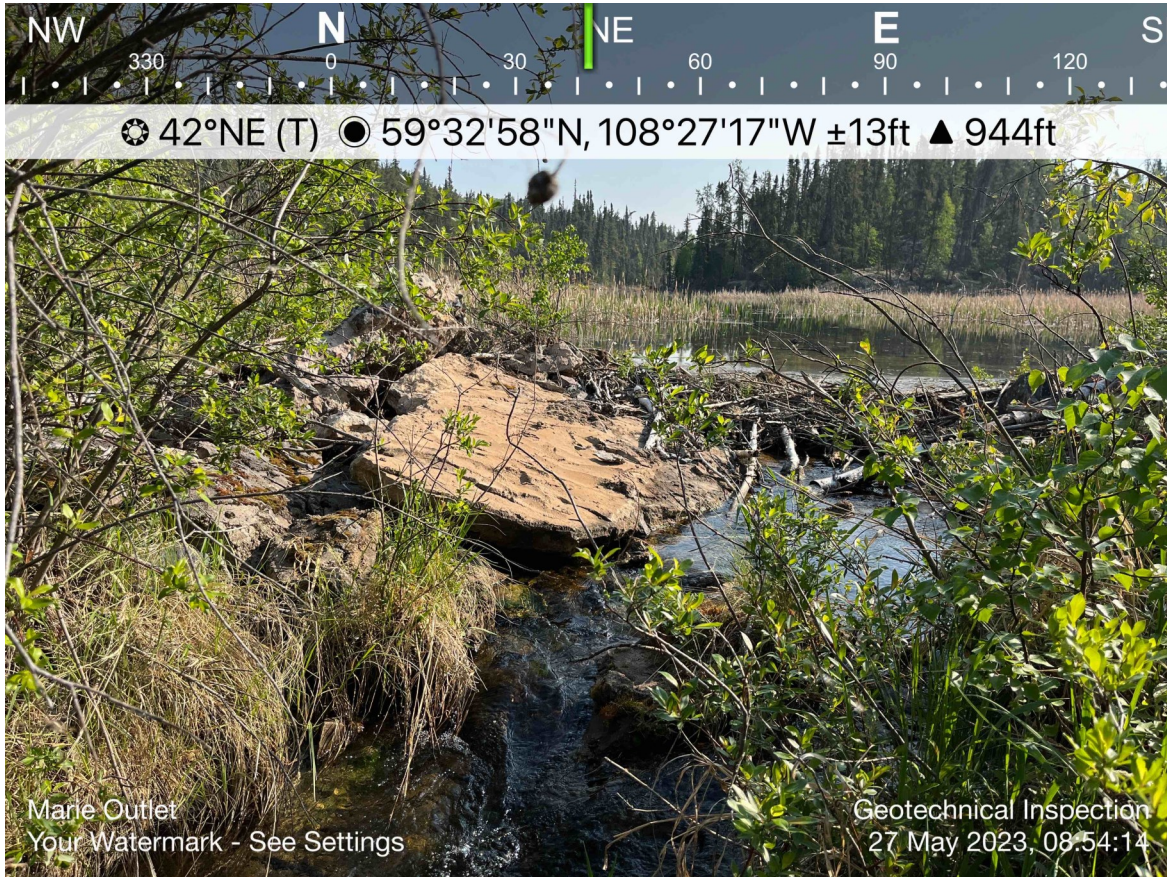
Photo A1 – Marie Reservoir Spillway looking upstream (May 2023)

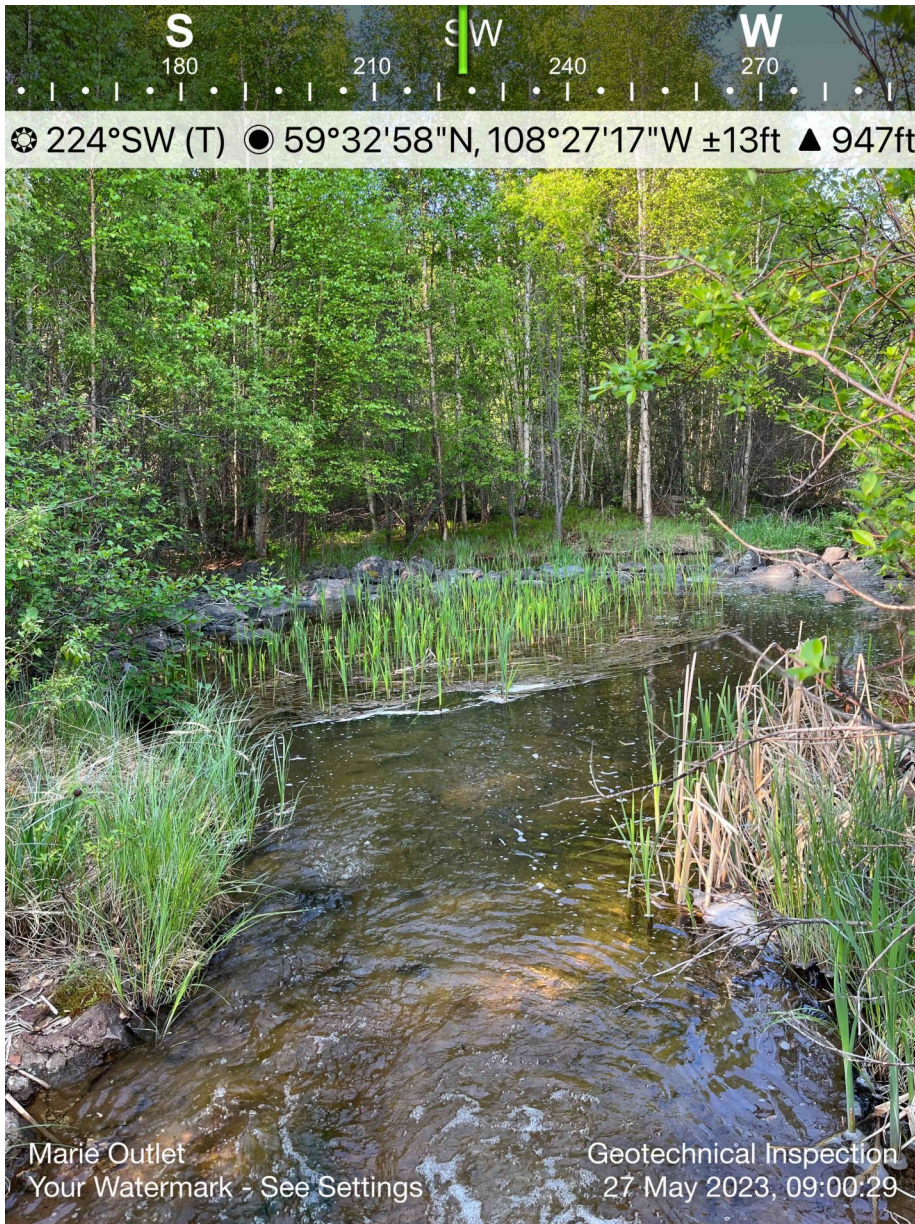
Photo A3 – Marie Reservoir Spillway (water flowing into stilling basin) (May 2023)

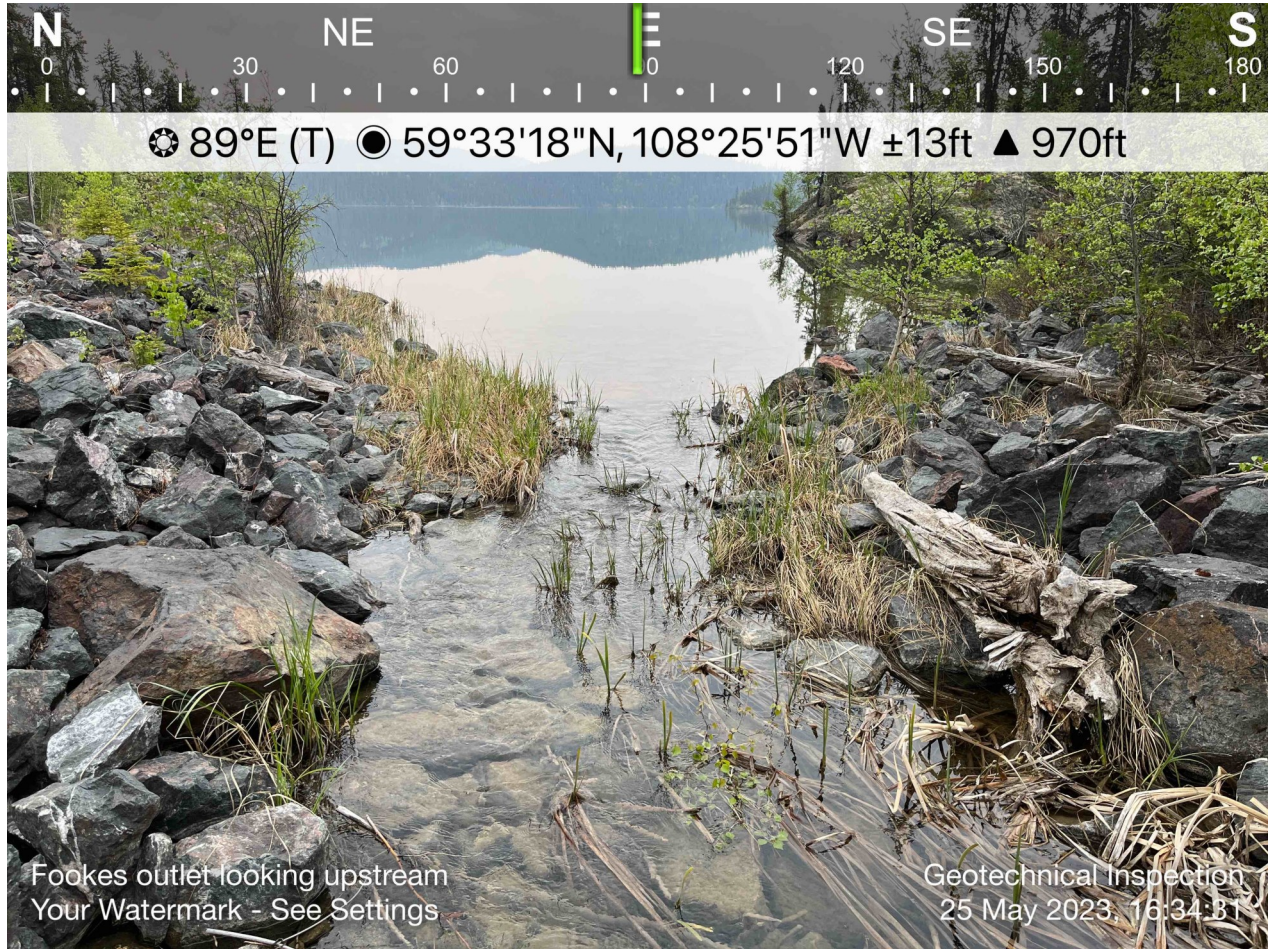
Photo B1 – Fookes Reservoir Spillway looking into Fookes Reservoir

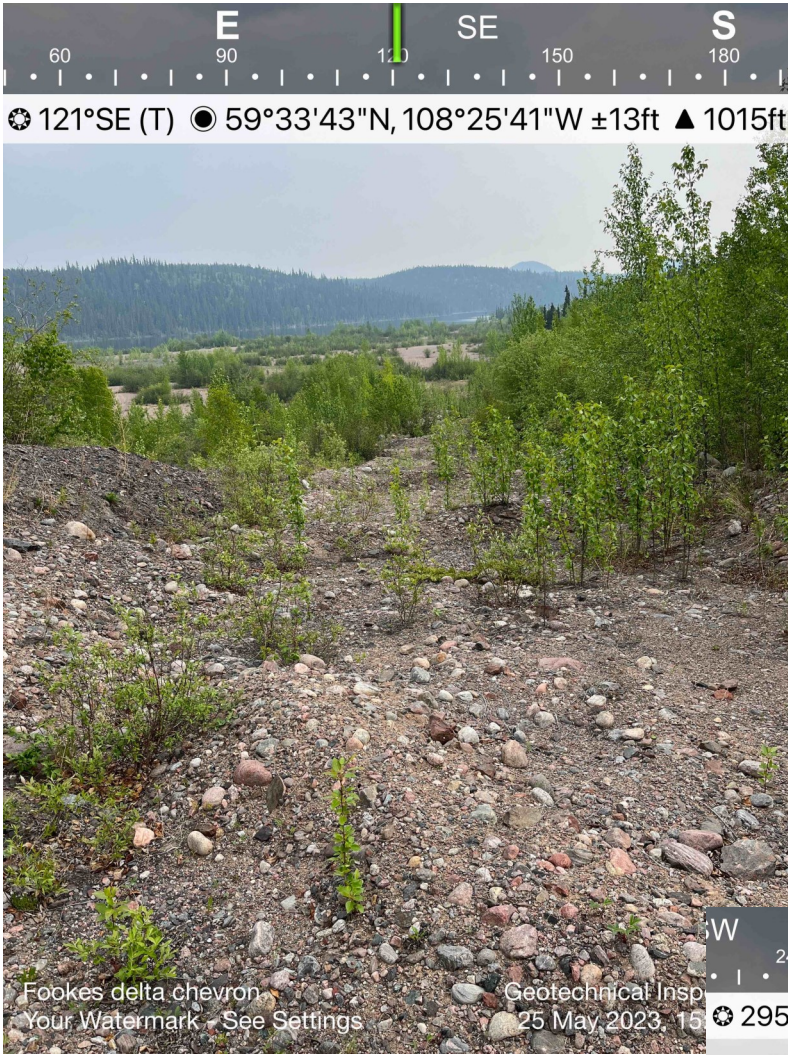
As part of the design and installation of the covers in 2005 and 2007, the area considered most vulnerable to erosion was in the area on and below the access ramp at the northwest corner of the delta (SRK, 2010). The general condition of the ramp is very good. Access to this ramp is closed off by a windrow of material at the top of the ramp, except for the small access trail to allow the remediation of the piezometer standpipes. The water bars (chevrons, **Figure 3**) are performing as expected and continue to show little sign of erosion (**Appendix C, Photo C1**).

Photo C1 – Chevrons in place on north access point to the Fookes delta looking south (May 2023)

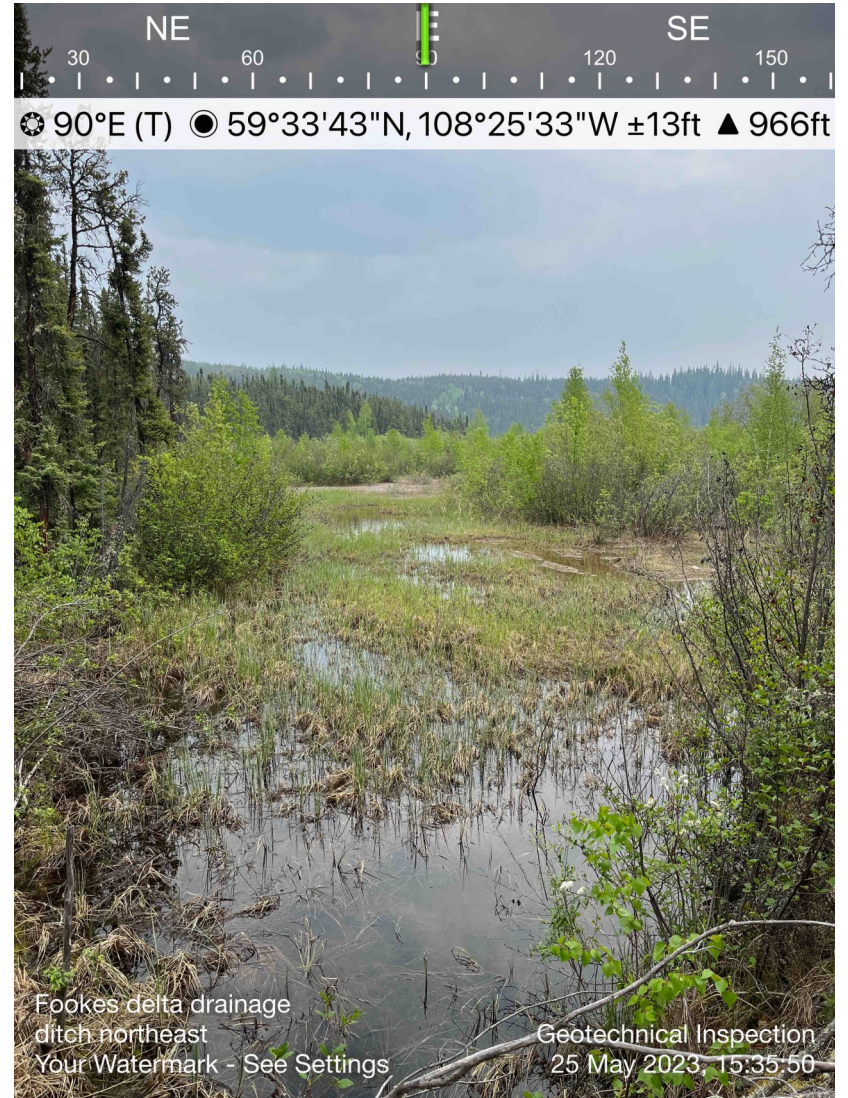
Photo C4 – Drainage collection area on edge of Fookes Tailings Delta approximately 100m from access point

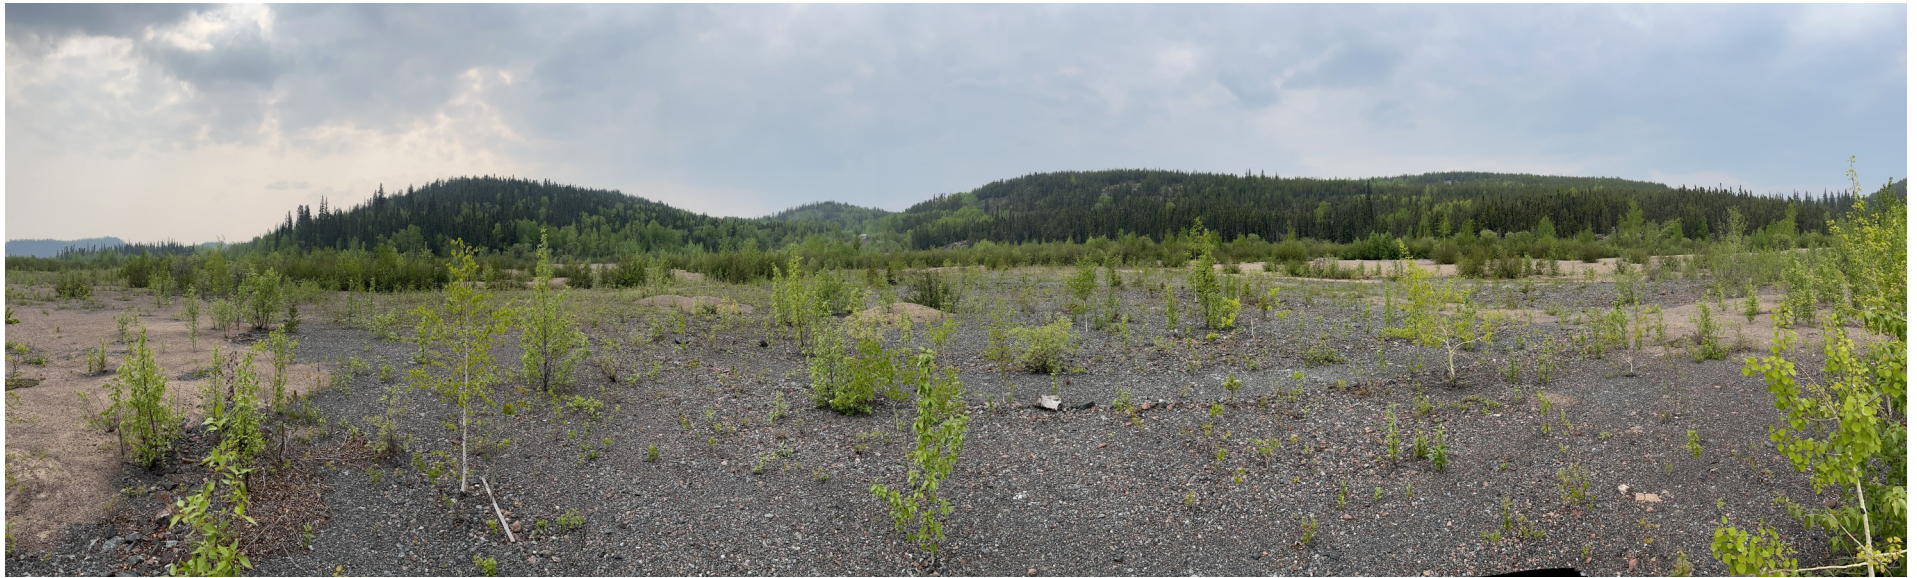
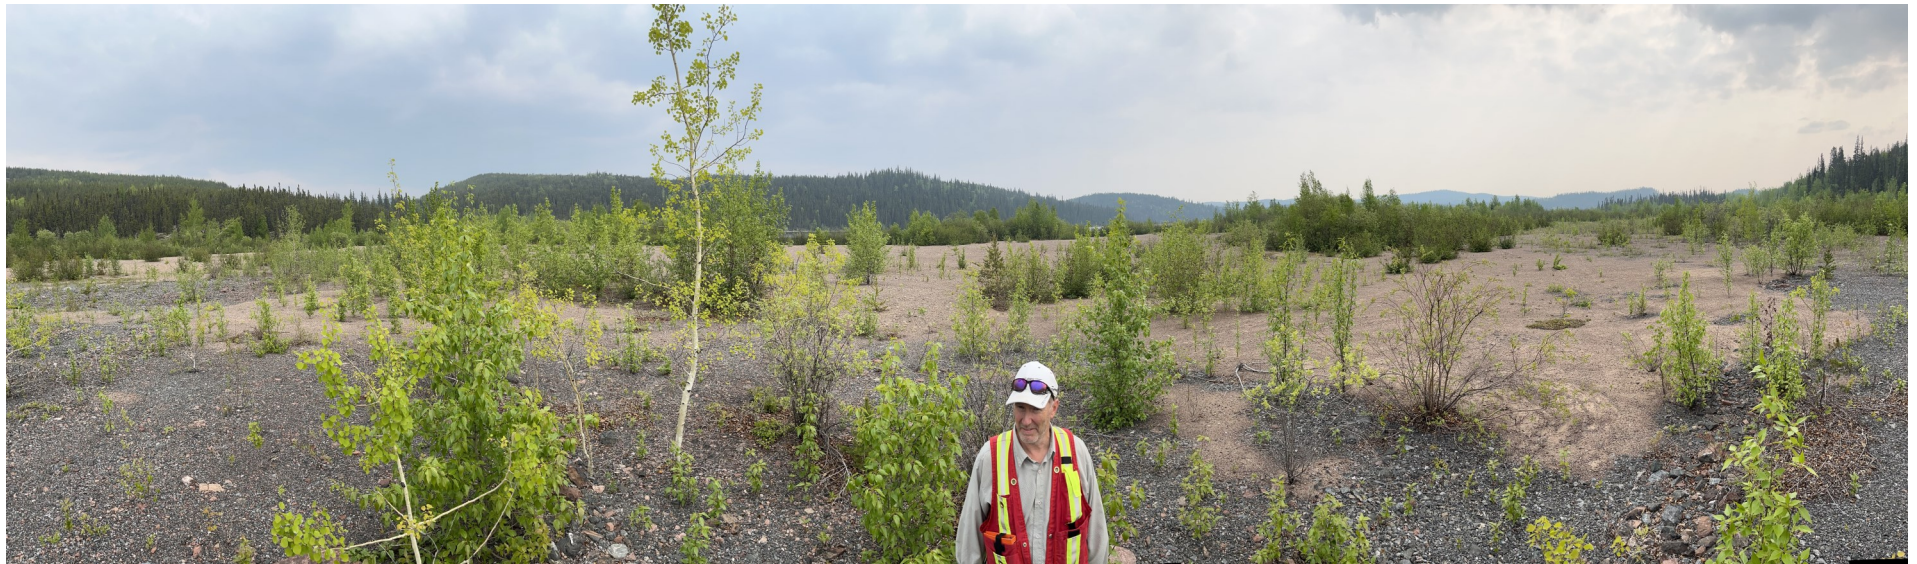
Photo C5a-b – Panoramic views of the Fookes cover (Photos taken May 2023) vegetations is yet to leaf-out

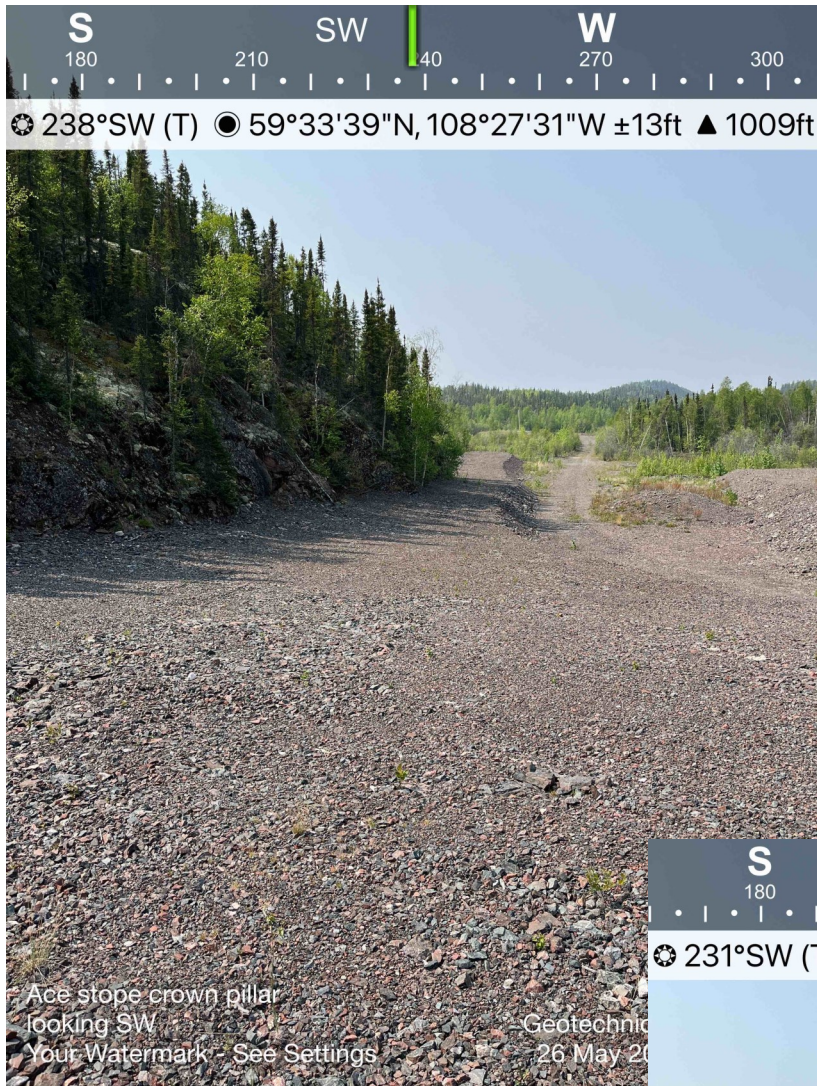
At the Ace area, the cover material over the stopes was inspected by walking the toe of the cover material, as well as the interface between the cover material and natural ground. No signs of tensions cracks or visible depressions were observed along the Ace stope cover material in 2023.

Photo D1 - View of the cover placed over Ace 201 Stope
