Beaverlodge Project 2023 Annual Report Year 38 Transition Phase Monitoring

Prepared for:
Canadian Nuclear Safety Commission
Compliance Report for Licence: WFOL-W5-2120.0/2025
& Saskatchewan Ministry of Environment
Compliance Report: Beaverlodge Surface Lease

Prepared and Submitted by:
Cameco Corporation

March 2024

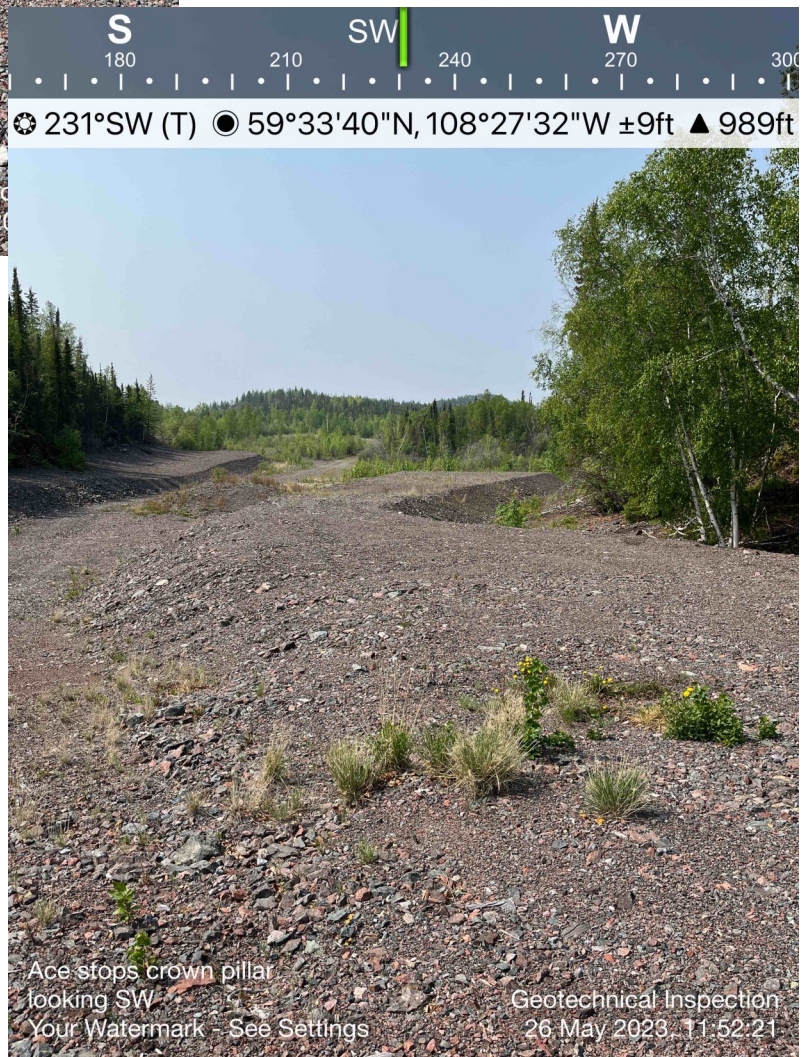
At the Ace area, the cover material over the stopes was inspected by walking the toe of the cover material, as well as the interface between the cover material and natural ground. No signs of tensions cracks or visible depressions were observed along the Ace stope cover material in 2023.

Photo D2 - view of Ace 105 and 208 Stope cover

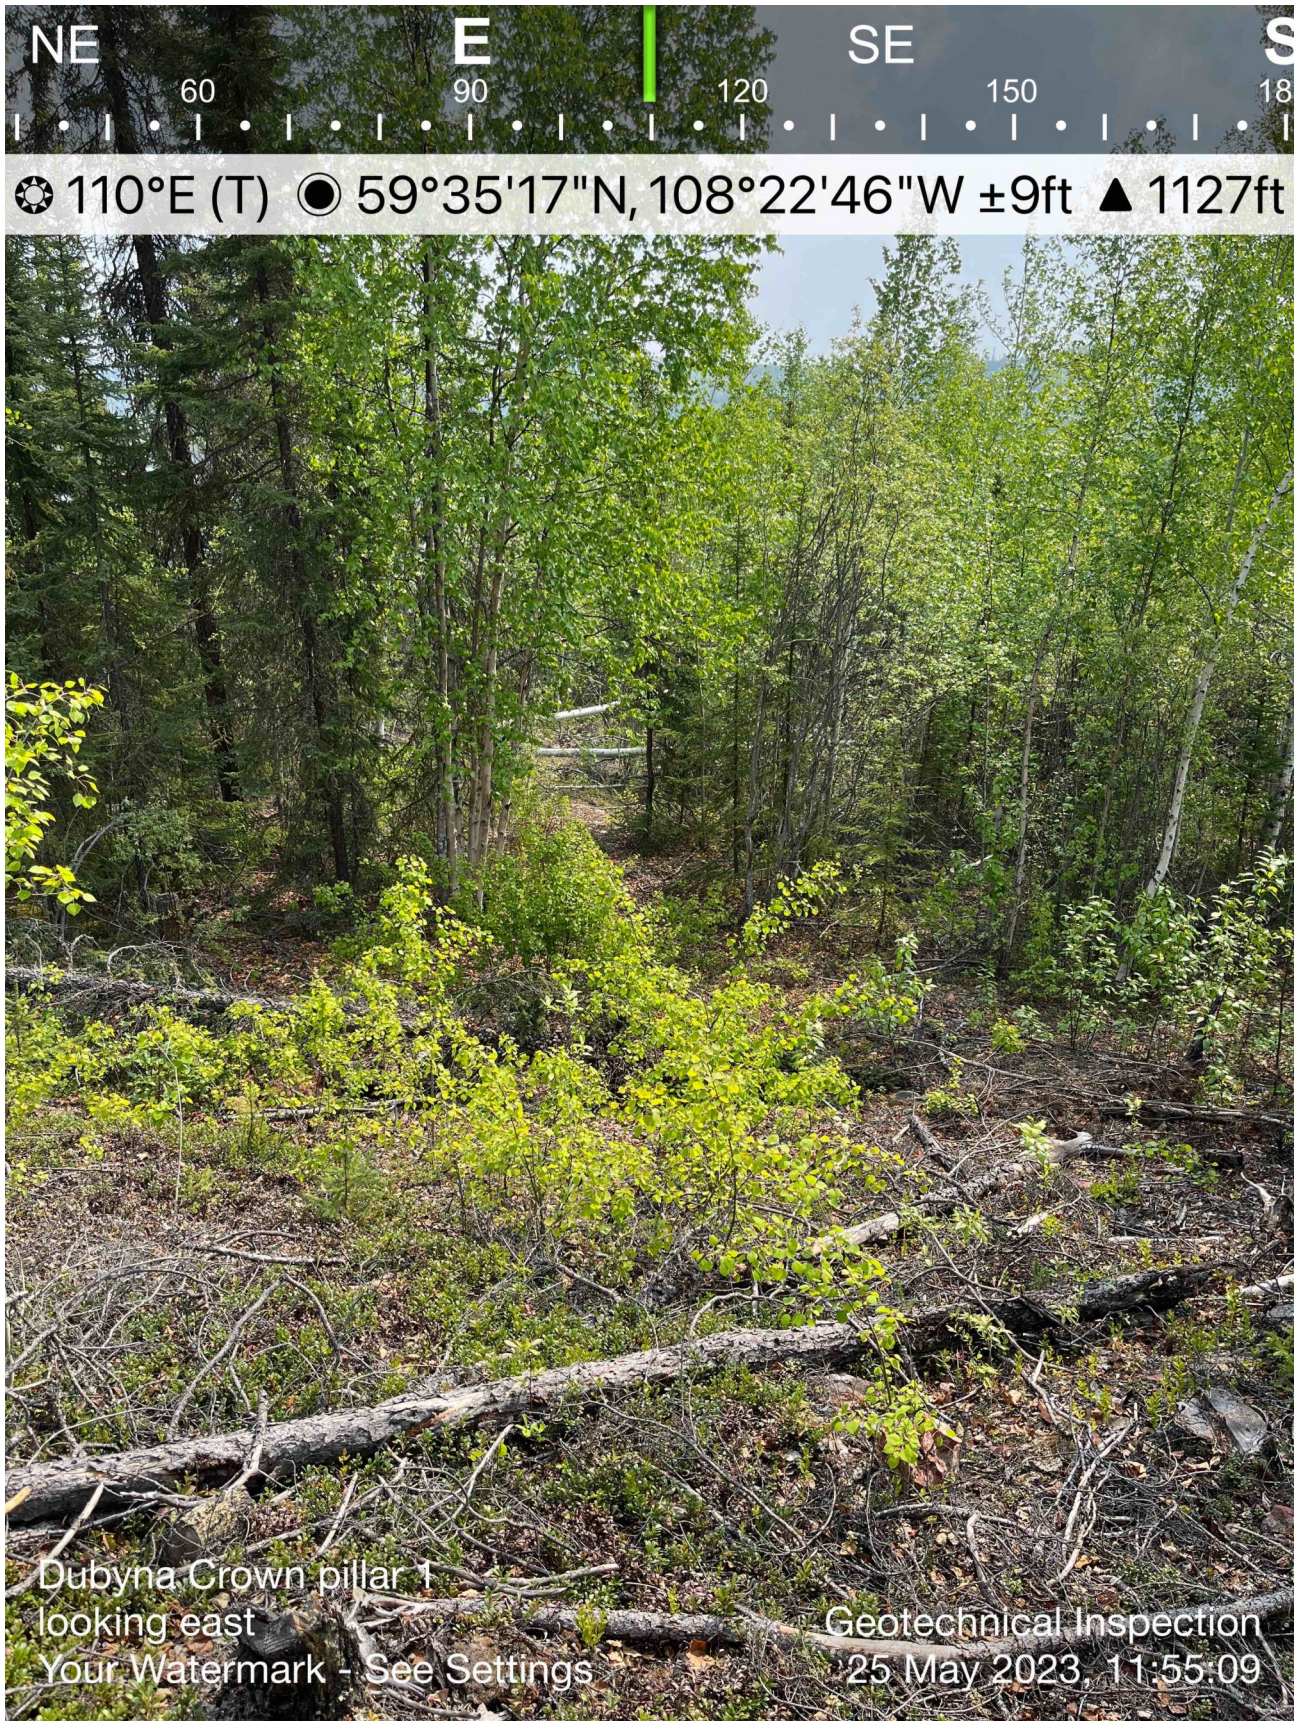
Photo D3—Dubyna CP-1 location (looking east)

The crown pillar monitoring points at Hab and Dubyna were located, and a visual walking inspection was completed at each site. The inspection involved walking between and around the points identified in **Tables 1** and **2**. Observations at both areas did not show any evidence of tension cracks or slumping in 2023.

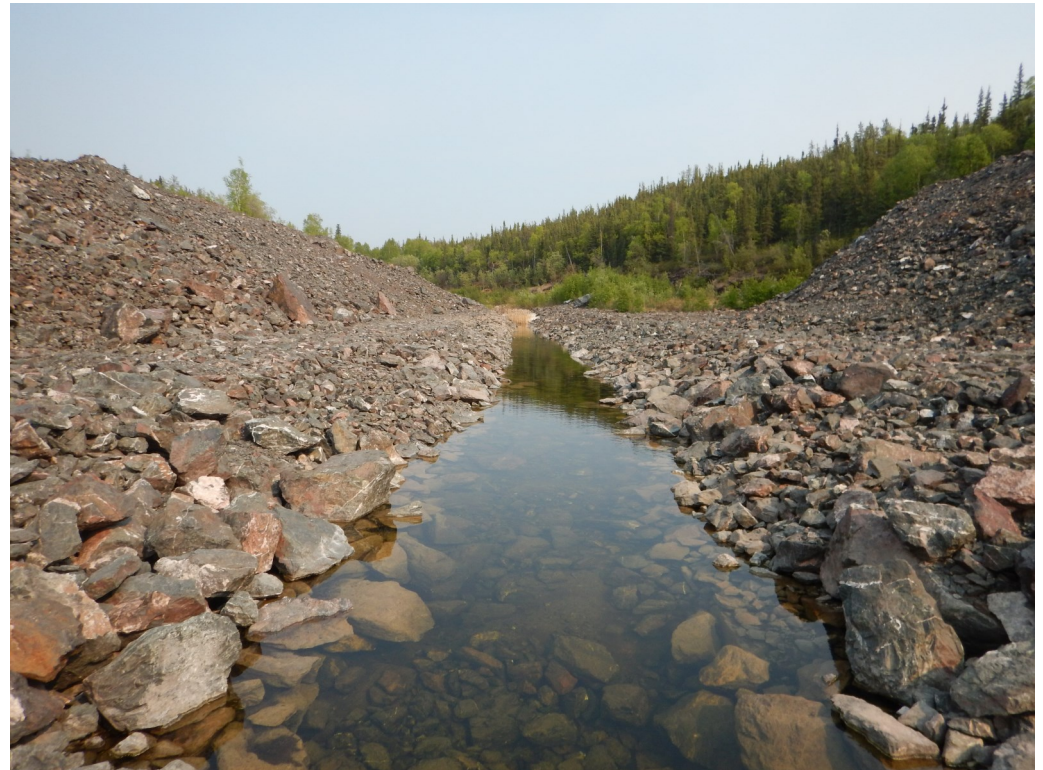
Photo E02—View from level crossing looking upstream towards Zora Lake (May 2023)
