Beaverlodge Institutional Control Inspection Field Guide

Ministry of Energy and Resources Government of Saskatchewan

Cameco Corporation

Issued Date: March 2024

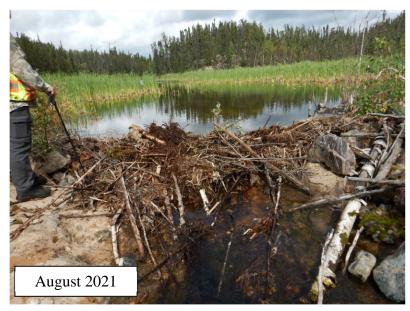
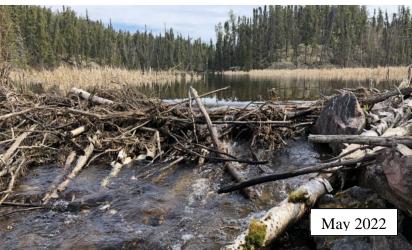
Beaver dam constuction at the outlet structure for Marie Reservoir

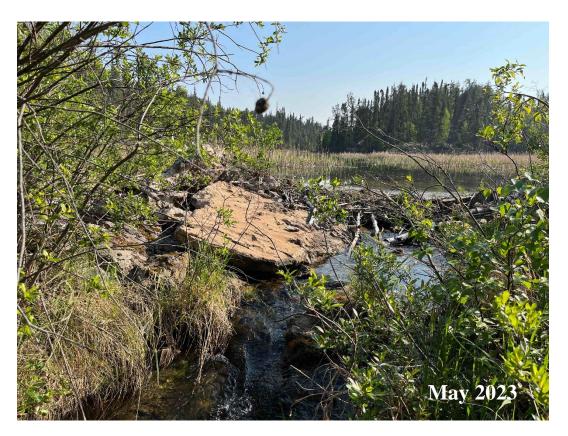
Marie Reservoir Outlet Structure

Ice jacked block of grout intruded rip-rap

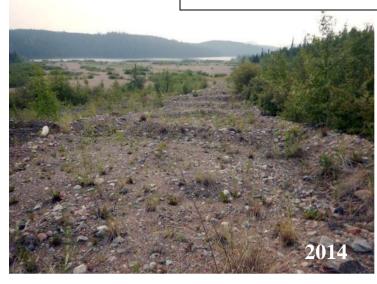
Chevrons in place on north access point to the Fookes Delta

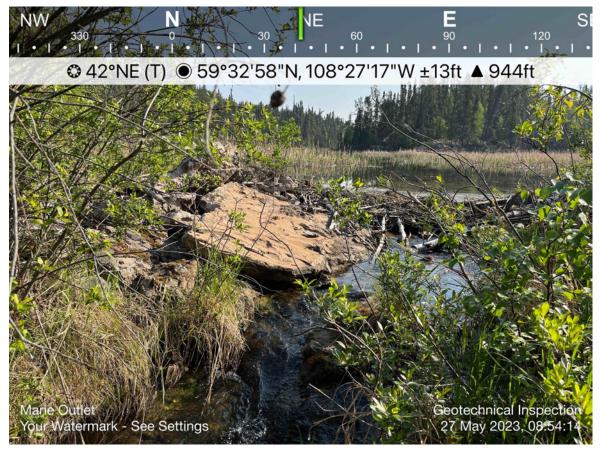
Photo A1 – Marie Reservoir Spillway looking upstream (May 2023)

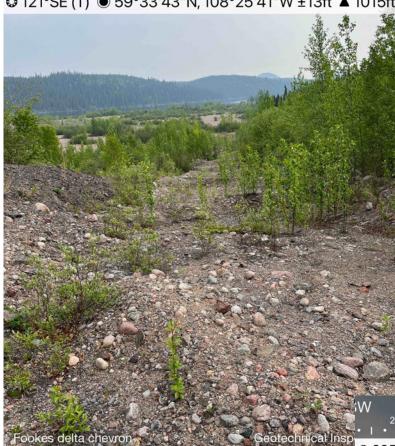
Photo C1 – Chevrons in place on north access point to the Fookes delta looking south (May 2023)

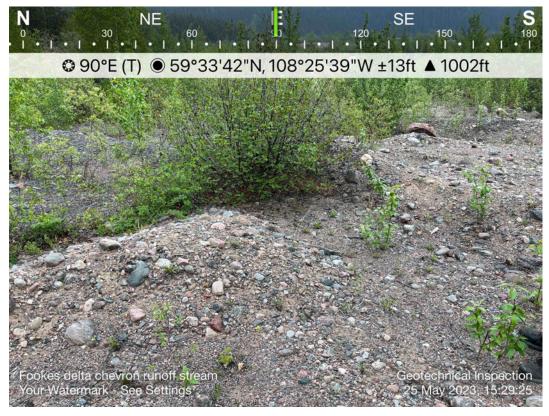
Photo C3 - Chevron run-out structure along north access road

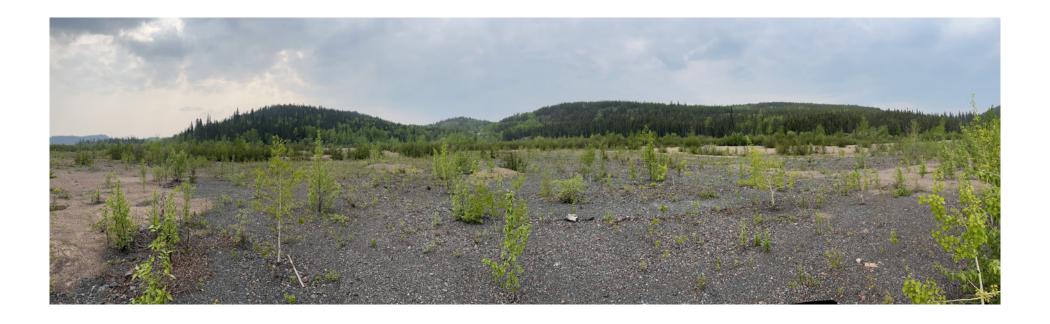
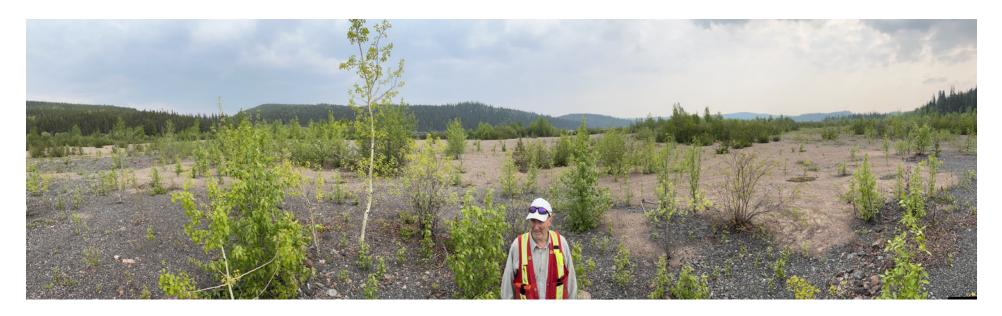
The Fookes Delta cover is in good condition and showed no sign of excessive erosion. As vegetation continues to establish on the shoreline, it will increase the stability of the cover.

Photo C5a-b – Panoramic views of the Fookes cover (Photos taken May 2023) vegetations is yet to leaf-out

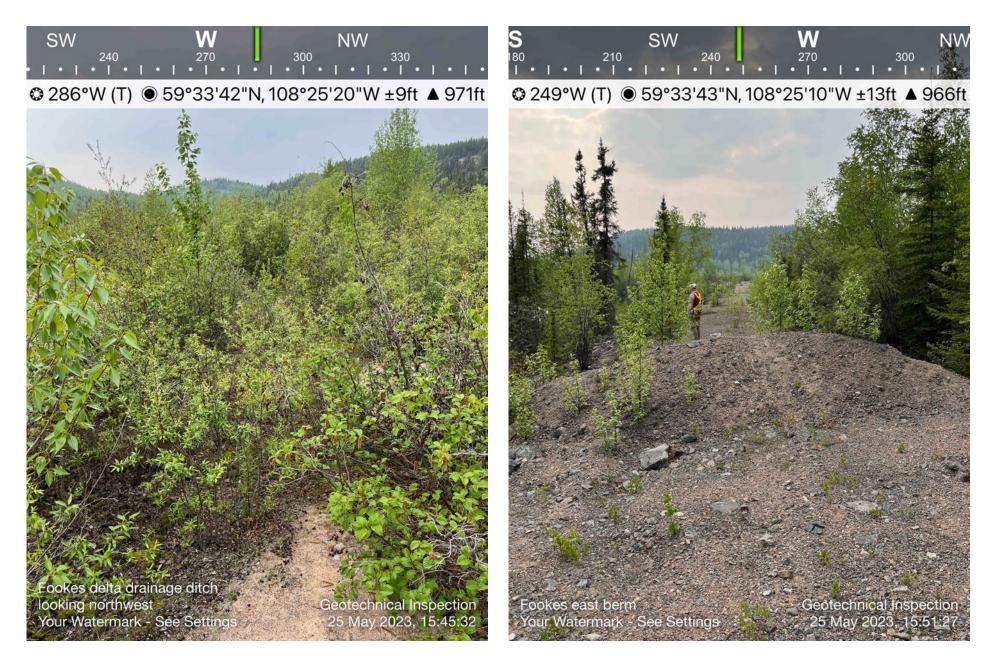
Photo C6 – View of vegetation establishing along drainage channel (May 2023).

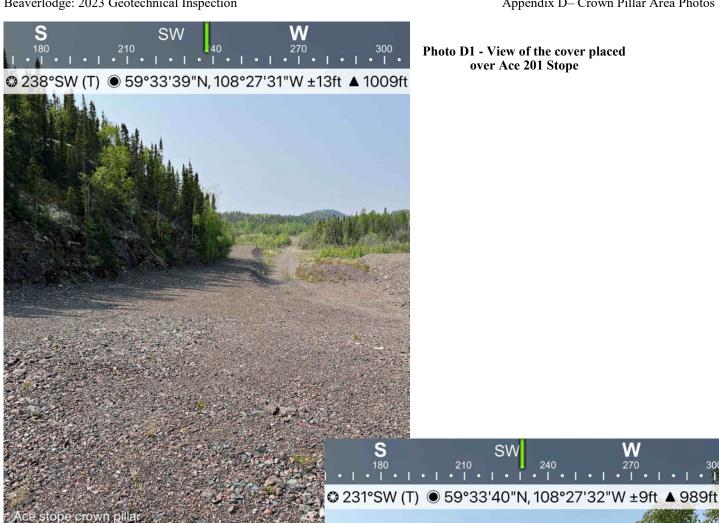
At the Ace area, the cover material over the stopes was inspected by walking the toe of the cover material, as well as the interface between the cover material and natural ground. No signs of tensions cracks or visible depressions were observed along the Ace stope cover material in 2023.

Photo D1 - View of the cover placed over Ace 201 Stope

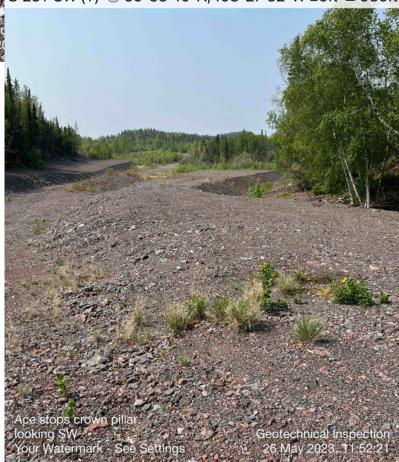
Photo D2 - view of Ace 105 and 208 Stope cover

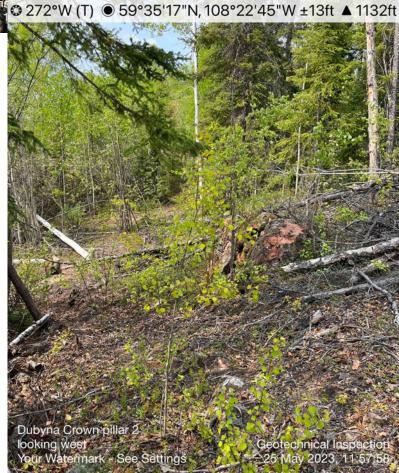
Photo D5—Dubyna CP-2 location (looking west)

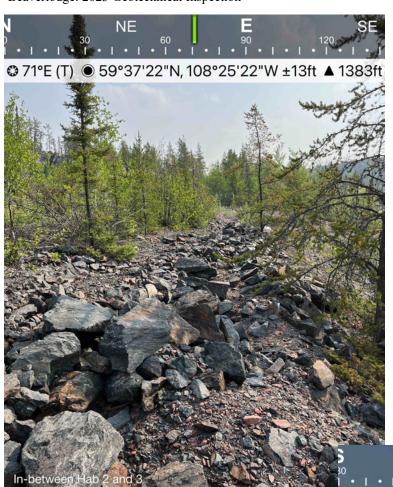
Photo D10—HAB039-02 location (looking east)

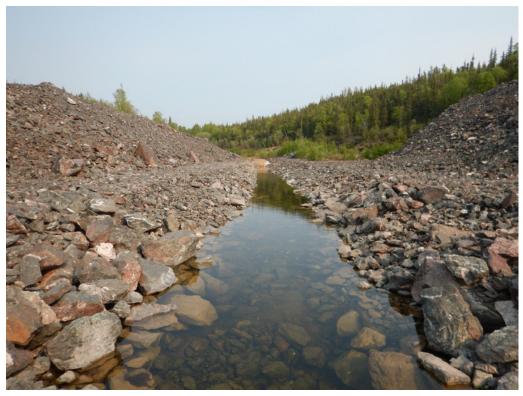
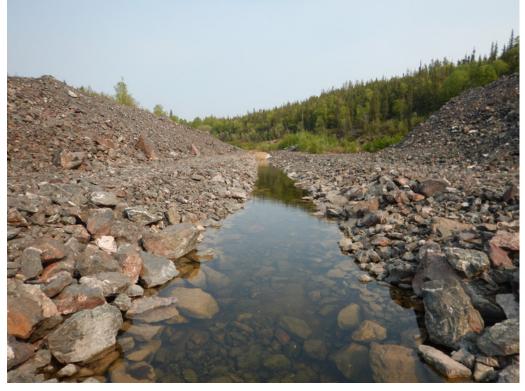
Photo E02—View from level crossing looking upstream towards Zora Lake (May 2023)

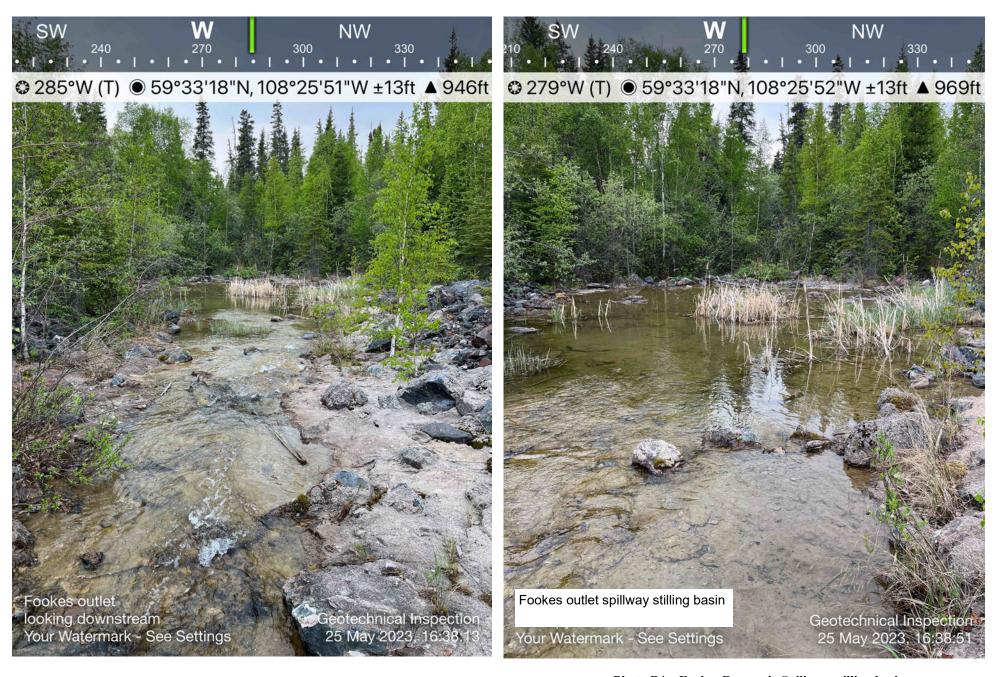
Photo B2 – Fookes Reservoir Spillway looking upstream

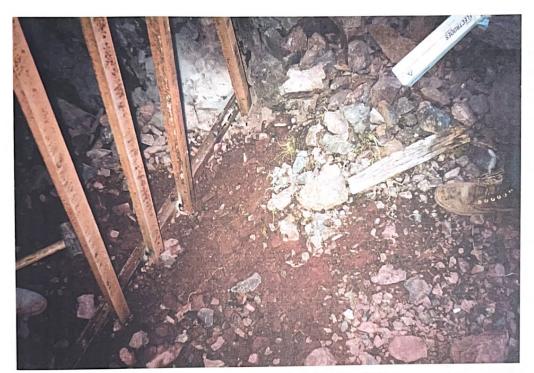
Photograph 3: Debris removed approximately 2 ft. to rock and backfilled on completion at bottom end.

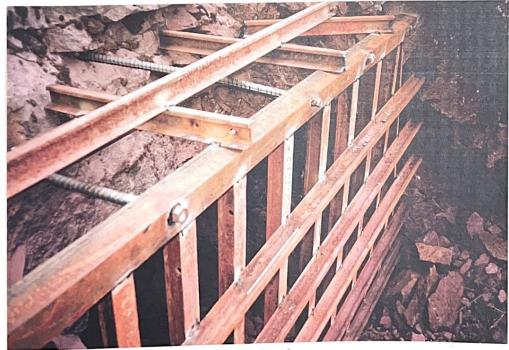
Photograph 4: Structure rock bolted and welded in place.

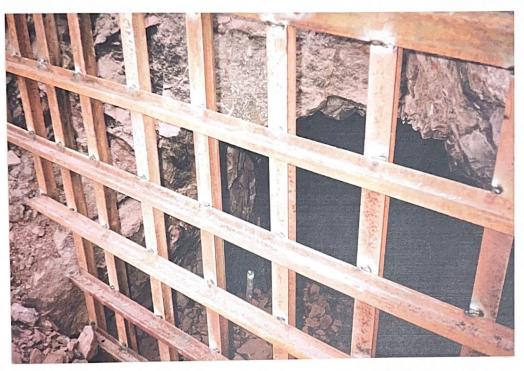
Photograph 5: View of welds at all cross members.

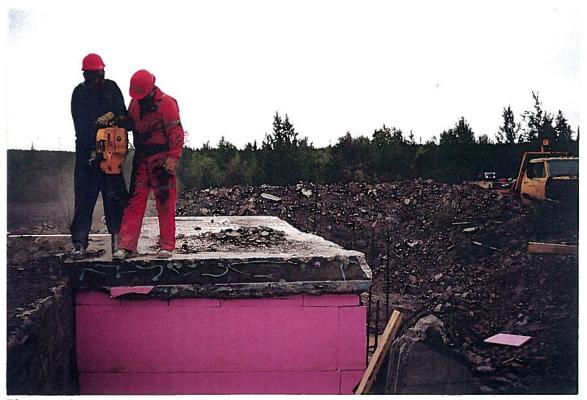
Photograph 2: Demolition of the existing ridge cap.

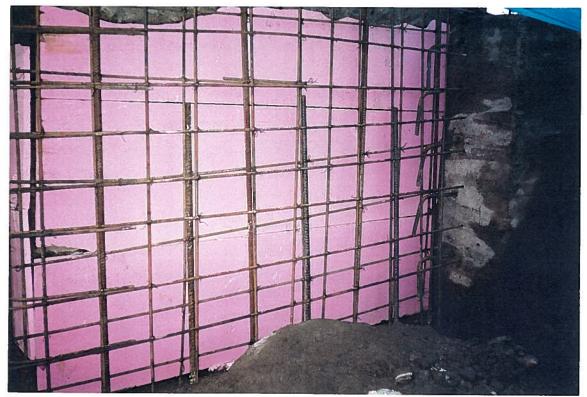
Photograph 3: Form break and rebar on the walls. Note: the rebar detail was revised to tie into existing wall.

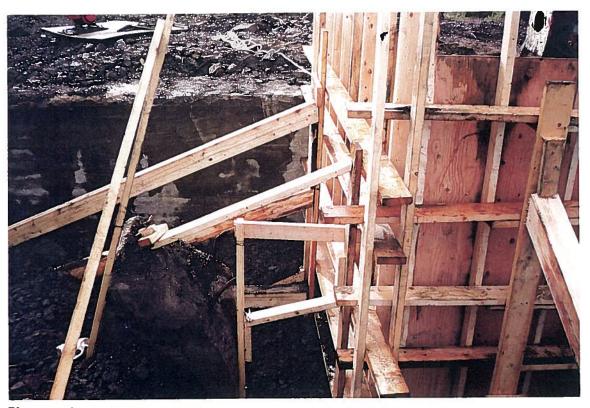
Photograph 4: Form work and false work on the walls.

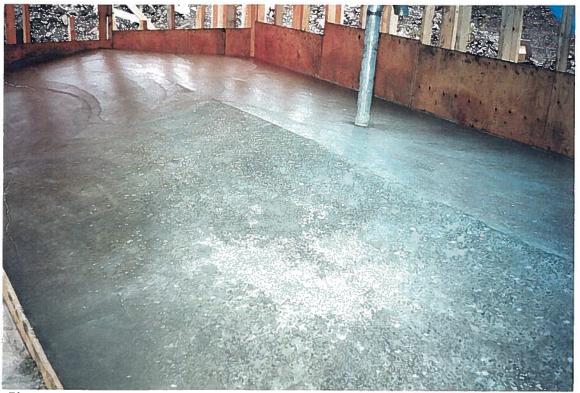
Photograph 6: Roof slab after the steel trowel finish.

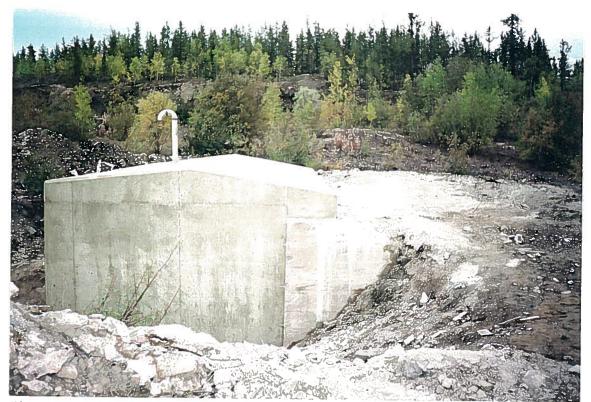
Photograph 7: Completed structure after the forms were removed.

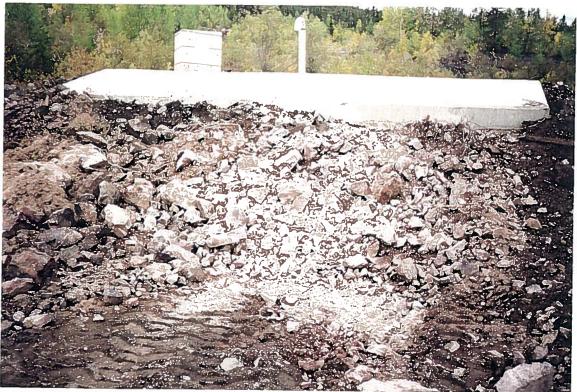
Photograph 8: Completed structure after placement of fill.

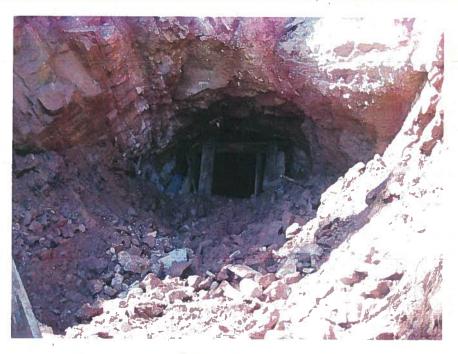
Figure 3 – Exposed Adit

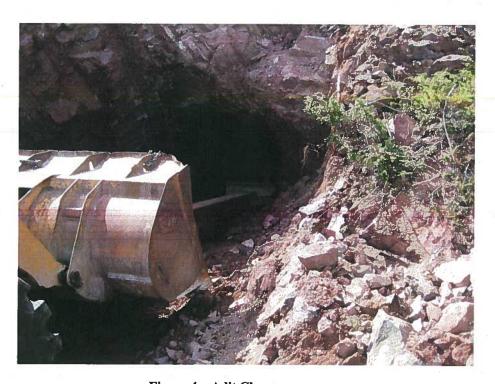
Figure 4 – Adit Closure

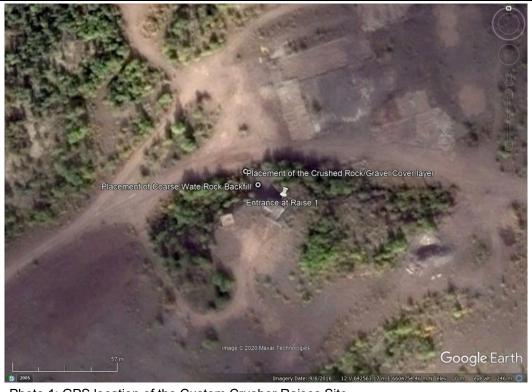
Photo 1: GPS location of the Custom Crusher Raises Site.

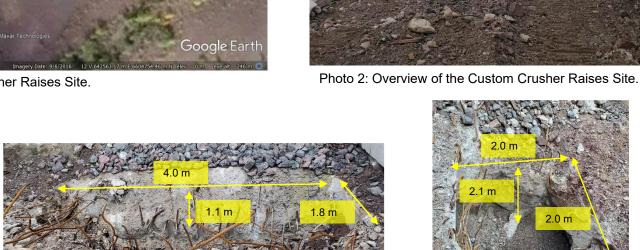
Photo 4: Close-up of Raise 2 that was excavated.

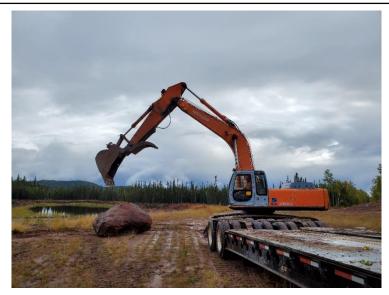
Photo 6: Location of the boulder for Raise 3, from an area approximately 9.0 km southwest of Uranium City.

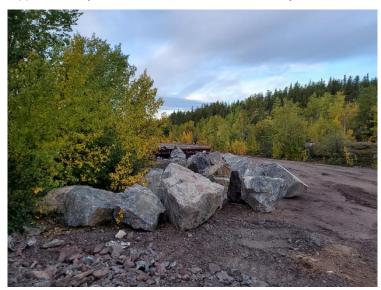
Photo 8: Boulders sourced by UCC and inspected by the SRK field engineer.

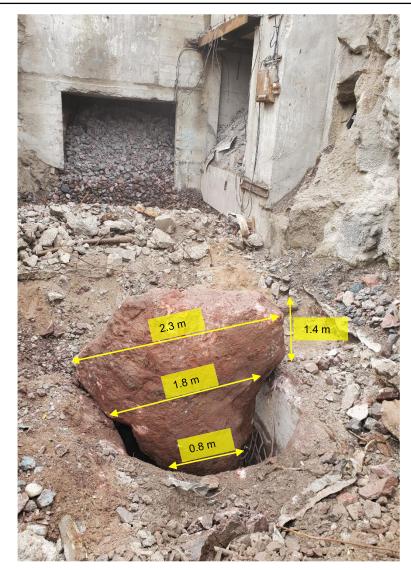
Photo 7: Dimensions of the pyramid-shaped boulder placed within Raise 3.

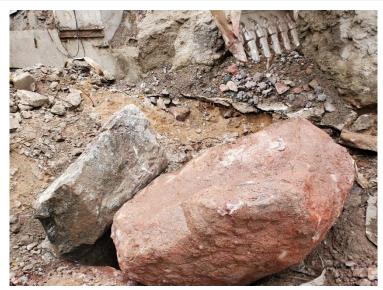
Photo 9: Rock Number 2 contributing to the wedging effect at Raise 3.

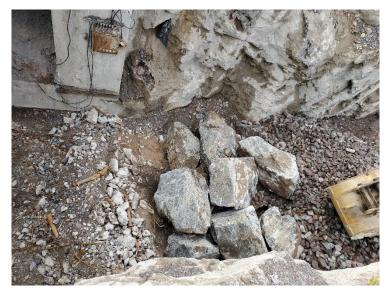
Photo 10: Top view of the 15 boulders placed at Raise 3.

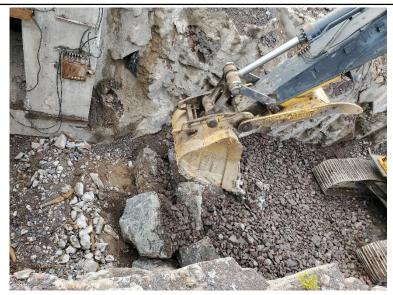
Photo 12: Placement of coarse waste rock over the boulders at Raise 3 to safely access Raise 2.

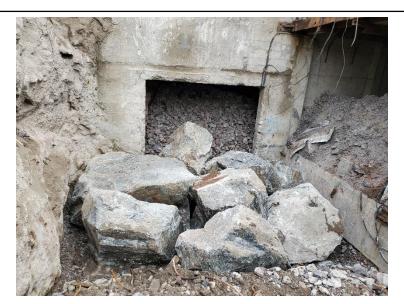
Photo 14: Total of 11 boulders placed for the permanent closure of Raise 2.

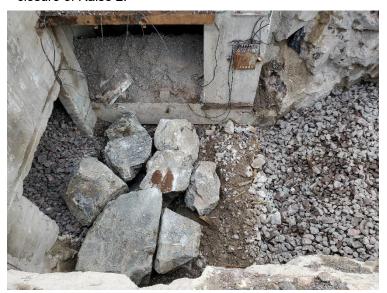
Photo 15: Top view of the 11 boulders placed at Raise 2.

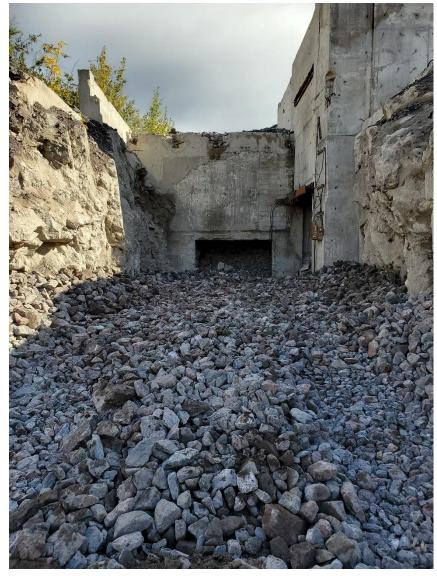
Photo 16: Placement of coarse waste rock over Raise 3 and 2, up to the entrance at Raise 1.

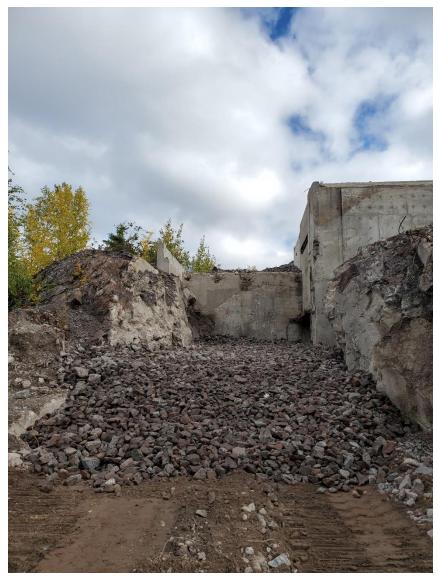
Photo 17: Additional placement of coarse waste rock over Raise 3 and 2, up to the entrance at Raise 1.

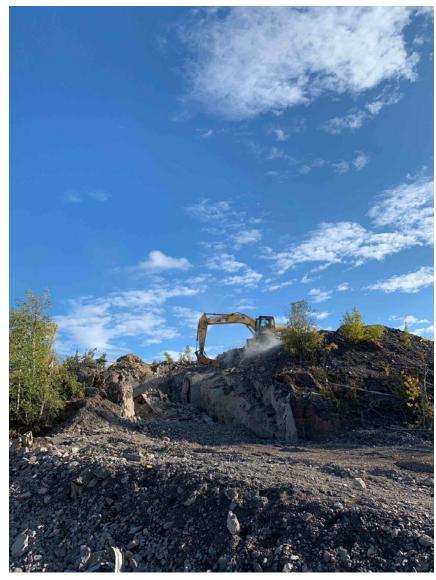
Photo 18: Demolition of the concrete dump chute.

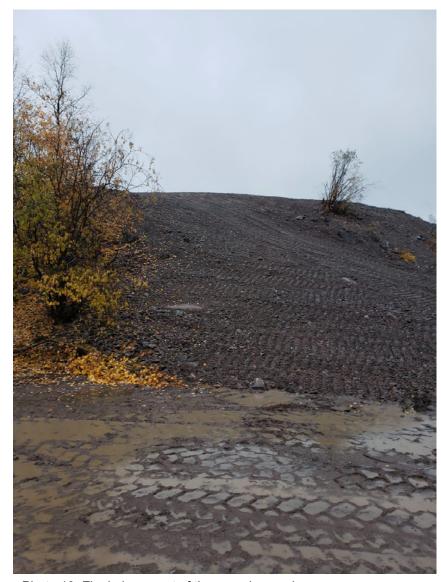
Photo 19: Final placement of the gravel cover layer.

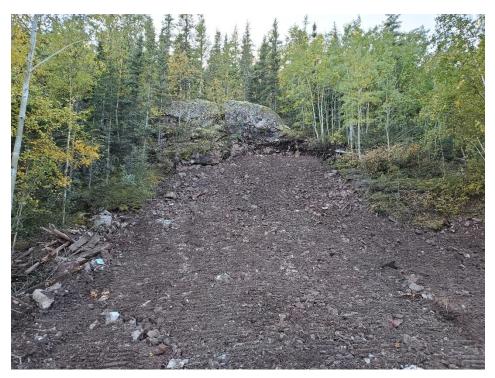
Photo 5: Final Placement of Backfill material along the Fishhook Bay Adit.

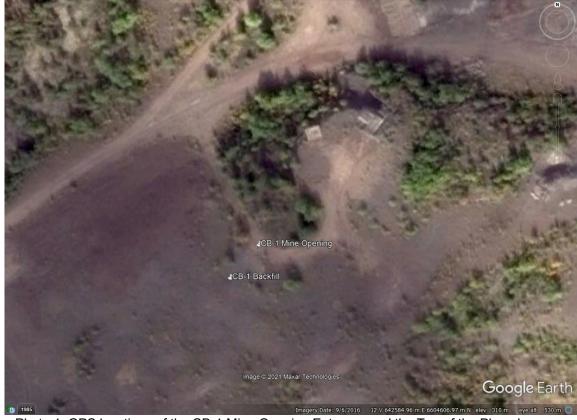
Photo 1: GPS locations of the CB-1 Mine Opening Entrance and the Toe of the Placed Backfill Material.

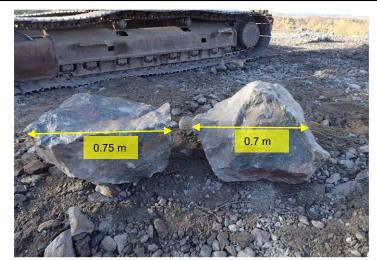
Photo 5: Boulder 3 (0.75 m x 0.6 m x 0.6 m) and Boulder 4 (0.7 m x 0.6 m x 0.45 m)

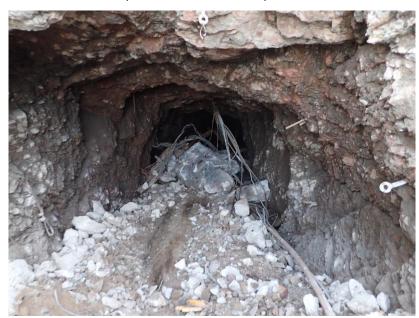
Photo 6: Four boulders placed within the mine opening. Cables were present on the left-hand side (that could not be removed. The cables in no way impacts the integrity of this closure design.

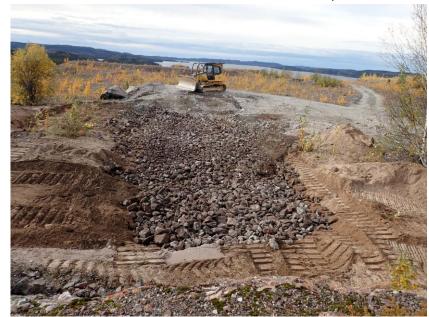
Photo 11: Looking southwest - Placement of sorted waste rock to level (competent rock passing approximately 200 mm).

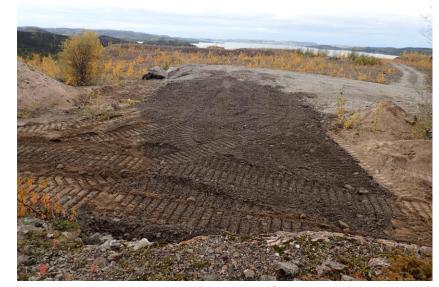
Photo 12: Looking southwest - Placement of waste rock (various sizes).

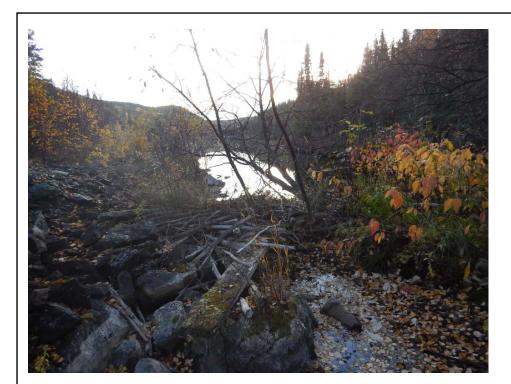
Photo 2: Looking East at Beaver Dam in Channel Inlet

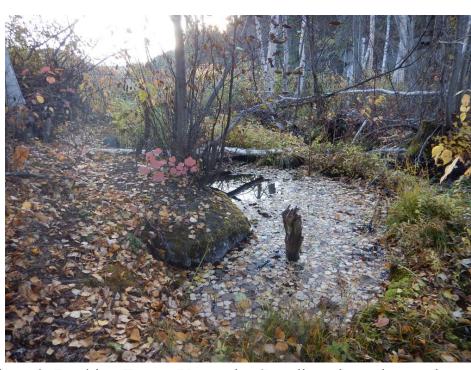
Photo 3: Looking East at Vegetation/Ponding along the south flank of Channel Inlet

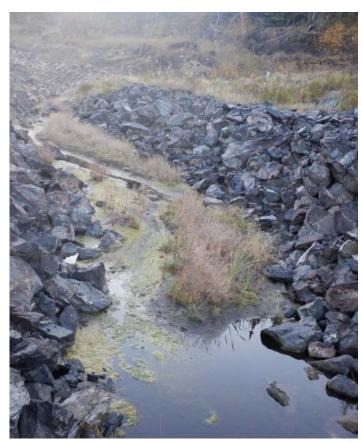
Photo 5: Looking East at Vegetation Growth in Channel Base at approximately Station 0+100

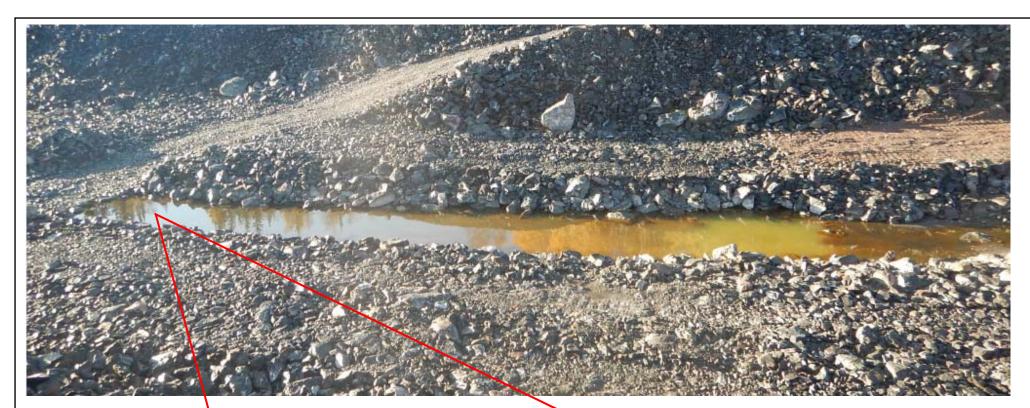
Station 0+215 is immediately downstream of the channel crossing where channel flow appeared to be stagnant up until approximately Station 0+240 (Photo 8, Figure 6). This area was observed to have sediment that was approximately 1.5 m deep, which unlike Station 0+090 was easily resuspended when the surface is agitated. As identified in the as-built (SRK 2017), this is primarily lake bottom sediments as this portion of the channel was founded on the western extent of the historical Down Lake. Photos 9 and 10 on Figure 4 show before and after sediment resuspension, respectively. There are no geotechnical related concerns with the sediment; however, should it become resuspended due to scour, transportation of sediments downstream is likely to occur.

Photo 8: Looking South and downstream of Channel Crossing

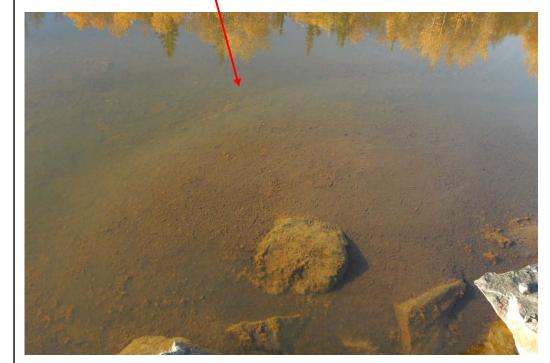
Photo 9: Looking South at Channel Base Sedimentation (Station 0+215)

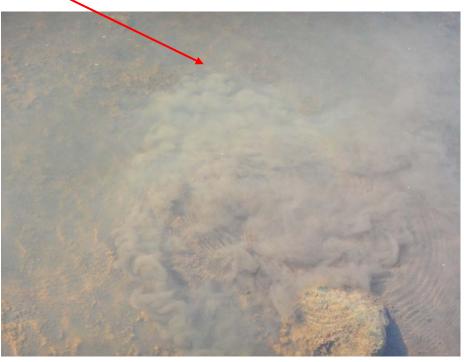
Photo 10: Looking South at Channel Base Sedimentation after resuspension (Station 0+215)

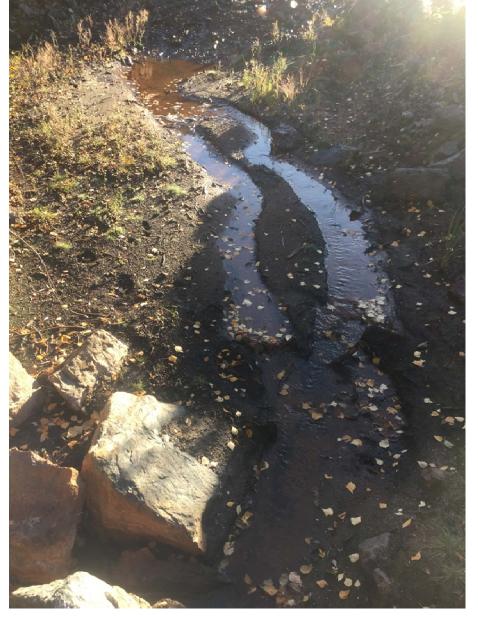
The channel outlet was observed to have sparse vegetation and heavy sedimentation (Photo 11, Figure 6). At the time of the inspection, discharge was observed to be clear and flowing at a rate considered a trickle due to the low flow conditions in late September 2017.

Photo 11: Looking West at Channel Outlet

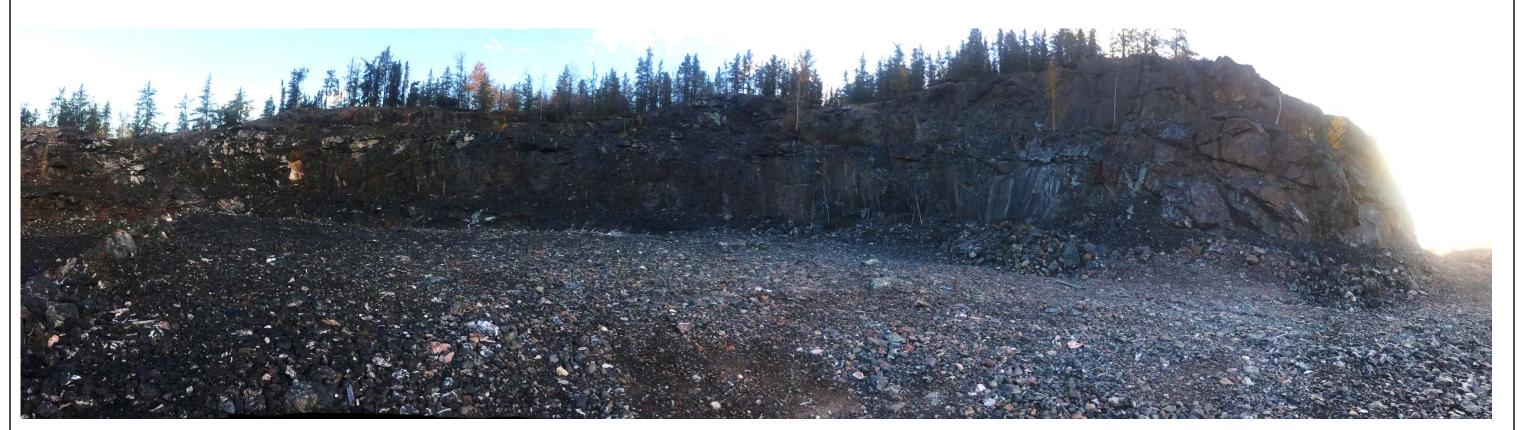
The Bolger Pit, which was further backfilled with waste rock as part of the channel reconstruction was inspected and there were no geotechnical concerns (Photos 12 and 13, Figure 7).

Photo 12: Looking at Northeast flank of Bolger Pit

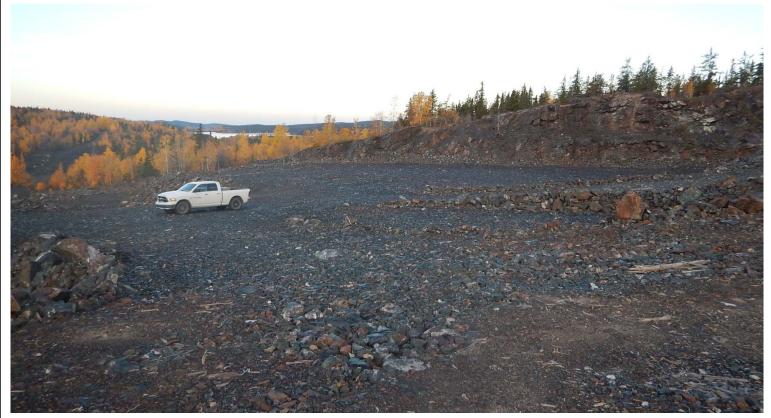
Photo 13: Looking Southwest from Northeast flank of Bolger Pit

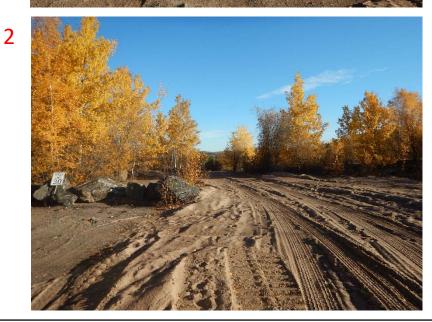
- 1. Road blockage using large boulders
- 2. Speed limit signage

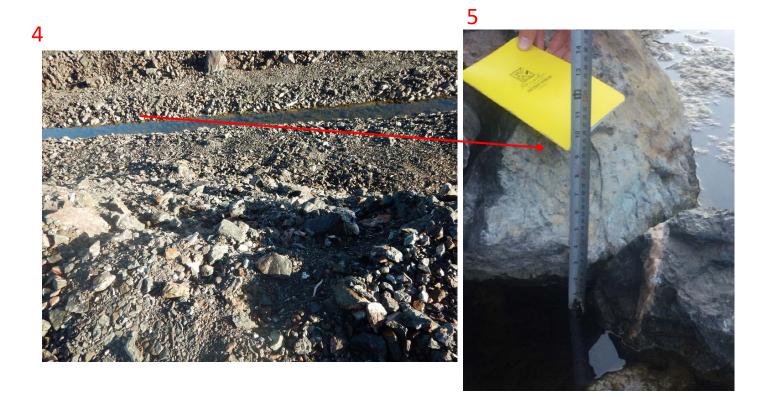
- Channel side slopes along base of channel
- High Water Mark

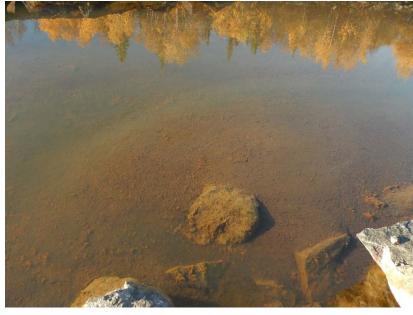
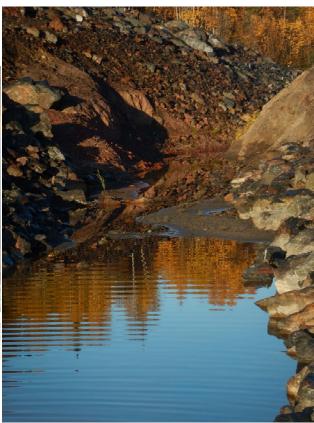
7

- 7. Downstream sedimentation at Station 0+215
- 8. Sedimentation extends towards downstream exposed bedrock

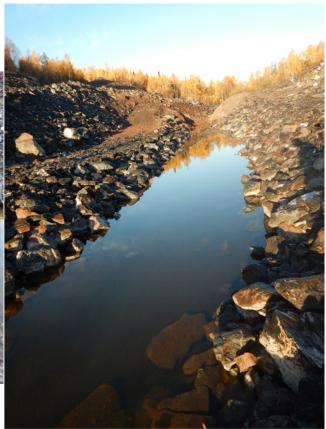
10

- 9. Upstream channel base with partial riprap blockage due to sediment build up (Station 0+145)
- 10. Downstream channel base (Station 0+150 to 0+210), no concerns

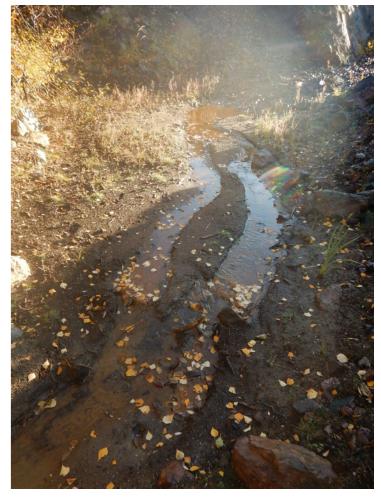
- 13. Outlet Sedimentation
- 14. Fow at V-Notch Weir
