Beaverlodge Project 2023 Annual Report

Year 38 Transition Phase Monitoring

> Prepared and Submitted by: Cameco Corporation

> > March 2024

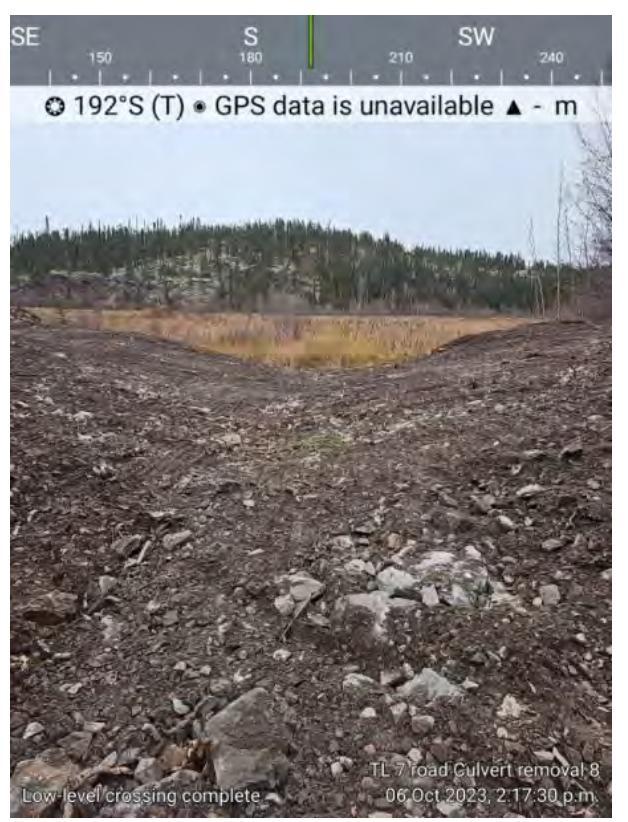
Photo 1 - Low level crossing at Meadow Fen

On September 22, 2023, Cameco requested approval to facilitate the removal of the culvert on the road to Meadow Fen outlet. The CNSC approval of the project on September 22, 2023 and SkMOE provided their approval of this activity on September 26, 2023. The culvert was removed on October 6, 2023, and the debris disposed of in Lower Fay Pit. Following removal, a level crossing was constructed to allow for water to continue to pass from the north side of the road to the south (see Photo below).

The road material removed was scanned in 2015 and the results were measured at $0.1 - 0.3 \mu$ Sv/h, well below the EPB 381 guideline (Northern Mine Decommissioning and Reclamation Guidelines) of 1 μ Sv/hr. As per the approved plan the material from the south side of the road was incorporated into the level crossing. The material from the north side of the road had no contact with precipitate from the Meadow Fen settling pond that was used during active operation of the tailings management area. The material excavated from the north side of the roadbed was used to build berms to restrict vehicular access to Ace Uplands and Minewater Reservoir. All disturbed areas will be rescanned in 2024 and updated results will be provided to the regulatory agencies.

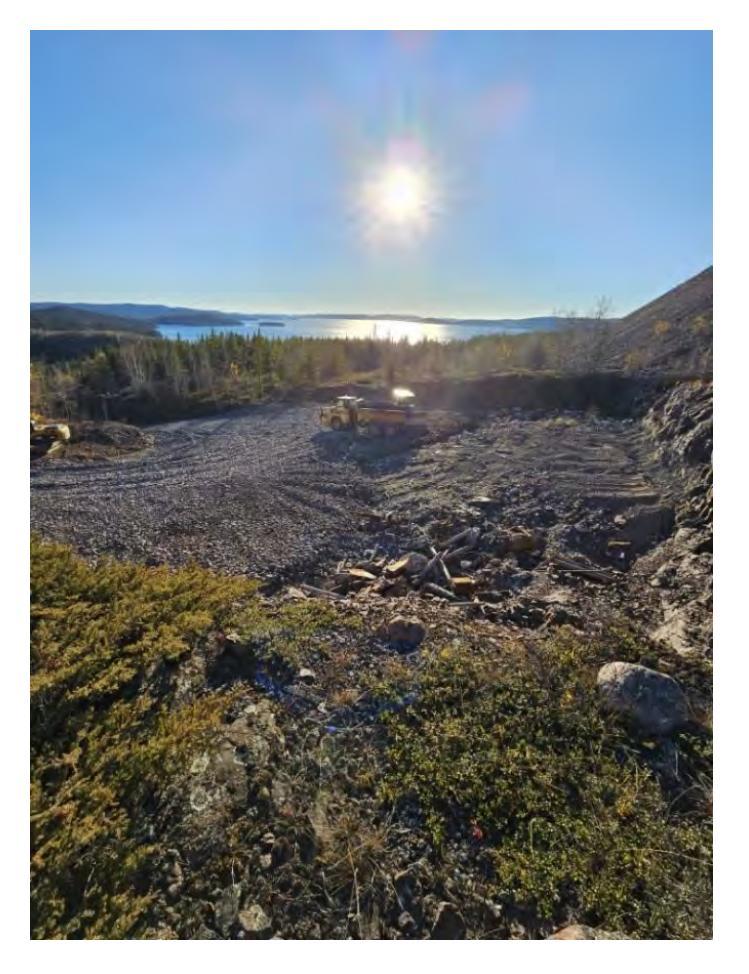
Photo 2- Lower Fay Pit being covered with waste rock

On September 27, 2023, SkMOE provided a letter approving the application of a 0.9m thick cover consisting of a layer of sorted waste rock (SWR) to cover the entire landfill, followed by a layer of clean waste rock.

The closure of the pit was completed in October 2023 (see Photo below). The SWR and clean waste rock was placed onto the compacted debris using load, haul, dump equipment and then spread with the use of a tracked bulldozer and/or backhoe. The driving of equipment on the material further compacted the debris and incorporated the SWR into the matrix of the debris, reducing the risk of settling in the future. Cameco will conduct a gamma scan of Lower Fay Pit and the SWR pile in 2024.

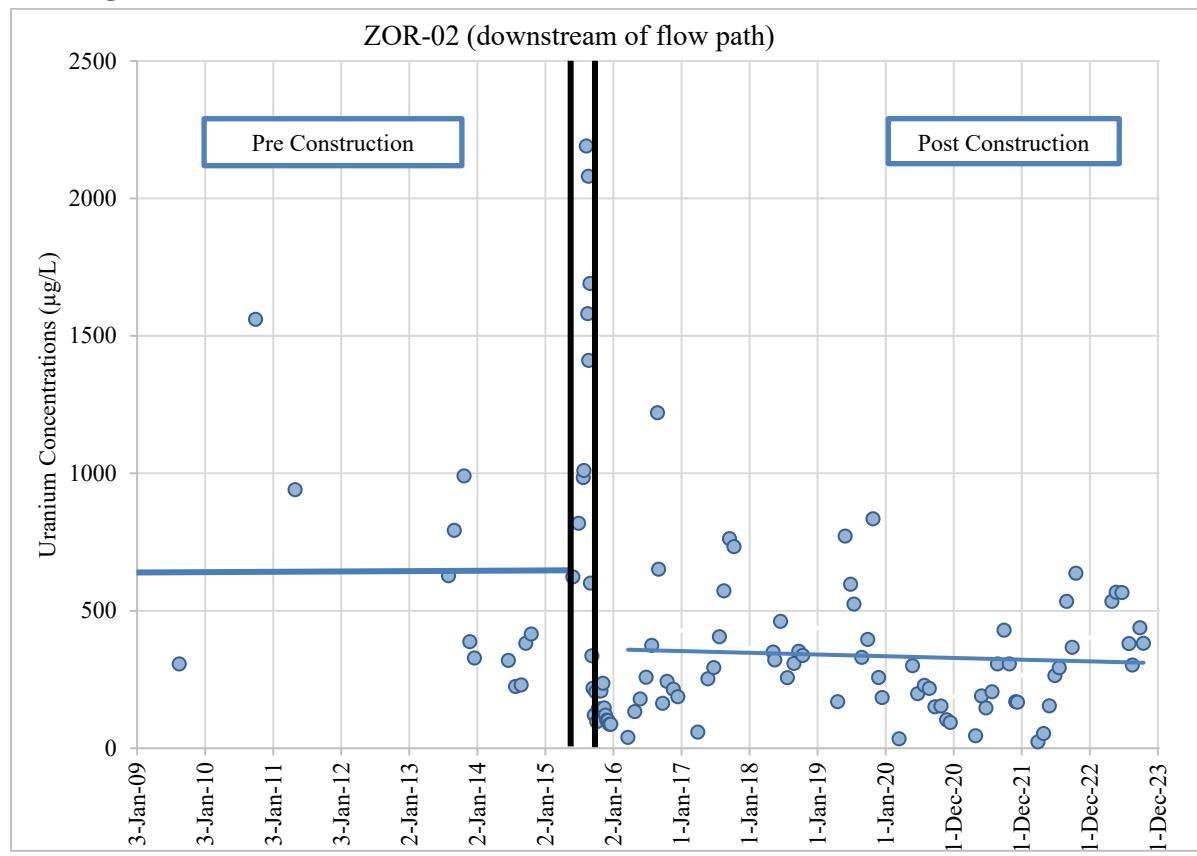
Figure 4.3-9 - ZOR-02 Uranium Concentrations Pre and Post Construction

Figure 4.3-9 shows the results of water sample data collected at ZOR-02 through the various phases of pre-construction, construction and post construction. Also provided are general trend lines showing the relative improvement in water quality post-construction. The Pre-Construction trend line is the overall average U concentration for that period, while the Post-Construction (starting in 2016) is a linear trend line created using the annual U concentration averages.

The fluctuations in U concentrations observed through construction and following construction are reflected in the concentration of U measured at the outlet of Verna Lake (AC-6A) which increased, as expected, immediately following construction but has seen improvement in subsequent years. Uranium concentrations measured at the monitoring station AC-8 located in Ace Lake (immediately downstream) have remained below the SEQG since 2012. A summary of annual mean U and Ra-226 data from 2010 to 2023 at ZOR-02, AC-6A, and AC-8 is presented in **Table 4.3.1-3**. As AC-6A flows into Ace Lake, data from the outlet of Ace Lake (AC-8) is presented for context, as the downstream water quality monitoring station meets SEQG.

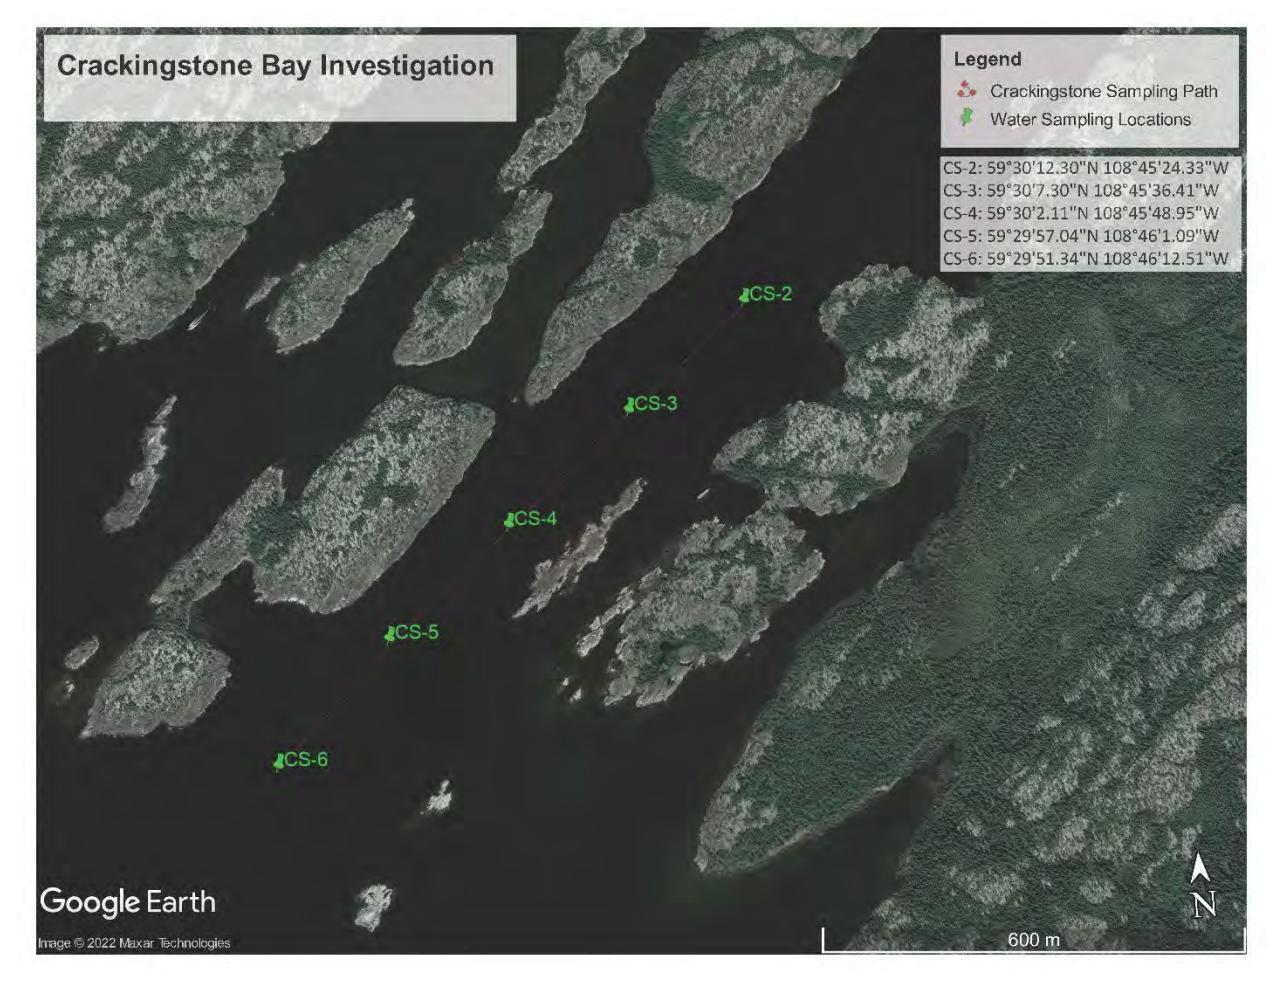
Figure 4.3.10 – Crackingstone Bay sample locations

Samples collected in August 2022 showed a lower U concentration at CS-2 than was observed in June of the same year, and there was a subsequent decrease at stations beyond CS-2. The concentrations recorded from CS-2 to CS-6 were 15 μ g/l, 5.2 μ g/l, 3.1 μ g/l, 3.2 μ g/l and 3.1 μ g/l, respectively. All these values are at or below the SEQG (15 μ g/l).

In August 2023, the same investigation was conducted at CS-2 and stations extending to CS-6, to compare to the study completed in August 2022. Of note is that U concentrations in 2023 were generally lower than measured in 2022 and met SEQG at every station monitored. The concentrations from CS-2 to CS-6 for 2023 were 5.9 μ g/l, 6.1 μ g/l, 5.2 μ g/l, 4.6 μ g/l, and 1.9 μ g/l, respectively. These results may represent a return to a more normal mixing zone regime in Crackingstone Bay. It is expected that once Lake Athabasca returns to normal (or average) lake levels that the water quality will continue to improve.

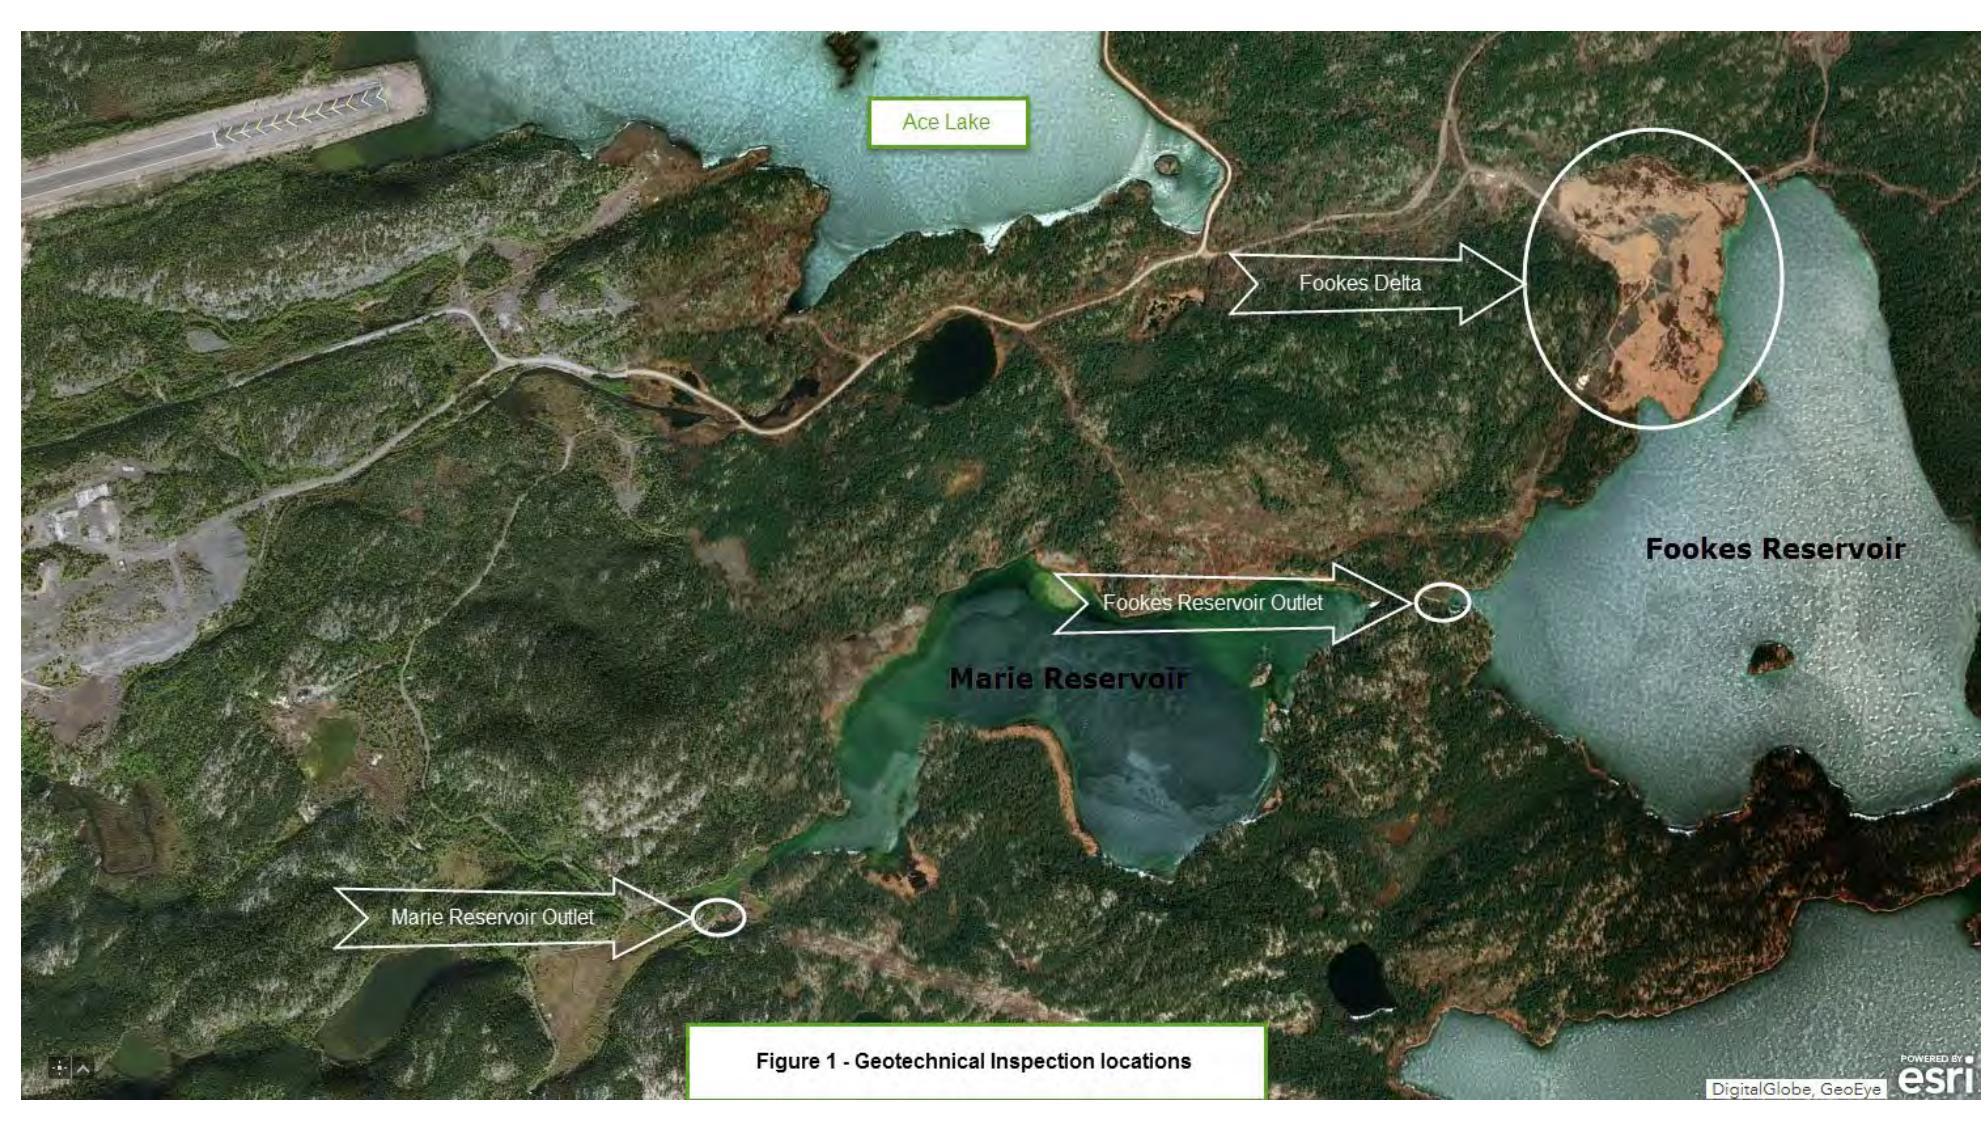
Figure 1. Geotechnical Inspection Locations

The 2015 geotechnical inspection completed by SRK concluded that overall; the Fookes cover, and the two outlet structures were performing as expected. The report concluded that it would be reasonable for Cameco to move towards final close out and a return to Institutional Control for the properties associated with the cover and outlet structures (*SRK*, 2016). SRK recommended that in the meantime, documented inspections by Cameco and/or regulators should continue on an annual basis. A follow-up inspection was completed in 2020 by SRK, who noted that there were no observable changes to the landform and no concerns identified. Following the 2020 inspection, SRK recommended that once the properties are transferred to the IC Program that they are inspected every five years for two cycles, then less frequently after that if the areas remain stable.

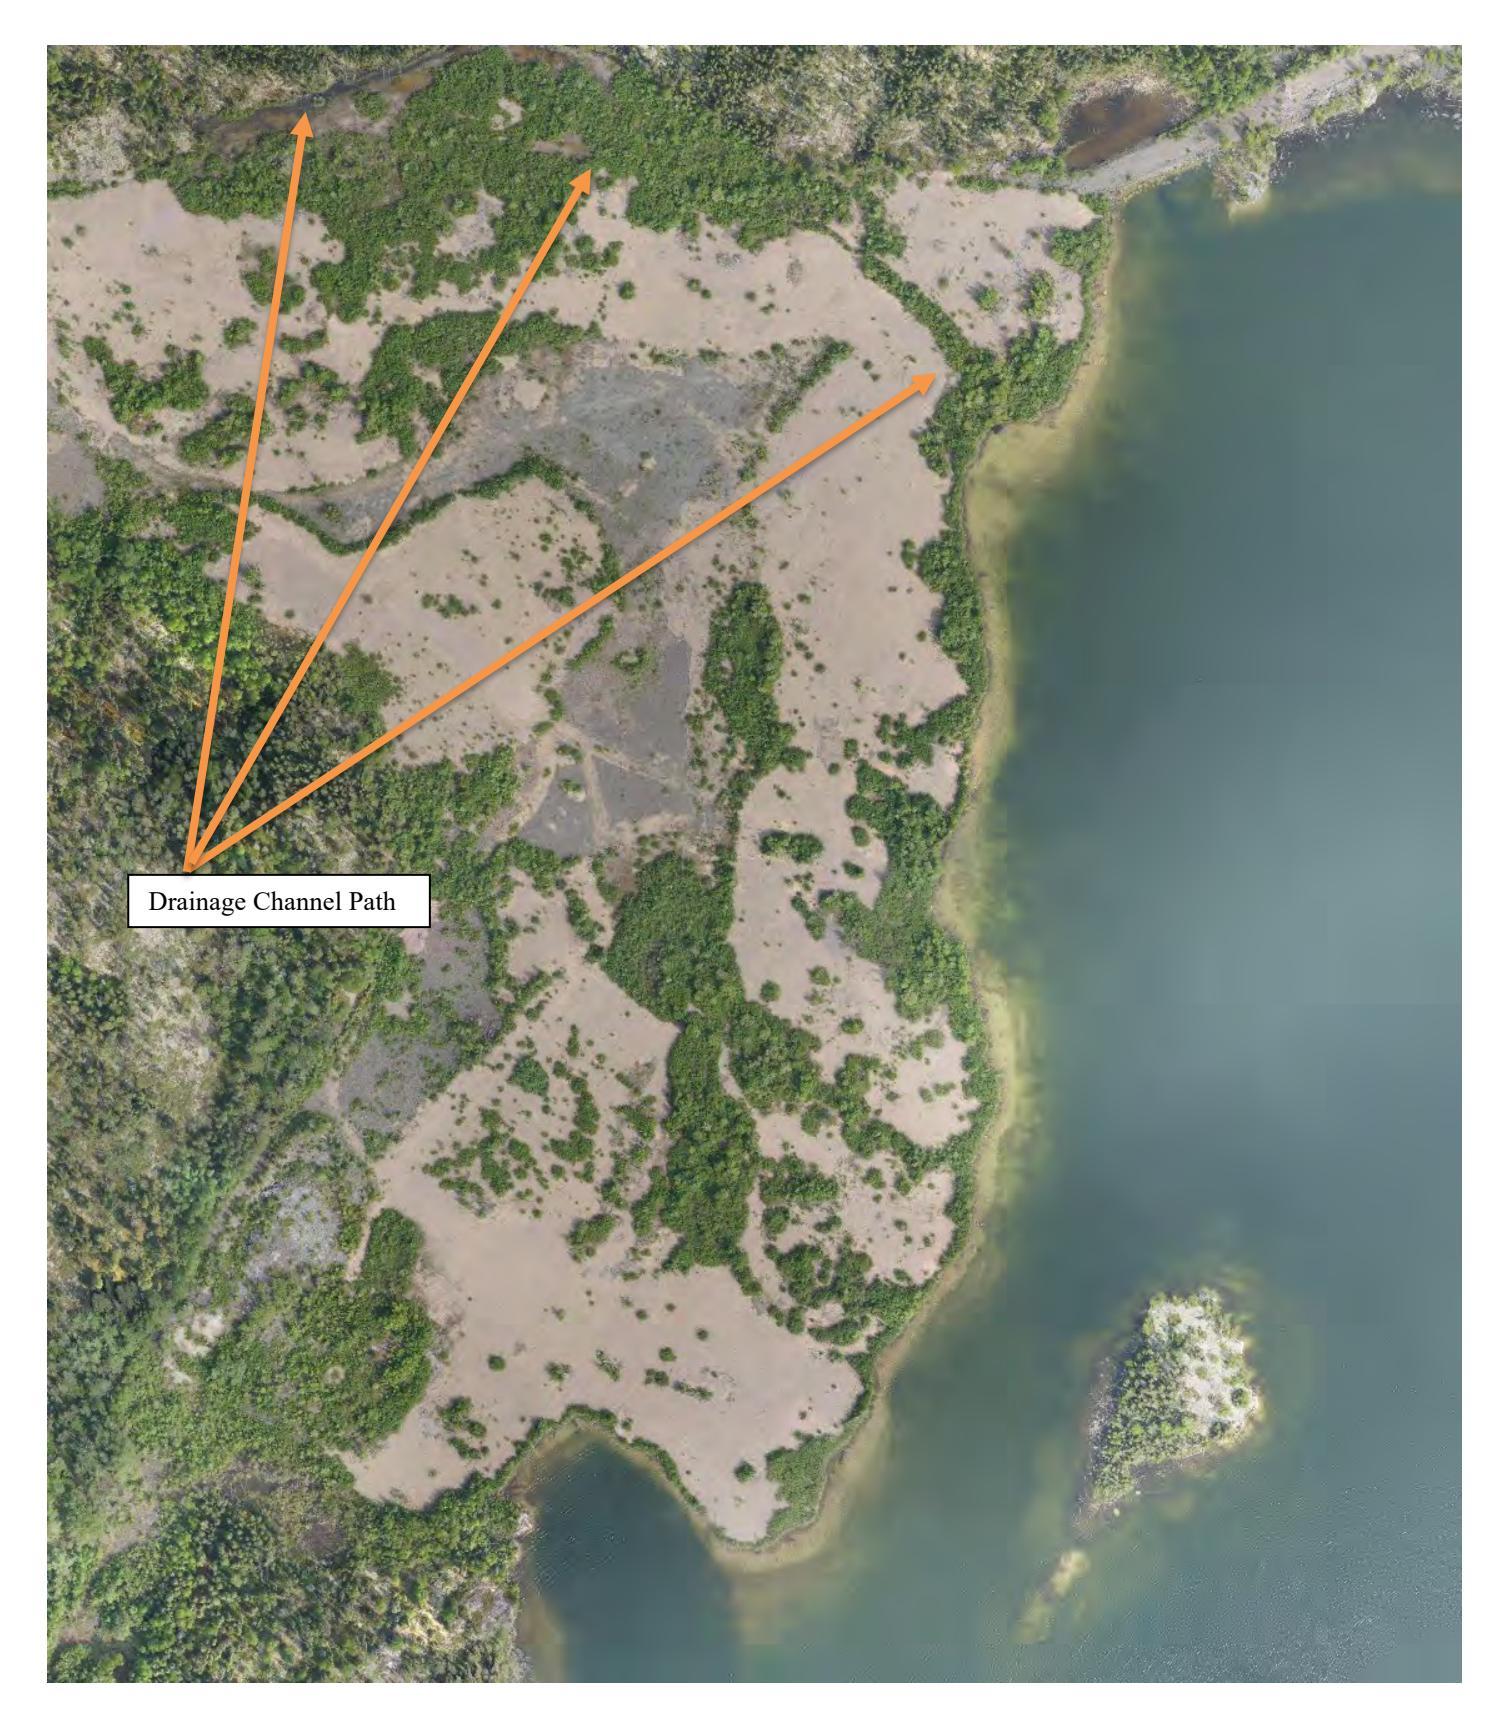
Figure 2. Fookes Overview

The 2023 inspection showed that water is being captured in the drainage channels as per design and there is no evidence of any significant erosion of the cover. The drainage channel continues to vegetate heavily as can be seen in the photos in Section 4 and **Figure 2**.

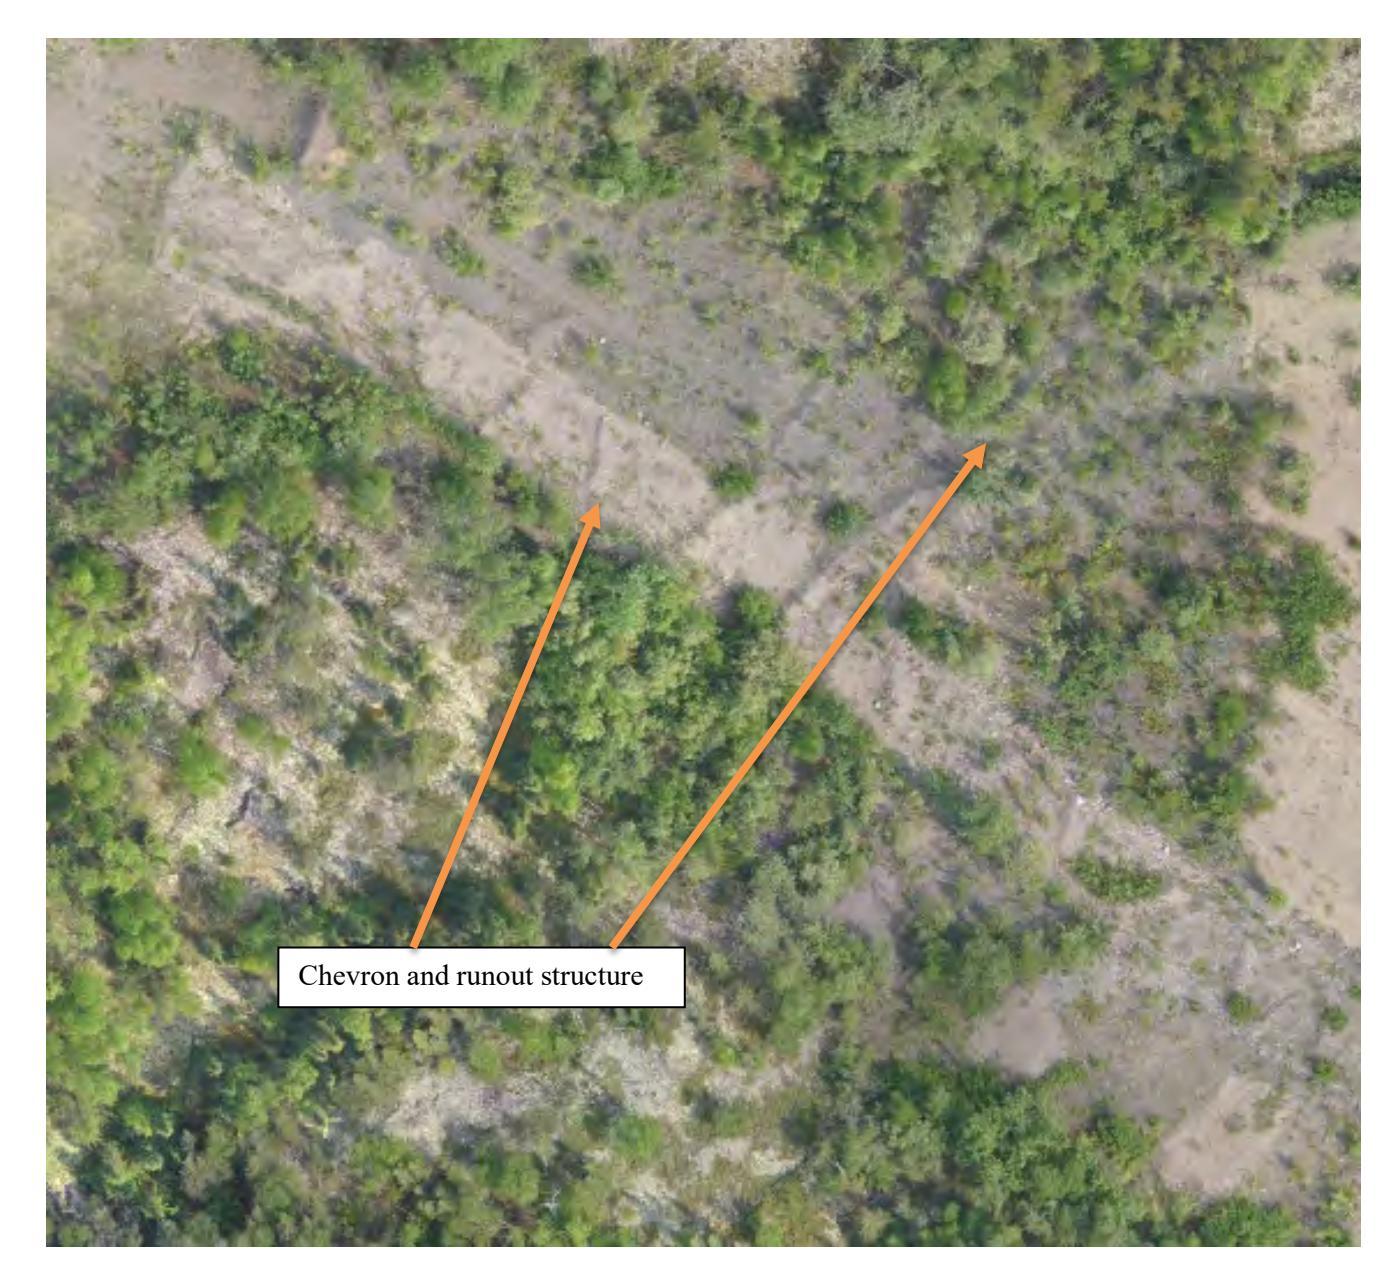
Figure 3. Fookes chevron and runout structure

As part of the design and installation of the covers in 2005 and 2007, the area considered most vulnerable to erosion was in the area on and below the access ramp at the northwest corner of the delta (*SRK*, 2010). The general condition of the ramp is very good. Access to this ramp is closed off by a windrow of material at the top of the ramp, except for the small access trail to allow the remediation of the piezometer standpipes. The water bars (chevrons, **Figure 3**) are performing as expected and continue to show little sign of erosion (**Appendix C, Photo C1**).

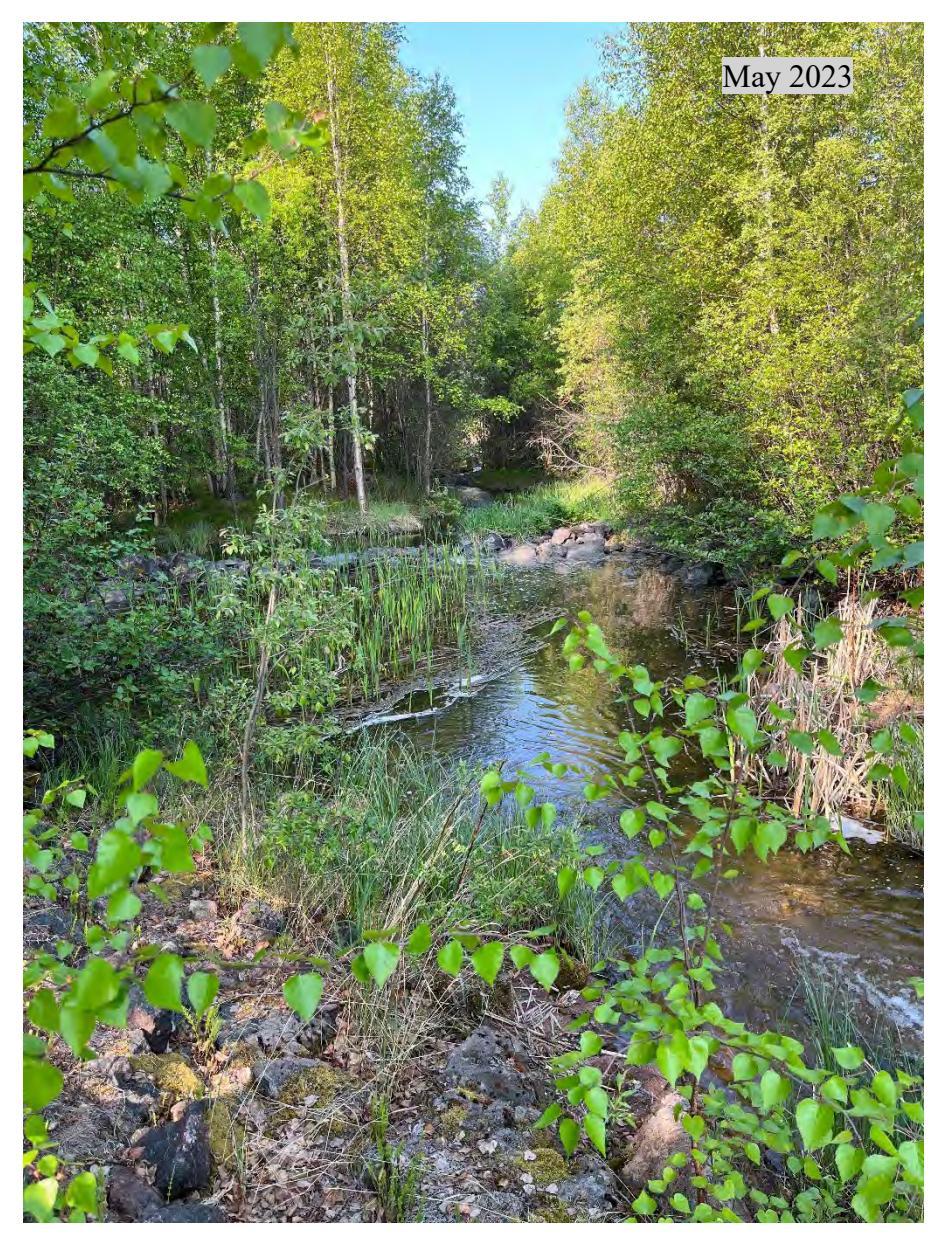
Marie Reservoir Outlet Structure

– Ice jacked block of grout intruded rip-rap

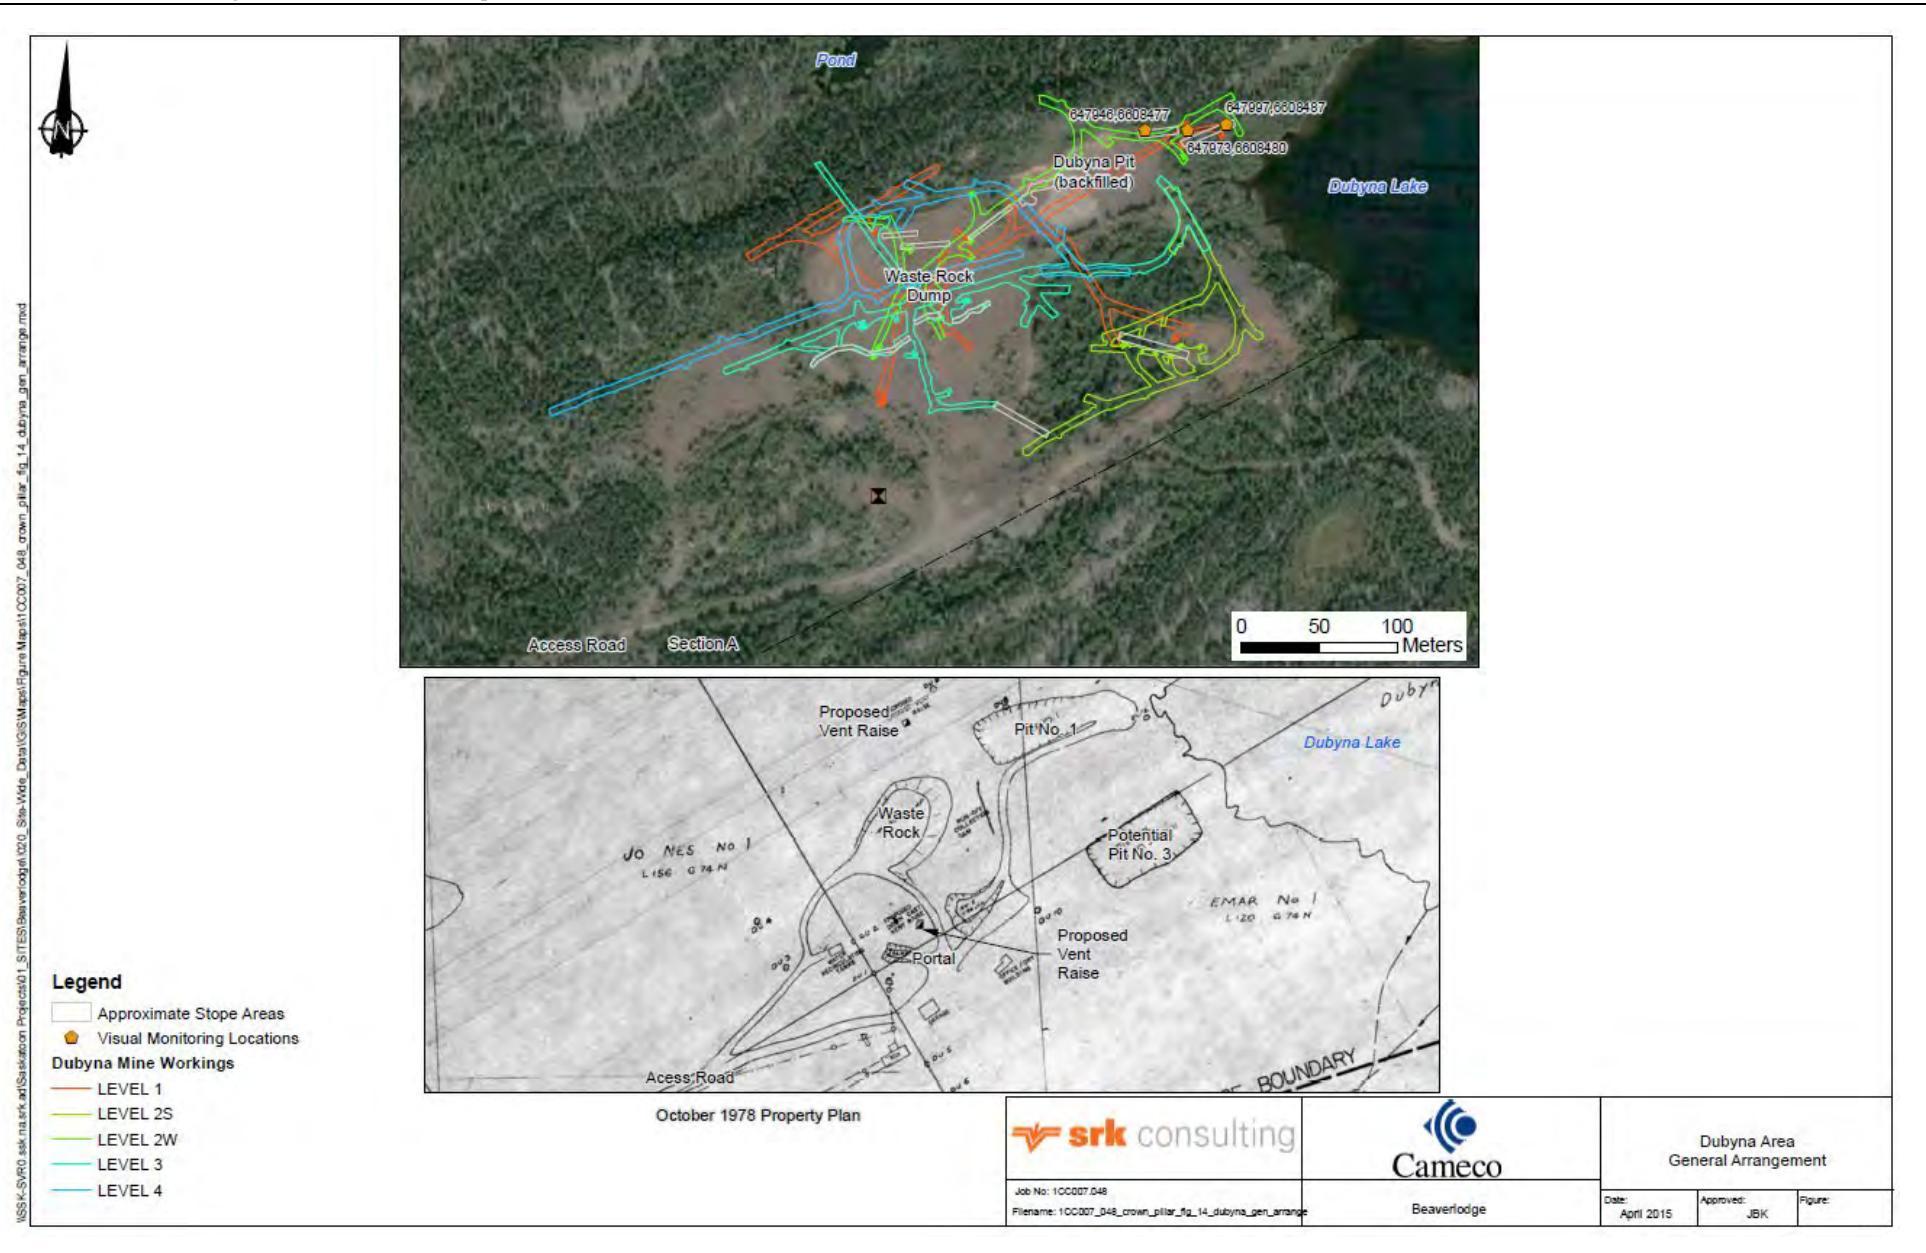
Figure 4. Dubyna area general arrangement

The crown pillar monitoring points at Hab and Dubyna were located, and a visual walking inspection was completed at each site. The inspection involved walking between and around the points identified in **Tables 1** and **2**. Observations at both areas did not show any evidence of tension cracks or slumping in 2023.

It was noted at Dubyna that recent beaver activity resulted in significant clearing along the crown pillar inspection area. As well, a beaver lodge was constructed along the shore of Dubyna Lake near furthest extent of the crown pillar.

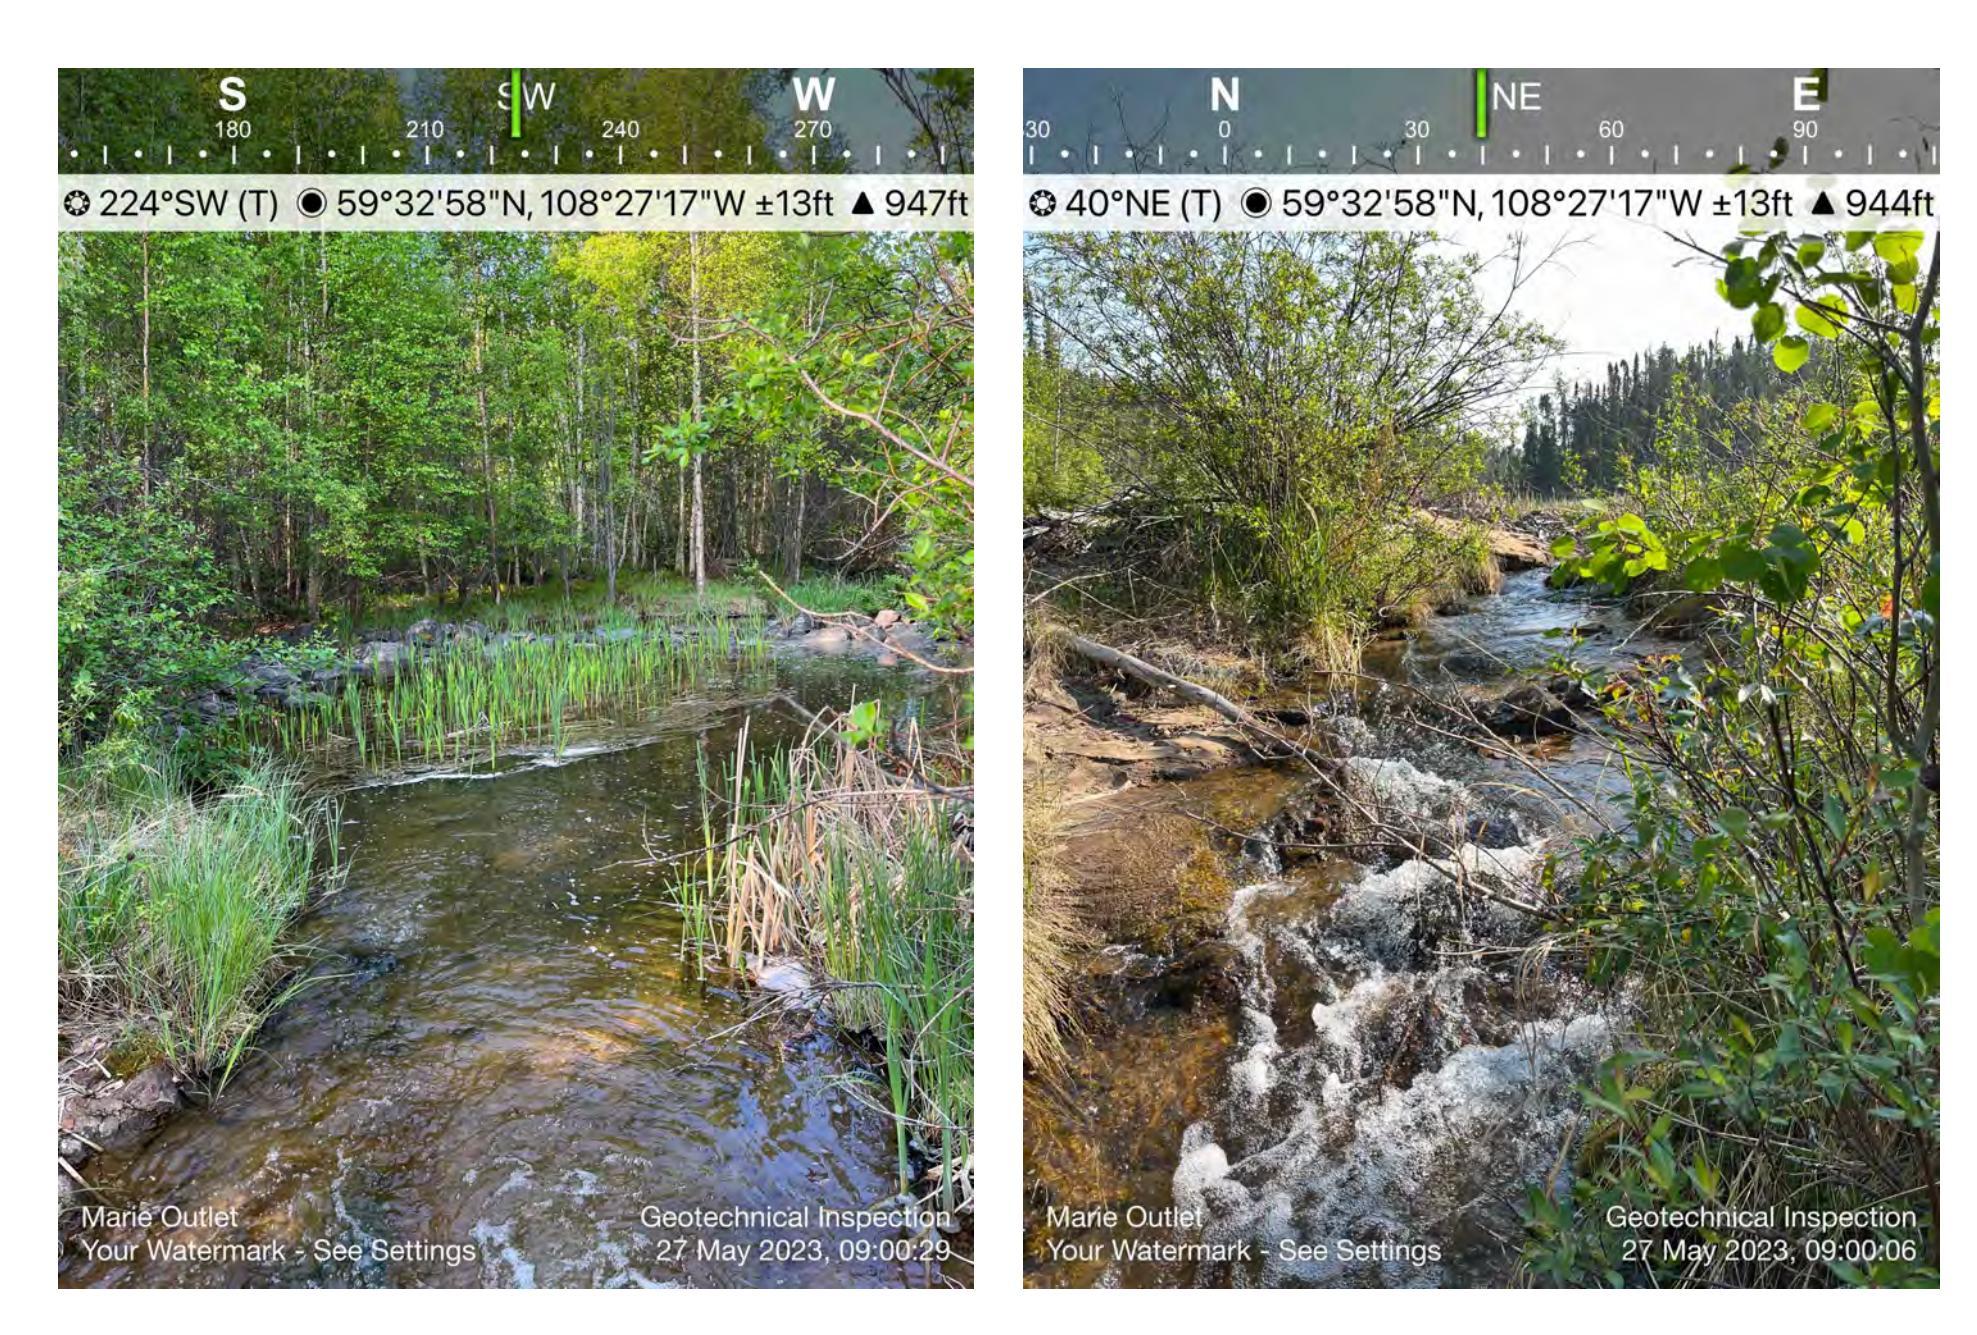
Photo A3 – Marie Reservoir Spillway (water flowing into stilling basin) (May 2023)

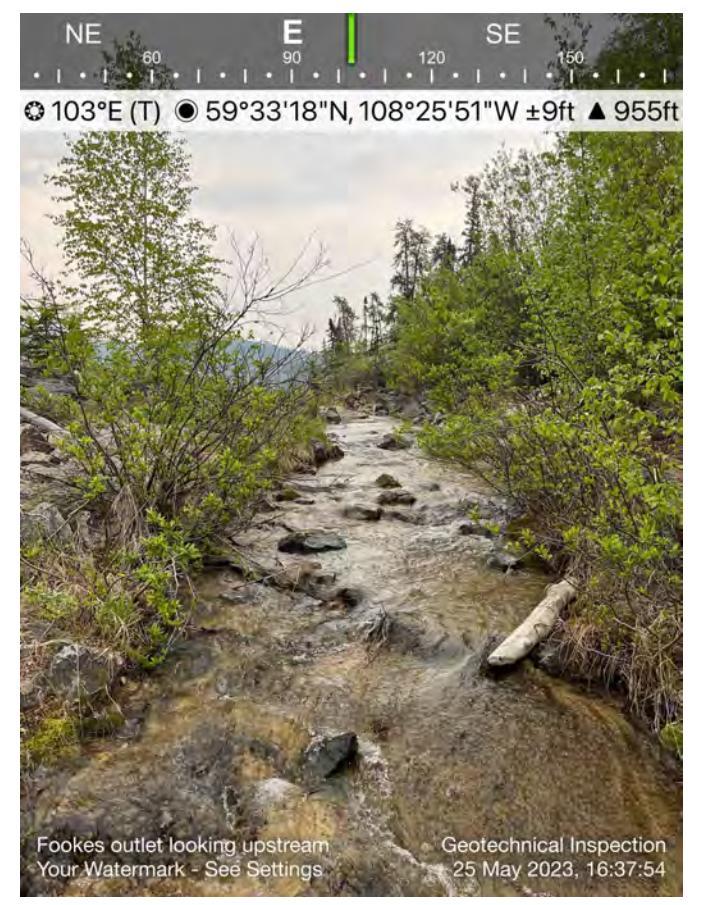
Photo B2 – Fookes Reservoir Spillway looking upstream

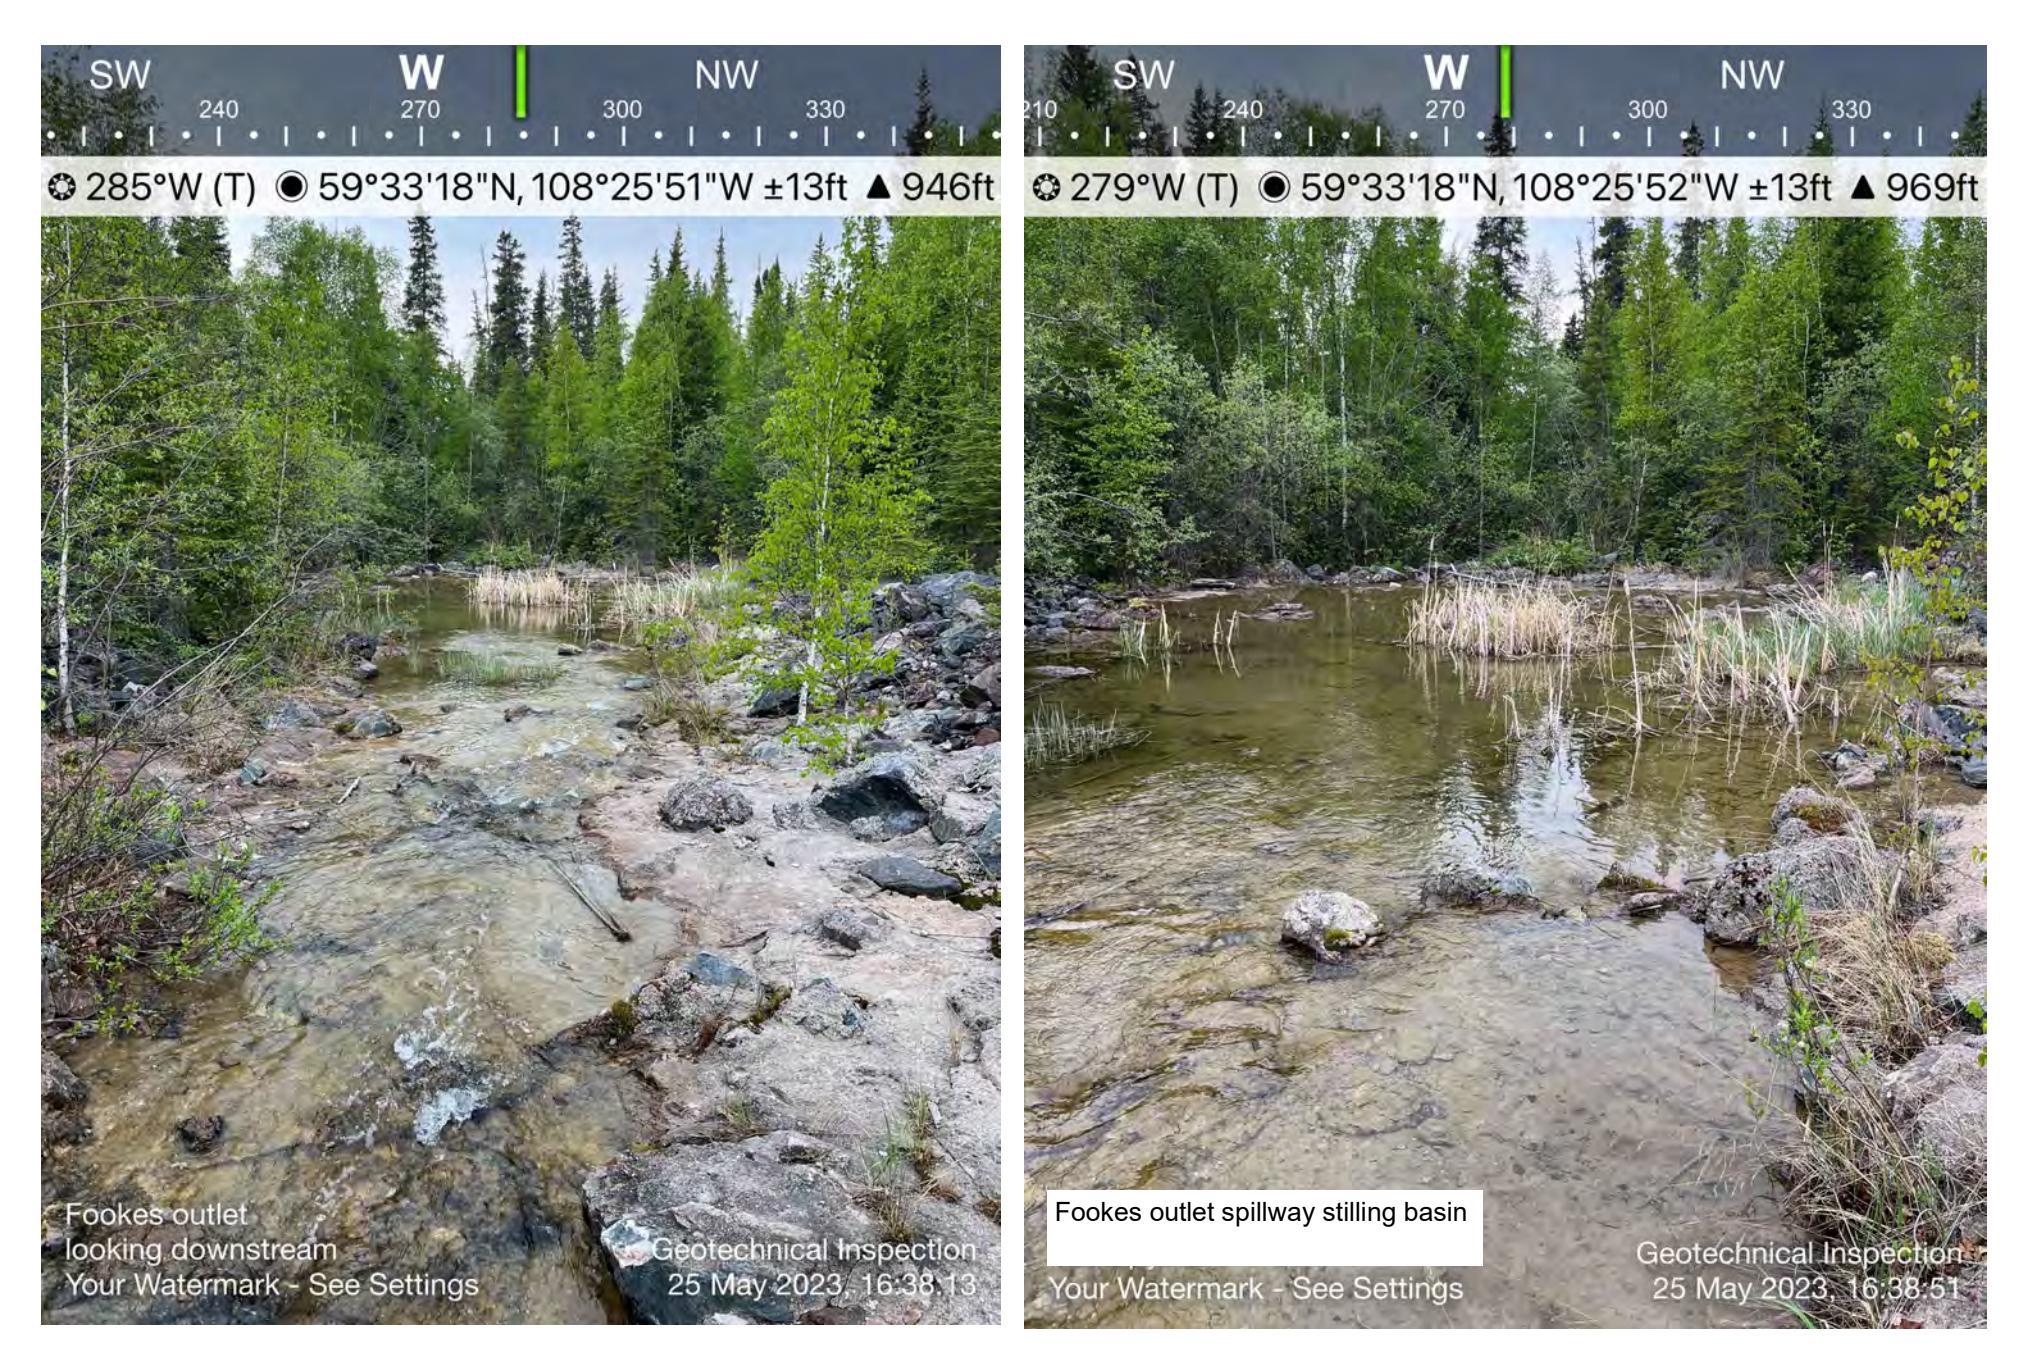
Photo B3 – Fookes Reservoir Spillway looking downstream (mid channel)

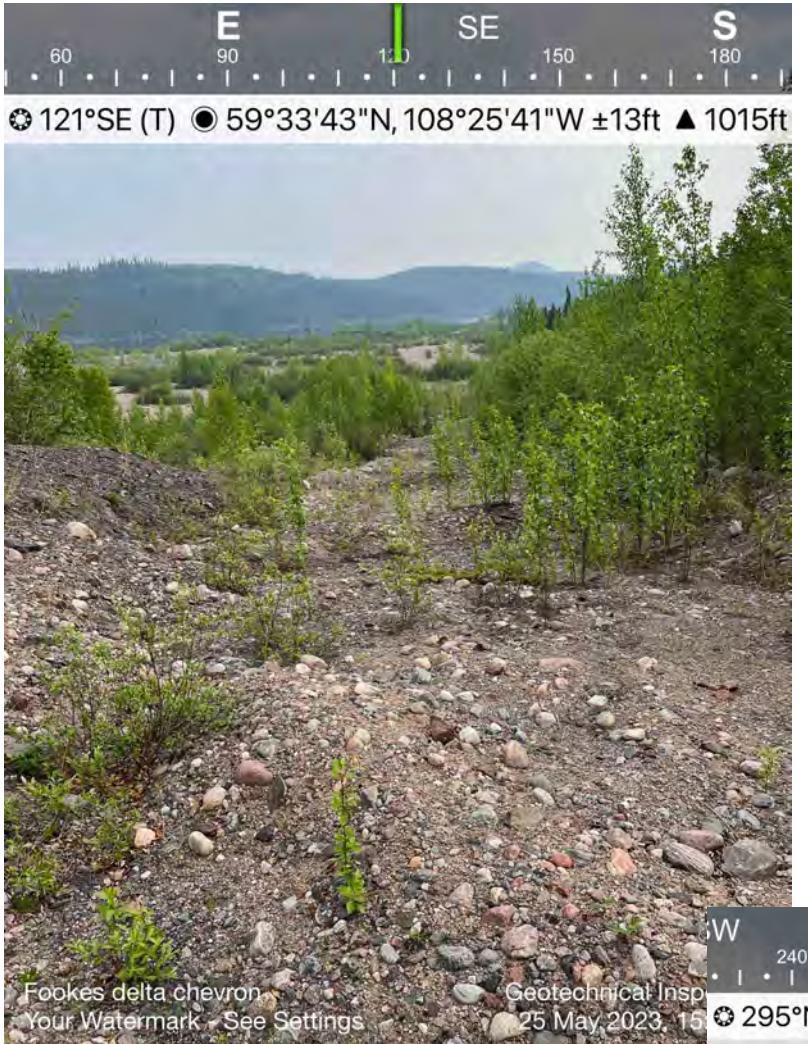
Photo C1 – Chevrons in place on north access point to the Fookes delta looking south (May 2023)
