Beaverlodge Project 2023 Annual Report

Year 38 Transition Phase Monitoring

> Prepared and Submitted by: Cameco Corporation

> > March 2024

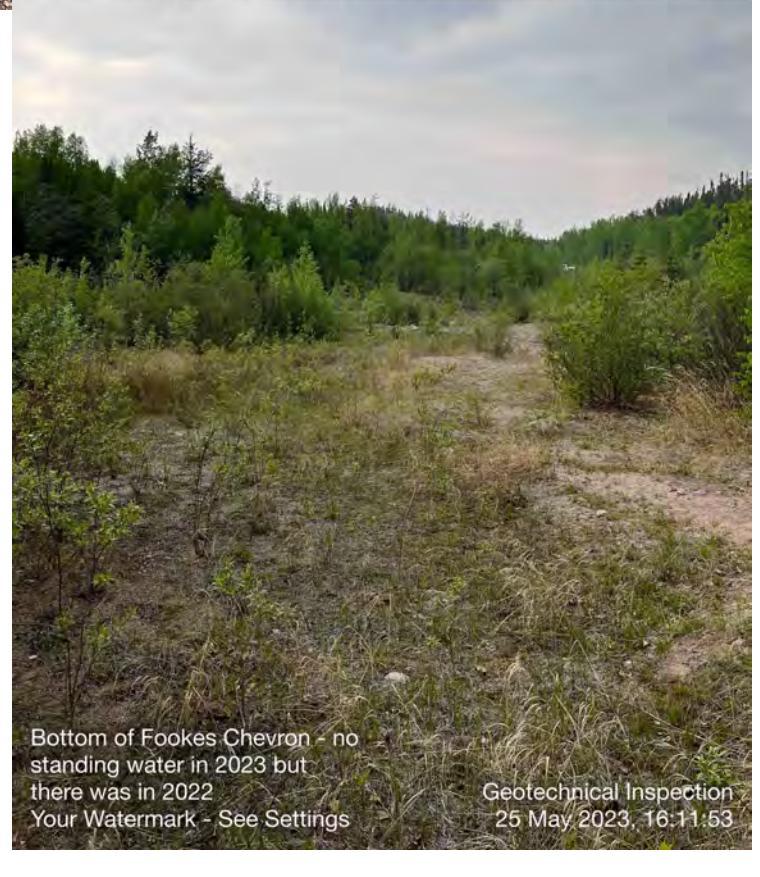
Photo C2 – no ponded water (May 2023). This area previously had ponded water on waste rock cover at bottom of hill near north access road during freshet in 2022.

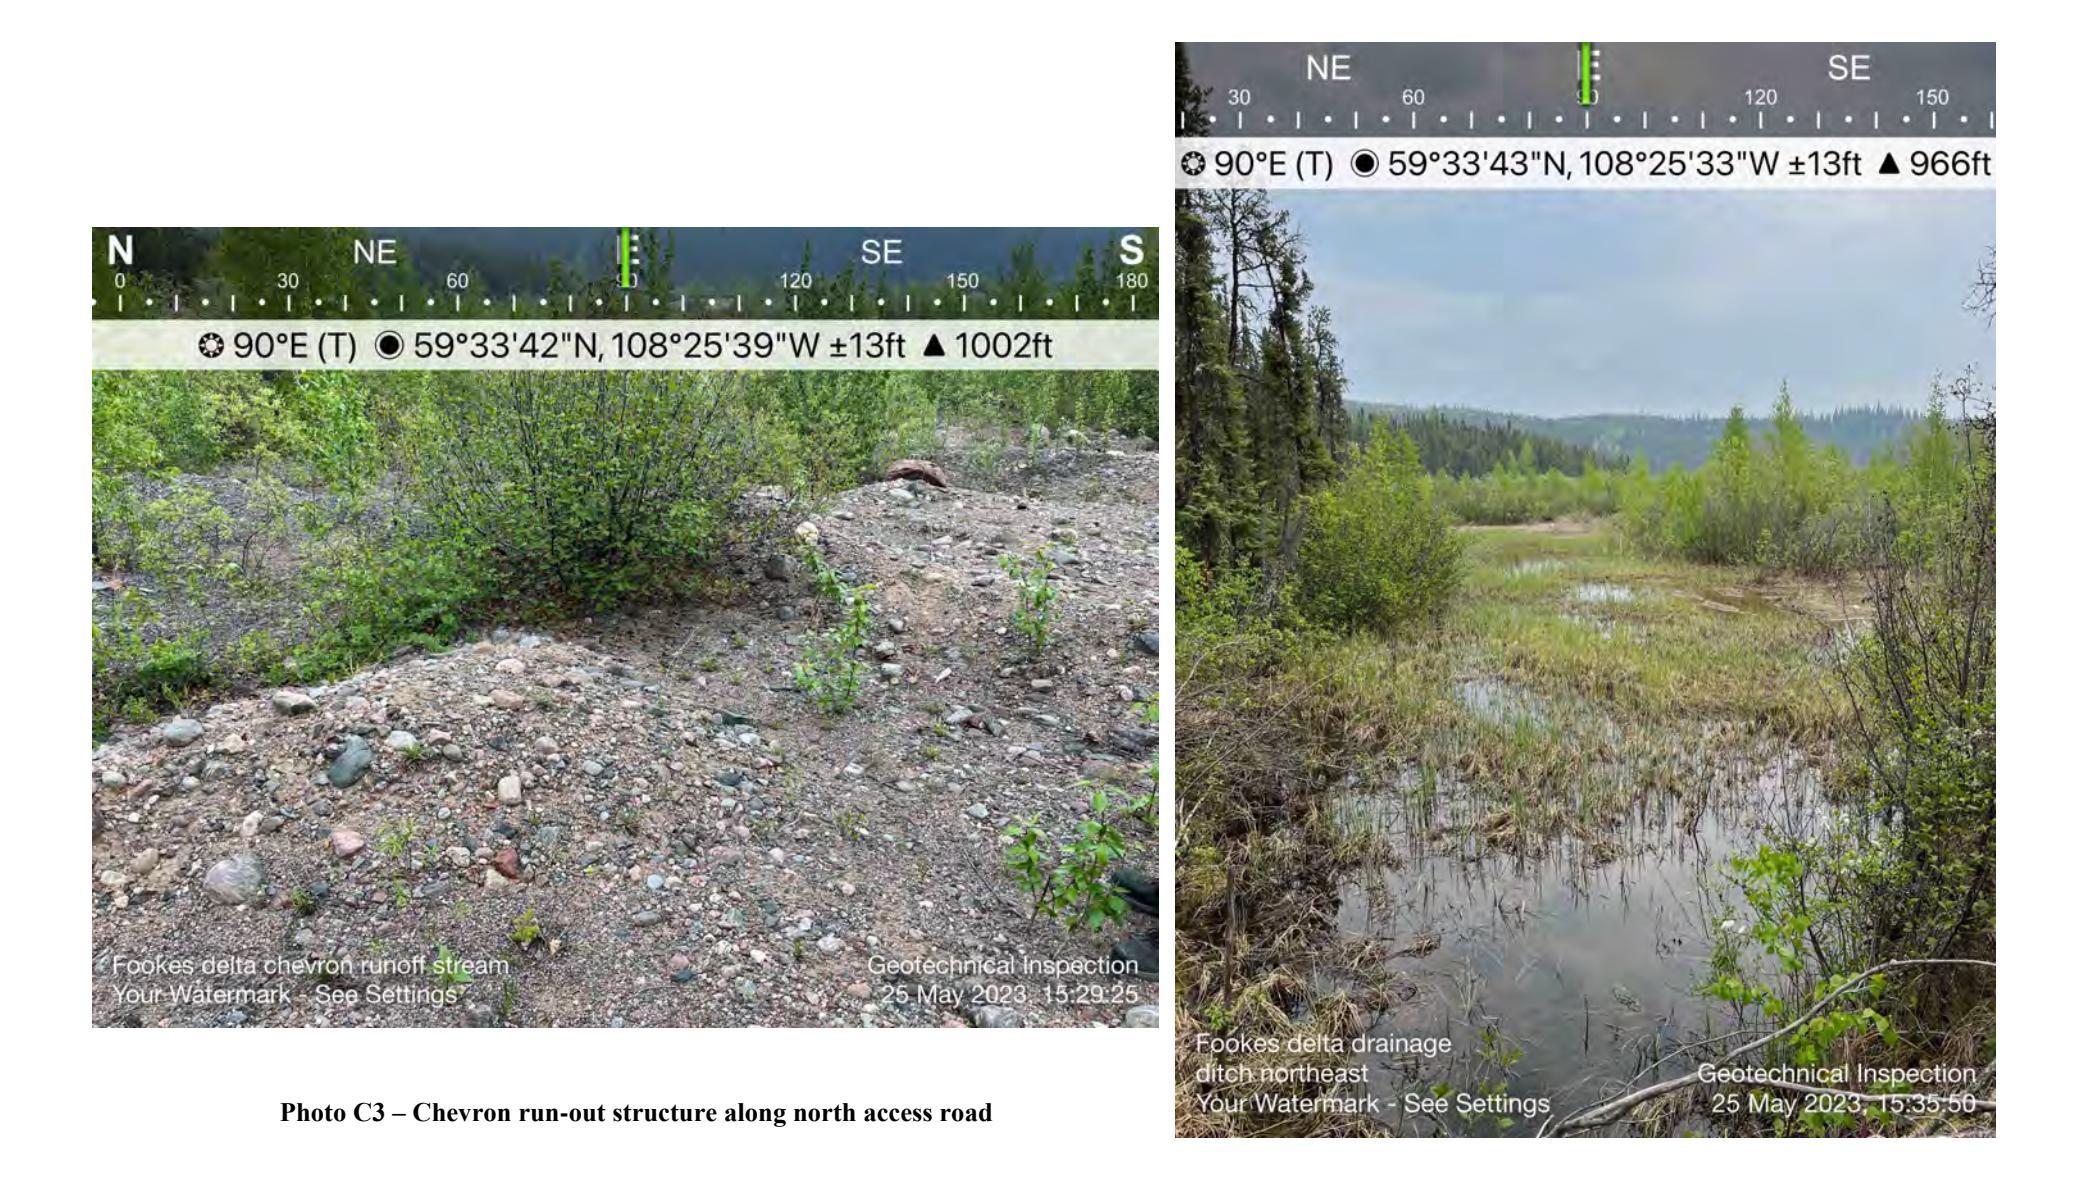
Photo C4 – Drainage collection area on edge of Fookes Tailings Delta approximately 100m from access point

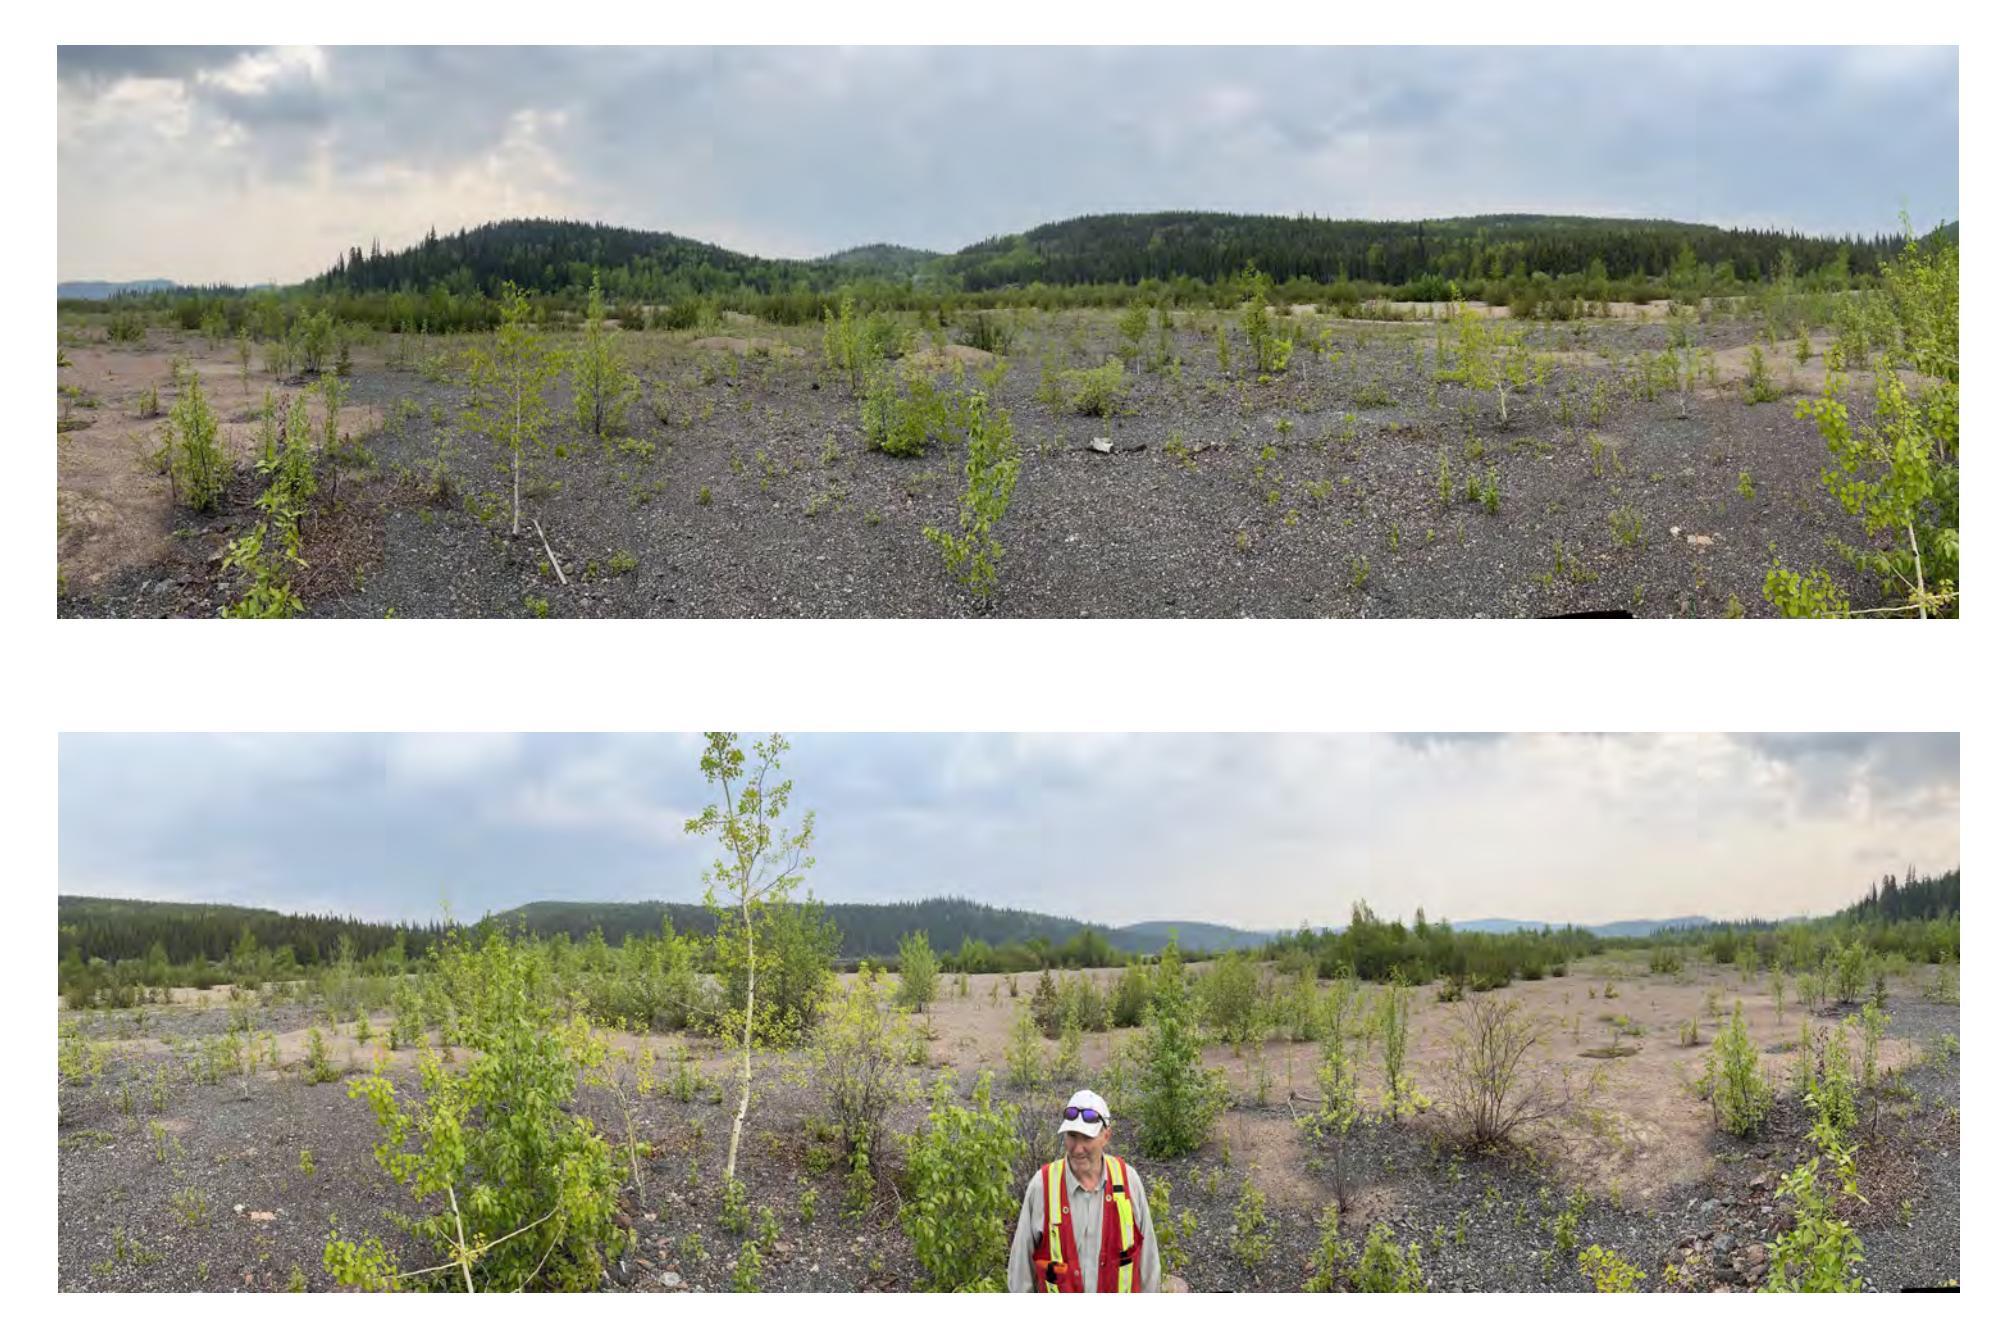
The Fookes Delta cover is in good condition and showed no sign of excessive erosion. As vegetation continues to establish on the shoreline, it will increase the stability of the cover.

Photo C5a-b – Panoramic views of the Fookes cover (Photos taken May 2023) vegetations is yet to leaf-out

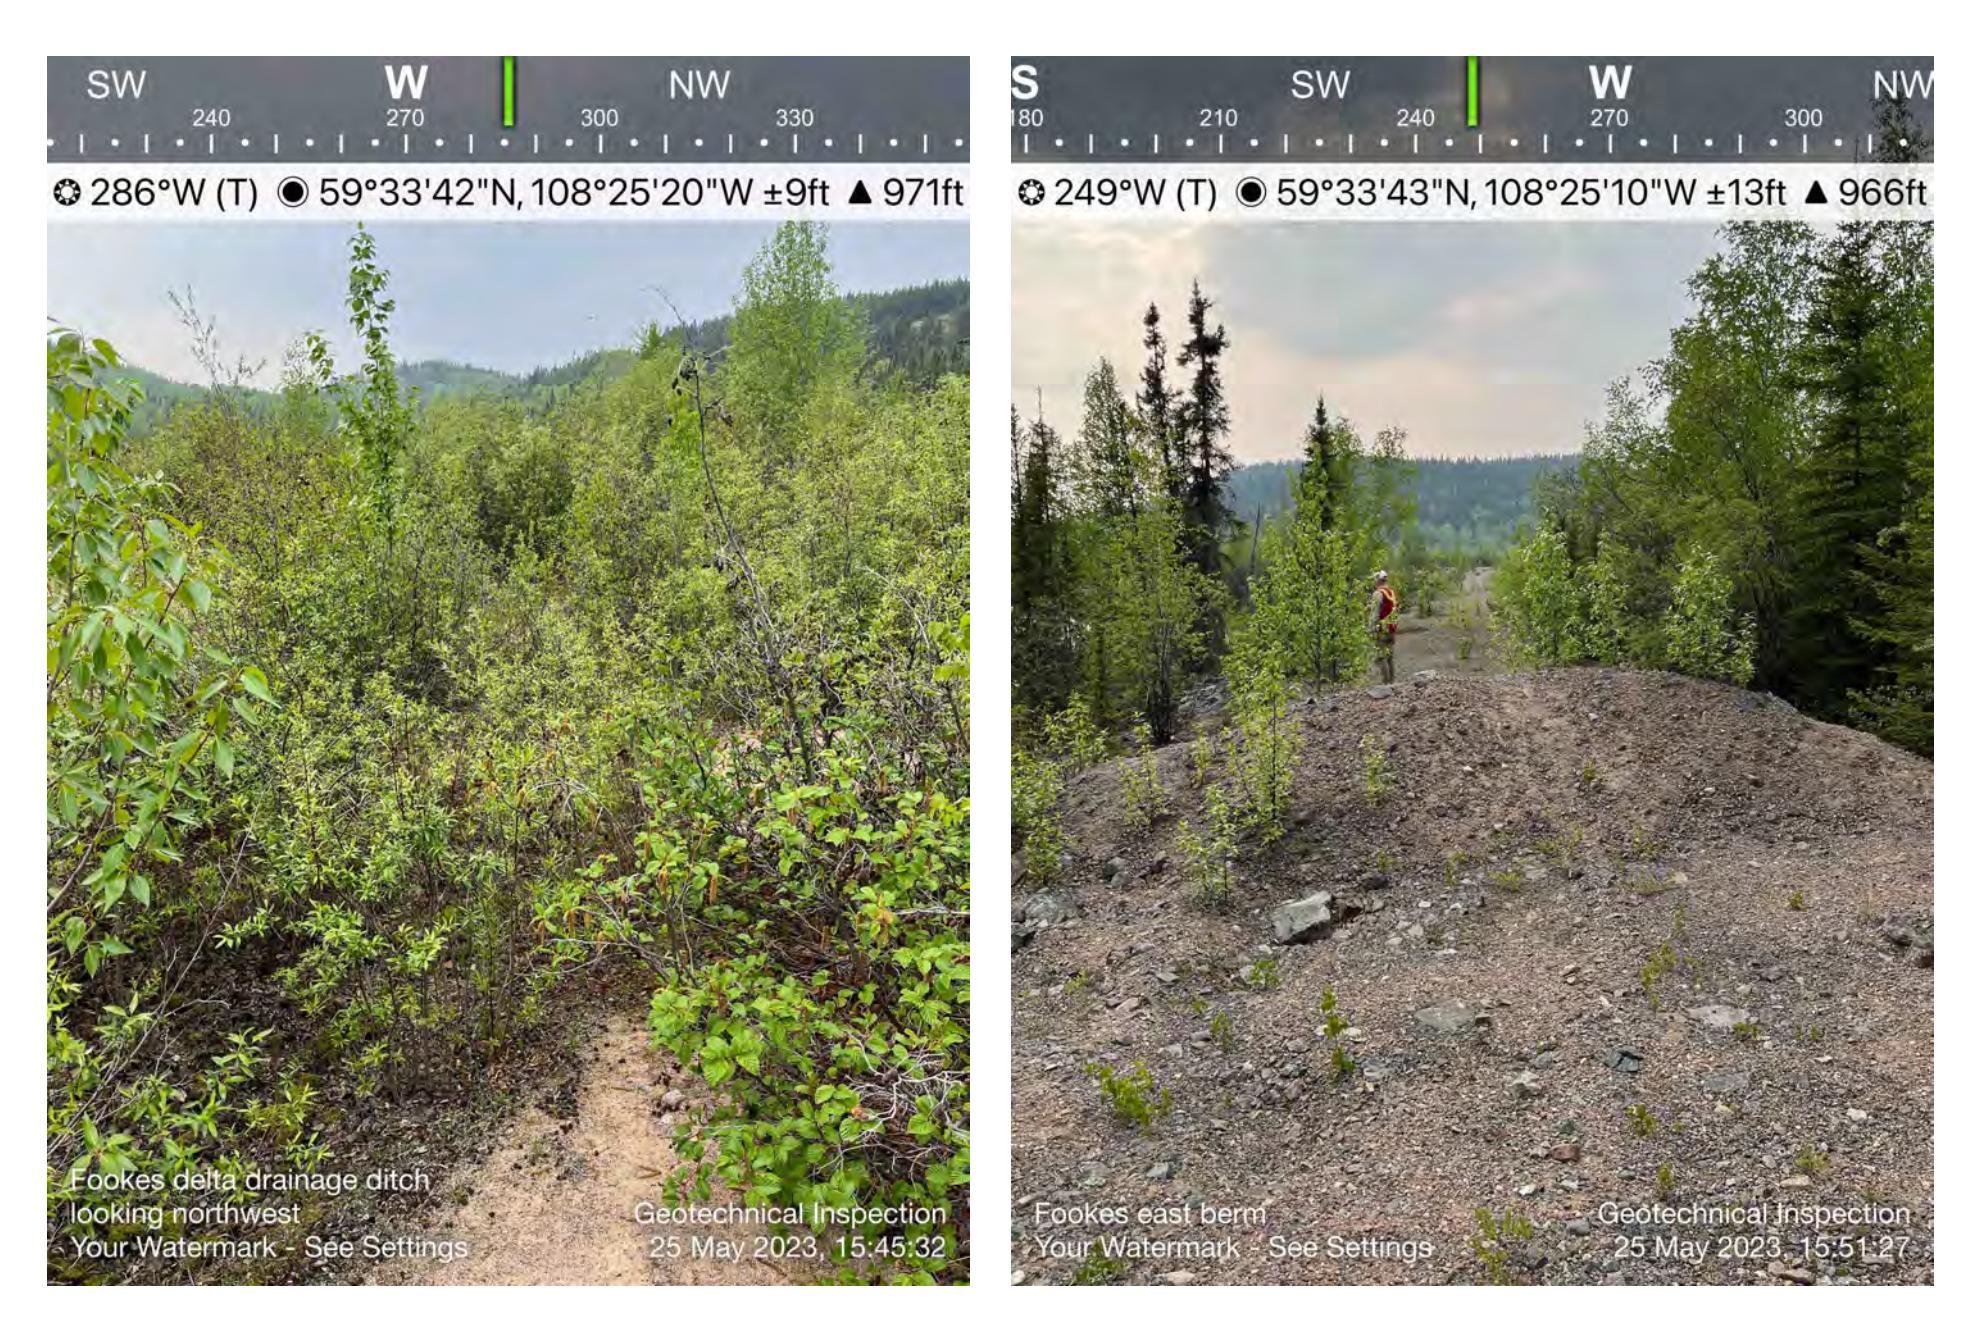
Photo C6 – View of vegetation establishing along drainage channel (May 2023).

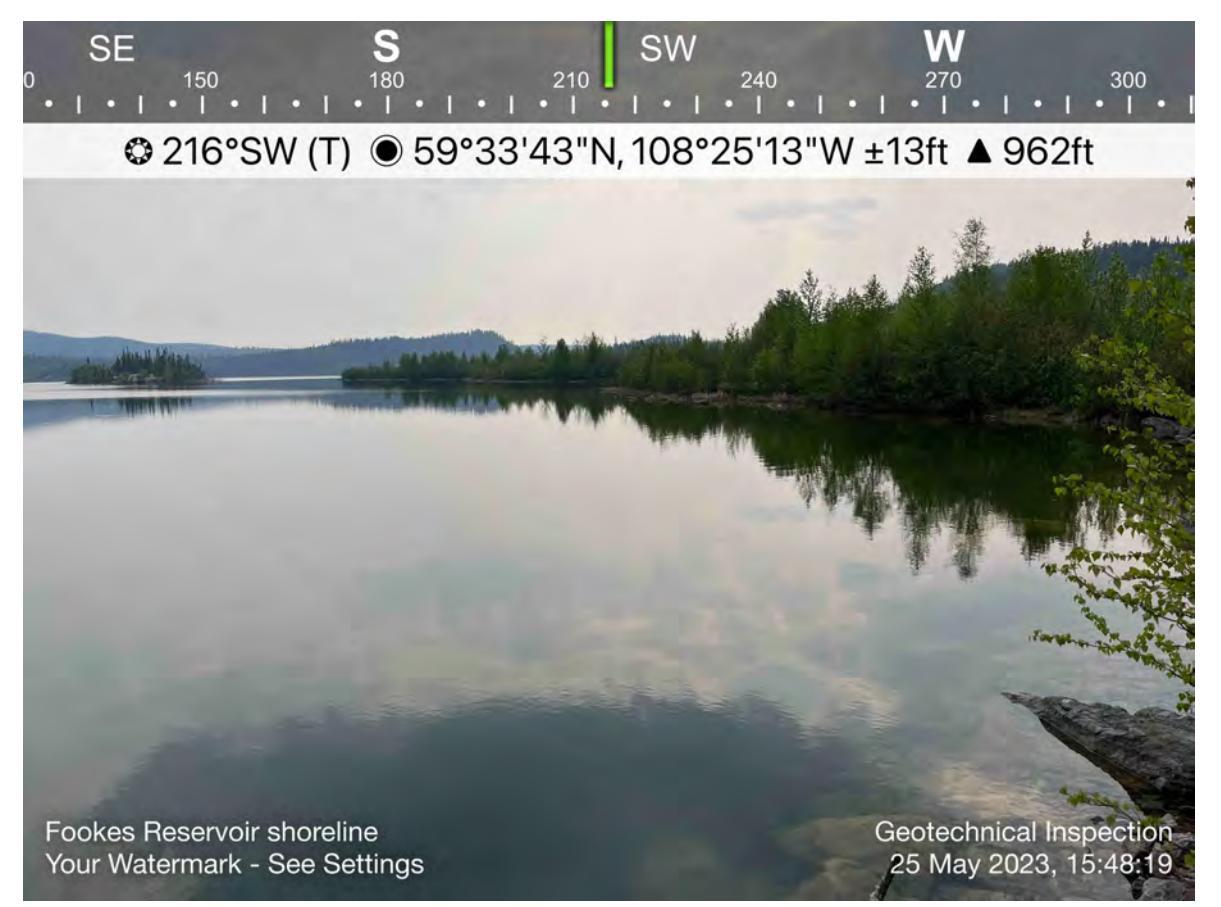
Photo C8—Fookes Reservoir shoreline (looking west) Note vegetation along shoreline is well

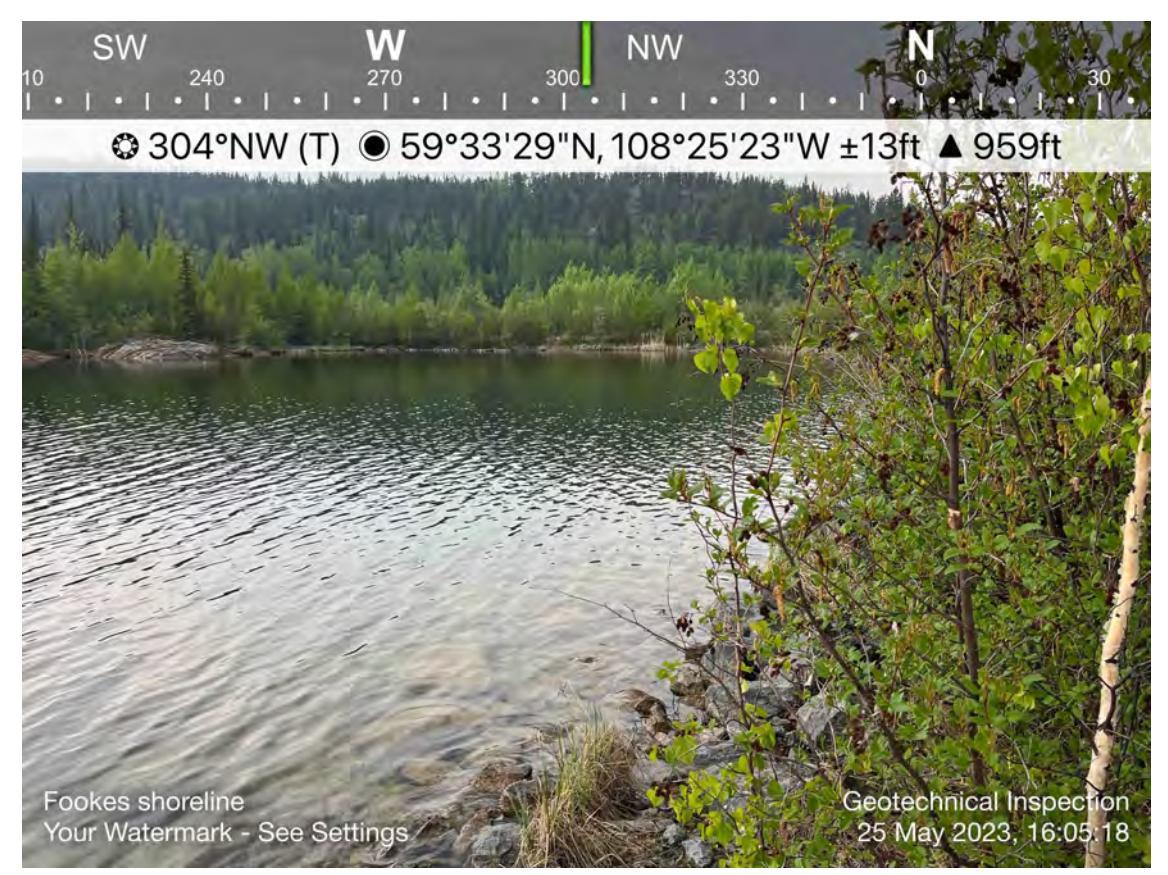
Photo C9—Fookes Reservoir shoreline (looking west).

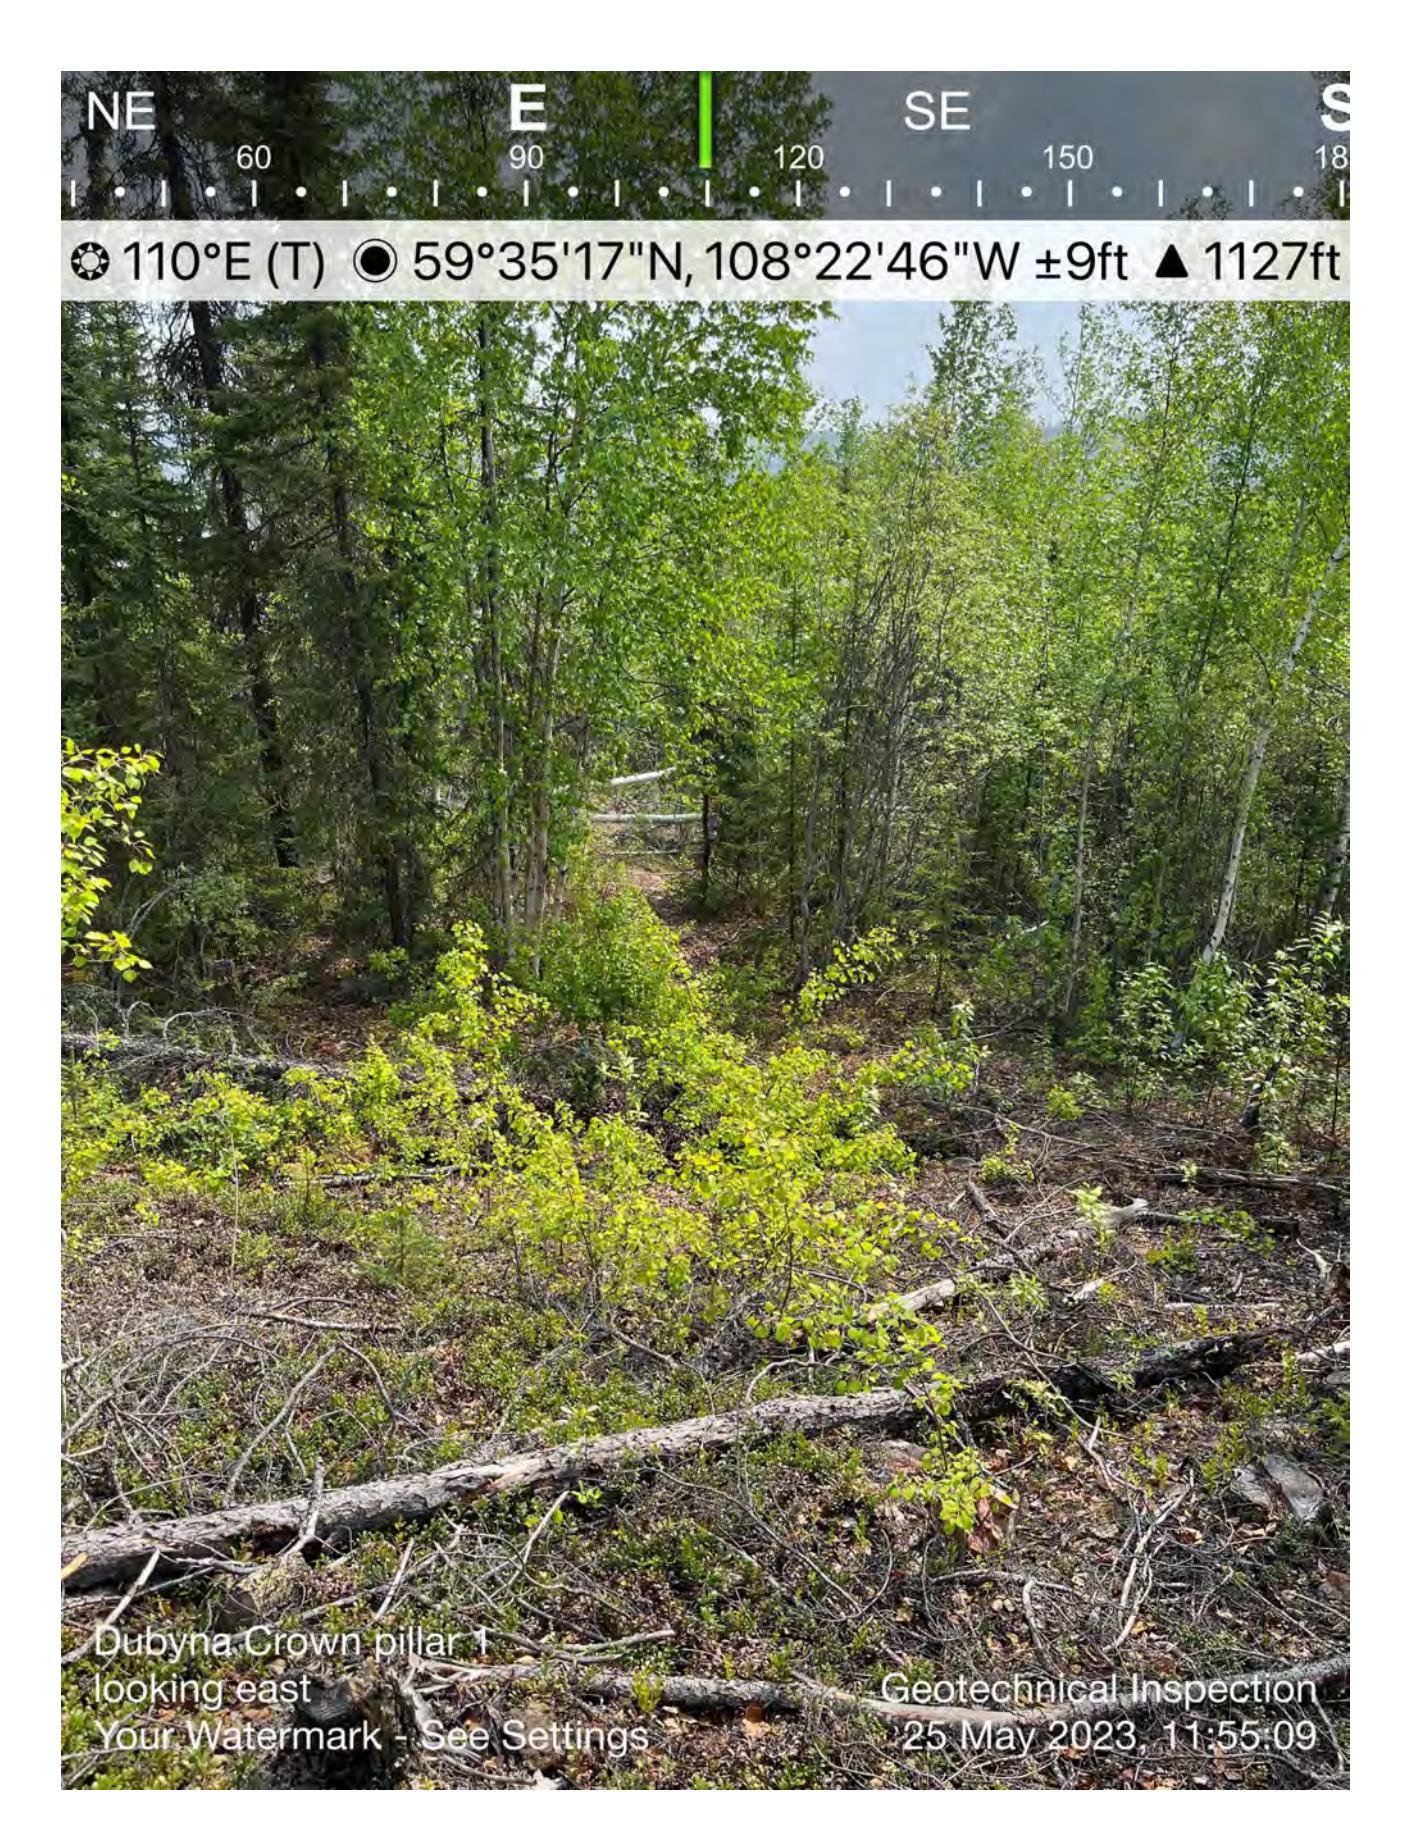
Photo D3—Dubyna CP-1 location (looking east)

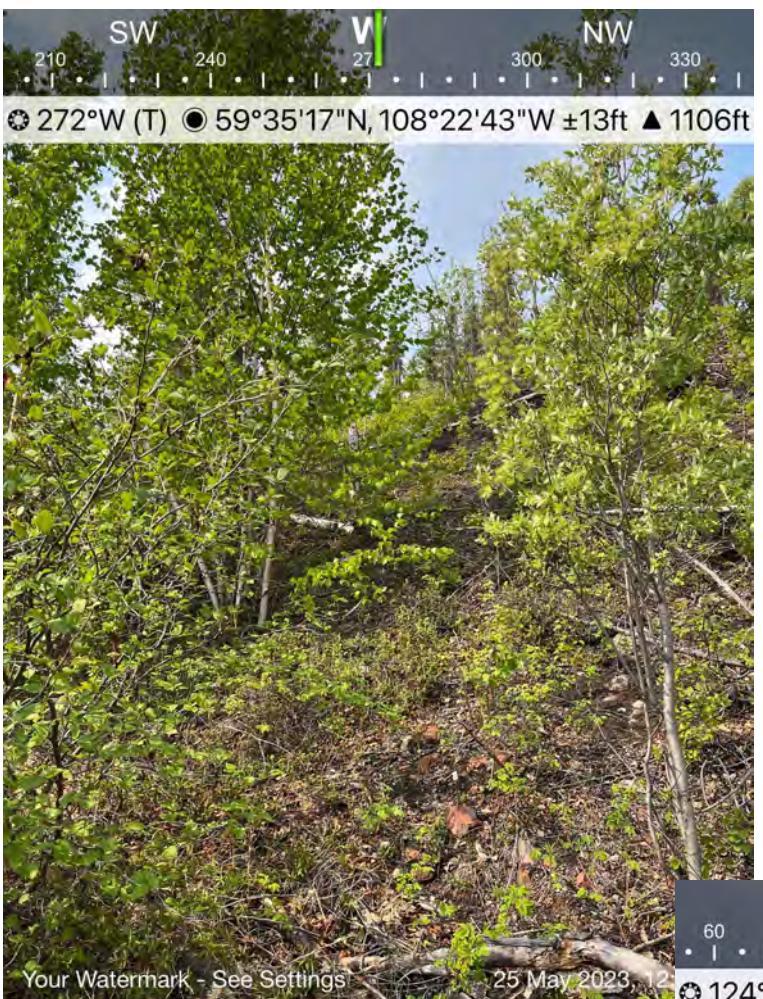
Photo D6—Dubyna CP-3 location (looking west)

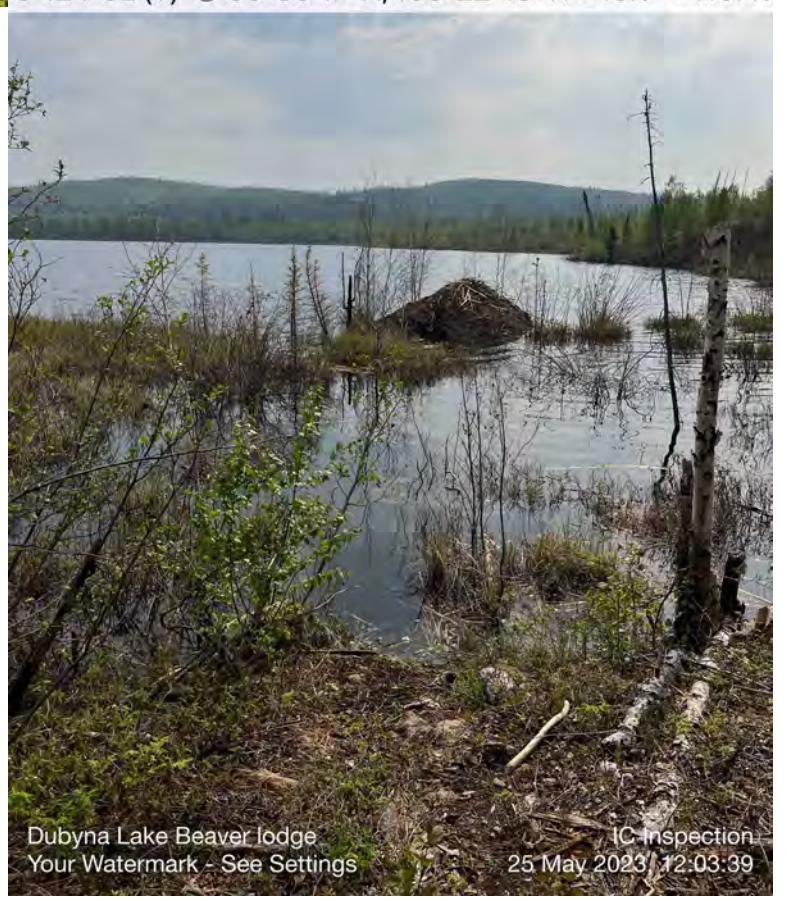
Photo D7—Dubyna CP– 3 location (looking east to Dubyna Lake)

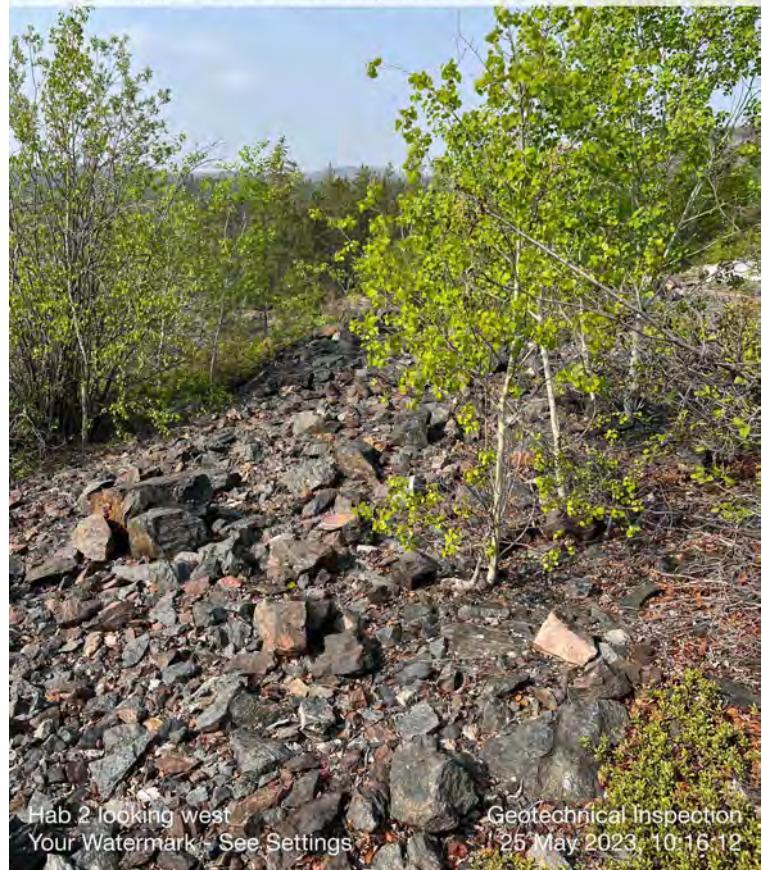
Photo D9—HAB039-02 looking west

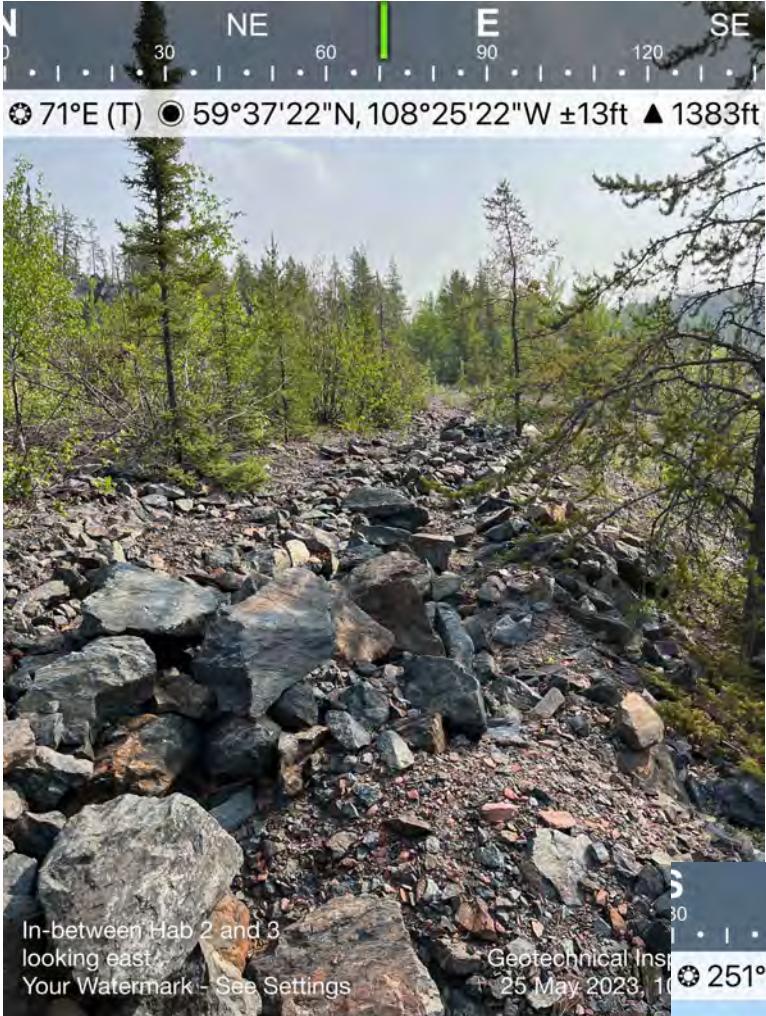
Photo D10—HAB039-02 location (looking east)

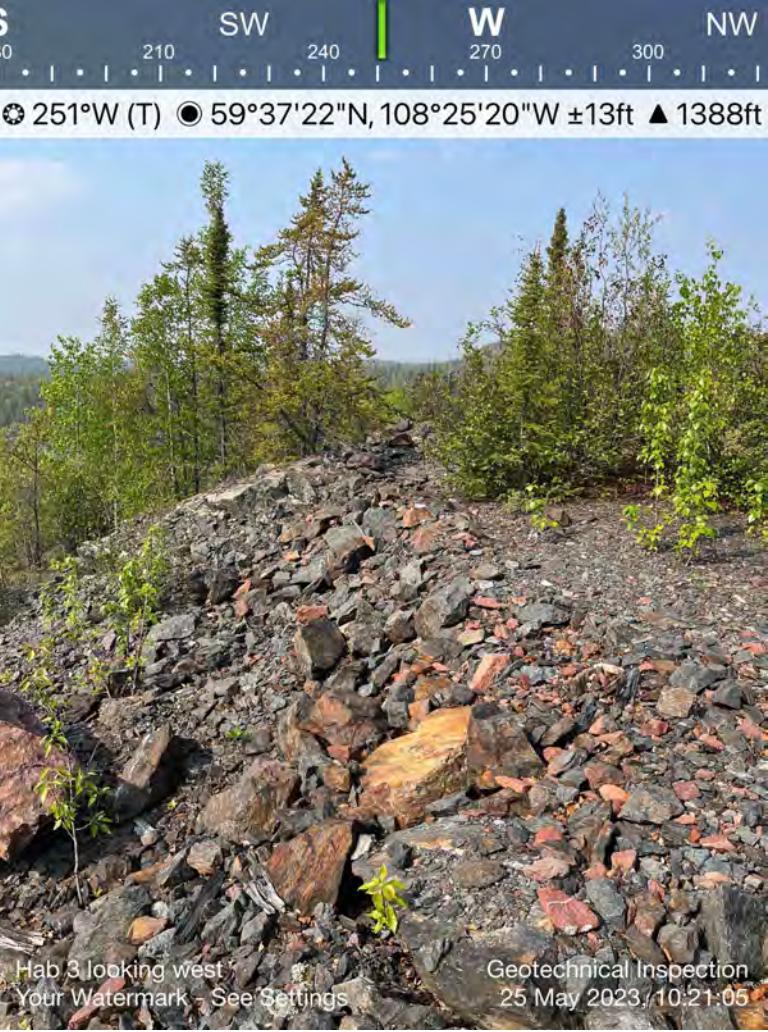
Photo D11—HAB039-03 looking west

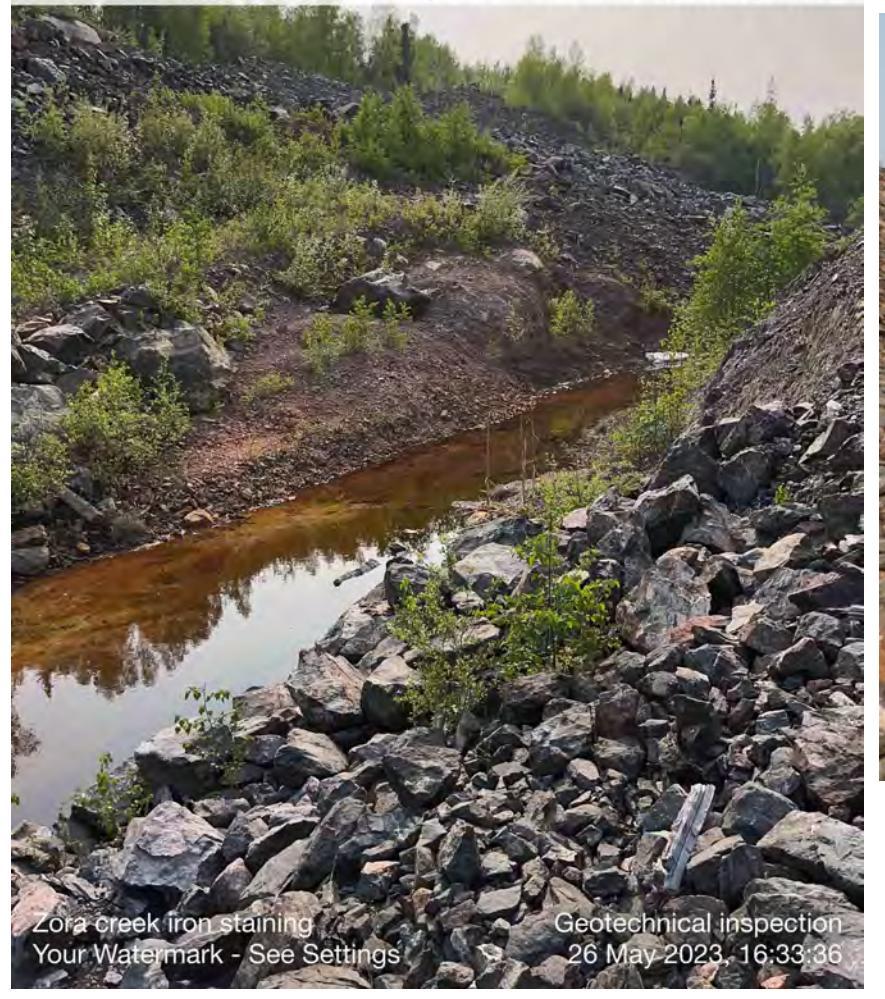
Photo E01—View looking downstream towards Verna Lake (May 2023)

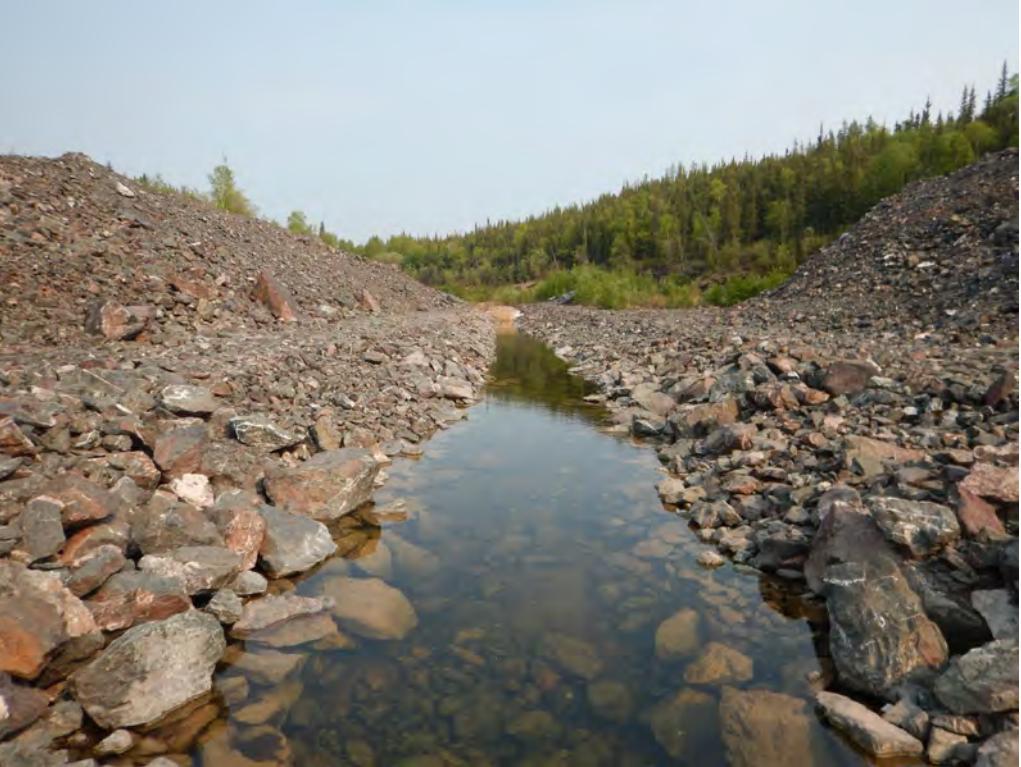
Photo E02—View from level crossing looking upstream towards Zora Lake (May 2023)

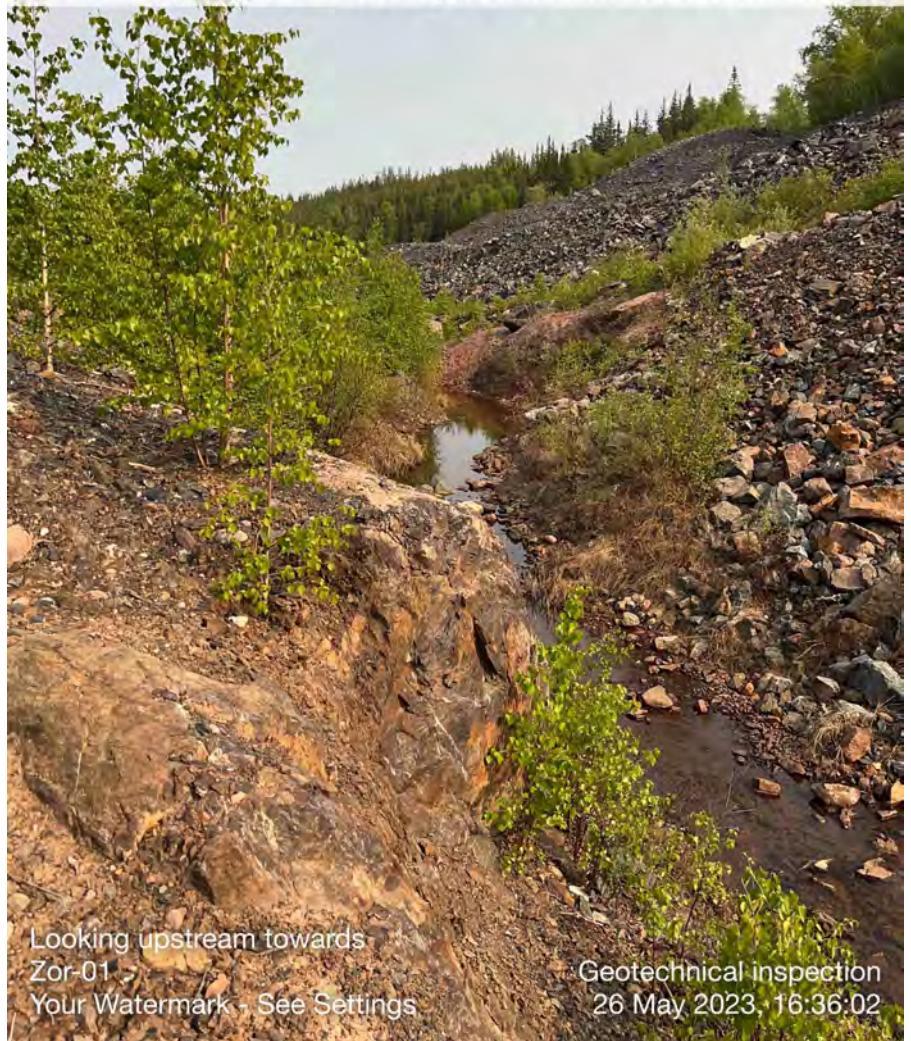
Photo E03—View near stilling basin looking upstream (May 2023)

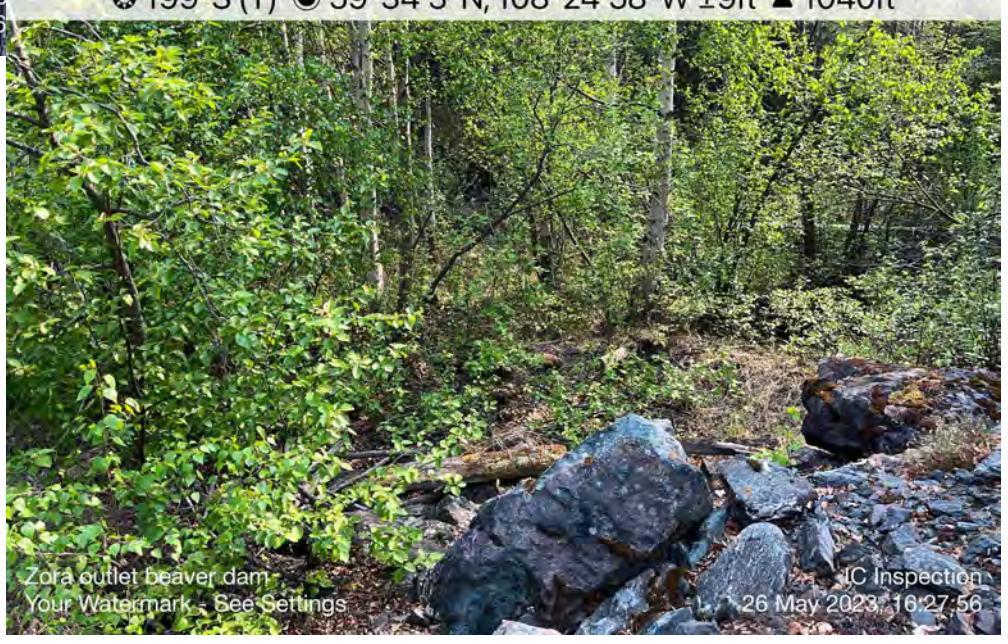
Photo E06—View near well-established beaver dam at outlet of Zora Lake, looking across Zora Creek looking south (May 2023)
